FINAL REPORT

CONTRACT NUMBER 11-177WPF
August 30, 2013

Arizona Water Protection Fund By the Gila Watershed Partnership of Arizona 711 S. 14th Avenue Safford, Arizona 85546

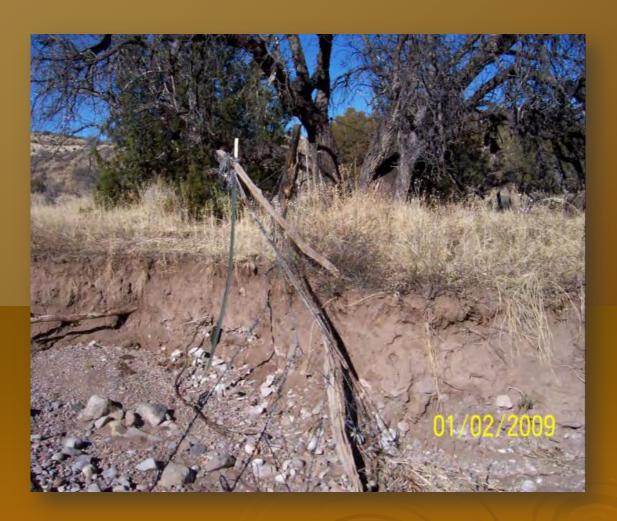
Off highway vehicles created down cutting, erosion and trails in the floodplain that result in gullies that carried sediment to the creek.

Trespass cattle overgraze the riparian area and deposit feces and urine in the creek.
