YUMA EAST WETLANDS

FINAL REPORT

YUMA EAST WETLANDS RIPARIAN REVEGETATION PROJECT (GRANT # 04-124WPF)

FEBRUARY 2008

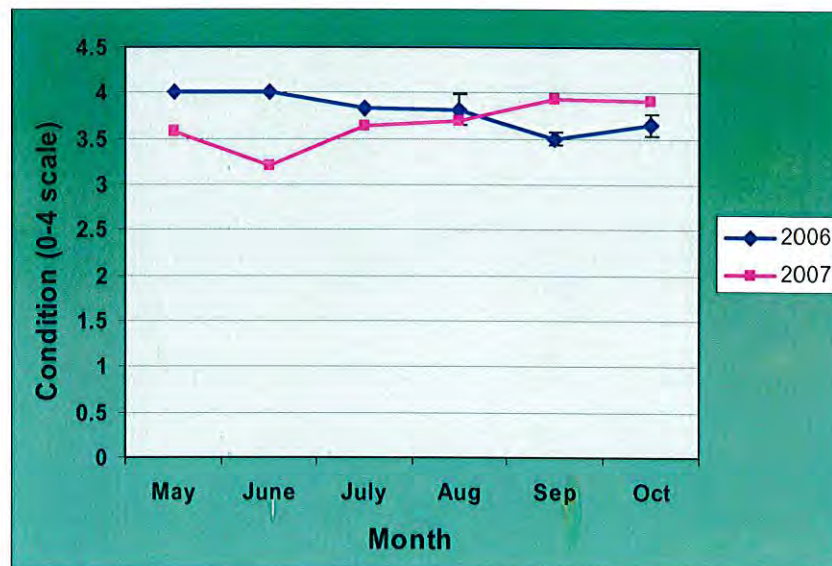
The overall condition of the surviving cottonwoods for the 2006 and 2007 growing seasons was good to excellent (Figure 4.1.2). Over the first two years of this project cottonwoods have experienced a 90% percent survival rate, losing 2.5% over the 2006/2007 winter and another 7.5% during the second growing season.

During the 2006 monitoring season cottonwoods had 100% survivorship. The primary factor affecting cottonwood health during the 2006 growing season was insect browsing from aphids that affected 60% of trees during the growing season. Insects were treated with soapy water which reduced the percent of the trees affected down to 10% by October. Salt stress, water stress, volunteer competition and hogwire rub affected cottonwoods during the 2006 growing season to a lesser extent, affected less than 13% of the individuals. During the 2007 growing season the primary factor impairing healthy growth was water stress, which in June affected 65% of the cottonwood trees monitored. Early in the season the project experienced large scale irrigation problems. The filtration system failed allowing large amounts of sediment to enter the irrigation lines which consequently clogged the emitters, requiring replacement of the filtration system and repeated flushing of the irrigation system to restore water to the trees. This event is almost entirely responsible for the lower condition rating observed in June and has a large part in the mortality experienced this summer. After the system was repaired plant health rose steadily for the remainder of the growing season. Minor factors also affecting health were insect browsing, hogwire rub and volunteer competition.

Figure 4.1.2: Average cottonwood condition for May to October, 2006 and 2007 for the Demonstration Garden site, Yuma East Wetlands. 0=dead, 1=poor, 2=fair, 3=good, and 4=excellent. Error bars signify standard error.

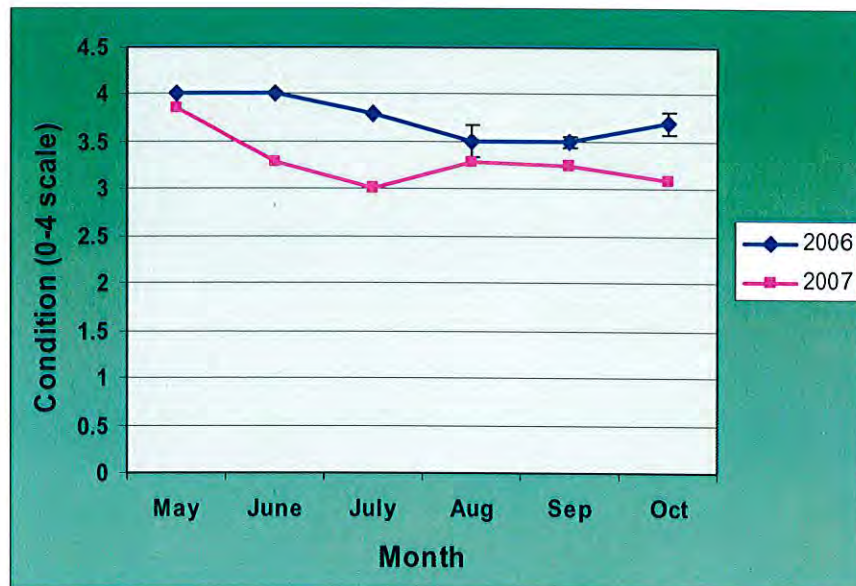
The overall condition of the surviving sandbar willows declined slightly in 2007 from 2006, however the individuals were consistently in good to very good condition during 2007 (Figure 4.1.4). Sandbar willow had a 100% survivorship rate in 2006 and one mortality during the 2007 growing season caused the survivorship rate to decline to 86%. The primary factor affecting sandbar willow condition at the Demonstration Garden in 2006 was insect browsing. In September 2006, 100% of the monitored sandbar willows were affected by insect browsing, however by October none were affected and average condition increased. Aphids were the primary insect observed on site, which were observed amassing on the tips of the tree branches. Mammal browsing also was a minor factor, affecting one individual in July 2006.

The primary factor affecting sandbar willow condition at the Demonstration Garden in 2007 was water stress, which is discussed above for cottonwoods. This was most likely the cause of the decline in growth and condition during August to September 2007. The other factors affecting the growth and health of the sandbar willows were insect browsing and volunteer competition. Volunteer competition came mainly from arrowweed and quailbush, both of which are native species which tend to quickly form monotypic stands squeezing out competitors. Although these species are native, their growth is controlled as part of routine maintenance in order to encourage growth and survivorship of planted native species. Insect browsing was a minor effect on overall sandbar willow condition, and shows that the site is promoting wildlife diversity and a food base for bird species.

Figure 4.1.4: Average sandbar willow condition for May to October, 2006 and 2007 for the Demonstration Garden site, Yuma East Wetlands. 0=dead, 1=poor, 2=fair, 3=good, and 4=excellent. Error bars signify standard error.

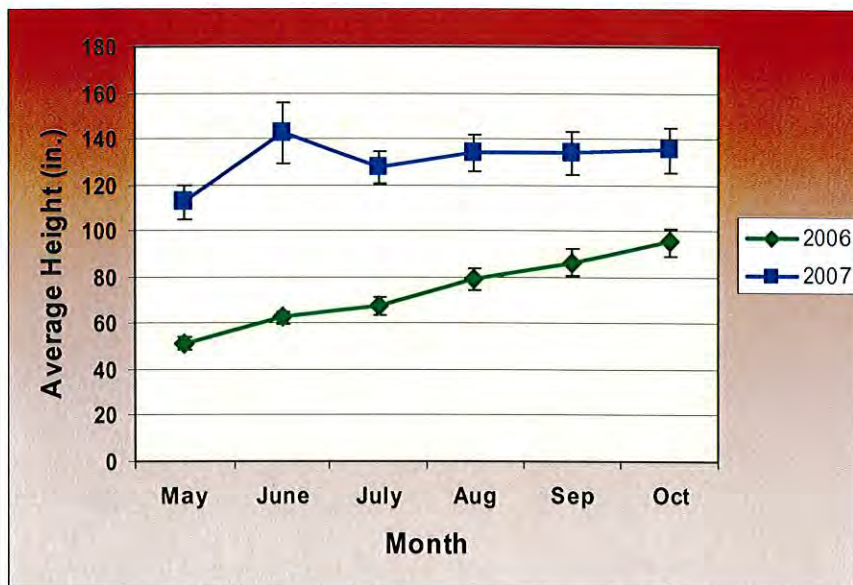
11, SE=4.78). The decline in Goodding willow growth in 2007 from 2006 was due to the irrigation problems experienced in June. Most of the negative growth observed in June was caused by the death of the upper branches of the Goodding willows.

Figure 4.1.5: Average Goodding willow height (in.) for May to October, 2006 and 2007 at the Demonstration Garden site, Yuma East Wetlands. Error bars signify standard error.

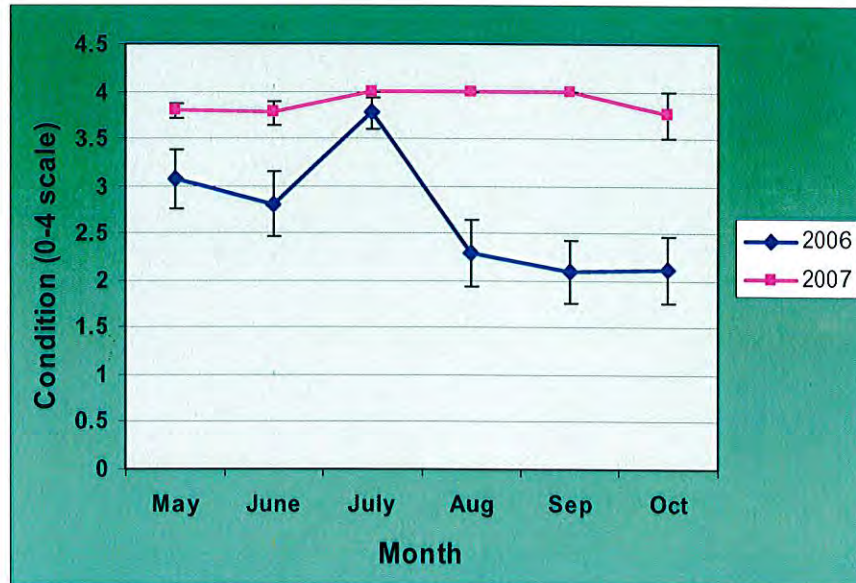
The overall condition of the surviving Goodding willow declined precipitously from July to September 2006 at the Demo Garden (Figure 4.1.6). Mortality during the 2006 growing season also increased during August and by the end of the season survivorship was 57%. The decline in Goodding willow condition and high mortality was likely due to water and/or salt stress. These conditions were not noted in the field, however the area where Goodding willow is planted along the Quechan marsh has high soil salinities. Other factors affecting Goodding willow condition during 2006 included insect browsing, volunteer competition, and hogwire rub. Although these factors were present at the site, only 3% were affected by insect browsing, insect presence and hogwire rub and 7% were affected by volunteer competition. Hogwire rub primarily affected the trees outgrowing their protective cages.

After the decreased condition observed for Goodding willow at the Demonstration Garden site during the end of the 2006 growing season, condition increased dramatically for surviving individuals during the 2007 growing season (Figure 4.1.6). The survivorship rate was 90% for the season, 93% of remaining individuals received a condition rating of excellent. Two of the three mortalities that occurred this growing season occurred in June, reflecting the strain the irrigation problems placed on the plants. The only other factor affecting Goodding willow condition within the Demonstration Garden

site was volunteer competition. Volunteer competition affected 21% of the Goodding willows until July at which time the competitors were pruned back in order to encourage the Goodding willow's growth. By August, all Goodding willows were in excellent condition with no measured factors affecting plant condition.

Figure 4.1.6: Average Goodding willow condition for May to October, 2006 and 2007 for the Demonstration Garden site, Yuma East Wetlands. 0=dead, 1=poor, 2=fair, 3=good, and 4=excellent. Error bars signify standard error.

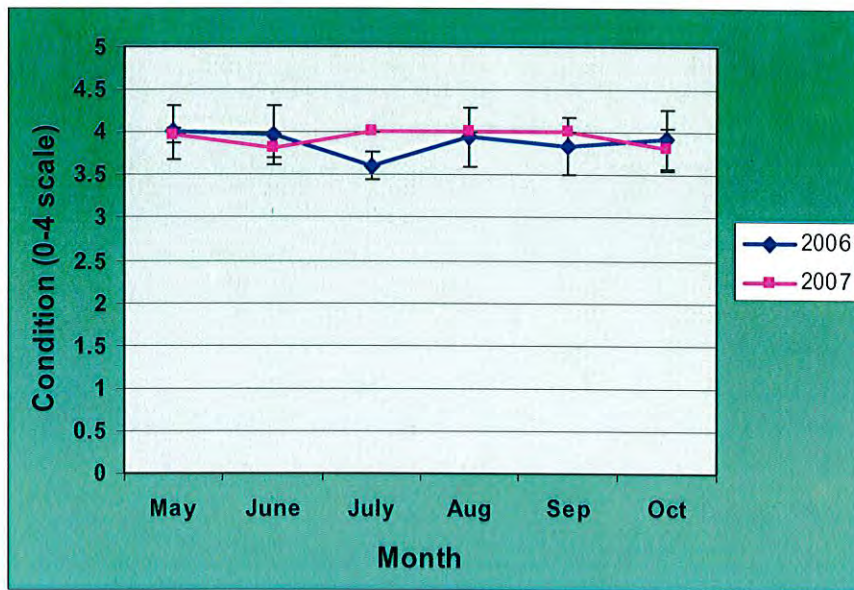
Screwbean mesquites were in very good to excellent condition throughout the 2006 and 2007 growing seasons (Figure 4.1.8). Also, there continued to be 100% survivorship for this species through the 2007 growing season. The primary factor that affected screwbean mesquite condition in 2006 was insect browsing. Although insect browsing affected 48% of the population in September, by October none of the screwbean mesquite individuals experienced this effect. Signs of insects browsing included: yellowed or deformed leaves and defoliation at the tips of branches. Aphids were the primary insect observed on the trees, and, often times, occurred in mass quantities on the younger portions of the trees. Other factors included root exposure from falling over, volunteer competition, and water stress. Only one tree fell over, which may have been blown over by the wind. Volunteer competition and water stress affected 4% of the population and only during one monitoring session each; therefore these factors did have a significant affect on all the monitored trees.

In 2007, the primary factor that affected screwbean mesquite condition was water stress. Water stress affected 8% of the trees monitored, but overall the irrigation problems had little effect on the screwbean mesquites. This indicates the drought tolerant nature of screwbean mesquites. Volunteer competition from quailbush also affected screwbean mesquite during August, however by September routine maintenance had cut back the competing species allowing the screwbean to be free of competition.

Figure 4.1.8: Average screwbean mesquite condition for May to October, 2006 and 2007 for the Demonstration Garden site, Yuma East Wetlands. 0=dead, 1=poor, 2=fair, 3=good, and 4=excellent. Error bars signify standard error.

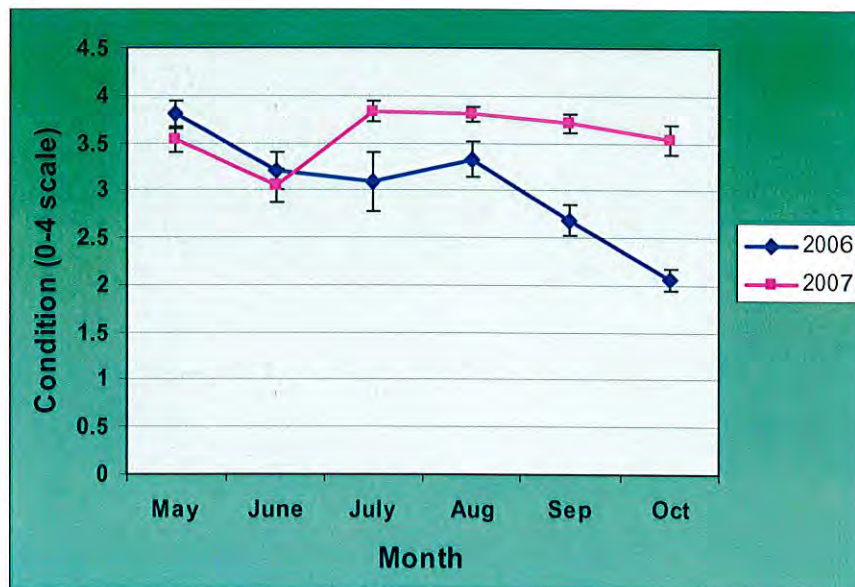
The average condition of the honey mesquites for the 2006 growing season declined over time, whereas condition during the 2007 growing season remained good to excellent (Figure 4.1.10). Despite the declined condition by the end of the 2006 growing season, there was a 96% survivorship rate the first growing season, and no new mortalities occurred during the 2007 growing season. Insect browsing and mammal browsing were the primary factors affecting honey mesquite condition in 2006. Insect browsing, primarily by aphids, affected 72% of the monitored individuals and was mainly observed in September and October. The aphids were observed in dense quantities on the younger portions of the trees. Various predatory arthropods, such as spiders, mantids (family: Mantidae) and assassin bugs (family: Reduviidae) were also observed feeding on the aphids, indicating a diverse trophic structure at the site. Signs of insect browsing included yellowed or deformed leaves and defoliation in many cases.

Mammal browsing affected 68% of the monitored honey mesquite in April-July 2006. The protective plastic tree shelters (Tubex) were prematurely removed from many honey mesquite trunks. This allowed rabbits to heavily browse on the trees, and could have increased the afflicted plants' susceptibility to aphids. Other minor factors that affected the monitored honey mesquite condition were water stress and volunteer competition, which affected 12% and 4% respectively. Water stress was most likely responsible for one mortality June. One individual was affected by volunteer competition by four-wing saltbush in May, however as growth progressed through the season the honey mesquite outgrew the four-wing saltbush.

In 2007, the average condition declined slightly during June due in large part to the irrigation problems discussed in earlier sections. However, the trees quickly recovered after the problems were solved. Honey mesquites were also affected by insect browsing, volunteer competition, and mammal browsing. Insect browsing affected 45% of the trees in June then had minimal affect for the rest of the growing season. Volunteer competition had more lingering affects, affecting 39% of the trees in June and 30% in October.

Figure 4.1.10: Average honey mesquite condition for May to October, 2006 and 2007 for the Demonstration Garden site, Yuma East Wetlands. 0=dead, 1=poor, 2=fair, 3=good, and 4=excellent. Error bars signify standard error.

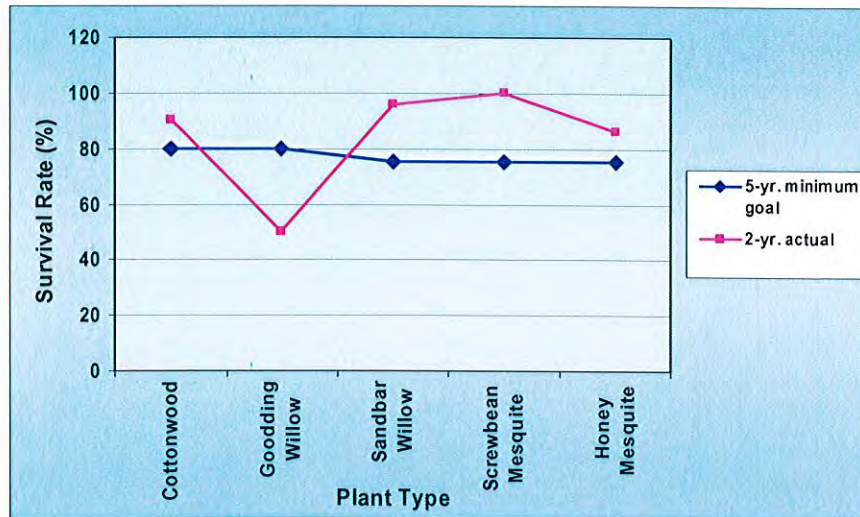
Goodding willows were the only species that fell below the expected minimum 5-year survival rate for the first two years of growth. Eighty-six percent of the mortality observed in Goodding willows occurred within the first year. The low survivorship rates for Goodding willow were primarily due to their placement. Many of the individuals were planted in low lying areas in which water pooled, concentrating salts found in the soil and the irrigation water. Infuric acid was

Figure 4.1.11: Actual 2-year percent survival rate versus the 5-year survival rate minimum goal for cottonwood, Goodding willow, sandbar willow, screwbean mesquite and honey mesquite for April 2006- October 2007 for the Demonstration Garden site, Yuma East Wetlands.

added to the site's irrigation water to help leach salts from the tree roots during 2006. Upon mortality, Goodding willow was replaced with more tolerant species such as inland saltgrass. Despite the low survival rates of Goodding willow, the other four species are above the desired parameters to determine project success. Survival rates should be calculated every year up to the five year date (after the 2011 growing season) to ensure that the expectations and successes of the project have been met.
