**Arizona Water Protection Fund
Fairchild Draw Riparian Restoration Project
Grant No. 07-150WPF**

Final Report

Submitted by David Dorum
Arizona Game and Fish Department

December 31, 2011

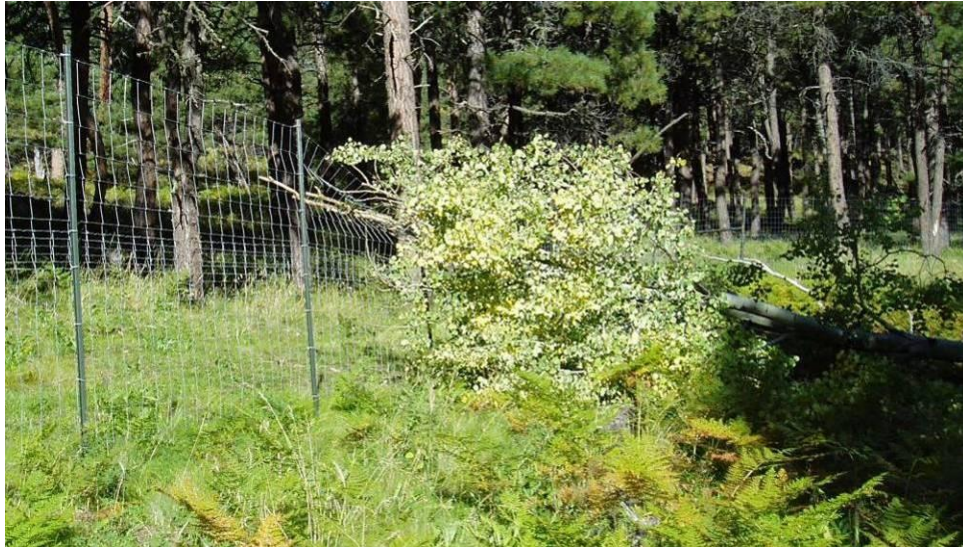
In 2008 enclosure fence condition monitoring was conducted on September 18, only two months following the completion of fence construction activities. Fence damage was recorded at one location near the upstream end of the upstream enclosure (UTM 493652/3814117) and was the result of an aspen tree falling onto the fence (Figure 29). Damage was minimal and consisted of the upper panel of field wire being pushed downward less than three feet. This damage did not compromise the integrity of the fence due to the branches of the aspen, which effectively filled the gap in the fence. At the time of the inspection, the aspen tree was cut off of the fence and the upper panel was pulled back up into place and secured to the t-post.

Figure 29. Fence damage from aspen, September 18, 2008.

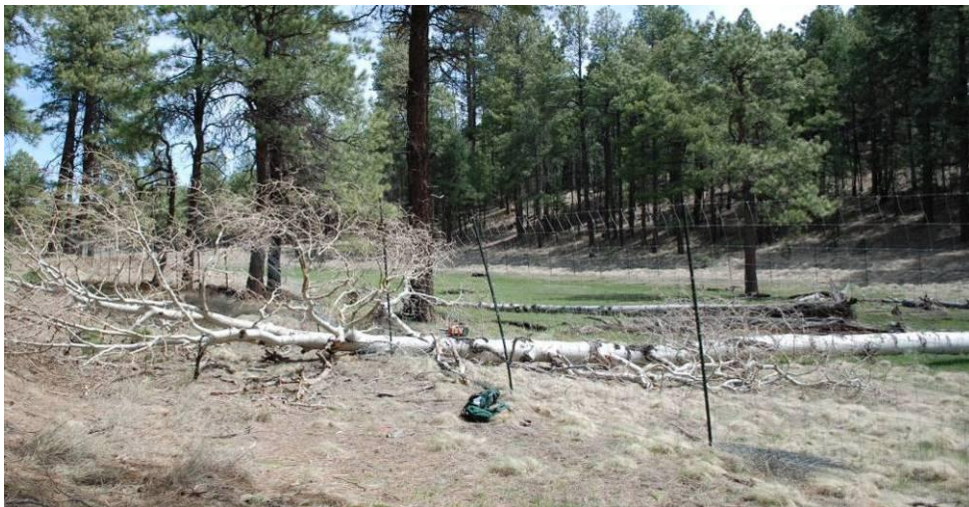
In 2010, enclosure fence condition monitoring was conducted on May 9 and September 10. The fence was in generally good condition. During this monitoring period, damage to the fence occurred as a result of a single large aspen falling from the inside of the enclosure across the fence (UTM 493600/3814934). The tree was cut off of the fence and the fence was repaired the same day as the May 9 inspection. A human caused cut in the north side of the upper enclosure fence was also found and repaired. In addition a few of the welds on the H-brace pipes were beginning to show signs of cracking. It is uncertain at this time whether the cracks in the welds pose any risk to the long-term integrity of the fence.

Figure 30. Fence damage from aspen, May 9, 2010.

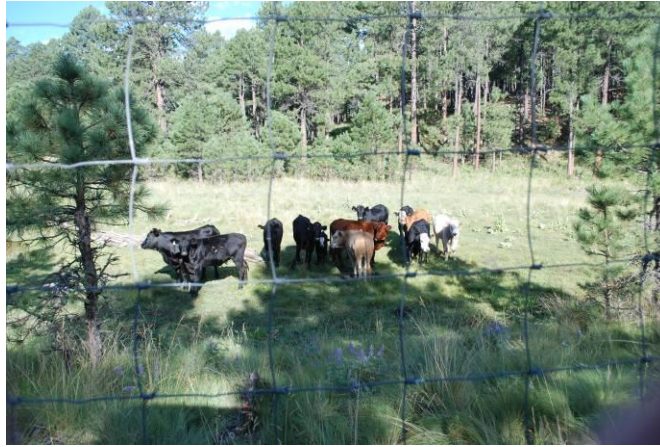
In 2010, however, the condition of the Upper Fairchild Draw elk exclosure fence began to significantly deteriorate. A few elk were observed within the exclosure in September of 2010,

and again in April 2011. In September 2011, cattle were found to also be accessing the enclosure.

Figure 47 Cattle in the Upper Fairchild Draw enclosure, 2011.

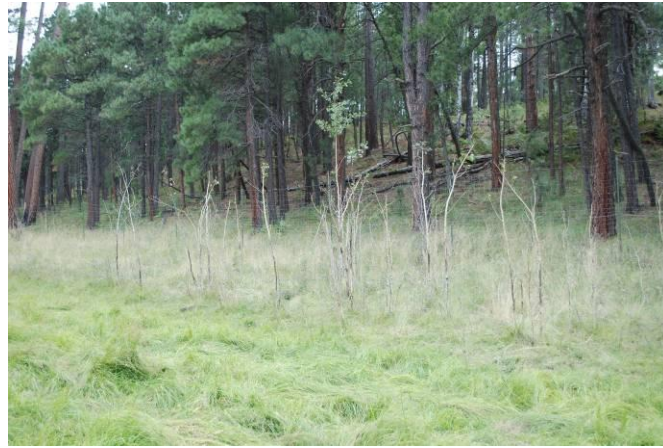
Figure 51. Browsed aspen
