Final Project Report
Little Colorado River and Nutrioso Creek Riparian
Enhancement Project
Springerville, AZ

AWPF Grant 07-143WPF

March 2013

Natural
Channel
Design, Inc.

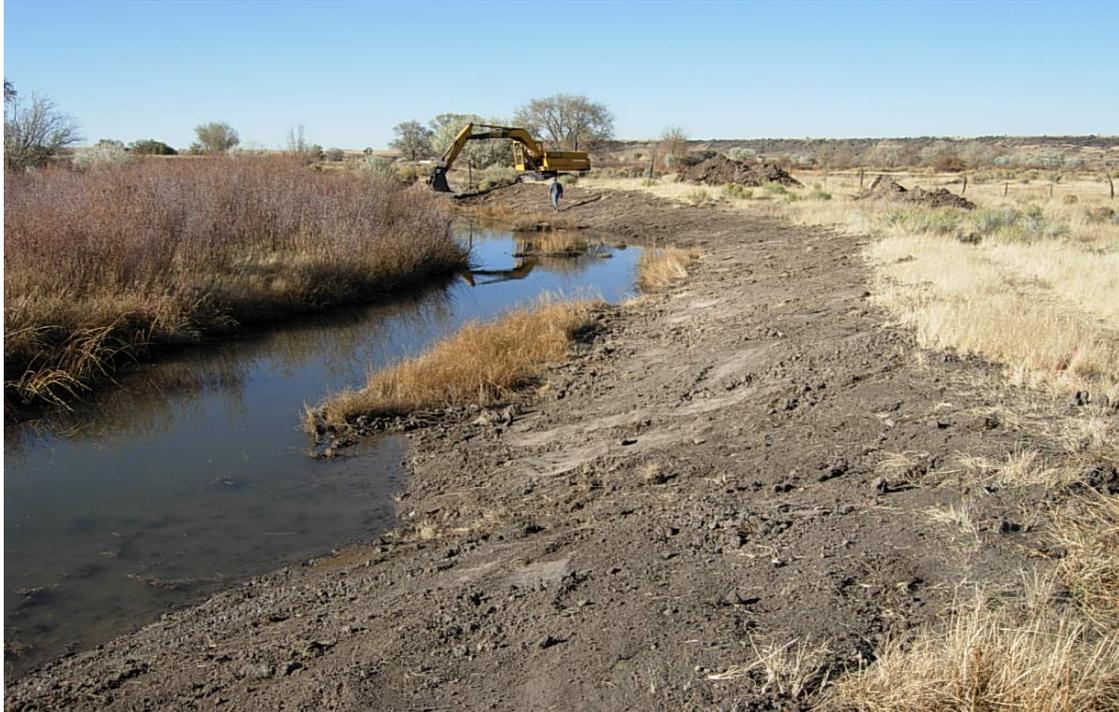
Figure 13. Raw banks after re-sloping

Re-vegetation efforts focused on the establishment of vegetation at eroding banks after the banks were resloped (Figure 13). Also targeted for re-vegetation were areas without sufficient woody species for habitat and restoration of areas disturbed by machinery during construction. The re-vegetation design included installing plantings along the toe of the active channel, on the floodplain, and on the terrace zones. These zones are primarily differentiated by distance from perennial flow, and as a result, soil moisture conditions. The active channel and floodplain zones represent moist soil conditions and support riparian wetland communities such as sedge/rush species. Most bioengineering practices take place within these zones. The terrace zone generally has lower soil moisture and supports grass and woody species.

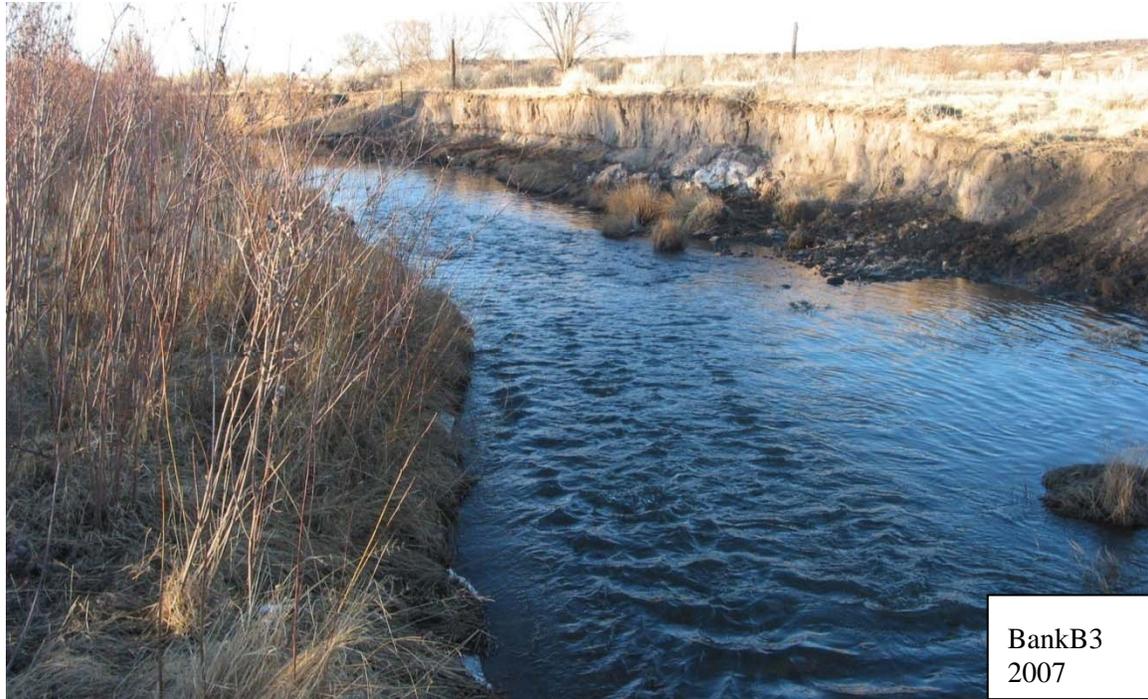
Figure 15. Example of vertical banks located throughout the project area.

Banks A through G were all re-sloped to a 3H:1V slope to eliminate the vertical cutbank that was initially located there. The sloped banks were then planted with willow clusters, seeded and covered with erosion control fabric (Figure 15 and Figure 16).

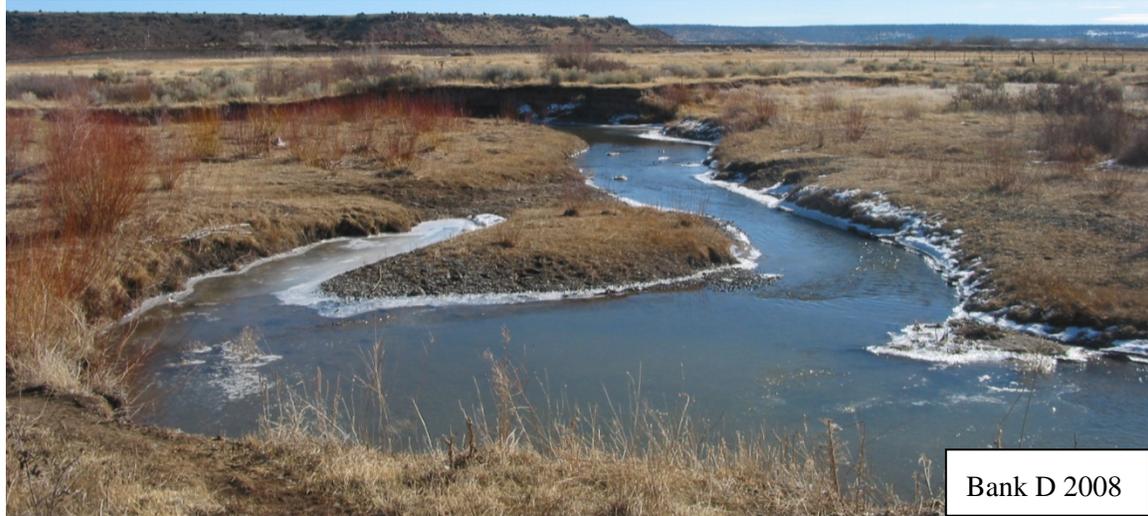
Figure 24. Split flow at Bank D

Bank D in particular required additional bank and channel work. At this location, the channel has a split flow caused by a small vegetated bar in the center of the channel (Figure 24). The channel on the left side of the bar was deepened to allow flow around this bar and reduce the back-eddy during high flows. The left bank was resloped and covered with a jute netting (Figure 25). This bank has now become vegetated with willows, sedges and grass and is stable (Figure 26).

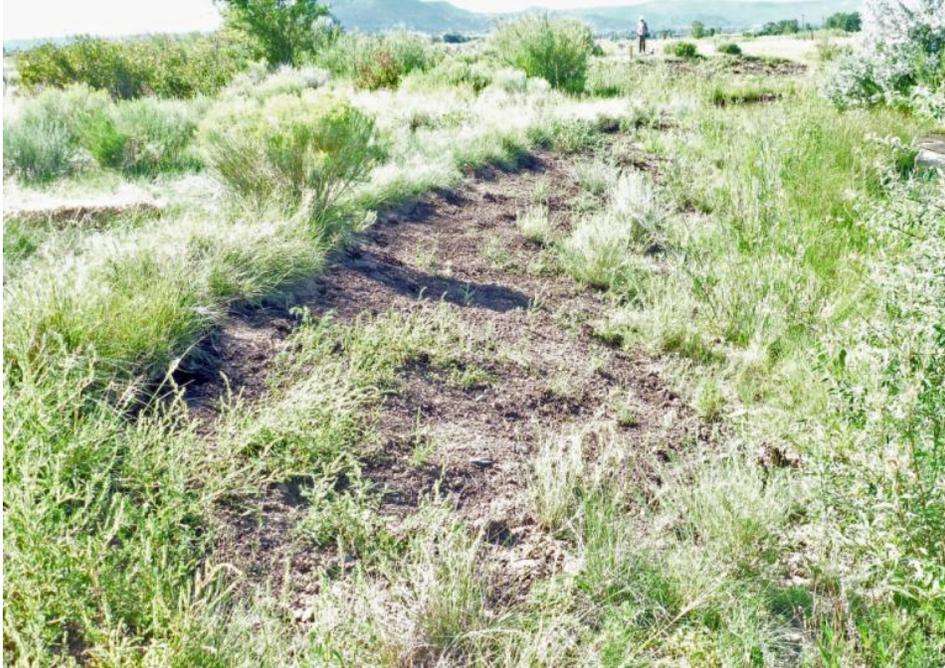
Figure 28. Compost spread over bare areas on Bank E1.

A shrub component to the seed mix was added during this effort. These species included four wing saltbush and native rose. Both species occur within the project area and this seeding will help to establish these plants on banks where other vegetation is having difficulties growing due to soil conditions.

Composted mulch was spread over and mixed into the top 3 inches of soil along all banks seeded. It is anticipated that this addition will improve moisture retention and help loosen the soil enough for the grasses to become established. Existing grasses were avoided during the mulching process (Figure 28) and areas with extensive grasses were spot treated.

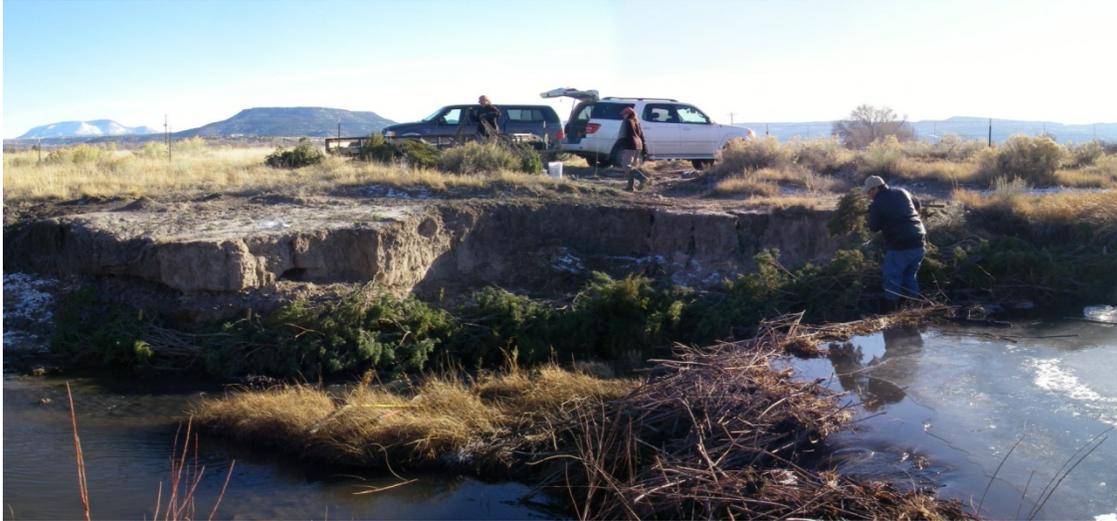
Figure 29. Installing brush revetment along Bank B1, 2011

To date, the revetment has accomplished the intended goal. Though the upper bank continues to slough off, the toe has stabilized and is becoming vegetated. The beaver dam will continue to divert flows towards this bank during high water events. But with a stable, vegetated toe, the extent of disturbance will be lessened.

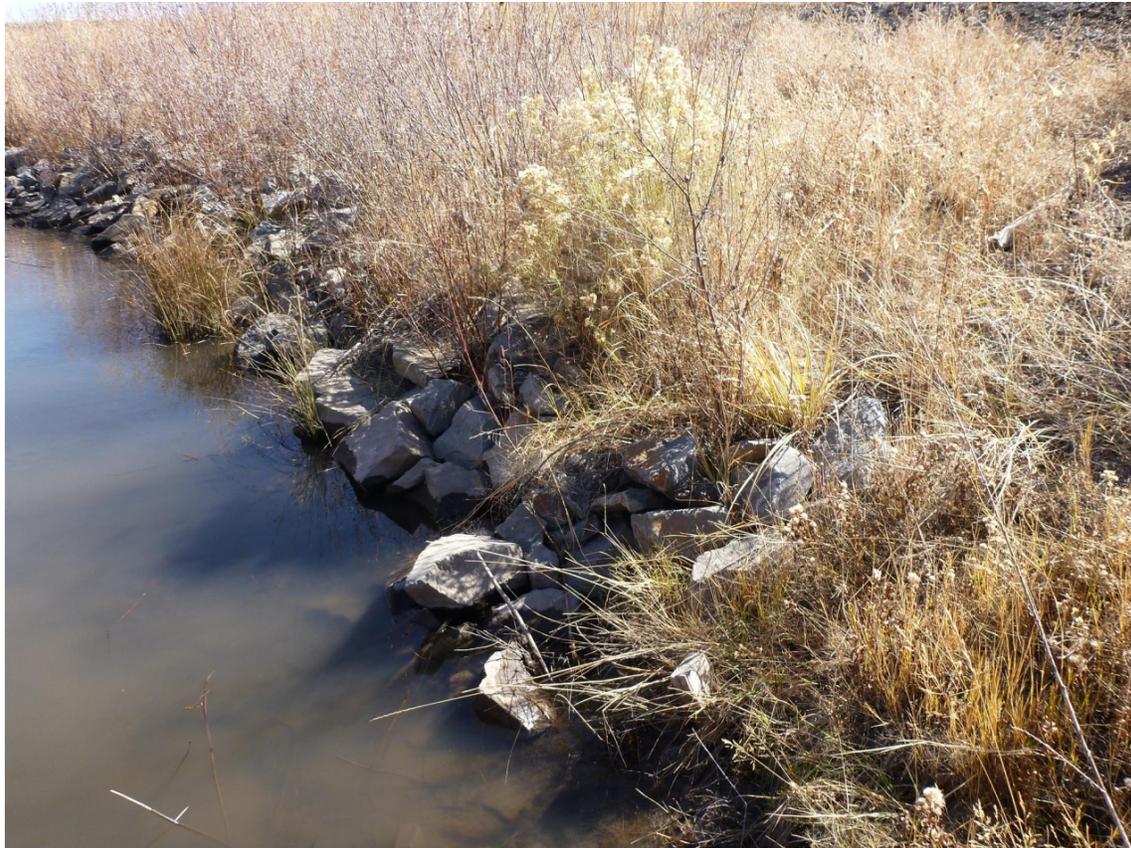
Figure 31. Bank B2 toe rock in 2012.

The structures installed in the project site include toe rock along bank B2 and the base rock and TRM fabric at Bank E1. Both of these structures are functioning as designed with no erosion taking place. Vegetation is continuing to fill in between the rock installed at B2 (Figure 31). See Figures 17 and 18 for additional photos of these two banks.

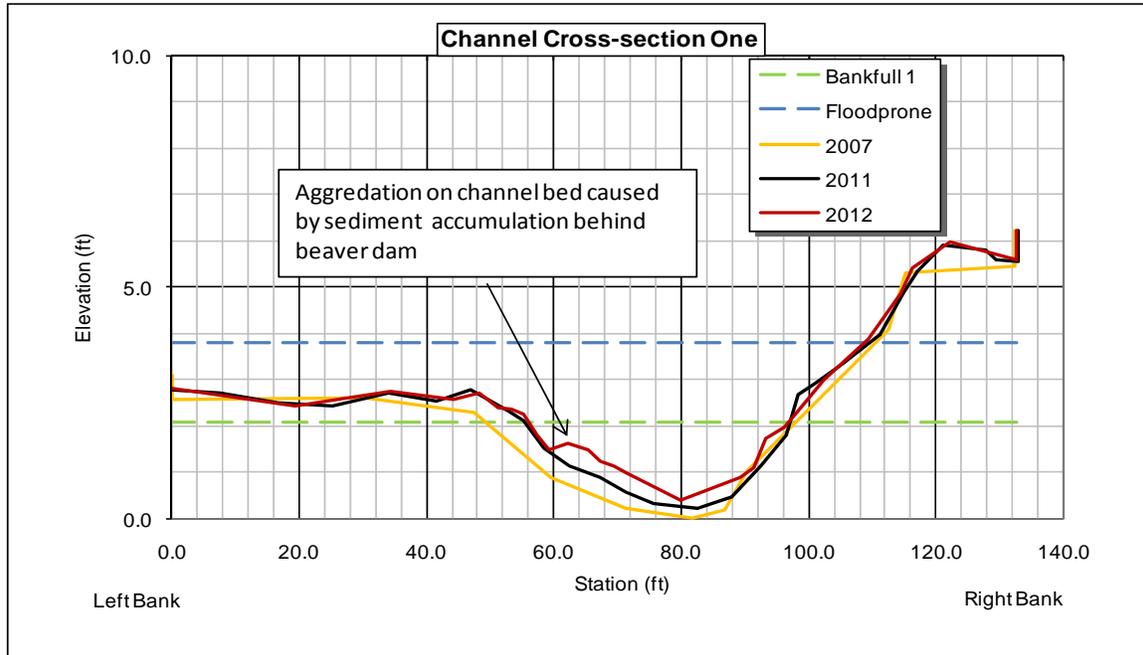
Figure 33. Channel Cross-section One Profile

There has been no change in channel geometry at this cross section other than the sediment accumulation behind the beaver dam. As shown on the graph, there was some buildup in 2011, and sediment continued to accumulate in 2012. This location has been affected by a beaver dam since initial construction (Figures 50 and 51). Even with the beaver dam, the cross-section is stable.

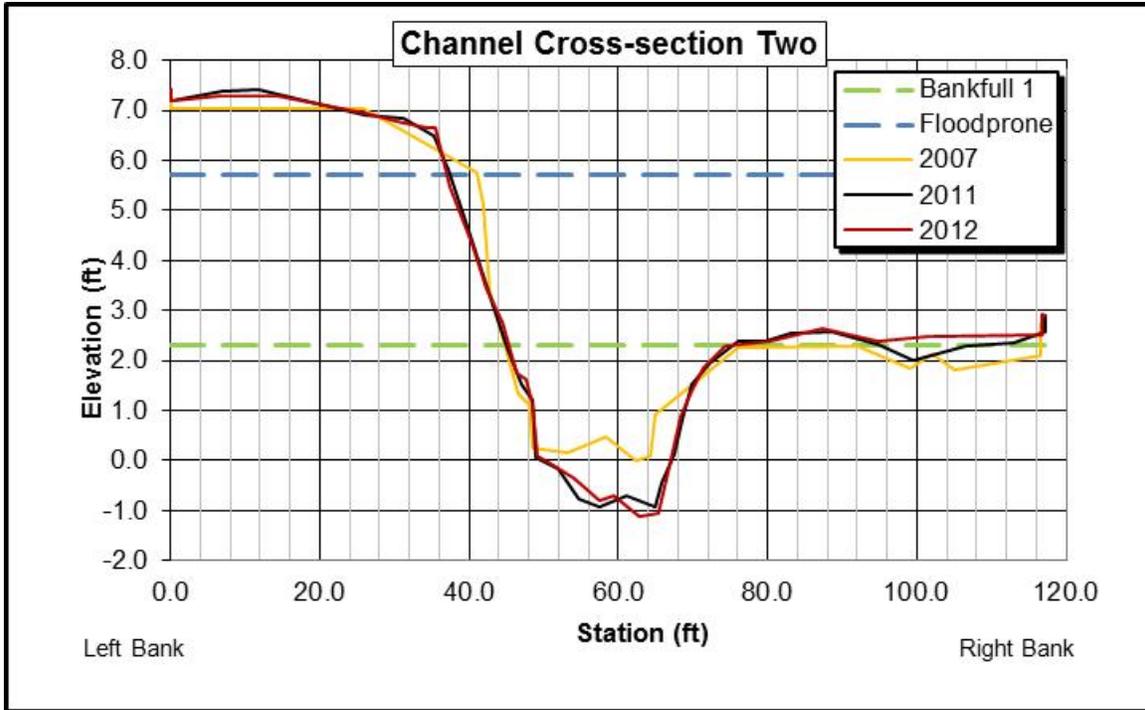
Figure 36. Channel Cross-section Two Profile

A large beaver dam was constructed approximately six feet upstream of this cross section soon after the initial survey. The change in bed elevations seen in the cross section graph was caused by water flowing around and over the dam (Figure 52). The dam washed out on 2010 and was not rebuilt. This channel has remained laterally stable throughout the past five years of monitoring. There was some scouring of the bottom of the bed as a result of the elimination of the dam, but the bed has remained stable since 2011(Figures 53 - 55).

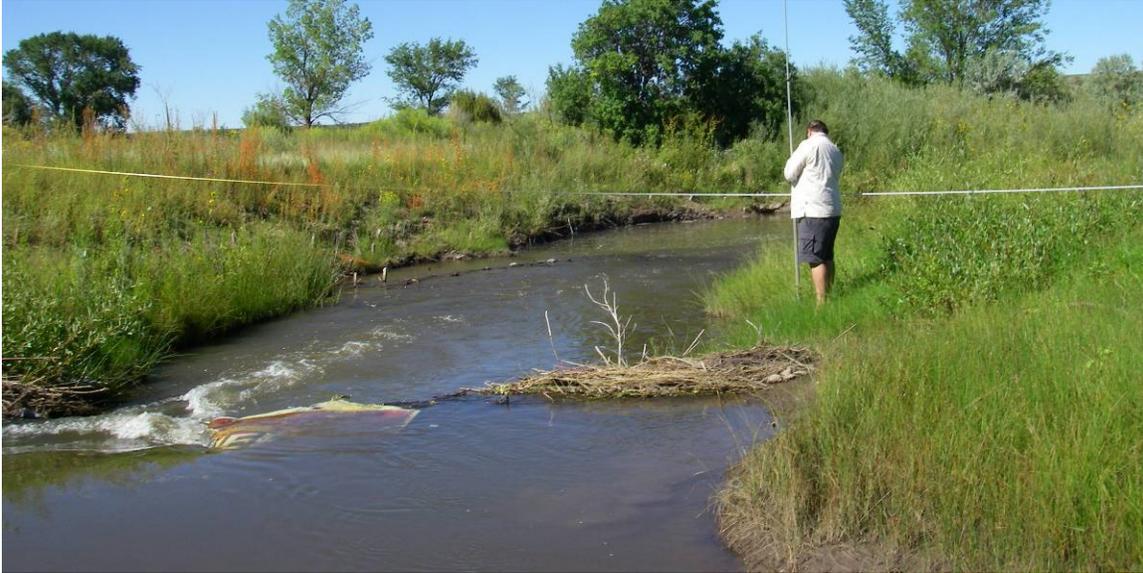
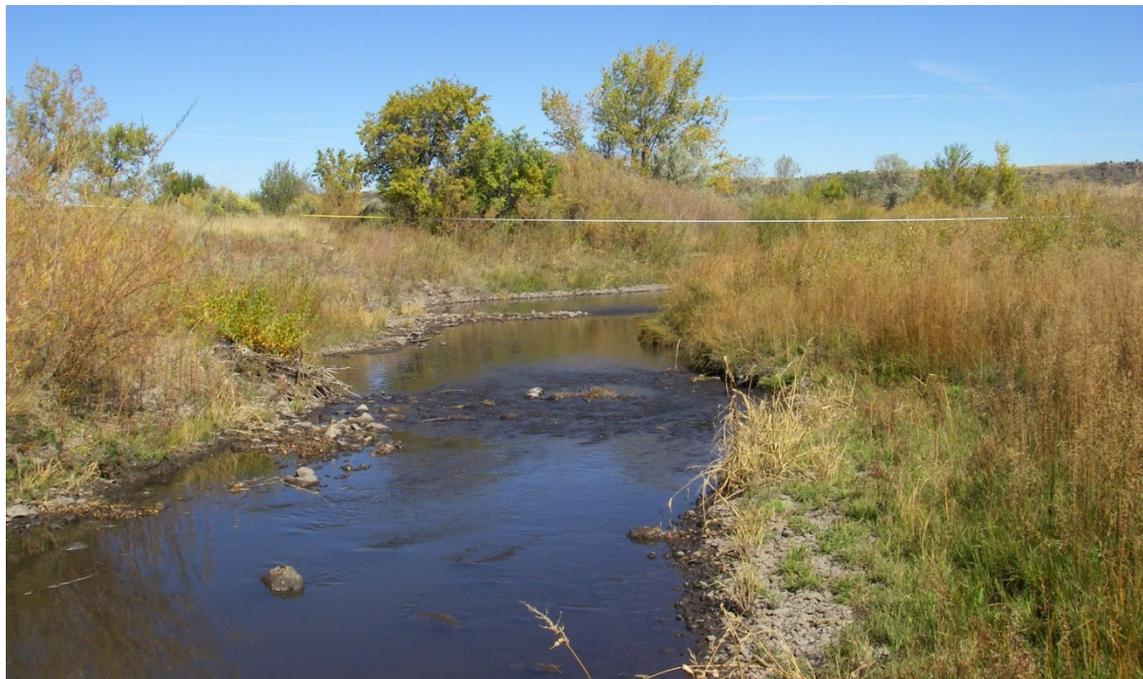
Figure 38. Cross-section two in 2010 and 2011.

September 2010-View is downstream from mid channel. Note the beaver dam is nearly gone.

October 2011-View is downstream from right bank. Beaver dam is gone.

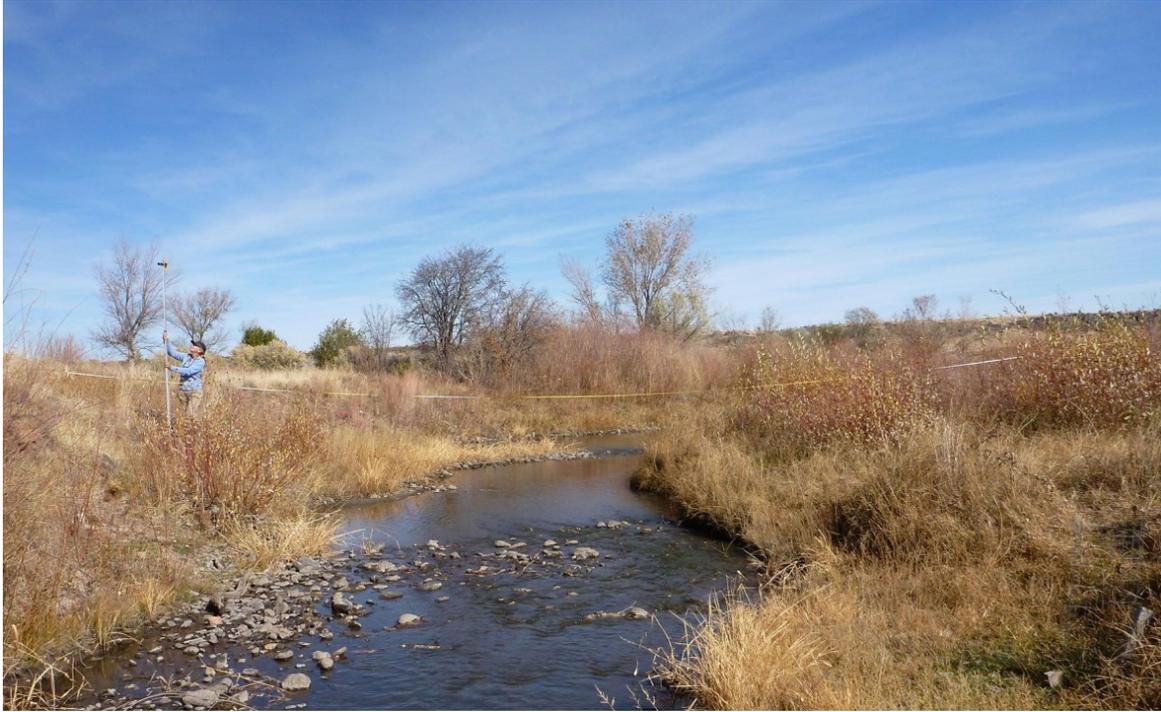
Figure 39. Cross-section two in 2012.

November 2012- Beaver dam has not been reconstructed at this location.

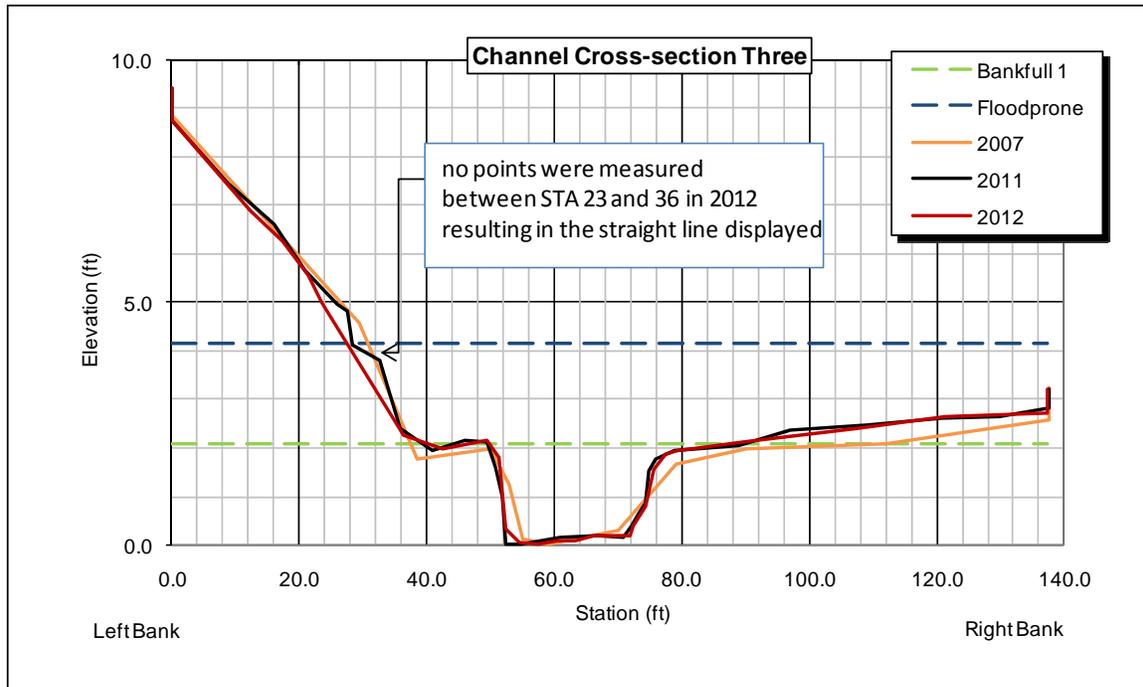
Figure 40. Channel Cross-section Three Profile

There have been no significant changes to this cross section over the past five years. High flows in early 2010 caused some sediment to be deposited on the point bar on the right, a normal occurrence for this type of channel. Vegetation along both banks remains robust and healthy (Figures 57-59).
