**Arizona Water Protection Fund
Application Cover Page
FY 2026**

<table><tr> <th style="text-align: left;"><u>Applicant/Agency/Organization:</u></th> <th style="text-align: right;"><u>Amount (\$):</u></th> </tr></table>

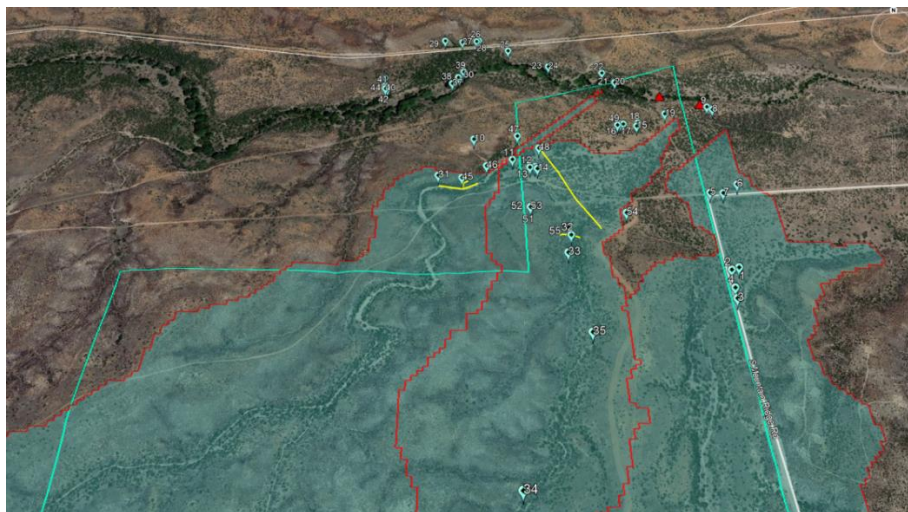
In Figure 3, the area to the right of the water tanks (on state land) is part of the Chase Emmerson property. This is a mesquite invaded grassland hosting cattle grazing, poorly drained roads, and failed water diversions. These feature concentrate stormwater flows, dry the landscape, and collectively put pressure on downstream headcuts.

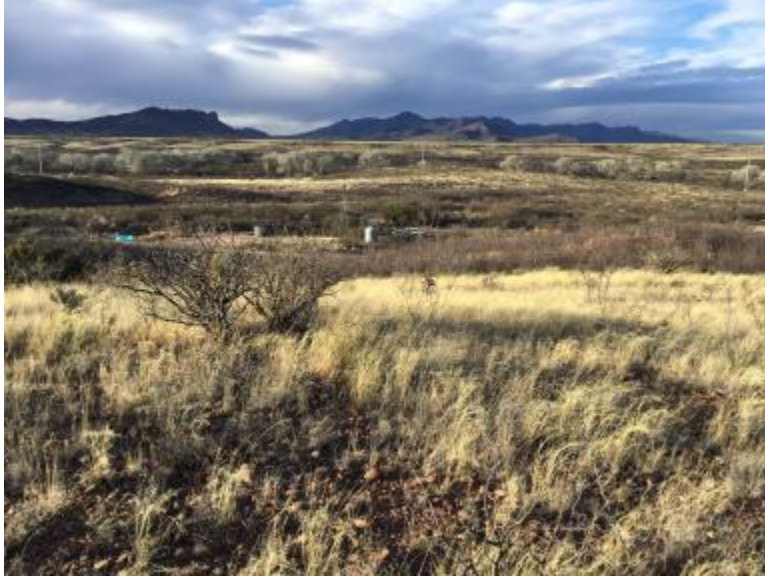
Figure 3a: Looking down at plunge pool of a major active headcut (vicinity of GPS point 9)

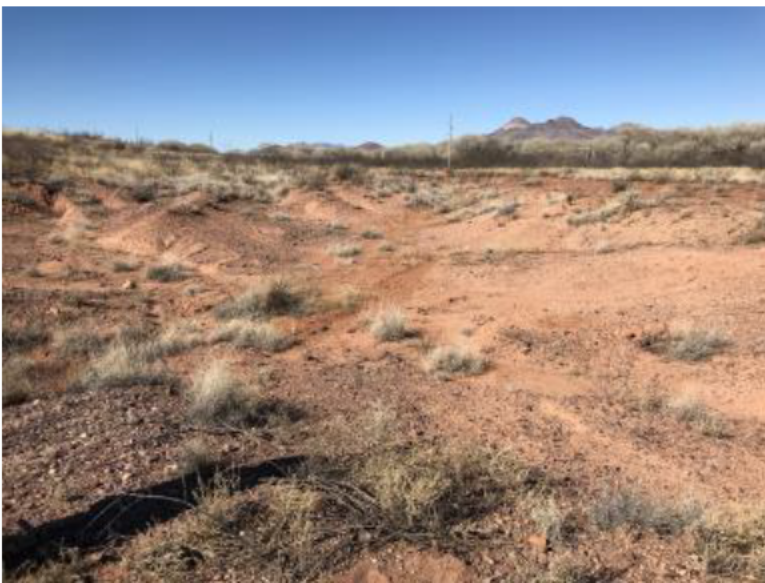
Eroded bowl contributing sediment to Tributary 3 (GPS point 10): This is a very small tributary valley on state land that is impacted by erosion. We speculate that this might be the route of a historic trail. One-rock dams in the mouth of this valley would cause it to aggrade and start to become grassed in again.

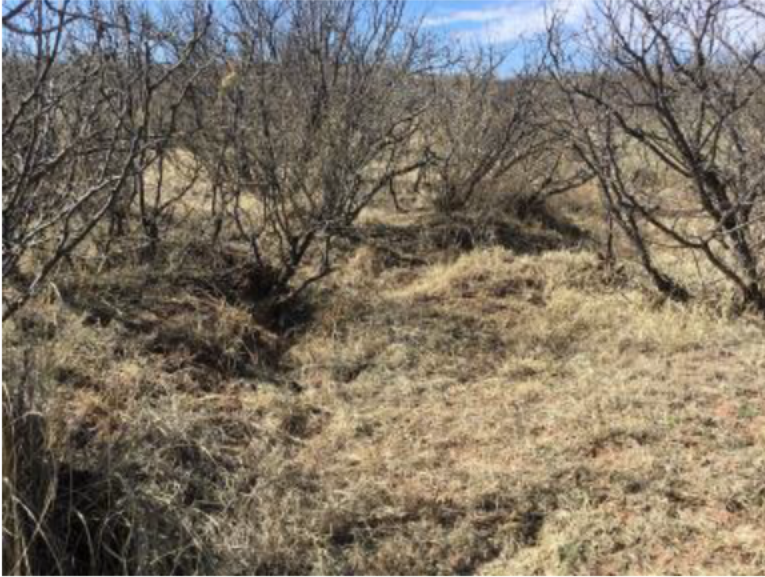
Old swale (GPS point 47): This is where the flows coming out of the bowl at GPS point 10 flow. This is a safe place for water to flow as it comes out at the angle berm discussed later.

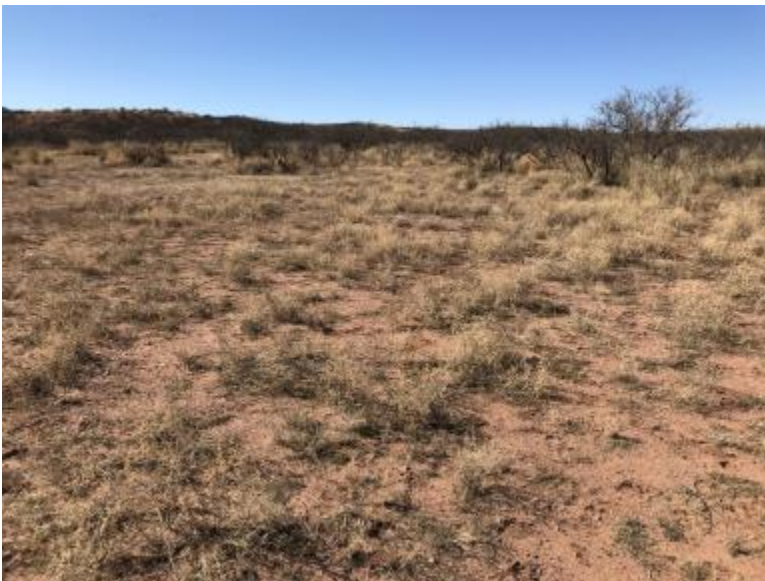
Preferred site to spread water diverted by upstream projects (GPS point 15): In this vicinity, we mapped an area of approximately 3 acres where we propose to uproot mesquite trees so that we can host a keyline plow and seeding project to optimize infiltration and grass regeneration.

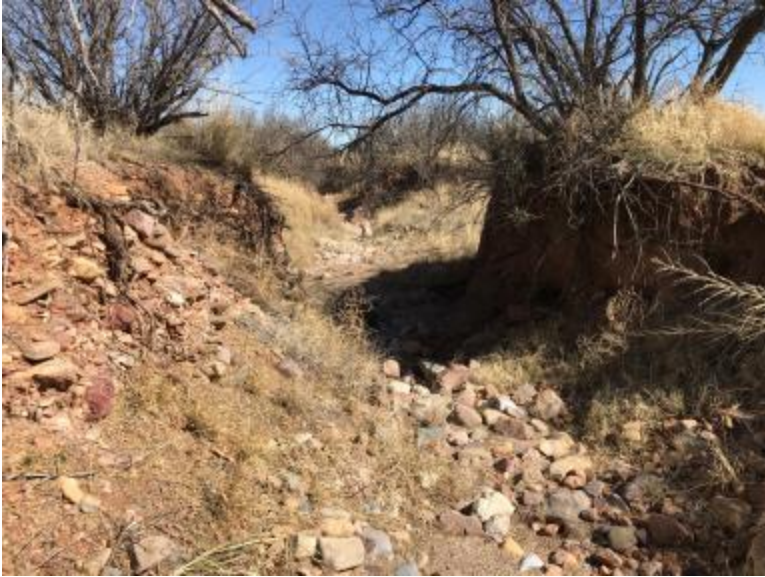
Location further downstream in collector channel (GPS point 18): Within the channel at this location we propose to use existing boulders to build grade controls such as one rock dams and Zuni bowls by hand.

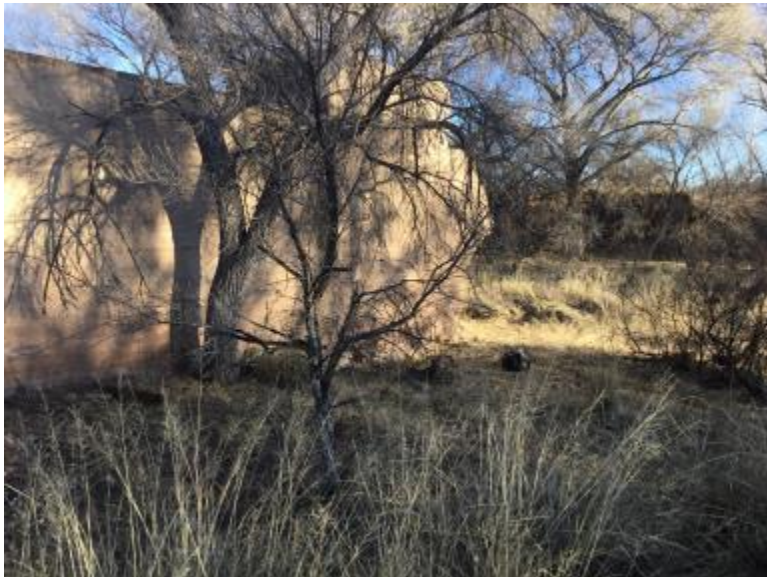
Showing how far right bank has eroded since dam failure (GPS point 41): The right bank is now over 200 feet south of where it was the day of construction of this legacy infrastructure.

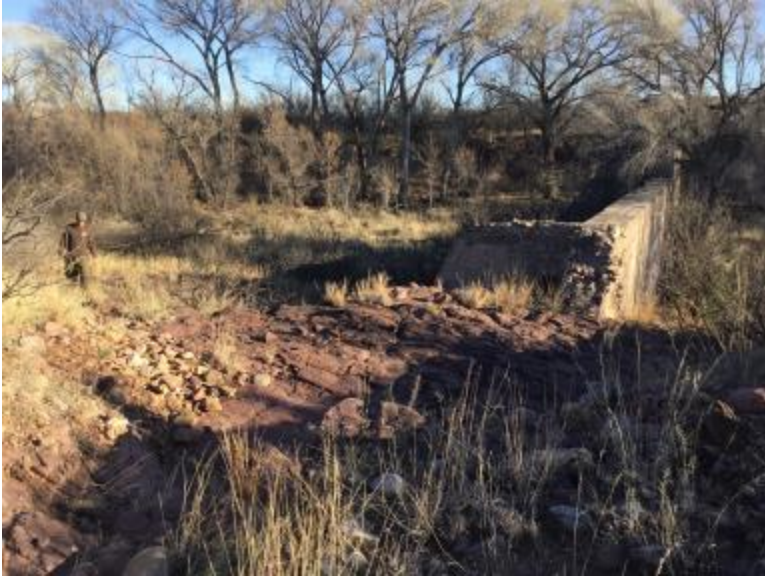
Dam where it is still keyed into left bank of Babocomari (GPS point 43): Here, we found evidence that the spillway was overtopped before any sediment was trapped behind the dam (i.e. the dam failed during the first significant flow event).

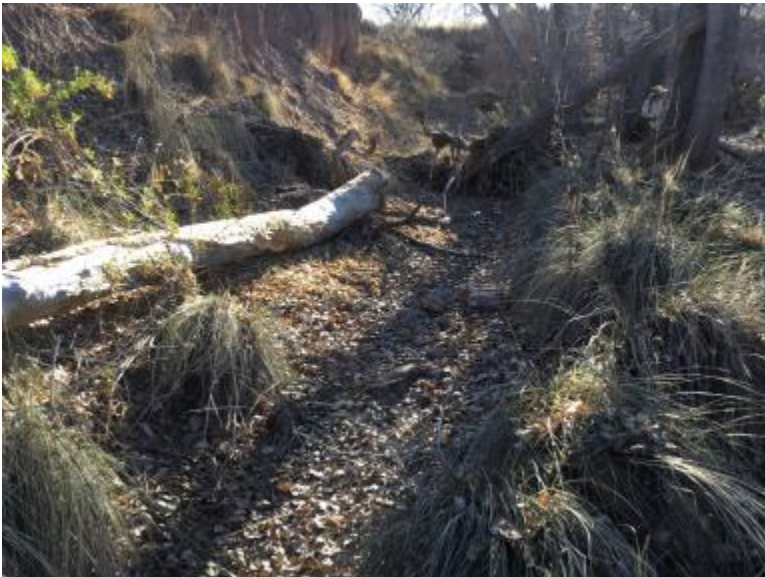
Observed debris in channel upstream of headcut (GPS point 37): The channel may be stable against downcutting at this point due to a bedrock outcrop downstream from here. In order to monitor the channel morphology, we suggest installing several monumented cross sections on Brophy property with landowner permission.

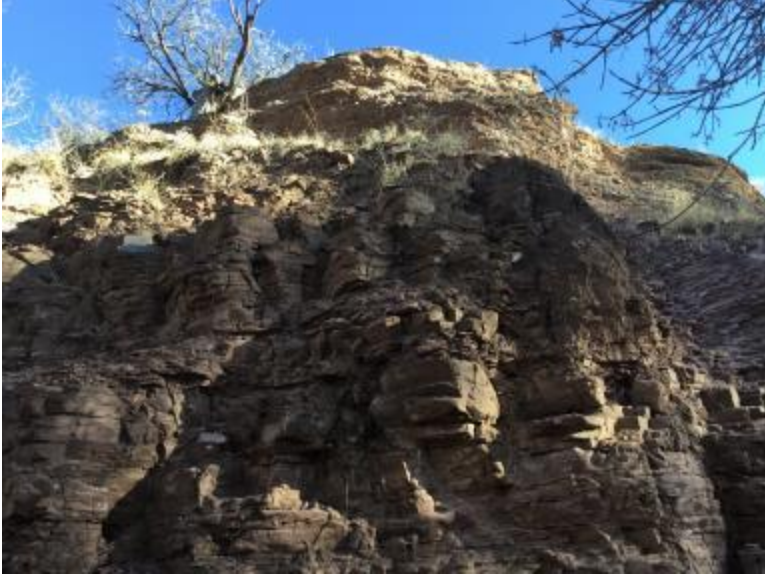
Channel is against stone toe of valley (GPS point 38): We are uncertain if this stone outcrop runs across the creek bottom under a thin layer of alluvium or not. This merits further investigation since it may influence strategies for grade control and headcut relief.

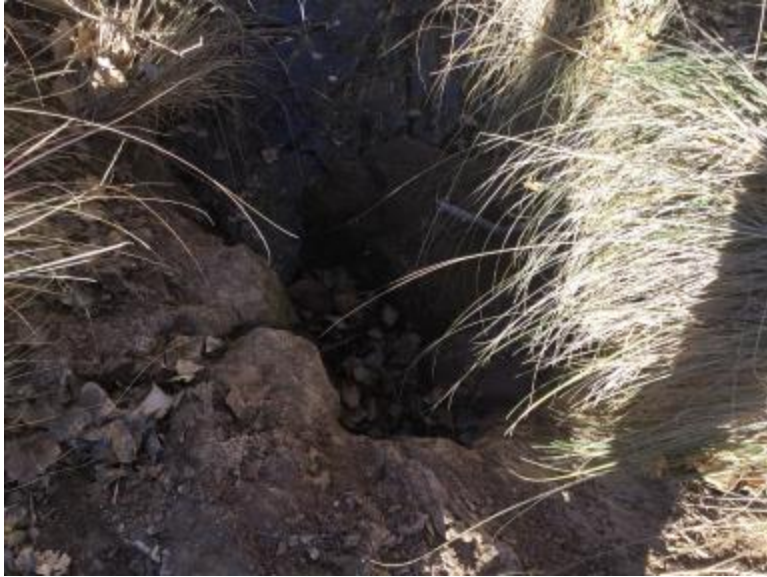
Looking down into the major headcut (GPS point 39): If this headcut is not self-stabilizing, this could pose an extremely serious resource damage point that could threaten stream channel stability, groundwater level, and water quality through increased sediment contributions. We recommend further investigation of the geology to better understand if grade control is happening naturally.

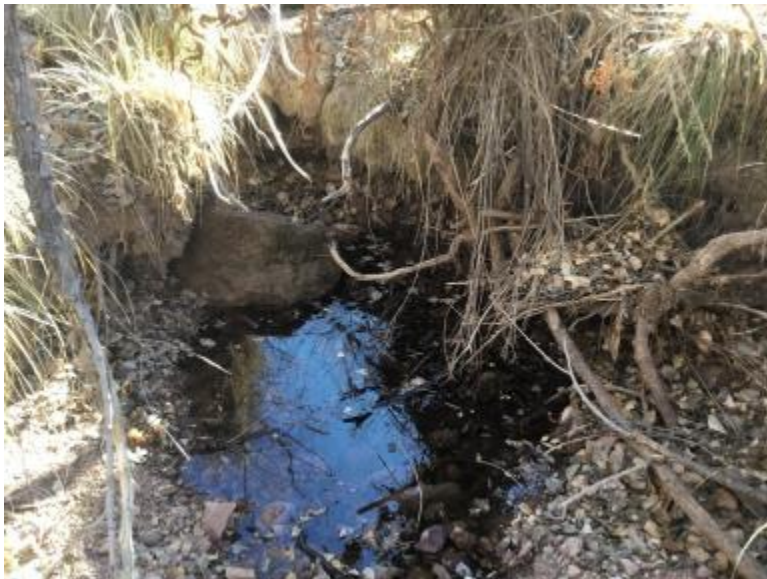
Water table elevation in headcut (GPS point 36): This is the only place we saw surface water in the Babocomari on January 28, 2020.

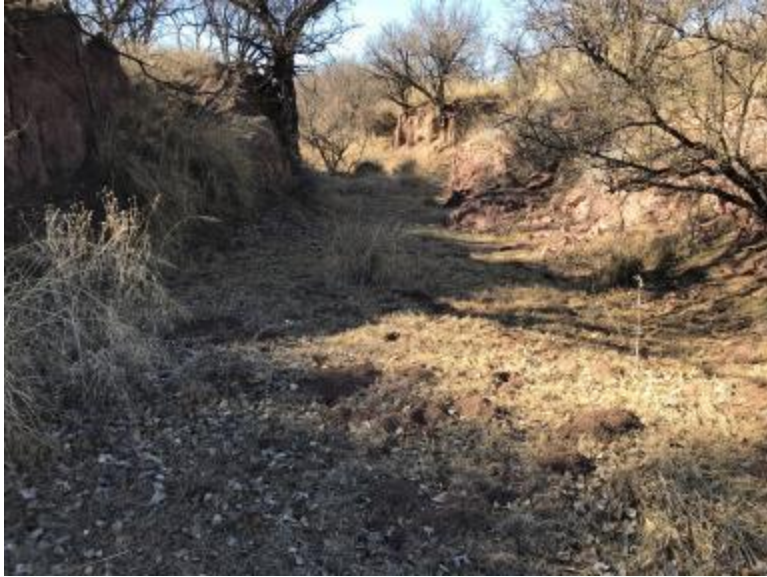
Looking upstream at incised tributary caused by railroad (GPS point 25): Flows from the respective culvert contributed to downcutting resulting in this massive headcut.

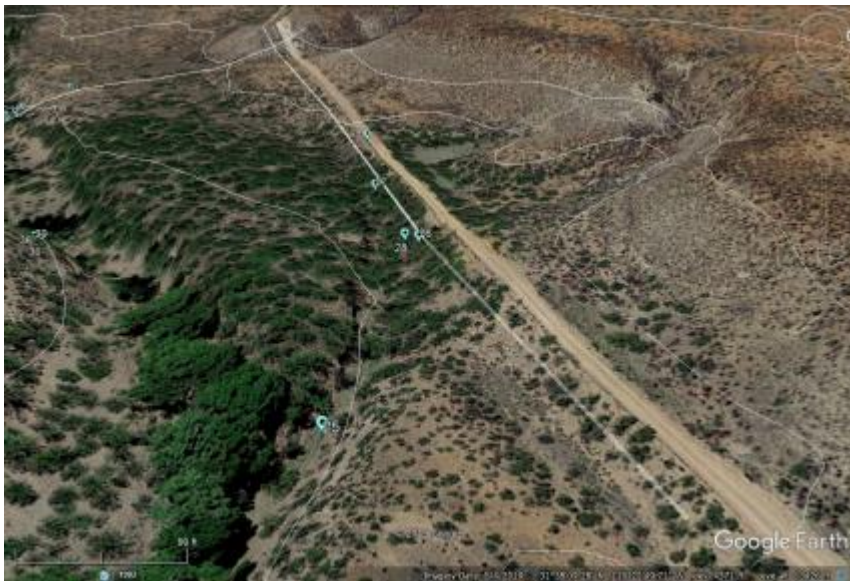
Google earth screen capture showing how the railroad-caused gully has a positive feedback loop with the incision of the Babocomari, creating an entirely different landscape.

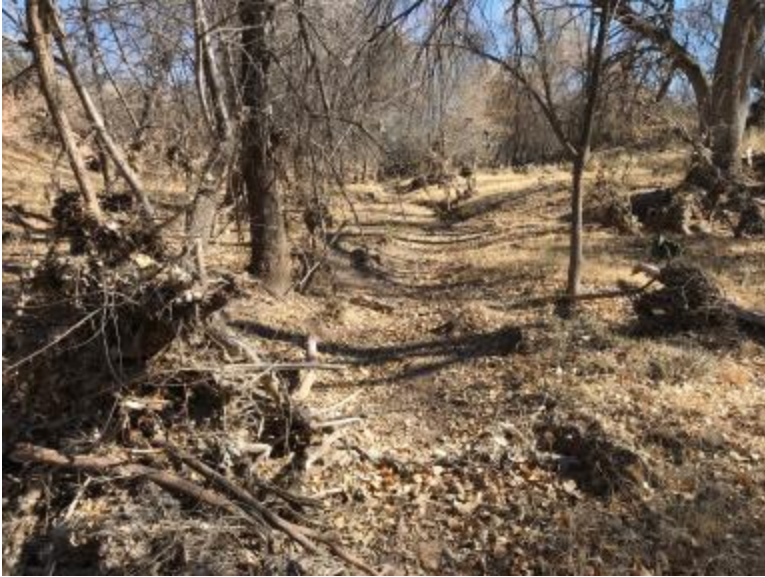
Babocomari has stabilized within historic incision (GPS point 22): The Babocomari has incised approximately 18 feet over the many years since the heavy handed manipulation of the stream channel. It has finally reached a new equilibrium by eroding laterally to create a tiny floodplain within the incised channel. This stability may be threatened by headcuts and [lack of] land management in the upper watershed.

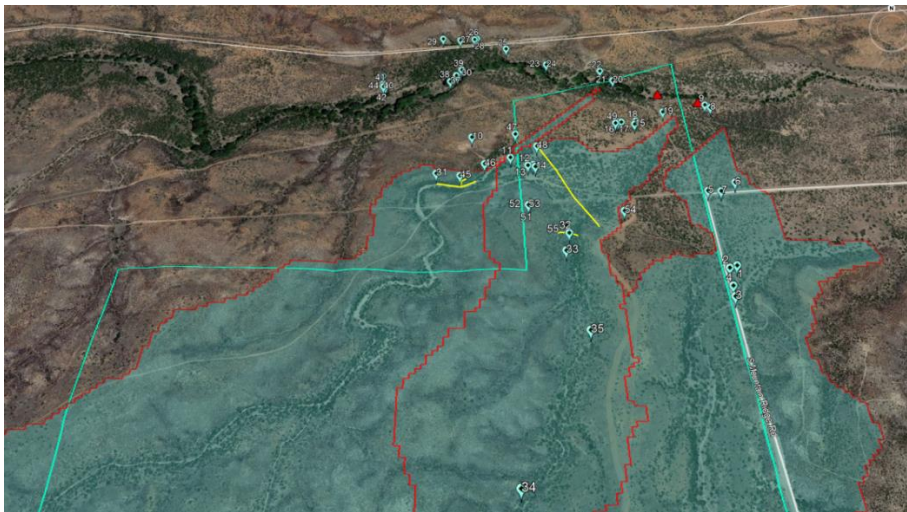
In Figure 3, the area to the right of the water tanks (on state land) is part of the Chase Emmerson property. This is a mesquite invaded grassland hosting cattle grazing, poorly drained roads, and failed water diversions. These feature concentrate stormwater flows, dry the landscape, and collectively put pressure on downstream headcuts.

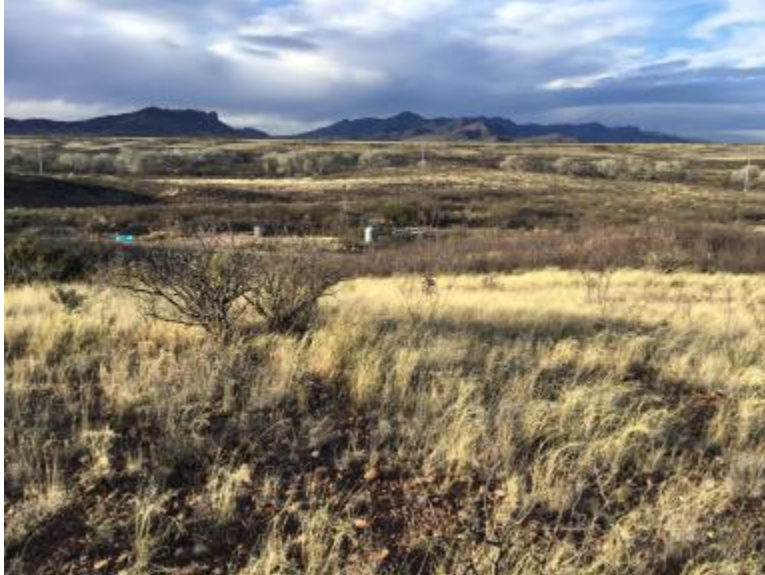
II. Ongoing Challenges

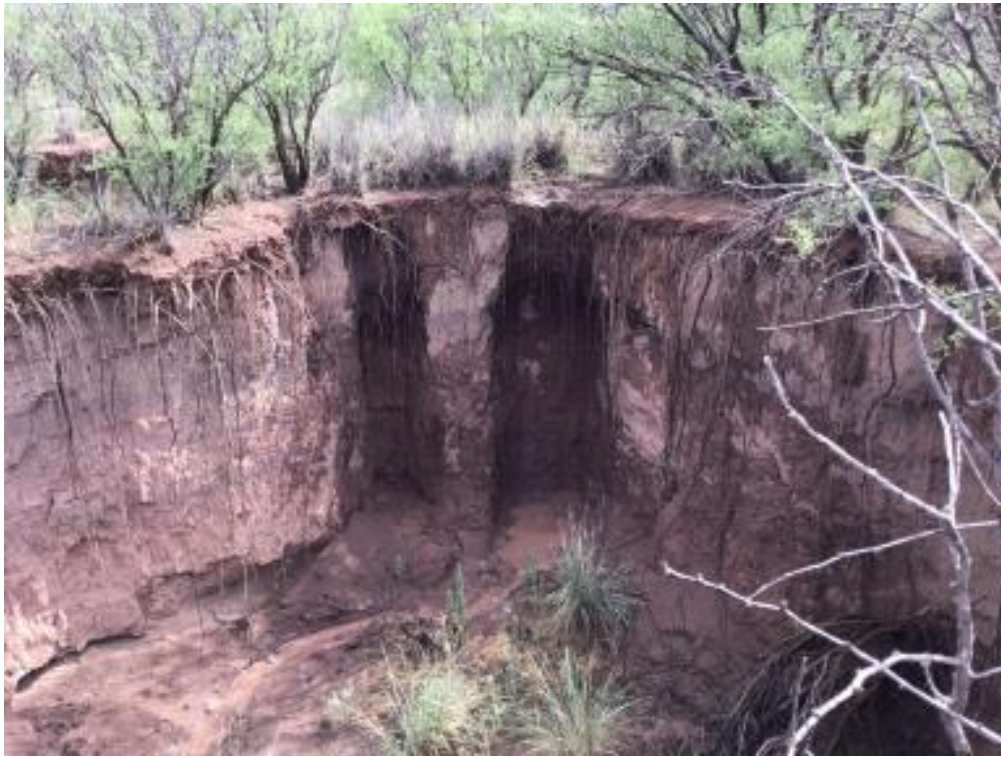
Figure 5: Drone imagery of Valley-eating headcut in the vicinity of Figure 4 and red dots in Figure 2

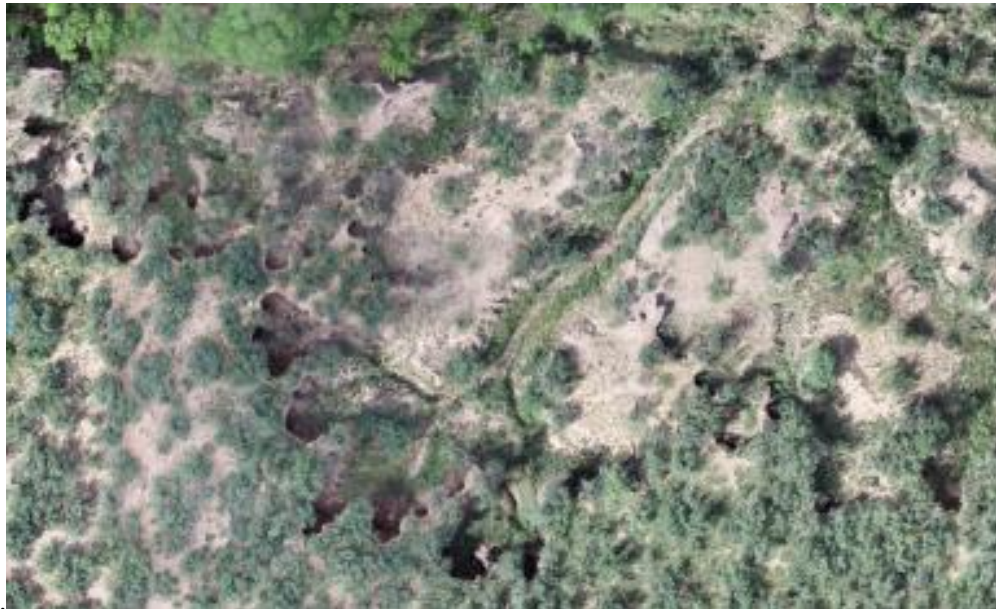
Figure 6: Google Earth screen capture near failed dam (GPS point 40) with cross section inset.

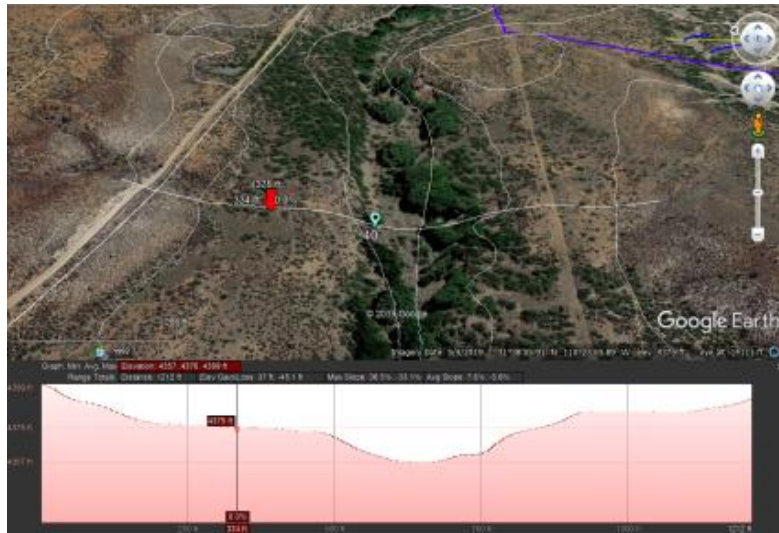
Tributaries draining into the Babocomari are also impacted by the historic downcutting. Within our study area, the ancient bajada created by the confluence of the alluvial fans of Blacktail Wash, Tributary 2, and Tributary 3 is now a hanging valley. Present day erosion is slowly cutting away at this bajada and creating a wide drop-off, or “Valley-Eating Headcut”. This erosion happens when surface flows arrive to the site of the drop-off, where they become waterfalls that scour material from the face and base of the drop-off, causing it to move upstream in response to hard rains (Figure 7). This is a natural geologic leveling of the landscape resulting from the watershed coming into equilibrium with recent land use practices and influences.

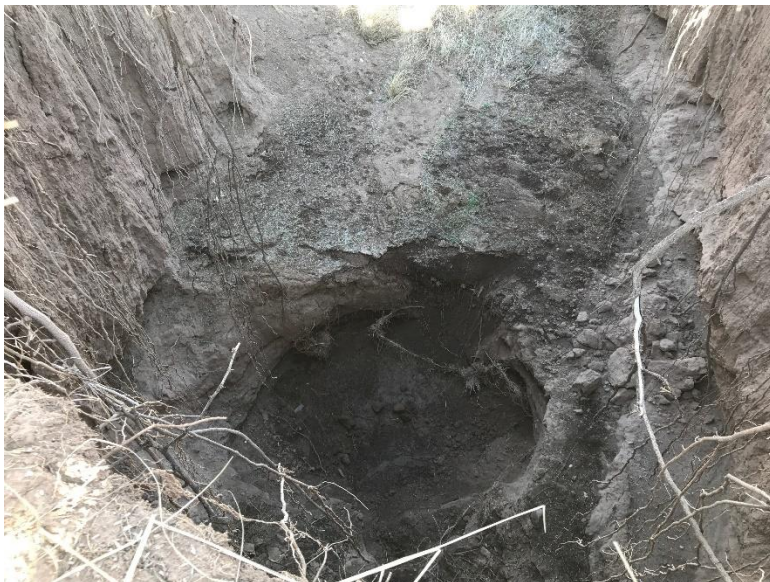
III. Suggested Remedies Summary

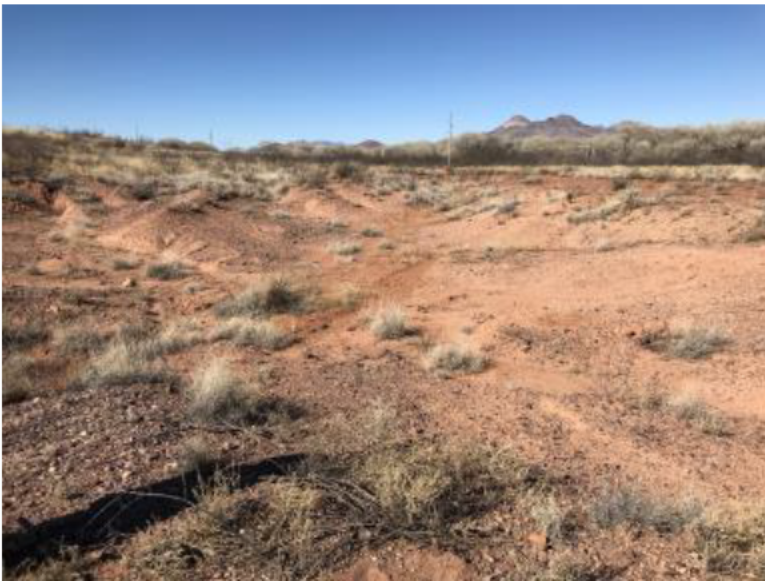
Eroded bowl contributing sediment to Tributary 3 (GPS point 10): This is a very small tributary valley on state land that is impacted by erosion. We speculate that this might be the route of a historic trail. One-rock dams in the mouth of this valley would cause it to aggrade and start to become grassed in again.

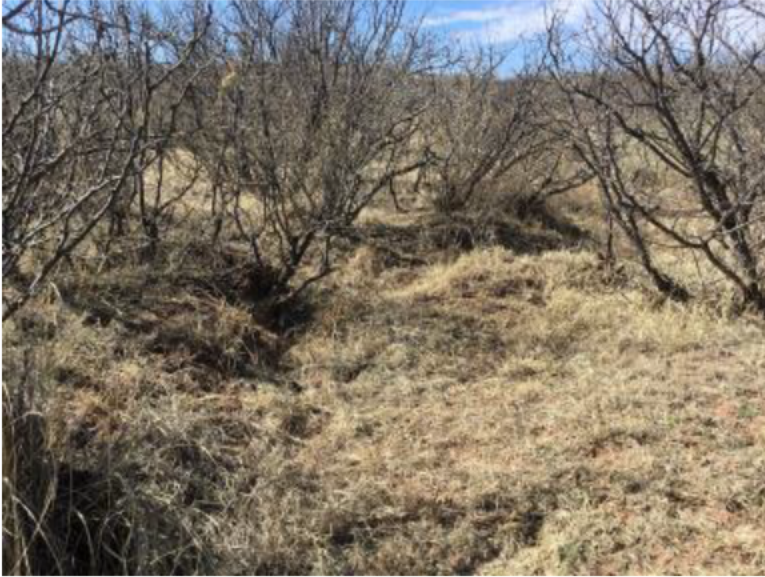
Old swale (GPS point 47): This is where the flows coming out of the bowl at GPS point 10 flow. This is a safe place for water to flow as it comes out at the angle berm discussed later.

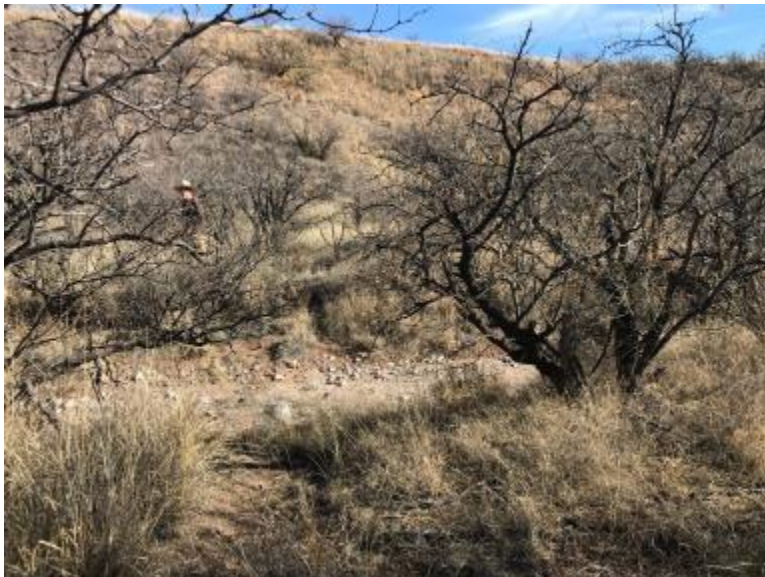
Van is standing in historic valley bottom (GPS point 34): This location is one-half mile up Tributary 2 from the road. Our walking tour discovered that this tributary has legacy issues due to old roads and trails that straightened the arroyo and caused it to downcut. At present, the drainage is trying to fix itself by eroding its banks and re-meandering. There are additional locations where the arroyo is still

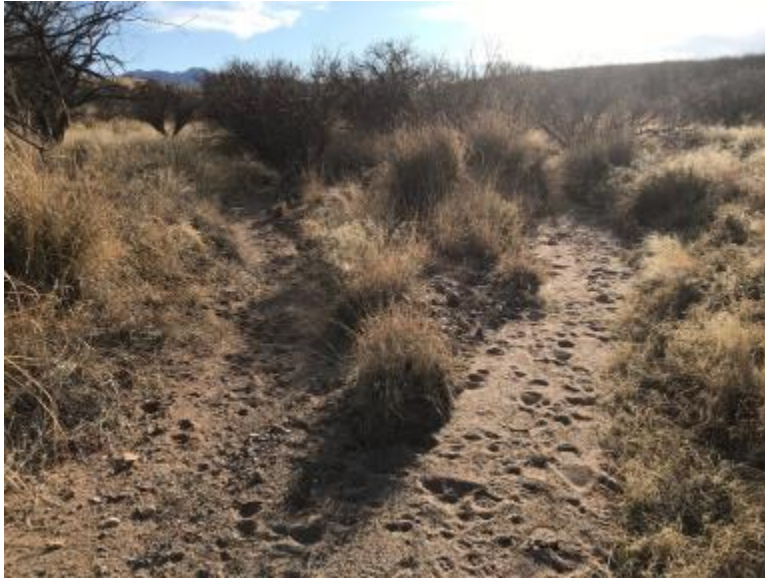
Historic valley bottom meets incised channel (GPS point 35): At a point several hundred feet upstream from here, small flows can escape the present day gully and flow along the historic valley bottom for several hundred feet. This area could use a more detailed survey to discern opportunities to enhance water harvesting and stability.

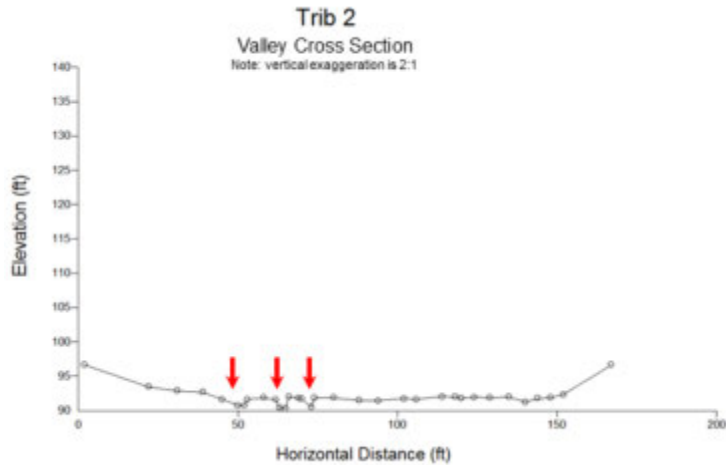
Tributary 2 cross section: The three red arrows represent three channels in a valley bottom that were probably caused by livestock trailing up and down the valley. We propose to correct this erosional issue by transplanting giant sacaton grass plants to plug these gullies in order to reinstate sheet flow.

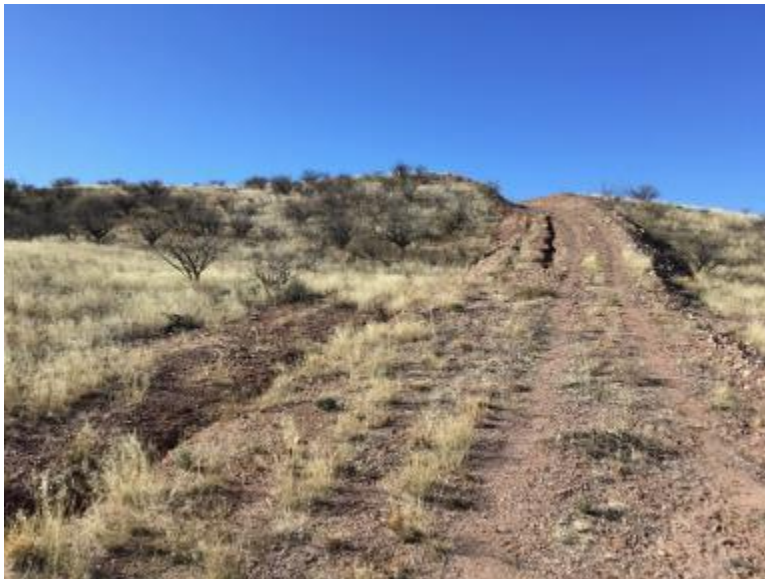
Significant erosion destroying steep road (GPS point 54): Poor drainage design is causing this road to self-destruct. We suspect these roads were installed immediately before the 2008 economic collapse. We propose to drain this road in three places to reduce its negative impact on the watershed with the understanding that if plans for the associated subdivision restart, it could pose serious challenges for the watershed especially if careful consideration is not given to increased runoff and proper spreading of downstream flows through fragile soils.

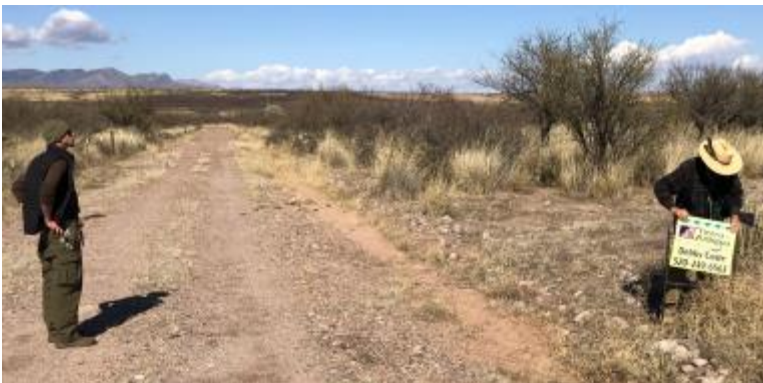
Blacktail Wash is captured in roadside ditch (GPS point 3): Our survey suggests that the flow from the wash crossed the alignment of the present day road toward a tank at GPS point 7. When the road was built, flow from Blacktail Wash was captured in a roadside ditch, causing erosion and sedimentation of the road in addition to increasing the rate of delivery of surface flows to the downstream valley-eating headcut (GPS Point 9). We propose to properly drain this road with a series of rolling-dip road drains to optimize water spreading and relieve the road from associated drainage issues.

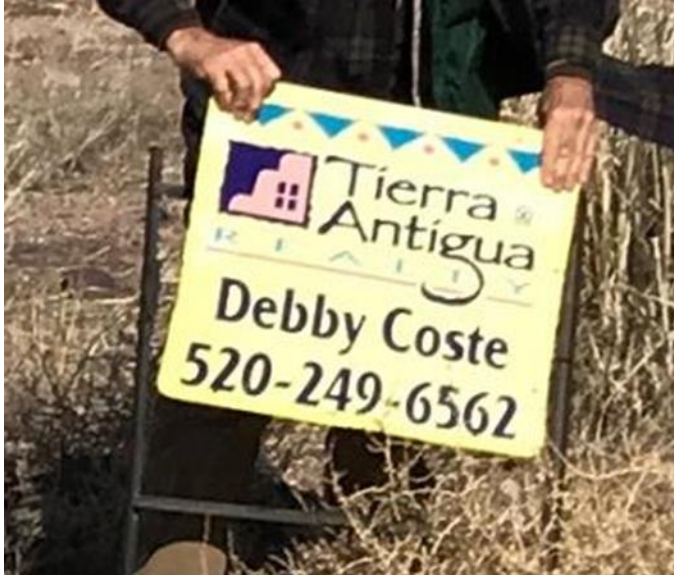
Looking down road. Sign has contact info for realtor. (GPS point 4): Since this road is not on Mr. Emerson's property, repairs would require approval from the adjacent-property owner. Perhaps Ms. Debby Coste could help us secure permission from this property owner to facilitate our prescription to relieve pressure on the valley-eating headcut.

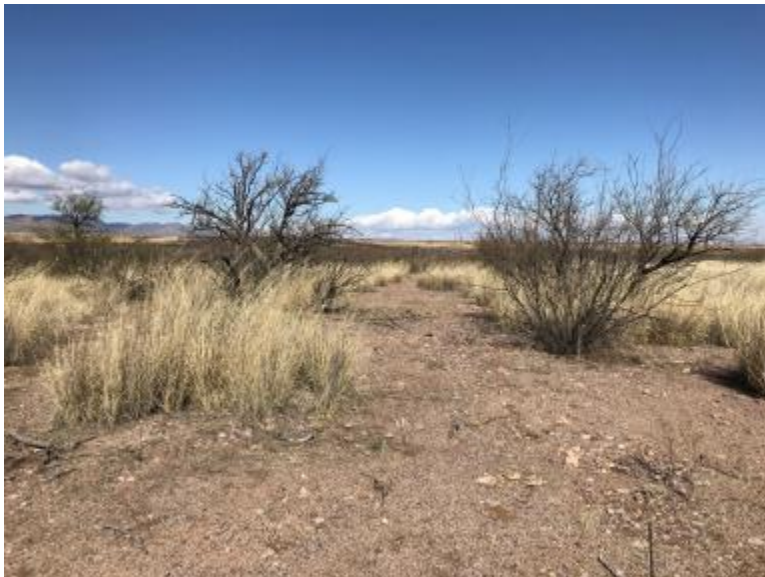
Location where we propose diverting water from the road ditch (GPS point 1): GPS point 1 is to the east of the road. It would be relatively easy to design and build rolling dips on the road to redirect the flow to a safe place where the water could slow down, spread out, and sink into the ground more than it currently does, thus relieving pressure on the valley-eating headcut.

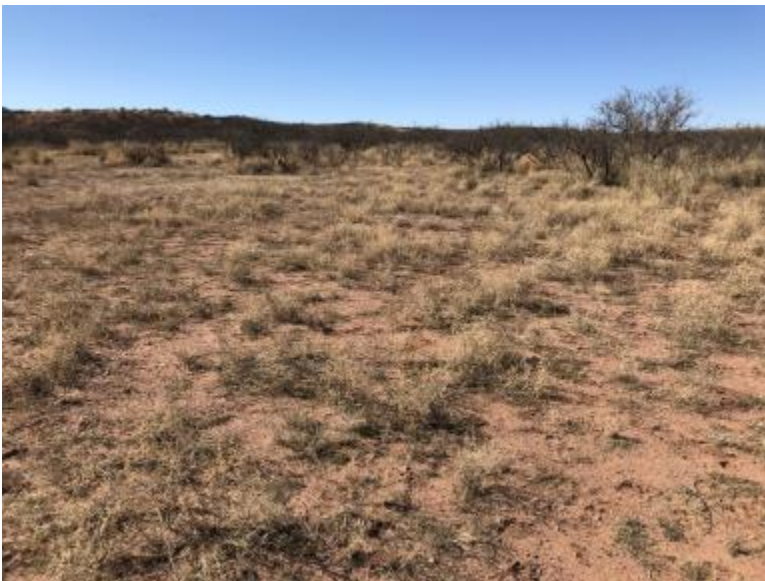
Preferred site to spread water diverted by upstream projects (GPS point 15): In this vicinity, we mapped an area of approximately 3 acres where we propose to uproot mesquite trees so that we can host a keyline plow and seeding project to optimize infiltration and grass regeneration.

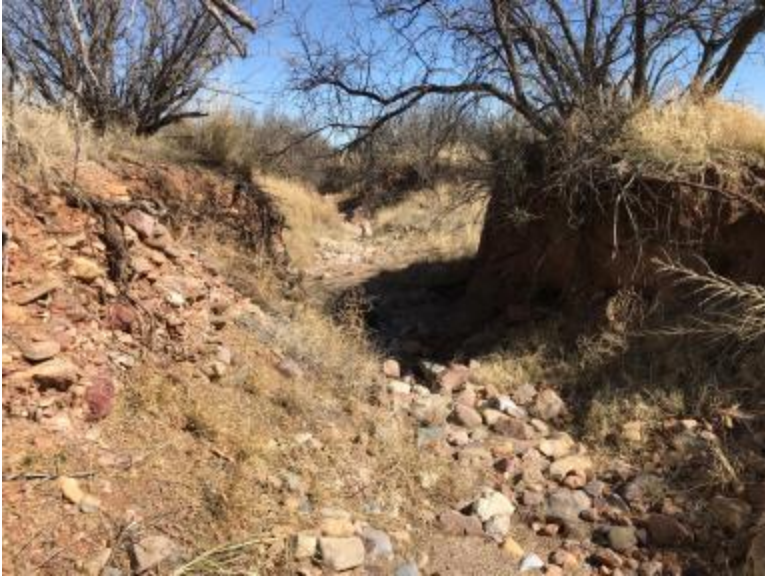
Location further downstream in collector channel (GPS point 18): Within the channel at this location we propose to use existing boulders to build grade controls such as one rock dams and Zuni bowls by hand.

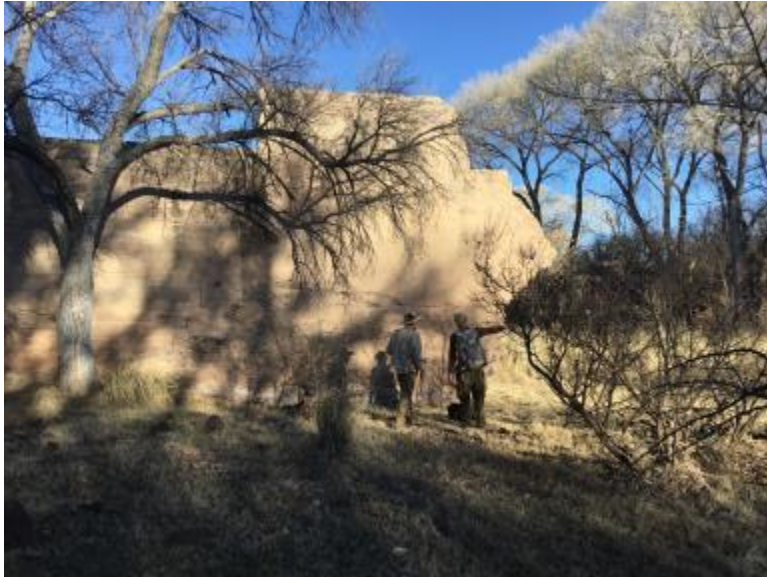
Historic infrastructure (GPS point 40): This is an old dam across the Babocomari. ADEQ communication with the property owner suggests this one of many features installed throughout the area to help mitigate soil loss between 1935 and 1940. Features on the concrete suggests it was keyed into both banks of the stream channel at the time of construction. We suspect this feature was likely overtopped early in its career resulting in catastrophic failure and causing the right bank to erode significantly while contributing a huge sediment load to the system. At present, the right bank of the Babocomari is over 200 feet away from the concrete dam. The feature is still keyed in to bedrock on the left bank.

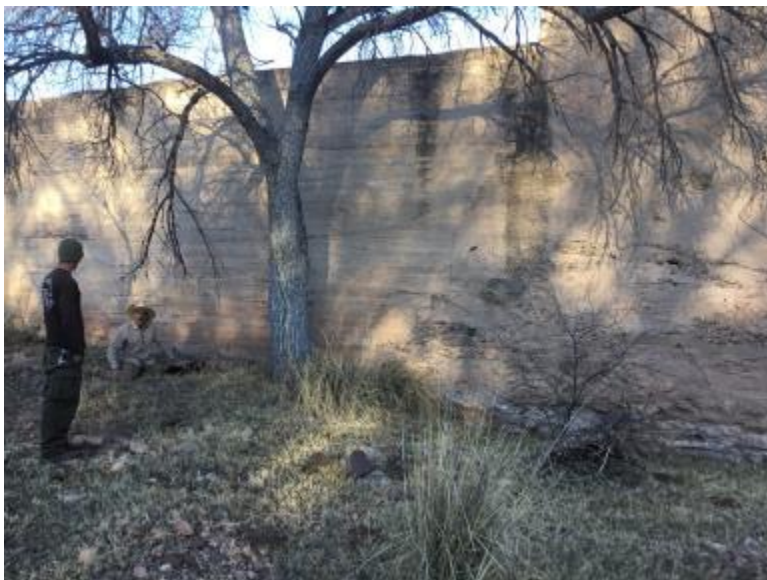
Drainage pipe at base of old dam (GPS point 44): We suspect the original engineers planned to relieve base flow of the flashy desert stream through this 9" diameter pipe at the base of the dam where Van is sitting. ADEQ informs us that the contributing watershed area at this location is 168 square miles.

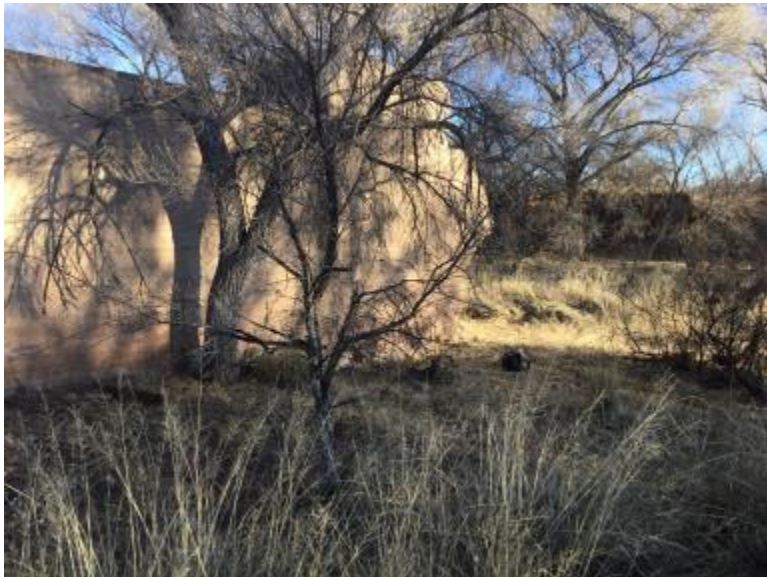
Showing how far right bank has eroded since dam failure (GPS point 41): The right bank is now over 200 feet south of where it was the day of construction of this legacy infrastructure.

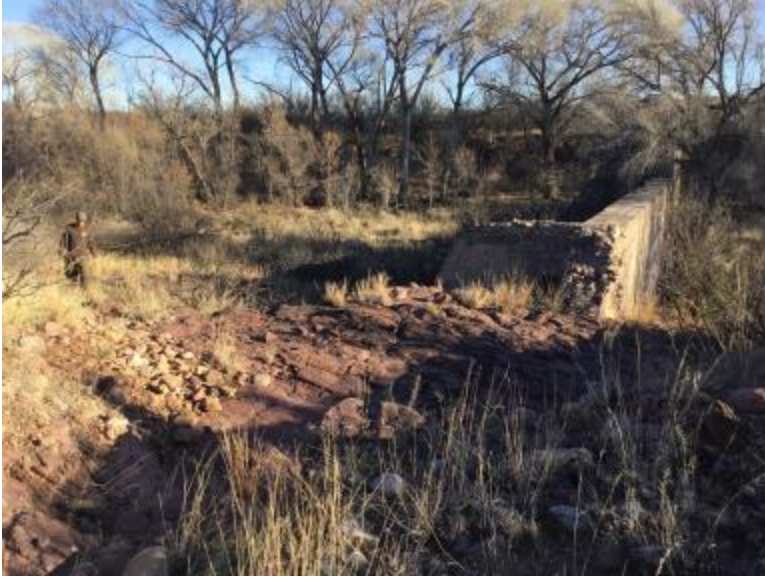
Dam where it is still keyed into left bank of Babocomari (GPS point 43): Here, we found evidence that the spillway was overtopped before any sediment was trapped behind the dam (i.e. the dam failed during the first significant flow event).

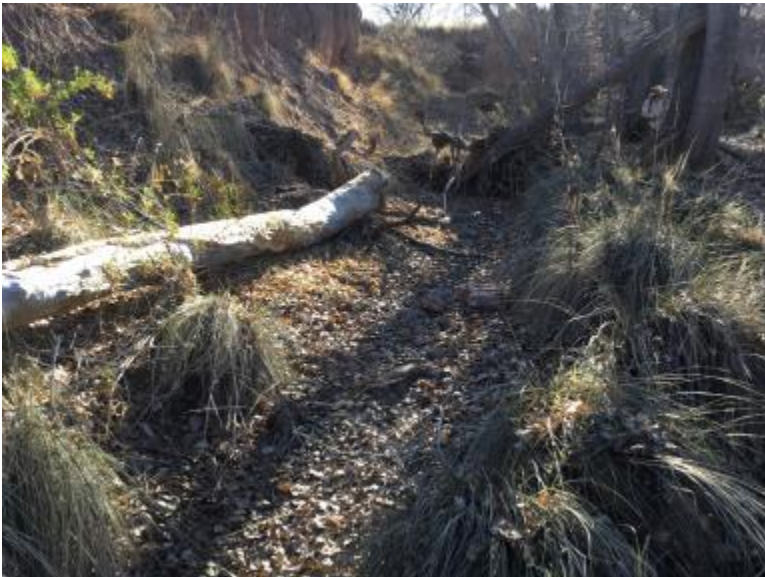
Observed debris in channel upstream of headcut (GPS point 37): The channel may be stable against downcutting at this point due to a bedrock outcrop downstream from here. In order to monitor the channel morphology, we suggest installing several monumented cross sections on Brophy property with landowner permission.

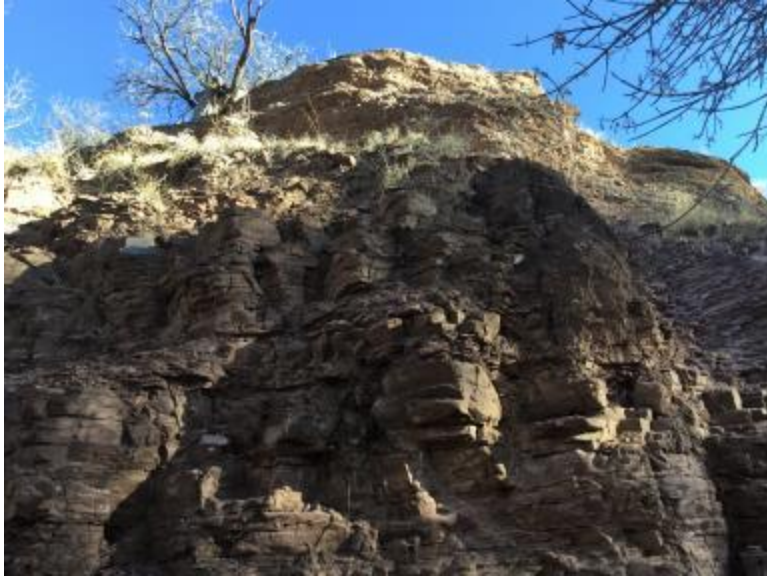
Channel is against stone toe of valley (GPS point 38): We are uncertain if this stone outcrop runs across the creek bottom under a thin layer of alluvium or not. This merits further investigation since it may influence strategies for grade control and headcut relief.

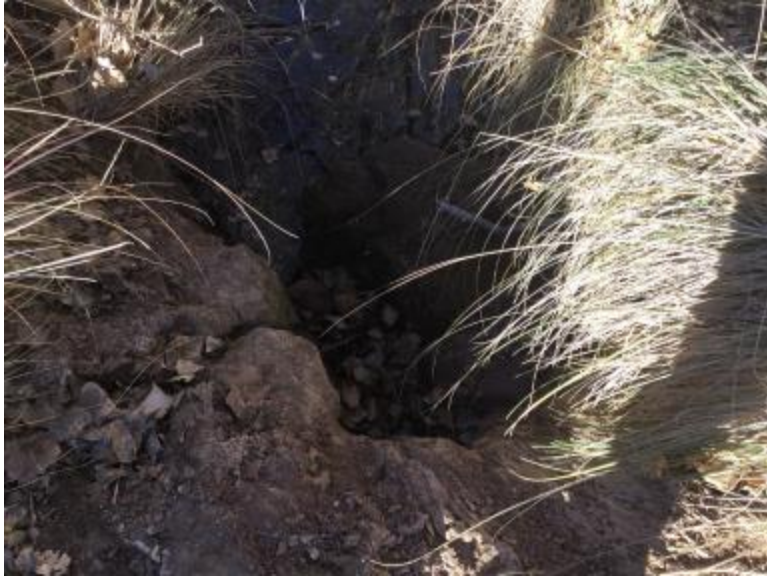
Looking down into the major headcut (GPS point 39): If this headcut is not self-stabilizing, this could pose an extremely serious resource damage point that could threaten stream channel stability, groundwater level, and water quality through increased sediment contributions. We recommend further investigation of the geology to better understand if grade control is happening naturally.

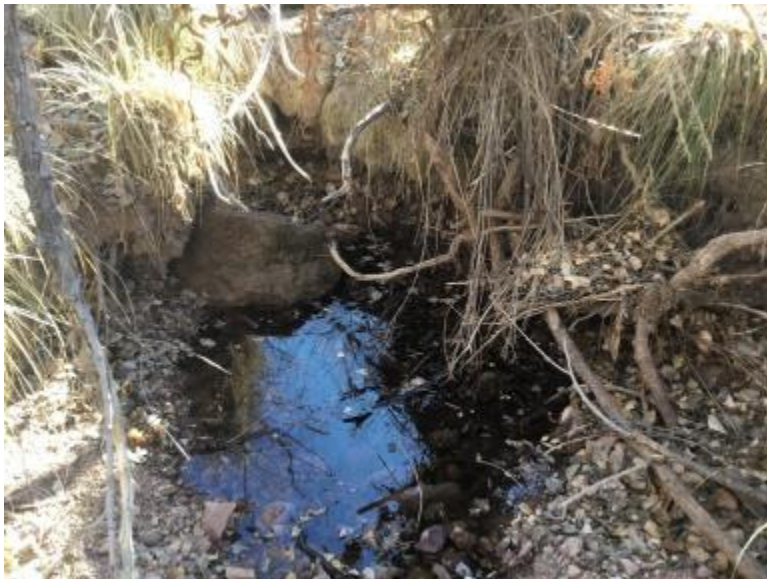
Water table elevation in headcut (GPS point 36): This is the only place we saw surface water in the Babocomari on January 28, 2020.

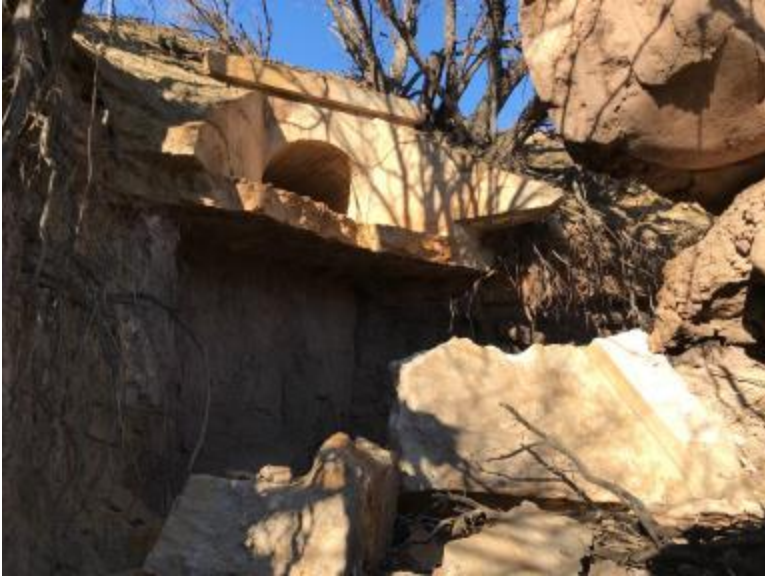
Failing railroad culvert and massive erosion (GPS point 28): The installed splash pad was not engineered to handle the respective flow concentration from this culvert. The splash pad was laterally flanked, causing flood flows to erode the fine grained soil resulting in catastrophic failure.

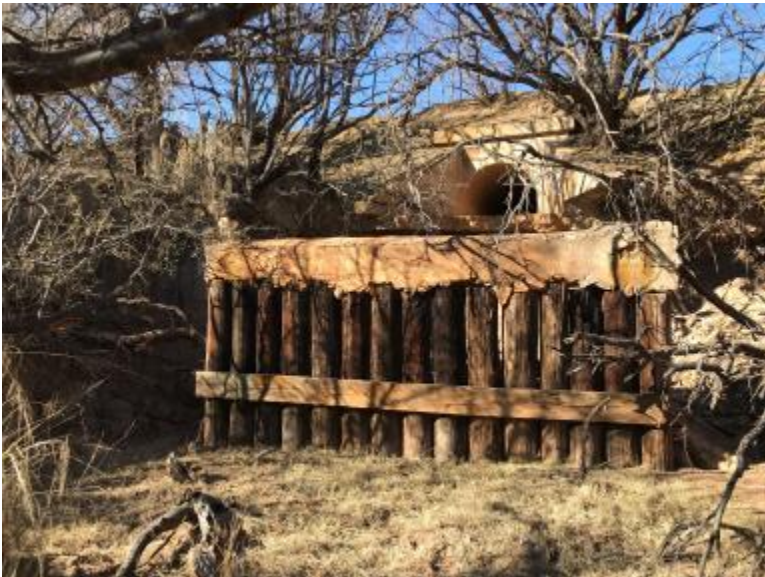
Another view of old railroad culvert (GPS point 26): This shows a post and concrete splash pad that has now collapsed 20 feet behind the structure.

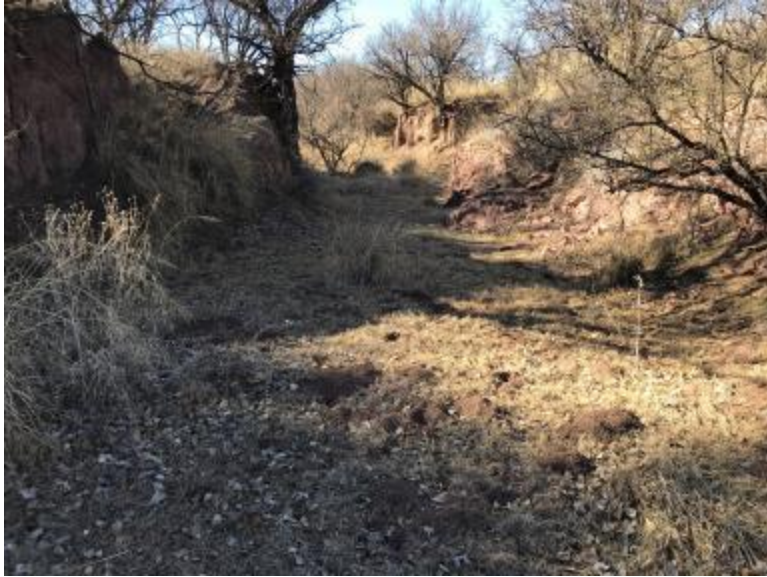
Looking upstream at incised tributary caused by railroad (GPS point 25): Flows from the respective culvert contributed to downcutting resulting in this massive headcut.
