**Arizona Water Protection Fund
Application Cover Page
FY 2026**

<table><tr> <th style="text-align: left;"><u>Applicant/Agency/Organization:</u></th> <th style="text-align: right;"><u>Amount (\$):</u></th> </tr></table>

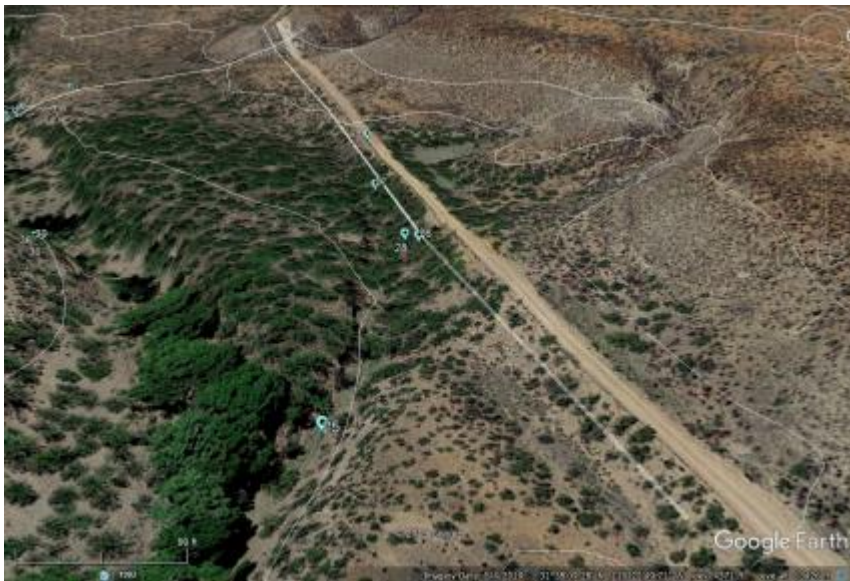
Google earth screen capture showing how the railroad-caused gully has a positive feedback loop with the incision of the Babocomari, creating an entirely different landscape.

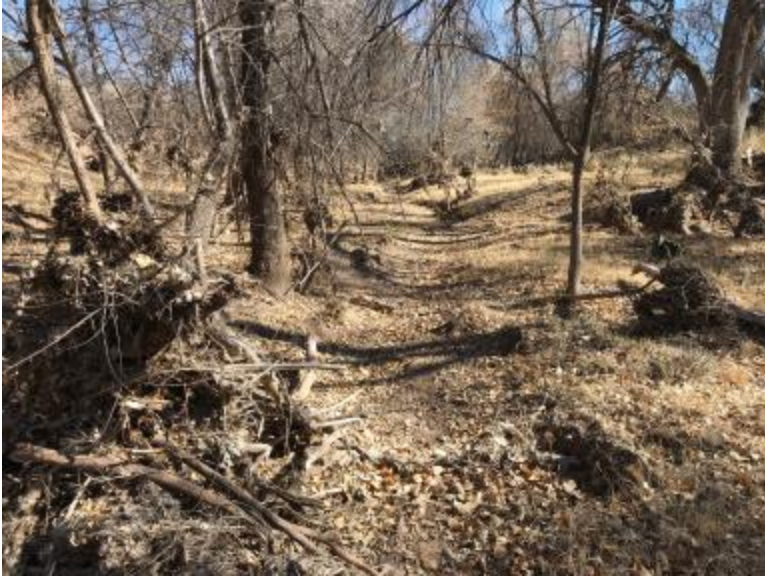
Babocomari has stabilized within historic incision (GPS point 22): The Babocomari has incised approximately 18 feet over the many years since the heavy handed manipulation of the stream channel. It has finally reached a new equilibrium by eroding laterally to create a tiny floodplain within the incised channel. This stability may be threatened by headcuts and [lack of] land management in the upper watershed.

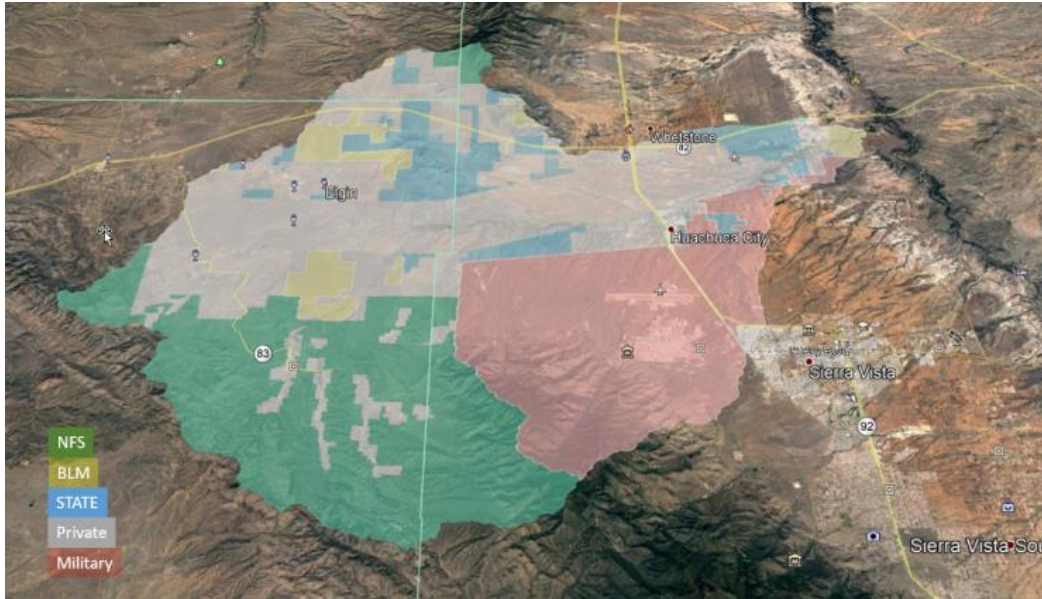
The associated potential for soil compaction, decreased land cover, and improper road maintenance are root-cause factors that can realize watershed-scale impacts beyond the local benefits of the modest project like the one presented here. We understand that recreational and agricultural activities support local and state economies through permit, lease, and commercial revenues, but also recognize that respective activities can realize significant costs requiring intervention.

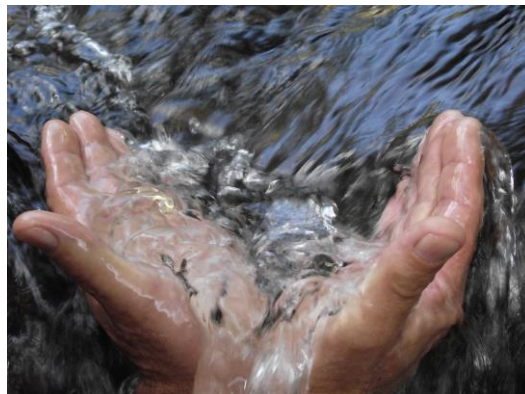
In regards to a recommendation for a sustainable strategy moving forward, we suggest evaluating agricultural and recreational receipts against the investments required by ADEQ for restoring watersheds in areas impacted by associated activities. We recommend you then engage with partner agencies and stakeholders regarding ADEQ investments so that more sustainable and equitable policies can be developed moving forward. By approaching these challenges holistically, we believe you will create an environment that will ensure the benefits of this project can stand out as an example that can be replicated and sustained over time.

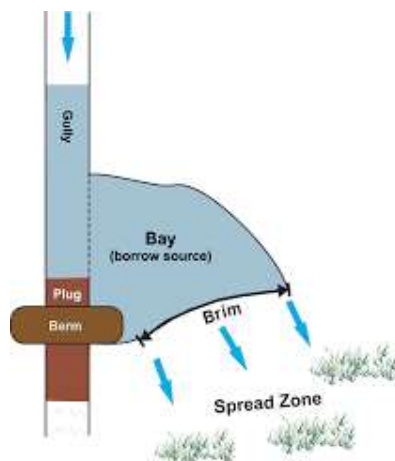
There are three alluvial fans that are a priority for repair. The most damaged, and therefore highest priority, is in the tributary we refer to as C2, followed by C4 and C9.

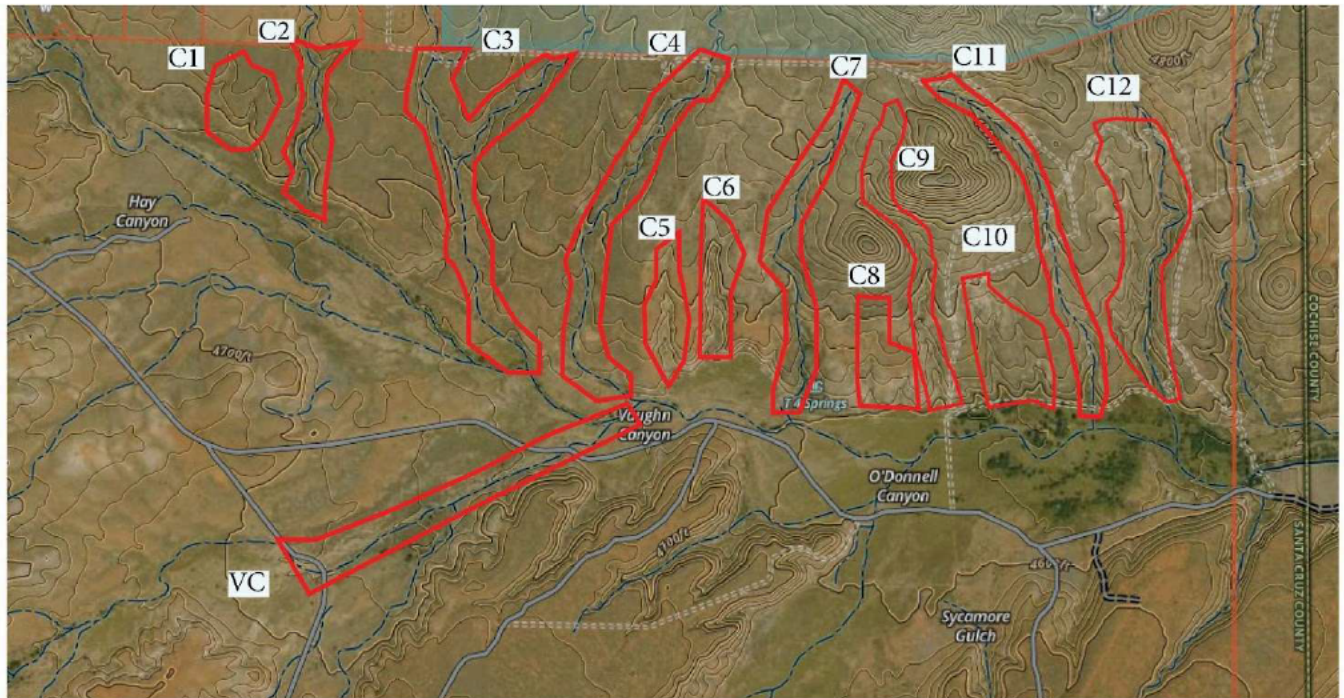
C1. The first set of channels that we have been tasked to look at begins near the westside of Babacomari Rd. Road work needed to the north, headcuts at the top and bottom. This cluster of 3 drainages have similar patterns. Relatively short length of channel with opportunities in the uplands before the channelization begins to keep the water up longer. Headcuts tend to follow with a transportation zone that is slightly incised that leads to a partial intact alluvial fan. We suggest that the fan be restored.

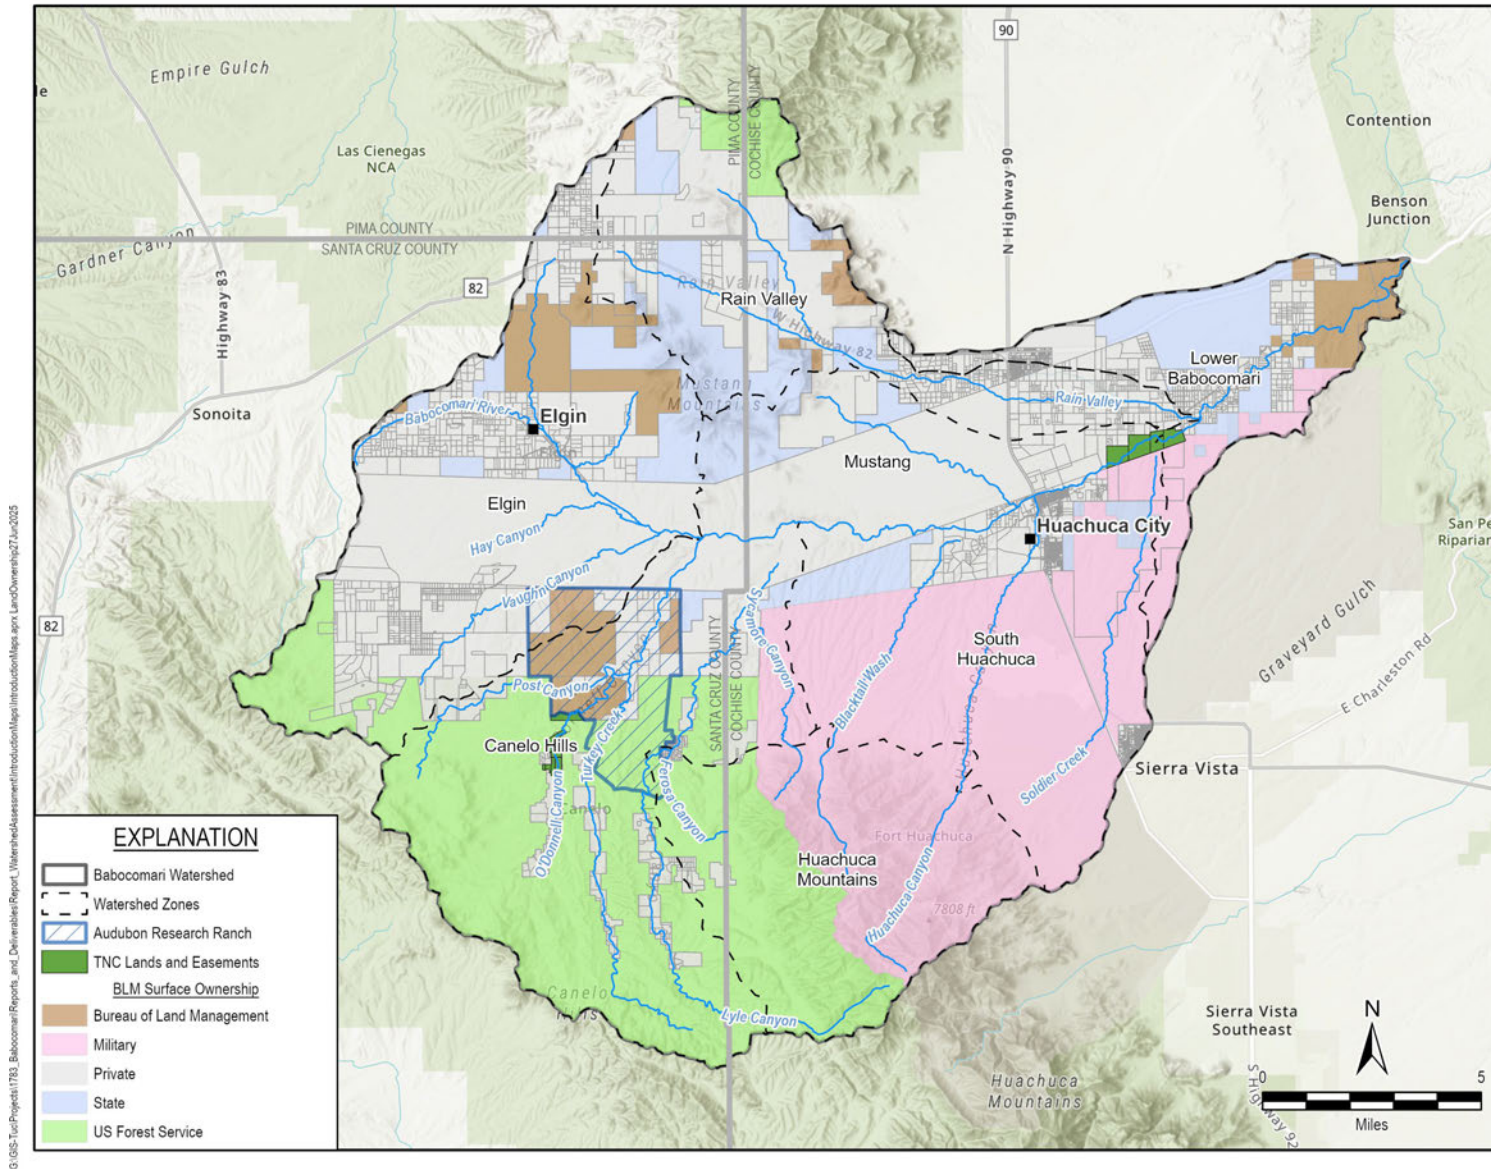
Figure 1. Watershed Features and Land Ownership

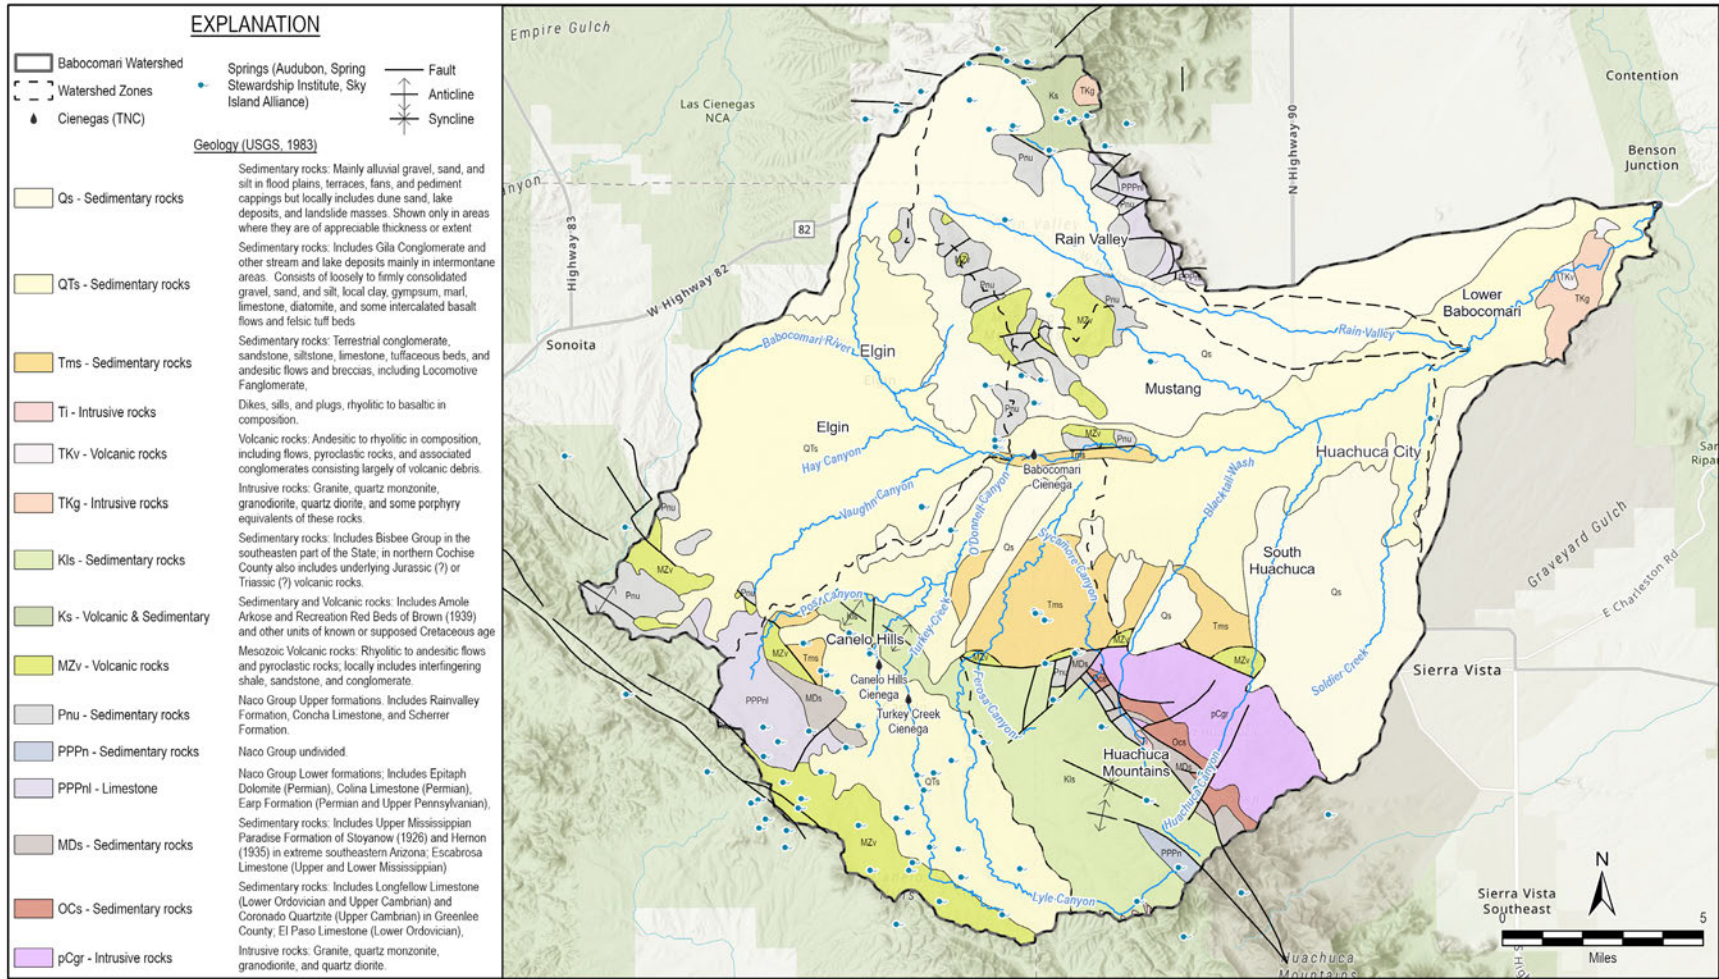
Figure 4. Geologic Map with Locations of Groundwater Dependent Ecosystems

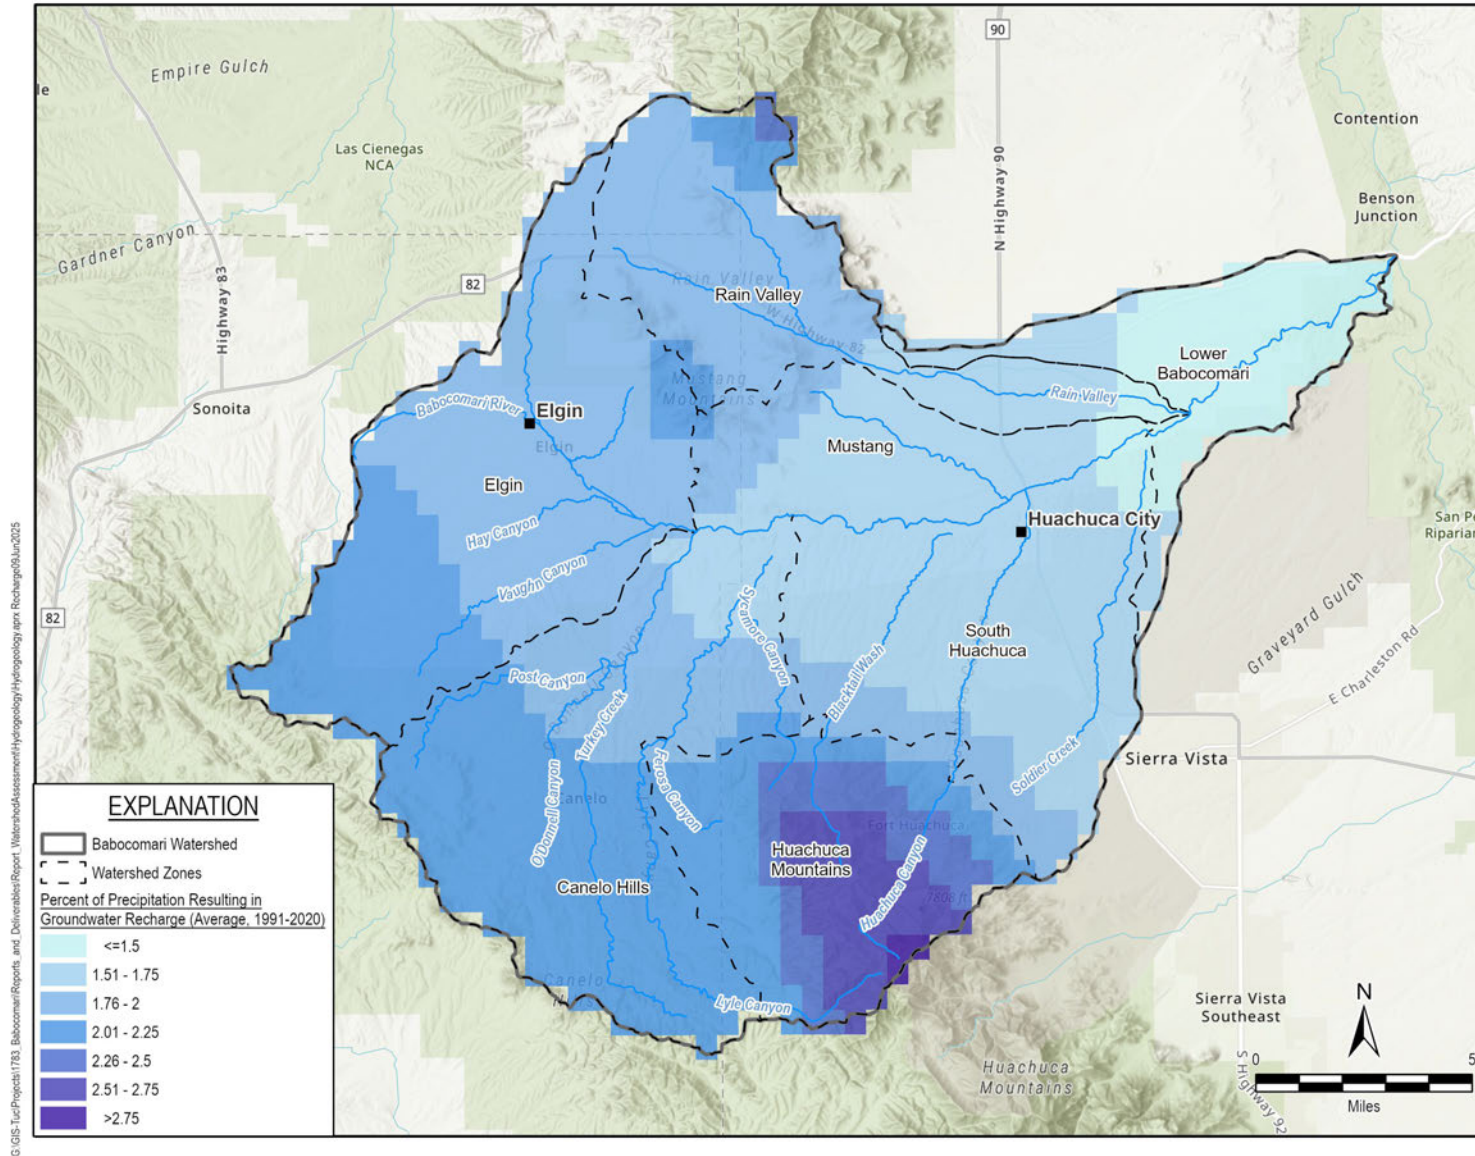
Figure 6. Percentage of Precipitation Resulting in Groundwater Recharge

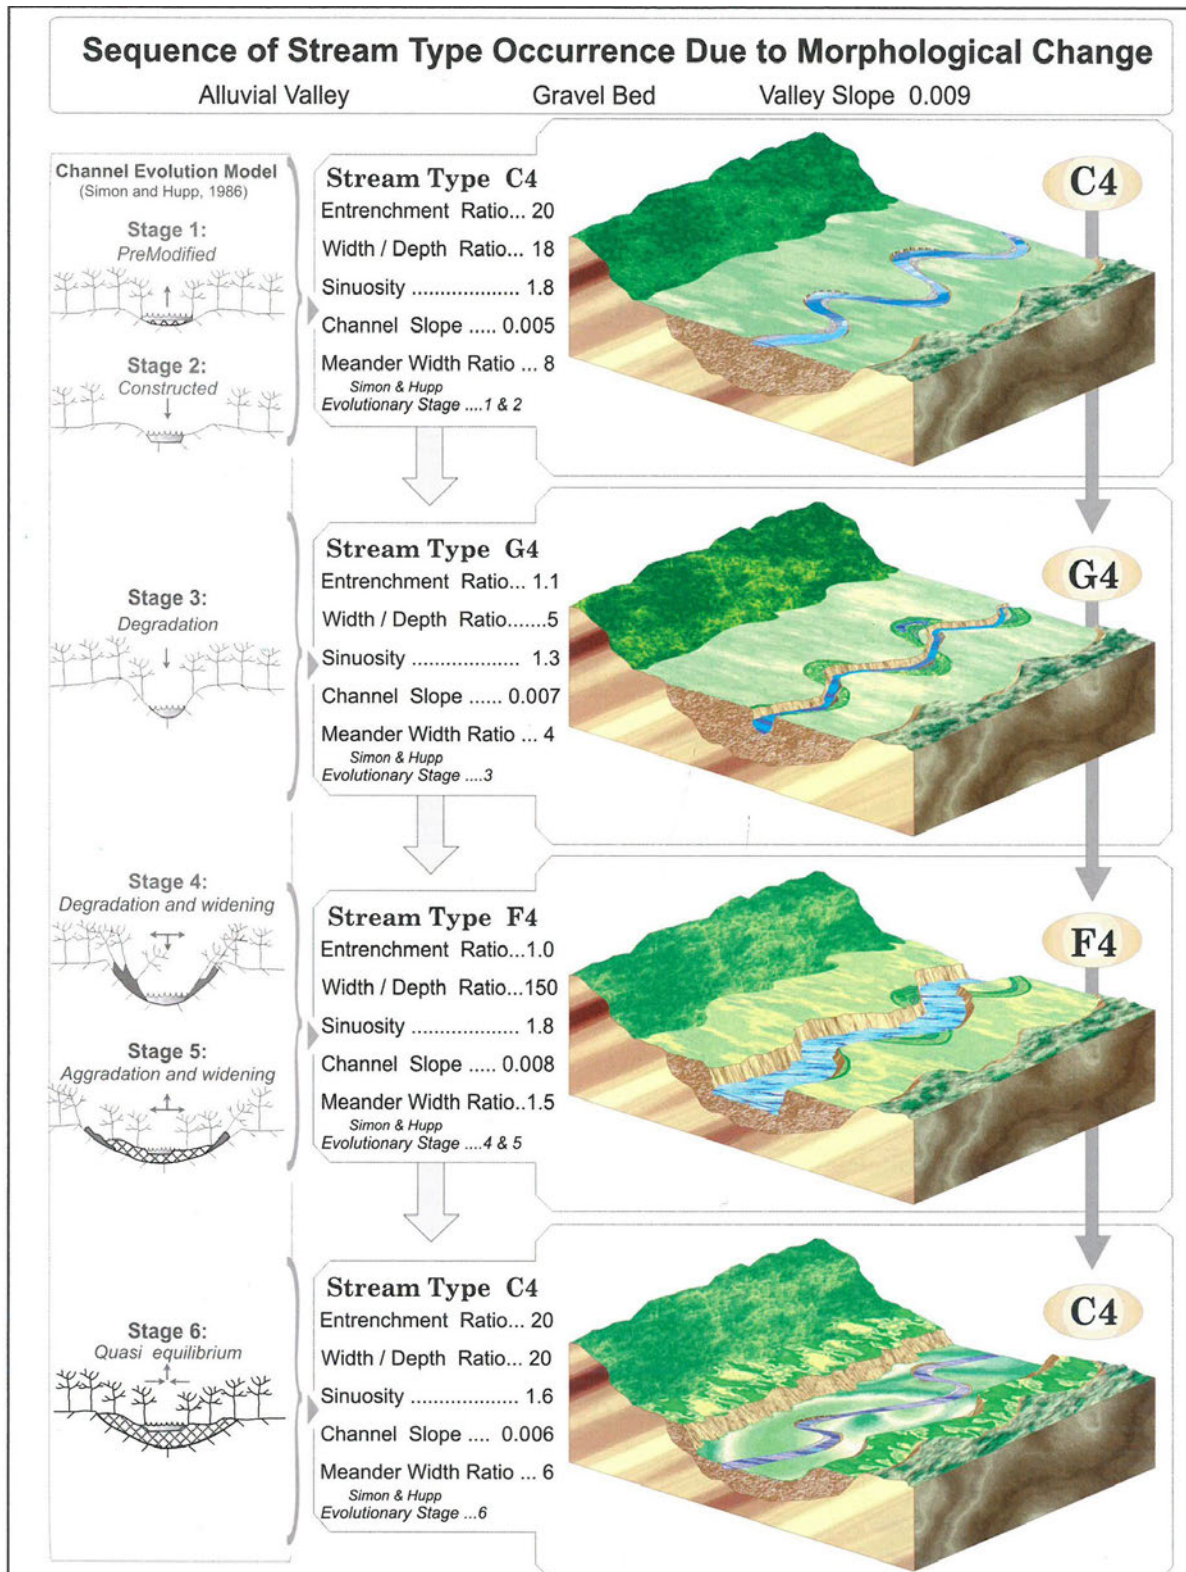
Note: modified from Simon and Hupp (1986) and Rosgen (1999)

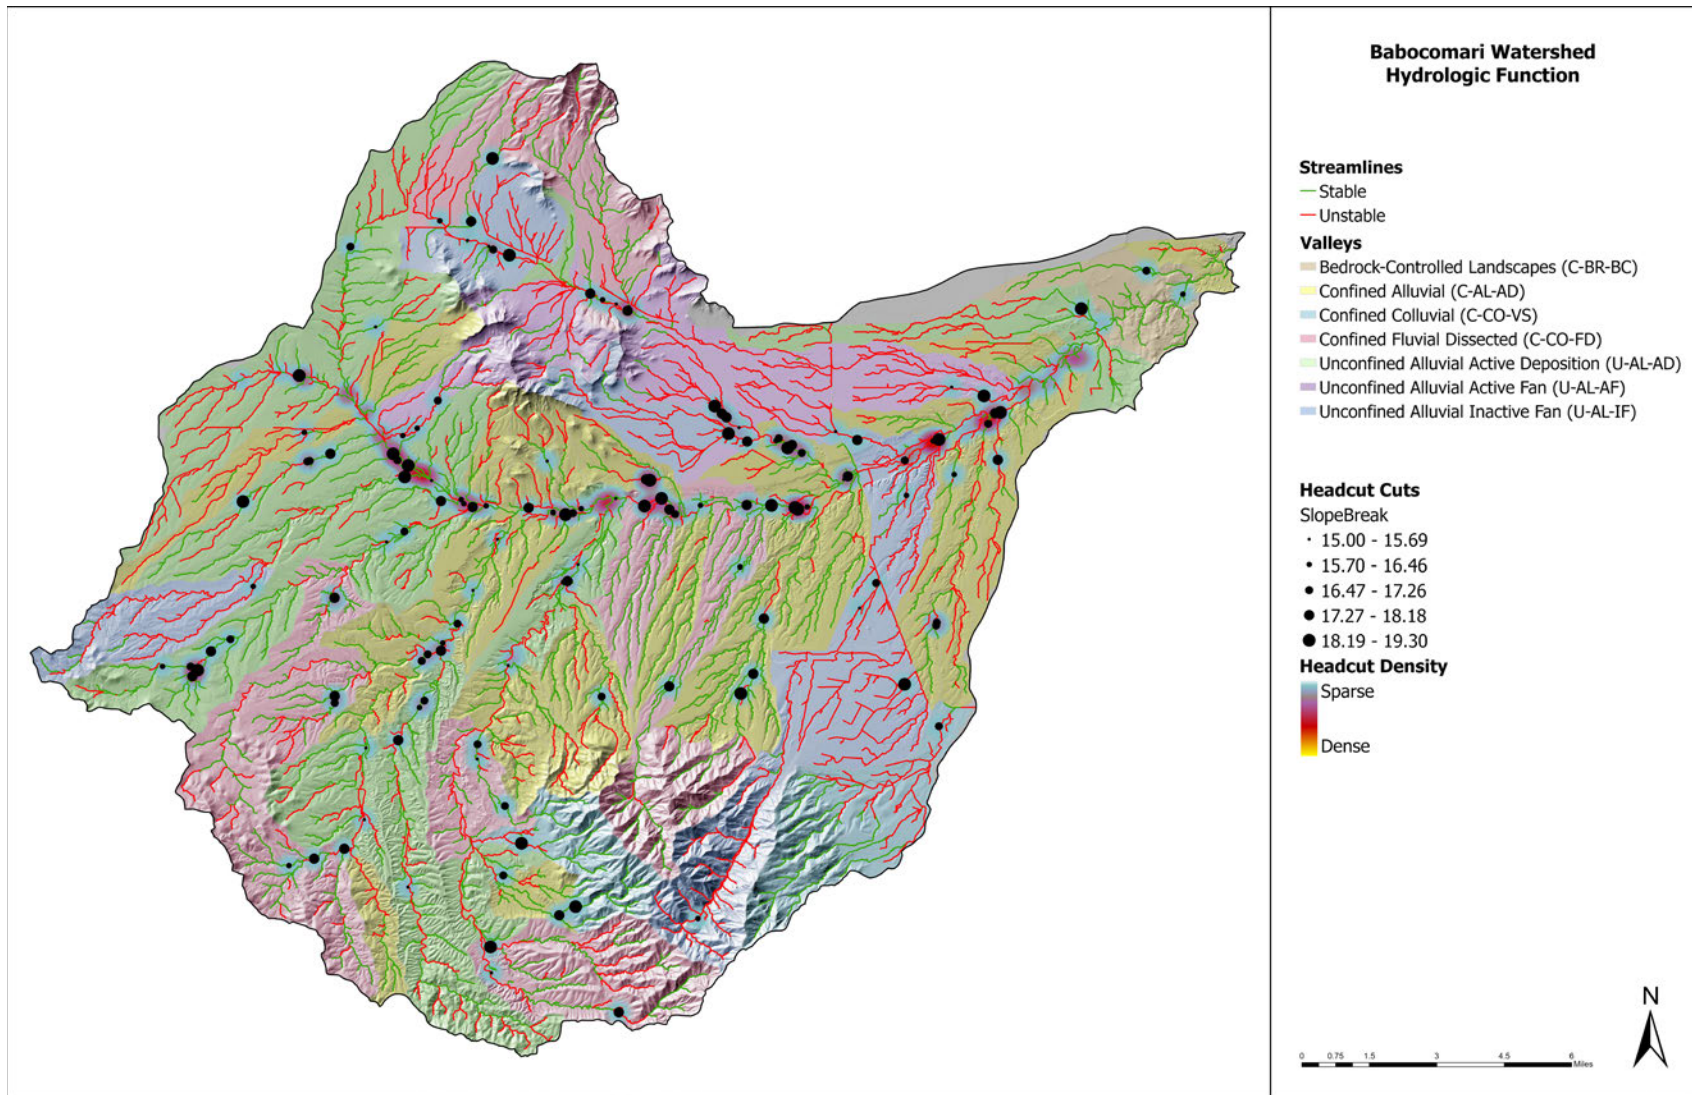
Figure 8. Valley and Channel Type and Locations of Headcuts

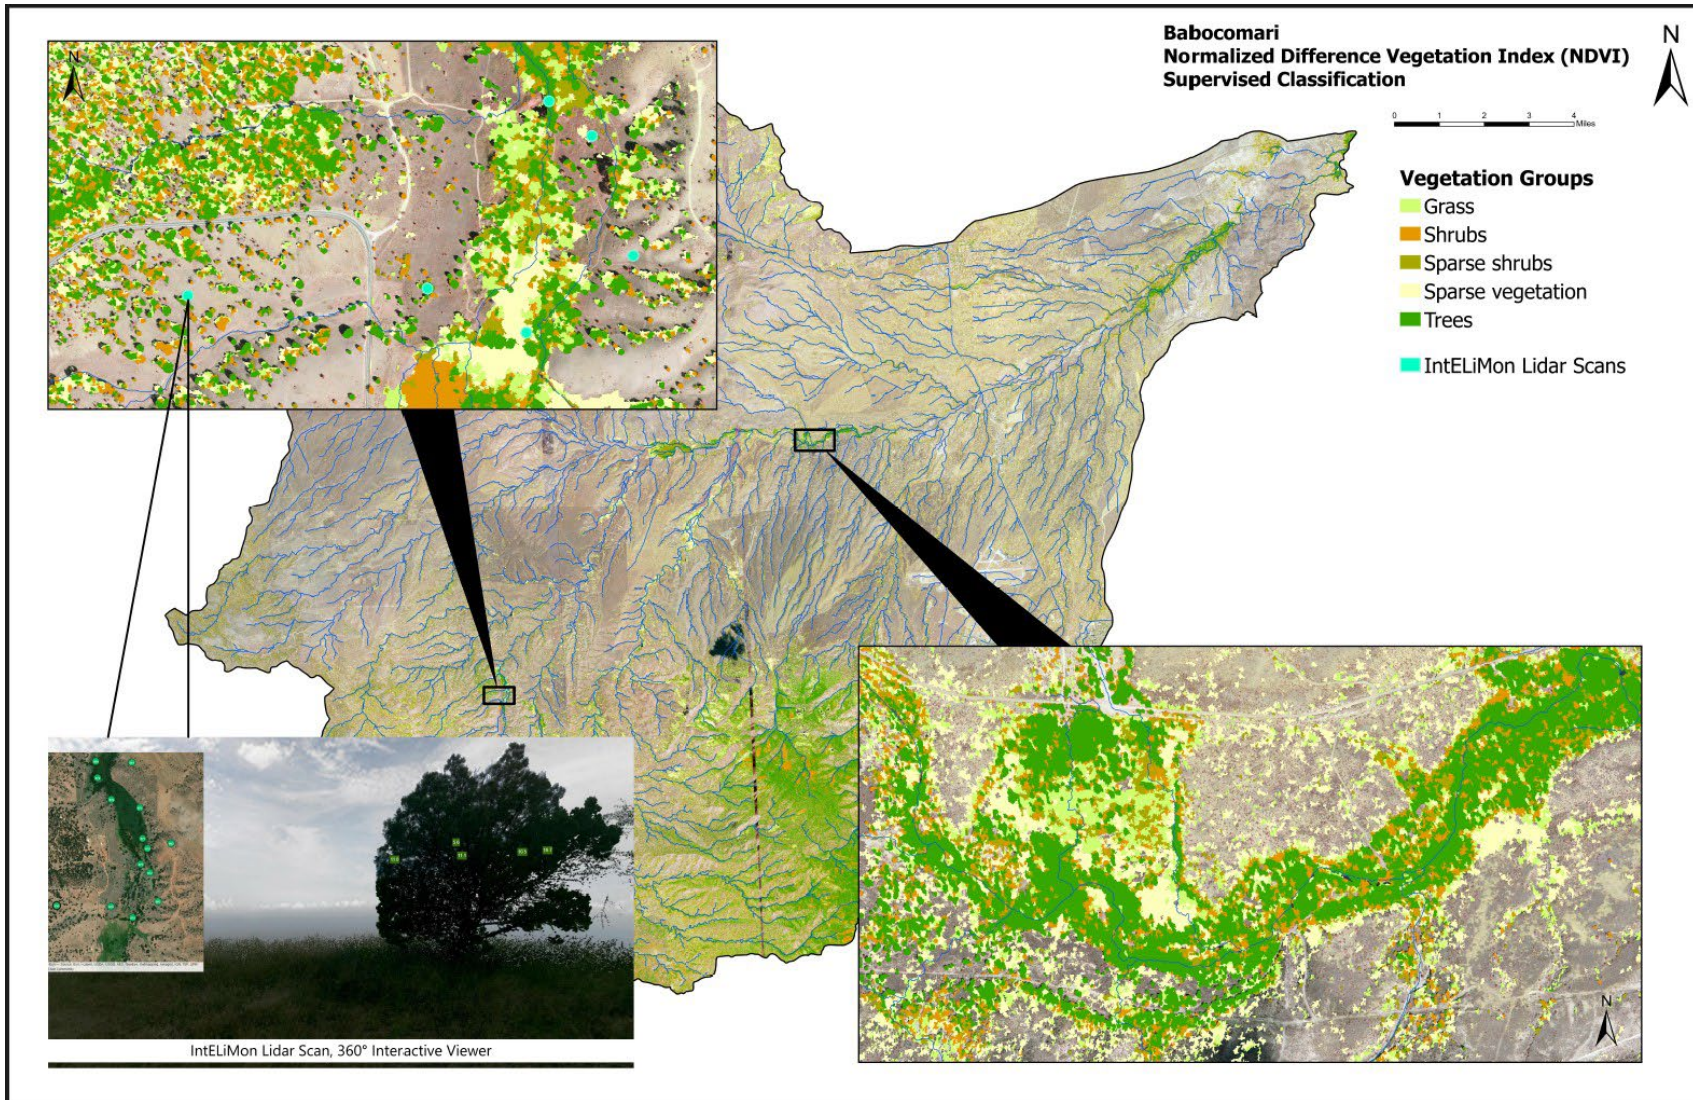
Figure 10. Vegetation Classification

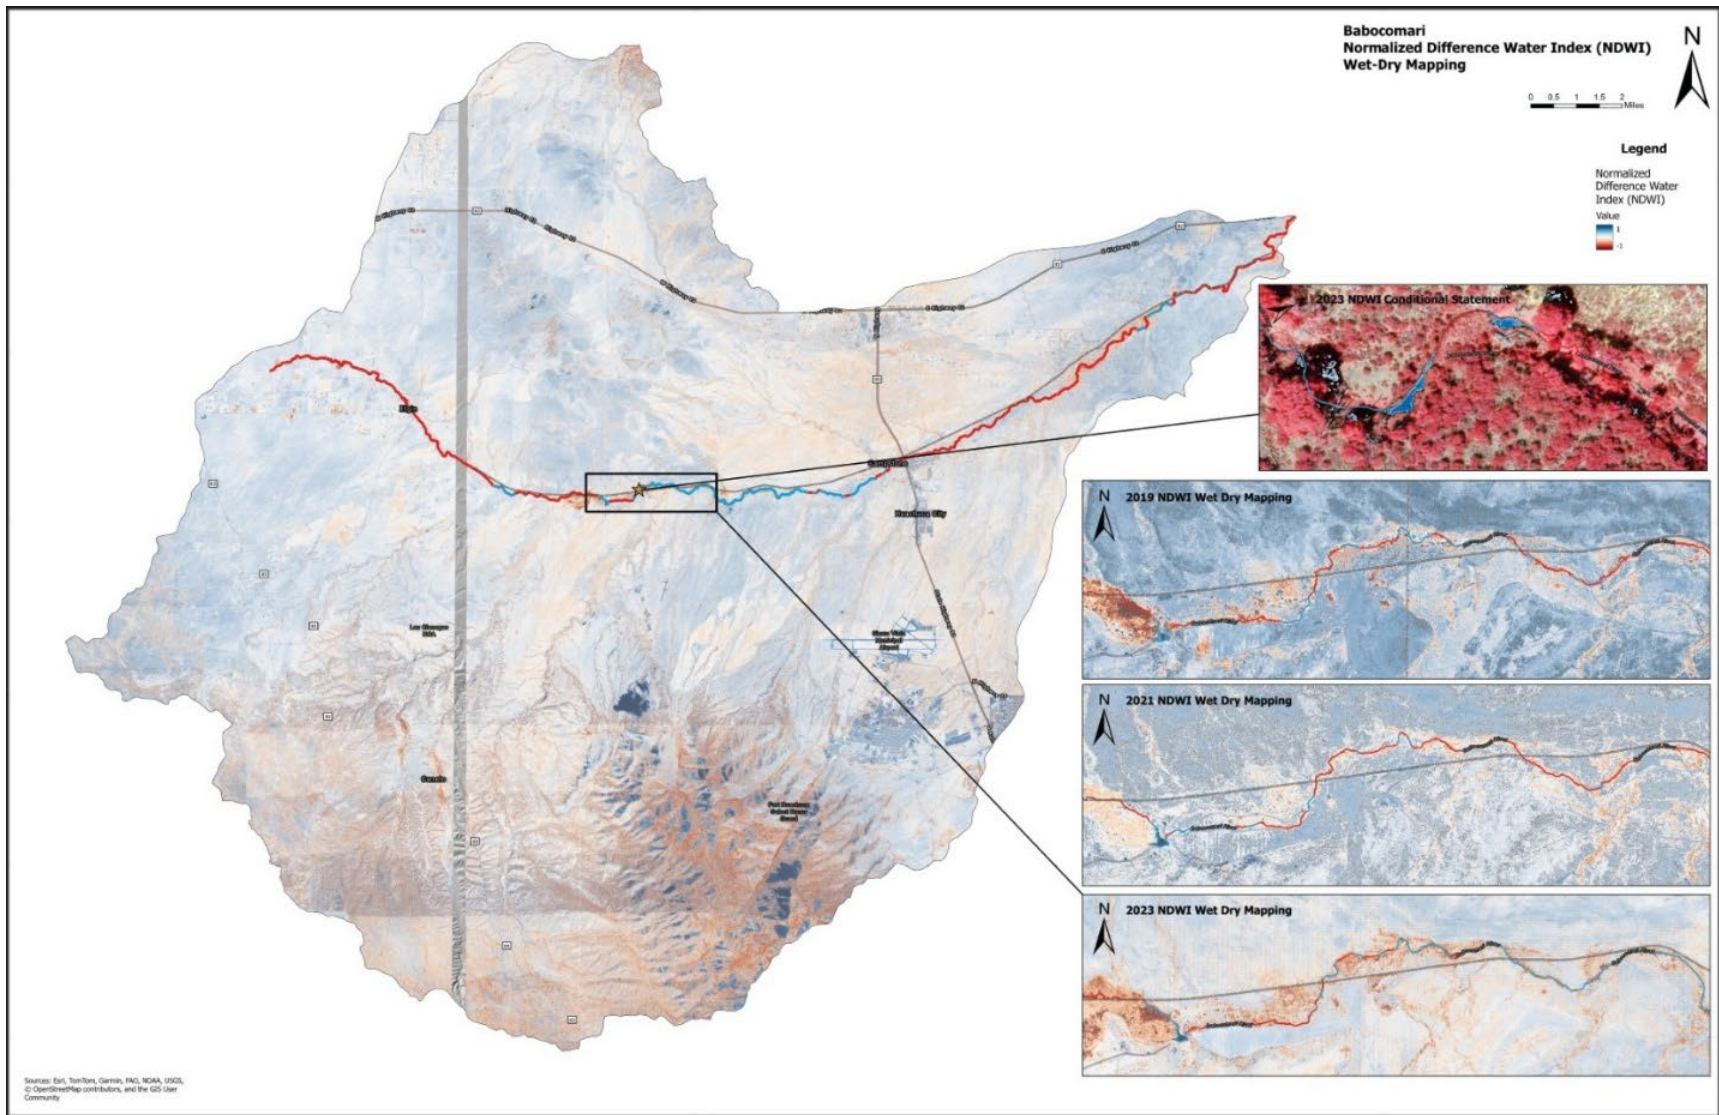
(July 2019, October 2021 and October 2023)

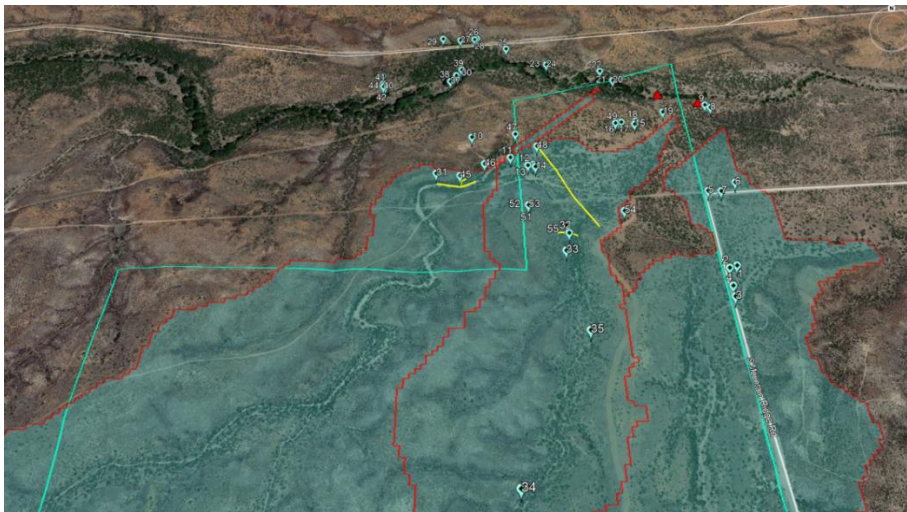
In Figure 3, the area to the right of the water tanks (on state land) is part of the Chase Emmerson property. This is a mesquite invaded grassland hosting cattle grazing, poorly drained roads, and failed water diversions. These feature concentrate stormwater flows, dry the landscape, and collectively put pressure on downstream headcuts.

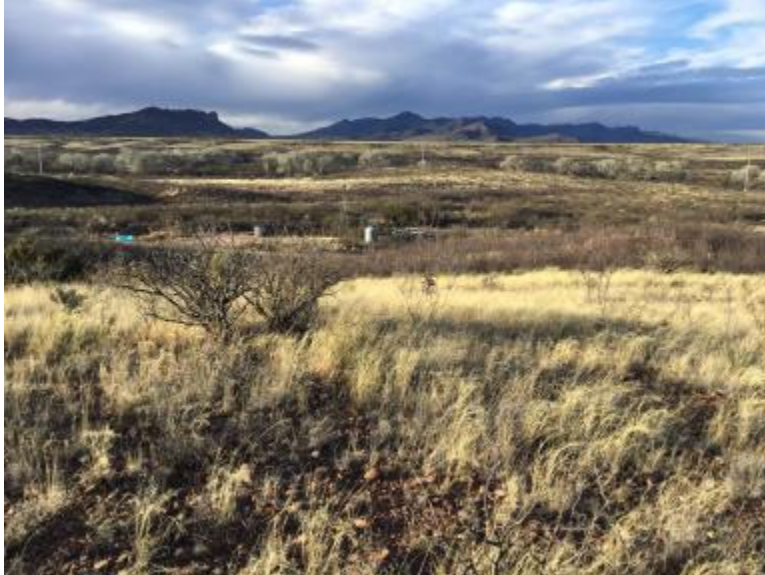
II. Ongoing Challenges

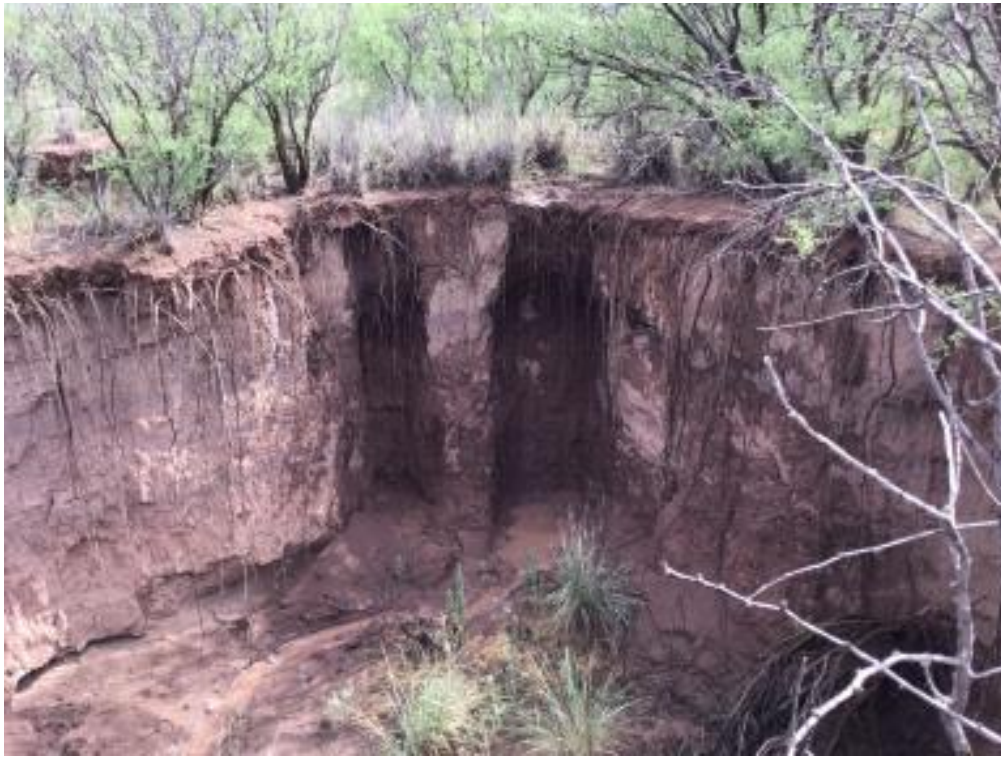
Figure 5: Drone imagery of Valley-eating headcut in the vicinity of Figure 4 and red dots in Figure 2

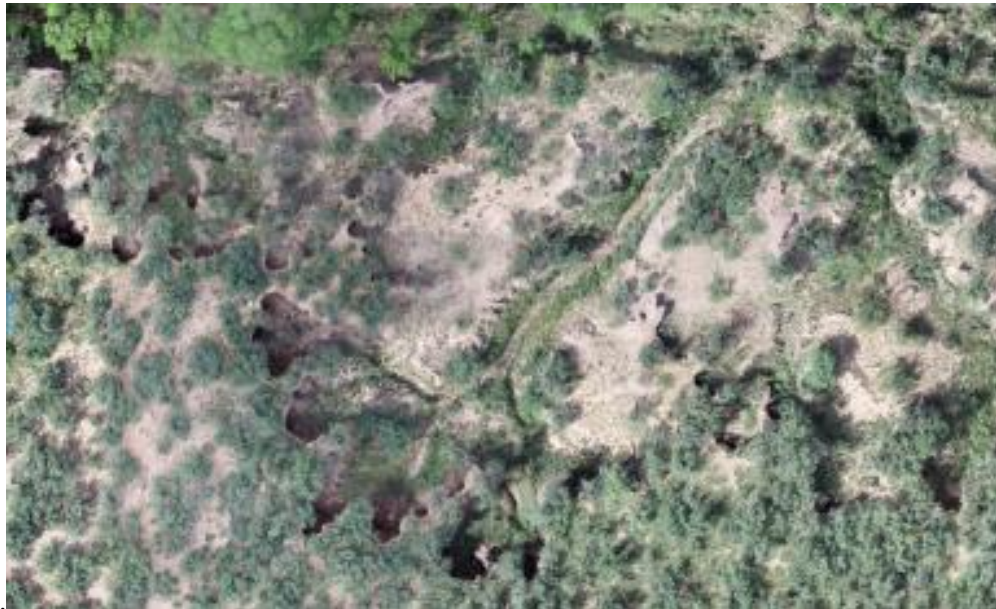
Figure 6: Google Earth screen capture near failed dam (GPS point 40) with cross section inset.

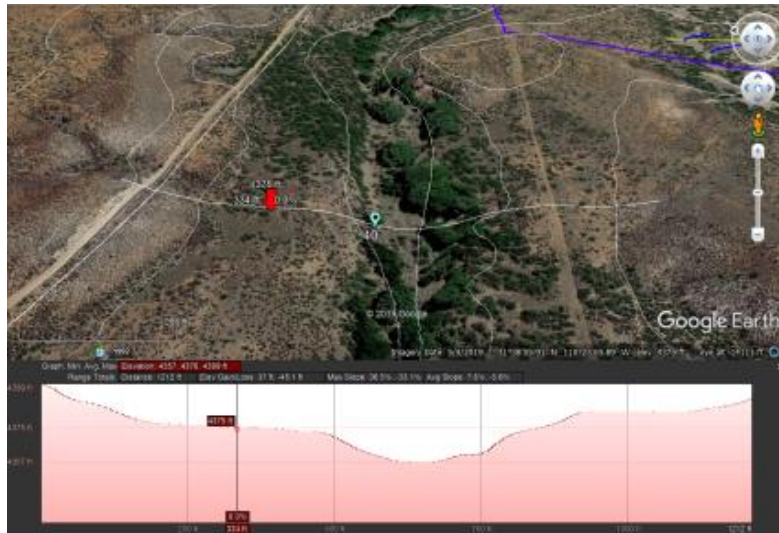
Tributaries draining into the Babocomari are also impacted by the historic downcutting. Within our study area, the ancient bajada created by the confluence of the alluvial fans of Blacktail Wash, Tributary 2, and Tributary 3 is now a hanging valley. Present day erosion is slowly cutting away at this bajada and creating a wide drop-off, or “Valley-Eating Headcut”. This erosion happens when surface flows arrive to the site of the drop-off, where they become waterfalls that scour material from the face and base of the drop-off, causing it to move upstream in response to hard rains (Figure 7). This is a natural geologic leveling of the landscape resulting from the watershed coming into equilibrium with recent land use practices and influences.

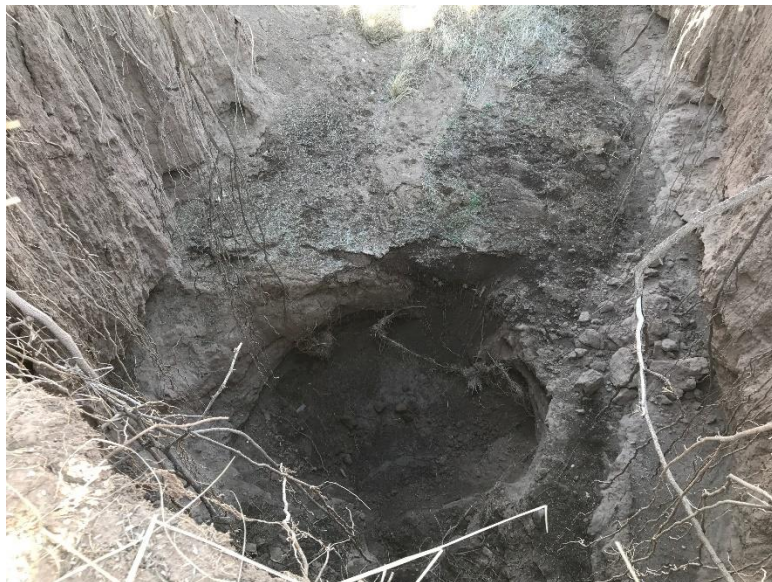
III. Suggested Remedies Summary

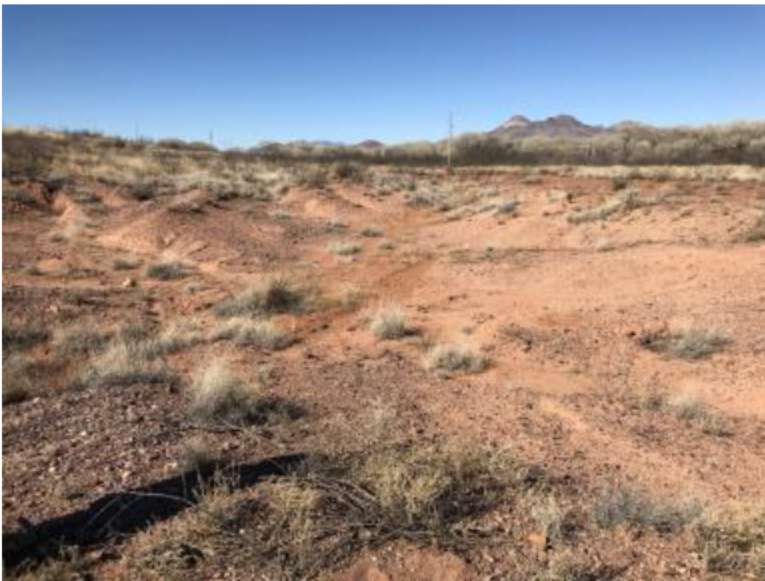
Eroded bowl contributing sediment to Tributary 3 (GPS point 10): This is a very small tributary valley on state land that is impacted by erosion. We speculate that this might be the route of a historic trail. One-rock dams in the mouth of this valley would cause it to aggrade and start to become grassed in again.

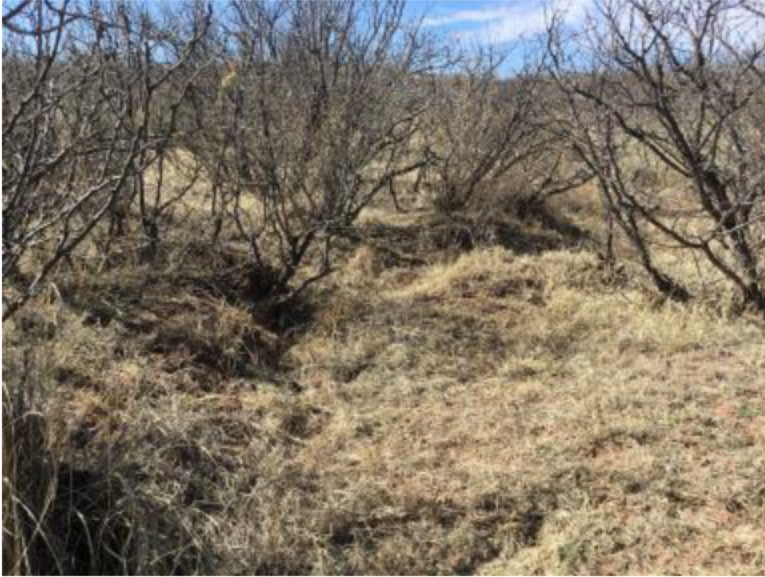
Old swale (GPS point 47): This is where the flows coming out of the bowl at GPS point 10 flow. This is a safe place for water to flow as it comes out at the angle berm discussed later.

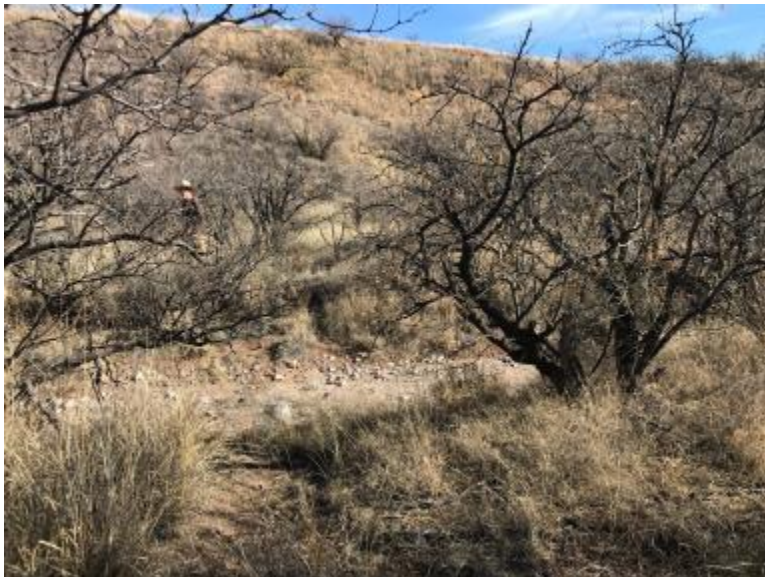
Van is standing in historic valley bottom (GPS point 34): This location is one-half mile up Tributary 2 from the road. Our walking tour discovered that this tributary has legacy issues due to old roads and trails that straightened the arroyo and caused it to downcut. At present, the drainage is trying to fix itself by eroding its banks and re-meandering. There are additional locations where the arroyo is still

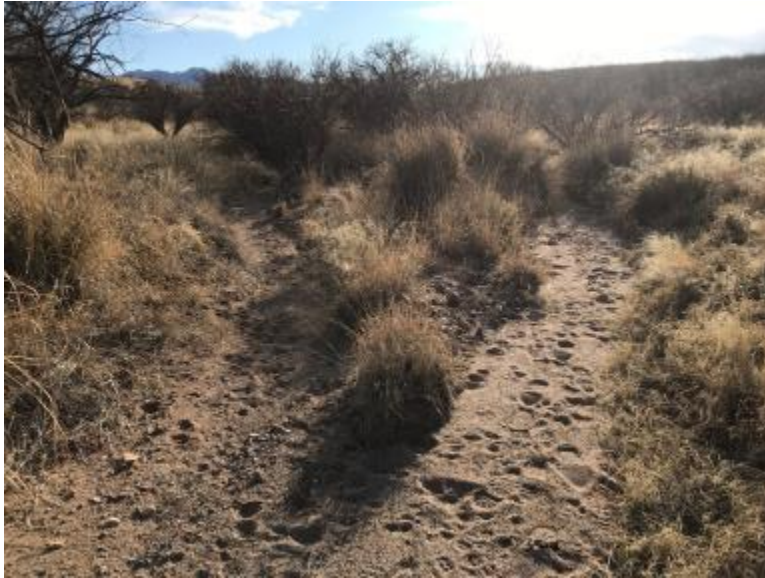
Historic valley bottom meets incised channel (GPS point 35): At a point several hundred feet upstream from here, small flows can escape the present day gully and flow along the historic valley bottom for several hundred feet. This area could use a more detailed survey to discern opportunities to enhance water harvesting and stability.

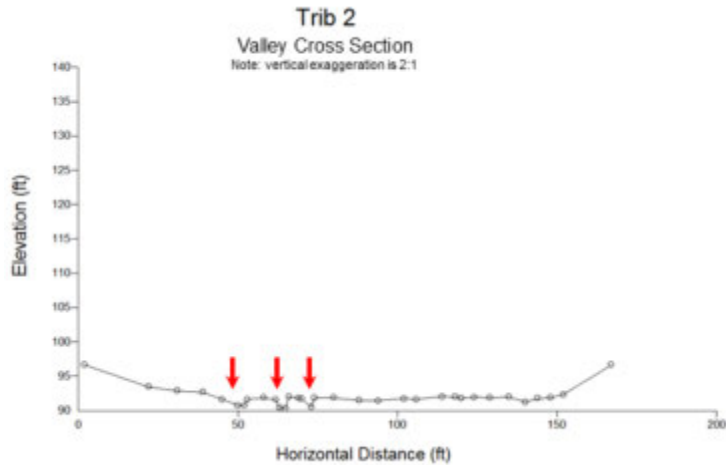
Tributary 2 cross section: The three red arrows represent three channels in a valley bottom that were probably caused by livestock trailing up and down the valley. We propose to correct this erosional issue by transplanting giant sacaton grass plants to plug these gullies in order to reinstate sheet flow.

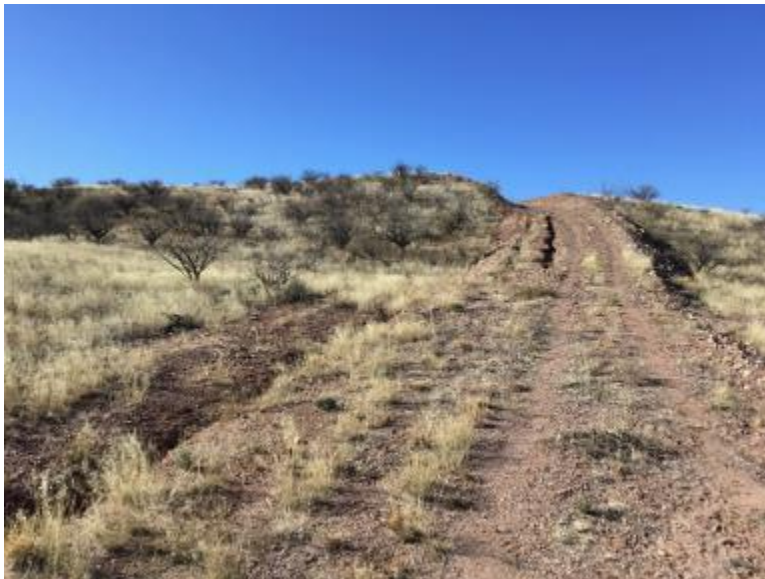
Significant erosion destroying steep road (GPS point 54): Poor drainage design is causing this road to self-destruct. We suspect these roads were installed immediately before the 2008 economic collapse. We propose to drain this road in three places to reduce its negative impact on the watershed with the understanding that if plans for the associated subdivision restart, it could pose serious challenges for the watershed especially if careful consideration is not given to increased runoff and proper spreading of downstream flows through fragile soils.
