**Arizona Water Protection Fund
Application Cover Page
FY 2026**

<table><tr> <th style="text-align: left;"><u>Applicant/Agency/Organization:</u></th> <th style="text-align: right;"><u>Amount (\$):</u></th> </tr></table>

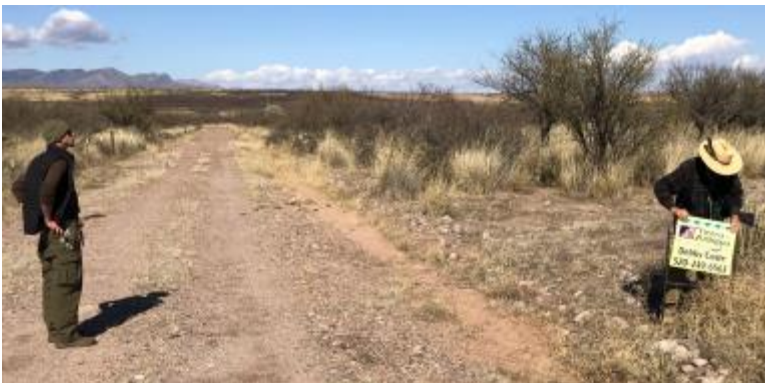
Blacktail Wash is captured in roadside ditch (GPS point 3): Our survey suggests that the flow from the wash crossed the alignment of the present day road toward a tank at GPS point 7. When the road was built, flow from Blacktail Wash was captured in a roadside ditch, causing erosion and sedimentation of the road in addition to increasing the rate of delivery of surface flows to the downstream valley-eating headcut (GPS Point 9). We propose to properly drain this road with a series of rolling-dip road drains to optimize water spreading and relieve the road from associated drainage issues.

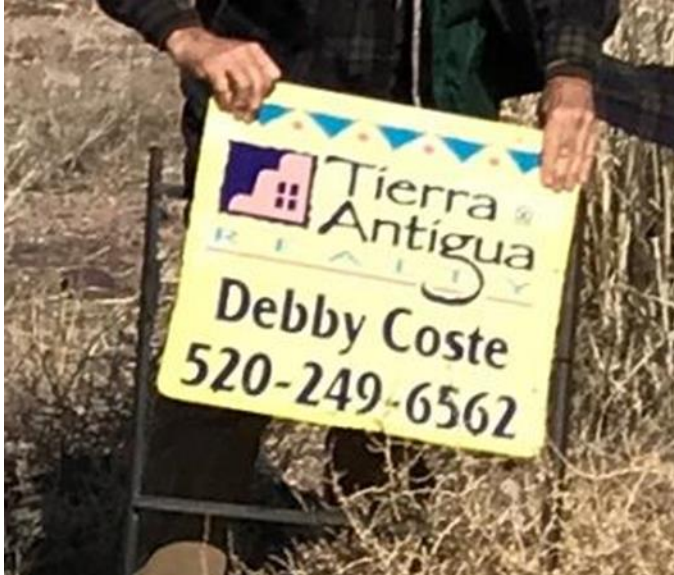
Looking down road. Sign has contact info for realtor. (GPS point 4): Since this road is not on Mr. Emerson's property, repairs would require approval from the adjacent-property owner. Perhaps Ms. Debby Coste could help us secure permission from this property owner to facilitate our prescription to relieve pressure on the valley-eating headcut.

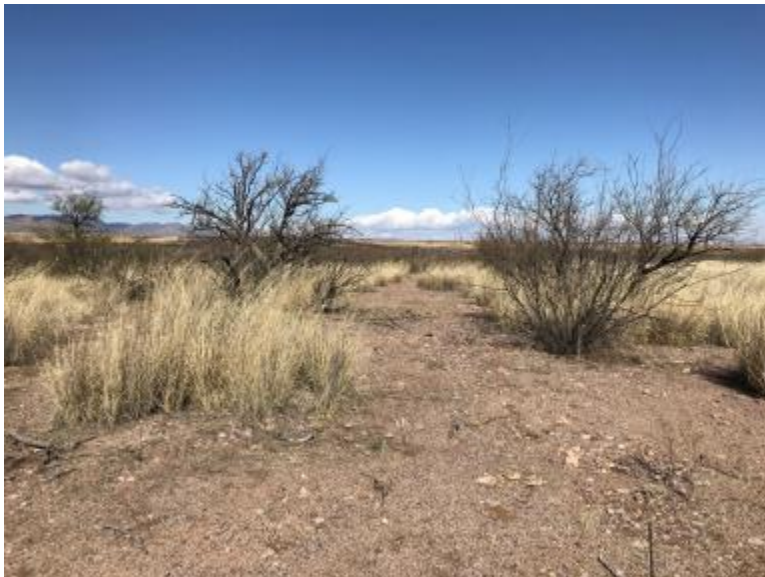
Location where we propose diverting water from the road ditch (GPS point 1): GPS point 1 is to the east of the road. It would be relatively easy to design and build rolling dips on the road to redirect the flow to a safe place where the water could slow down, spread out, and sink into the ground more than it currently does, thus relieving pressure on the valley-eating headcut.

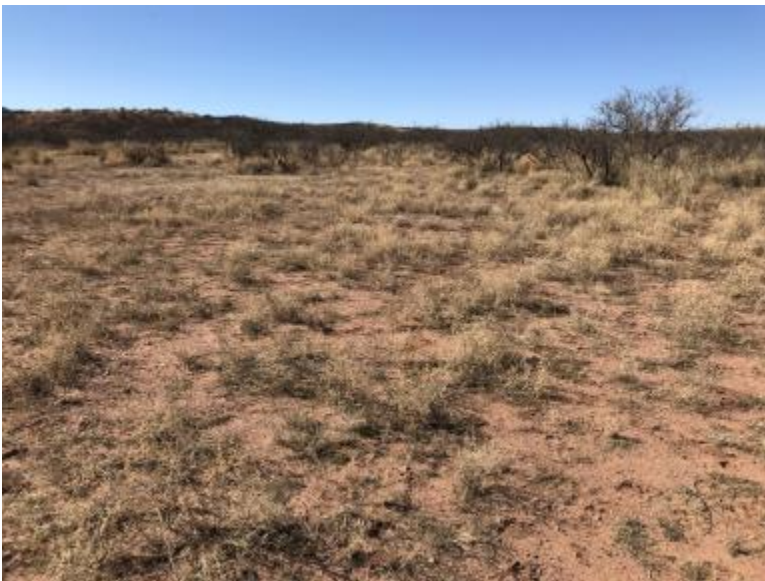
Preferred site to spread water diverted by upstream projects (GPS point 15): In this vicinity, we mapped an area of approximately 3 acres where we propose to uproot mesquite trees so that we can host a keyline plow and seeding project to optimize infiltration and grass regeneration.

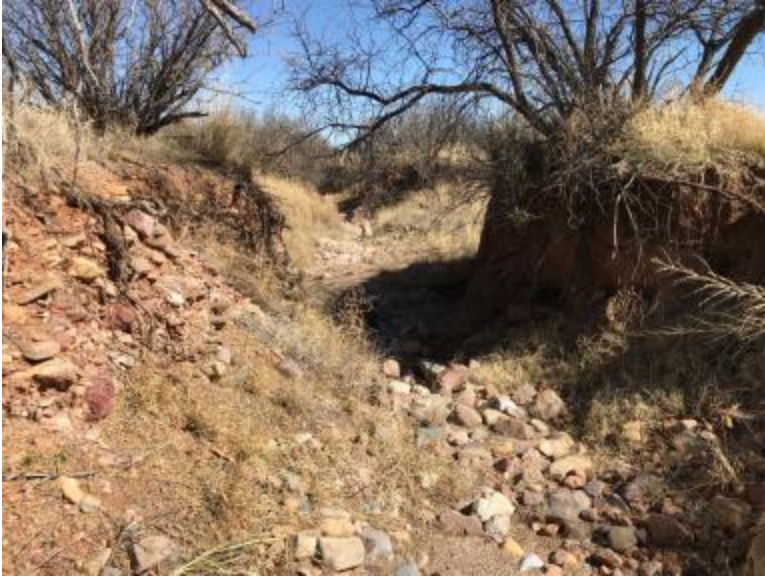
Location further downstream in collector channel (GPS point 18): Within the channel at this location we propose to use existing boulders to build grade controls such as one rock dams and Zuni bowls by hand.

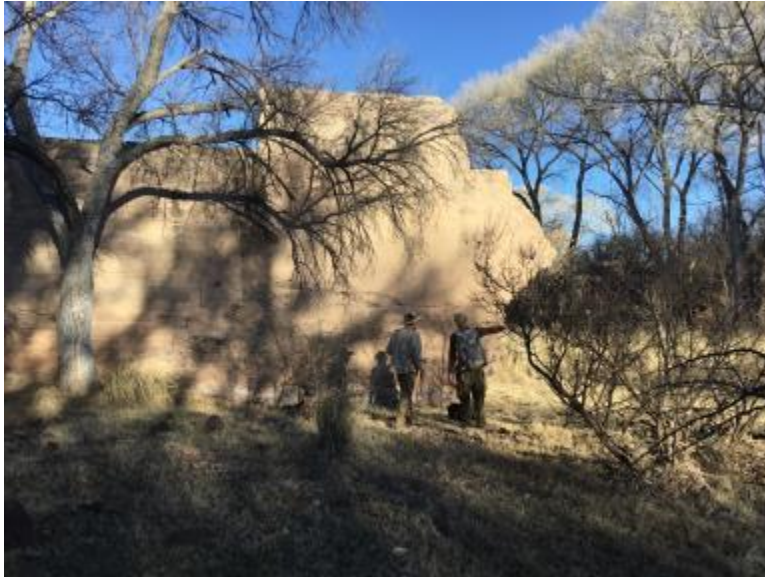
Historic infrastructure (GPS point 40): This is an old dam across the Babocomari. ADEQ communication with the property owner suggests this one of many features installed throughout the area to help mitigate soil loss between 1935 and 1940. Features on the concrete suggests it was keyed into both banks of the stream channel at the time of construction. We suspect this feature was likely overtopped early in its career resulting in catastrophic failure and causing the right bank to erode significantly while contributing a huge sediment load to the system. At present, the right bank of the Babocomari is over 200 feet away from the concrete dam. The feature is still keyed in to bedrock on the left bank.

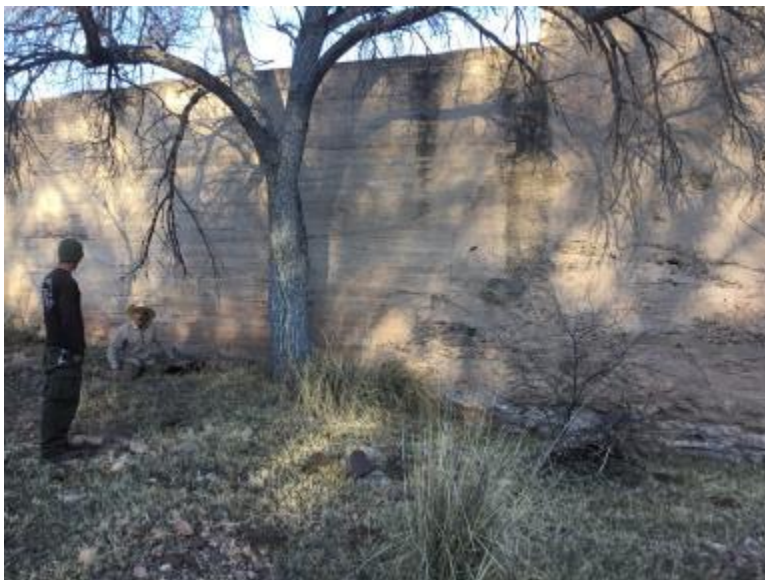
Drainage pipe at base of old dam (GPS point 44): We suspect the original engineers planned to relieve base flow of the flashy desert stream through this 9" diameter pipe at the base of the dam where Van is sitting. ADEQ informs us that the contributing watershed area at this location is 168 square miles.

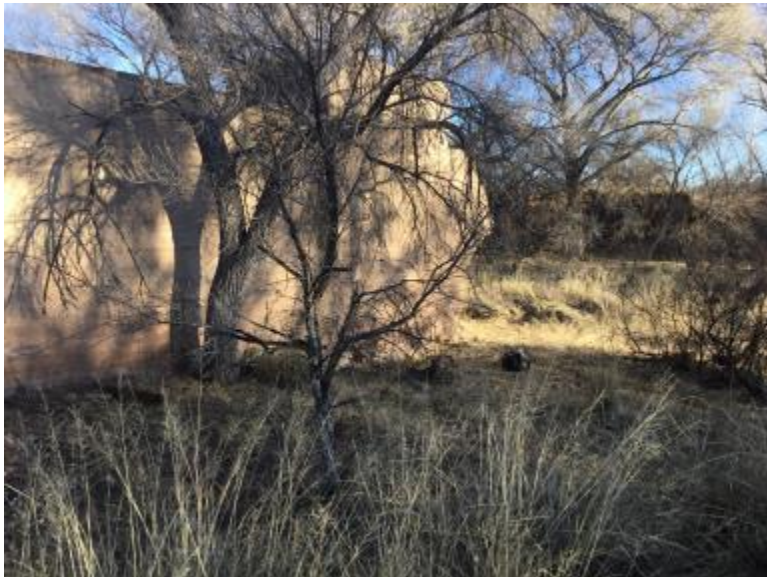
Showing how far right bank has eroded since dam failure (GPS point 41): The right bank is now over 200 feet south of where it was the day of construction of this legacy infrastructure.

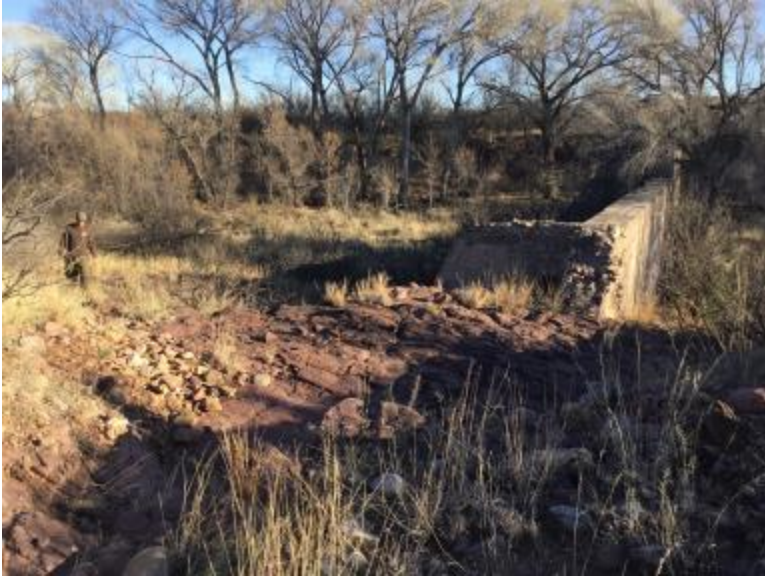
Dam where it is still keyed into left bank of Babocomari (GPS point 43): Here, we found evidence that the spillway was overtopped before any sediment was trapped behind the dam (i.e. the dam failed during the first significant flow event).

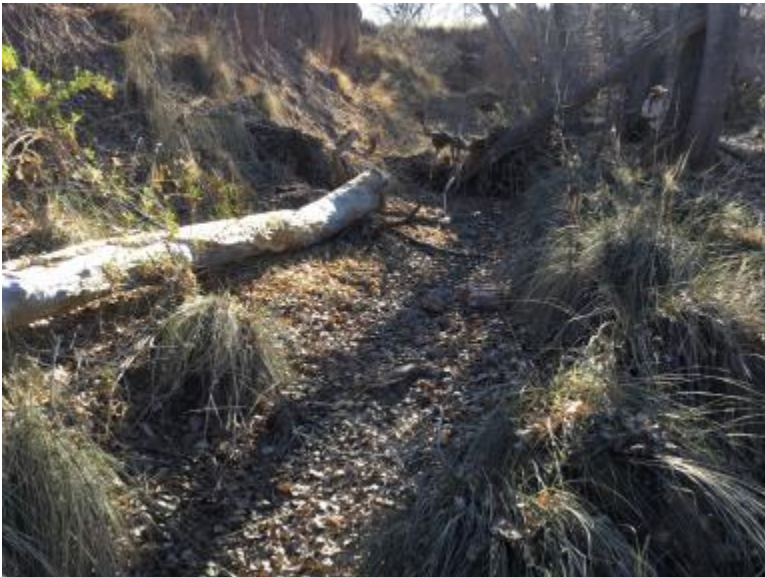
Observed debris in channel upstream of headcut (GPS point 37): The channel may be stable against downcutting at this point due to a bedrock outcrop downstream from here. In order to monitor the channel morphology, we suggest installing several monumented cross sections on Brophy property with landowner permission.

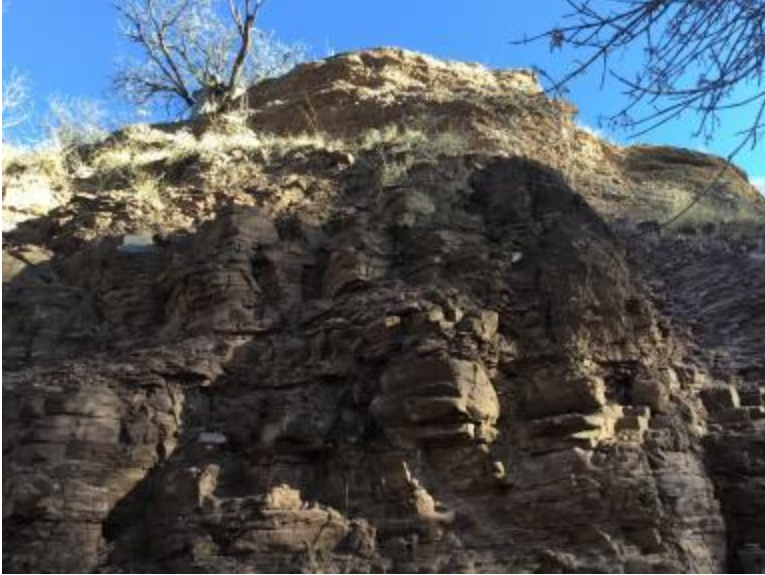
Channel is against stone toe of valley (GPS point 38): We are uncertain if this stone outcrop runs across the creek bottom under a thin layer of alluvium or not. This merits further investigation since it may influence strategies for grade control and headcut relief.

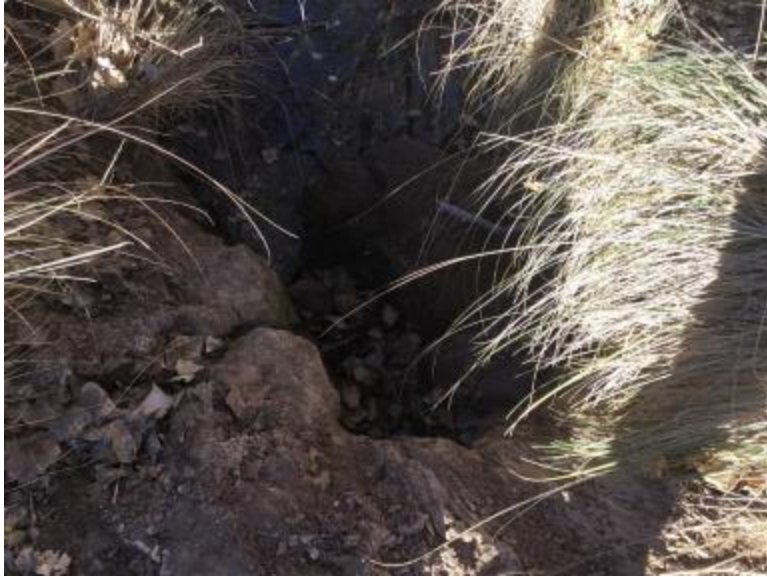
Looking down into the major headcut (GPS point 39): If this headcut is not self-stabilizing, this could pose an extremely serious resource damage point that could threaten stream channel stability, groundwater level, and water quality through increased sediment contributions. We recommend further investigation of the geology to better understand if grade control is happening naturally.

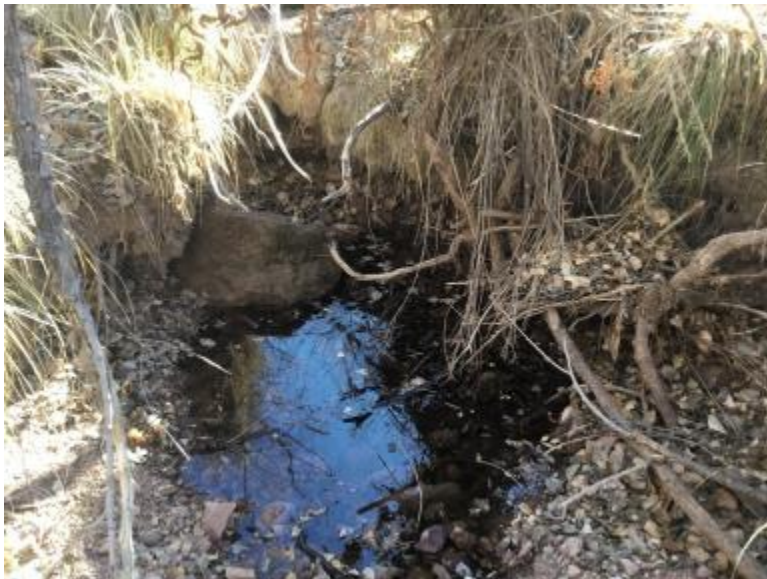
Water table elevation in headcut (GPS point 36): This is the only place we saw surface water in the Babocomari on January 28, 2020.

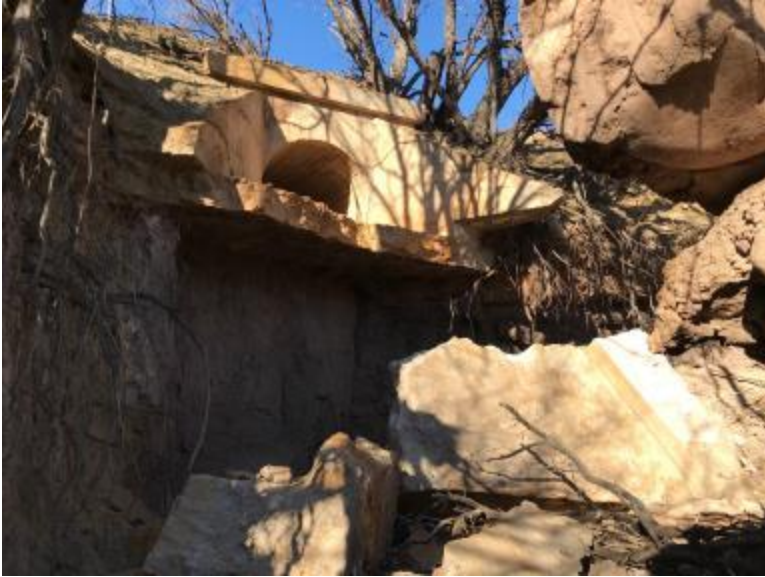
Failing railroad culvert and massive erosion (GPS point 28): The installed splash pad was not engineered to handle the respective flow concentration from this culvert. The splash pad was laterally flanked, causing flood flows to erode the fine grained soil resulting in catastrophic failure.

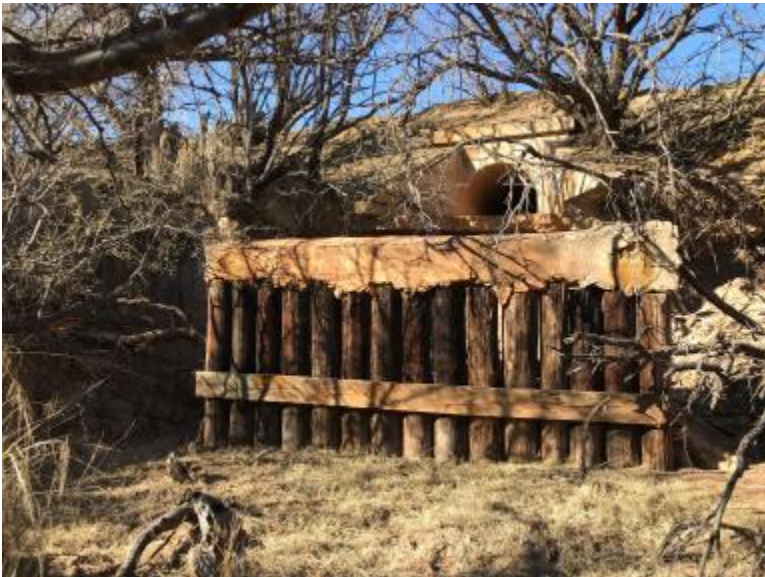
Another view of old railroad culvert (GPS point 26): This shows a post and concrete splash pad that has now collapsed 20 feet behind the structure.

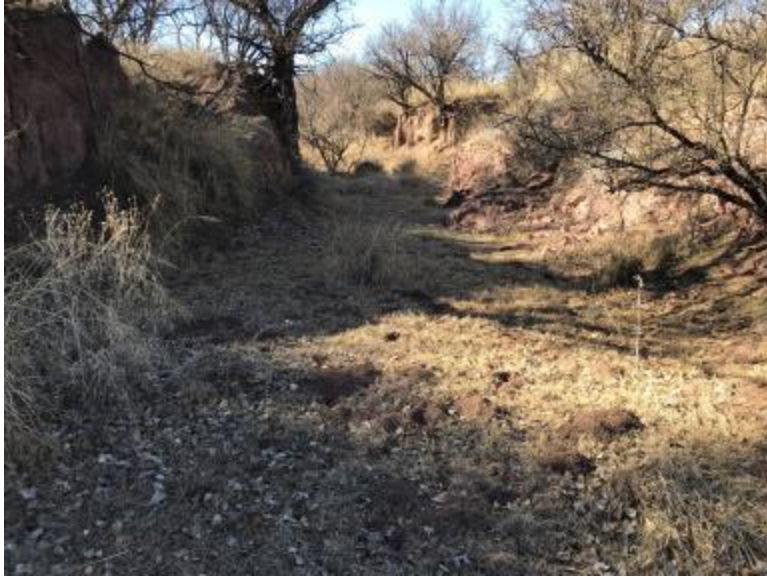
Looking upstream at incised tributary caused by railroad (GPS point 25): Flows from the respective culvert contributed to downcutting resulting in this massive headcut.

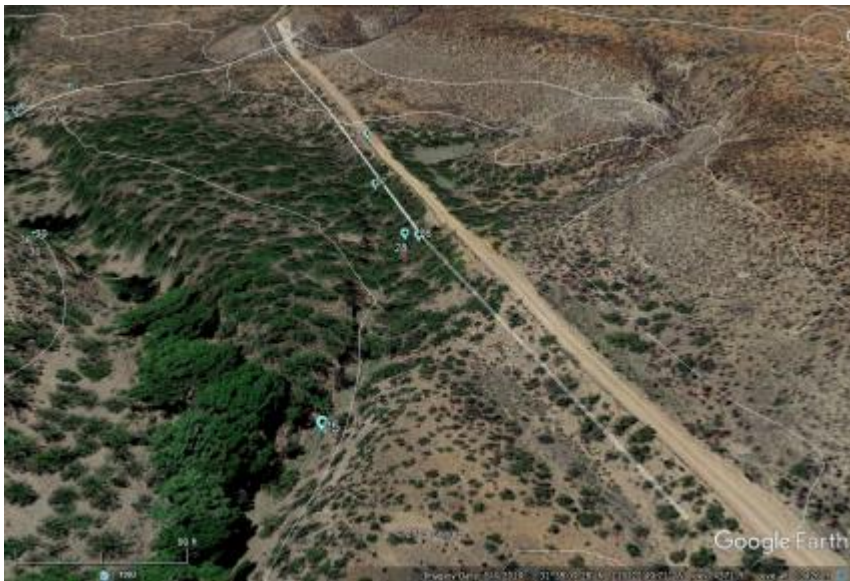
Google earth screen capture showing how the railroad-caused gully has a positive feedback loop with the incision of the Babocomari, creating an entirely different landscape.

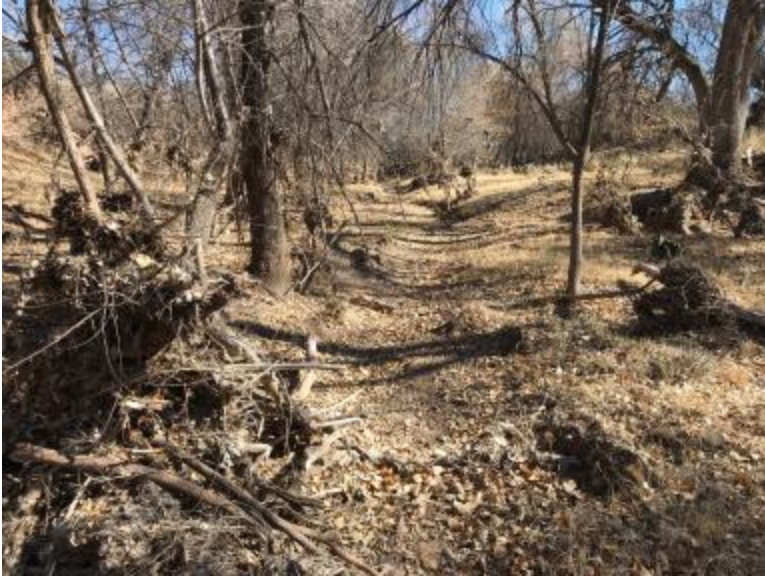
Babocomari has stabilized within historic incision (GPS point 22): The Babocomari has incised approximately 18 feet over the many years since the heavy handed manipulation of the stream channel. It has finally reached a new equilibrium by eroding laterally to create a tiny floodplain within the incised channel. This stability may be threatened by headcuts and [lack of] land management in the upper watershed.

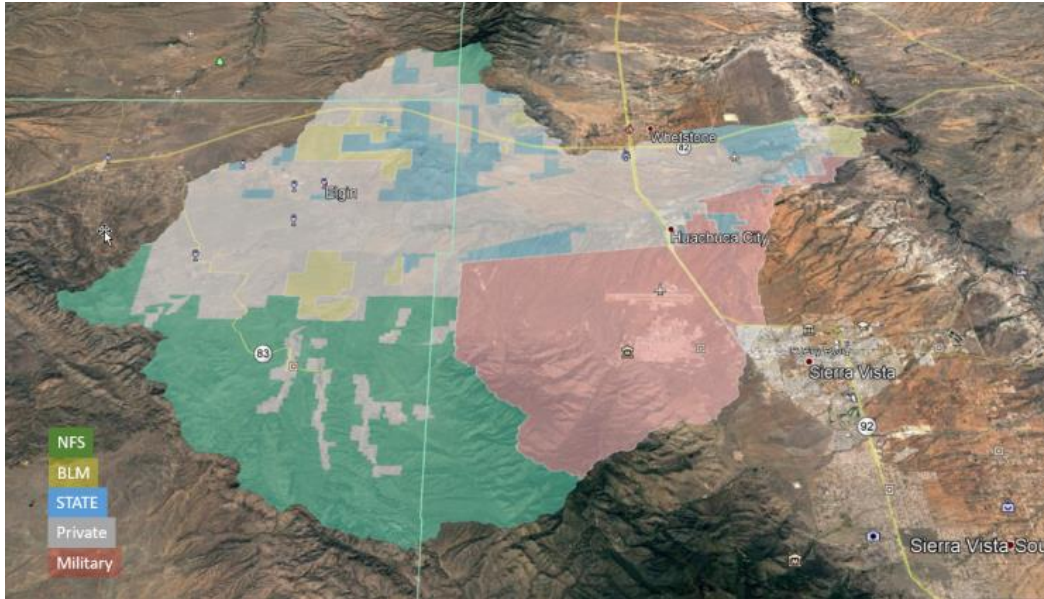
The associated potential for soil compaction, decreased land cover, and improper road maintenance are root-cause factors that can realize watershed-scale impacts beyond the local benefits of the modest project like the one presented here. We understand that recreational and agricultural activities support local and state economies through permit, lease, and commercial revenues, but also recognize that respective activities can realize significant costs requiring intervention.

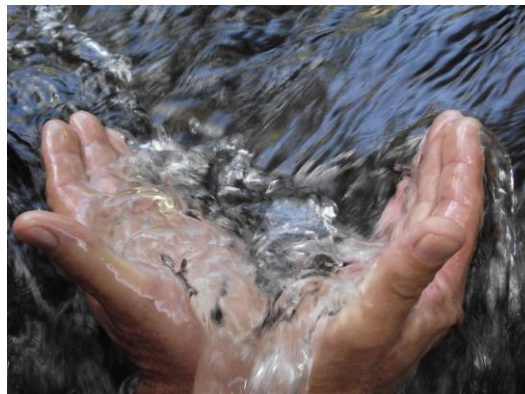
In regards to a recommendation for a sustainable strategy moving forward, we suggest evaluating agricultural and recreational receipts against the investments required by ADEQ for restoring watersheds in areas impacted by associated activities. We recommend you then engage with partner agencies and stakeholders regarding ADEQ investments so that more sustainable and equitable policies can be developed moving forward. By approaching these challenges holistically, we believe you will create an environment that will ensure the benefits of this project can stand out as an example that can be replicated and sustained over time.

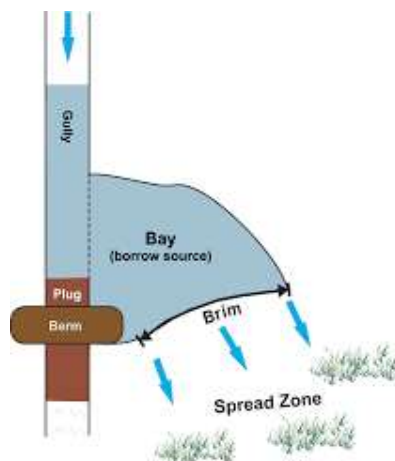
There are three alluvial fans that are a priority for repair. The most damaged, and therefore highest priority, is in the tributary we refer to as C2, followed by C4 and C9.

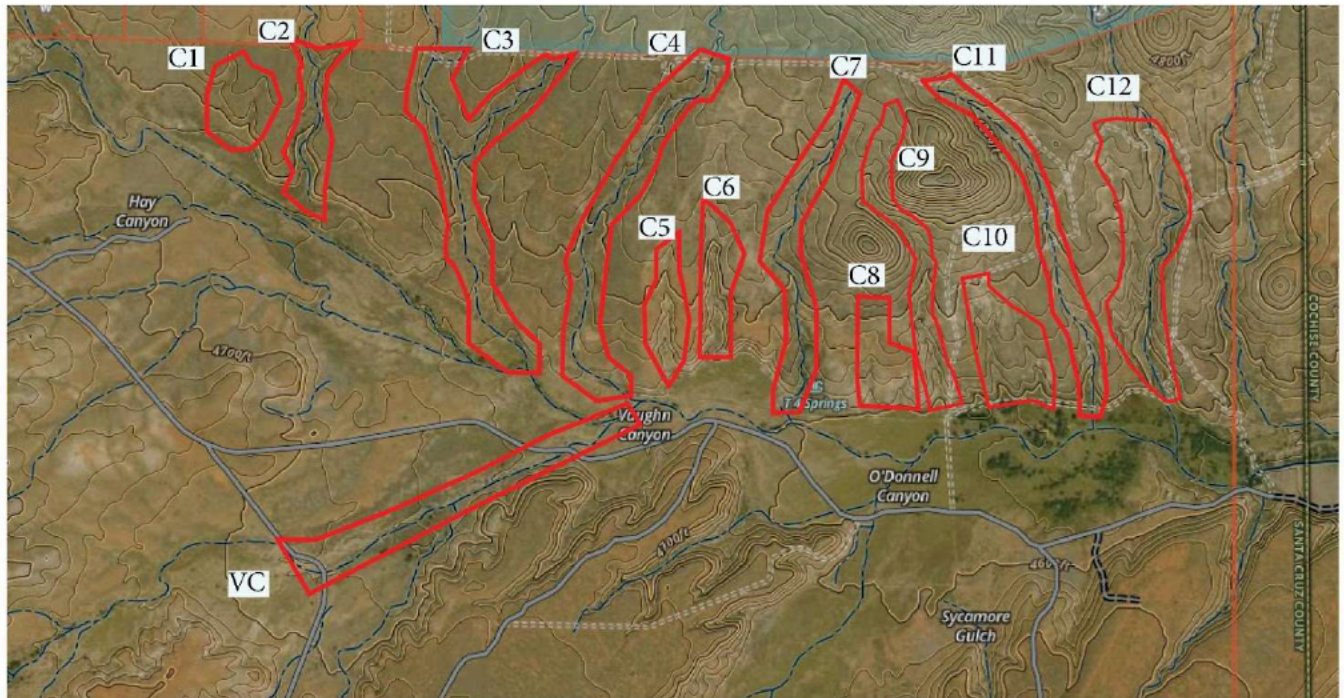
C1. The first set of channels that we have been tasked to look at begins near the westside of Babacomari Rd. Road work needed to the north, headcuts at the top and bottom. This cluster of 3 drainages have similar patterns. Relatively short length of channel with opportunities in the uplands before the channelization begins to keep the water up longer. Headcuts tend to follow with a transportation zone that is slightly incised that leads to a partial intact alluvial fan. We suggest that the fan be restored.

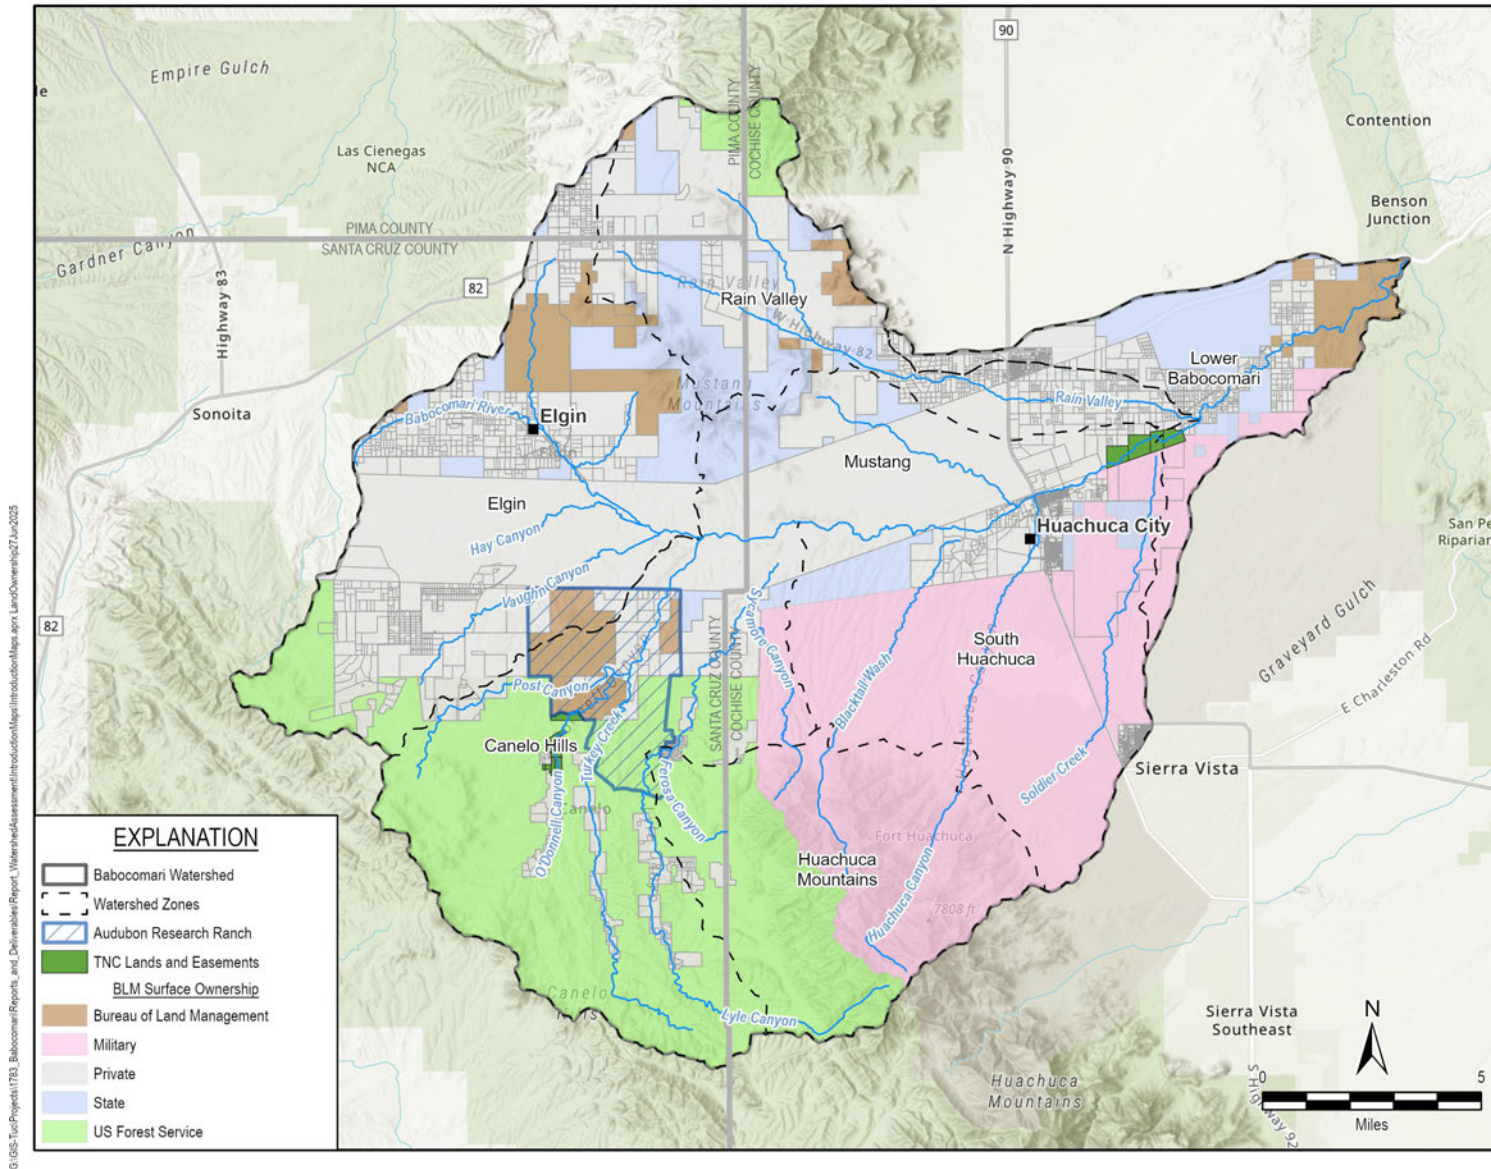
Figure 1. Watershed Features and Land Ownership

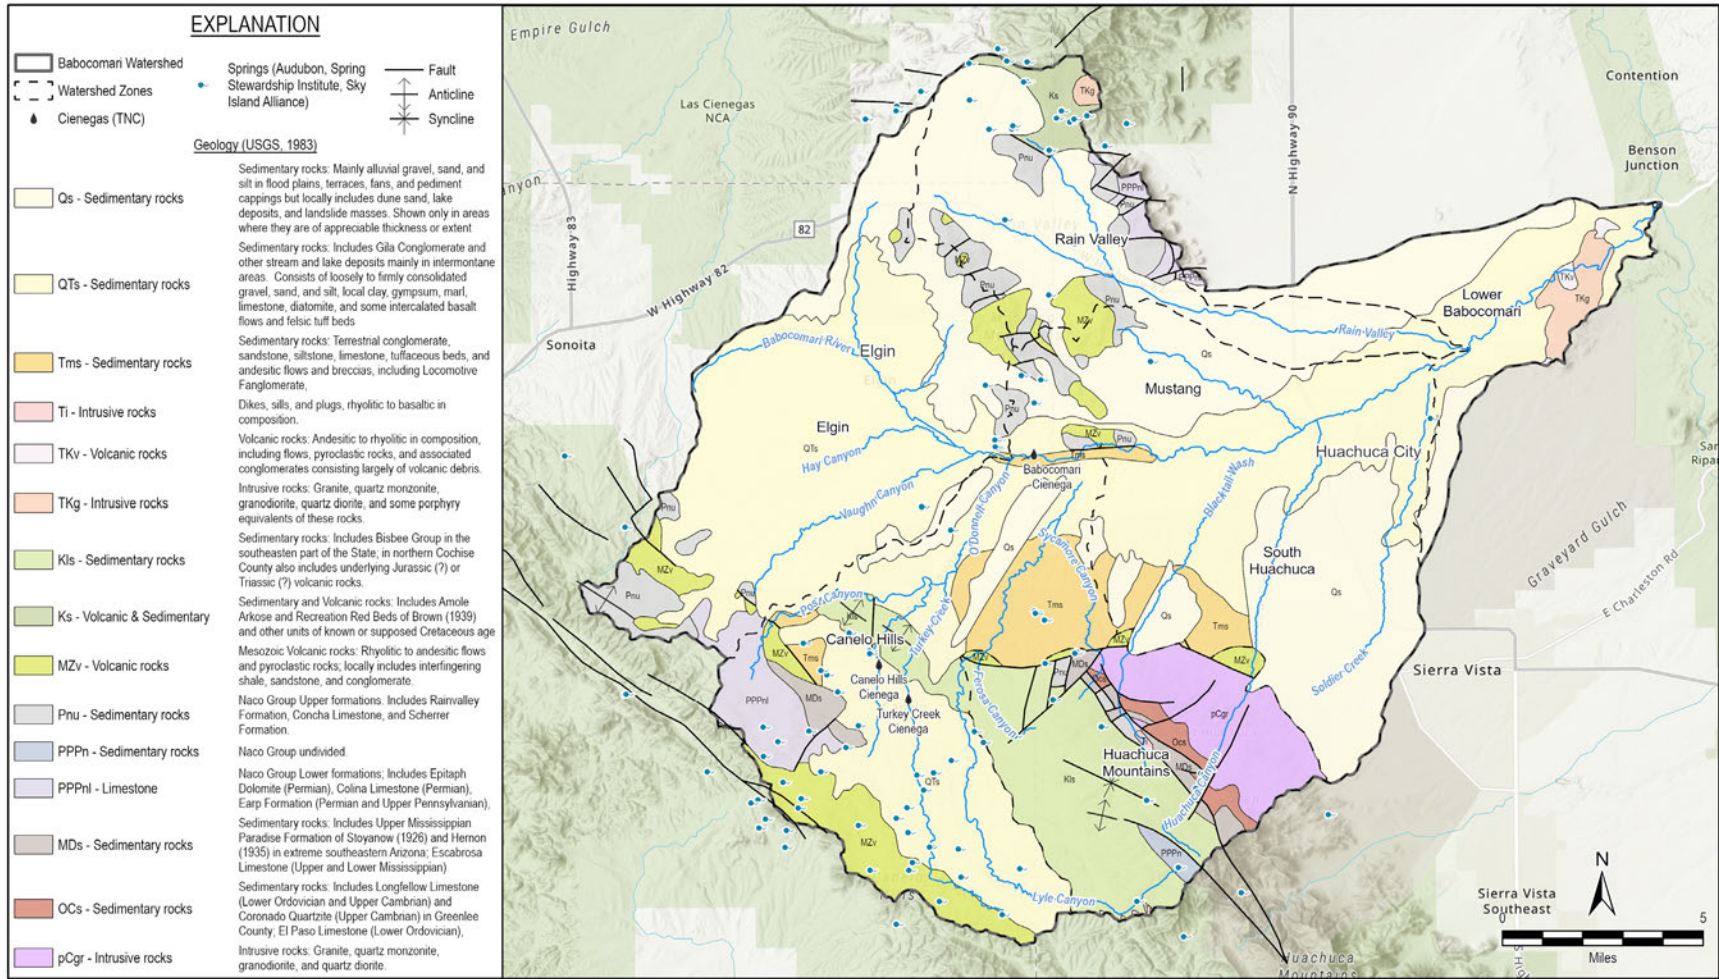
Figure 4. Geologic Map with Locations of Groundwater Dependent Ecosystems

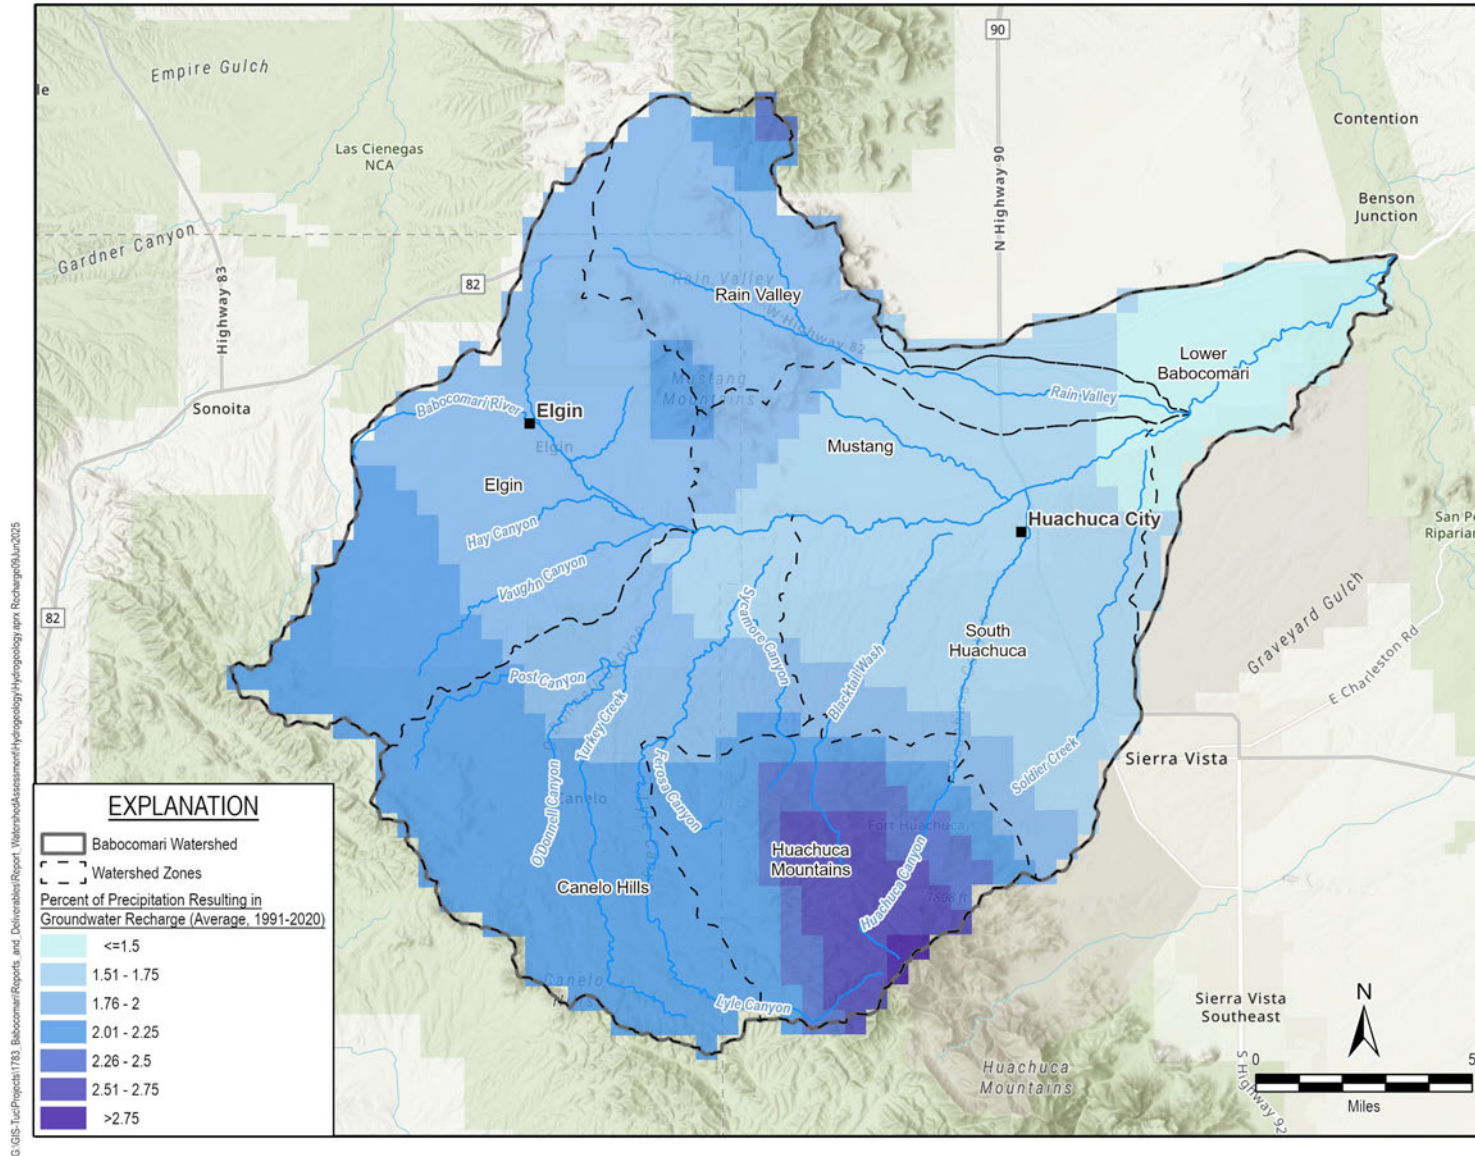
Figure 6. Percentage of Precipitation Resulting in Groundwater Recharge

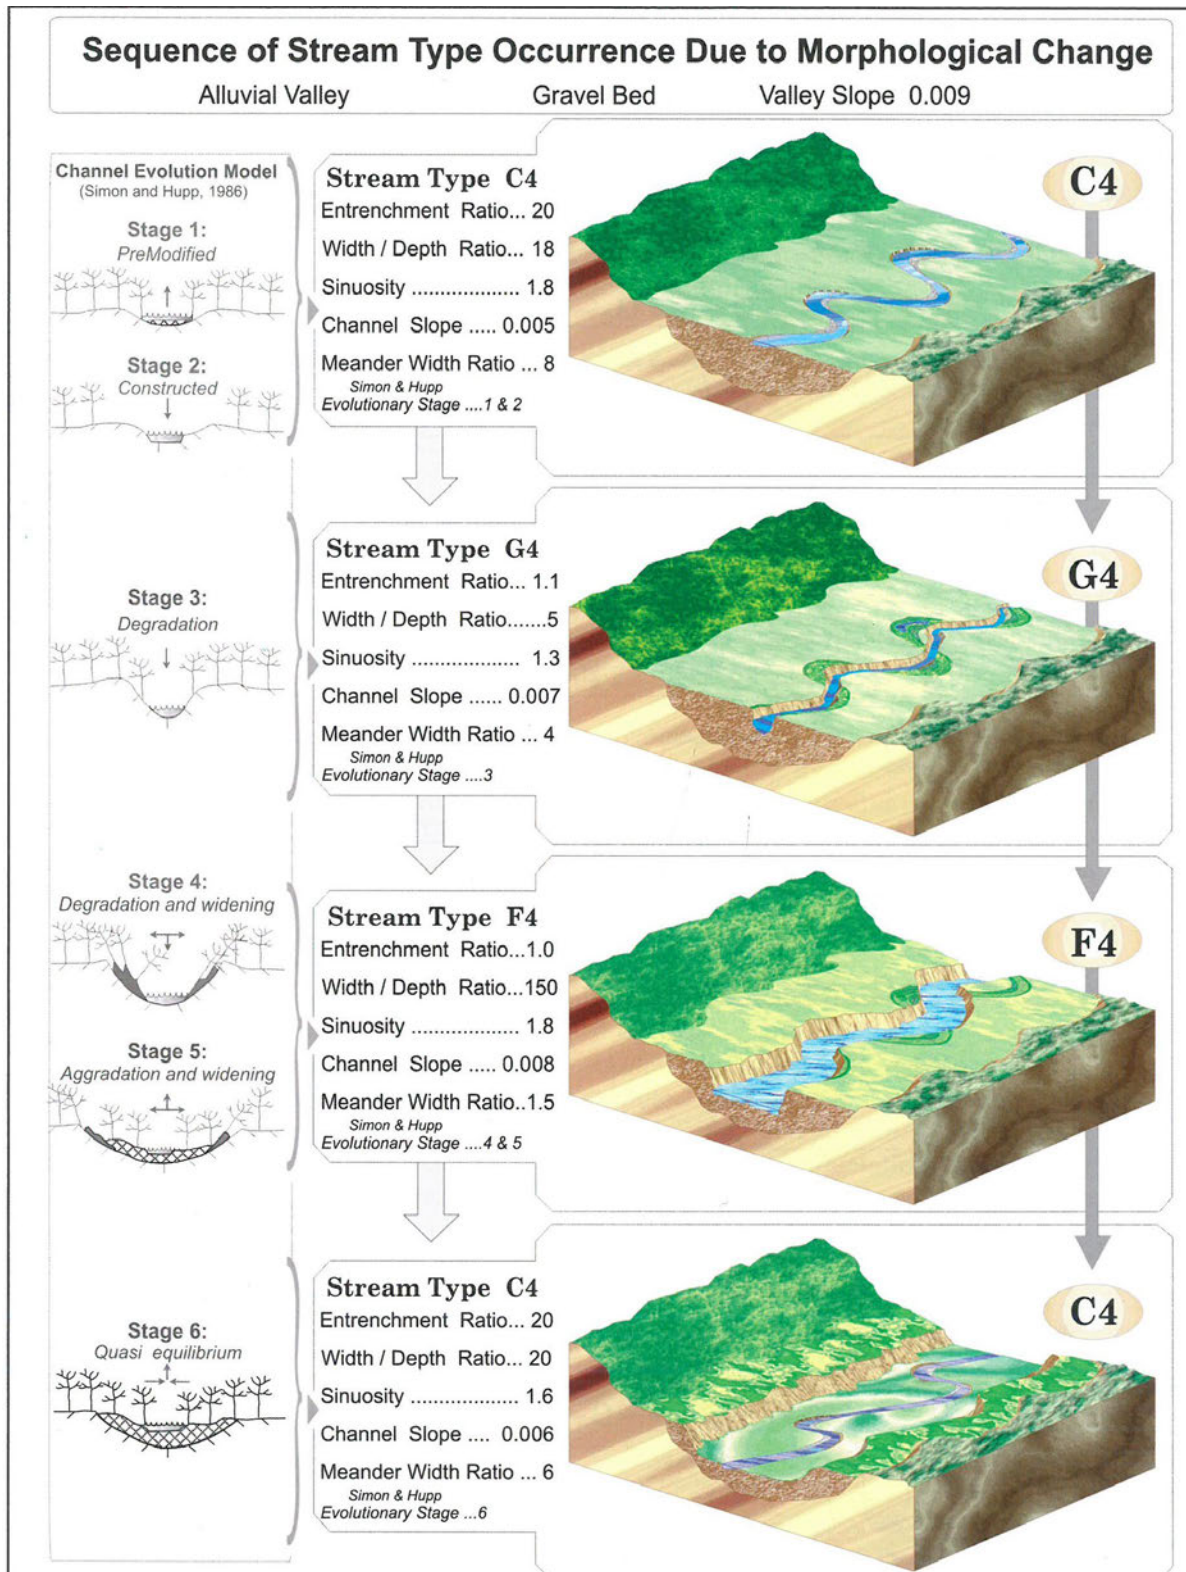
Note: modified from Simon and Hupp (1986) and Rosgen (1999)

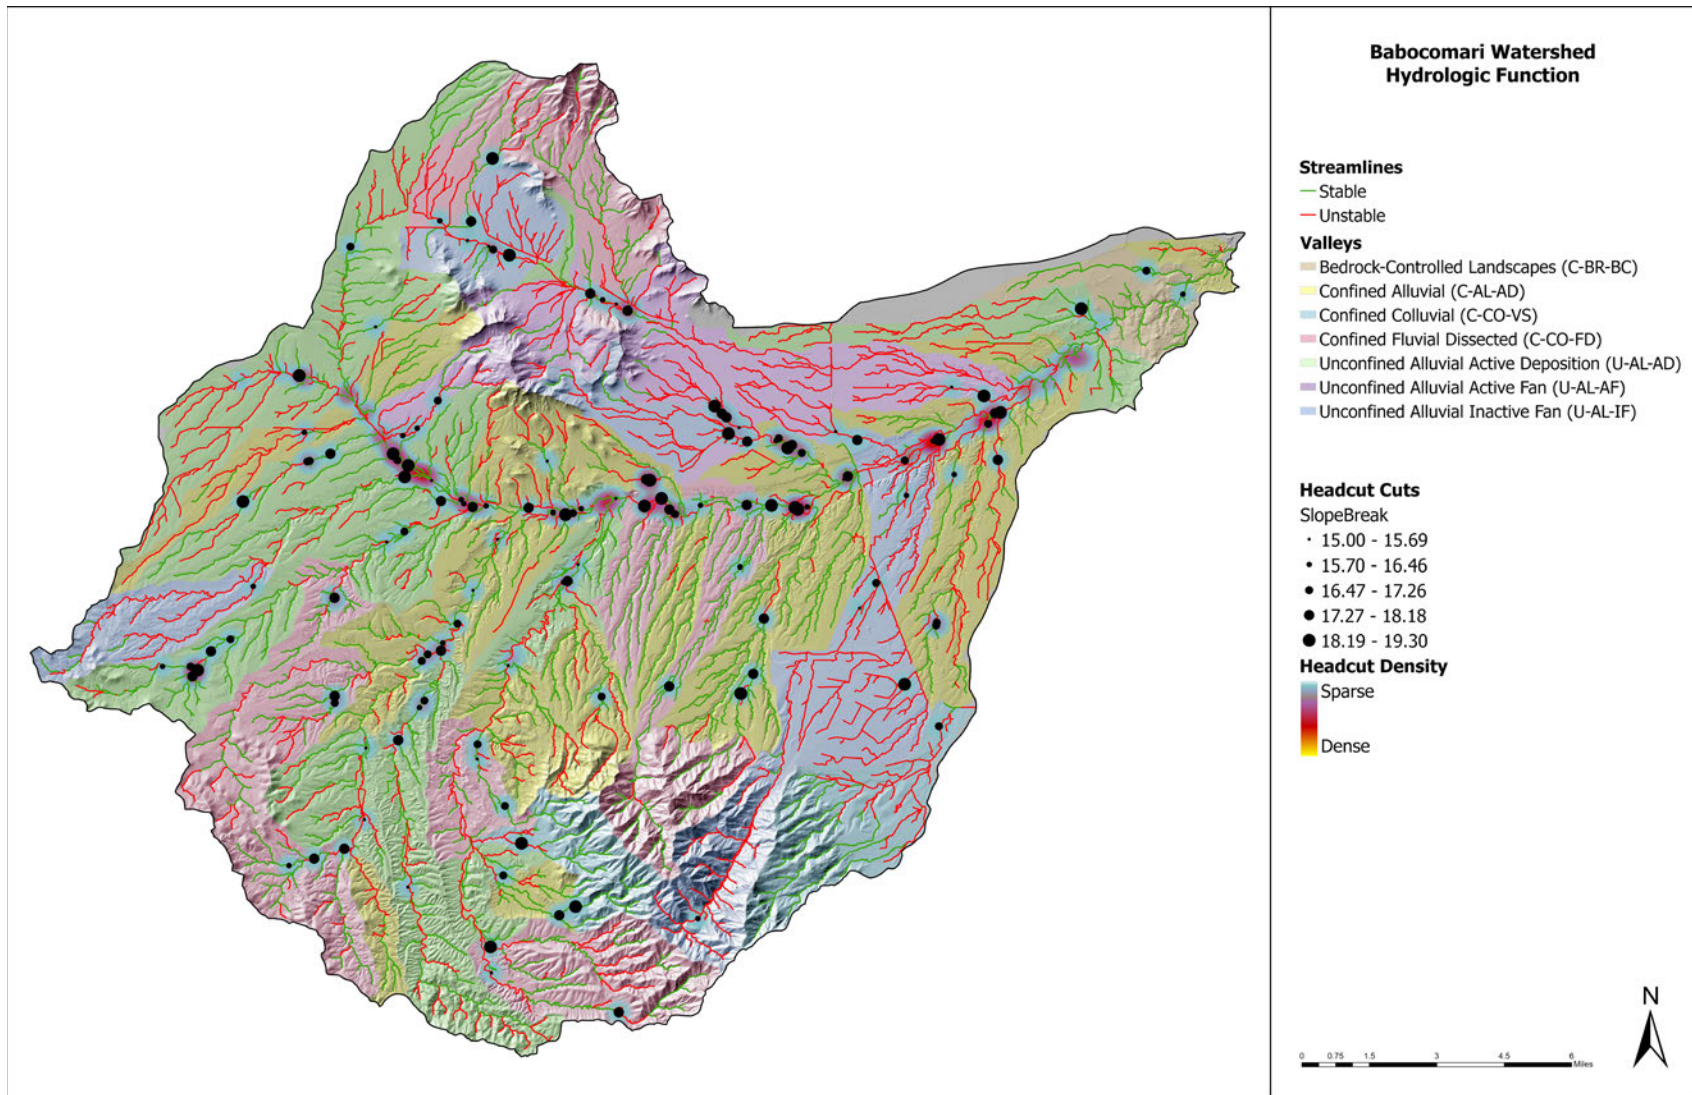
Figure 8. Valley and Channel Type and Locations of Headcuts

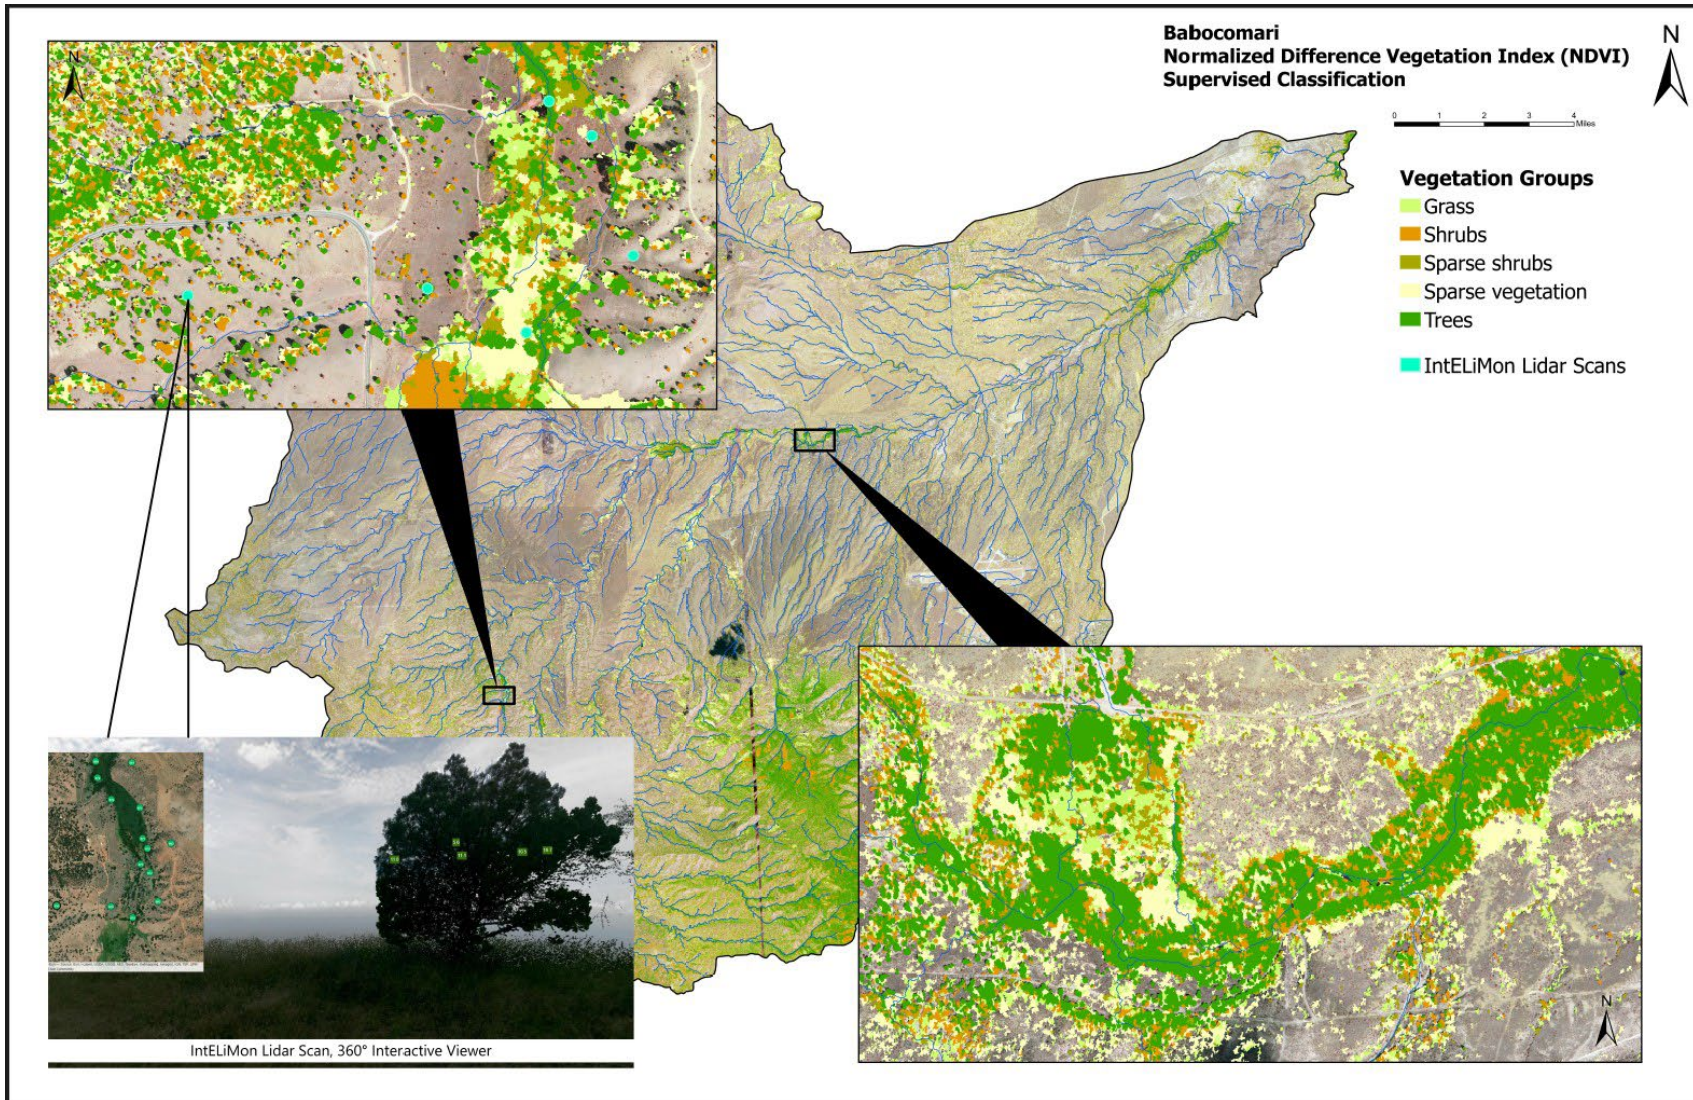
Figure 10. Vegetation Classification
