**Arizona Water Protection Fund
Application Cover Page
FY 2026**

<table><tr> <th style="text-align: left;"><u>Applicant/Agency/Organization:</u></th> <th style="text-align: right;"><u>Amount (\$):</u></th> </tr></table>

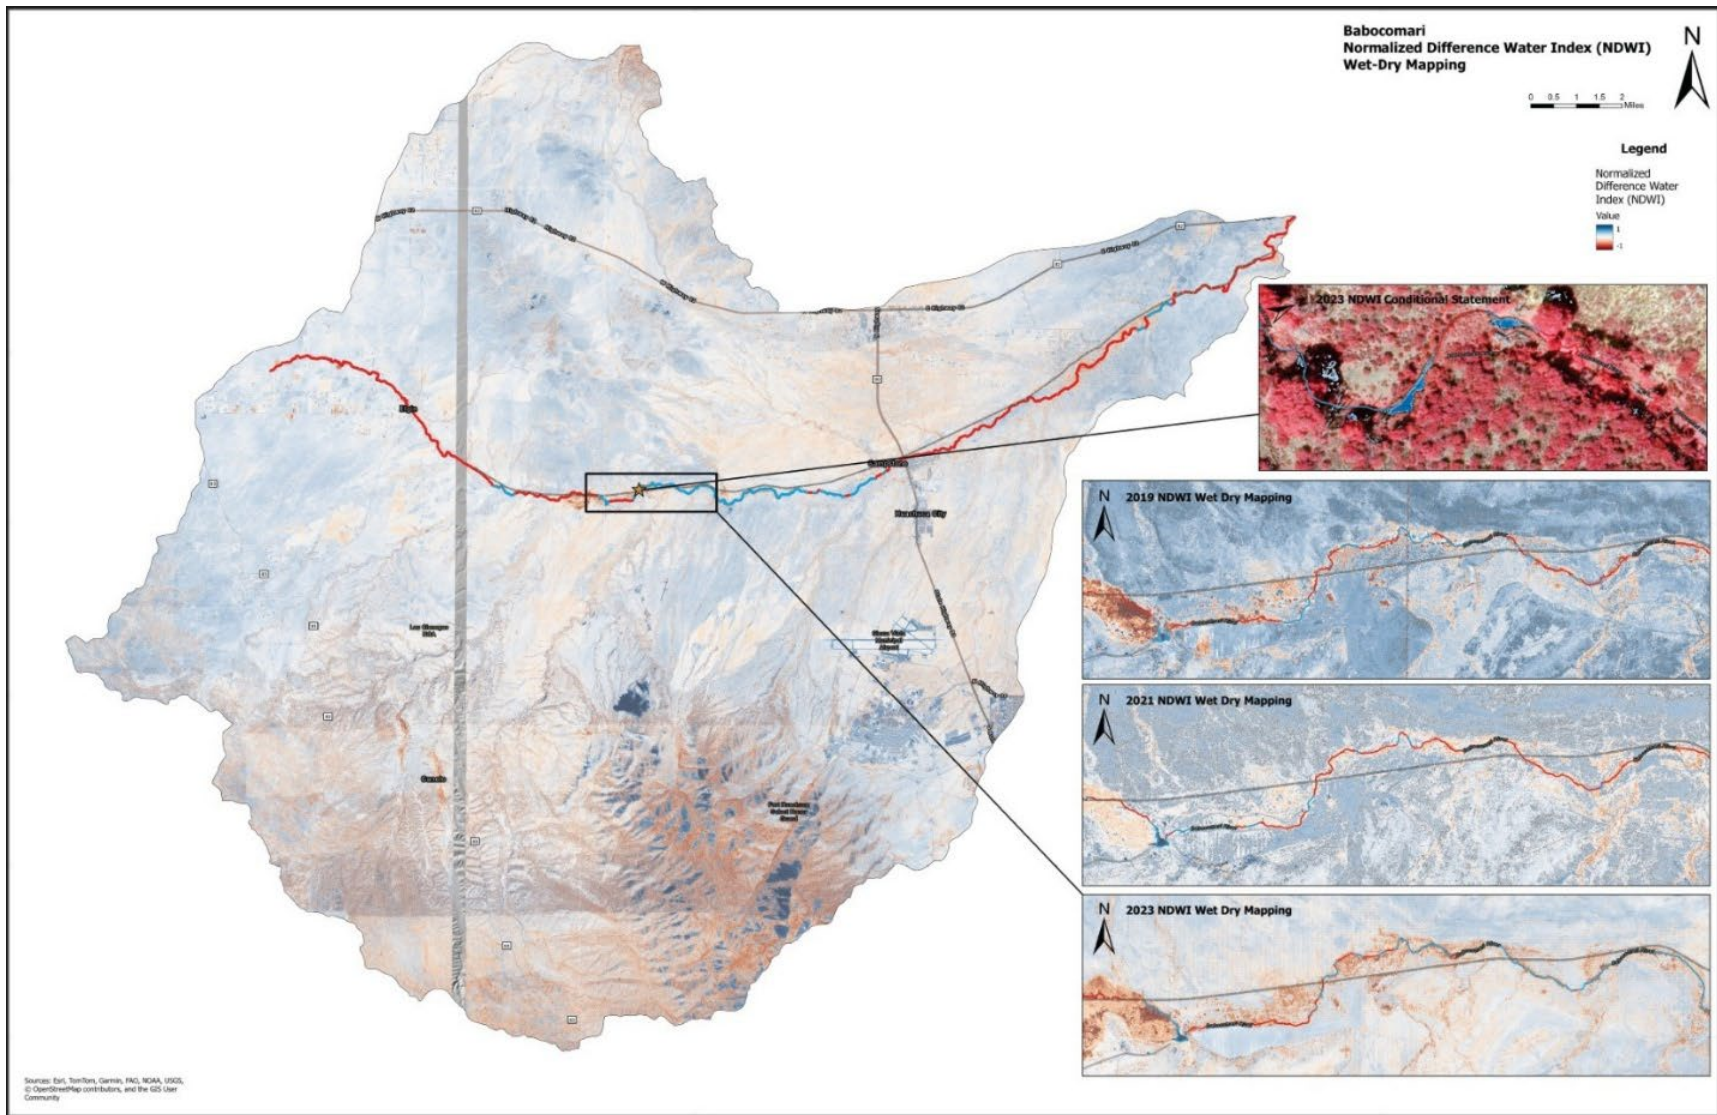
(July 2019, October 2021 and October 2023)
