PAKOON SPRINGS REHABILITATION FINAL REPORT

(TASK #9, AWPf GRANT CONTRACT #06-137WPF AND INCLUDING TASK #4 AND
TASK #8 FINAL MONITORING REPORTS)

Grand Canyon Wildlands Council, Inc.
P.O. Box 1594
Flagstaff, AZ 86002
(928) 556-9306
grandcanyonwildlands.org

30 December 2010

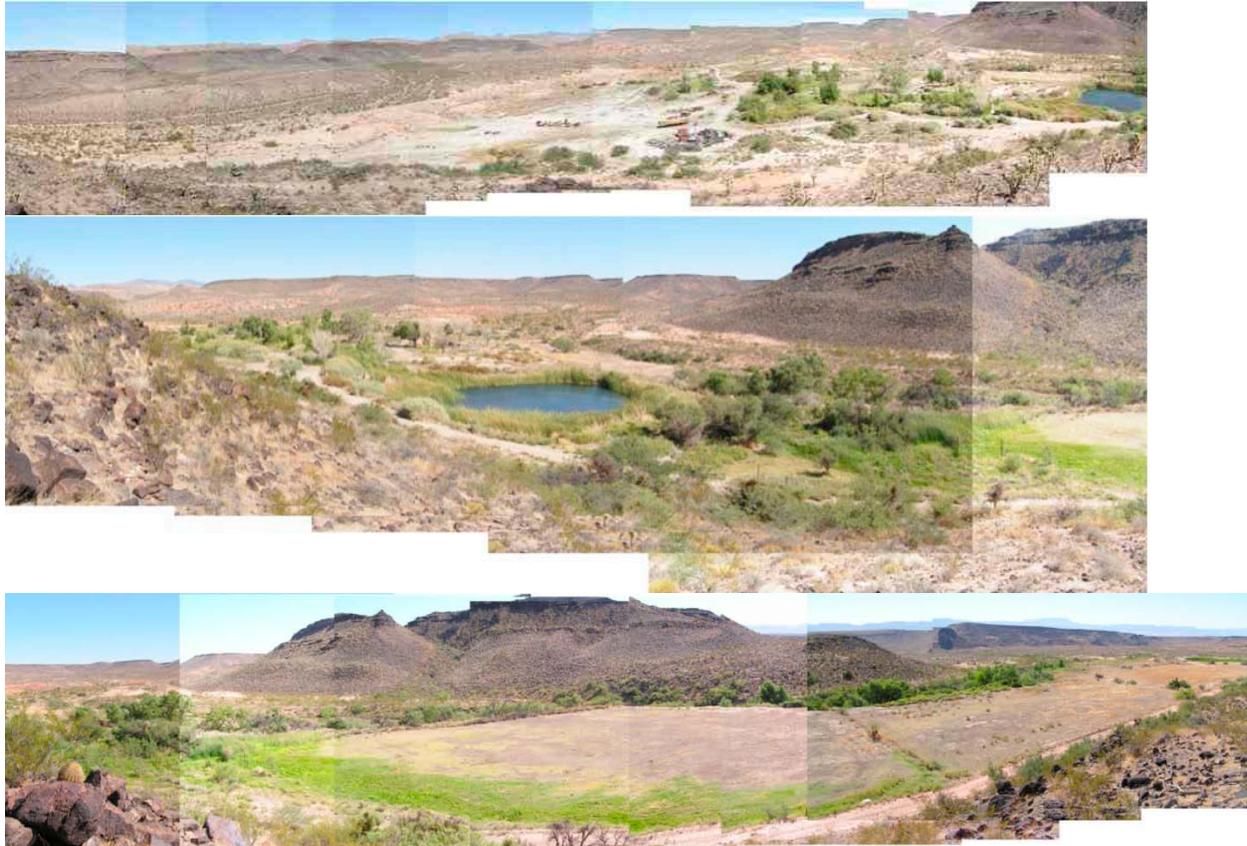
Figure 4-8 Prior to rehabilitation initiation, panoramas (25 August 2006) from photo locations 1, 2, and 3 respectively. Pre-existing ponds in Arenas 1, 2, and 3 are obscured by dense cattail stands. Flow exiting the big pond in Arena 4 was watering a long green strip of spikerush and other wetland plant species. Green vegetation in photo 1 is at the northern end of the springs area; photo 2 is the middle; photo 3 is the southern end of springs area, Pakoon Wash, and the agricultural fields south of the springs.

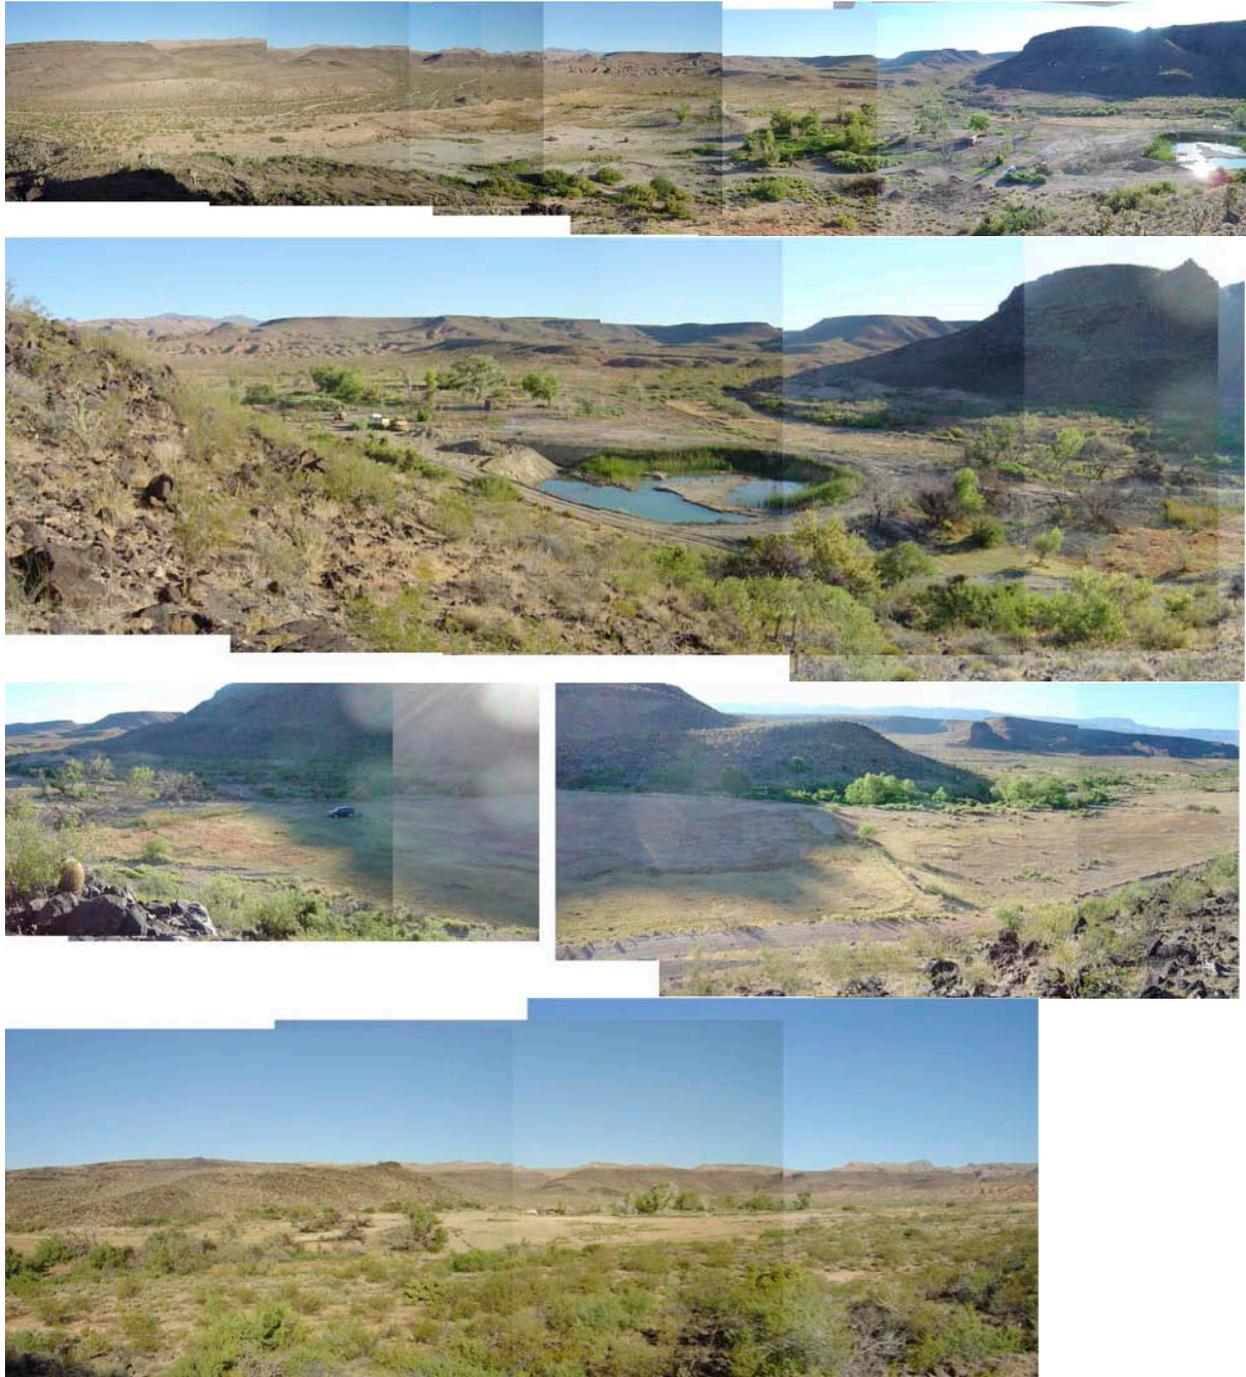
Figure 4-9 Post-rehabilitation activities (06 June 2008) panoramas from designated photo locations 1-4 respectively. Photo location 4 added after work initiated. Pond in Arena 4 is now drained through irrigation pipes to the far south end of the agricultural fields of photo 3. Note reddish strip of dried vegetation no longer supported by pond leakage, at the upper end of the agricultural fields. Recontouring most visible between the big pond in arena 4 and the cottonwood/willow trees at the north end of the springs area (arena 2). Recontouring also visible to the west of the big pond where a smaller pond was breached, providing significant additional perennial flow to the wash we refer to as Pakoon Wash, to the east of the springs area and along the east edge of the agricultural fields. Photo

location 4 is across the wash, looking to the west. In the center of the photograph, flow out of recontoured arena 3 creates a green area barely visible within the open pale green area.

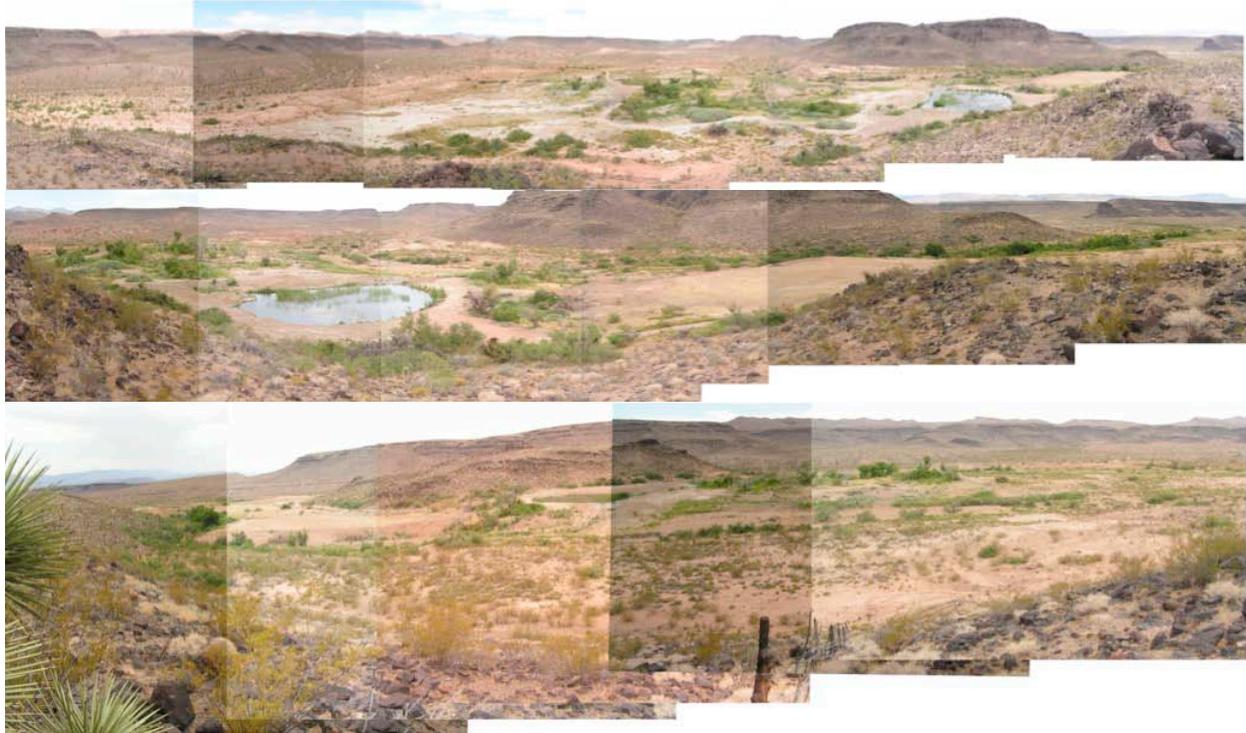
Figure 4-10 Post rehabilitation, panoramas (July 10, 2009) from photo locations 1, 2, and 4. Arena 1 has continued to wet out the hill-slope. Arenas 2 and 3 have demonstrated significant recovery of plant growth following the rehabilitation work. In arena 4, the reduced berms are visible. Additionally, the western hill-slope was restored after the agricultural road was removed and the contour was established to match the preexisting grade. The agricultural fields are shown on the right. Photo location 4, this panorama is from the new photo-location, which faces west, arena 4 is in the center of the photo and arena 1 is on the right. A thin green line of wetland plants shows where the flow from arena 3 heads toward Pakoon wash.

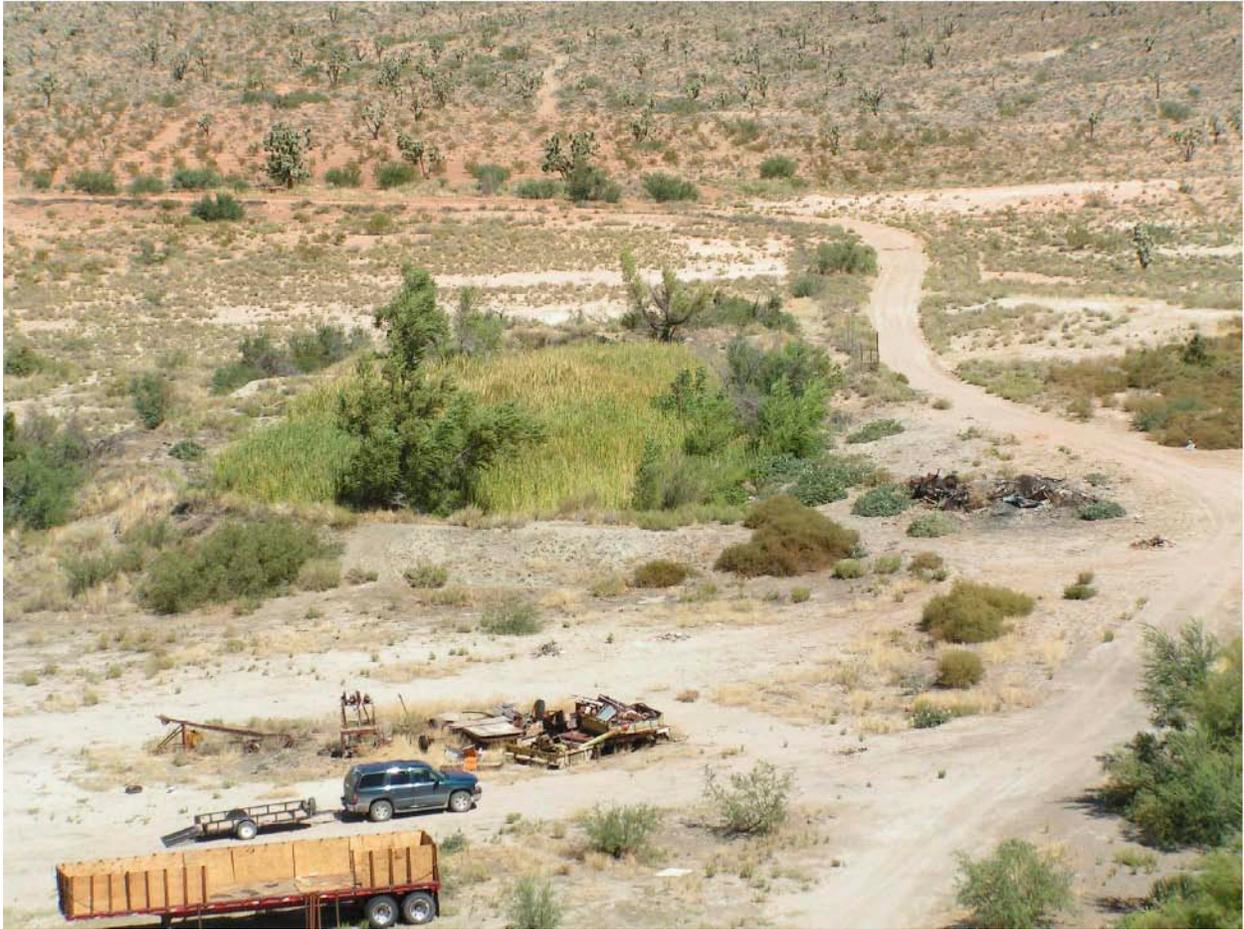
Figure 4-14 Arena 1 prior to initiation of rehabilitation (26 August 2006). Note berm and cattail-filled pond.

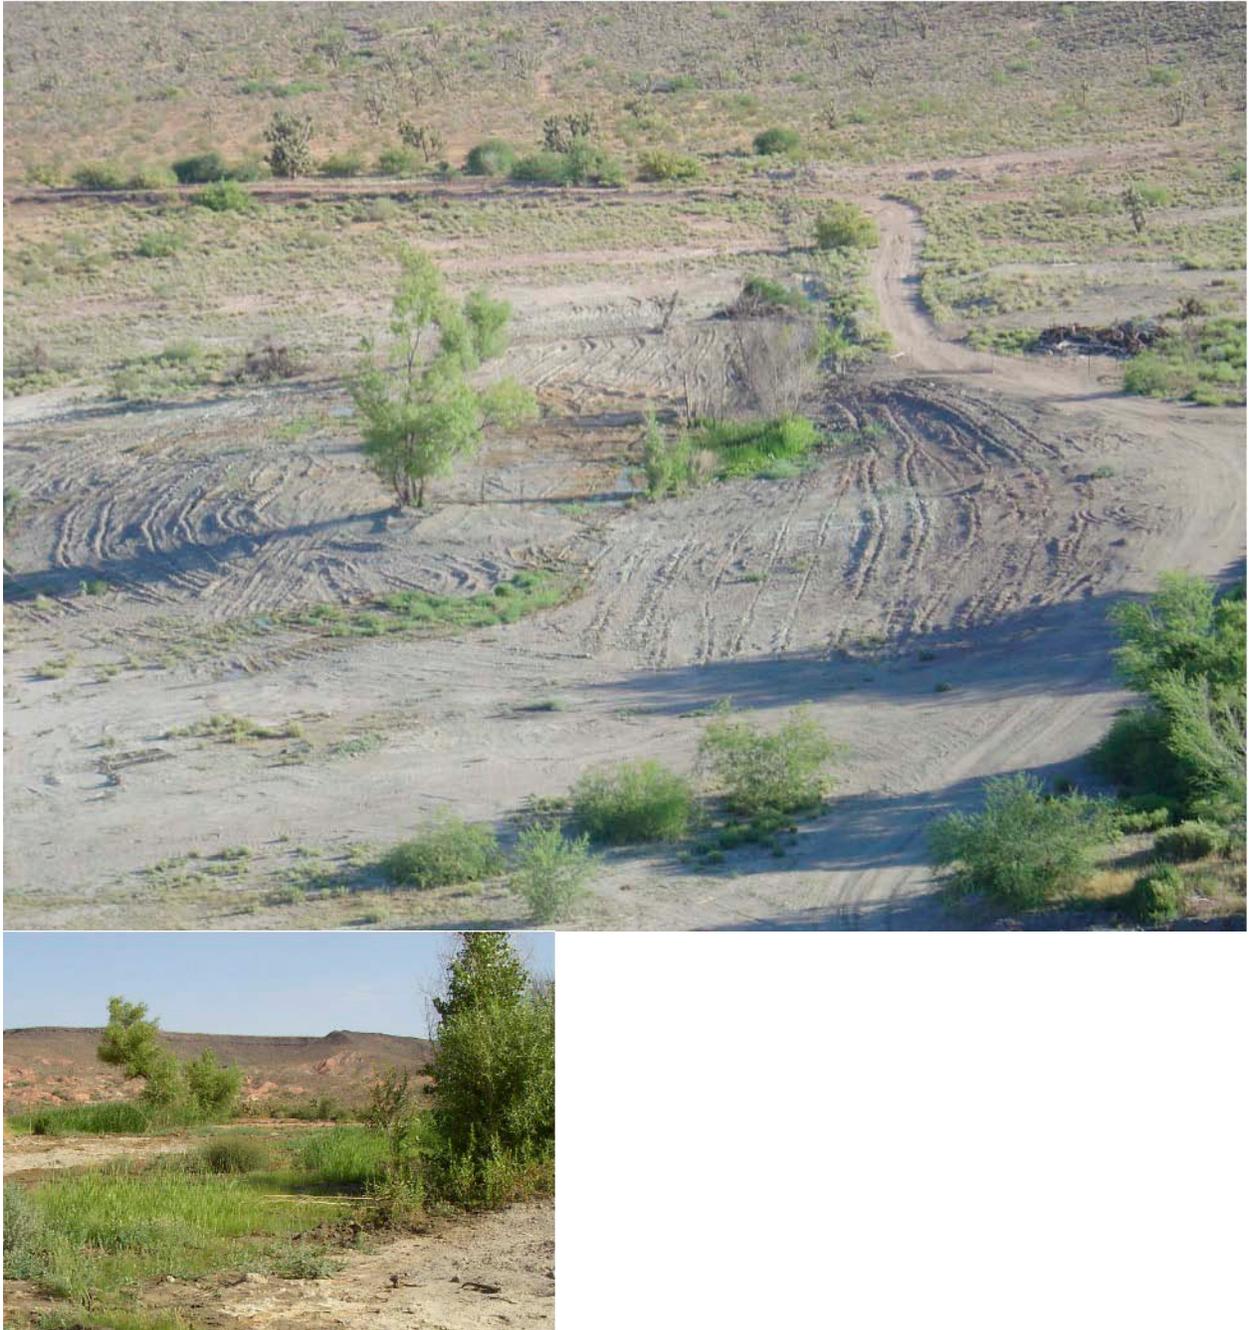
Figure 4-15 Arena 1 rehabilitation progress (06 June 2008). Berms removed, pond filled and recontoured, cattail stand buried. Goodding's willow trees preserved on perimeter of former pond. Small photo (15 July 2008) shows native wetland and riparian vegetation at two spring sources (wetted areas) that emerged after recontouring. Center of large image is the photo location for the small image.

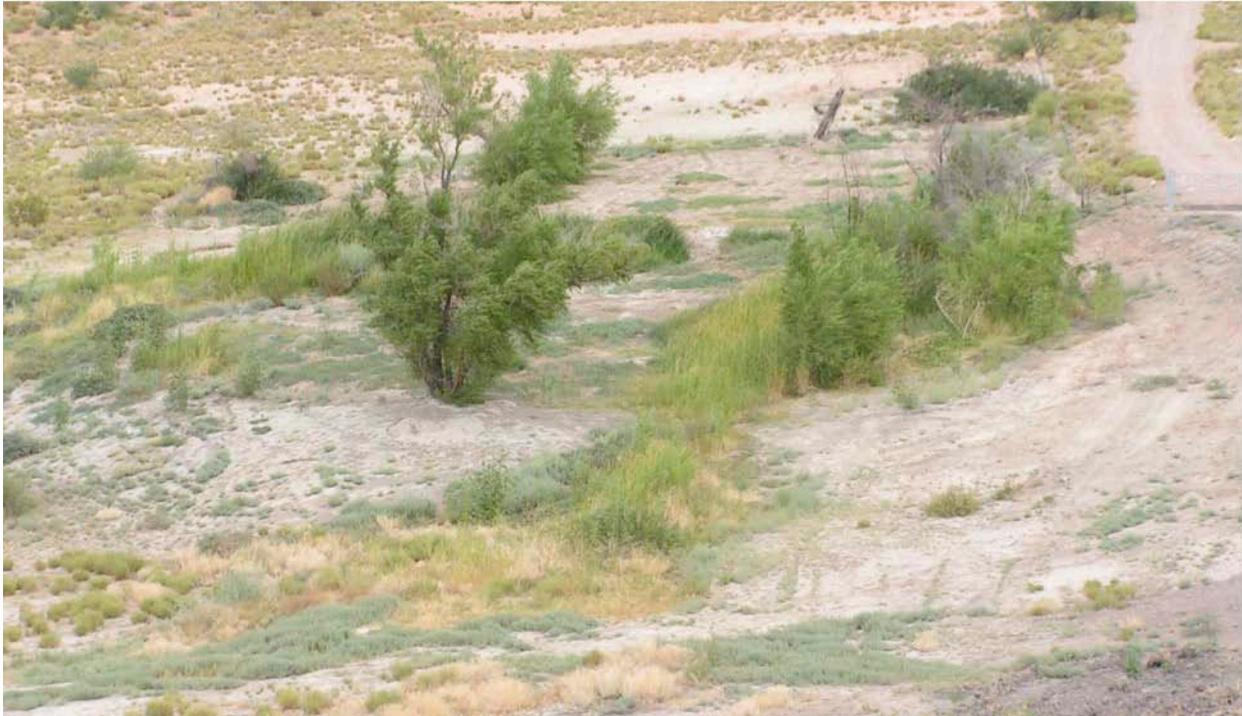
Figure 4-16 The transplanted riparian vegetation in Arena 1 springs (July 2009) is thriving and non-transplanted native vegetation has sprouted. The springs have developed into two main groups: on the right side of the image the ground has wetted out, flowing in a southern direction toward the bottom of the image, and in the center of the image the springs have spread across the hillslope in a western direction (toward the left side of image).

In the two springs sources detected within Arena 1 (Fig. 4-16), some of the moist soil surface was initially revegetated with native wetland vegetation derived from local stock. The following species were planted: bulrush (*Schenoplectus*), spikerush (*Eleocharis*), and yerba-mansa (*Anemopsis*), along with Goodding's willow (*Salix gooddingii*) in areas with wet or saturated soil, and riparian seepwillows (*Baccharis*). Plantings and reseeding included honey mesquite (*Prosopis glandulosa*) and quailbush (*Atriplex lentiformis*) in riparian areas, and paleosprings jimmyweed (*Isocoma*), inkweed (*Sarcobatus*), and related vegetation in the drier periphery. In the spring of 2010, approximately 50 additional Goodding willow poles were planted in the wet soil. Wetland plugs (up to 2 feet in diameter) were removed from other arenas or the stream habitat area and established at 1-2' intervals. Five or six *Baccharis* plants were successfully rescued from the future outflow area of the Arena 4 pond and transplanted to Arena 1 using the trackhoe and skidsteer. A similar attempt was made with a large quailbush but the root structure was too large to fully dig up even with the excavator, and the transplant failed. Fifteen to twenty poles of *Salix gooddingii* were pole planted to generate a transition from wetland to dryland riparian vegetation, in a design consonant with the available habitat. Peripheral, drier habitat was planted with saltgrass (*Distichlis spicata*) rootstock, and opuntia cactus pads and seeded with *Isocoma*, *Sarcobatus*, and *Atriplex lentiformis*. Saltgrass is spreading across and covering much of the top of the newly created spring mound surface.

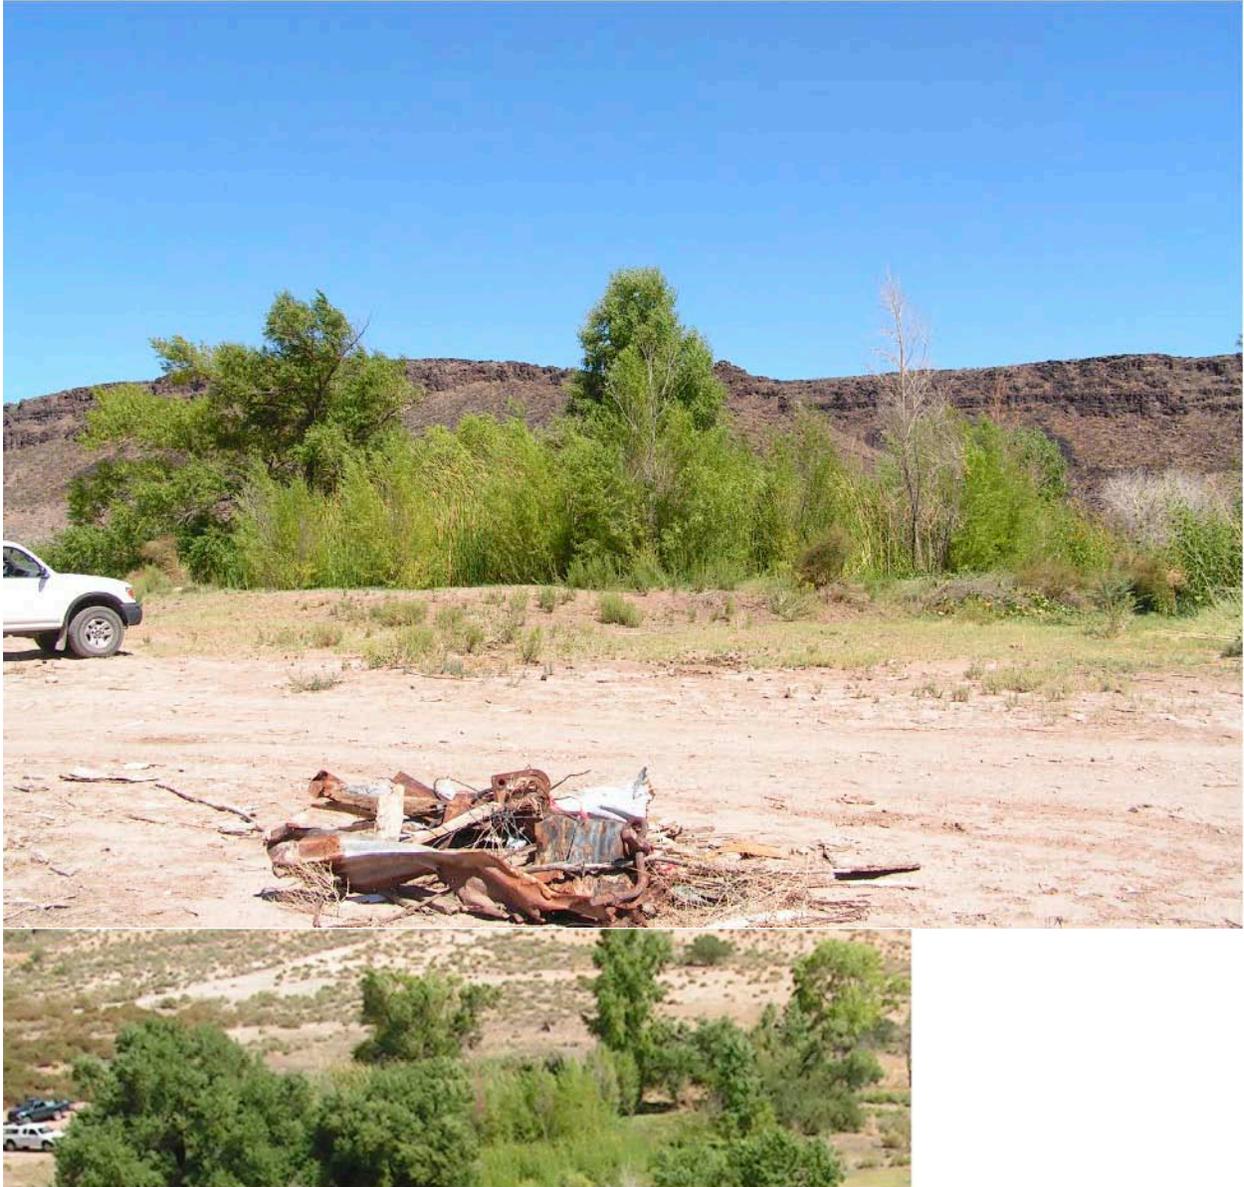
Figure 4-17 Arena 2 prior to rehabilitation activities (25 August 2006). View toward northeast of berm around cattail pond. Thin band of smaller willows and cottonwood around periphery. Tall willow and cottonwood are on north side. Inset overview shows same 2 large trees on north side with cattail stand in center. Willows on right side of inset were growing on top of culvert with spring source emerging through the mound it formed.

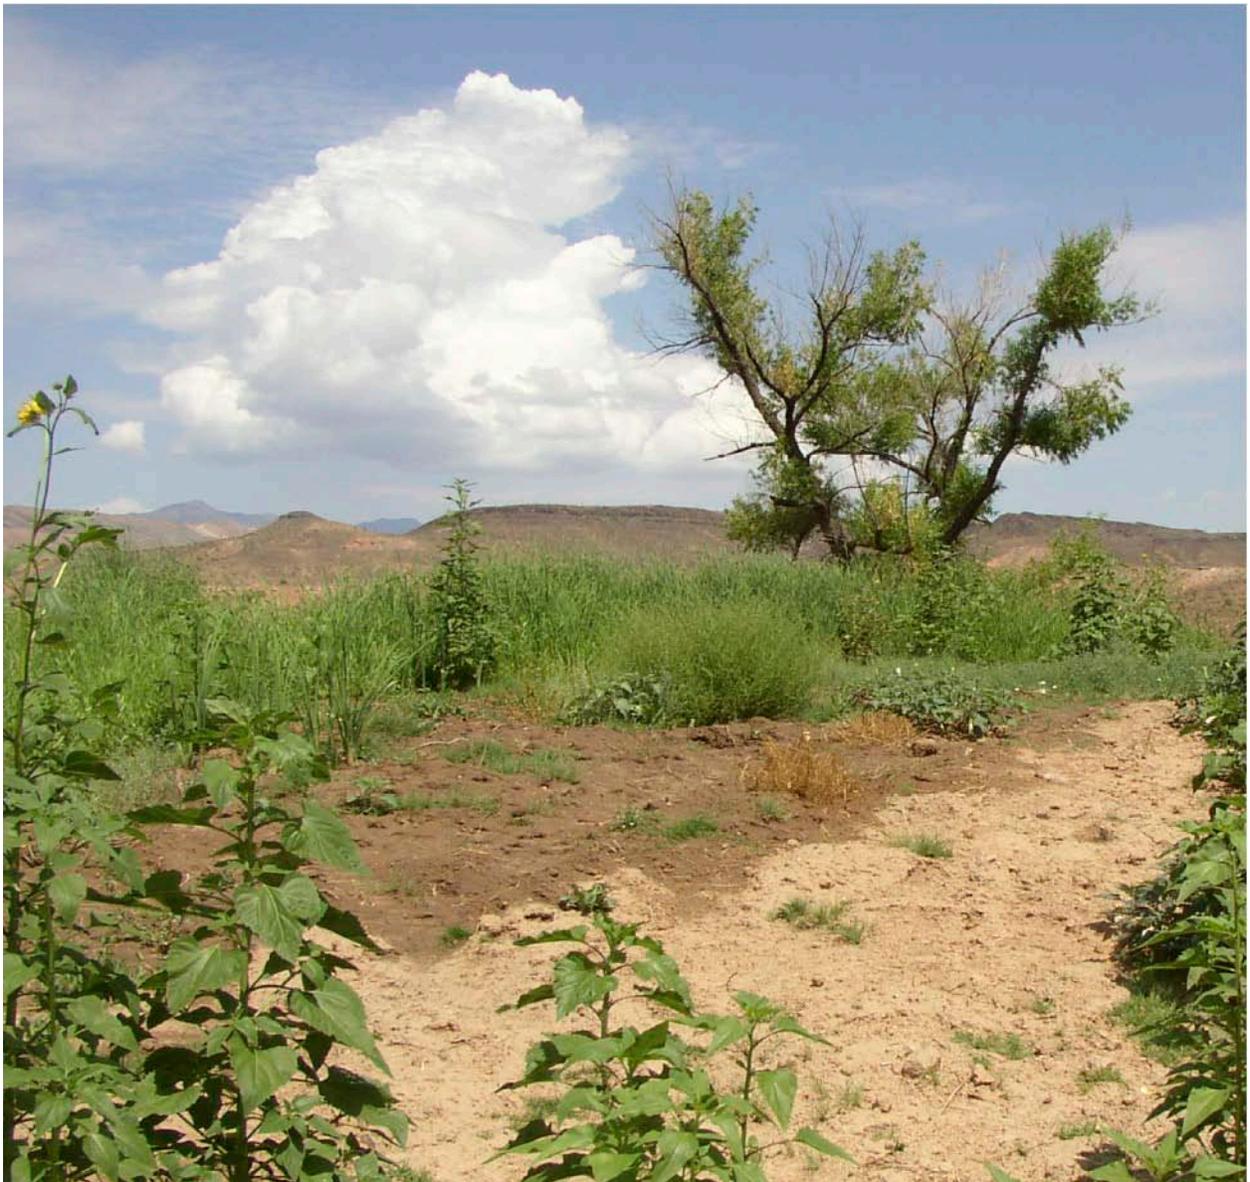
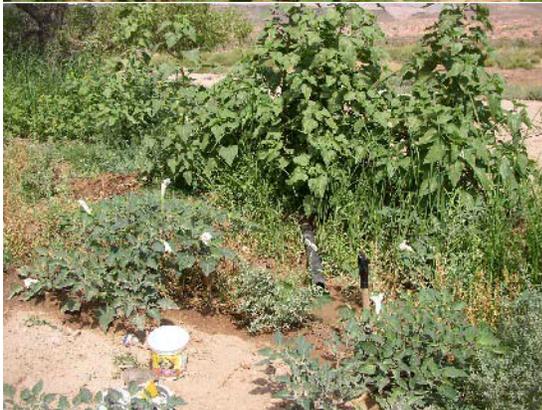
Figure 4-18 Arena 2 rehabilitation progress after removal of berm and infilling of pond (15 July 2008) showing recontoured slightly mounded area with spring emerging near Goodding's willow. Much of the flow

was to the east from the tall Goodding's willow. Inset shows colonization by native datura, rushes and sunflowers around flow on north side, east of the tall willow. With removal of buried piping some trees were expected to readjust their architecture in response to changing soil moisture conditions.

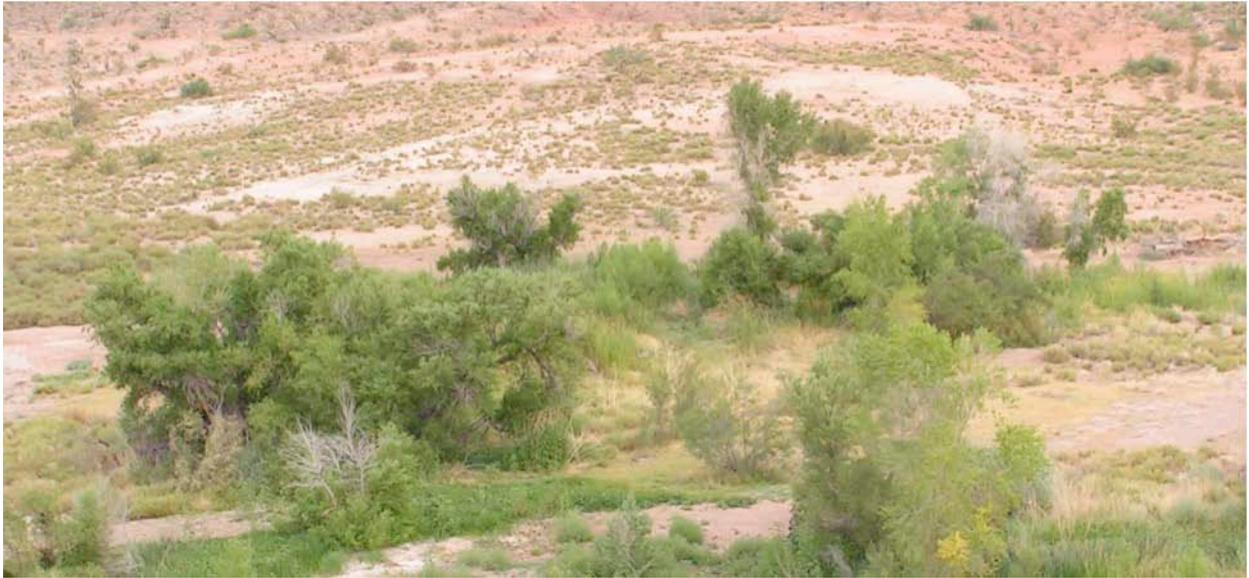
Figure 4-19 Arena 2 after rehabilitation in July 2009, springs spread out and flowed from Arena 2 in northern, western, and eastern directions although reestablished vegetation in the photo obscures the view of these small channels. The wetland vegetation recovered from rehabilitation work and spread as the springs wetted new soil.

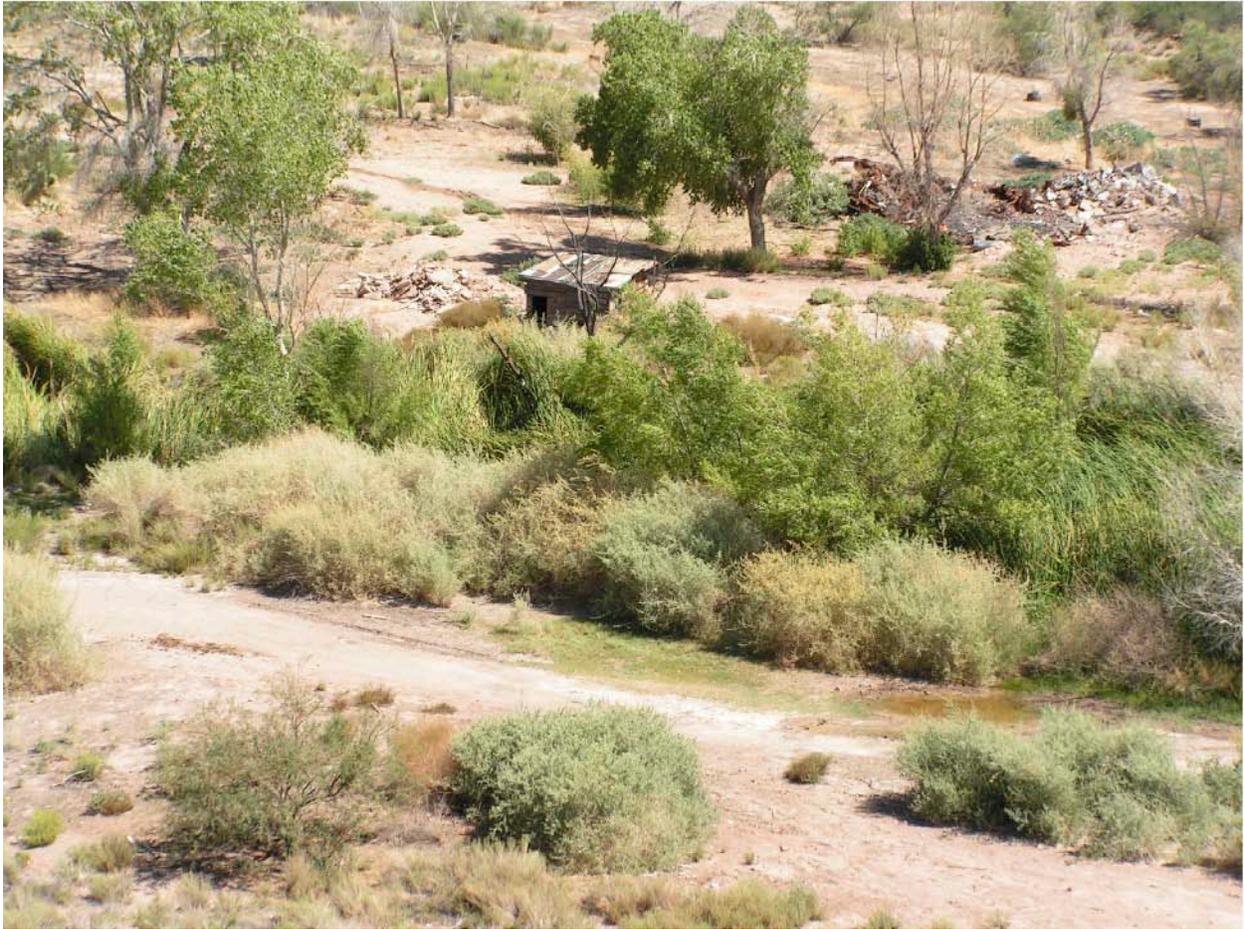
Figure 4-20 Arena 3 (middle section; see Fig. 4a panorama) prior to rehabilitation activities (25 August 2006). Long narrow, relatively deeply excavated channels filled with cattail, with some Goodding's willow and quailbush on outer edge of channel. Note wooden shed for reference.

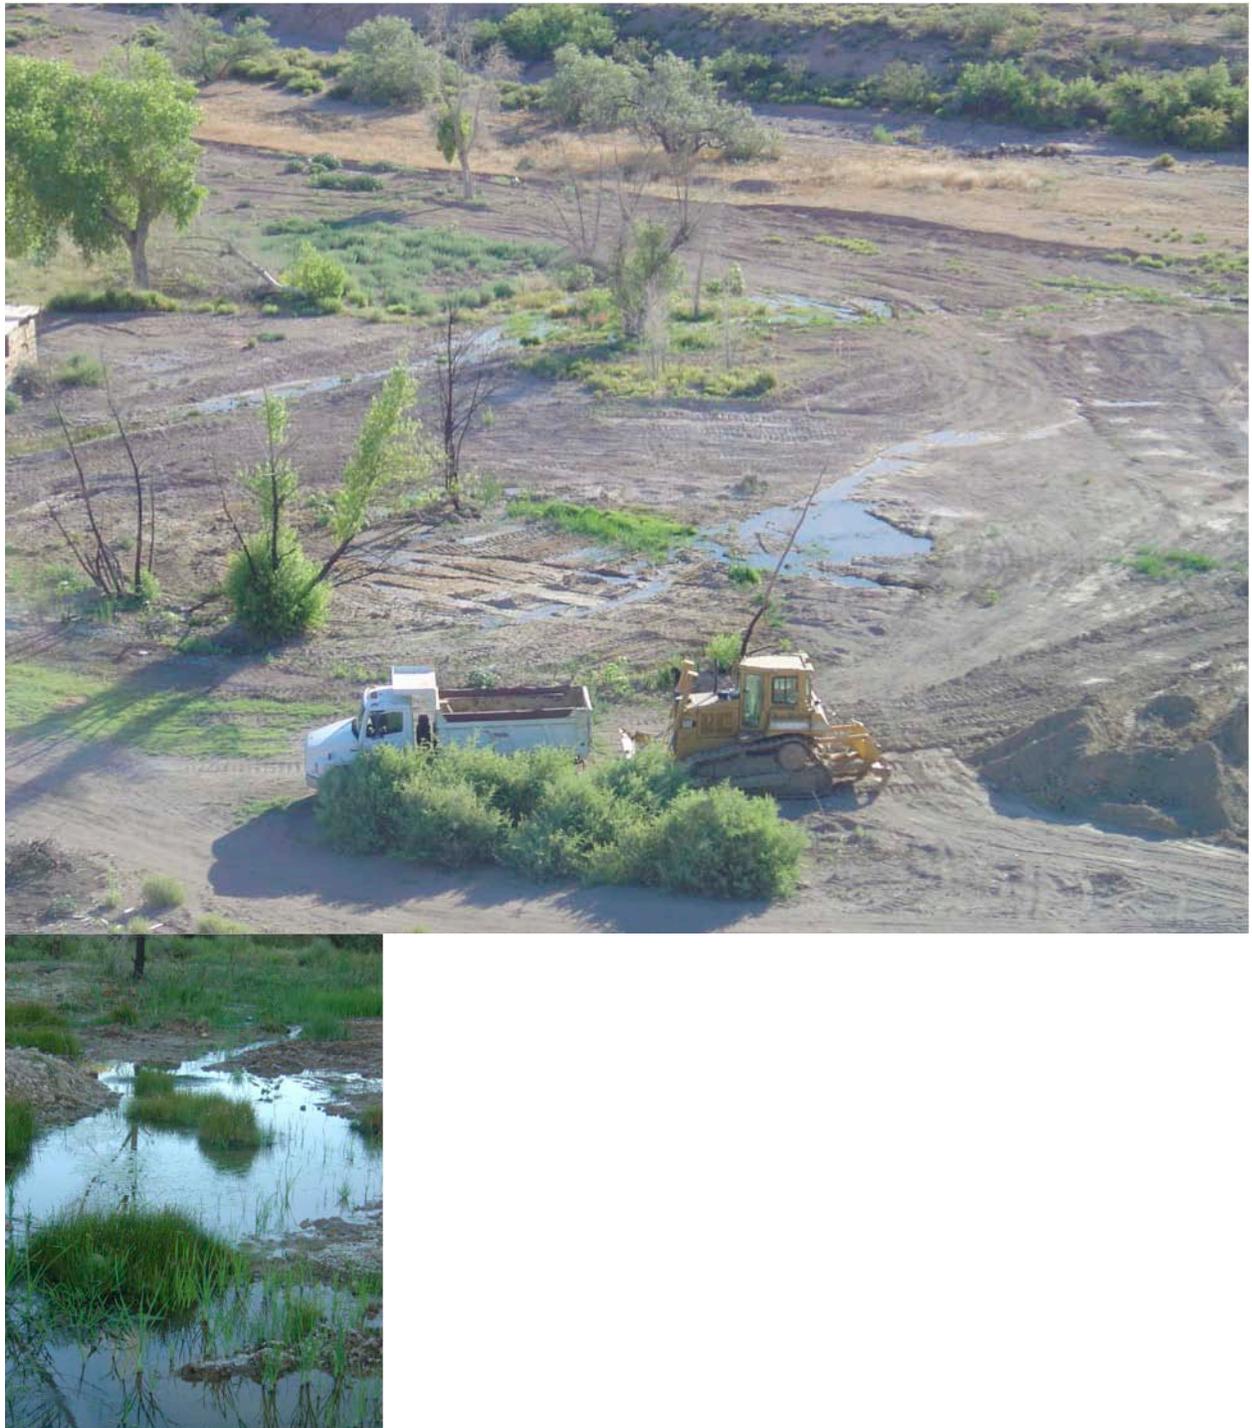
Figure 4-21 Arena 3 rehabilitation progress (06 June 2008). Wooden shed is on upper left side of photo. Springs are emerging from the now-infilled channel and flowing to east across gentle recontoured slope. Pakoon Wash is visible along upper edge of photo. Willow in upper center of photo was dewatered after irrigation piping removal. Spring flow directed toward the willow is restoring water to that tree. Arena 4 pond is to the right beyond this photo. Small image (15 July 2008) shows revegetated wetlands in spring-flow between wooden shed and the Goodding’s willow tree, with bulrush and spikerush.

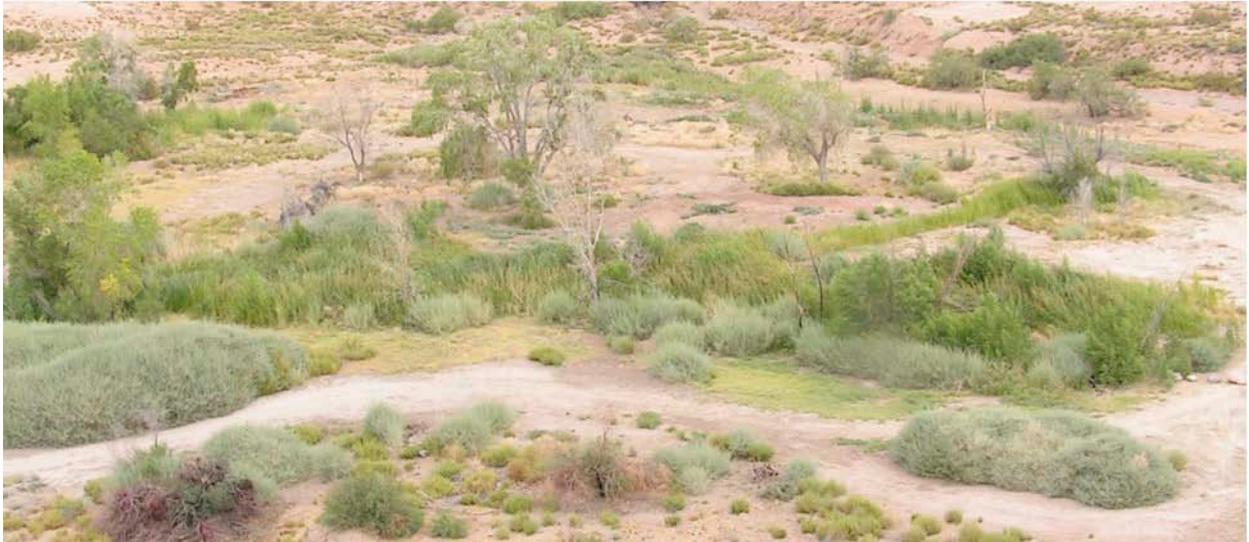
Figure 4-22 Arena 3, July 2009, riparian vegetation has recovered and the springs have spread out flow in an easterly direction, towards Pakoon wash. The northern section of the springs has spread northward and is close to joining the wetted soils of Arena 2. The shed was destroyed in a fire in 2008.

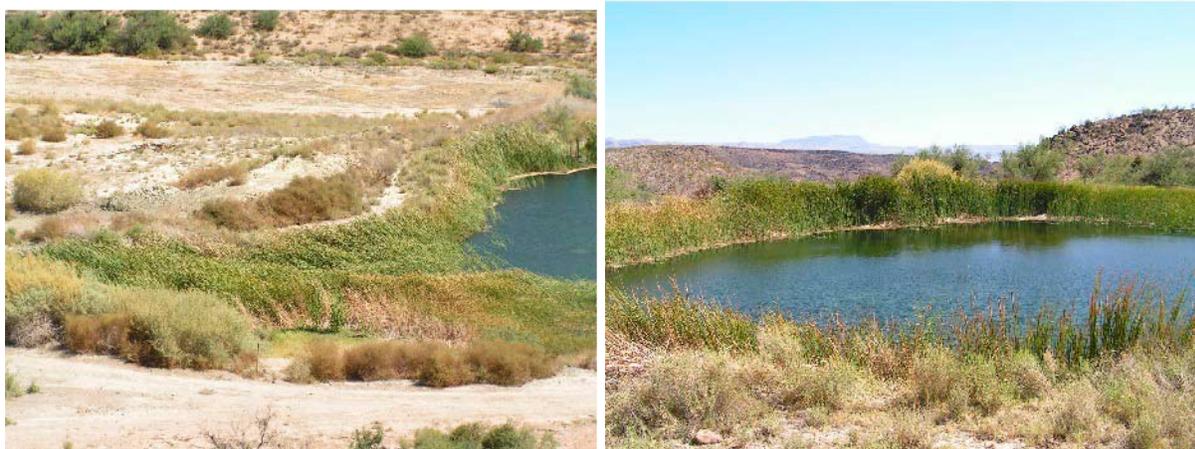
Figure 4-23 Arena 4 prior to rehabilitation activities (25 August 2006). Photos of big pond. Left photo shows north end where flow was coming south (left side of photo) from Arena 3 into the big pond.

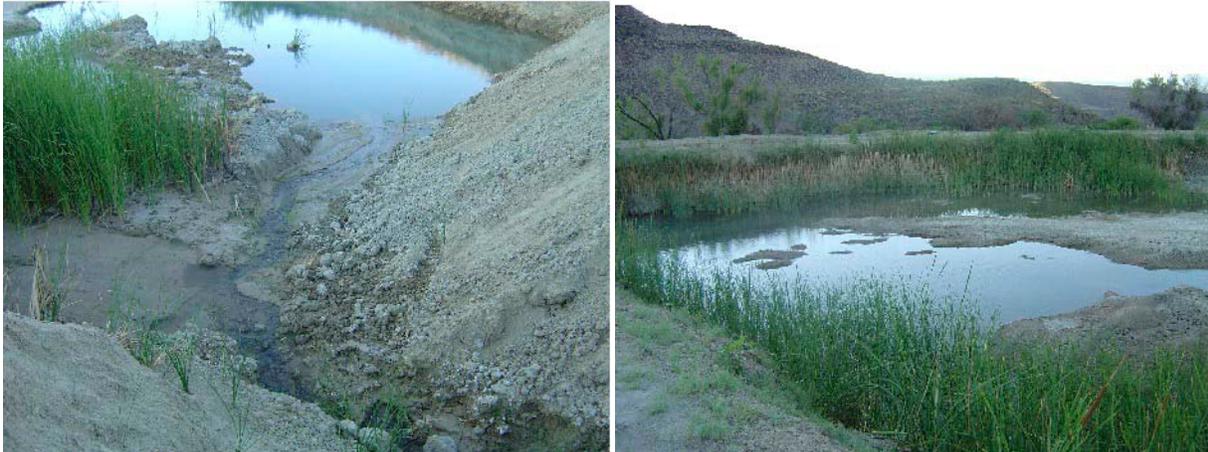
Figure 4-24 Arena 4 rehabilitation progress (06 June 2008) showing pond now drained, and formerly gently sloping inside edge of berm (along lower edge of right photo) was steepened/deepened to help maintain open water. Left photo shows significant new spring source that emerged in the area where Arena 3 formerly flowed into the big pond, after Arena 3 was breached and drained, and after the connection between Arena 3 and 4 was completely in-filled and remaining flow from Arena 3 spring sources emerged and was redirected to the east towards Pakoon Wash.

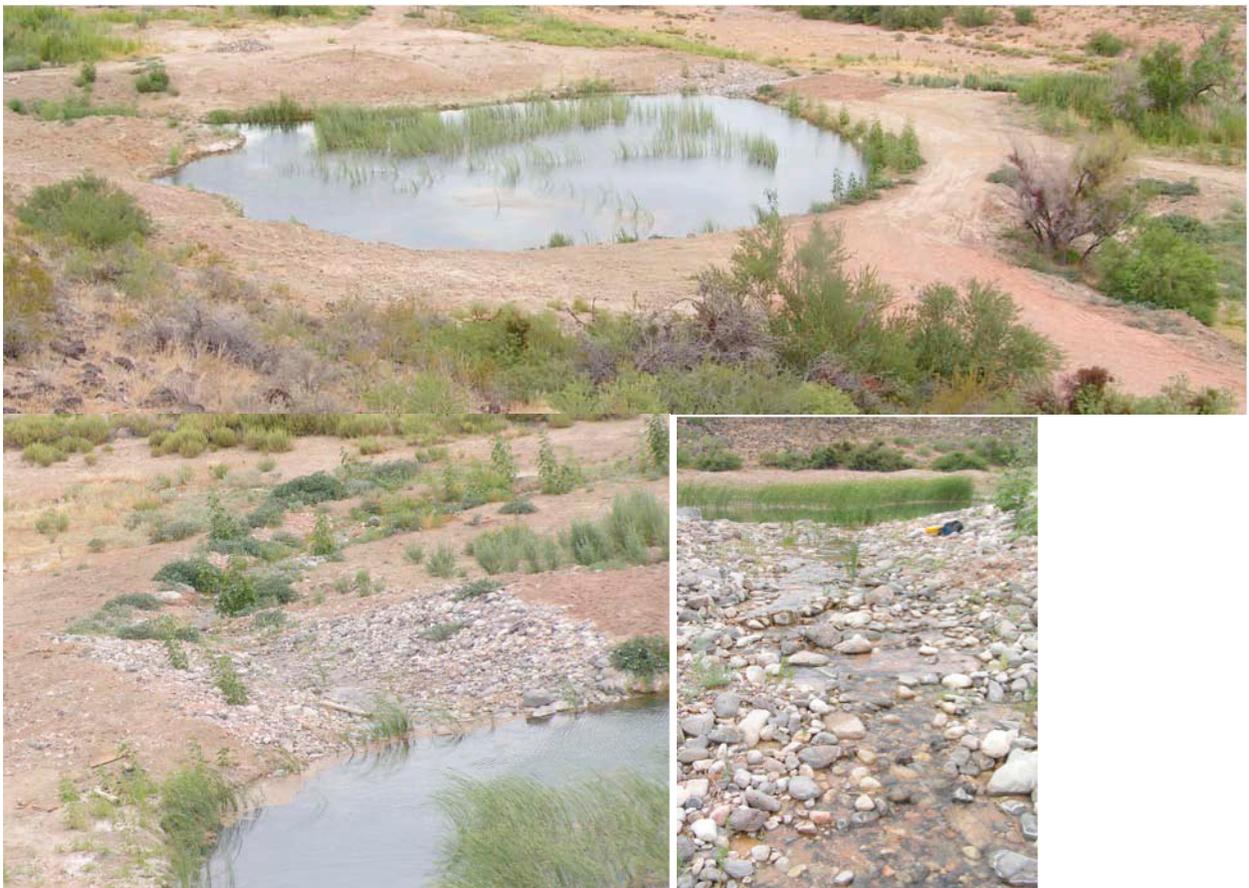
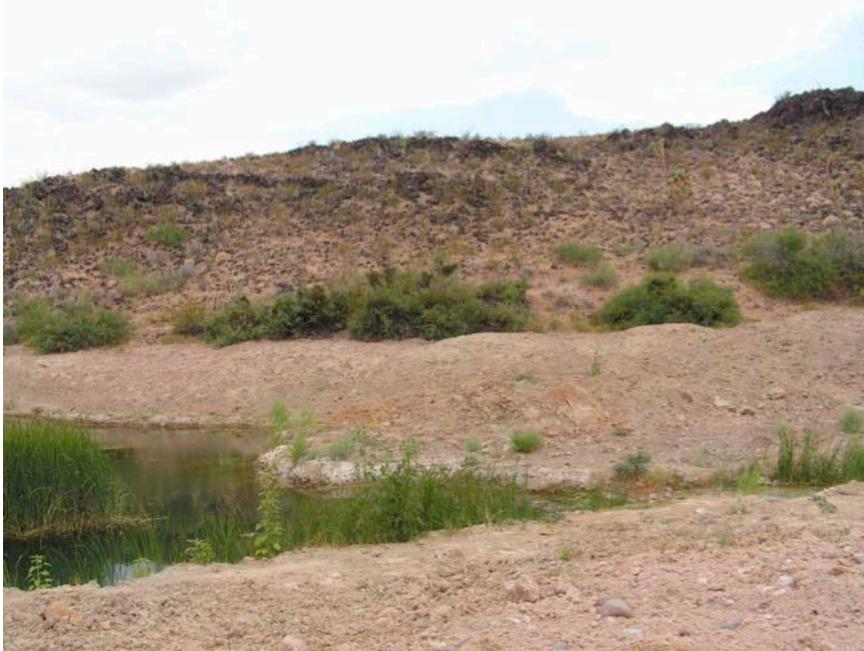
Figure 4-25 Arena 4 rehabilitation progress (July 2009), the image depicts the lowered berms and reduced open pond area. The cobble lined channel, created in 2009, allows flow from arena 4 toward Pakoon wash, and is shown in the close up photos. The re-contoured western hill-slope is also depicted, which obliterated the agricultural road, and now provides a gradual slope, matching the hill's contours.

In 2010, pole plantings of Goodding's Willow and cottonwoods were planted along the eastern edge of the pond, to stabilize the hillslope and spread out the trees. Two rows of tree poles were made, one adjacent to the pond and the other 2 – 3 feet higher on the slope, with holes that reached moist soil. Additionally, Goodding's willow pole plantings and yerba mansa plugs were transplanted into the newly wetted soils in the eastern edge of the arena that developed since 2009. These plantings will help stabilize the downslope from the pond berm to Pakoon Wash.
