Evaluation of Riparian Habitat and Headcutting Along Lower Cienega Creek

Pima Association of Governments

Final Report

**Arizona Water Protection Fund
Grant #07-144**

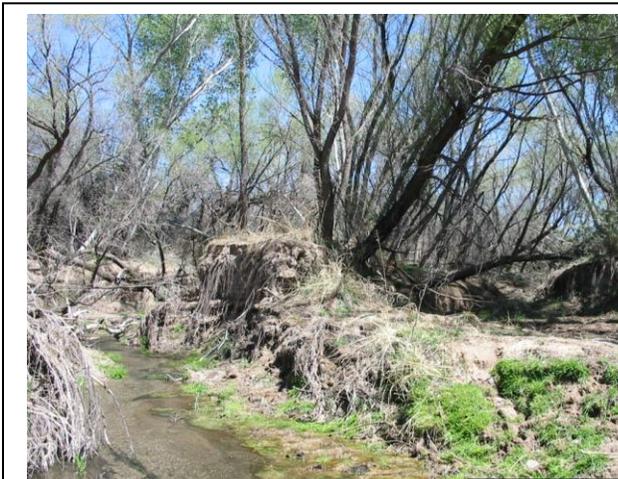
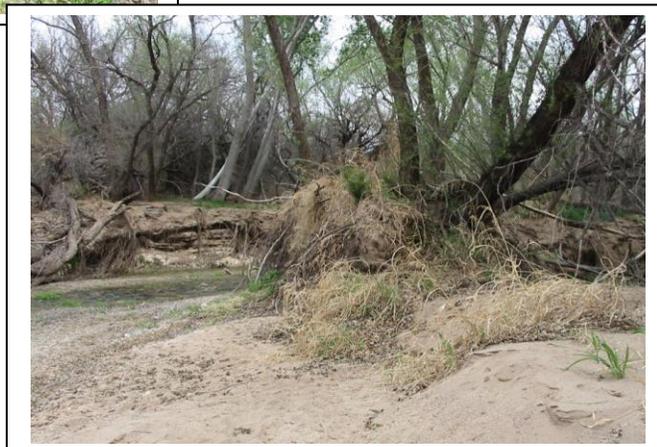
Headcut Erosion on Cienega Creek

Erosion along the creek has caused undercutting of trees resulting in tree fall and loss of overstory canopy vegetation.

These two photos are from Repeat Photography Site 7, the location of the nick point in 2001 and the intersection of the primary channel with the middle branch. These were taken during the annual habitat surveys in March 2008 and 2009. The headcut is currently about 10 feet deep at this location (last measured in 2010).

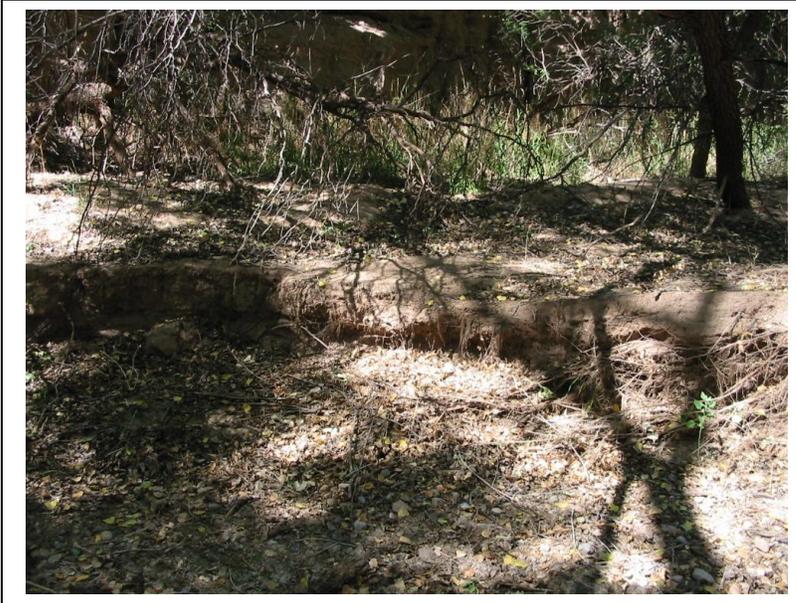
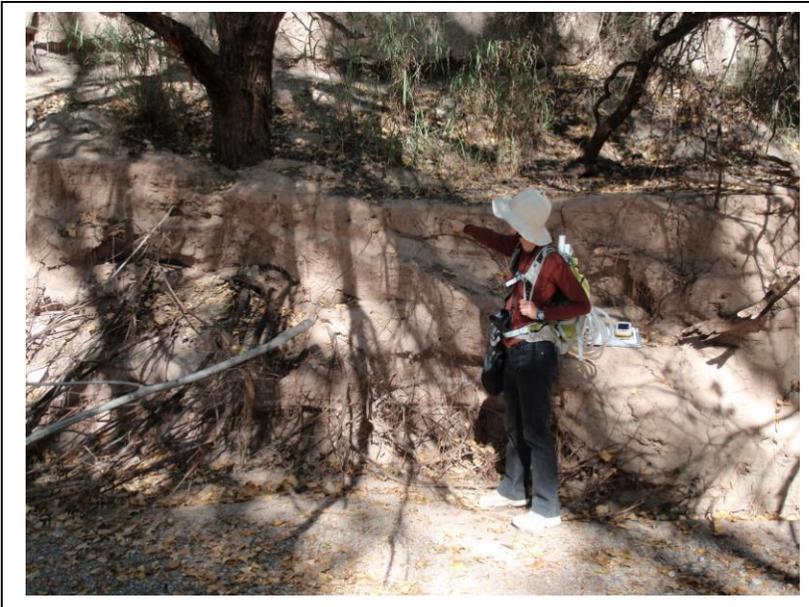
Headcut Erosion on Cienega Creek, contd.

The nick point is located at the upstream end of the headcut. This is the point we locate using GPS in order to track the upstream migration of the feature.

These two photos were taken at Repeat Photography Site 11 and demonstrate channel deepening. The headcut grew from 3 to 5.5 feet deep at this location. The first photo is from May 2008 and the second from November 2009.

Erosion caused cut banks to form that measured over 15 feet in height in some places. Dewatering in the bank cut areas causes loss of vegetation along the creek, furthering the potential for erosion into the stream banks.

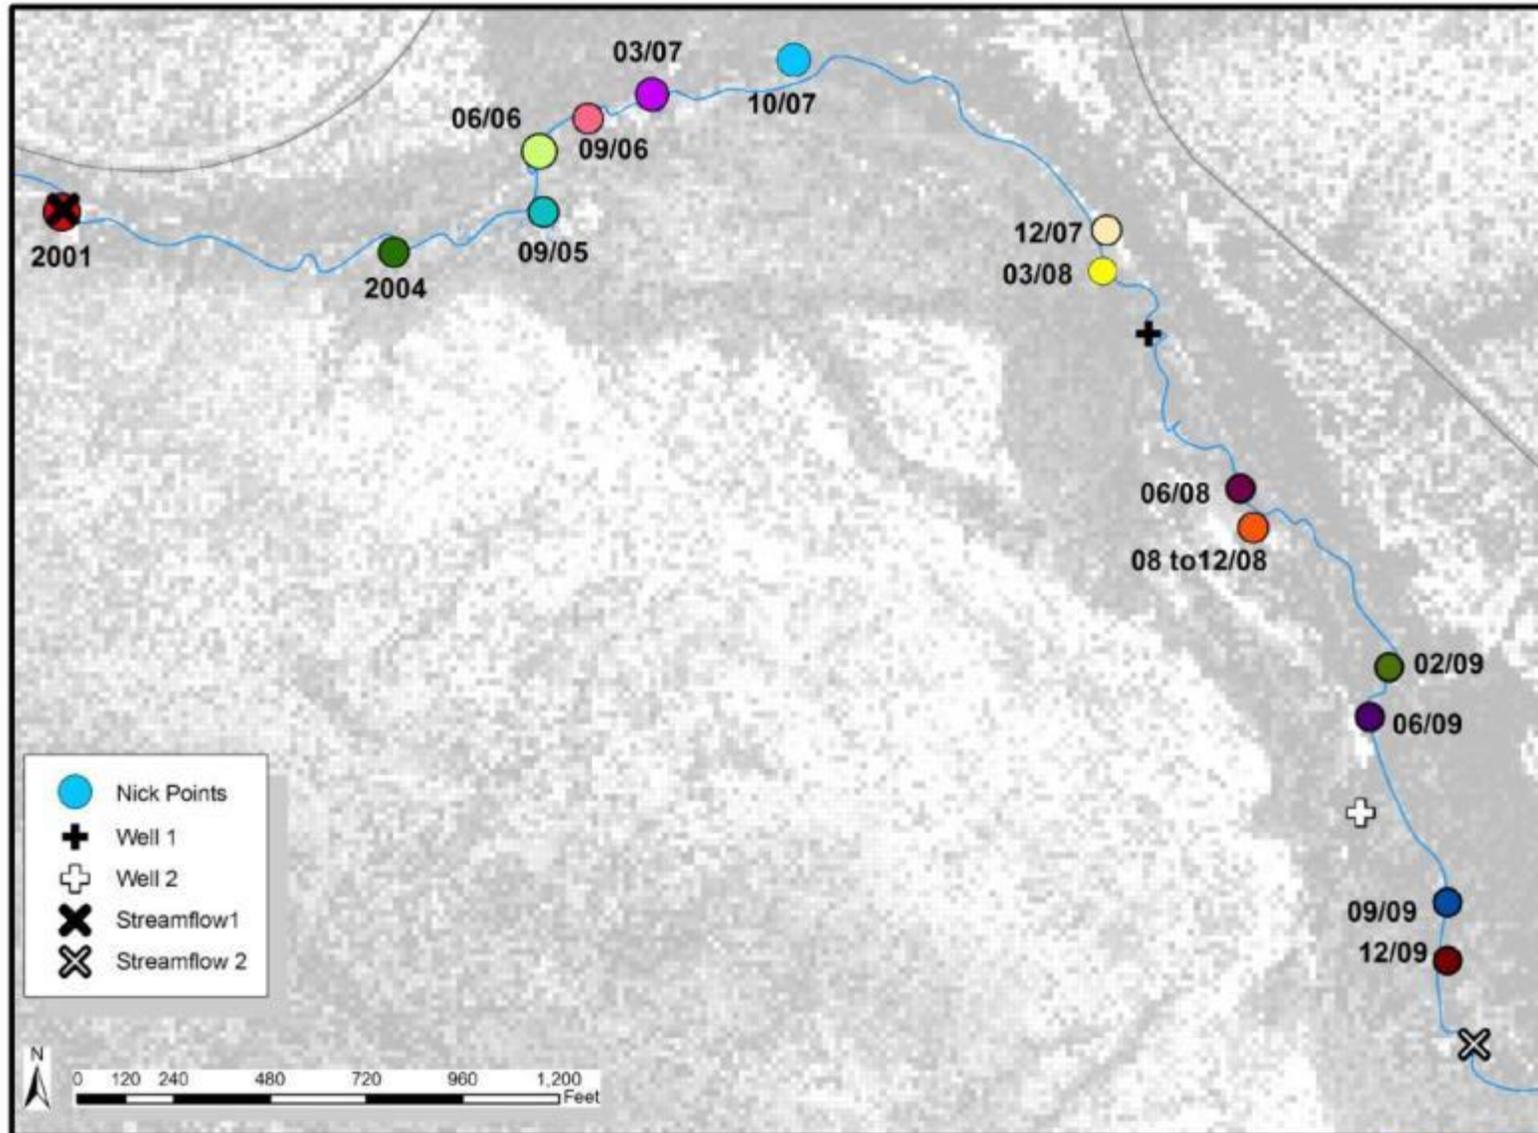
Figure 6: Headcut Nick Points Map within the Cienega Creek Headcut Study Area

Figure 4 shows the location of nick points of each branch of the headcut through the active zone. Scouring was present primarily in the active headcut zone. Table 5 shows the one year change of these branches, as recorded during annual surveys in March. The length of the primary channel incision was measured from where the nick point was first noticed in 2001 to where the nick was recorded in the survey. The primary channel had a gradual sloping of entrenchment of several hundred feet, while the two side branches had deep plunging nick points. The primary channel nick point advanced 270 feet between habitat surveys.

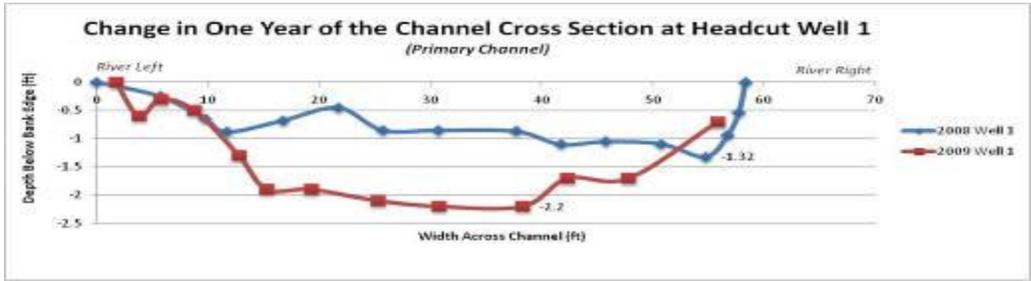
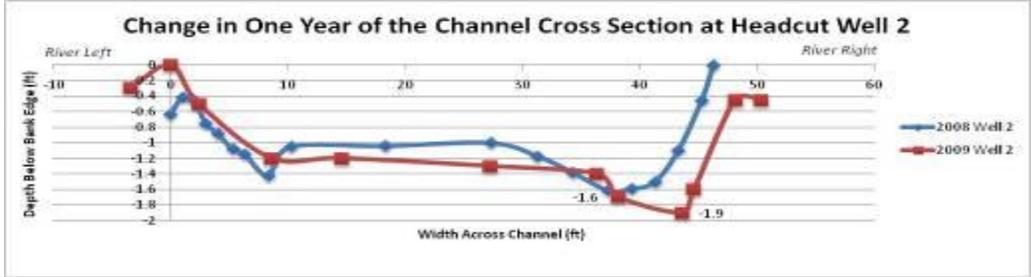
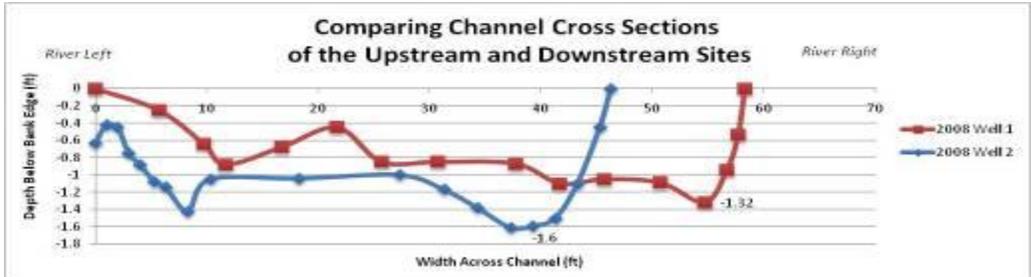
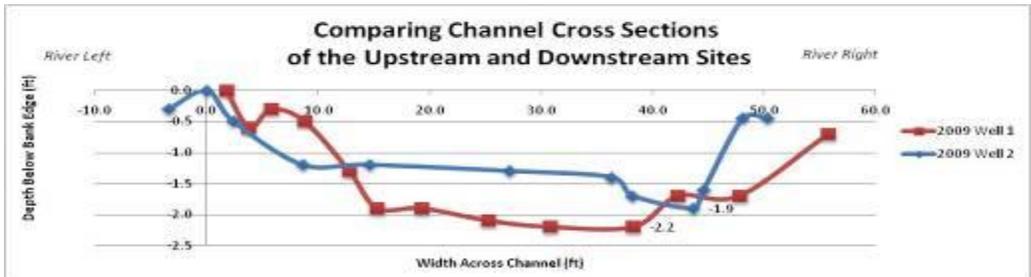
Figure 5: Geomorphic Transect Comparisons

Cross-section measurements recorded the impact of loss of sediments at stationary transects sites. The transect sites were measured in the streambed adjacent to the wells, which were located upstream of the nick point at the beginning of the study period. The entrenchment of the banks at the well sites that occurred over one year is recorded in Table 4 and Figure 5. The streambed transitioned from having no evidence of erosion between the well's transect sites in the first year, to having distinguishable erosion effects migrating gradually upstream. In 2008, the well sites' transects had similar profiles. At Well 1, we began seeing numerous fallen Cottonwood trees due to unstable soils at the beginning of May 2008. By the end of May, the erosion had traveled upstream cutting into the stream channel at Well 1. This coincides with the observation of a drop of groundwater levels, streamflow levels, and mid-month storm after a two-month dry spell. We continued to see more significant change at Well 1 in July 2008, with flood waters causing debris piling on the banks and more trees uprooted and leaning. Sediments appeared to be mobilized by the end of 2008, forming an undulating shape in a streambed of sand, but there was not a clear incision near the downstream well. The cross-section profile comparison of May 2008 to June 2009 reveals an increase in streambed depth (degradation) near Well 1 by 0.87 feet, whereas the upstream well site, Well 2, increased in depth by only 0.29 feet.

Note: Debris pile-up affected streambed width more so than erosion affected it.
