**Billy Creek Natural Area  
Riparian Restoration Project**

**Task 9: FINAL REPORT**

**AWPF Grant 08-154WPF**  
Town of Pinetop-Lakeside, AZ

January 2014

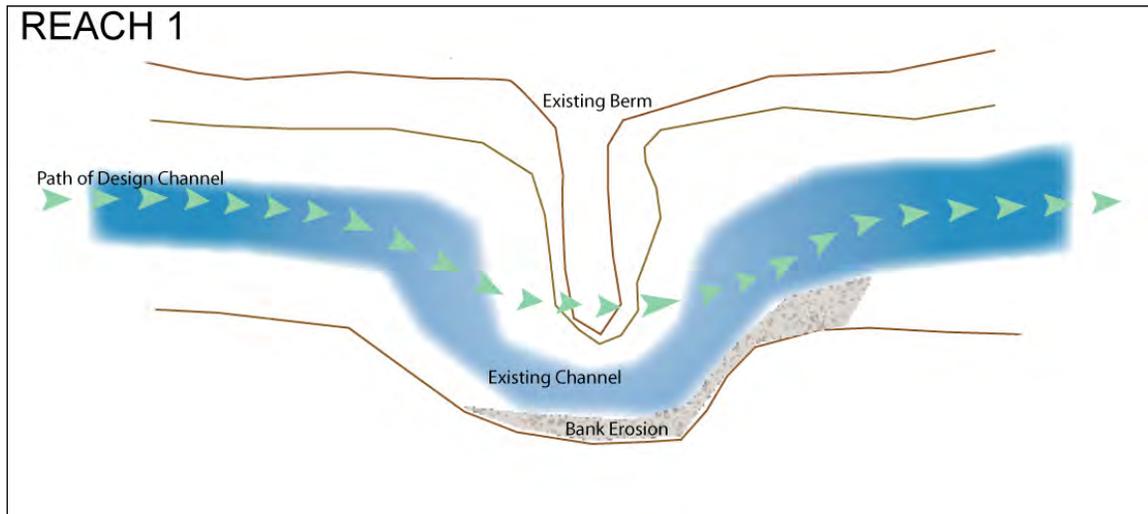
**Figure 12. Graphic of channel realignment in Reach 1.**

*In Reach 1, bank erosion existed on the outside of the current meander. The meander bank was repaired, the berm removed and the channel realigned. The light green arrows indicate the approximate placement of the new channel.*

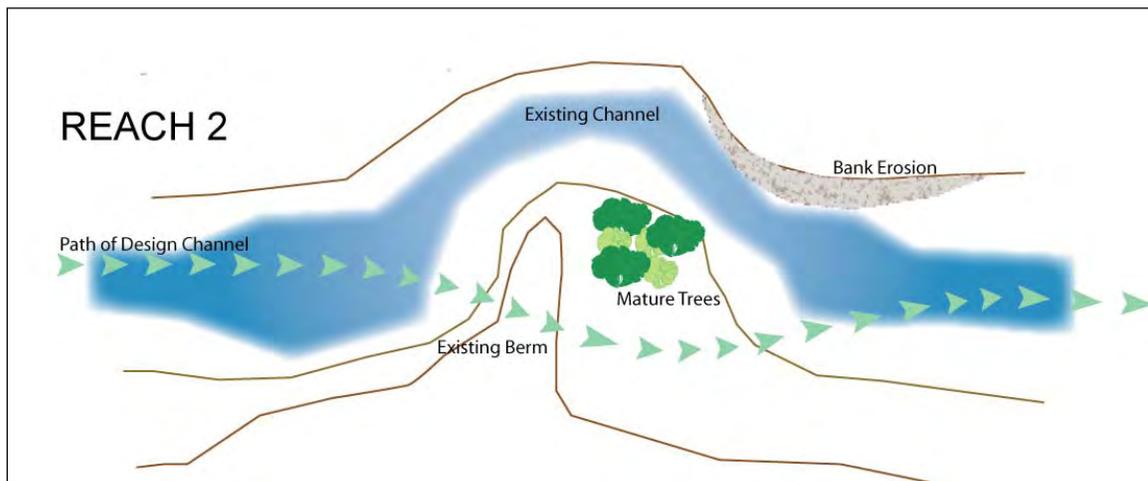
**Figure 13. Graphic of channel realignment in Reach 2.**

*In Reach 2, bank erosion existed on the outside of the current meander. The meander bank was repaired and the channel realigned. The light green arrows indicate the approximate placement of the new channel. The existing channel was backfilled and extensively re-vegetated. Mature trees located just downstream of the berm were preserved.*

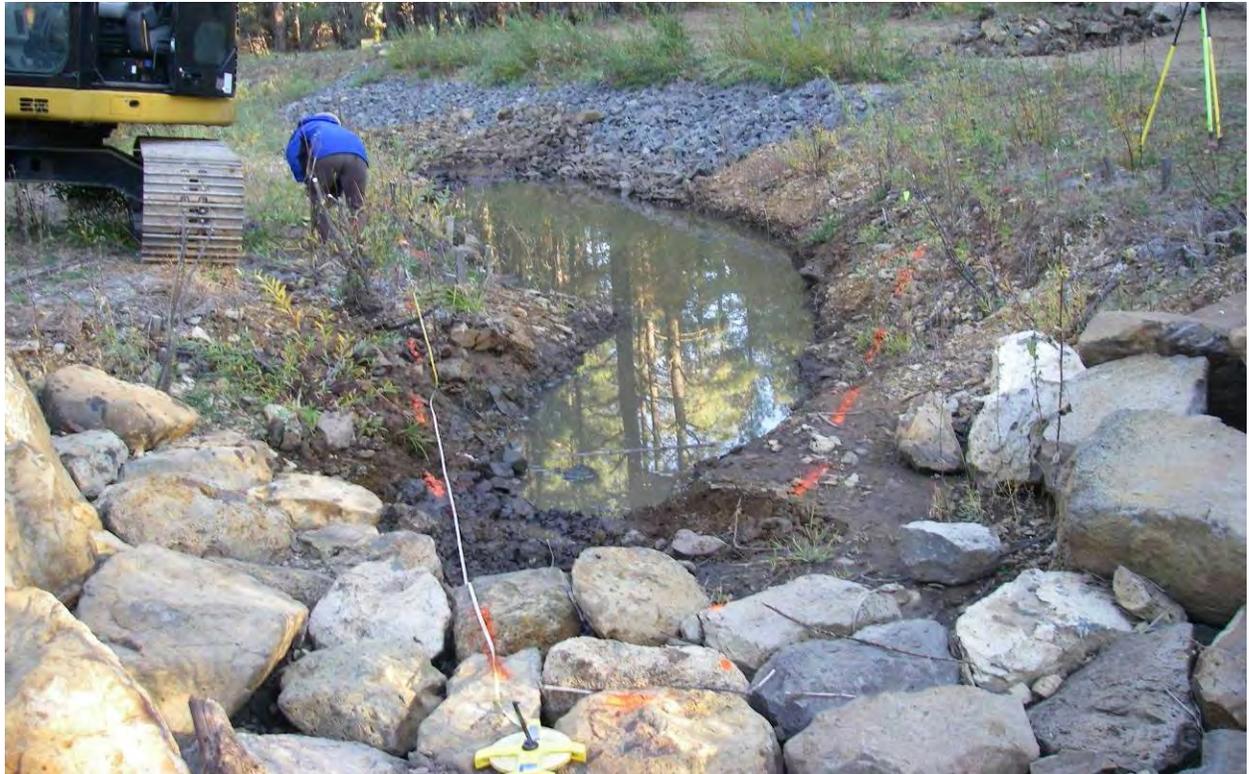
**Figure 47: Layout of the new weir structure.**

During the annual monitoring, it became clear that the two project areas saw relatively little disturbance from the flows that occurred that year. The one exception was the rock weir in Reach 1. The high water flowing over the structure caused some of the rock to fall away and also

resulted in a deep scour hole at the base of the structure. During the following spring and summer, a new topographic survey was completed at the site and a new modified grade stabilization structure was designed. The second phase of construction to repair the weir and to install additional plantings commenced in October of 2011.

During the second phase of construction, a modified grade stabilization structure was designed and installed to replace the original weir structure. The flow event that damaged the first structure was large (~25-yr recurrence interval event), so the site and structure was first analyzed to determine the cause of failure.

The original structure utilized rock found on site during the initial construction and the structure was ultimately too small for the elevation drop of the stream. The replacement structure utilized more and larger rock and also incorporated two smaller step-pools to aid in energy dissipation. This new structure was tested in 2013 when several flows over bankfull occurred (the largest at 259 cfs or ~10-year event). No damage to the structure occurred during that flow.

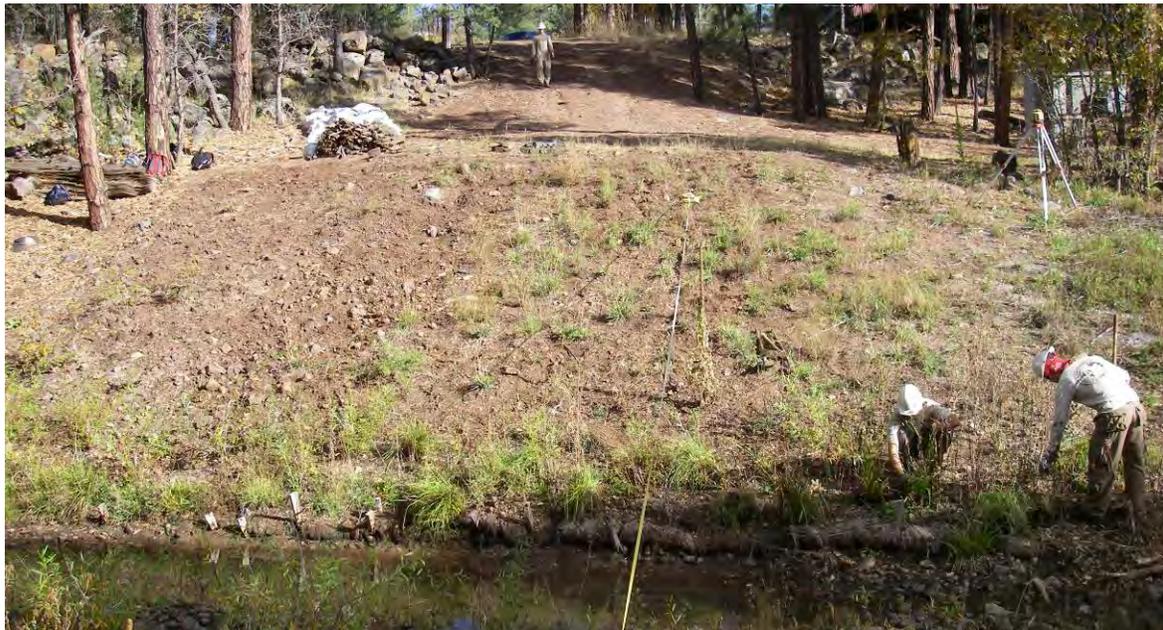
**Figure 62: Right berm bank in Reach 2 prior to seeding.**

*Vegetation on this bank has been struggling due to aspect and poor soil conditions.*

The last item for Reach 2 was the preparation and re-seeding of the right bank where the berm was removed. The old netting and stakes were removed to expose the ground surface. Once exposed, the top 2-3 inches of the ground was tilled with picks and shovels. Once scarified, 155 cubic feet of composted mulch was spread over the 1,400 square feet of bank. This mulch was then mixed into the soil in preparation for seeding. A native seed mix blend (Table 1) was hand broadcast over the bank. Finally the bank was covered with a single net straw erosion control fabric to provide temporary protection from wind and water erosion (Figure 62-64). Existing grass plants were pulled through cuts in the fabric to allow them to continue to grow.

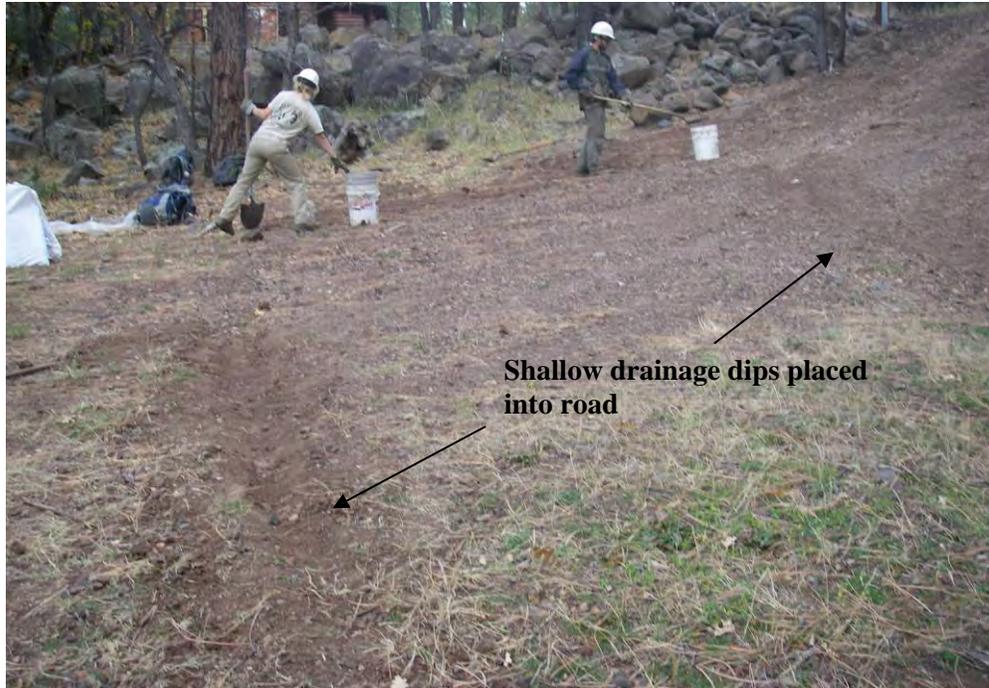
**Figure 65: Redirecting road runoff away from the bank.**

At the top of this bank, runoff from the access road had been concentrating and flowing down this bank, causing some minor erosion. Two small drainage dips were dug across the road uphill from this bank. This will help to redirect the flow from the road down across an undisturbed grassy area (Figure 65).

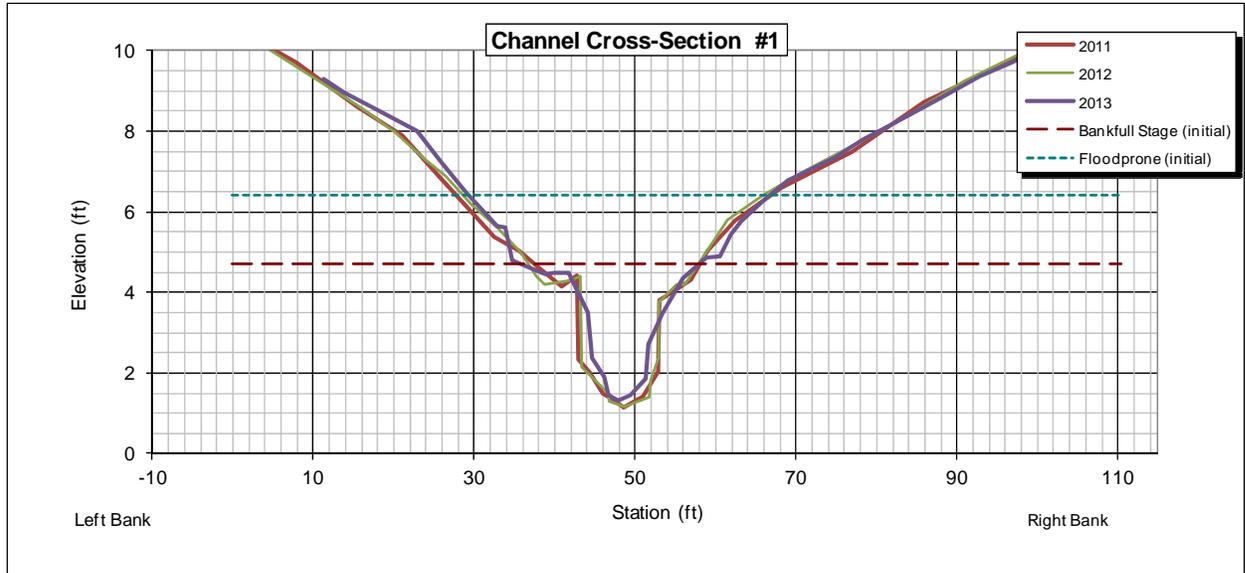
Figure 67: Cross-section 1, 2011 to 2013 profiles

During the 2013 survey, the left end pin for this cross section was found to be missing, so the cross section in 2013 does not line up perfectly with previous years. This resulted in a slight shift in the cross section and is the reason that some of the cross section data is different in 2013 compared with the previous two years. This cross section is stable and in the throat of the rock weir. No rocks have moved since the previous survey. The vegetation continues to grow and fill in around the channel and weir. There was a small amount of scour around the top end of the right side of the weir but it is not threatening the integrity of the structure and the weir is intact and functioning properly.

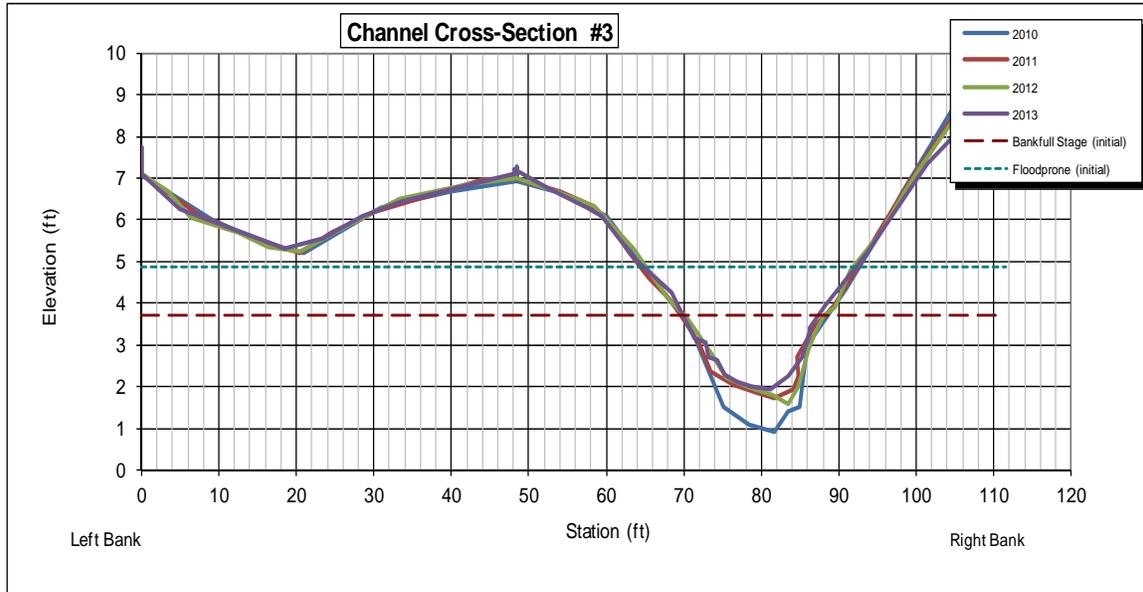
Figure 71. Cross-section 3, 2010 to 2013 profiles

Cross-section 3 is located at the outlet of the pool in Reach 2. The flood in 2010 causes some scour in the soft, newly constructed bed that has since filled to the current, stable elevation.

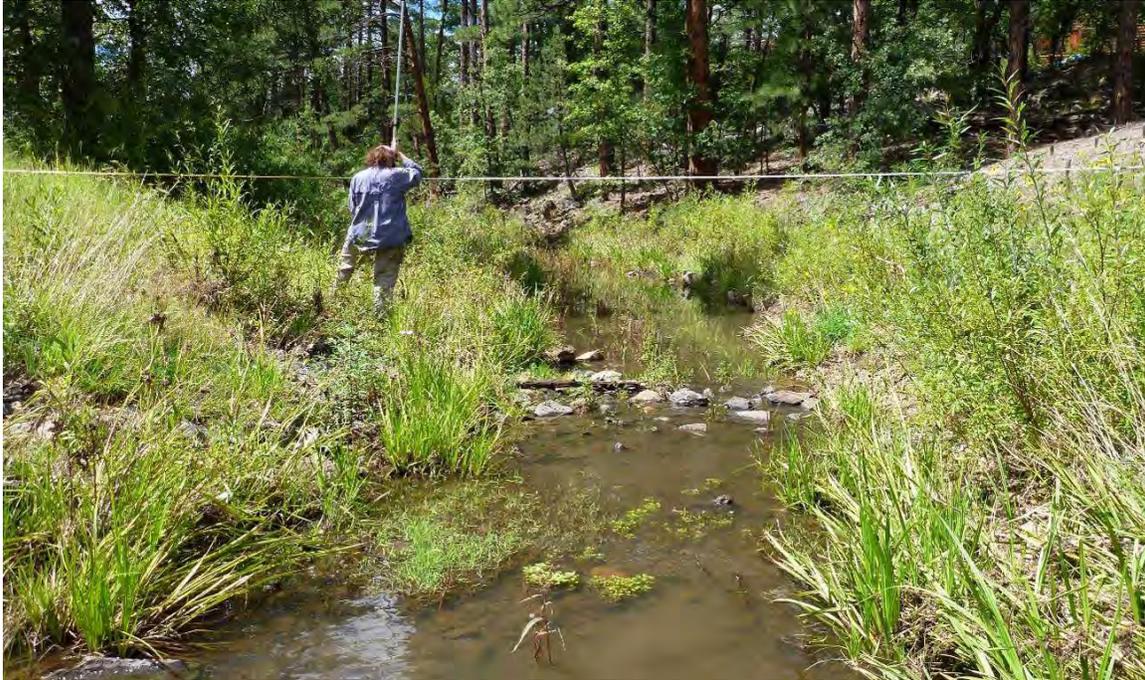
Figure 73. Cross-section 3, September 2013.

The channel at this site is starting to narrow as vegetation fills in along the edges as seen in Figure 73.

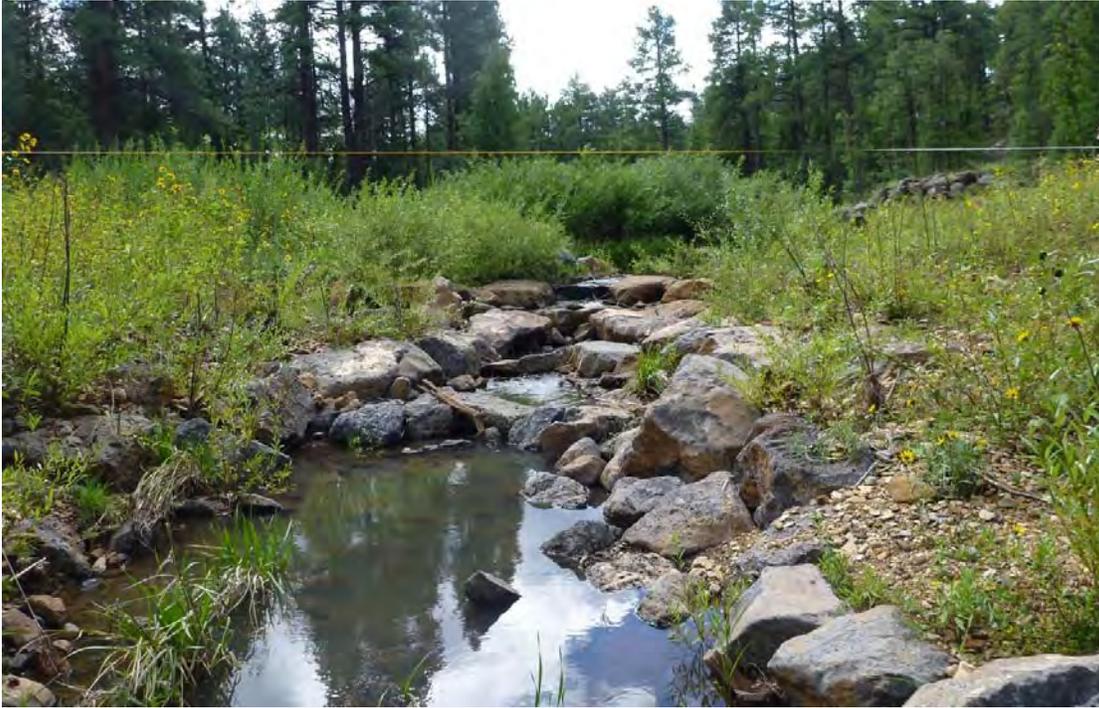
**Figure 76: Looking upstream through modified weir in Reach 1**  
*Rocks are all still in place and functioning. Planted willows are filling in around the structure.*

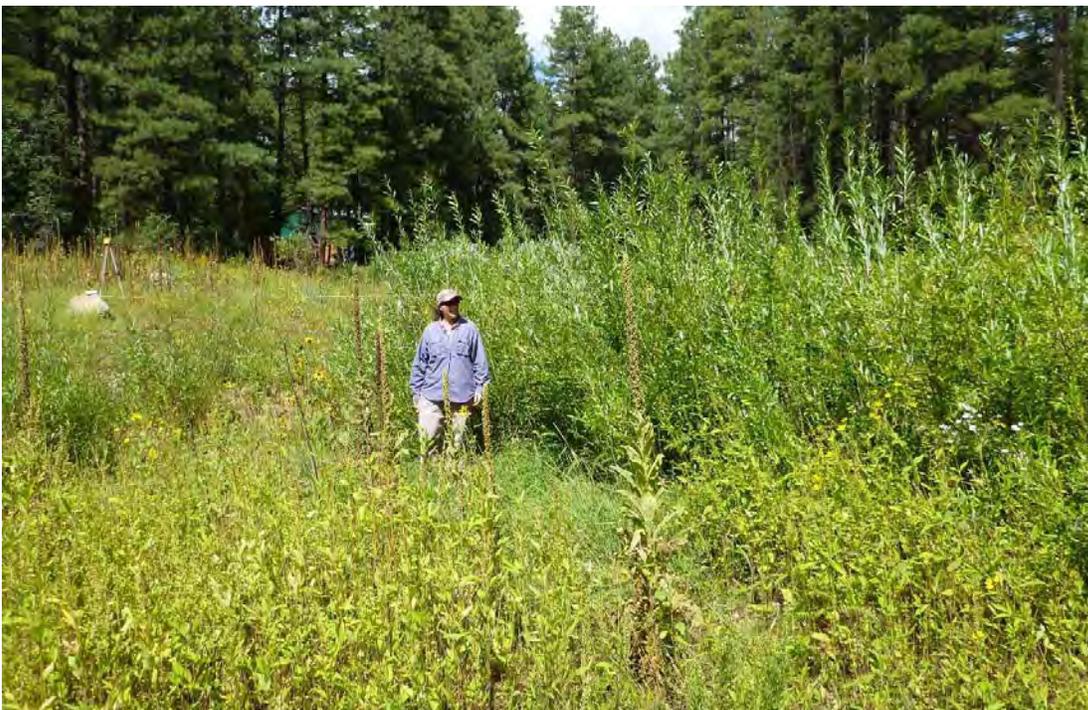
**Figure 77. Rock sill location in Reach 1**  
*The cutoff rock sill in Reach 1 is hidden beneath vegetation.*
