E. COLI REDUCTION ON THE SAN FRANCISCO RIVER THROUGH
ALTERNATIVE LIVESTOCK WATER ON THE KALER RANCH

FINAL REPORT

CONTRACT NUMBER 11-175WPF

May 31, 2013

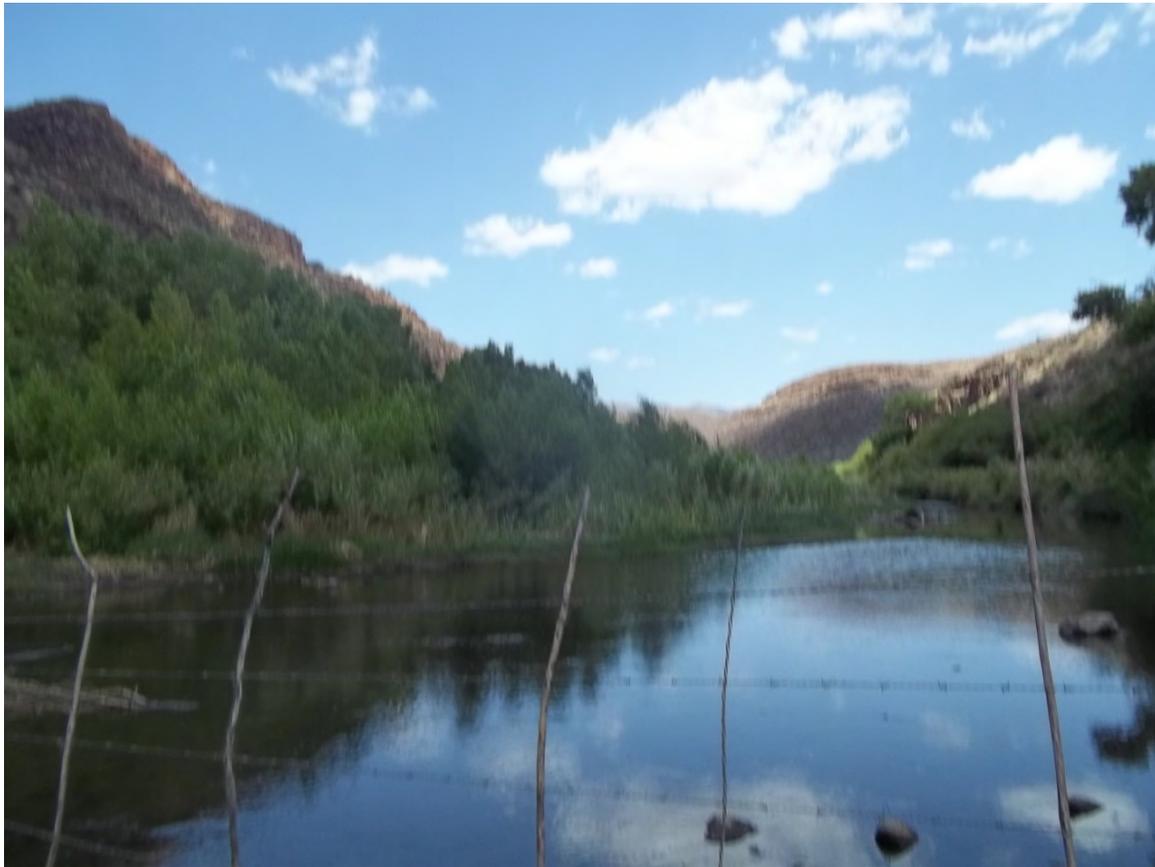
#1 – North, looking up the river (poor focus in this shot)

Notes: densely vegetated bank on both sides of river and both sides of boundary fence. No cattle sign.

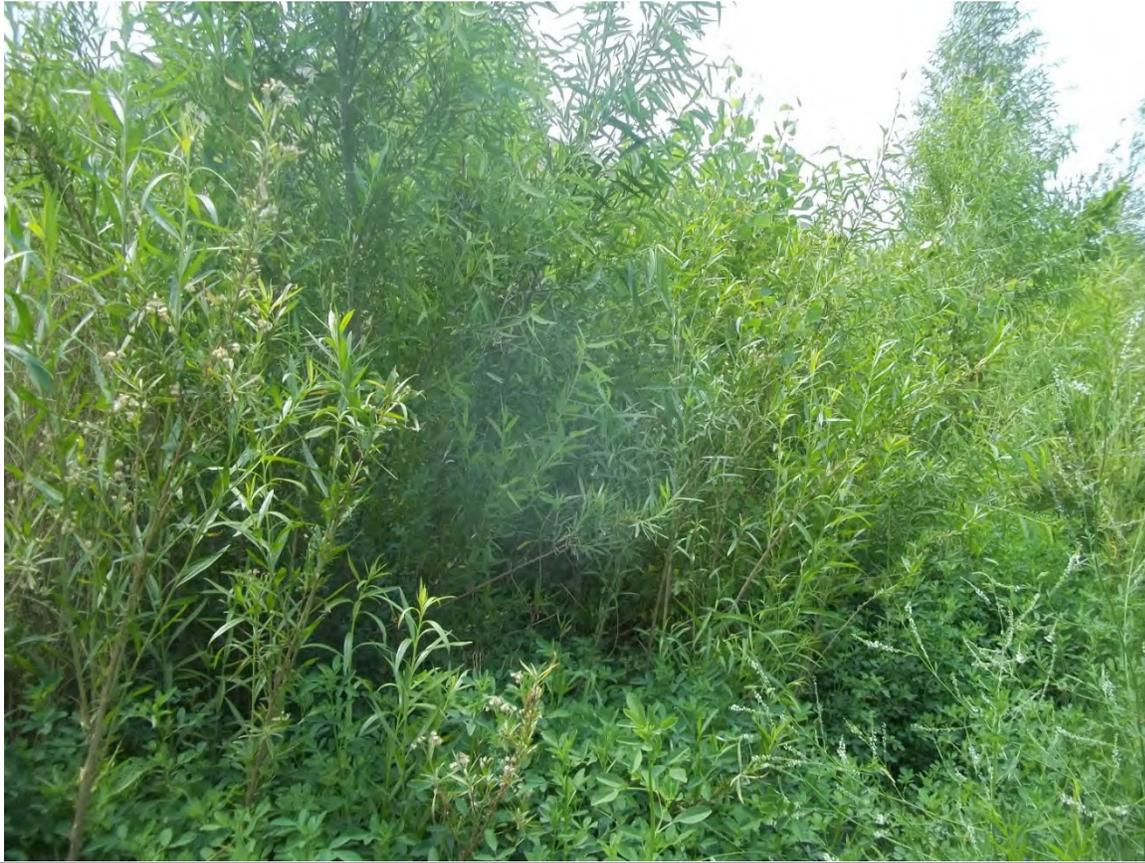
#1 – South, looking down into the east bank (river is out of the frame to the right, south)
GPS reading 12S 0660527, UTM 3667609

Notes: willows and other vegetation on the low, flat east bank are too dense to penetrate. A narrow ATV track still runs upriver behind this 10-20' green barrier.

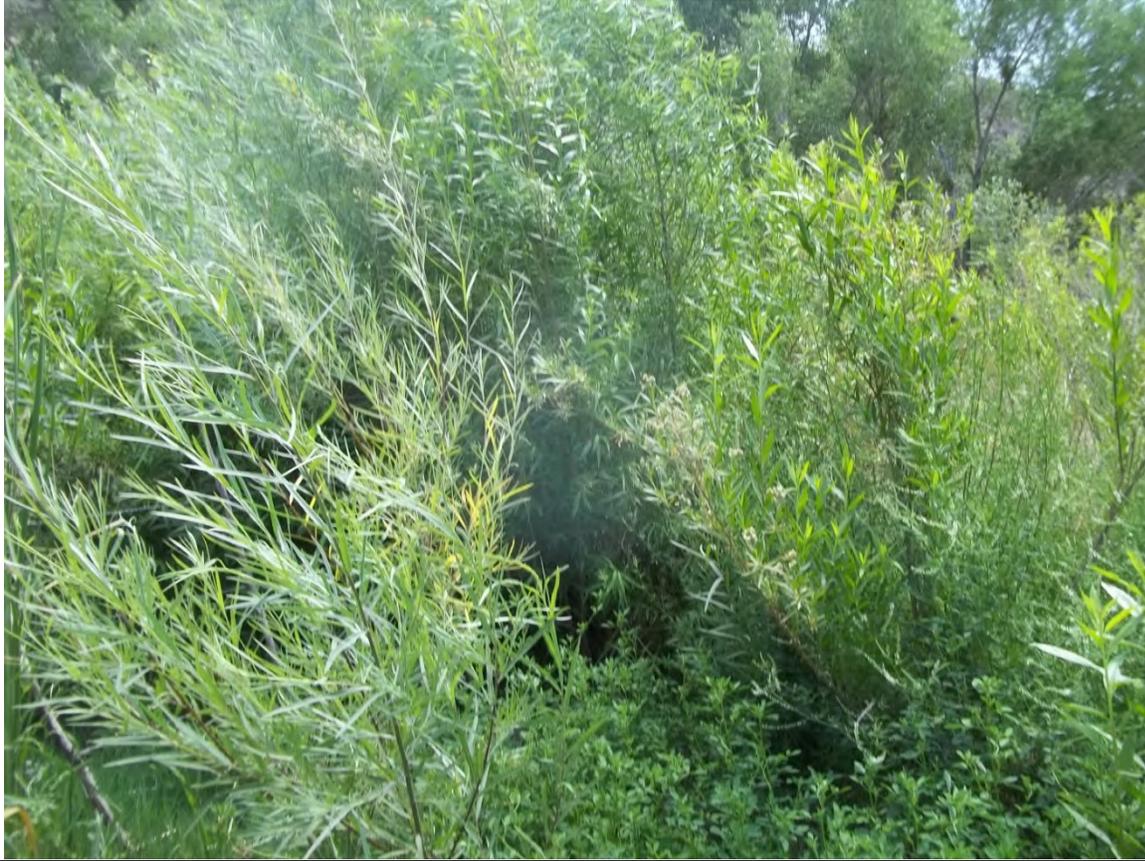
#1 – East, looking into the east bank, where earlier photo point is located, now too densely vegetated to enter.

Notes: vegetation barrier is up to 25' wide on this stretch of the east bank because table is low and flat.

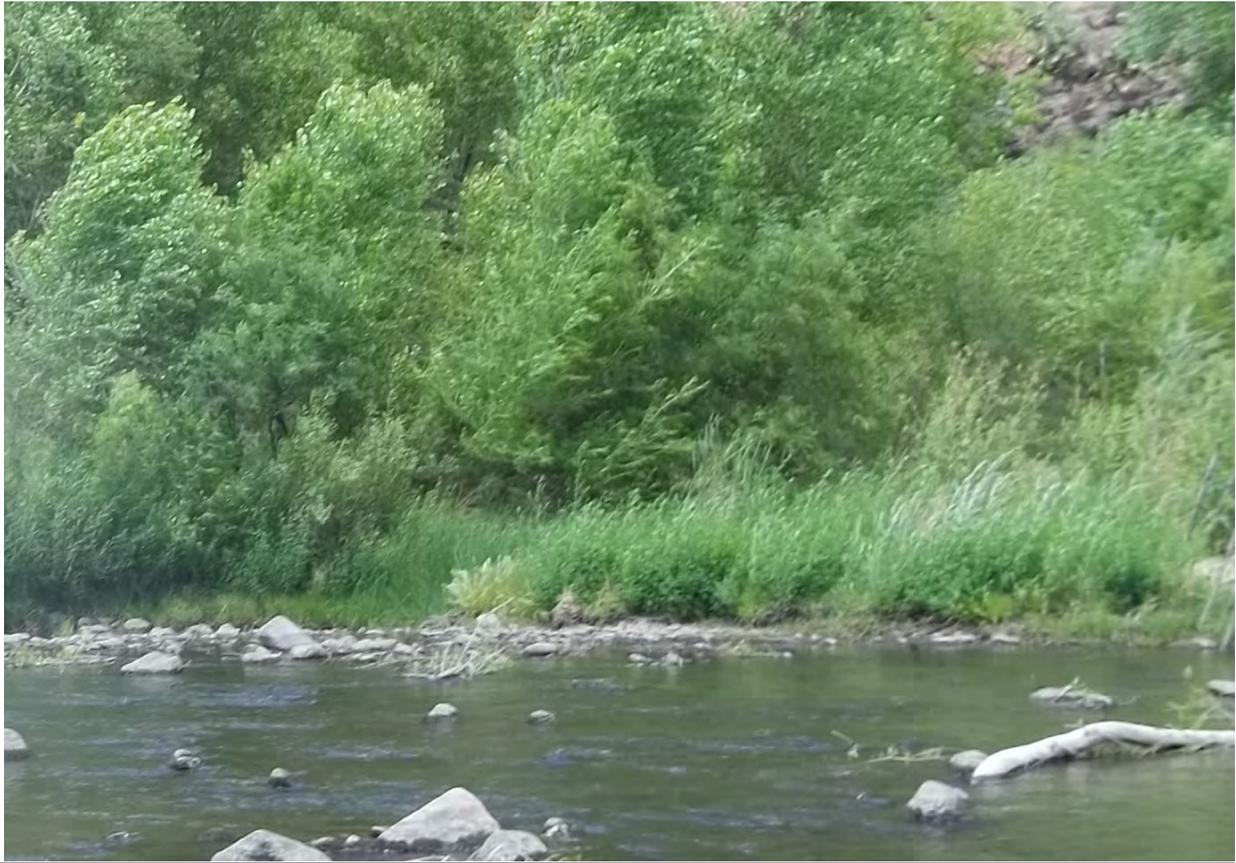
#1 – West, looking across the river at the west bank.

Notes: dense willow growth fills in around young cottonwoods at the bottom of a steep slope.

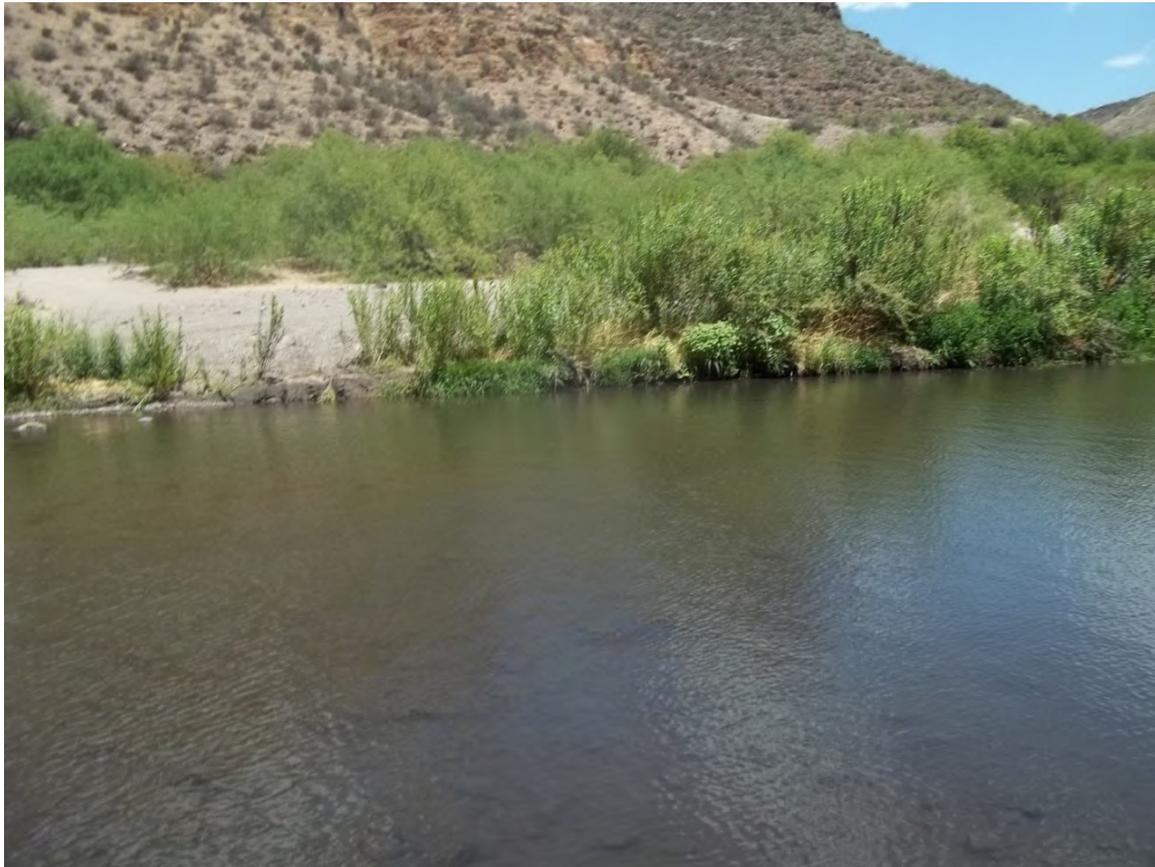
#2 – North, looking across the river

Notes: densely vegetated bank on either side of vehicle trail. No cattle sign.

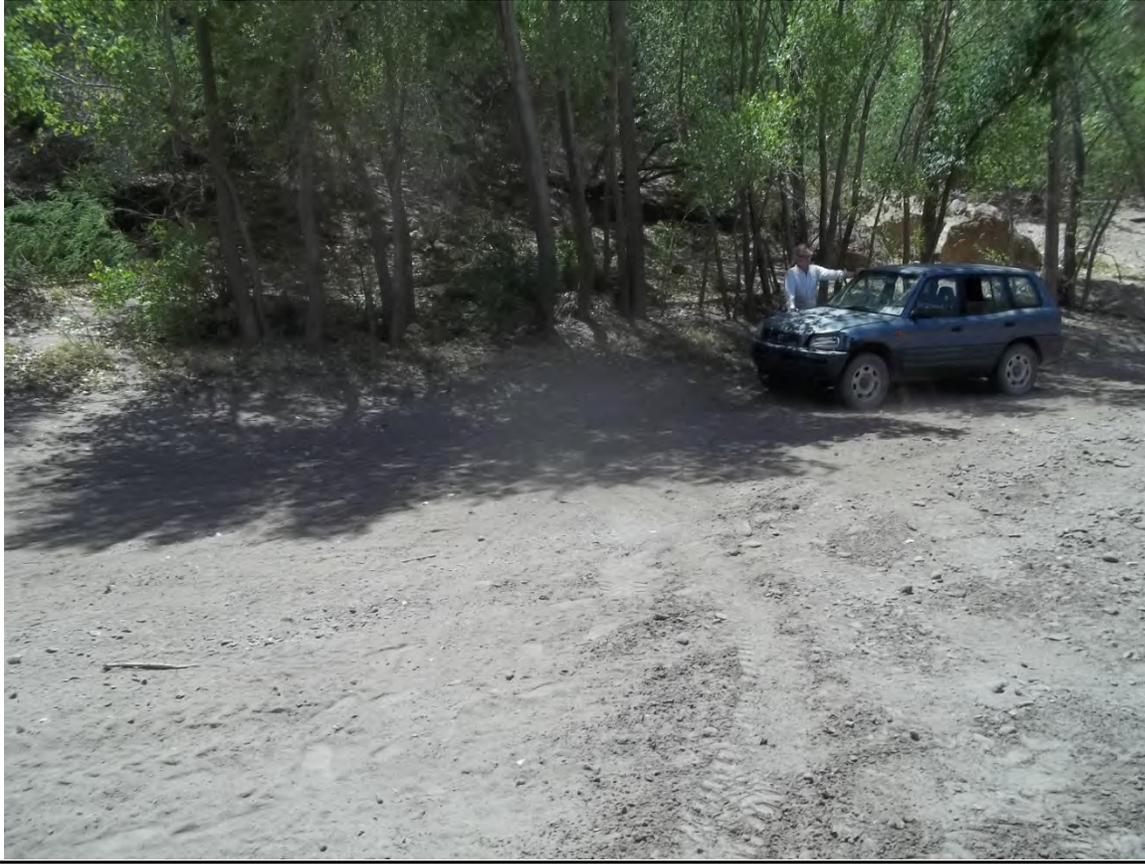
#2 – South, looking into a heavily used parking area for recreation, next to the crossing.
GPS reading 12S 0660233, UTM 3667336

Notes: no revegetation in this immediate area due to heavy vehicle use.

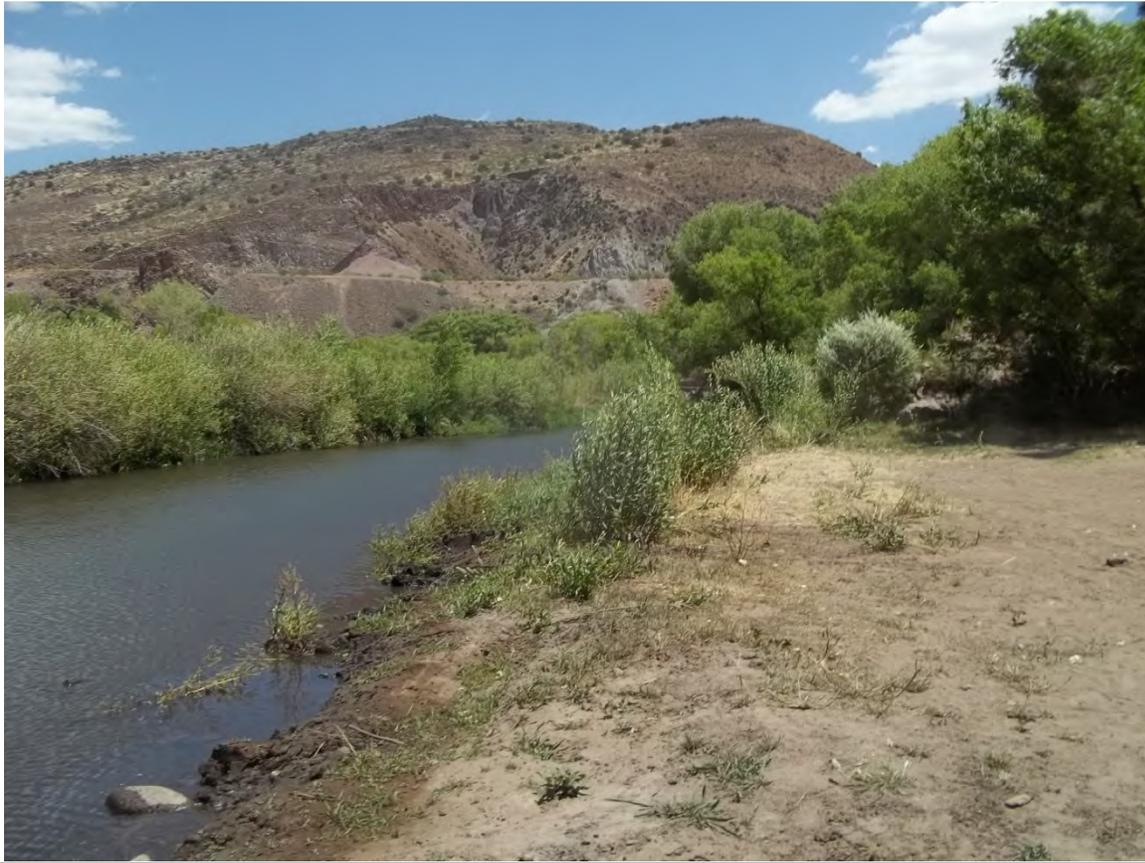
#2 – East, looking upriver.

Notes: there is some vegetative recovery at the point where vehicle use drops off. In the past, this area was characterized by heavy cattle sign.

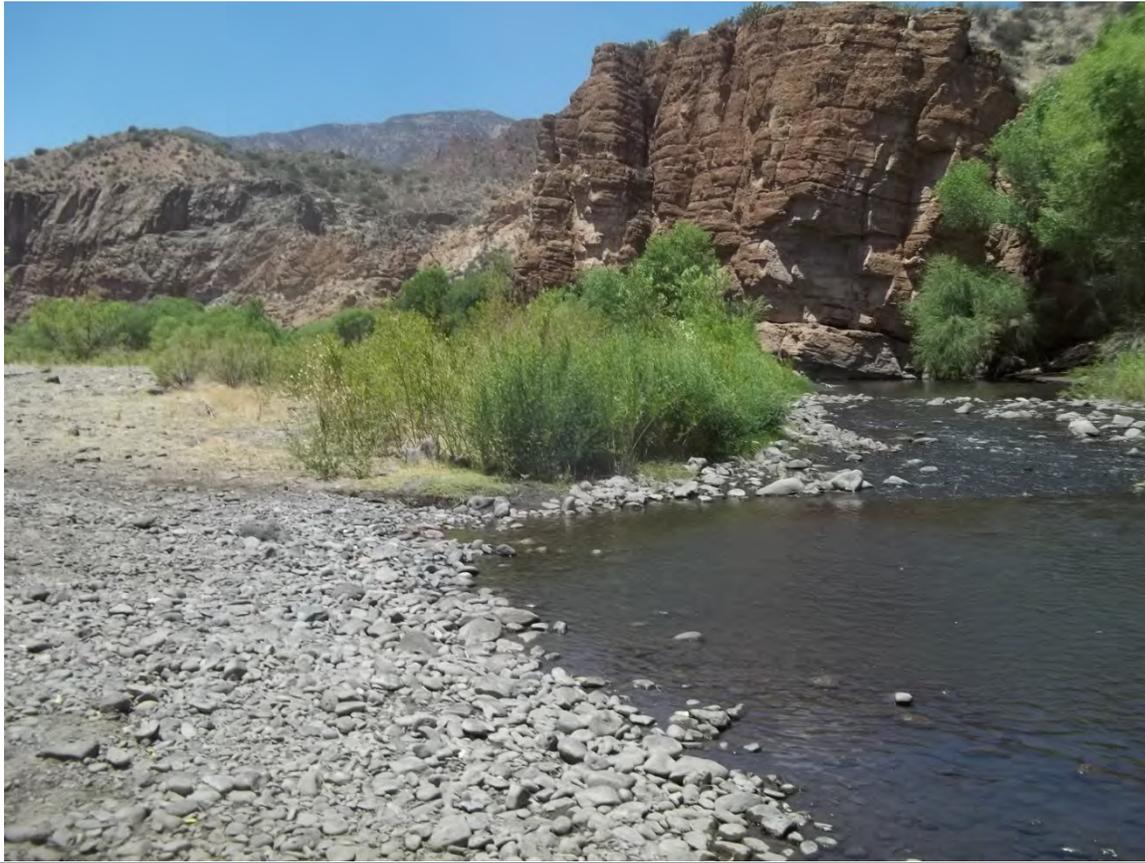
#2 – West, looking downriver.

Notes: again, there is some vegetative recovery where vehicle use drops off.

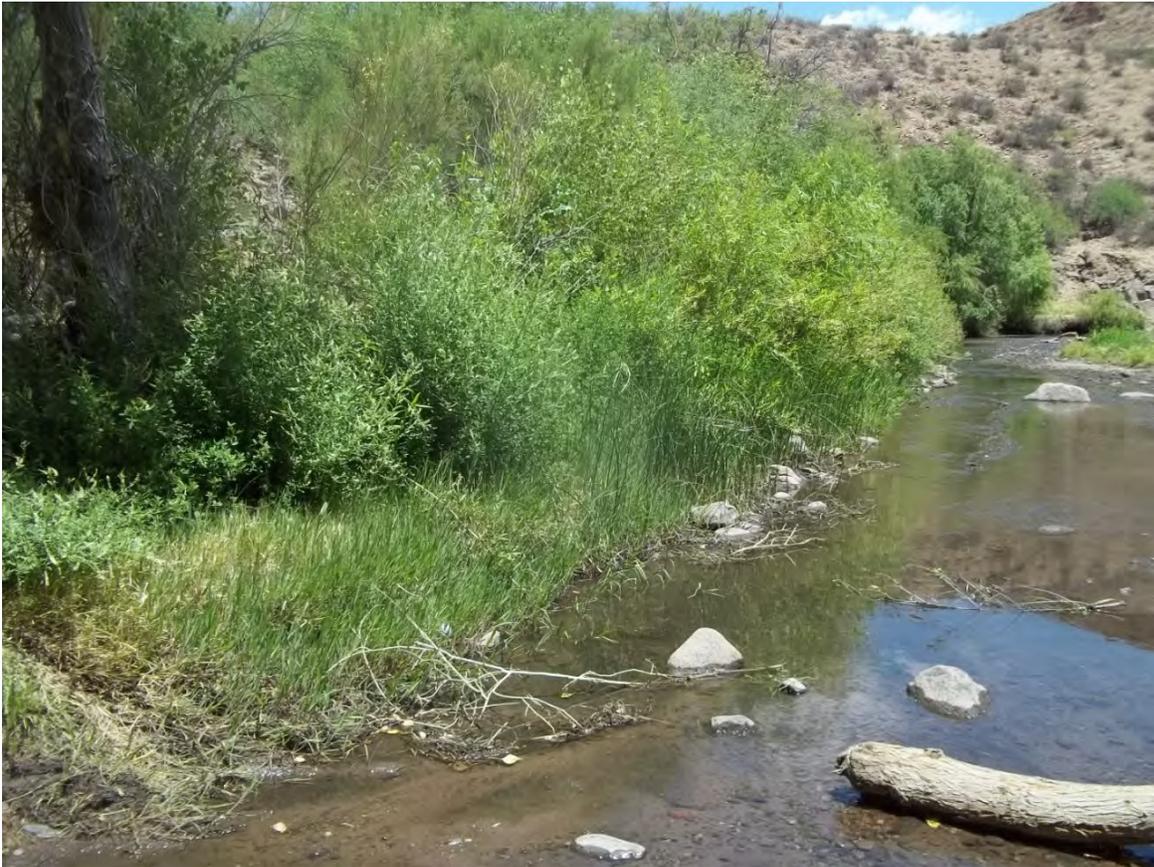
#3 – North, looking downriver

Notes: densely vegetated bank downstream of parking area. No cattle sign.

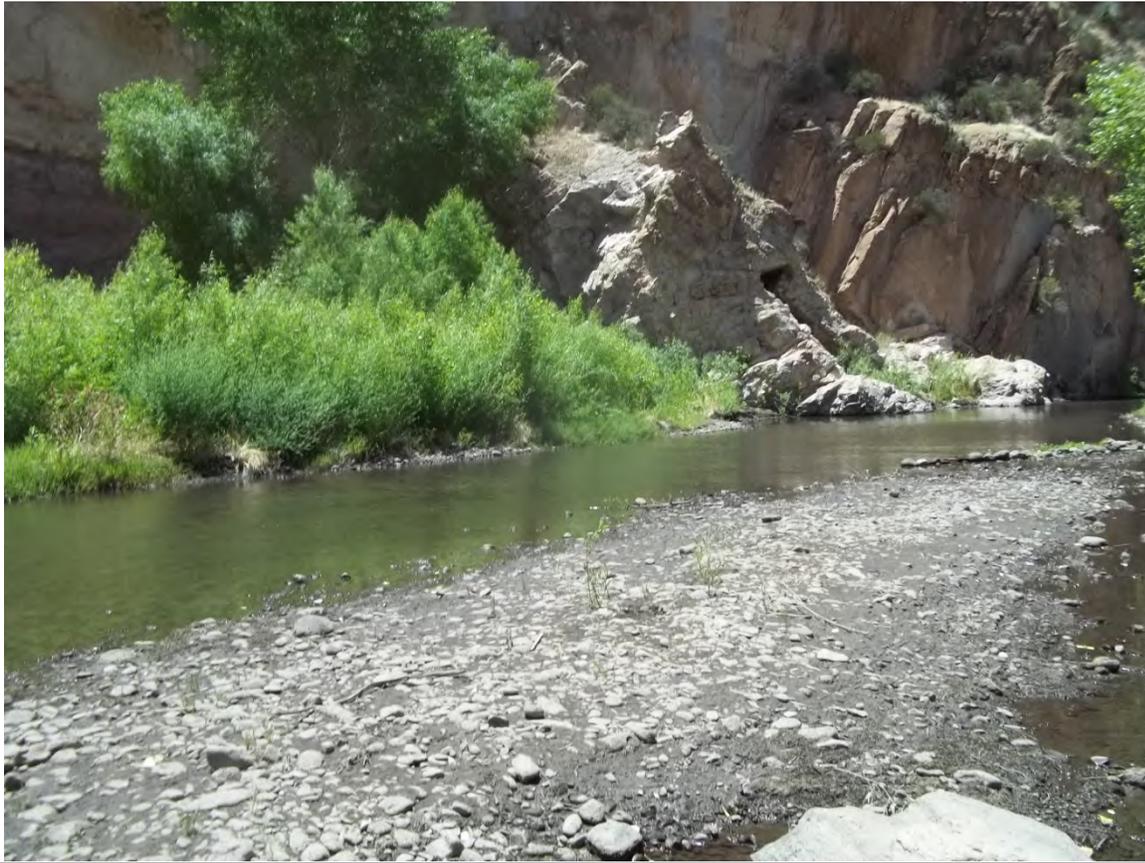
#3 – South, looking upriver toward the feature that gives the site its name.

Notes: willows and other low vegetation on the east bank (to the left), which previously was a rocky flat with no vegetation present.

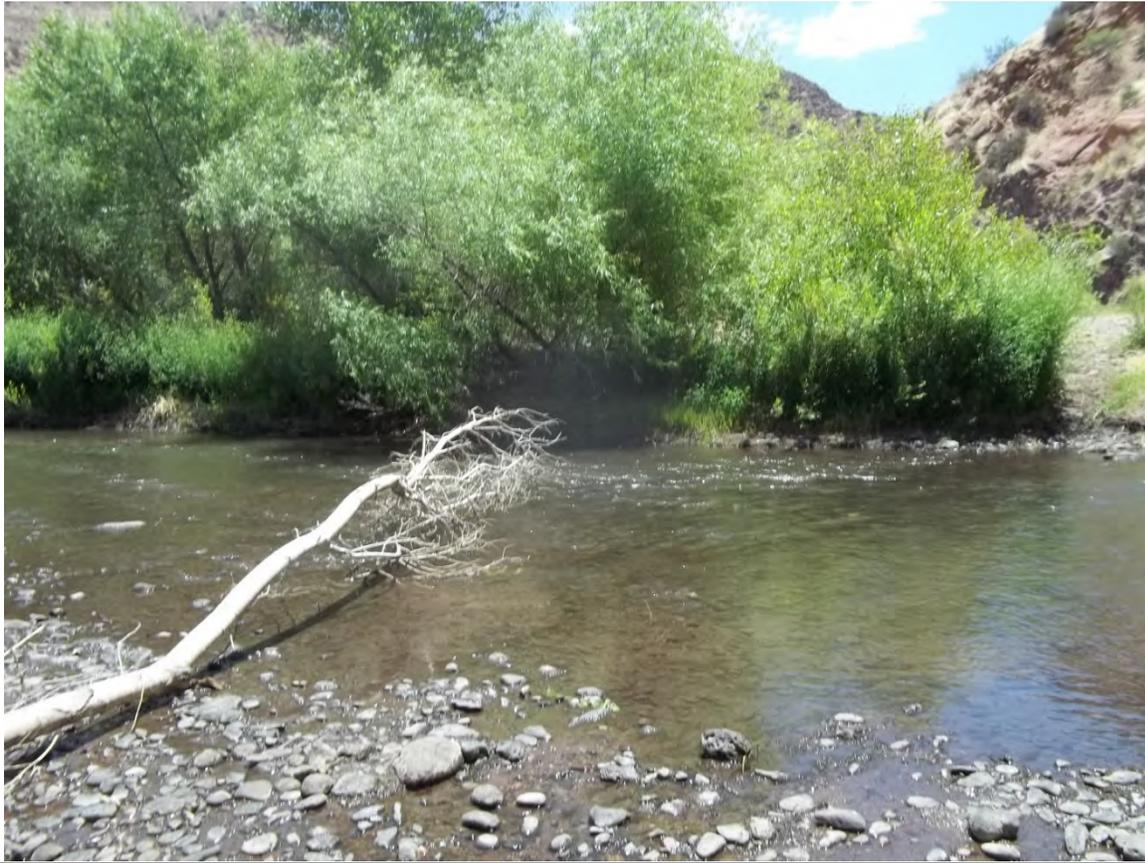
#3 – East, looking across the river.

Notes: this is another view of the rocky flat that previously had no vegetation on it.

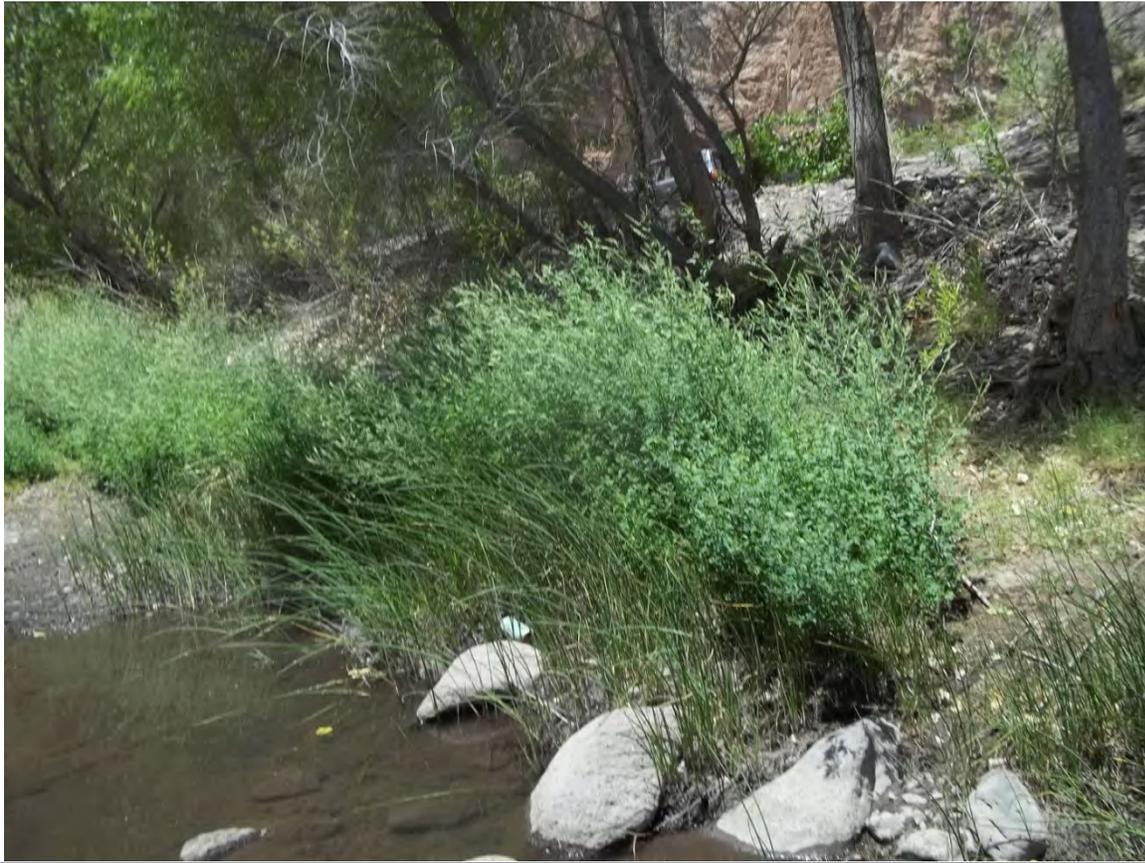
#3 – West, looking at bank near parking area.

Notes: this bank, just below a parking area, was previously free of vegetation.

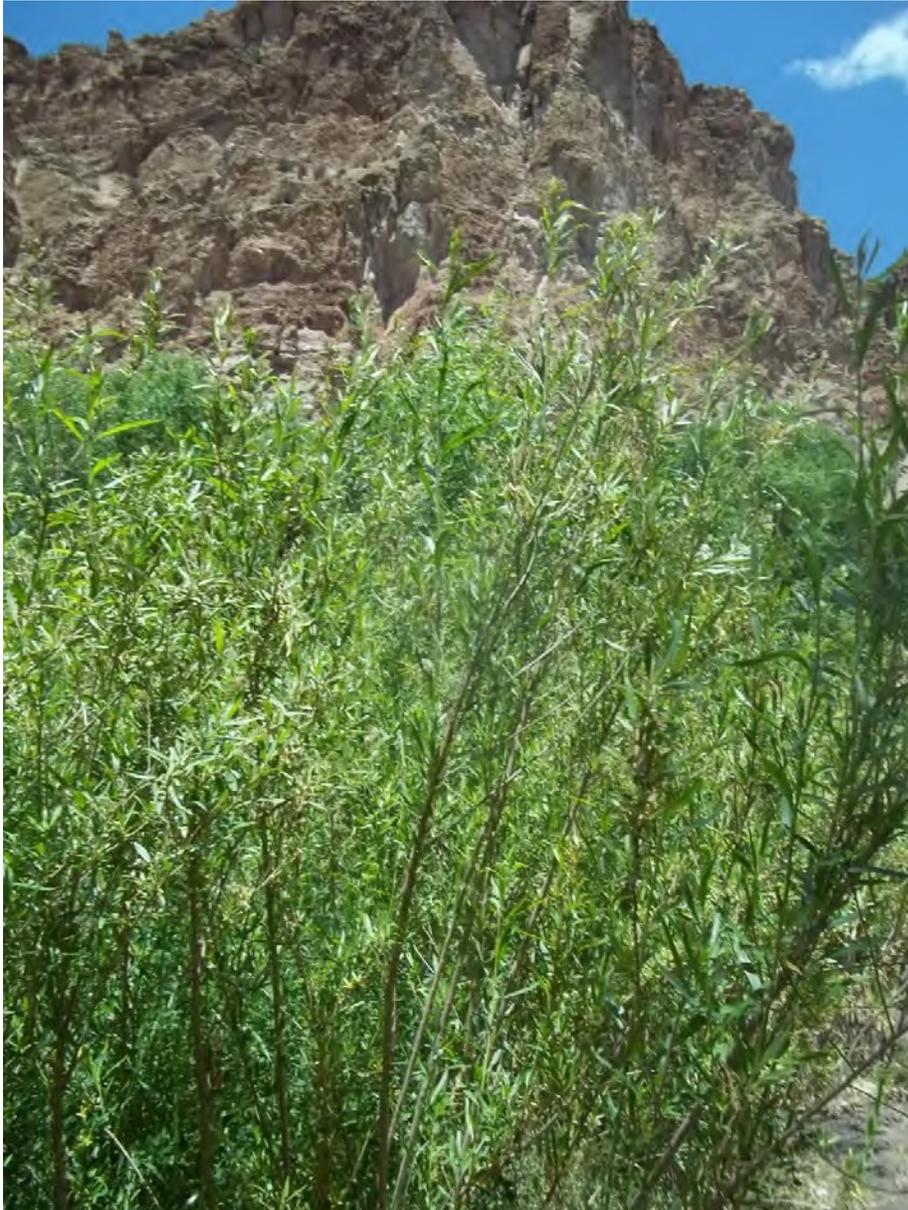
#4 – North, looking upriver

Notes: the river is running downstream toward the photo point behind this densely vegetated bank. No cattle sign.

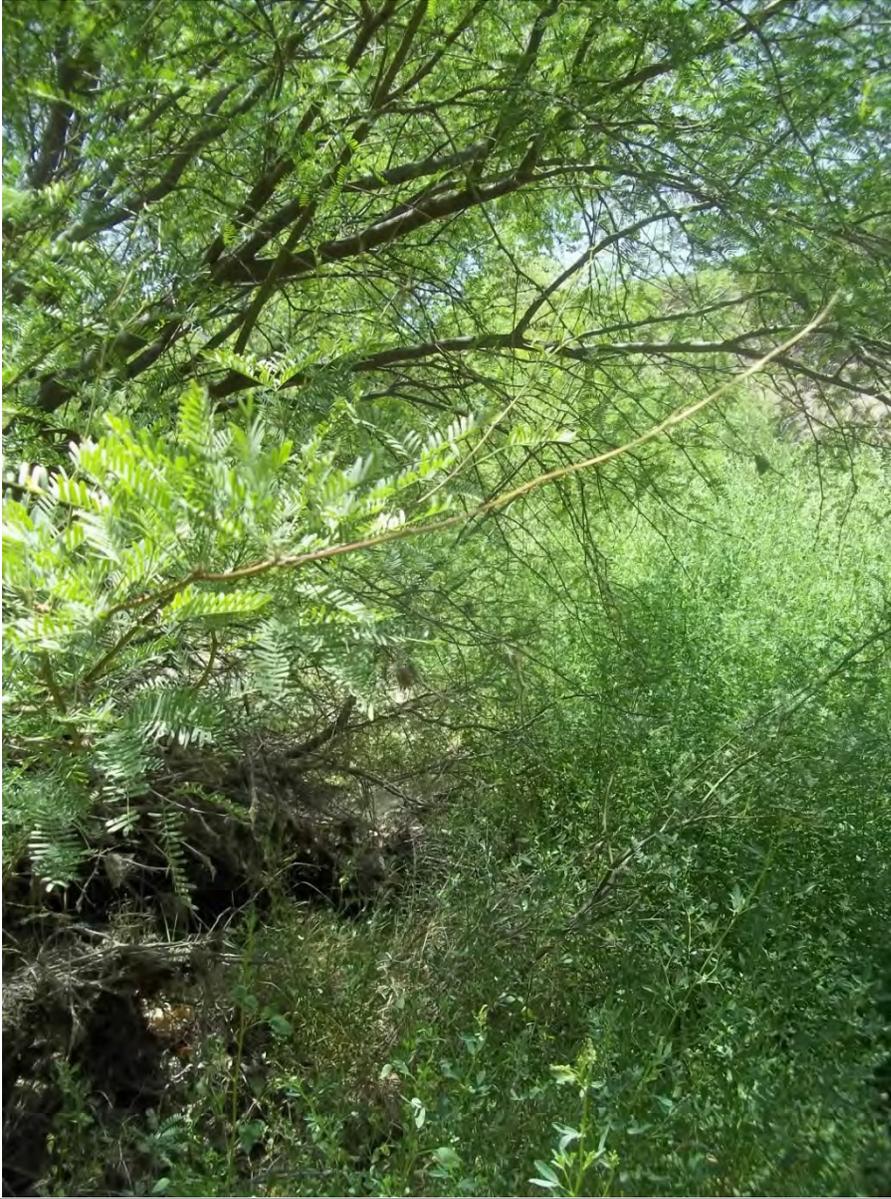
#4 – South, looking downriver toward the confluence with Cottonwood Creek.
GPS reading 12S 0659994, UTM 3666071

Notes: the river is running downstream away from the photo point behind this densely vegetated bank. No cattle sign.

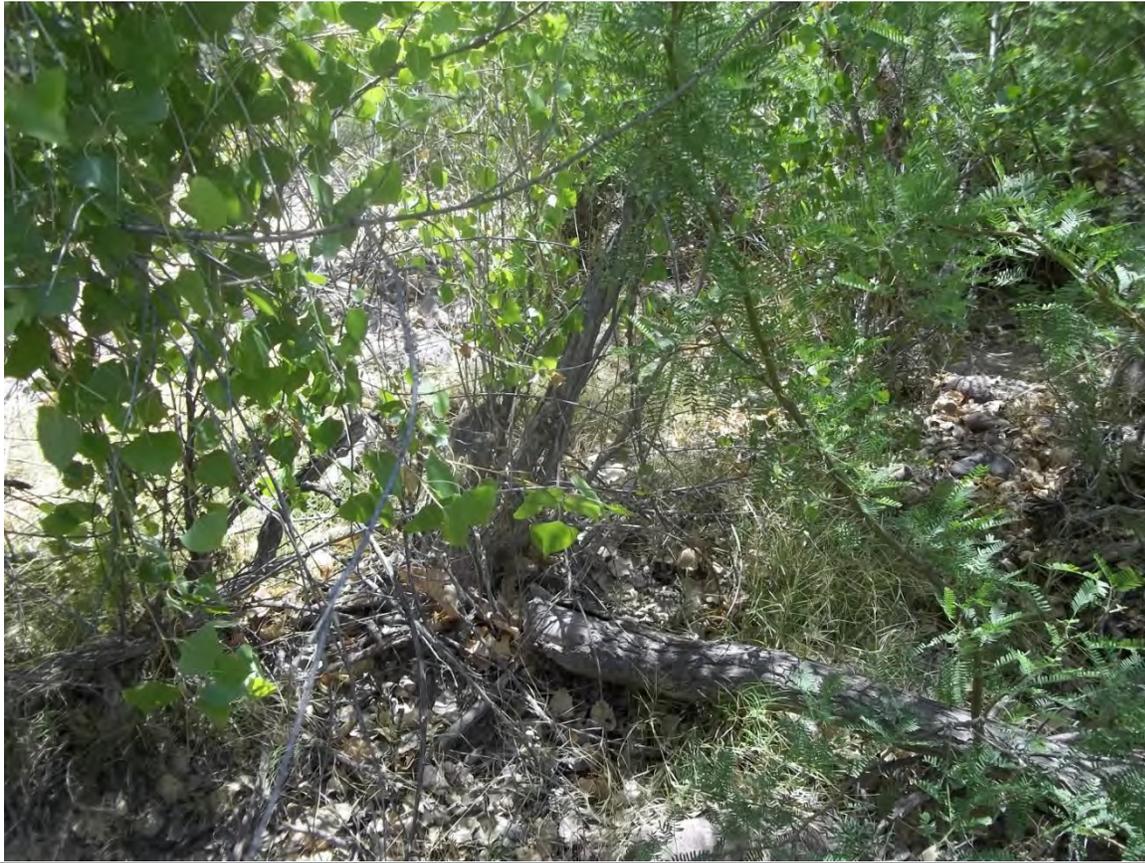
#4 – East, looking into the dry floodplain.

Notes: this looks out from the dense vegetative barrier at the river's edge.

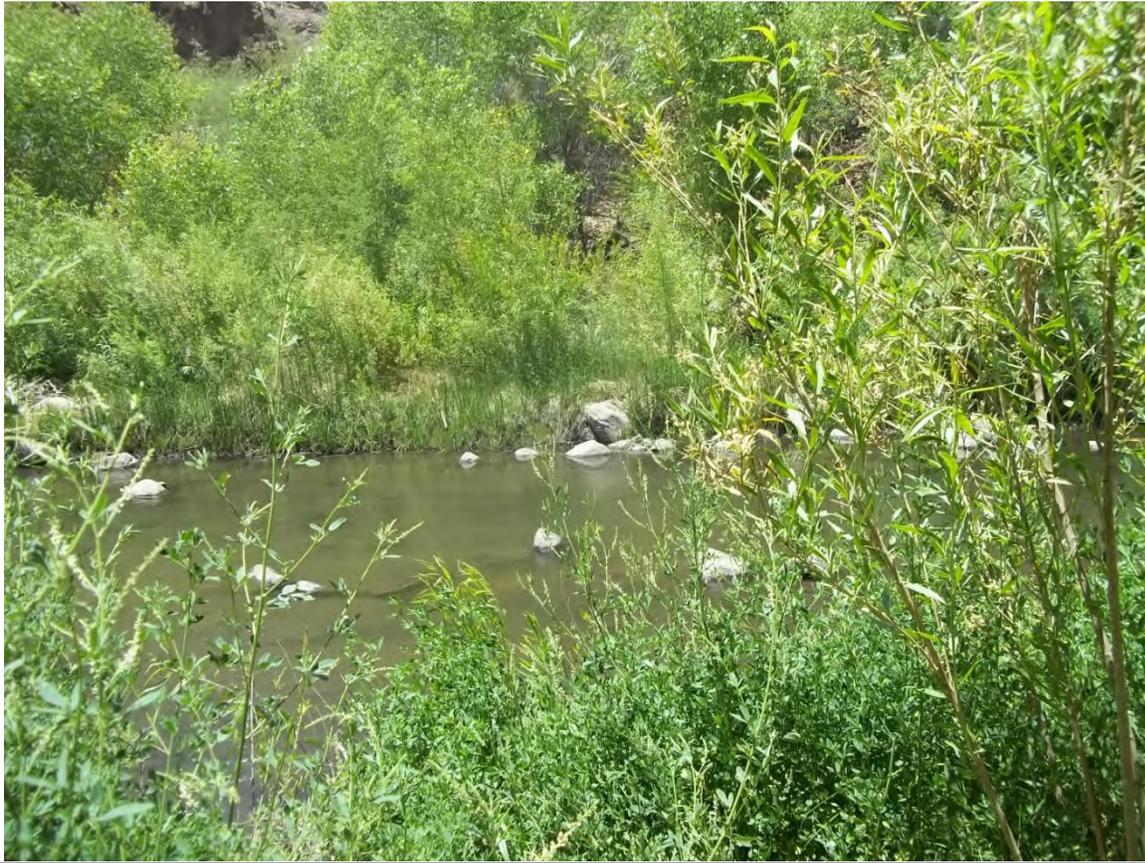
#4 – West, looking across the river.

Notes: there is equally dense vegetation on the other side of the river.

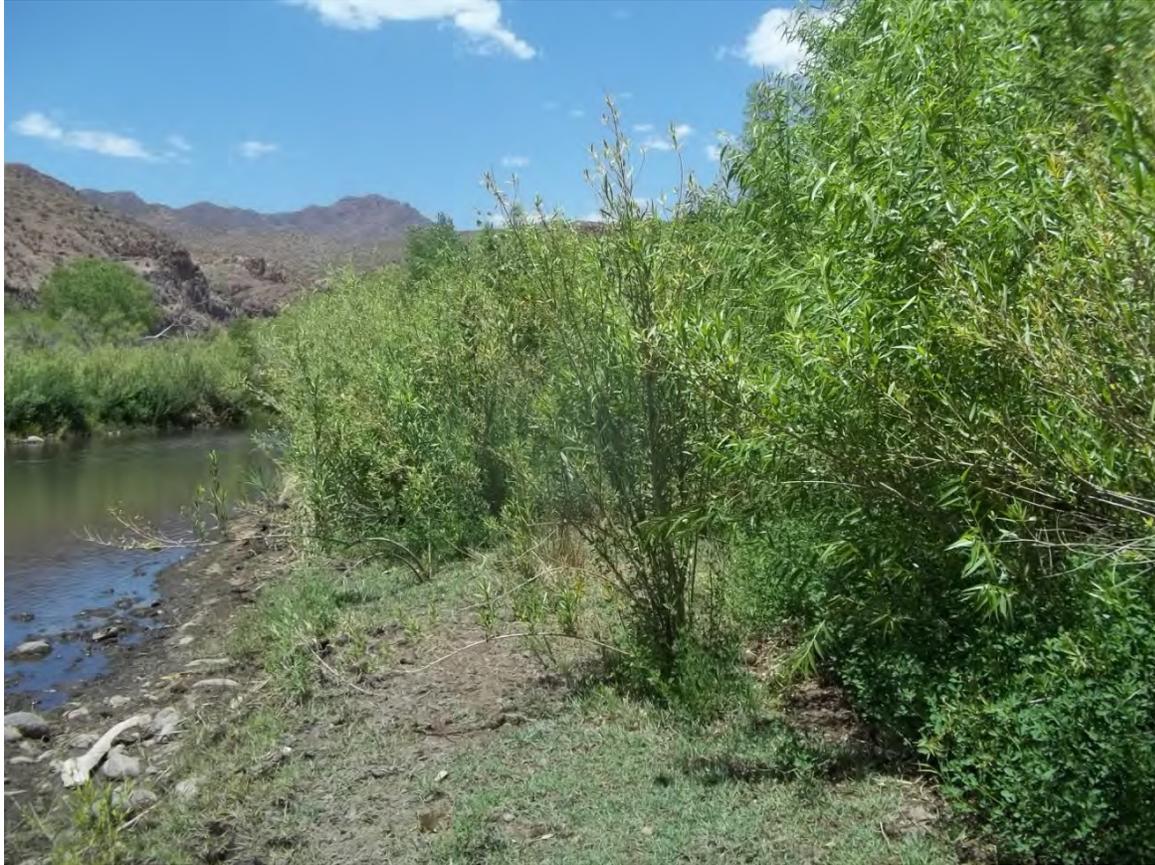
#5 – North, looking upriver

Notes: vegetative recovery is strong on both sides of the vehicle/horse trail crossing the river to the uplands pastures, but is affected on the trail route itself. Prints are made by horses' hooves.

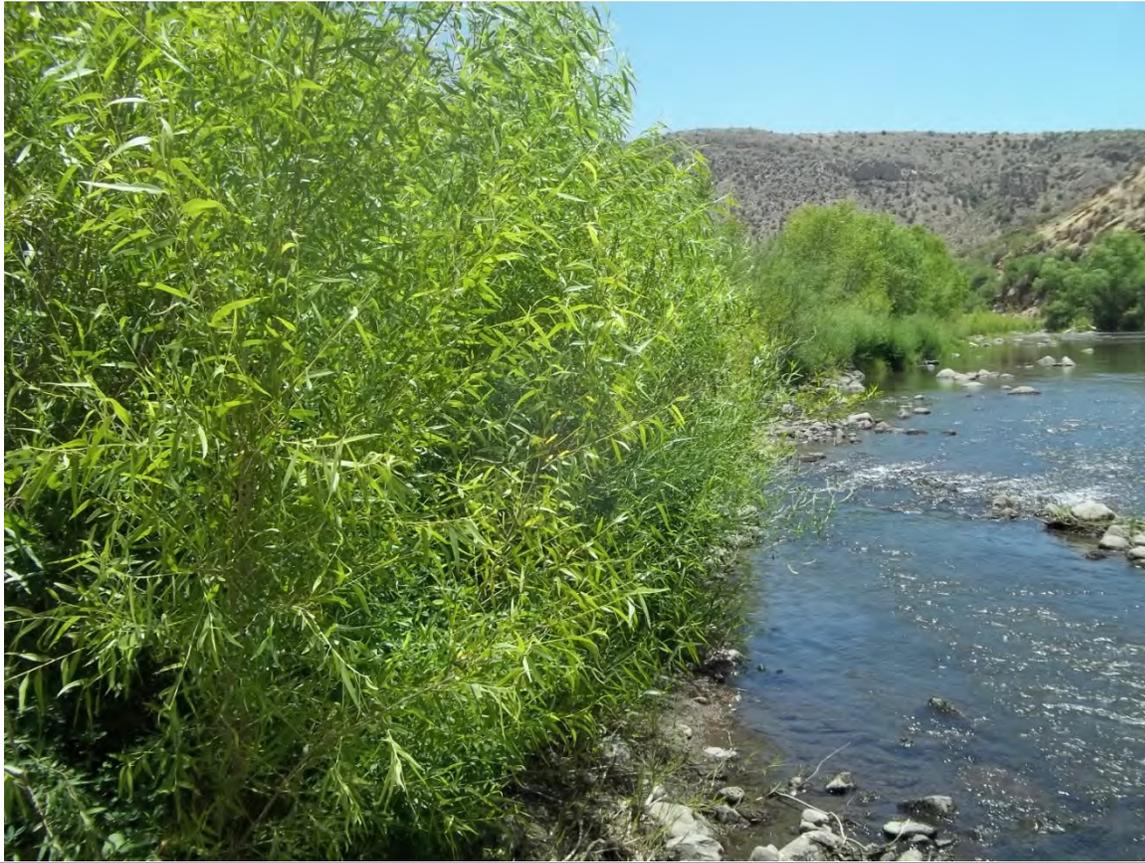
#5 – South, looking downriver below the crossing.

Notes: same as previous.

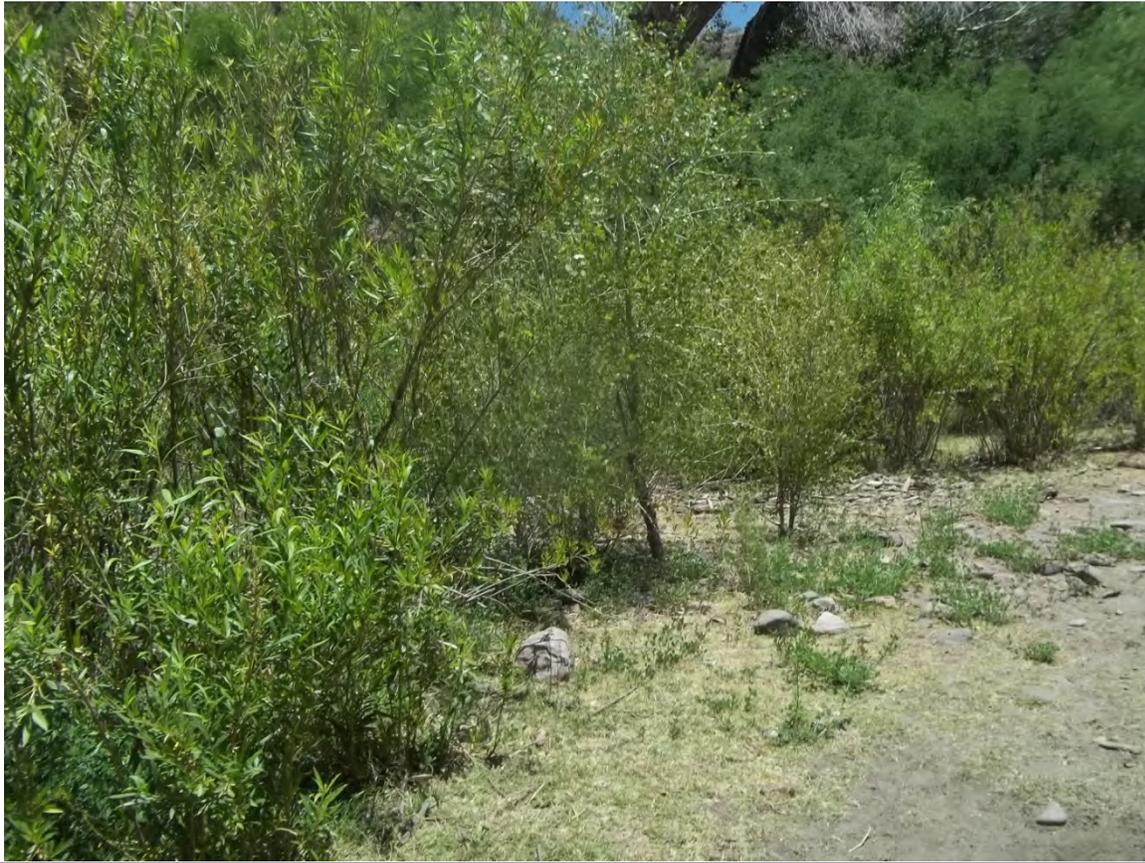
#5 – East, vehicle/horse trail is on the right.
GPS reading 12S 0660147, UTM 3665583

Notes: strong vegetative recovery outside the trail itself.

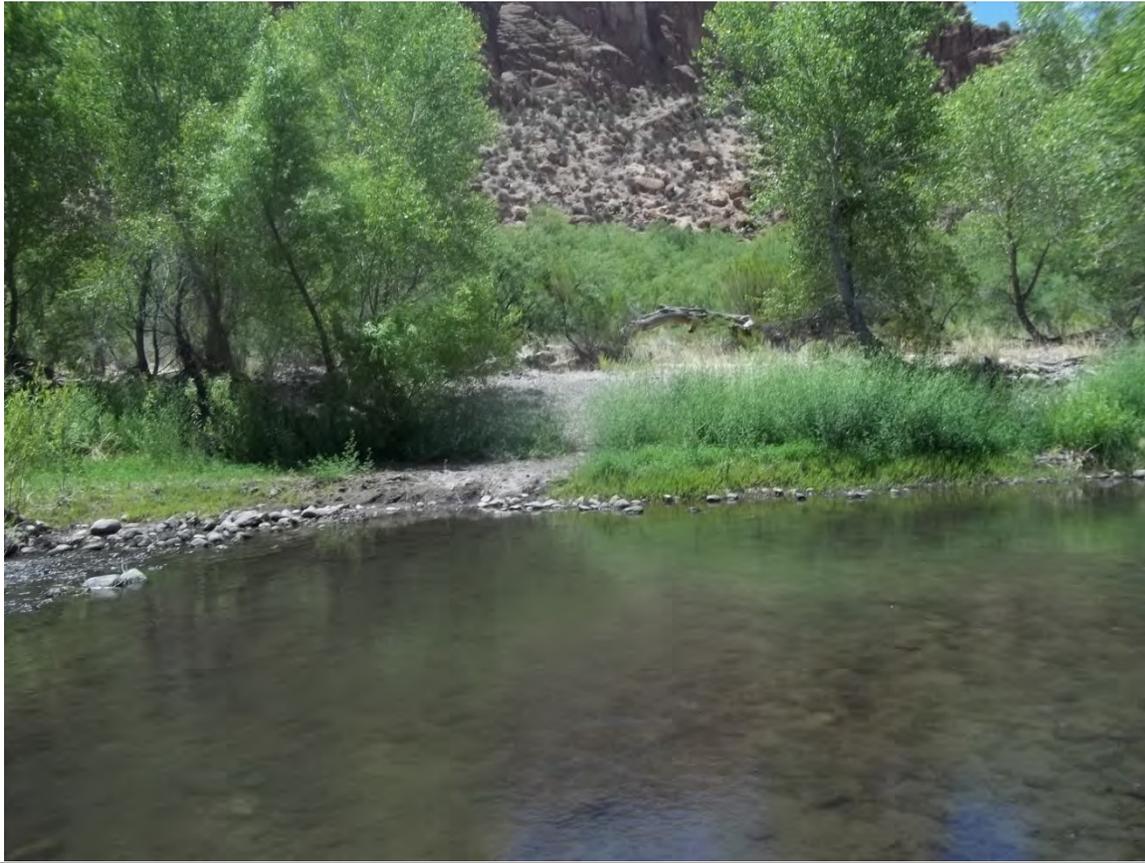
#5 – West, looking across the river.

Notes: on the other side of the river, the continuing trail cuts through new vegetation.

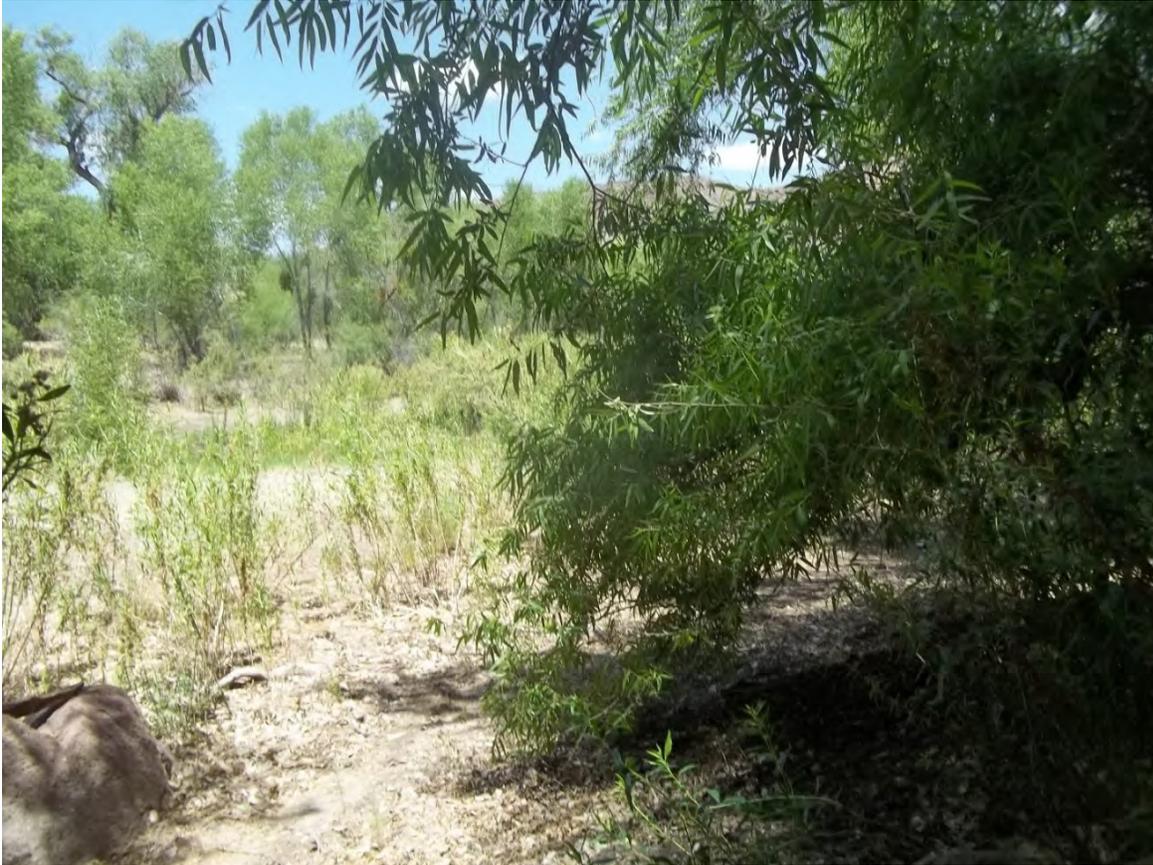
#6 – North, looking upriver

Notes: the big rock itself is not visible through new willow growth at the photo point used on previous monitoring occasions. New low vegetation is occurring across this often-scoured sandy bar.

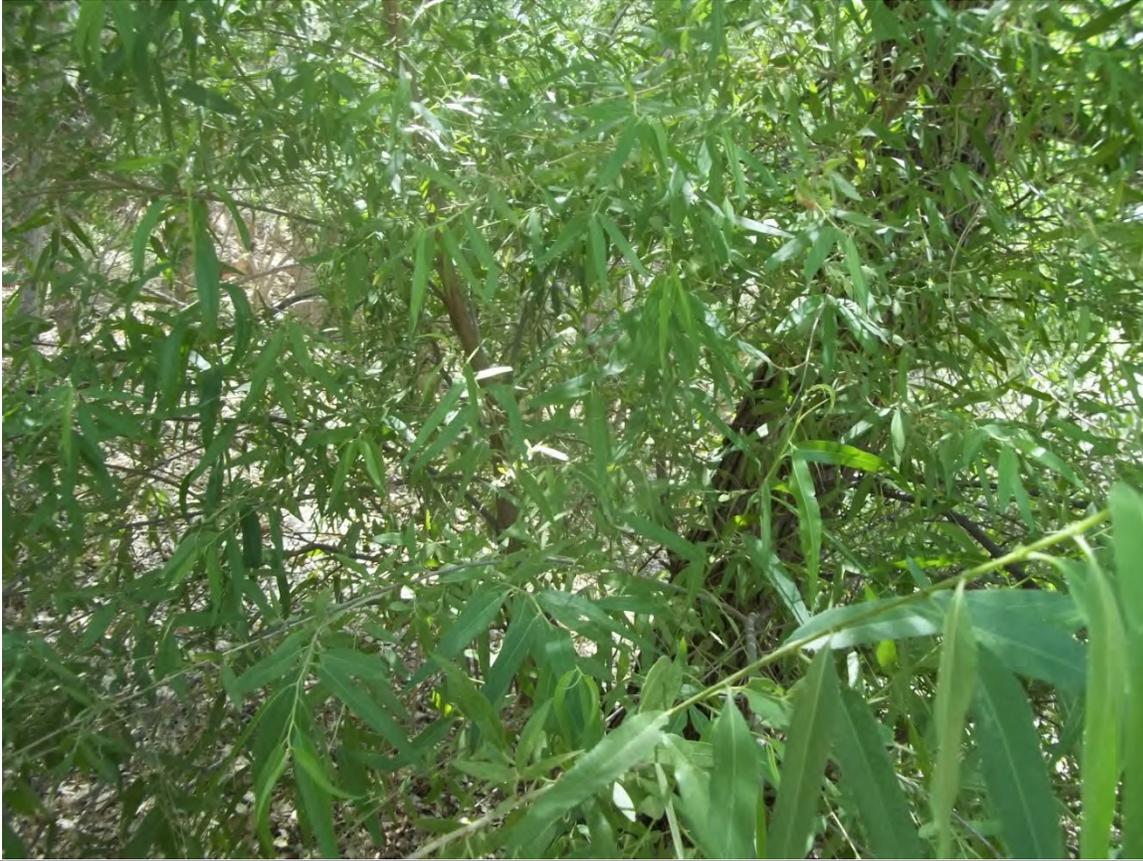
#6 – South, looking downriver below the crossing.

Notes: vegetation obscures the downstream view from the photo point.
