E. COLI REDUCTION ON THE SAN FRANCISCO RIVER THROUGH
ALTERNATIVE LIVESTOCK WATER ON THE KALER RANCH

FINAL REPORT

CONTRACT NUMBER 11-175WPF

May 31, 2013

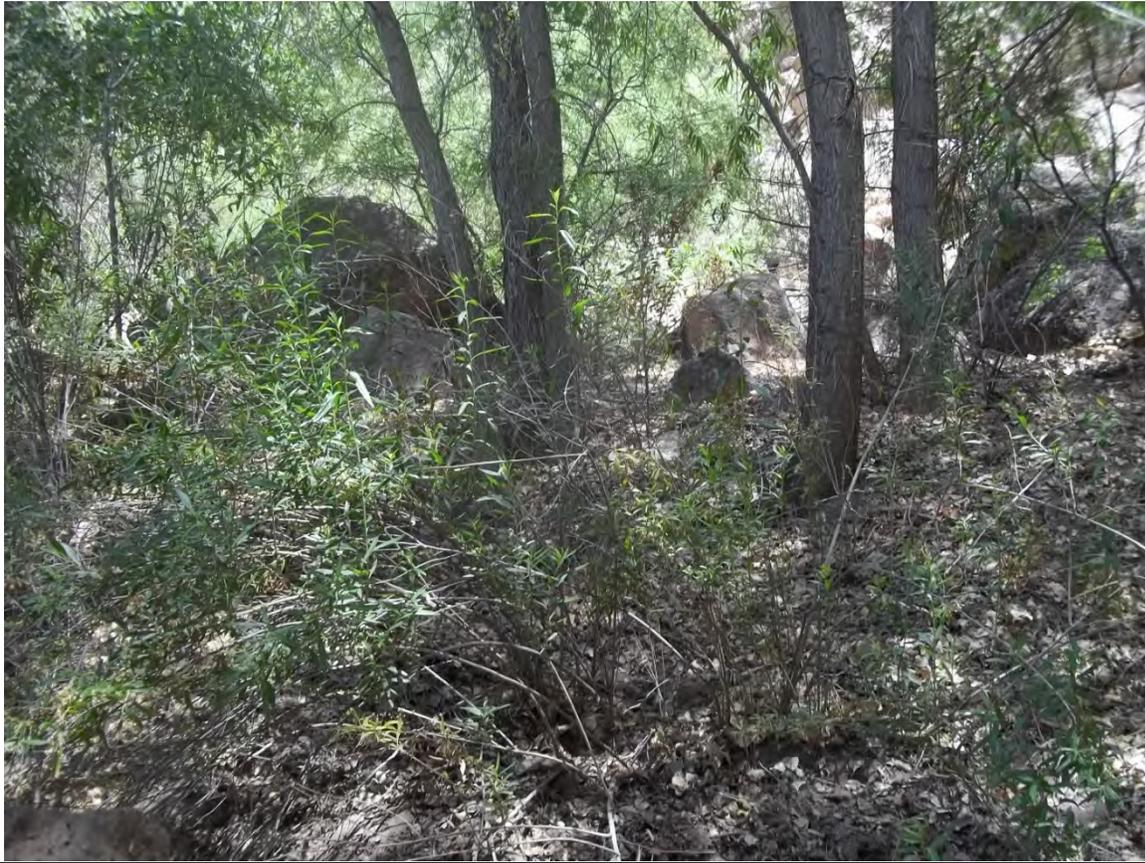
#6 – East, looking up a small slope to the access road and parking area, heavily used in the past for recreation but closed to the public for the last few years.

Notes: this shady area is higher than the main river channel, the boundary between the two marked by new willow growth.

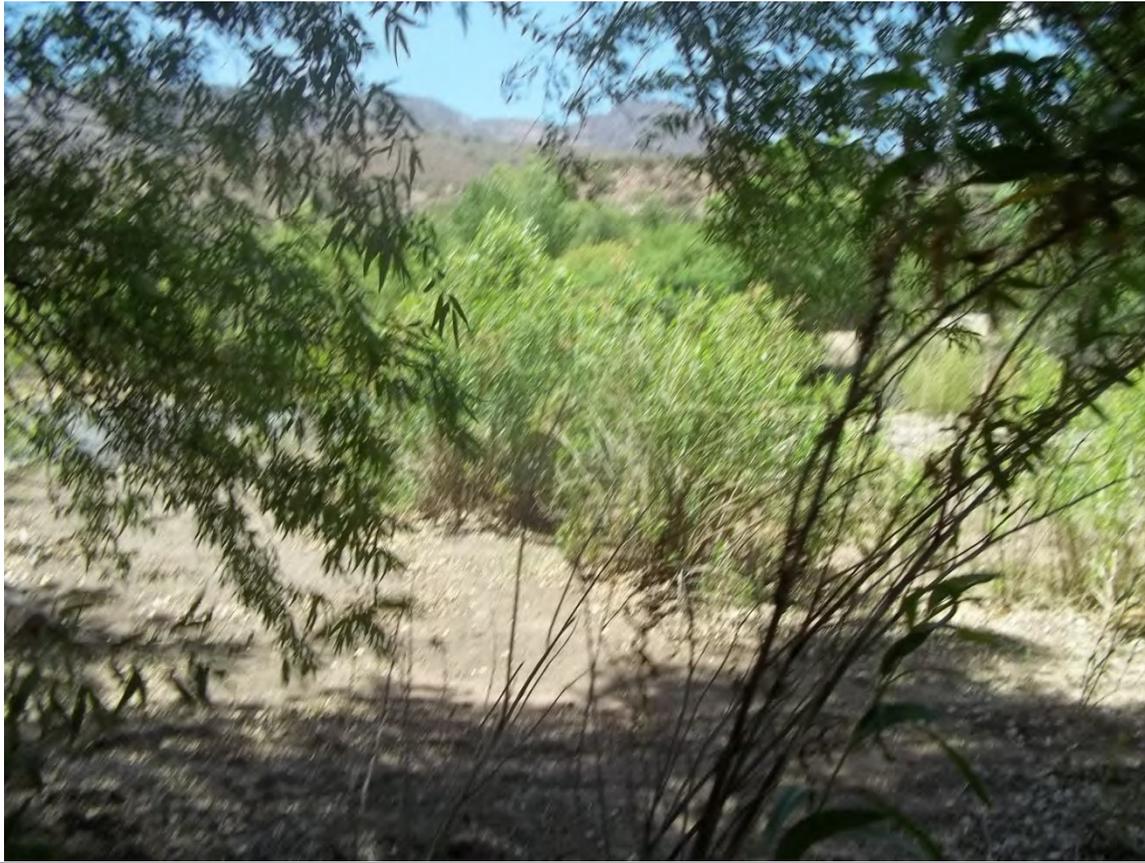
#6 – West, looking across the river (barely visible through willow leaves on the left).
GPS reading 12S 0660054, UTM 36649196

Notes: as noted above, this sandy bar is frequently scoured but has a lot of new willow growth. There were a few piles of very dry, aged cattle manure at the entry to the flat area from the access road.

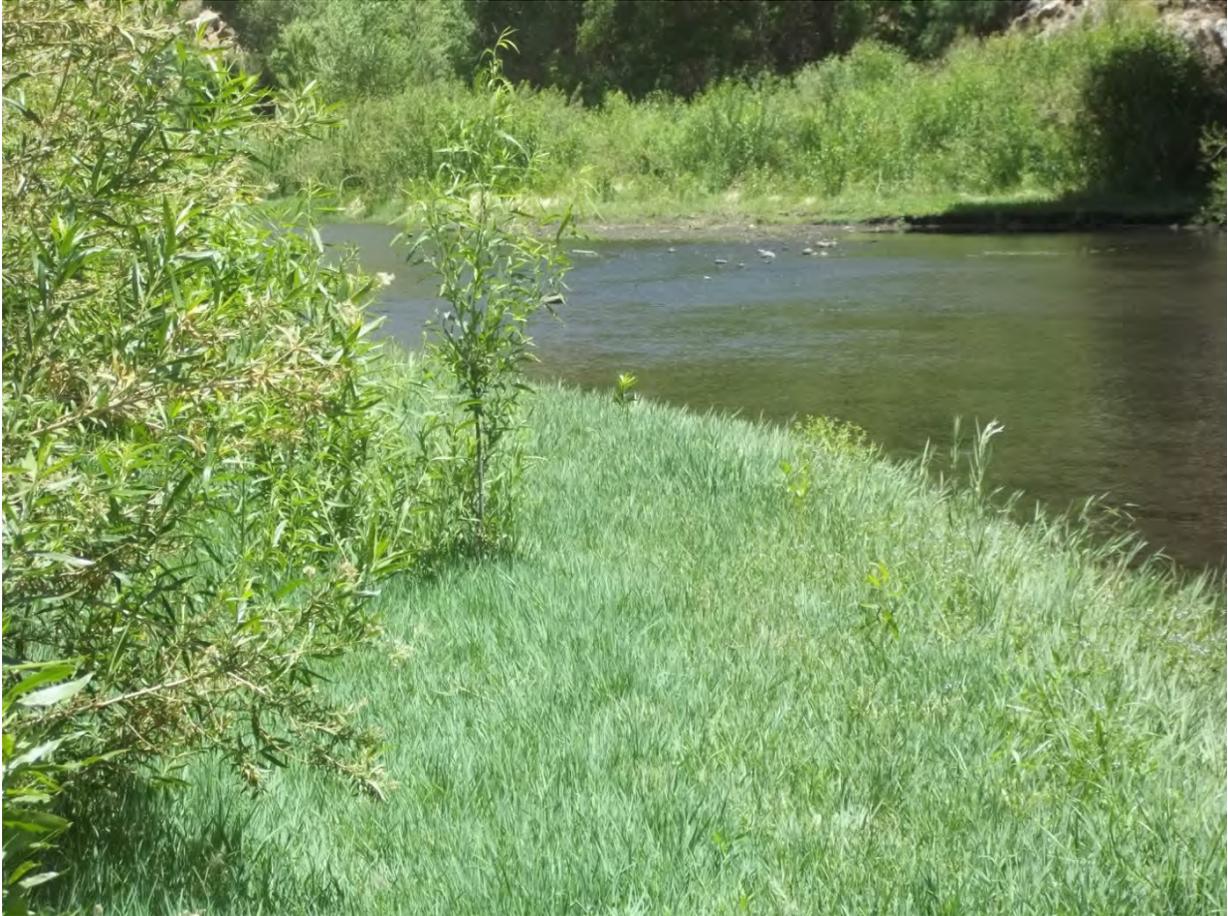
#7 – North, looking upriver

Notes: dense grasses grow to within inches of the water's current edge.

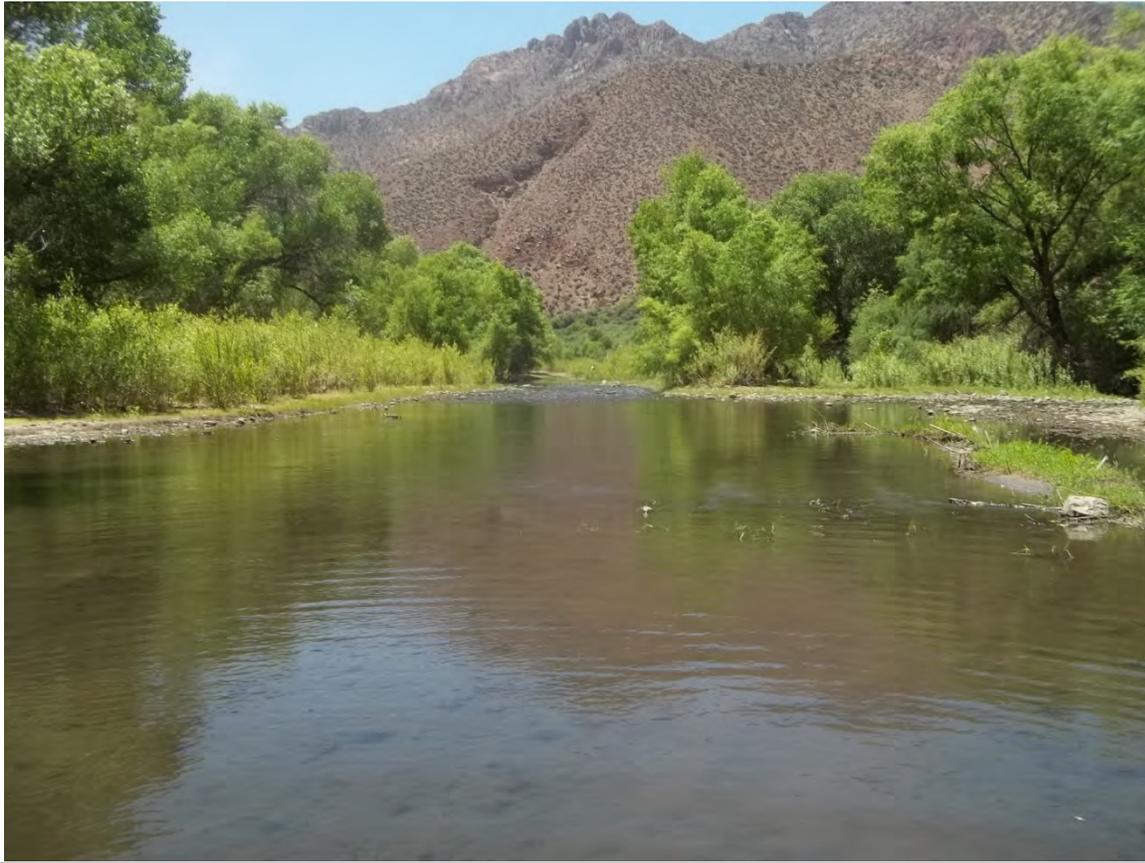
#7 – South, looking downriver below the crossing, into Freeport McMoRan property.

Notes: both river banks in this stretch of the neighboring property are disturbed by cattle hooves. There is fresh cattle manure present, and a strong odor of manure as one walks down the river. The river's edges are denuded of grasses.

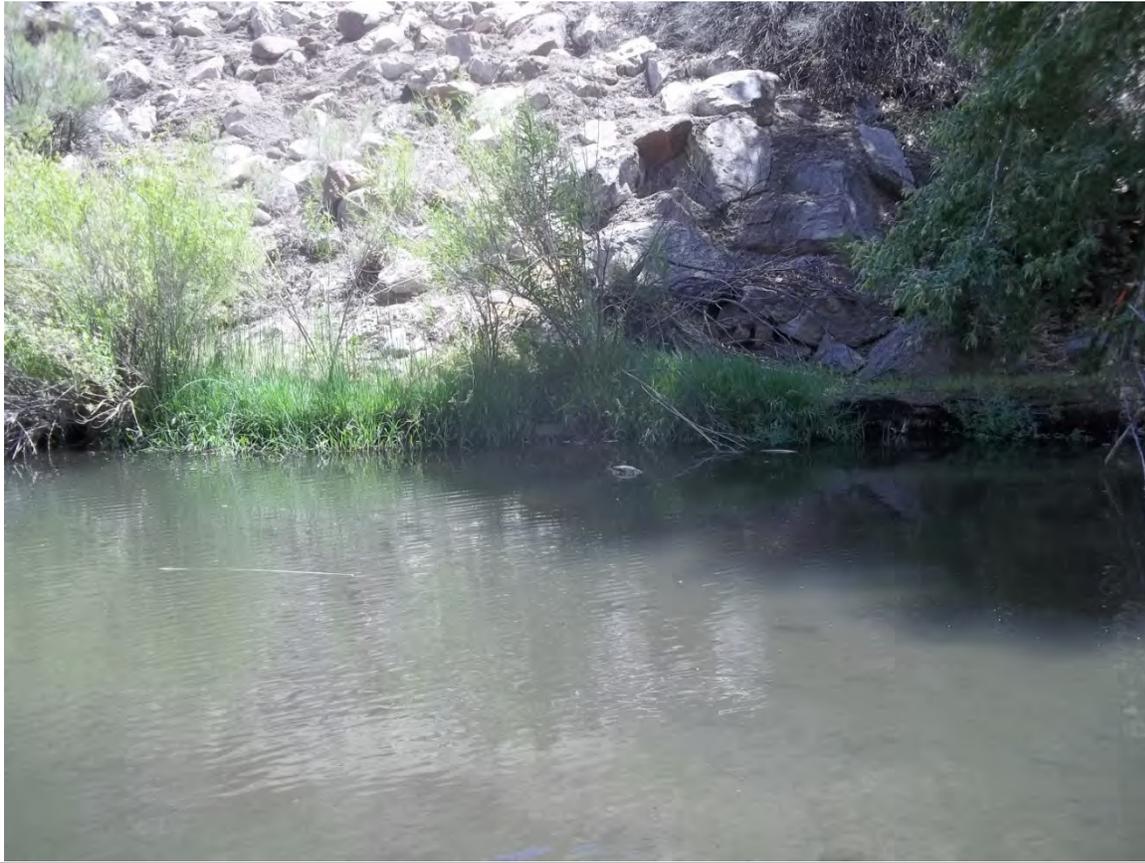
Notes: grasses and willows fill the narrow border between the rocky slope and the water's current edge.

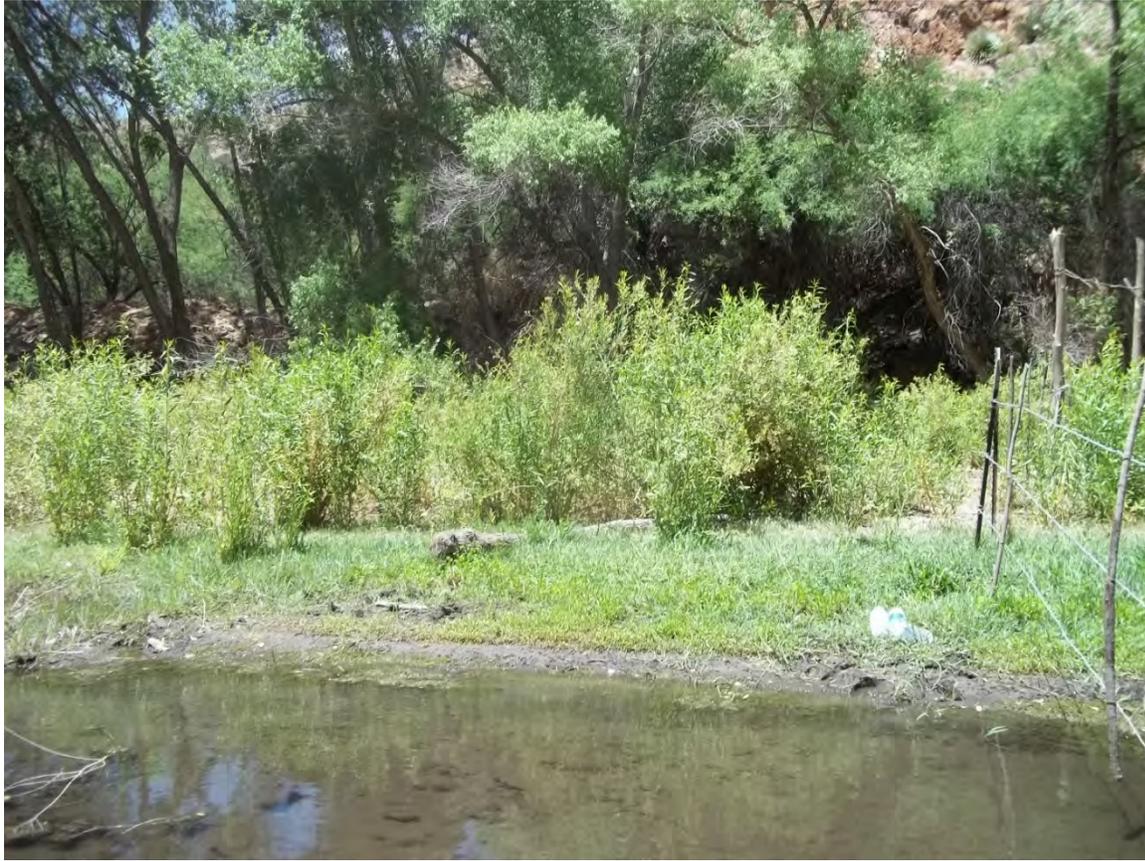
Notes: footprints at right were left by the monitor when entering the stream to collect water samples. Grasses are less dense at the water's edge in this small triangle between the fence and a braided reach of the river on Freeport McMoRan property.

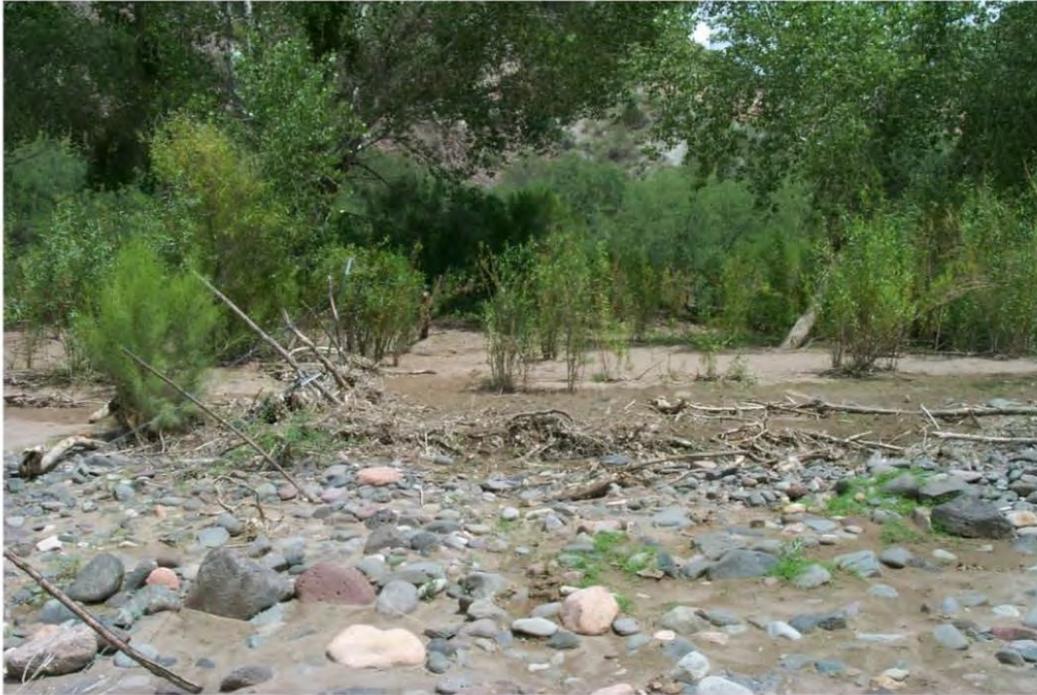
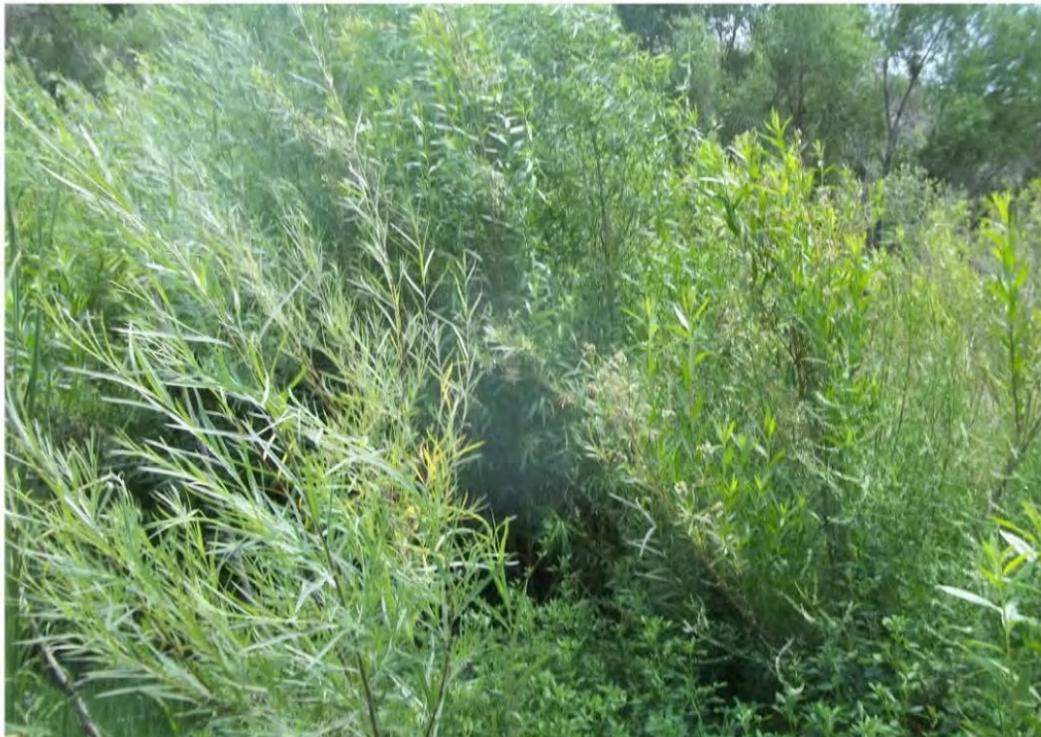
Comparison of site before and after exclusion of Kaler Ranch cattle from the San Francisco River. The two photos above were taken of the same sites from points about 10' apart. The bottom photo could not be taken from exactly the same point because the wide vegetation buffer on the flat riverbank had grown too dense to enter.

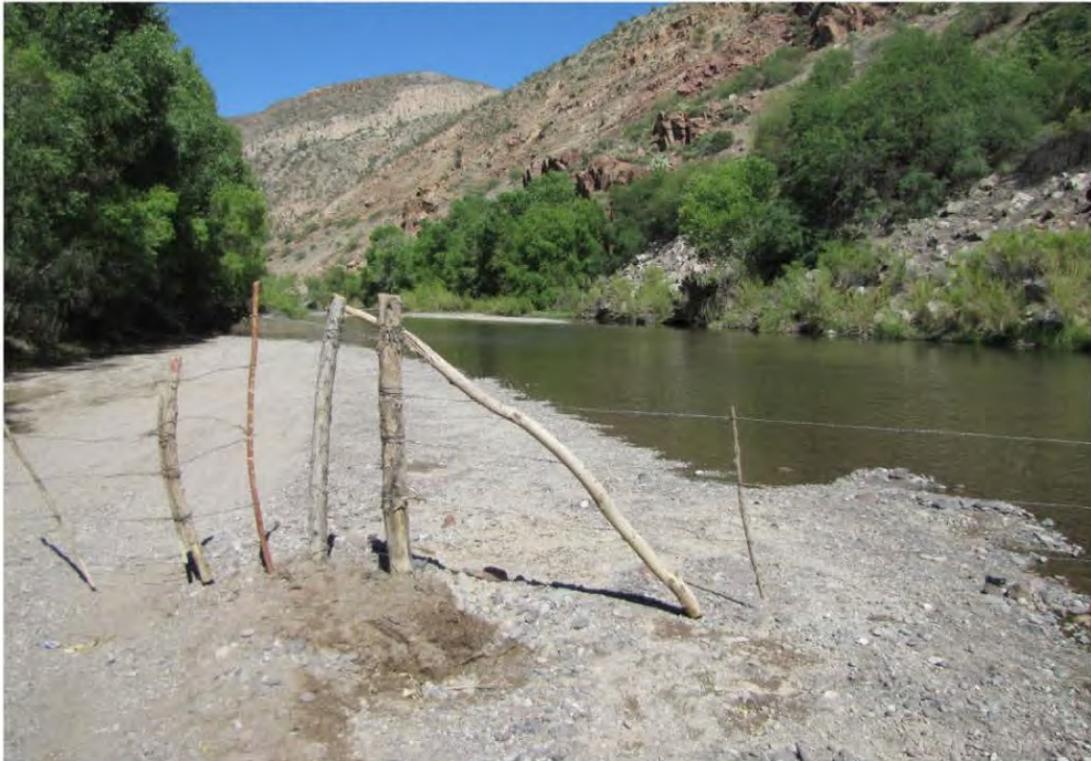
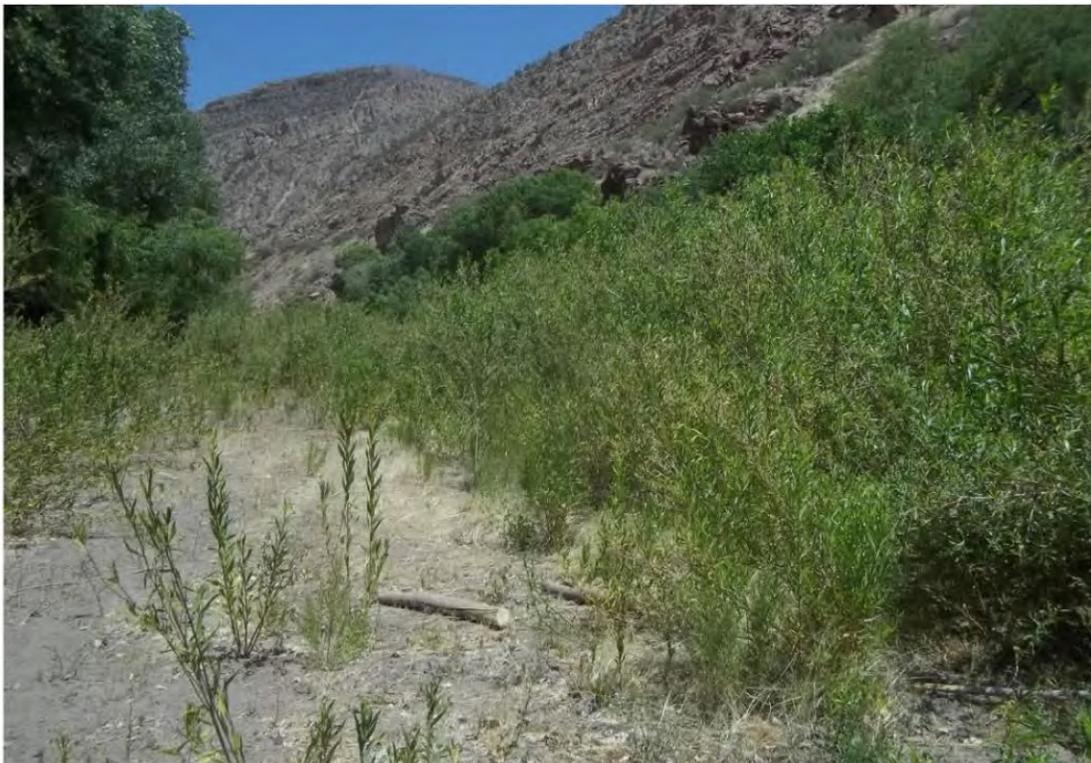
Kaler Ranch, south end of deeded land looking north

Comparison of site before and after exclusion of Kaler Ranch cattle from the San Francisco River.

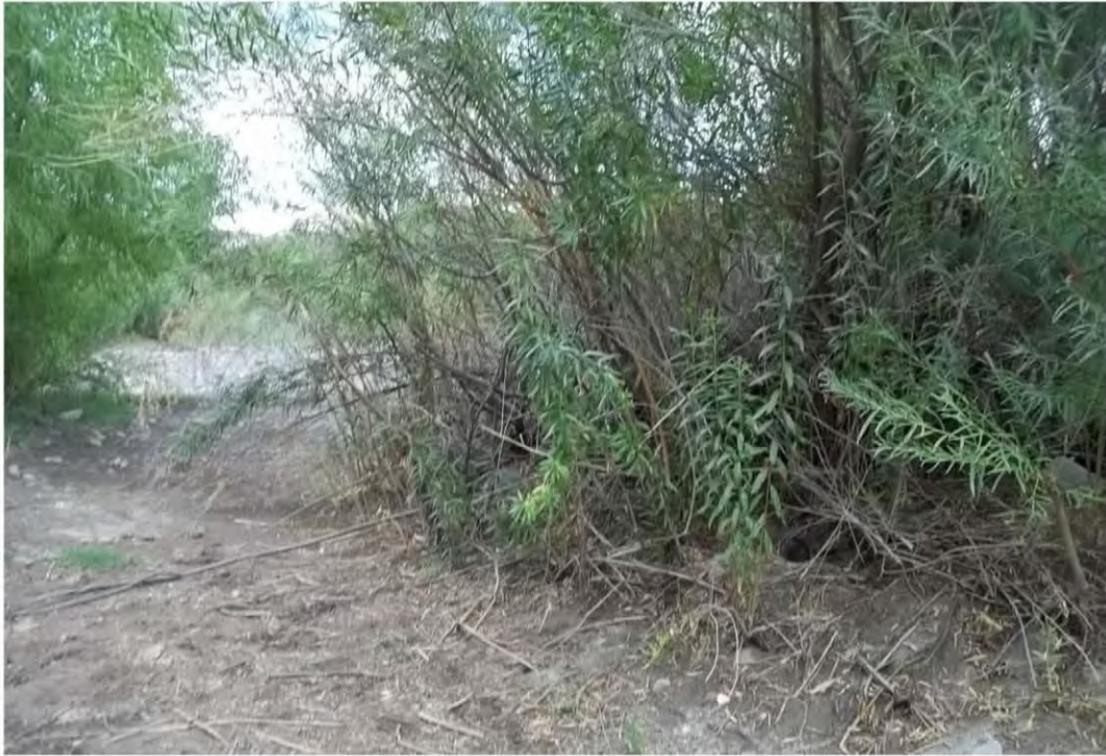
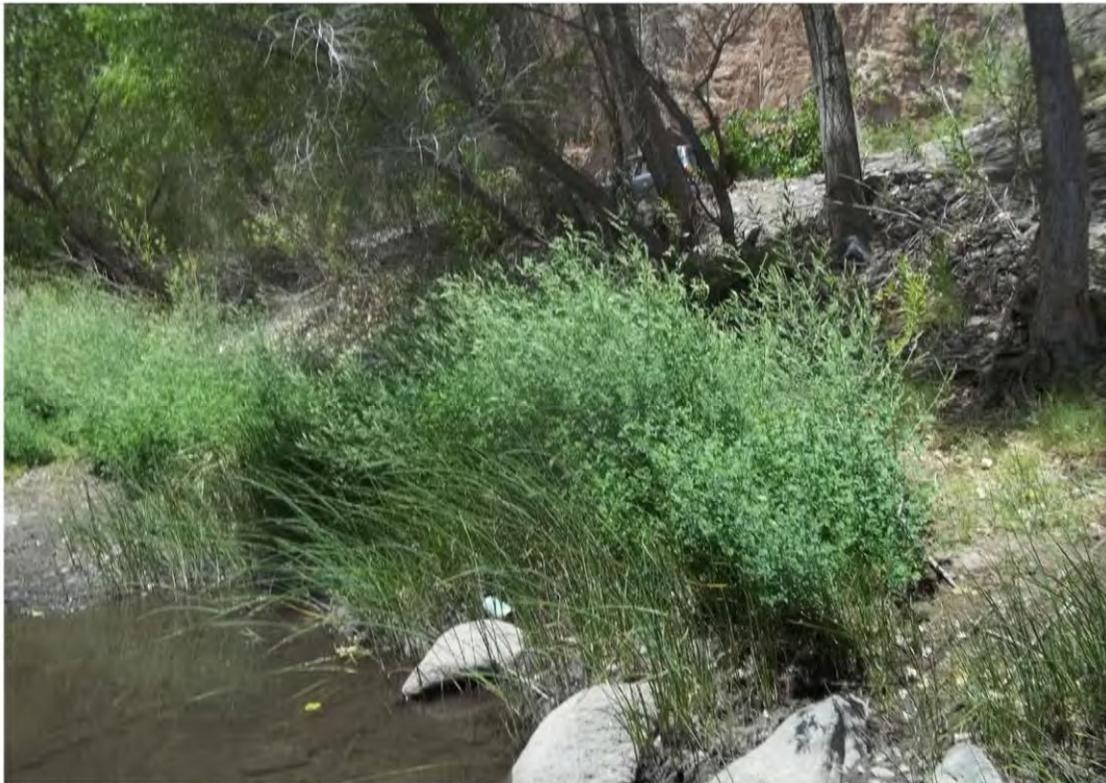
Comparison of site before and after exclusion of Kaler Ranch cattle from the San Francisco River.
