# YUMA EAST WETLANDS

## QUECHAN ARIZONA WATER PROTECTION FUND REVEGETATION PROJECT

### FINAL REPORT

**February 2009**

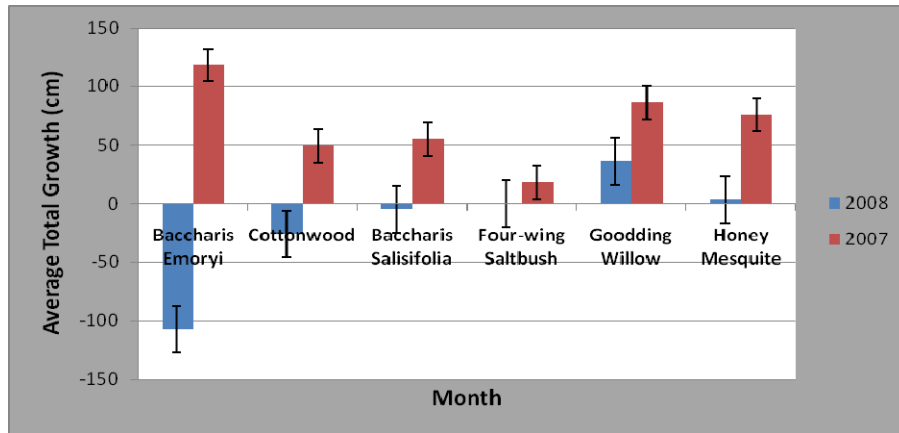
**Figure 1-1.** Average total growth (cm) of Emory baccharis, Fremont cottonwood, *Baccharis salisifolia*, four-wing saltbush, Goodding willow and honey mesquite from May to October, 2007 and 2008 growing seasons for the riparian revegetation 25 acre QAWPF site. Error bars signify standard error.

Overall, the 25-acre QAWPF project successfully transformed severely degraded habitat dominated by exotic saltcedar and desiccated wetlands into naturally functioning wetlands and productive riparian and upland habitat. Total growth showed a decline for the 2008 growing season when compared to 2007 primarily due to a large flood event in August 2008 (**Figures 1-1 and 1-2**). The flood waters spanned the low lying areas of the project site, causing salts to migrate to the surface, making the area inhospitable for many species. Despite the declined growth and condition of the riparian species, little mortality occurred with the

exception of Emory baccharis which had 100% mortality. By the end of the growing season all riparian species showed signs of recovery. The wetland experienced vigorous growth with dense thickets of native California bulrush, Olney threesquare, and alkali bulrush. The site has recovered the bird life that once utilized this site prior to wetland desiccation and non-native species invasion, including the Yuma clapper rail and least bitterns.

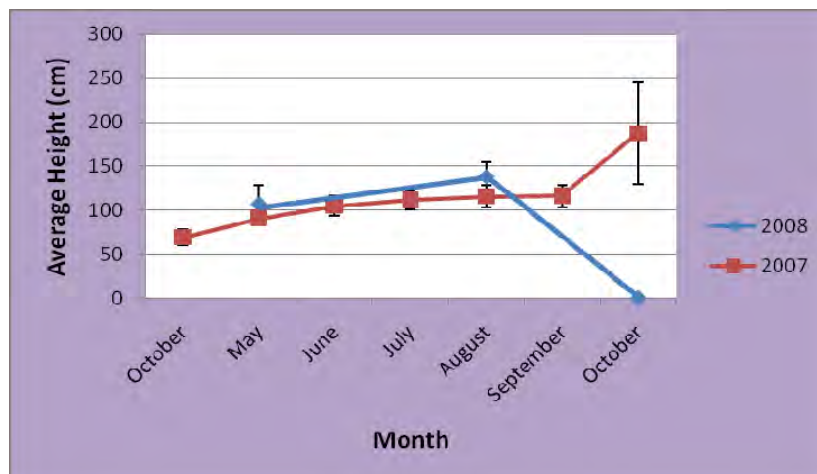
**Figure 3-1.** Average Emory baccharis height (cm) for October 2006, May to October, 2007 and 2008 at the QAWPF site, Yuma East Wetlands. Error bars signify standard error.

Emory baccharis height increased 1.6 times from May to October in 2007, the first growing season (**Figure 3-1**), for a total average growth of 118 cm (N=5, SE=52.93). Emory baccharis had a 100% survivorship for all individuals monitored during the 2007 growing season. From May to August 2008 Emory baccharis height increased an average of 64.8 cm (N=5, SE=22.1), and had a 100% survivorship for all individuals monitored during this period. In late August, there was a significant flood event, which redistributed the salt content in the soils across the Yuma East Wetlands. This flood event caused a high number of mortalities in many species, including 100% of the Emory baccharis.

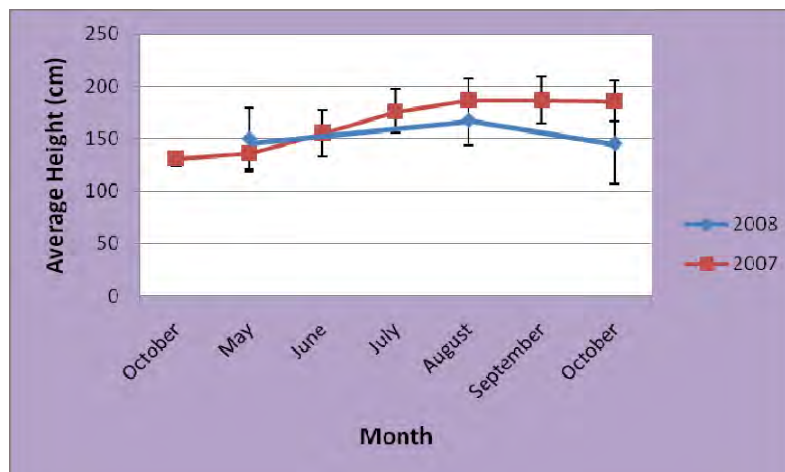
**Figure 3-7.** Average seep willow height (cm) for October 2006, and May to October, 2007 and 2008 at the QAWPF site, Yuma East Wetlands. Error bars signify standard error.

Overall, seep willows had positive growth for the 2007 growing season, as well as for the first four months of the 2008 growing season (**Figure 3-7**). In 2007, seep willows had an average total growth of 23cm (N=5, SE=23.76), and in 2008 the average total growth was 3cm (N=5, SE=19.57). Once again, the flood event in August 2008 caused a decline in growth as well as in condition for seep willows.

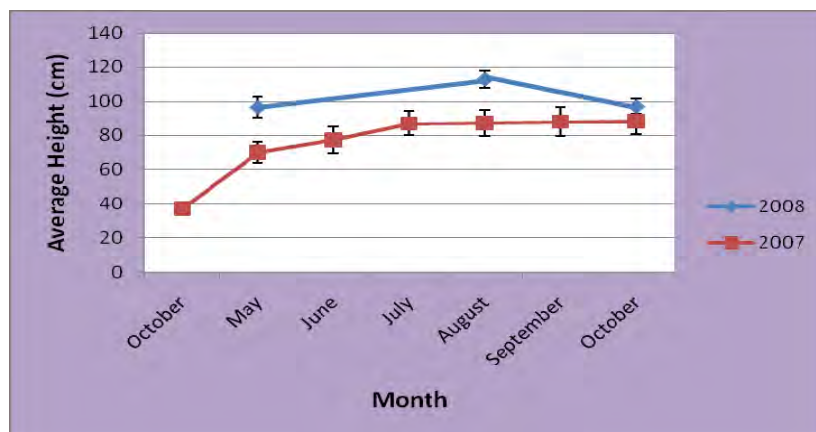
**Figure 3-10.** Average four-wing saltbush height (cm) for October 2006, and May to October, 2007 and 2008 at the QAWPF site, Yuma East Wetlands. Error bars signify standard error.

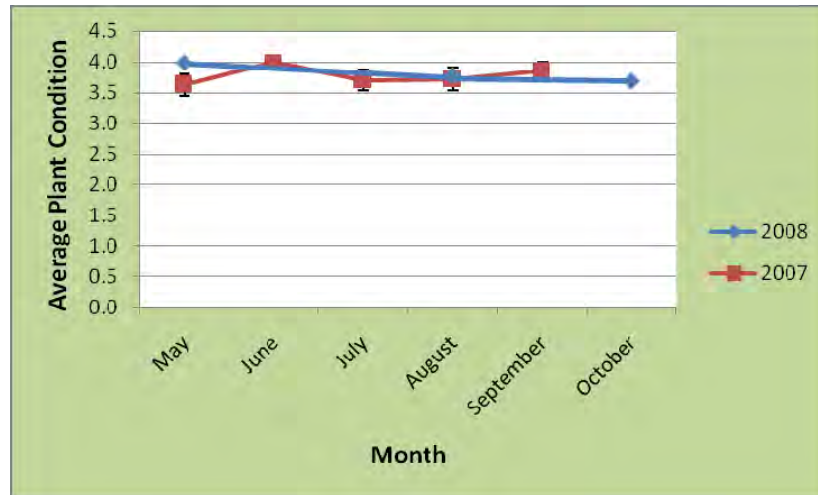
**Figure 3-14** Average Goodding willow condition for May to October, 2007 and 2008 for the QAWPF site, Yuma East Wetlands. 0=dead, 1=poor, 2=fair, 3=good, and 4=excellent. Error bars signify standard error.

The condition of the surviving Goodding willow plants was good to excellent throughout the 2007 growing season, and in 2008 the condition was excellent with a slight decline to a very good condition later in the growing season (**Figure 3-14**). Water and salt stress affected 58% of the Goodding willows throughout the 2007 growing season (**Figure 3-15**). In the 2008 growing season salt stress affected 55% of the Goodding willows in the month of August and affected 86% of the Goodding willows in the month of October. The Goodding willows were planted along the perimeter of the 5.4 acre wetland area. Soil salinity is high in this area which is evident due to the salt crust on the soil's surface. Also, when the water levels are increased in the South Channel by the placement of the stoplogs in the outlet, the wetland, including the willow planted area is inundated for long periods of time, which may adversely affect the trees. This is also the most likely cause for the mortality experienced during the 2007 growing season. Mammal and insect browsing affected 16% and 8% of the trees respectively during May 2007, however these effects were not observed later on in the growing season. Overall, Goodding willow showed to have great success throughout the two growing seasons, with condition and growth declining slightly, caused by the flood in late August.

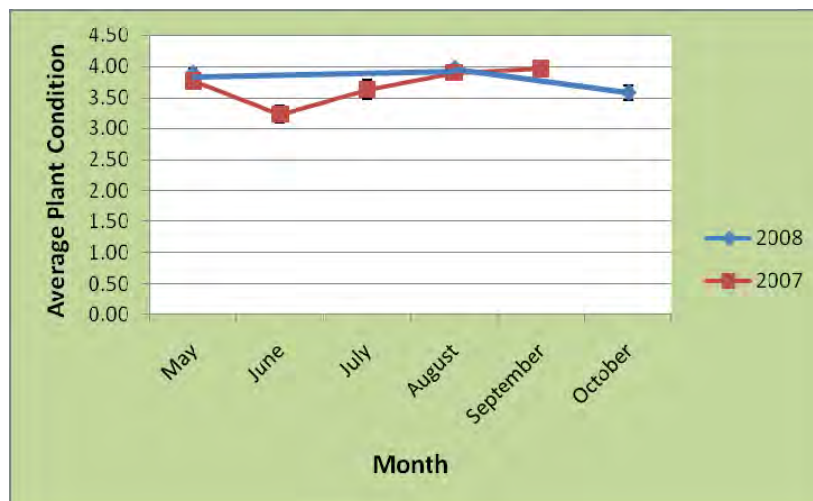
**Figure 3-17** Average honey mesquite condition for May to October, 2007 and 2008 for the QAWPF site, Yuma East Wetlands. 0=dead, 1=poor, 2=fair, 3=good, and 4=excellent. Error bars signify standard error.

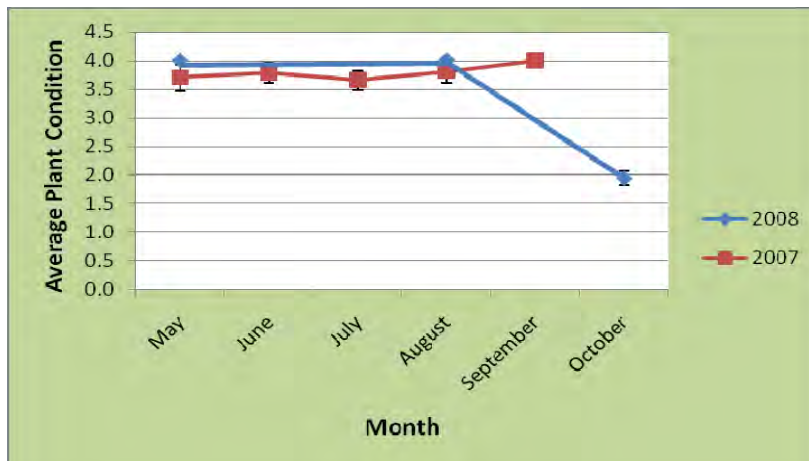
Figure 3-26 Average screwbean mesquite condition for May to October, 2007 and 2008 for the QAWPF site, Yuma East Wetlands. 0=dead, 1=poor, 2=fair, 3=good, and 4=excellent. Error bars signify standard error.

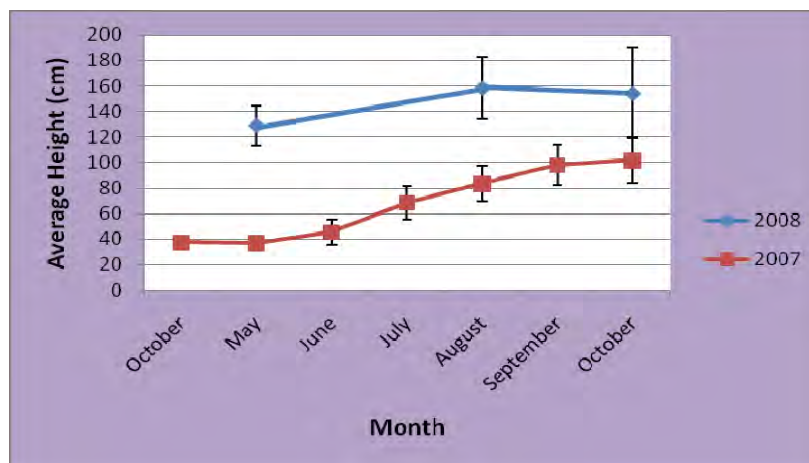
**Figure 3-31.** Average blue palo verde height (cm) for October 2006, and May to October, 2007 and 2008 at the QAWPF site, Yuma East Wetlands. Error bars signify standard error.

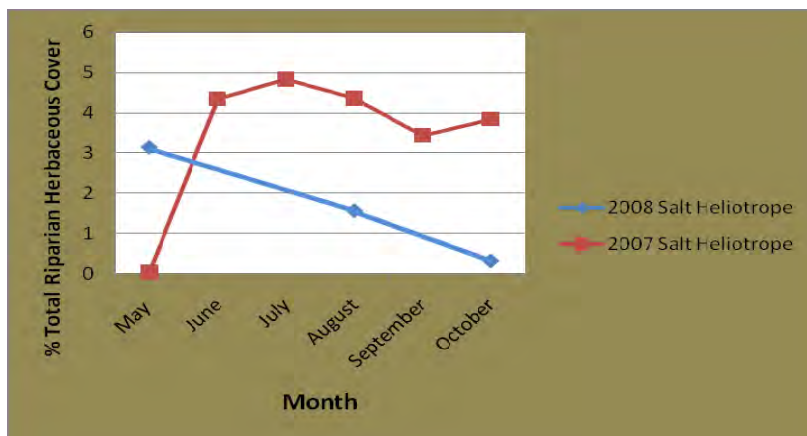
**Figure 3-35:** Total percent herbaceous cover for salt heliotrope from May to October, 2007 and 2008, for the 19.6 acre riparian and upland habitats in the QAWPF revegetation site, Yuma East Wetlands.

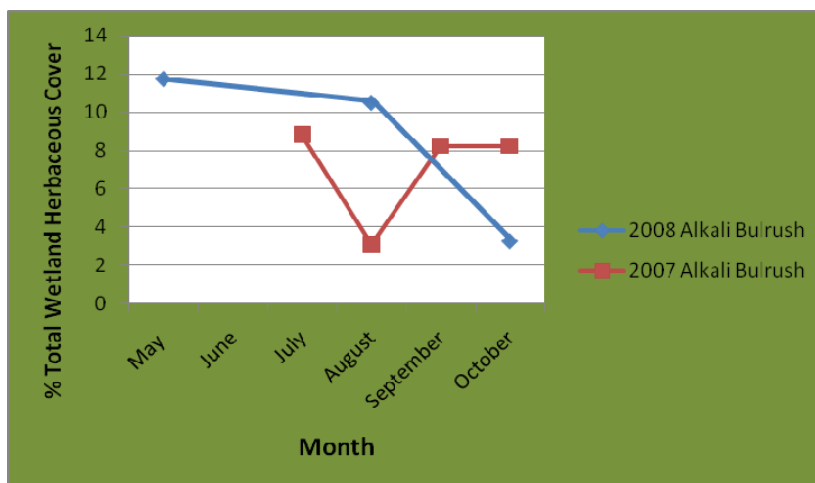
**Figure 3-38.** Total percent herbaceous cover for alkali bulrush from May to October, 2007 and 2008 for the 5.4 acre wetland habitat in the QAWPF revegetation site, Yuma East Wetlands.
