**UPPER VERDE RIVER
TAMARISK REMOVAL PROJECT**

FINAL REPORT

ARIZONA WATER PROTECTION FUND COMMISSION

Contract #07-149WPF

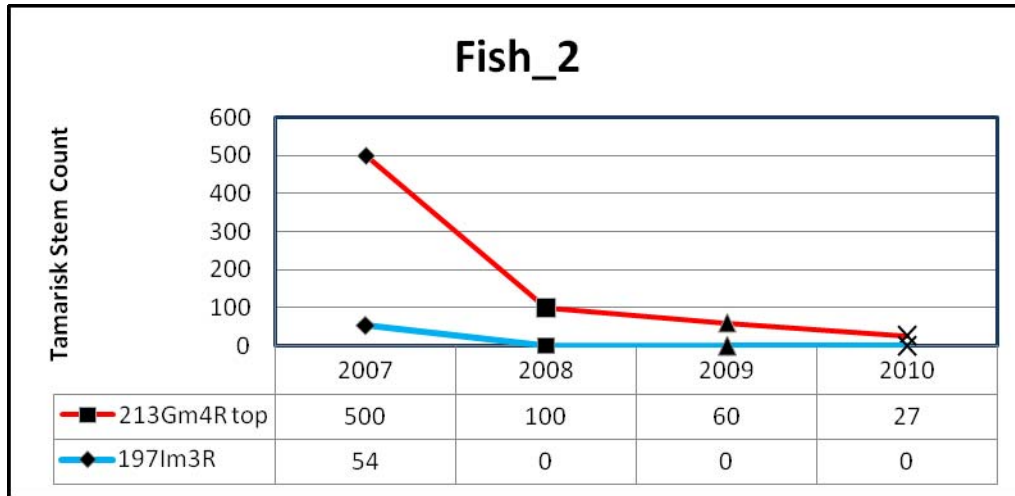
Figure 6. Tamarisk was reduced by 95% and 100%, respectively, on a very large group.

Site Fish_2 contained a very large group of tamarisk that required extensive excavation and removal of debris to expose the base roots. This station was added to the long-term vegetation monitoring scheme on the upper Verde River in 2006 and was established to co-occur with fish monitoring plots, thus the name. Like Station 4 this site also had two tamarisk photopoint sites within 100m. One of the photopoint sites had 54 stems in 2007 and was killed in 2008 and had no re-sprouts in 2009. The other had 500 stems in 2007, was reduced to 100 stems in 2008, and had 60 stems in 2009 (Figure 6). Fish_2 had the second highest stem density of tamarisk of the 7 selected stations across all years. This station also had a fairly robust native woody plant community largely dominated by seep willow, velvet ash, and willow species. The proportion of native species importance value increased from 2007 to 2009, although only slightly (65% in 2007 to 69% in 2009). Overall, the proportion of importance value accounted for by non-vegetative elements decreased over time from 57.5% in 2007 to 43.5% in 2009. Much like the other stations litter came to dominate the non-vegetative elements in 2009 while soil was the dominant in 2007.

Figures 6-12 illustrate typical responses to treatments. Resprouting is noted within a year, which is retreated with herbicide. A second treatment may not be necessary in some cases, as the plant may be incurring a slow physiological death, but re-spraying insures mortality. It is difficult to predict whether resprouts are a response to the herbicide or simply regrowth of an unsprayed stem. While some plants or group complexes may be effectively killed by a single treatment of cutting and herbicide, there is no way of knowing if the plant is dead unless you have subsequent visits in a second or third year. This especially true of groups that have been heavily covered-up by river debris and or overburdened by sediment deposits, and or are intermixed with other down woody vegetation.

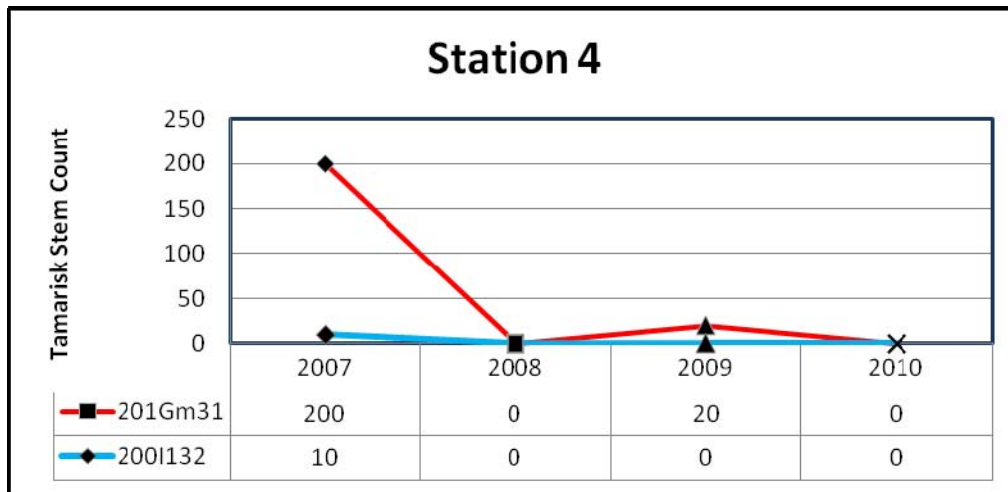
Figure 7. This site exhibited typical resprouting after a year, but was killed following a second herbicide treatment.

There were two tamarisk photopoint sites within 100m of Station 4. The first had 10 tamarisk stems in 2007, which were reduced to 0 in 2008 and remained at 0 for 2009. The other site however, had 200 stems in 2007, a figure reduced to 0 in 2008, but sustained an increase in tamarisk stem density in 2009 back to 20 stems (Figure 7). The number of stems in 2009 is 10% of the stem count in 2007. Station 4 also showed a decrease in stem density for most native trees (Table 2) from 2007 to 2009. Native plants accounted for 81% of the importance value in 2007, a figure reduced to 71% by 2009. The proportion of non-vegetative elements also decreased by 10% from 2007 to 2009. The ground cover of Station 4 like the others was dominated by soil in 2007 but was dominated by litter in 2009 (22.4% soil in 2007 vs. 21.98% litter in 2009 – Table 3).

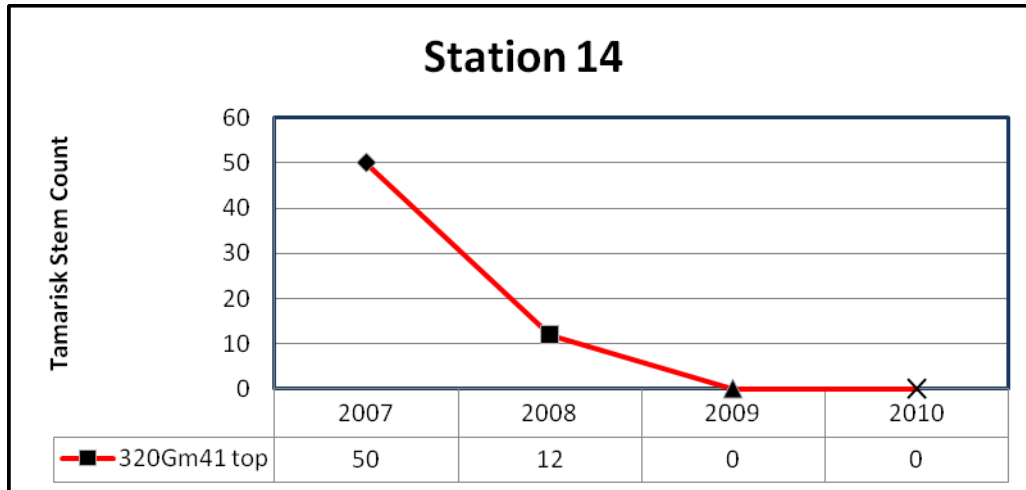
Figure 9. This site contained a large tree that was successfully treated despite a 20 percent resprout rate.

The tamarisk photopoint site within 100m of station 14 had 50 tamarisk stems in 2007, 12 in 2008 and none in 2009 (Figure 9). Station 14 had a dense woody plant community in 2007 and was little changed by 2009, with the exception of a decrease in tamarisk stem density. The woody plants associated with station 14 were characterized by dense growth of seep willow, velvet ash, and willow species. Another exotic tree, Siberian elm, was present in all years and increased in stem density in 2009. While the woody plant community remained dominated by native tree species, the herbaceous plant community changed from being dominated by native plant proportion of importance value to introduced proportion of importance value. The proportions of these importance values were exactly reversed during the monitoring period; the proportion of native plant proportion of importance value in 2007 was 61%, while at the end of the monitoring period the proportion of introduced proportion of importance value was 61%. While the proportions of native and introduced proportion of importance value changed dramatically, the proportion of non-vegetative proportion of importance value remained nearly the same from 2007 to 2009 at station 14. Non-vegetative proportion of importance value was 44.5% in 2007 and was 46% in 2009. Like Station 13, the dominant non-vegetative element at Station 14 was soil in 2007(23.6%) and litter in 2009 (24.3%) (Table 3).

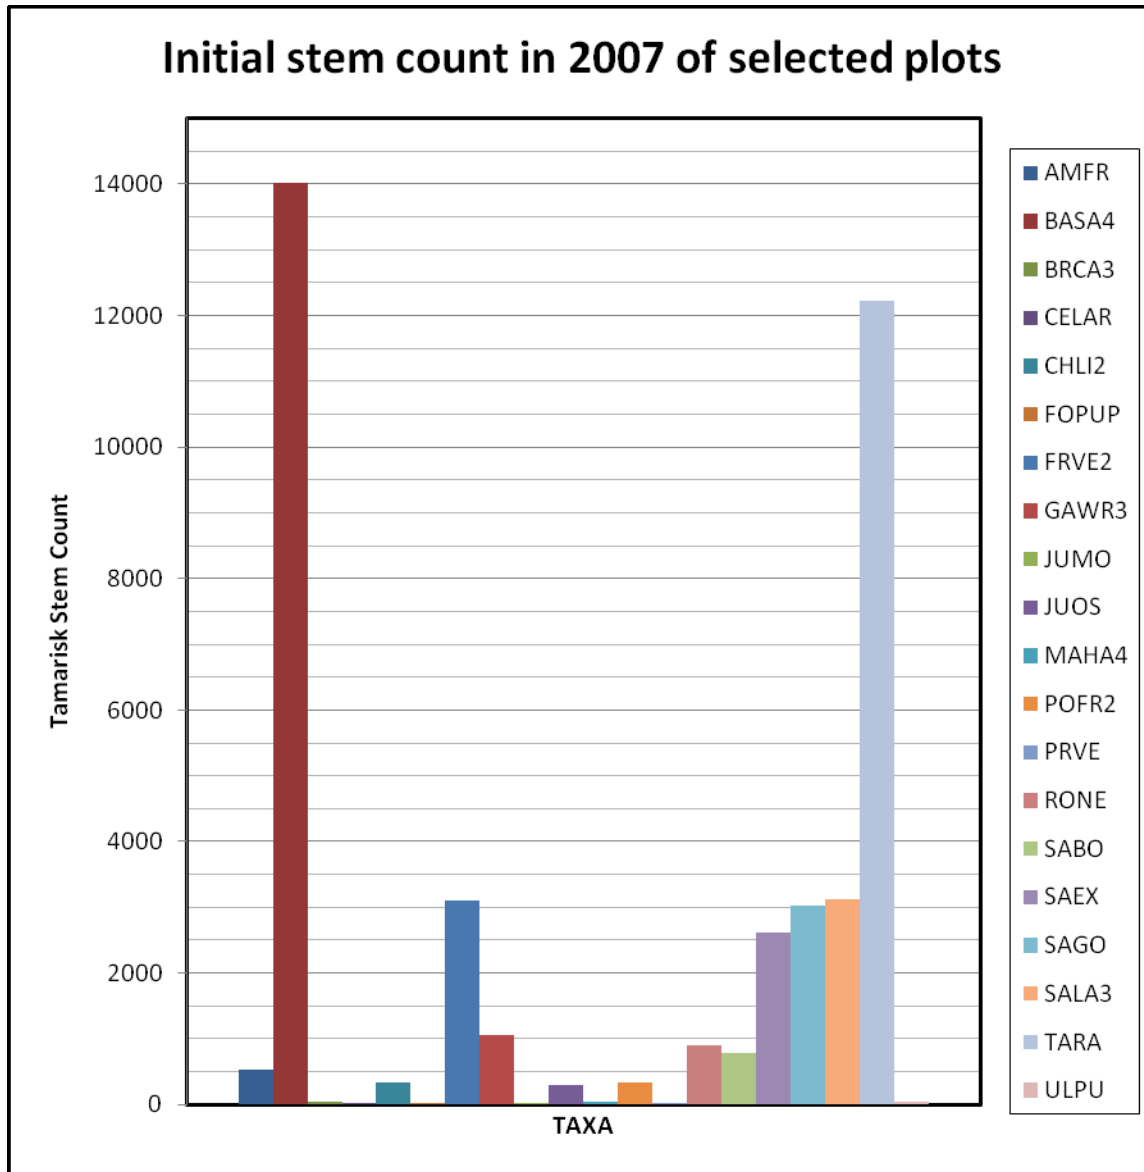
Figure 13. This graph illustrates the stem counts and relative abundance of 20 species of woody plants prior to treatment.

Most plants retained their initial abundance, but an increase in *Juniperus osteosperma* (JUOS) is noted. This is likely due to a shift in the main channel to a position against upland terraces where Utah juniper prevails. Utah juniper is a common woody component in the floodplain as well, being a long term resident in comparison to the younger obligate riparian species.

The effects of seasonal (summer and winter) floods are notable. The combination of floods and the current high density of cottonwoods and willows create multiple channels with eroded bedload material accumulating as windrows or levees behind the trees. These levees essentially create a highly braided channel network that is hydrologically unstable and creates site habitat for the establishment and propagation of other woody plants. These sites are the typical location where large tamarisk stands were found. These sites are elevated 2-4 meters relative to the main channel, as the combination of dense wooded habitats and levee networks aid the degradation of the channel. The channel downcutting causes the main channel to migrate further away from its historical position and up against the terraces.

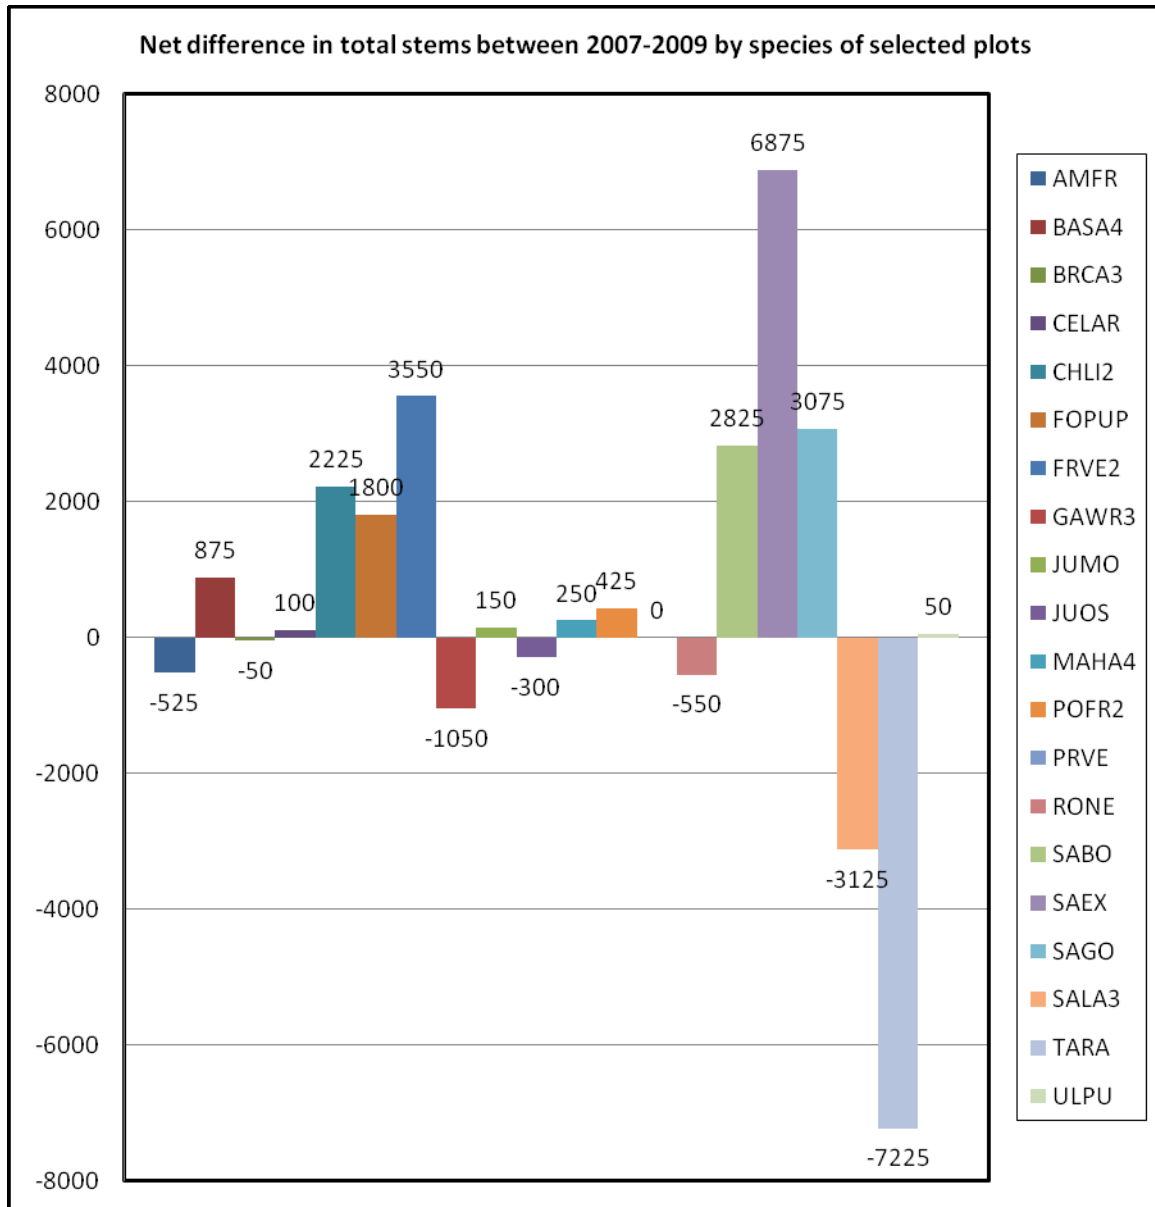
Figure 14. This graph illustrates the post treatment relative abundance of the same 20 species noted in Figure 13. Species response may be due to other factors, e.g. flooding, channel changes, besides removal of tamarisk.

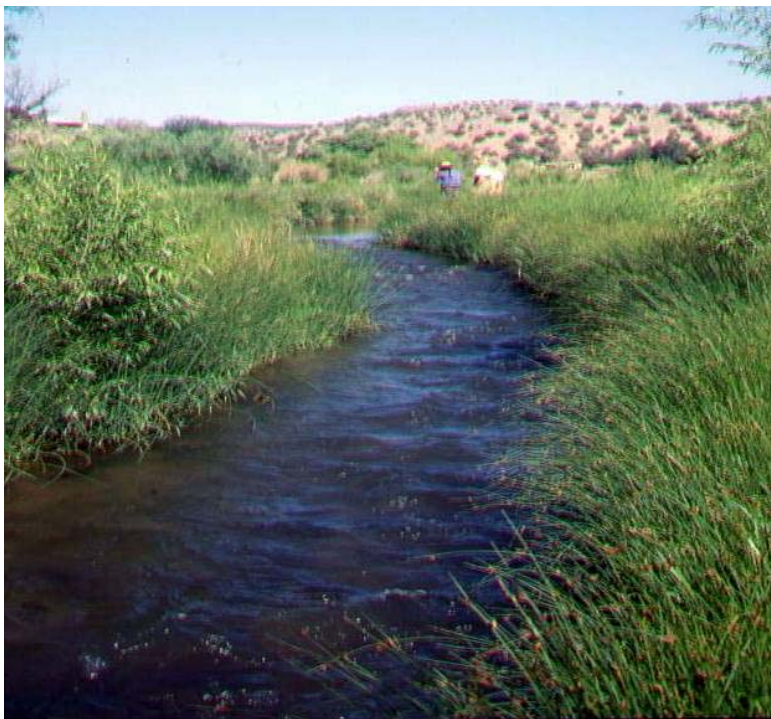
Photo 1. This photo illustrates the habitat potential properly managed wetland on private lands of the Verde River Ranch. The site is managed using cattle to suppress exotic plants and promote perennial graminoids, such sedges and rushes.

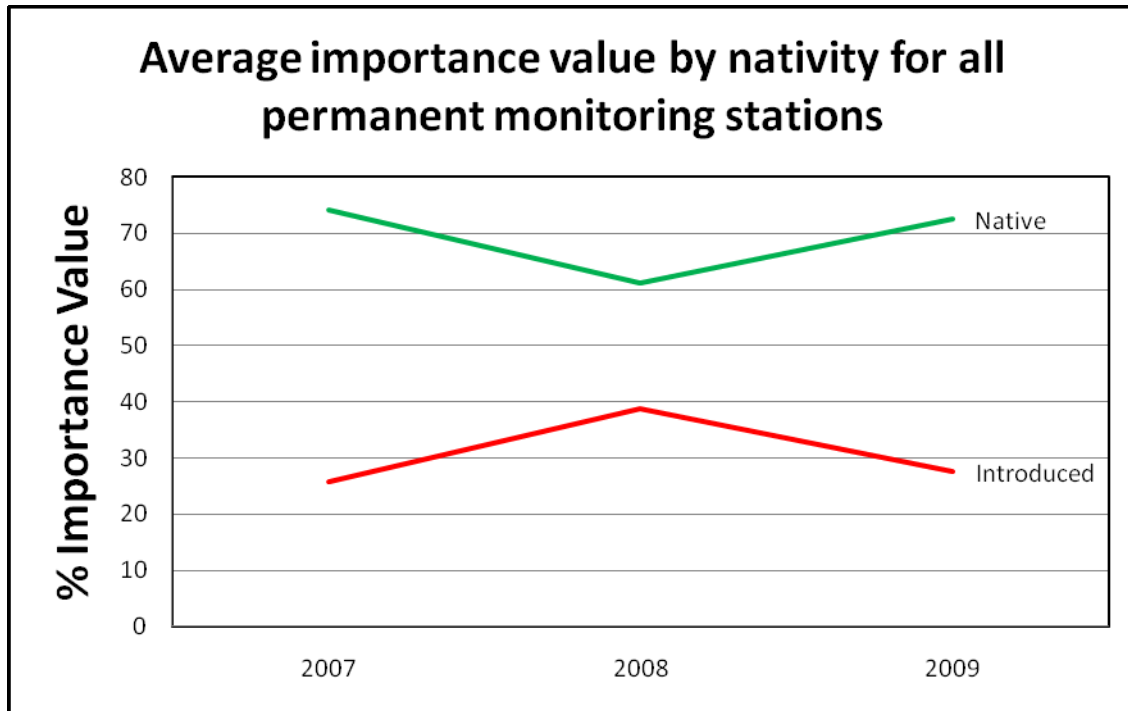
Figure 15. This graph illustrates the average importance value by nativity for all 18 permanent monitoring stations.

Native plants accounted for 69% of the vegetative cover averaged across all years, native plant diversity ranged from 54 native species in 2007 to 47 native species found in 2009, while introduced plants accounted for 30% of vegetative cover and had diversities ranging from 22 in 2009 to 29 in 2008. Figure 15 shows the average percent importance value for native and introduced plants across all 3 monitoring periods. Plants that grow perennially accounted for 75% of the vegetative cover averaged across all years while annual plants averaged 10% of vegetative cover. Average cover by perennial plants was very stable across the 3 monitoring periods, ranging from 77% in 2007 to 74% in both 2008 and 2009 (Figure 16). Across all years wetland plants averaged 81% of the vegetative cover, 64% of which was cover by obligate wetland plants and 17% was cover by facultative wetland plants. Figure 17 shows the yearly

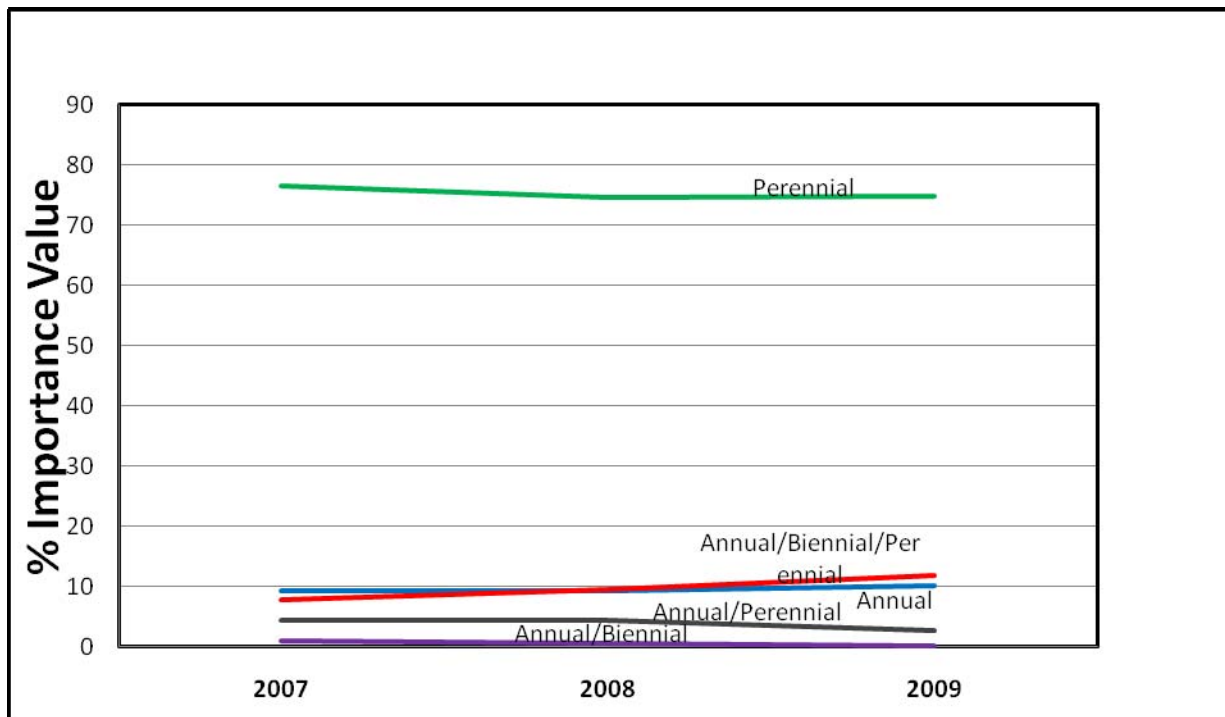
Figure 16. This graph illustrates the difference between life forms as expressed by their importance values.

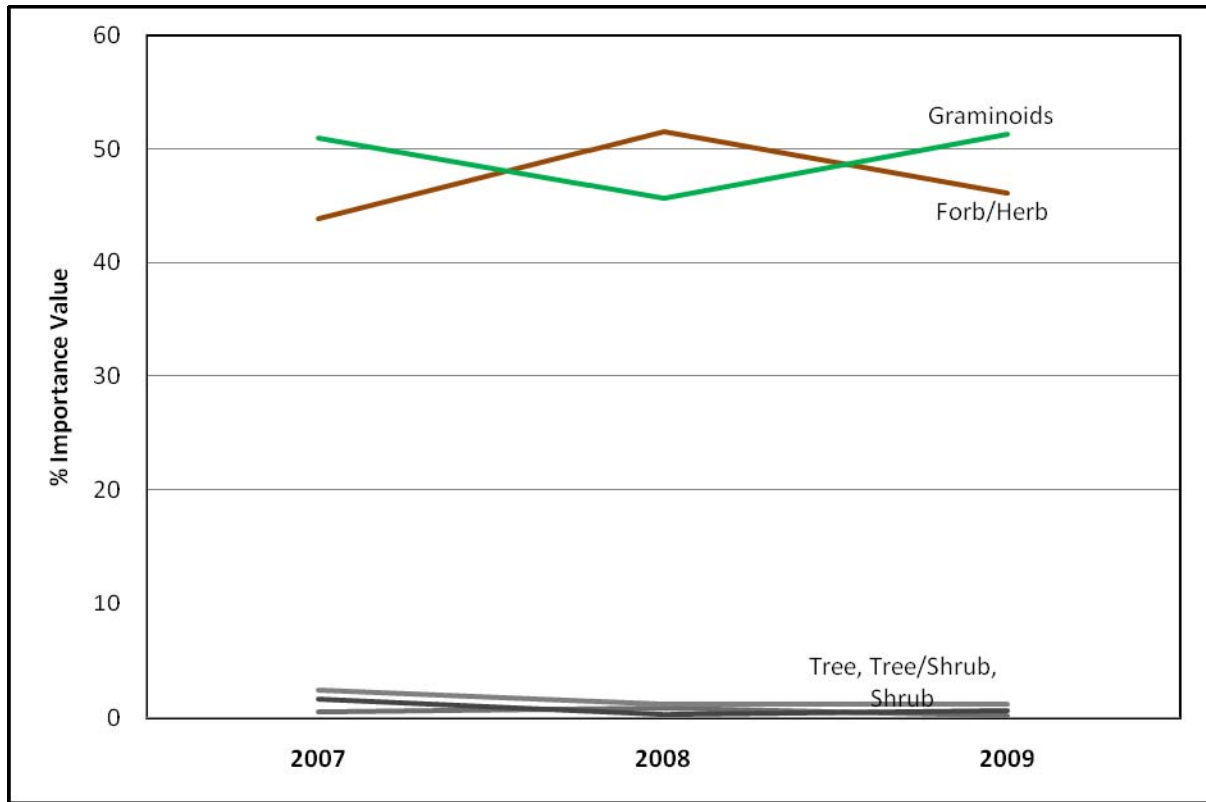
Figure 18. This graph illustrates the relationship between growth forms as expressed by their importance values. Note that not much difference exists between woody plants.

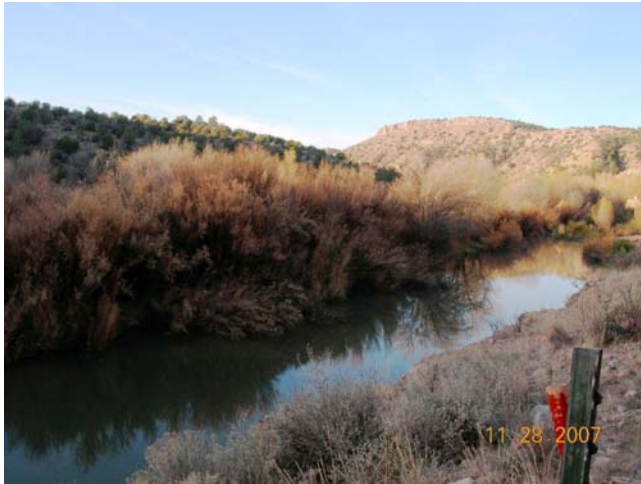
Photo 2. This large stand of tamarisk required a crew of 30+ and took nearly 4 days to treat.

The physical treatment process is a major factor affecting the degree of plant mortality. Highly skilled technicians were used to perform the physical and chemical treatment of very large mixed aged stands, some requiring extensive labor to prepare (Photo 2), while others are easier to access, yet require removal of debris about the basal area (Photos 3, 4). Failure to remove debris and expose the basal stems can result in high resprouting rates and require retreatment and possibly even subsequent re-excavation. A common fault of tamarisk cutting is to "crew cut" the stems at 2-3 feet and leaving stubble-stumps, rather than cutting at the root crown level or thereby. This stubble creates obstacles where flood debris gathers and causes undue bed erosion about the plant stubble. The desired outcome should be obstacle-free. Cut stems should be removed from the floodplain wherever feasible and stacked on adjacent terraces in key locations so as to create cover habitat for ground dwelling birds and other wildlife, as well as to abate erosion from terraces (Photo 5).

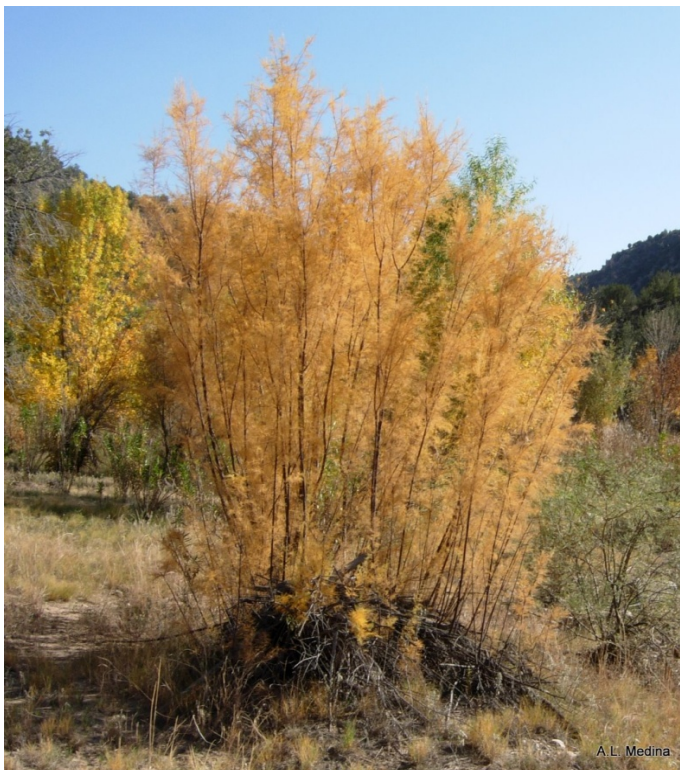
Photo 3. This young tamarisk is considerably easier to access and treat, yet requires removal of the basal debris.

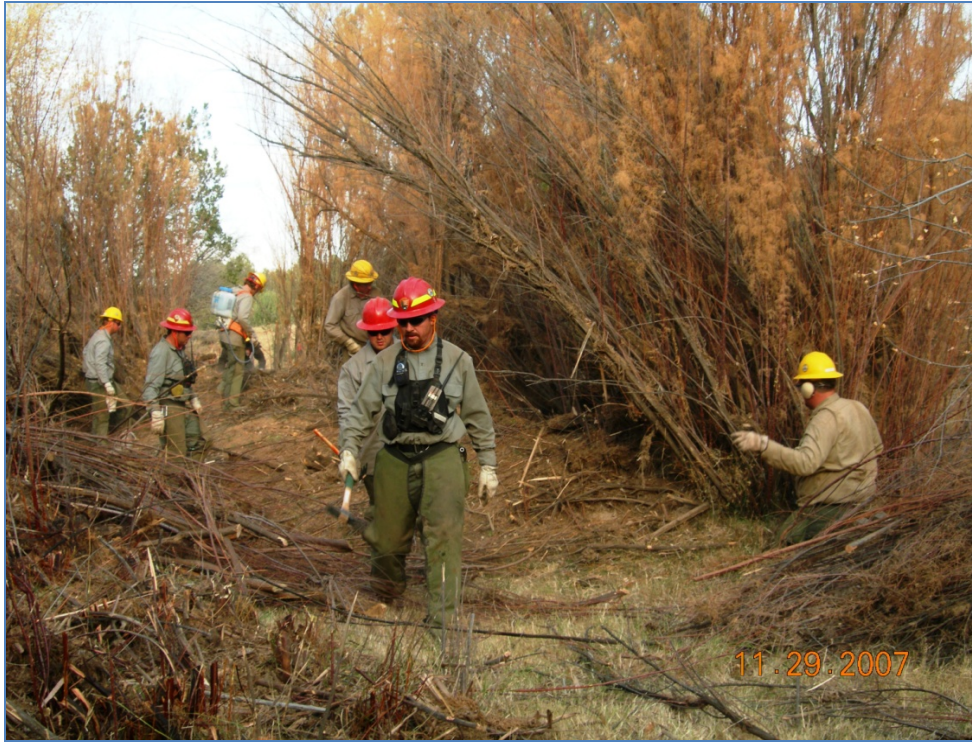
Photo 4. Extensive preparation of tamarisk plants may be required before cutting and spraying with herbicide.

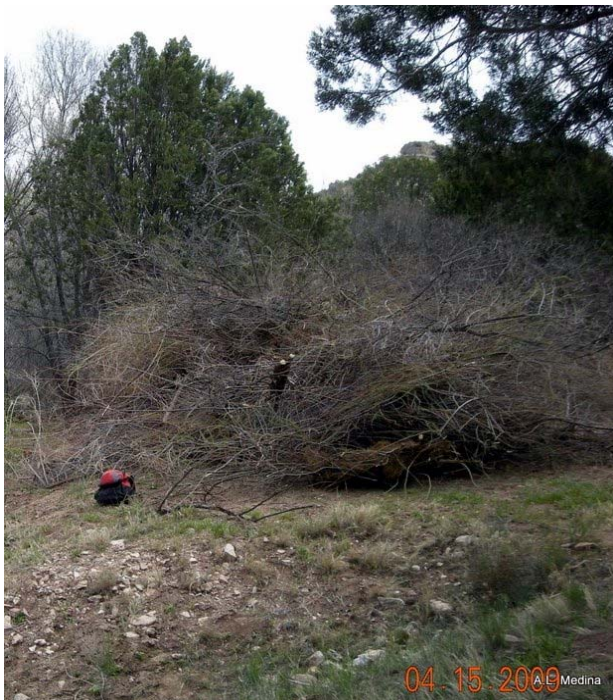
Photo 5. Cut brush should be stacked on adjacent terraces to create habitat for wildlife.

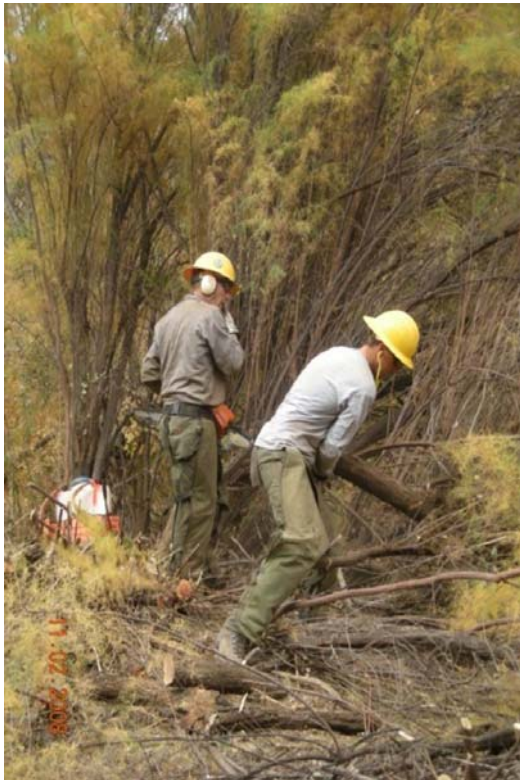
Photo 6. Some tamarisk stands are very dense with old growth and require removal of cut brush away from the work area.

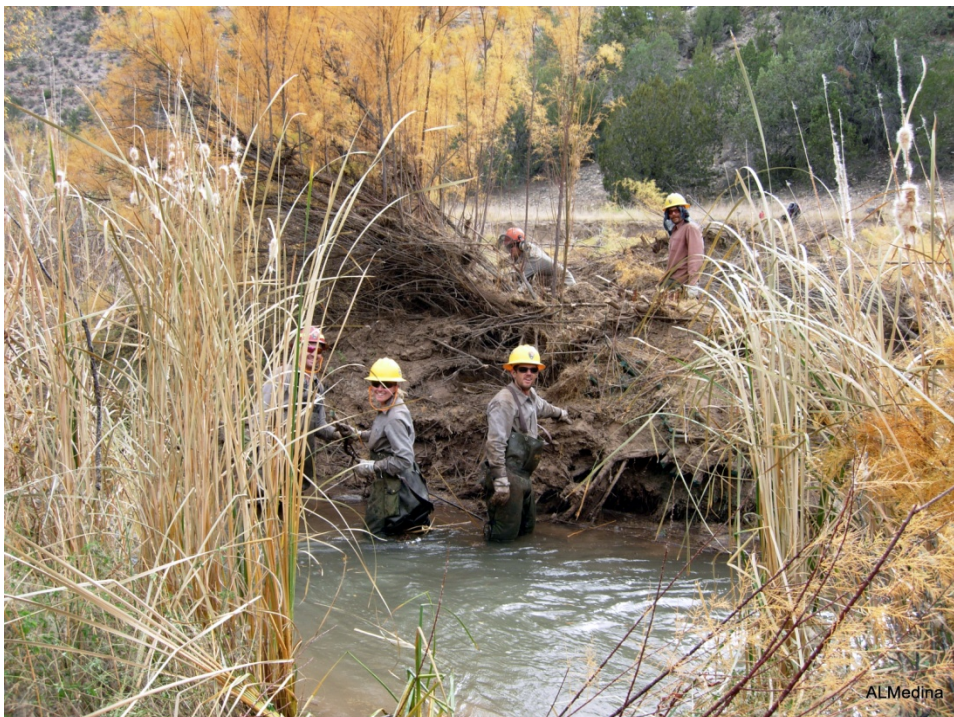
Photo 7. Crews are often required to prepare tamarisk stands by working in the water, thereby making the tasks more hazardous.

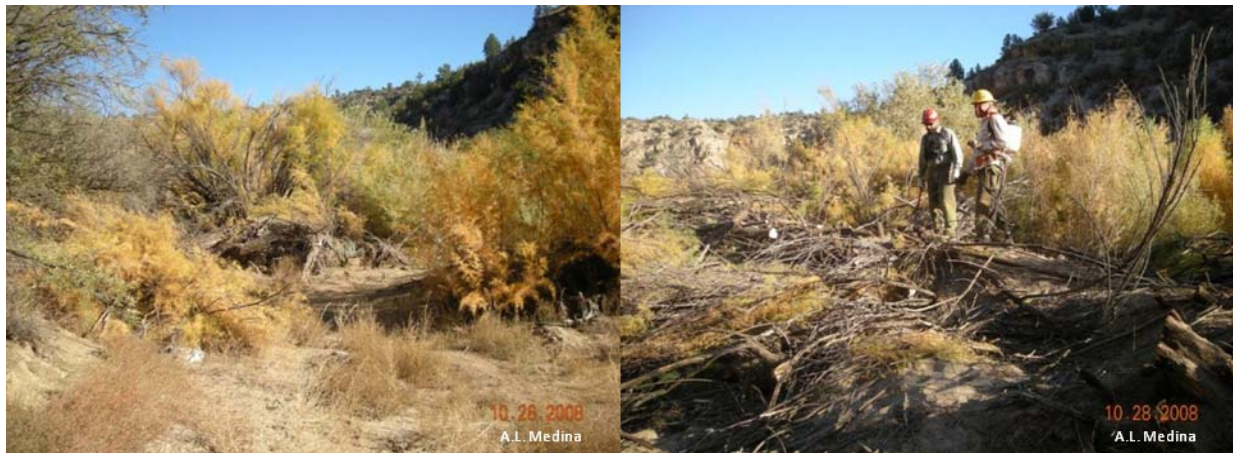
Photo 8. These paired photos exemplify a typical tamarisk stand before and after treatment on the upper Verde River.
