AWPF Grant Projects Evaluation
Phase II: Case Studies

Arizona Water Protection Fund
Phoenix, AZ

October 2007
Revised January 2008

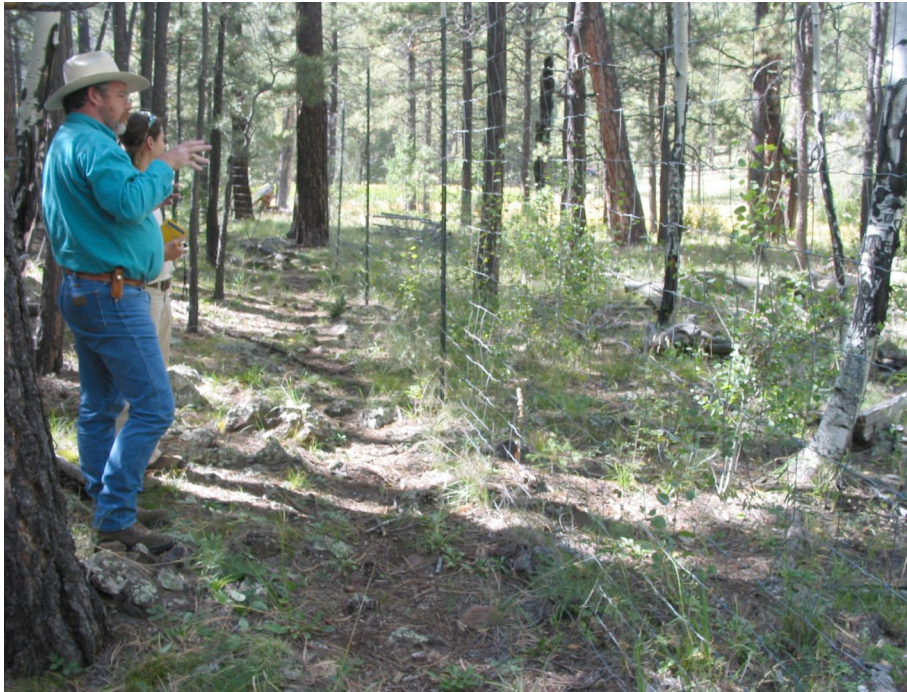
Figure 2. Elk enclosure at project site (#03-119WPF) with aspen saplings within enclosure.

The elk enclosure at Little Valley Springs clearly shows how directly fencing can benefit the riparian area. Aspen regeneration is absent outside the fencing, while many aspen saplings are present within the enclosure (right-hand side of photo).

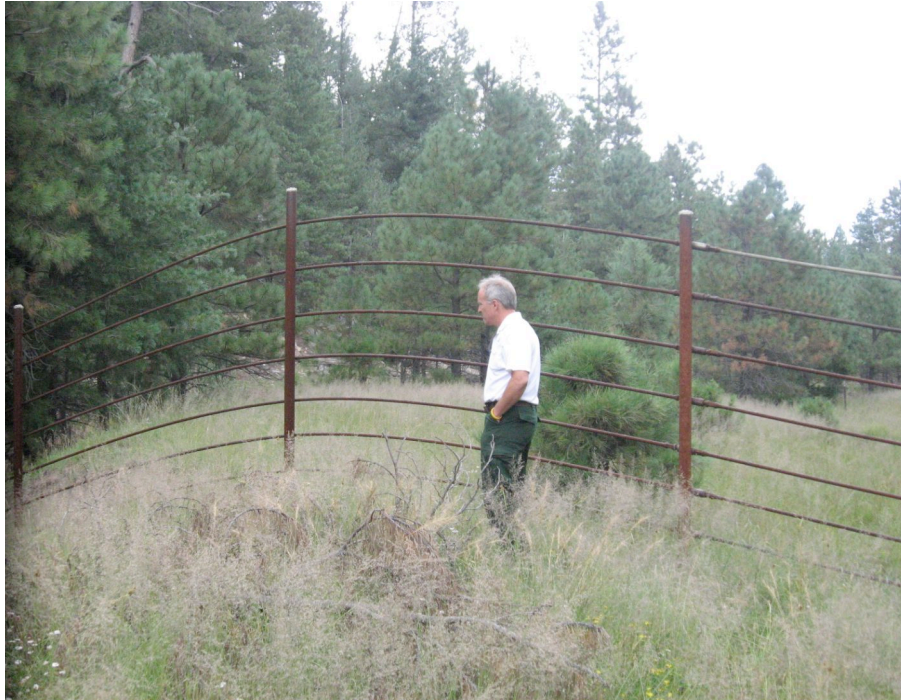
Figure 3. Low maintenance and innovative elk fence on Coconino National Forest installed by grantee Dick Fleishman using Arizona Game and Fish Habitat Partnership dollars at General Springs.

Elk fence, made of metal posts and sucker rod welded together, installed by Dick Fleishman of the Coconino National Forest. Although materials may be more expensive, this fence follows the contour of the land well, needs much less maintenance, and does not deteriorate as quickly as some other fencing materials resulting in complete exclusion of elk for a long period of time.

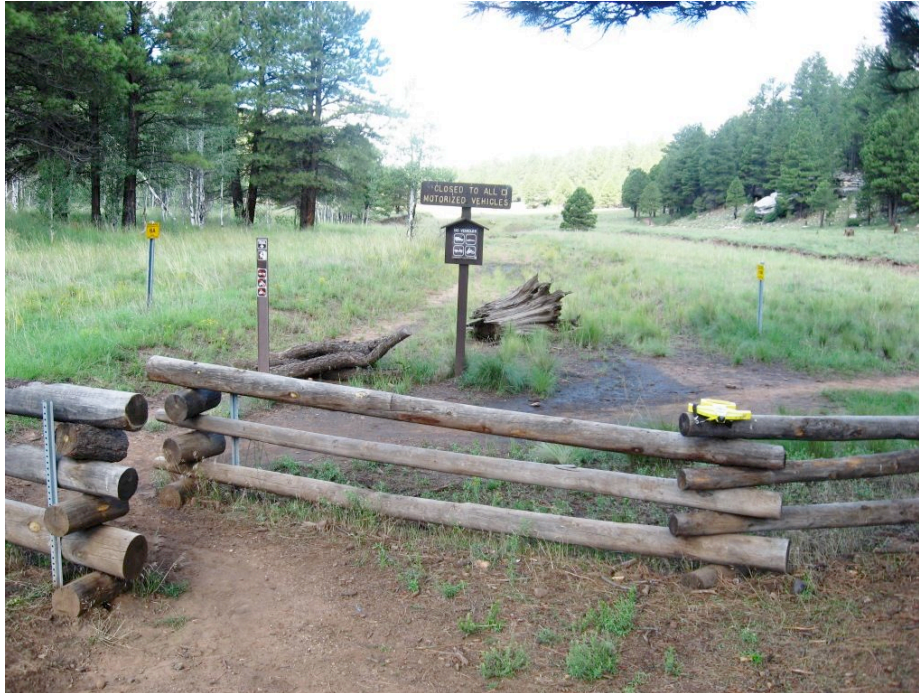
Figure 4. Fencing and signage used to exclude vehicle access at the Lake Mary Watershed Restoration project site (#00-108WPF).

One of the objectives for the Lake Mary Watershed Restoration (#00-108WPF) was to restrict vehicle access at Priest and Howard Draw. AWPf funds were spent to build this buck-n-pole fence, construct the sign, obliterate the road (just beyond the sign), and seed the abandoned road.

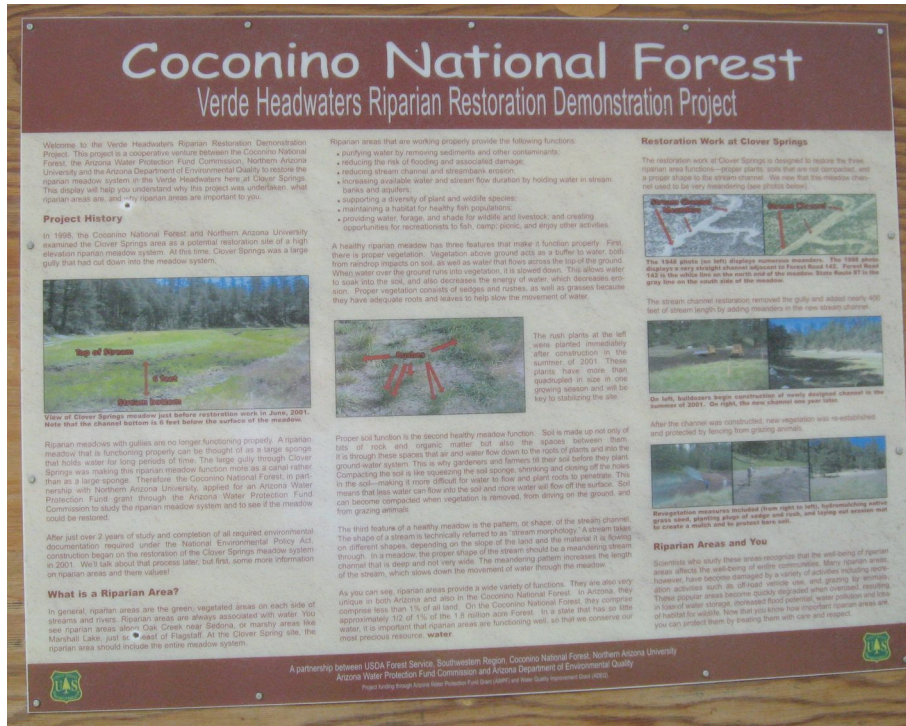
Figure 5. Interpretive sign at the Verde River Headwaters Riparian Restoration Project (#98-059WPF).

Large kiosks were installed at the upstream and downstream end of the project site with information about riparian areas and the restoration process.

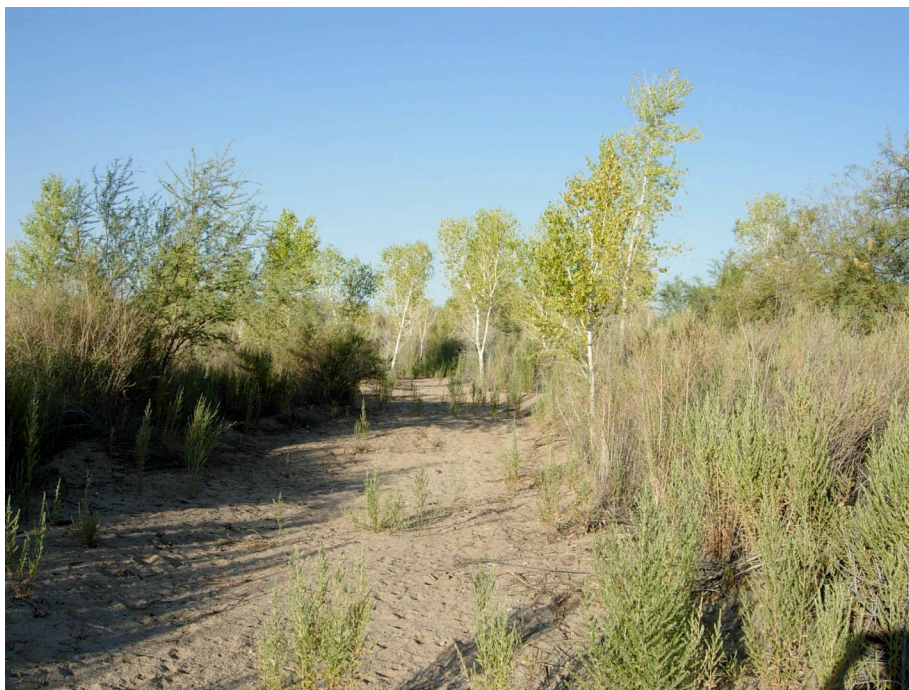
Figure 6. Successful cottonwood post plantings at the 'Ahakhav Tribal Preserve project site (#96-0016WPF).

With supplemental irrigation, cottonwood post plantings were highly successful. Natural recruitment was observed during the site visit.

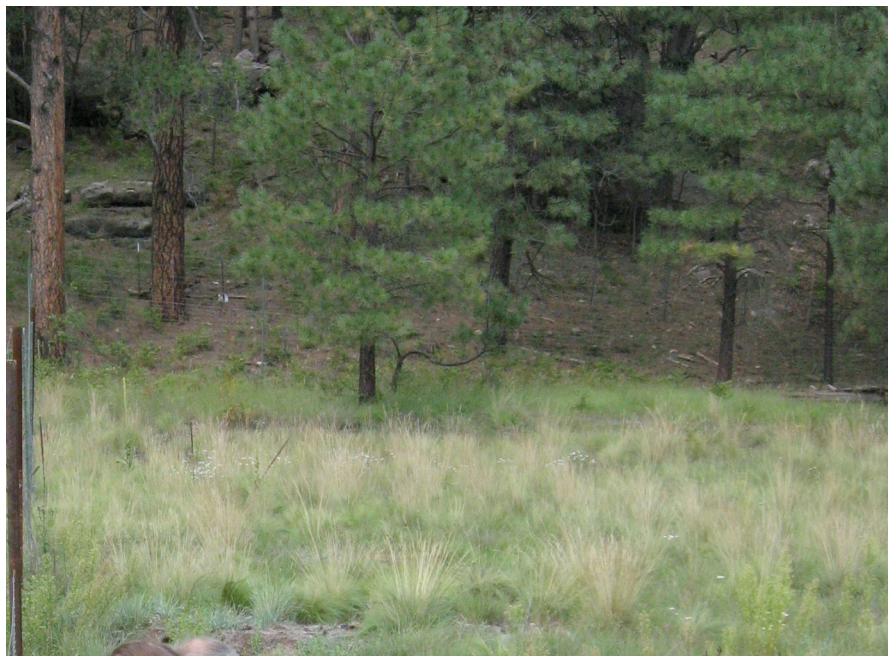
Figure 7. Fabric was used after seeding at the Verde River Headwaters Riparian Restoration Project (#98-059WPF).

Fabric used to cover grass seeds after construction appears to have increased germination success. Notice many bunches of Arizona fescue.

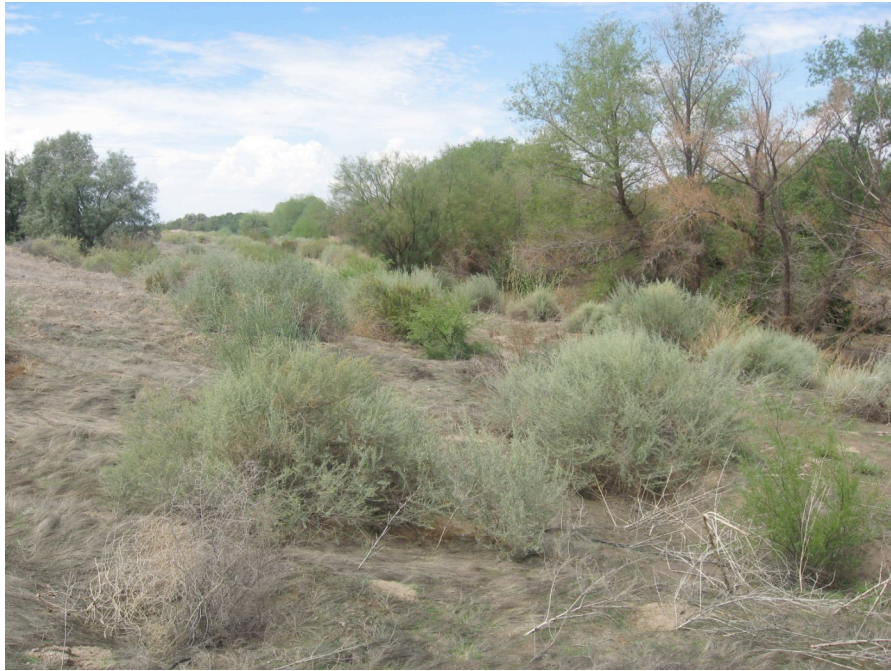
Figure 8. Upland (flood terrace) plantings at the Tucson Audubon Society North Simpson Farm Riparian Recovery Project (#00-115WPF).

Drought tolerant species were planted on the flood terrace and existing berm. Micro-basins were created around each plant to catch rainwater; drip irrigation was used for two years to establish plants.

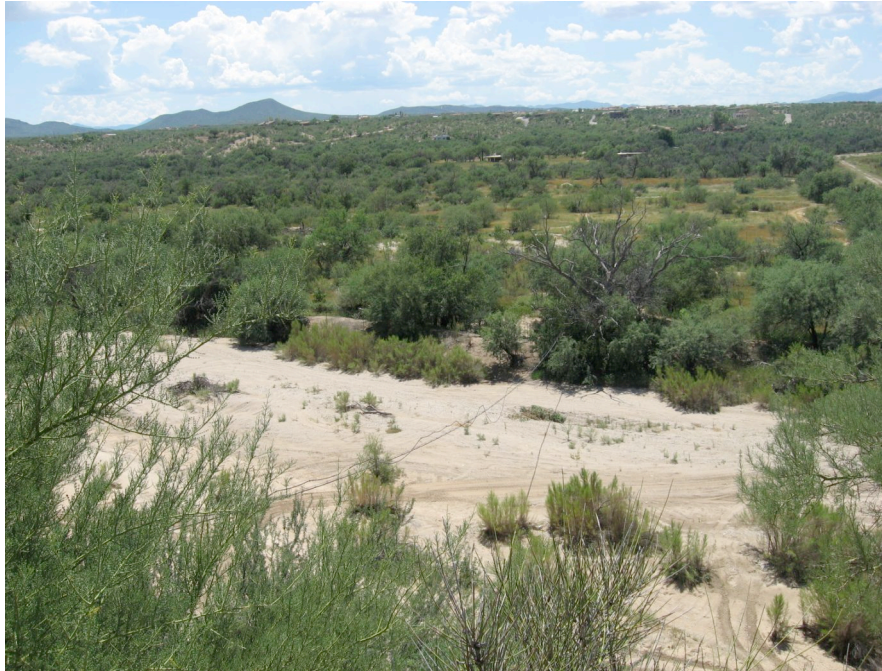
Figure 9. Mesquite plantings in background at the Partnership for Riparian Conservation in Northeast Pima County II Project (#98-062WPF).

At this project site, Partnership for Riparian Conservation in Northeast Pima County II, supplemental irrigation was used to start obligate riparian species and facultative upland species. Mesquite plantings in the background of this photo taken August 2007 shows established mesquite trees that no longer require supplemental irrigation.

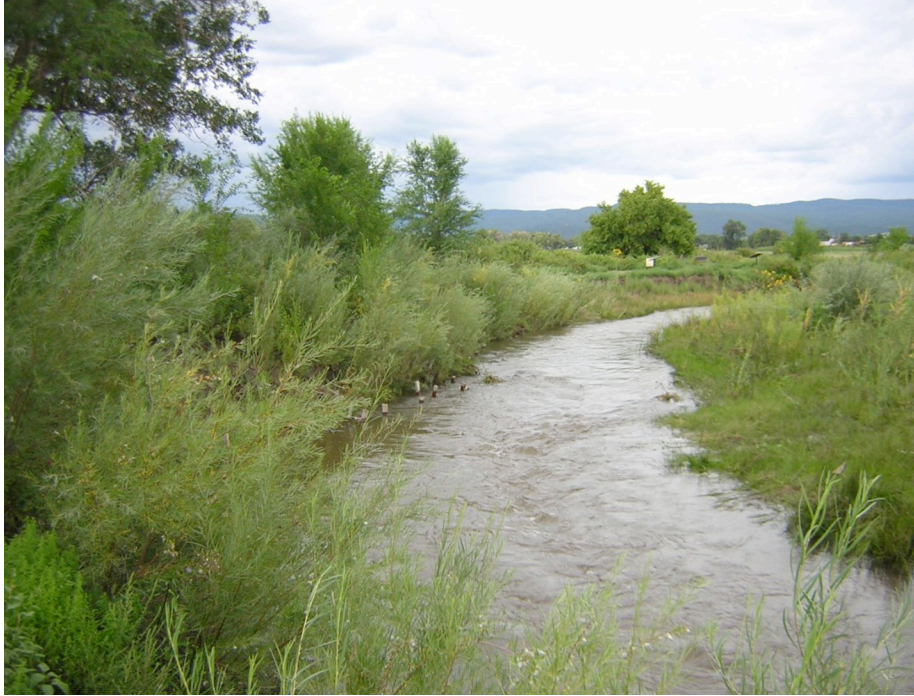
Figure 10. Vertical willow bundles used for bank stabilization at the Little Colorado River Enhancement Demonstration Project (#99-092WPF).

Willow stems bundled together, trenched into the bank, and laid vertically sprout roots and provide an effective method to stabilize stream banks.

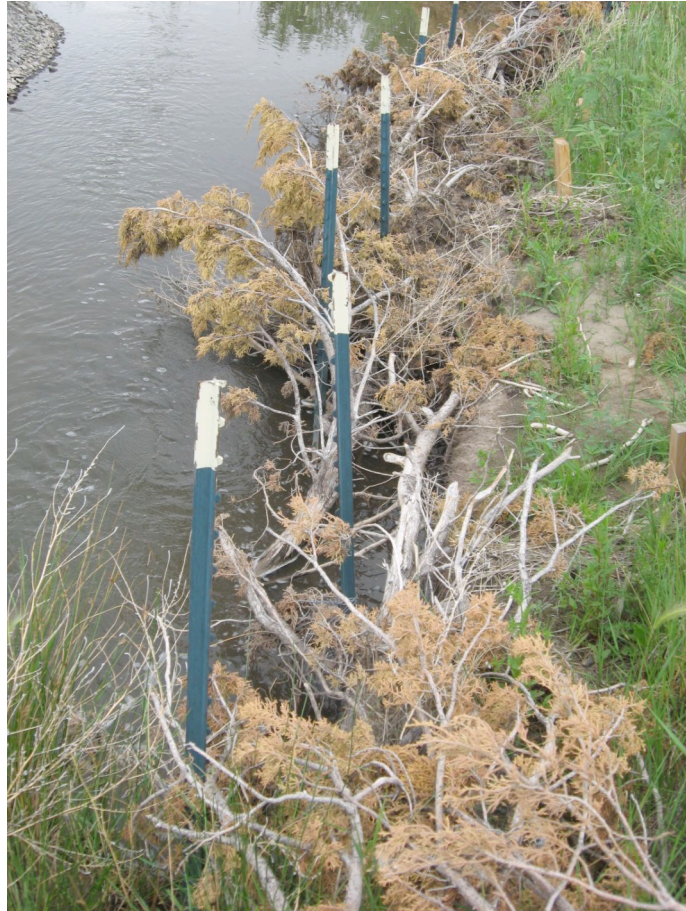
Figure 11. Brush revetments on the Little Colorado River (#99-092WPF).

Christmas trees were used as brush revetments and were placed at the base of the willow plantings to provide temporary bank protection at the Little Colorado River Enhancement Demonstration Project (#99-092WPF). The trees were installed during the fall of 2006 and will eventually become buried by gravel and fine sediments.

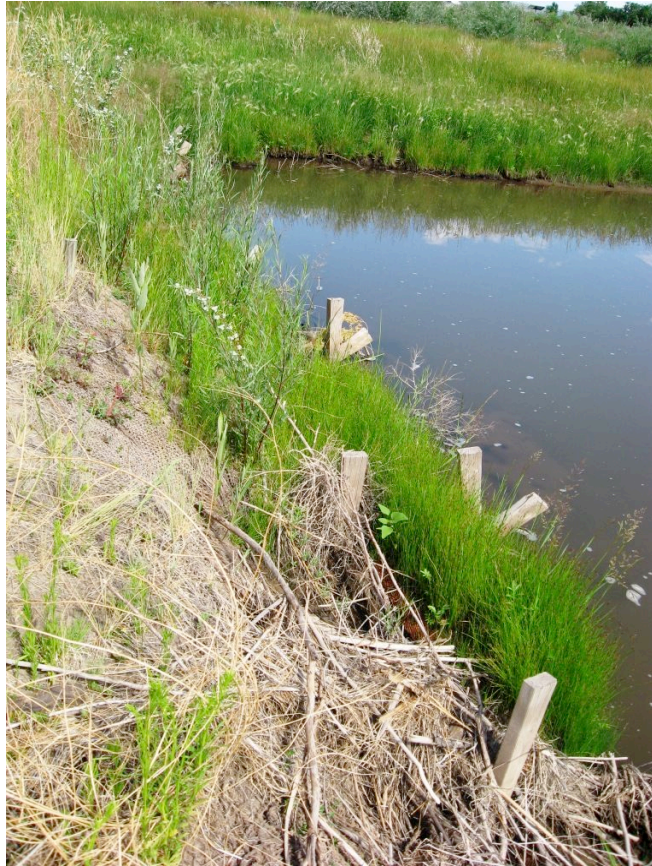
Figure 12. Bio-logs provide temporary bank protection along the Little Colorado River (#99-092WPF).

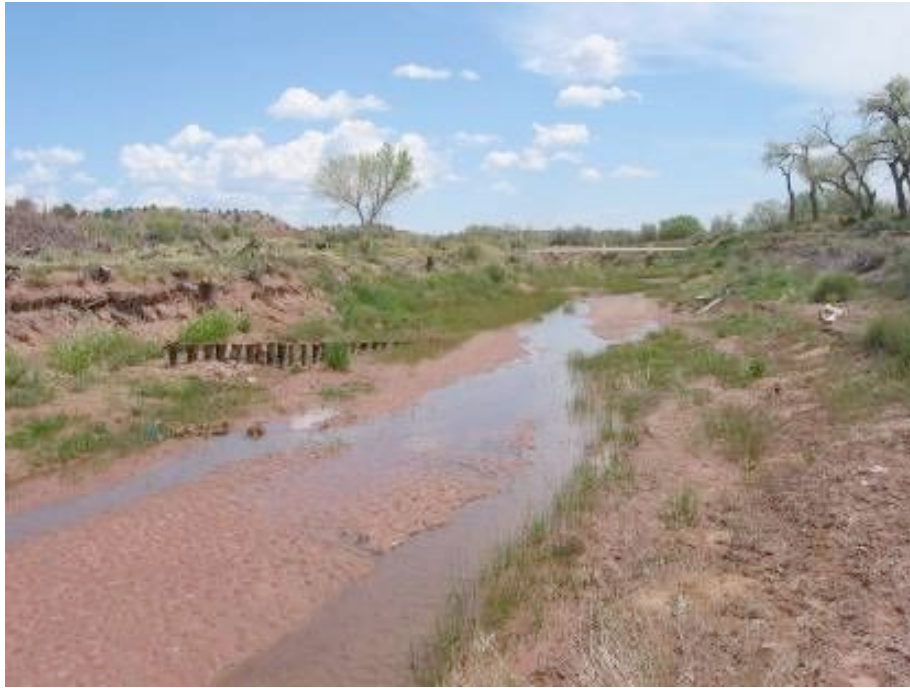
Figure 13. Post vane used for bank stabilization at the Demonstration Enhancement of Pueblo Colorado Wash at Hubbell Trading Post and Continued Enhancement projects (#97-029WPF and #00-104WPF) (left-hand side of picture).

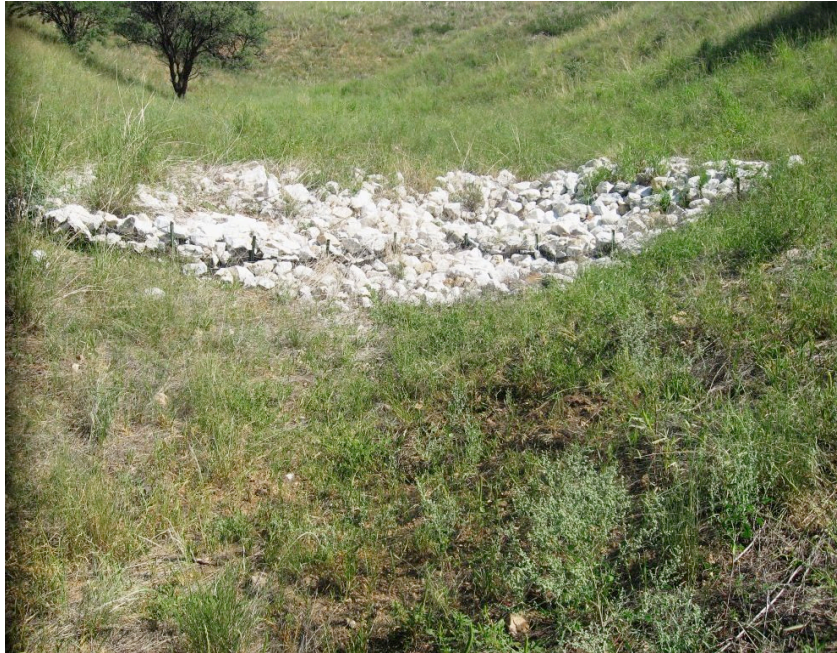
Figure 14. Rock structures stabilize headcuts at Oak Tree project (#97-034WPF).

Low hand-placed rock structures successfully stabilized active headcutting in Oak Tree Wash watershed in the Coronado National Forest.

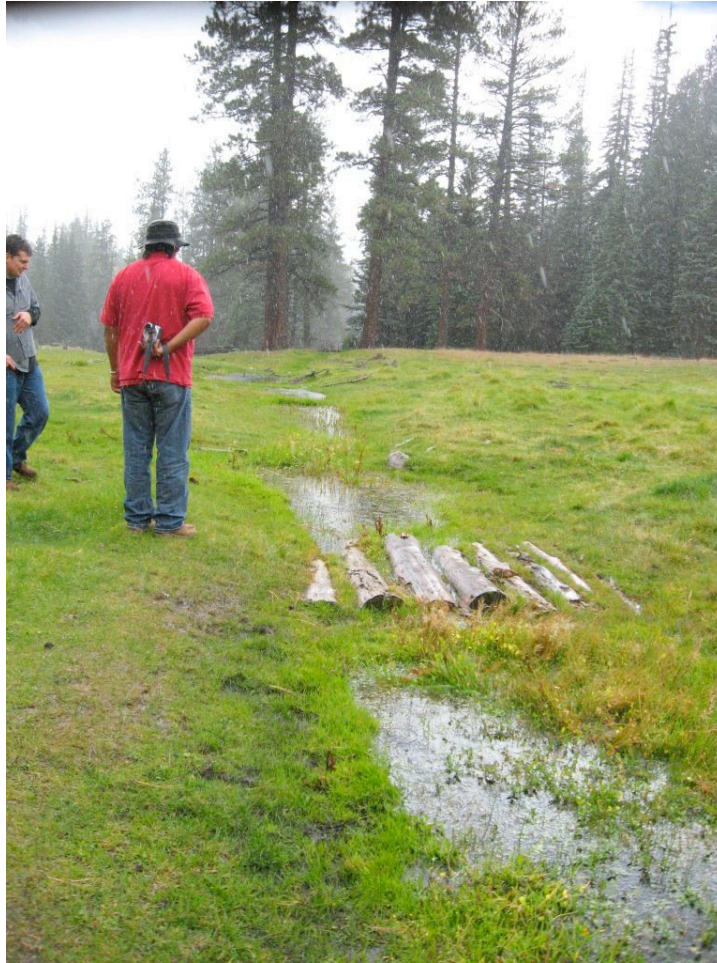
Figure 15. Log and sand bag structure at the Tsaile Creek Watershed Restoration Demonstration project (#96-0025WPF).

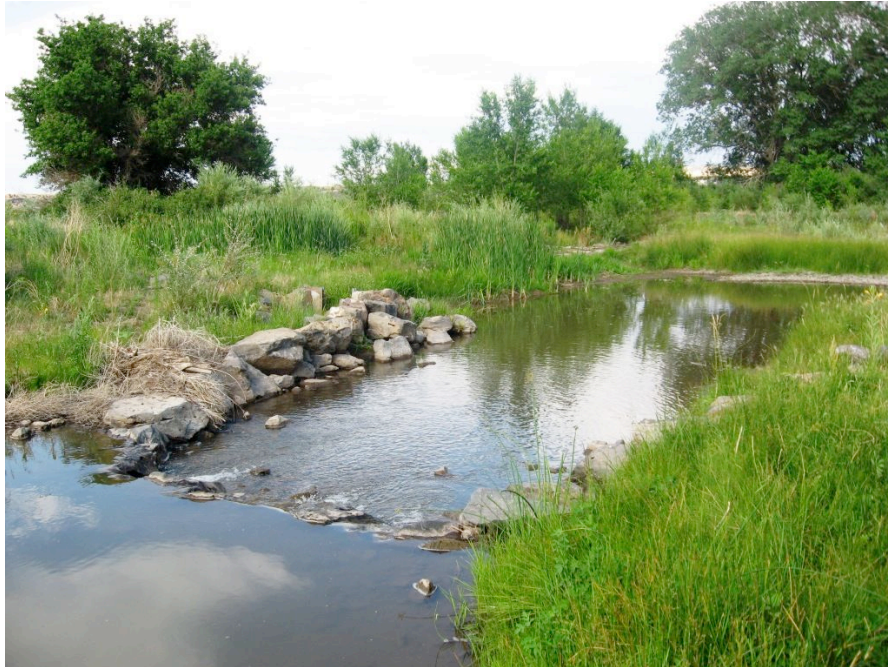
Figure 16. Cross-vane weir structure demonstrates improved diversion at the LCR Demo project site (#99-092WPF).

A low weir structure allows water diversion while maintaining sediment transport and allowing fish passage on the Little Colorado River.

Other AWPf projects utilized these practices in a variety of new and innovative ways. At the LCR Demo project site (#99-092WPF), an innovative cross-vane weir demonstrated a more effective diversion structure (Figure 16). At Cottonwood Creek (#03-116WPF) hundreds of small, hand-placed rock structures were installed in small ephemeral channels to slow velocities, dissipate energy, store sediment, and increase infiltration to benefit riparian vegetation downstream (Figure 17). This application was less successful in a more arid region of the state (#95-020WPF).

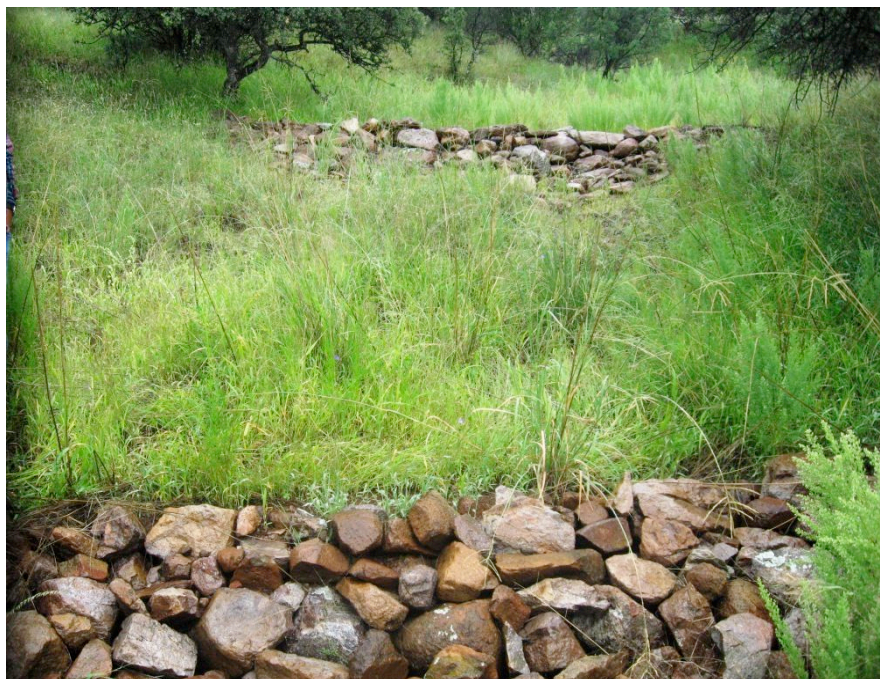
Figure 17. Rock structures at Cottonwood Creek (#03-116WPF).

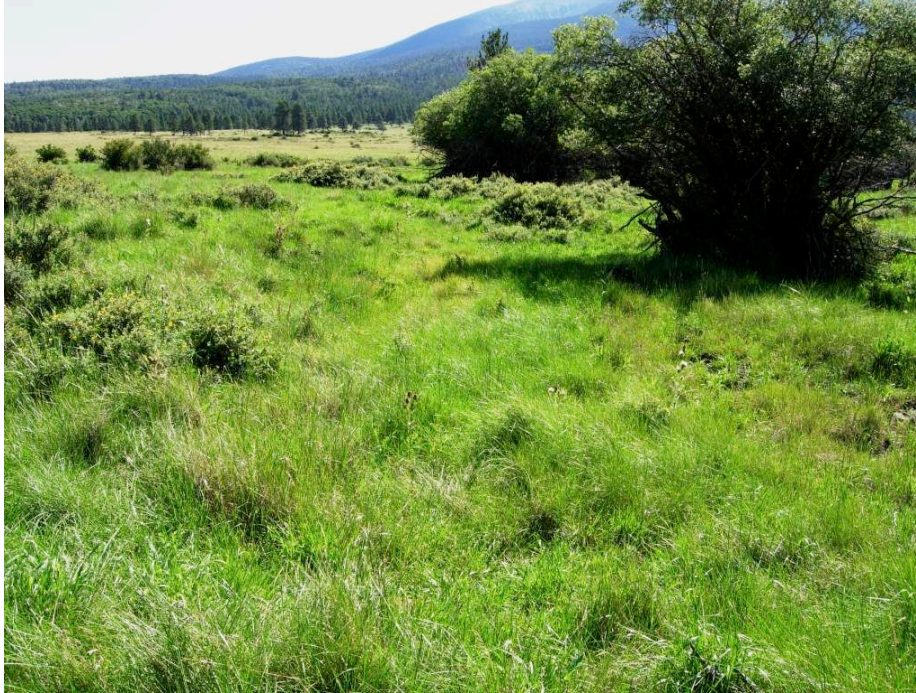
Figure 18. Area where an old dirt tank was removed and gradient was reconnected to the historic channel (#98-050WPF).

At Hart Prairie Preserve, The Nature Conservancy used specific engineer-approved design plans to fill in an old dirt tank. The Nature Conservancy collected data in order to re-contour the land area to reconnect flows to the historic channel and to mimic the historic micro-topography.

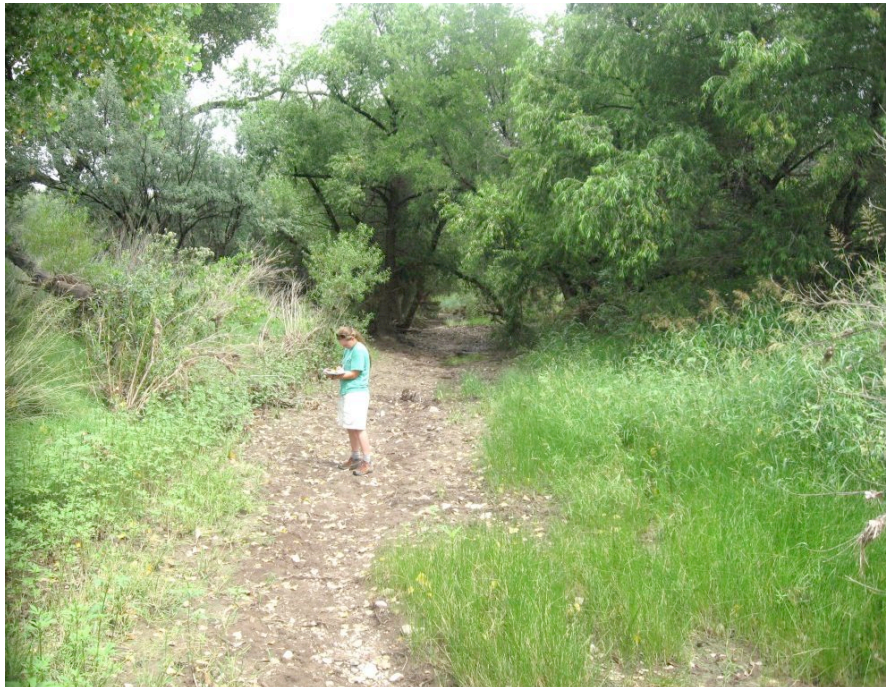
Figure 19. Restored channel at Cienega Creek (#96-0020WPF).

The Cienega Creek channel had been diverted to protect and irrigate adjacent agricultural fields. The project removed the diversion dike and restored the historic channel. The enhanced riparian vegetation is evident in this photo.

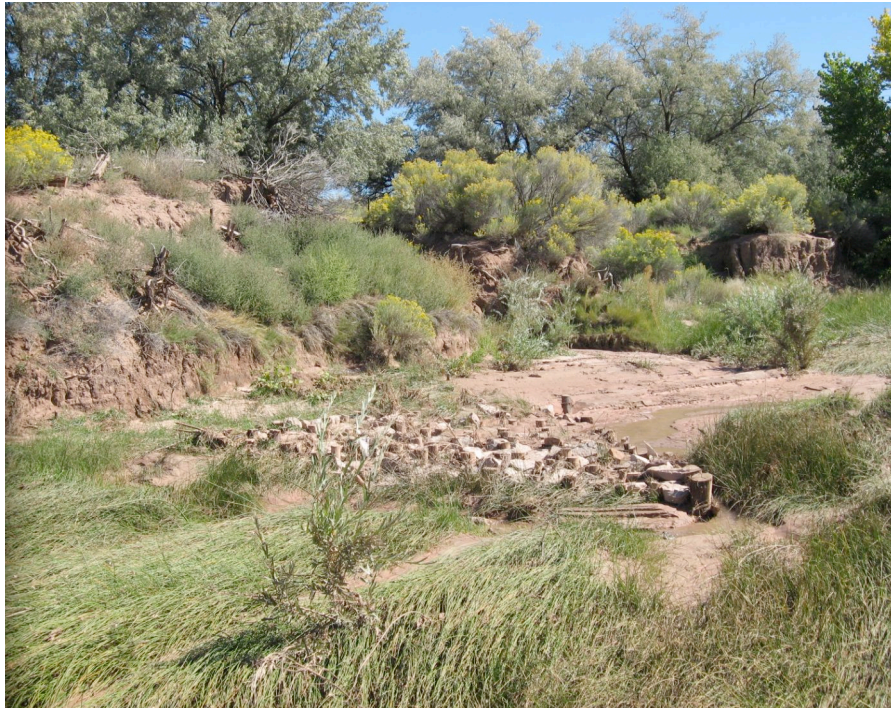
Figure 20. Induced meander structure, or baffle, at the Hubbell Trading Post project site (#00-104WPF).

Logs driven into the ground with rock pointing into the stream help create point bars and increase meander.

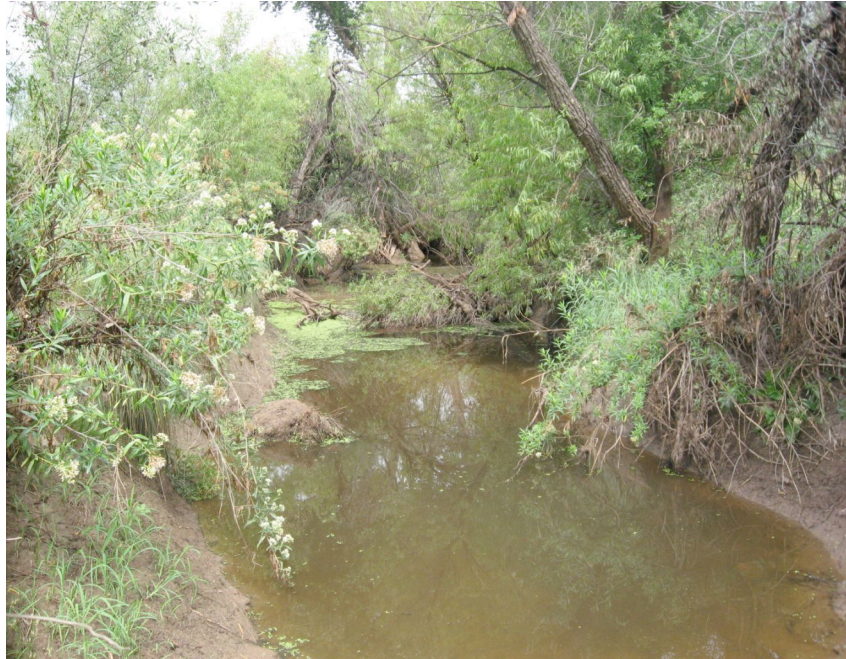
Figure 21. Backwater habitat created by plugging an old diversion ditch the Cienega Creek Stream Restoration project (#96-0020WPF).

Using existing conditions, such as diversion ditches or channelized stream segments to create backwater during restoration implementation is innovative and benefits the riparian area greatly.

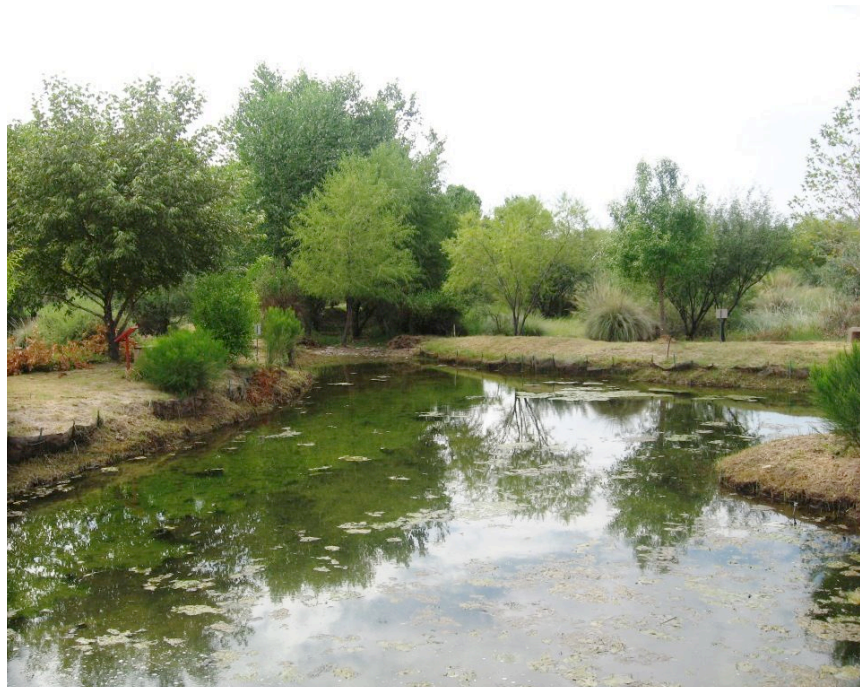
Figure 22. Off channel backwater at San Xavier Indian Reservation (#96-0026WPF).

Backwater pond habitat created at San Xavier Indian Reservation. Two ponds were created. Both ponds are fed through open channel irrigation. The project successfully created riparian habitat, increased public awareness, and the intrinsic value of the area to local residents.

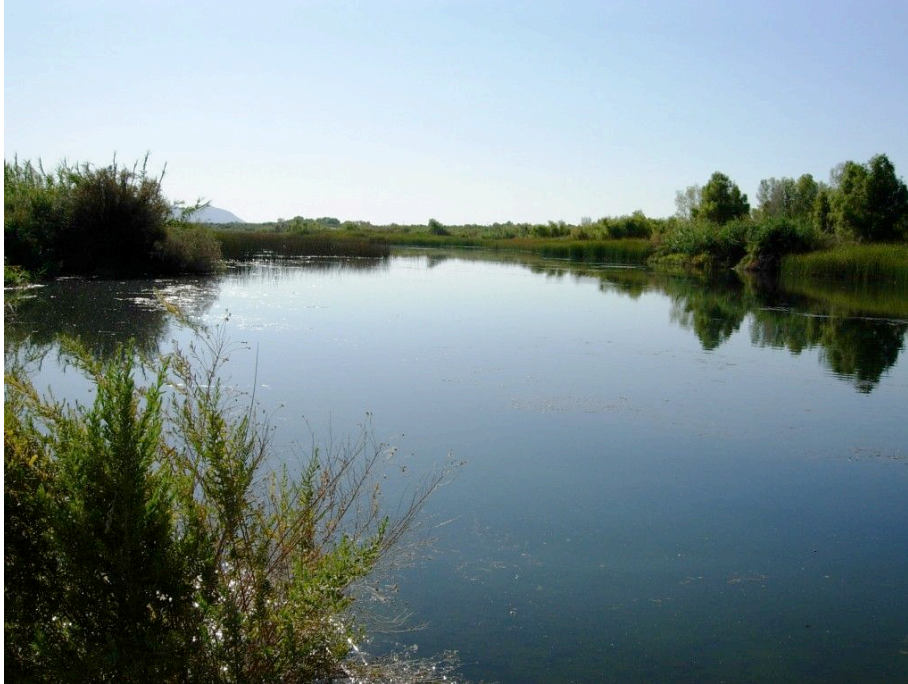
Figure 23. 'Ahakhav backwater created through the 'Ahakhav Tribal Preserve project (#96-0016WPF).

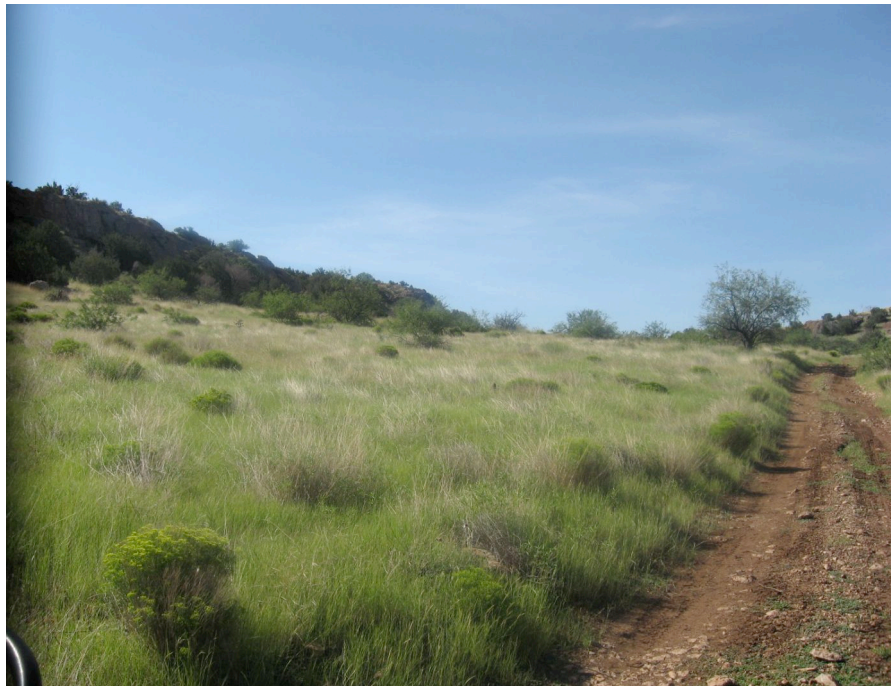
Figure 24. Prescribed burn to control woody encroachment and increase grasses at the Watershed Improvements to Restore Riparian and Aquatic Habitat on the Muleshoe Ranch project (#97-035WPF).

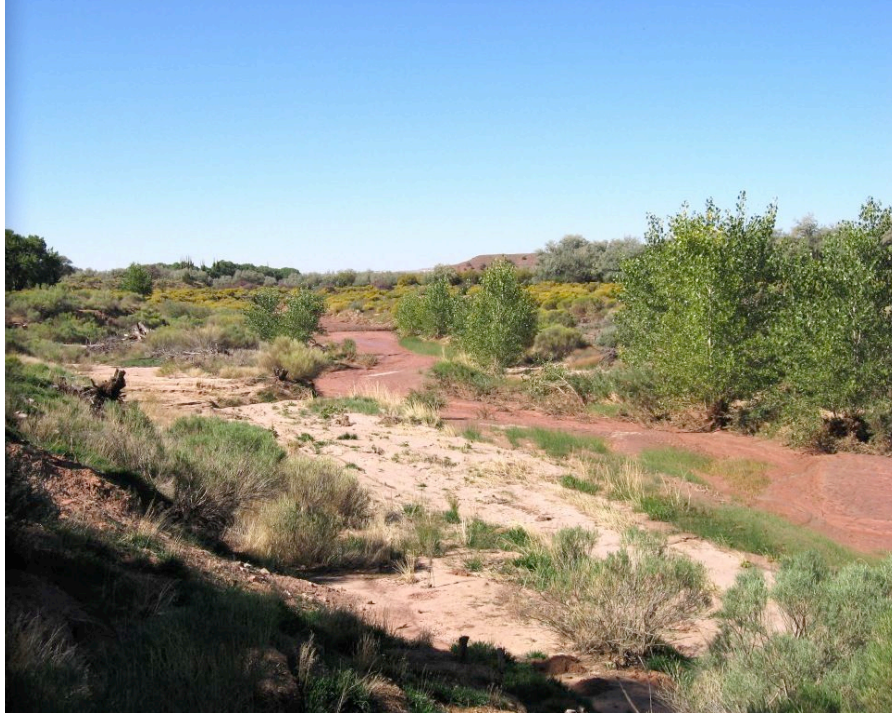
Figure 25. Post tamarisk treatment at the Hubbell Trading Post project site (#97-029WPF).
