**Final Report  
Task #9**

**Montezuma Well Riparian Restoration Project**

Montezuma Castle National Monument,  
Montezuma Well Unit, AZ

AWPF Project #: 08-161

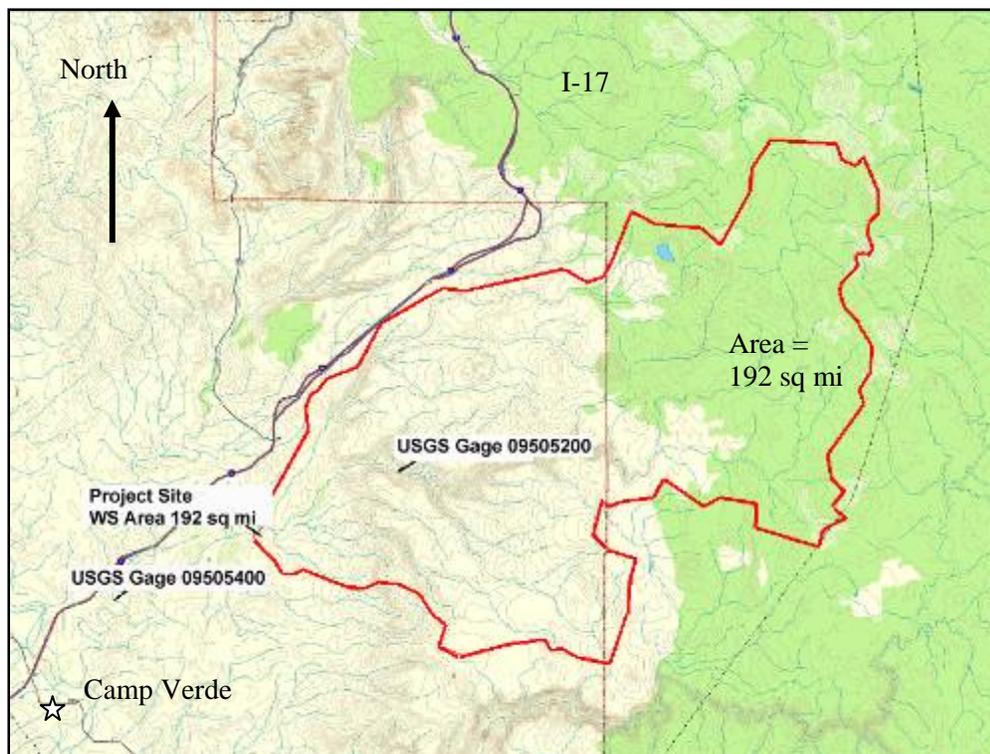
Figure 3. Watershed area for the project site

Wet Beaver Creek at the project site has a total watershed area of approximately 192 square miles (Figure 3). The stream originates along the southern edge of the Colorado Plateau on the Mogollon Rim at an elevation of 6,200 feet in the Beaver Creek Wilderness Area and enters the Verde River, approximately 25 miles downstream, at 3,000 feet. The stream is perennial and unregulated with the exception of minor baseflow diversions above the project site. The watershed area above the Mogollon Rim is dominated by Ponderosa Pine forest. The lower watershed drains more arid ecosystems such as pinon-juniper woodlands and desert shrublands. The creek has a robust riparian plant community including cottonwoods, sycamores, and alders.

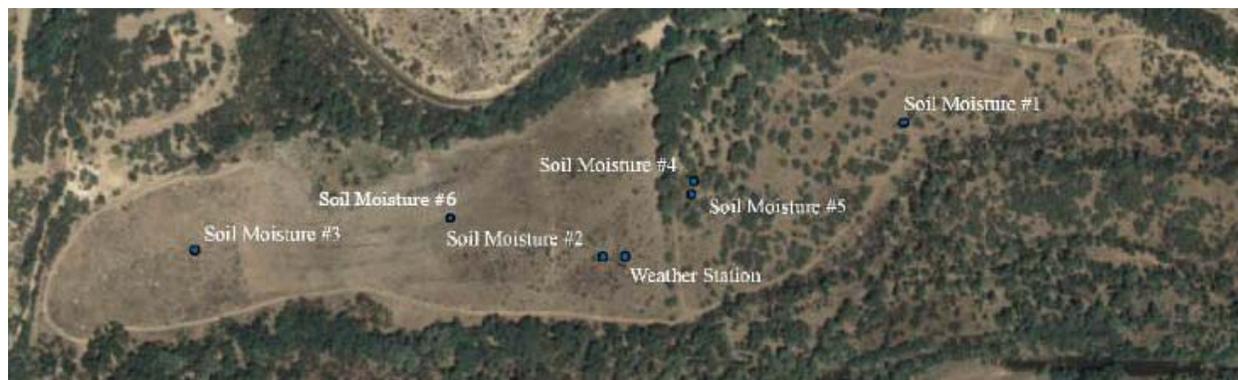
**Figure 6. Soil moisture probes locations**

Soil moisture probes are used to measure soil moisture at varying depths. Four probes were installed in November 2008 with a fifth in April 2009. A final sixth probe was installed in the spring of 2011. The probes measure moisture at 6-inch increments from the soil surface to a depth of 36 inches (Figure 6). The probes provide a spot check of soil moisture data to aid in the timing and quantity of water needed for the plants.

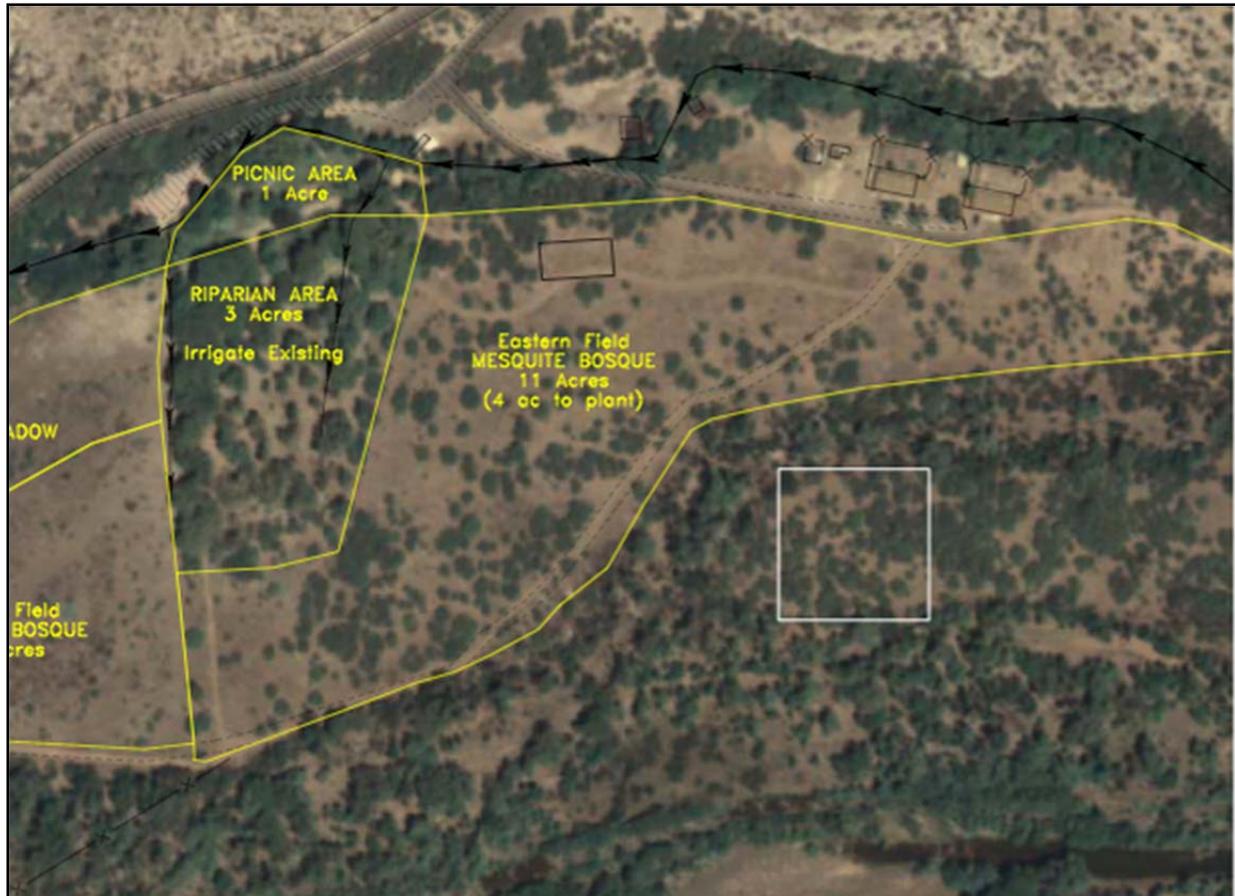
**Figure 8. Reference area; transition zone/mesquite bosque**

*The density and distribution of woody and grass species for planting design was based on existing vegetation in the East Field and unaltered areas to the east (upstream) of the project site. A density of 65 trees and 130 shrubs per acre was selected for the planting design to provide approximately 50% canopy and 50% open space.*

The ultimate planting design is intended to include diversity in vertical structure, species, and density. Dense thickets should be separated by more open, grassy areas. To identify a planting density, a reference area was identified in the unaltered transition zone/ mesquite bosque immediately upstream of the project area. The area is populated by a mature mixture of mesquite, shrubs, and grasses providing a diversity of structure, canopy, open areas, and species desired for higher quality wildlife habitat. The number of mature trees within a 1-acre plot were identified and counted on an aerial photo (Figure 8). The number of trees varied from 55 to 65 per acre. This produces a mixture of approximately 50% canopy and 50% open spaces and is roughly equal to the unaltered areas to the east of the project. A density of 65 trees per acre was selected for design purposes.

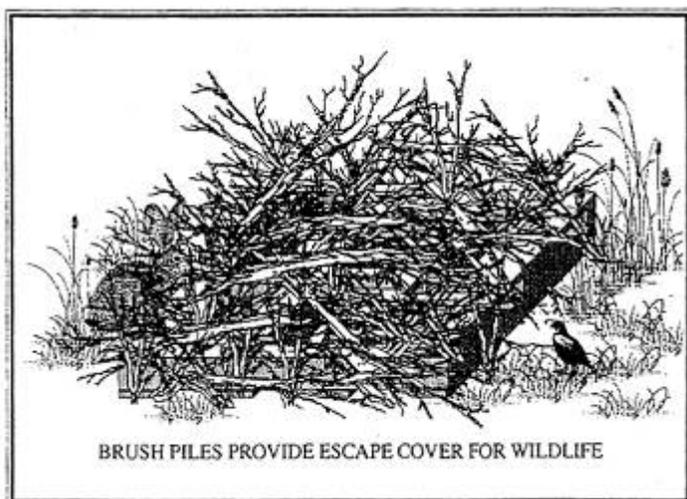
Figure 12. Brush pile

A brush pile is a mound of woody vegetative material to furnish additional wildlife cover. Loosely formed brush piles can provide nesting habitat, resting areas, concealment, and protection from predators. Brush piles are placed along field edges.

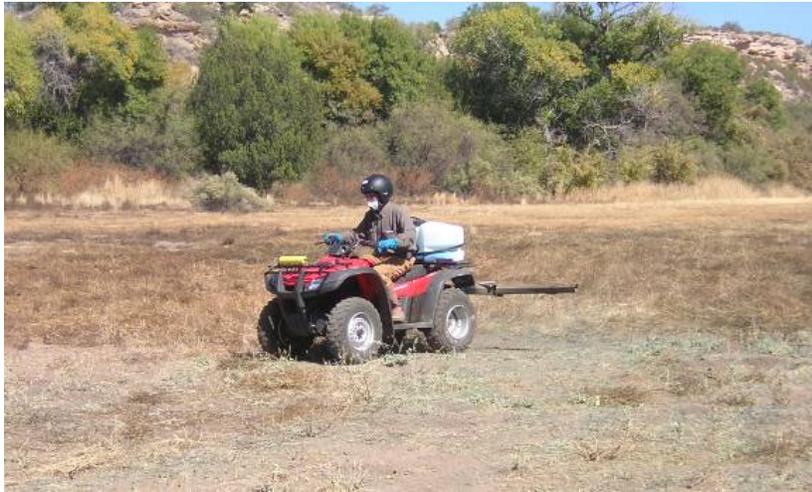
**Figure 15. ATV mounted boom sprayer.**

The herbicide was applied with backpack sprayers for individual spot spraying with Milestone, or with a boom sprayer attached to an ATV or UTV (Figure 15) when broadcast application with Roundup was warranted.

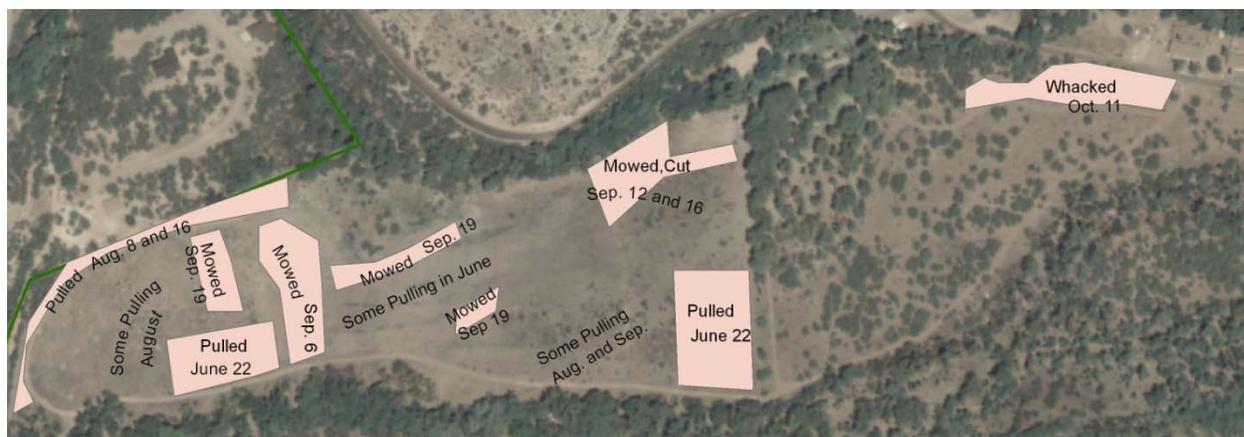
**Figure 16. Mechanical Weed Treatment Areas**

During the 2011 season, more effort was made in the mechanical control of weeds. Mechanical weed treatment involved using a gas powered weed trimmer, a mower, as well as rakes, hoes, and scythes to chop down Russian thistle, bull thistle, and annual sunflower some of which were over six feet tall. These annual plants are effectively controlled by mechanical removal before they go to seed. Some hand-pulling of Maltese starthistle, Russian thistle, and bull thistle was performed by NCD personnel and NPS with the volunteer help of American Conservation Experience (ACE), Coconino Rural Environmental Corps (CREC), Camp Verde High School students, and other volunteers. See Figure 16 for areas where mechanical weed treatment was performed.

Invasive weeds were often benefiting from irrigation and became quite vigorous in the vicinity of the caged plants. In order to prevent over-shading and competition for available nutrients, the invasive weeds needed to be removed. This was an ongoing process throughout the growing season. Whenever time was available during operation of the irrigation system, weeds were pulled and/or dug out. About 25% of the time reported operating the irrigation system was spent weeding manually.

The efficacy of the weed treatments has had mixed results. Silverleaf nightshade and horehound remain as problematic perennials. Treatment of these plants has decreased their density somewhat and kept their distribution from increasing. These plants have not responded to herbicide as well as other plants do. It could be that a different method of applying the herbicide should be used instead of straight down, such as spraying from all sides. It may be that these plants must be removed mechanically instead of chemically. It is clear from monitoring efforts that further weed treatments need to be done.

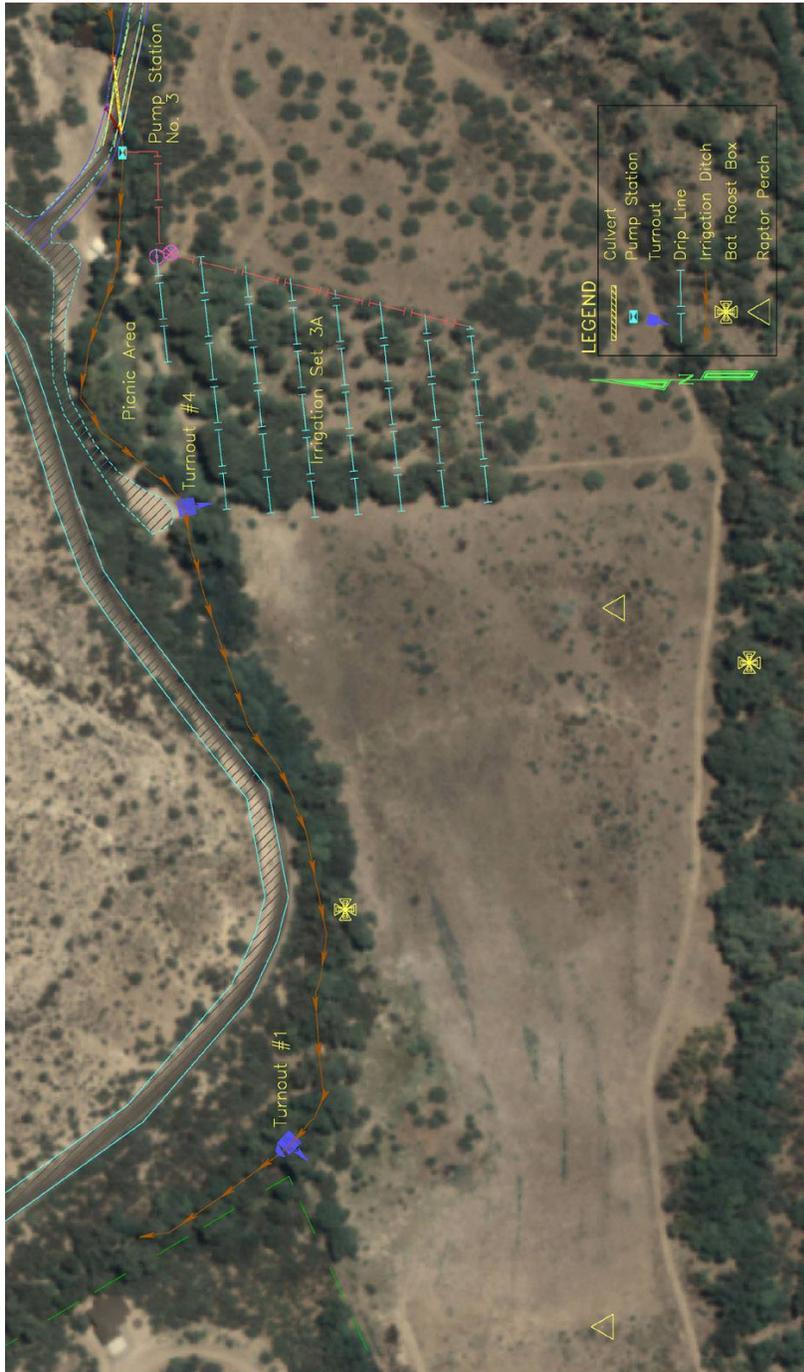
Figure 17. Site map with irrigation activities in 2009.

The construction, maintenance and operation of the irrigation system was an ongoing process for this project. Construction efforts started in 2009 with the maintenance of the main ditch and installation of new water control turnout boxes (Figure 17).

Ditch repairs included raising and reinforcing the ditch berm where water had eroded the surface whenever the ditch became blocked and water overflowed. Maintenance also included clearing out lateral ditches in the picnic area. In addition to the ditch work, two water control structures were replaced at turnouts number 1 and 4 (Figure 17 and 18).

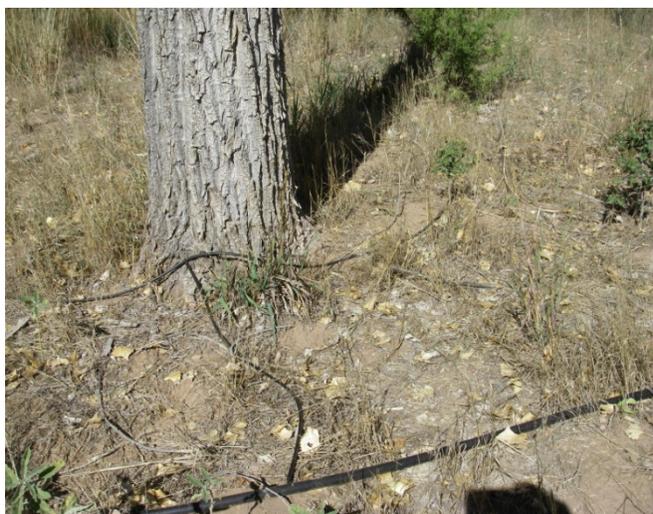
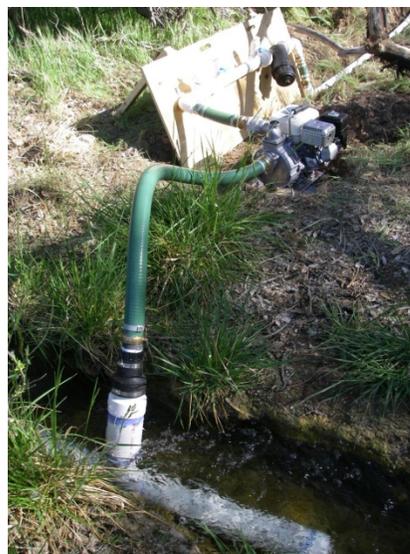
Figure 19. Pump and irrigation lines

2009 also saw the installation of the drip irrigation in the riparian buffer zone, which fed off pumping station number 3 (Figure 19). A gas powered pump was installed at station 3 and a one-inch polyethylene (PE) irrigation main line was routed adjacent to the riparian buffer zone. ½ inch PE laterals fed off the main line through the targeted zone and ¼ inch drip lines with 1 gallon/hour emitters were strung out to irrigate a total of 68 trees in this zone.

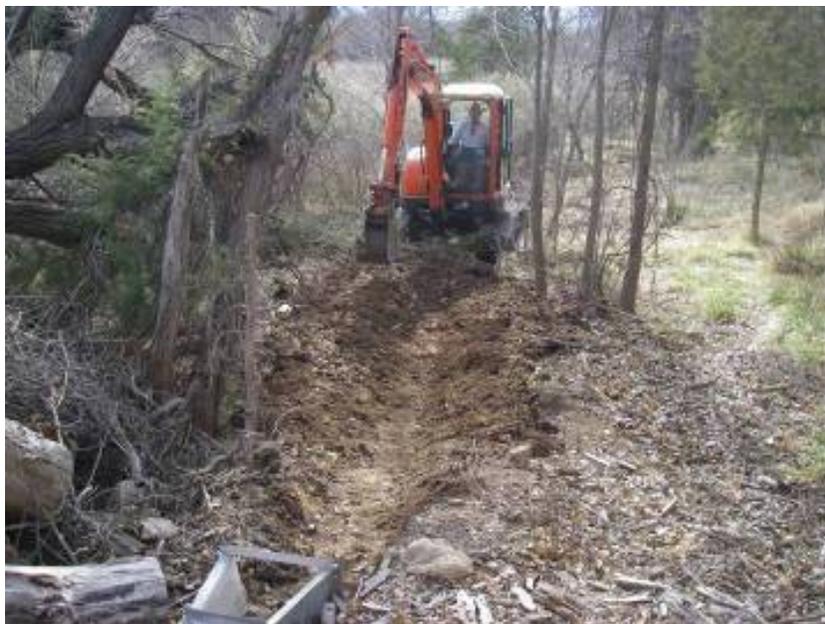
Figure 21. Irrigation lateral ditch excavation

A mini-excavator was used for clearing debris and renovating the ditch laterals. Ditches were cleaned along historical irrigation ditch routes to approximately 6 inches below existing depth (Figure 21). These ditches were used to flood irrigate the riparian area adjacent to the picnic area and the butterfly garden area.

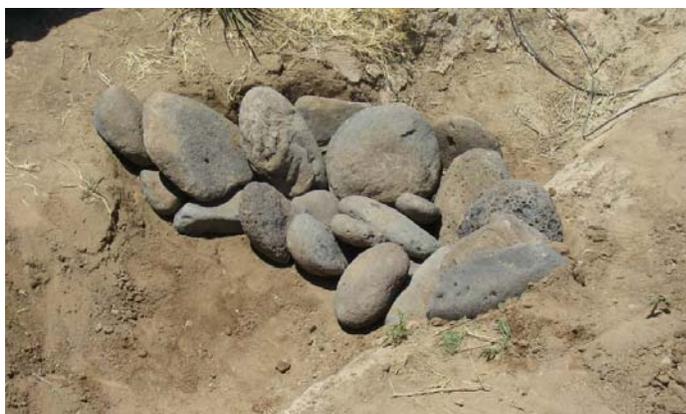
**Figure 27. Grade-Control Weir Installed in the West Ditch**

The west ditch was also seeing some erosion during 2011. Several grade-control structures were installed by one NCD and two NPS personnel with the help of the Coconino Rural Environment Corps (CREC). Grade-control weirs consisted of 8-16 inches in diameter rock. The weir spans the ditch channel but dips to only a few inches above the bed of the channel in the middle and rises up as the arms tie into the downstream portion of the ditch sidewalls (Figure 27).

*Three of these loose rock weirs were installed in the west border ditch to provide grade-control.*

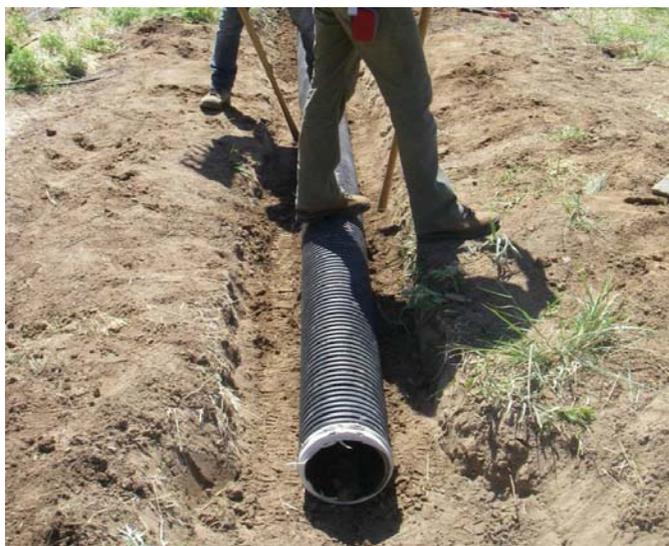
**Figure 28. Installation of the West Ditch Culvert**

Also of concern was where the west ditch tailwater spilled out. This tailwater ditch would spread out over an area that impacted the adjacent service road. To remedy this, an 8-inch dual-wall High Density PolyEthylene (HDPE) culvert pipe was installed to allow the water to flow under the service road before spreading out into the lower part of the field (Figure 28). Half-inch rebar was bent in a loop and installed at each end and in the middle of the pipe to anchor the pipe down. This pipe and the aforementioned loose rock weirs that comprise the west ditch improvements were not part of the original irrigation design. The installation is part of ongoing maintenance of the irrigation infrastructure and costs were not billed to Arizona Water Protection Fund.

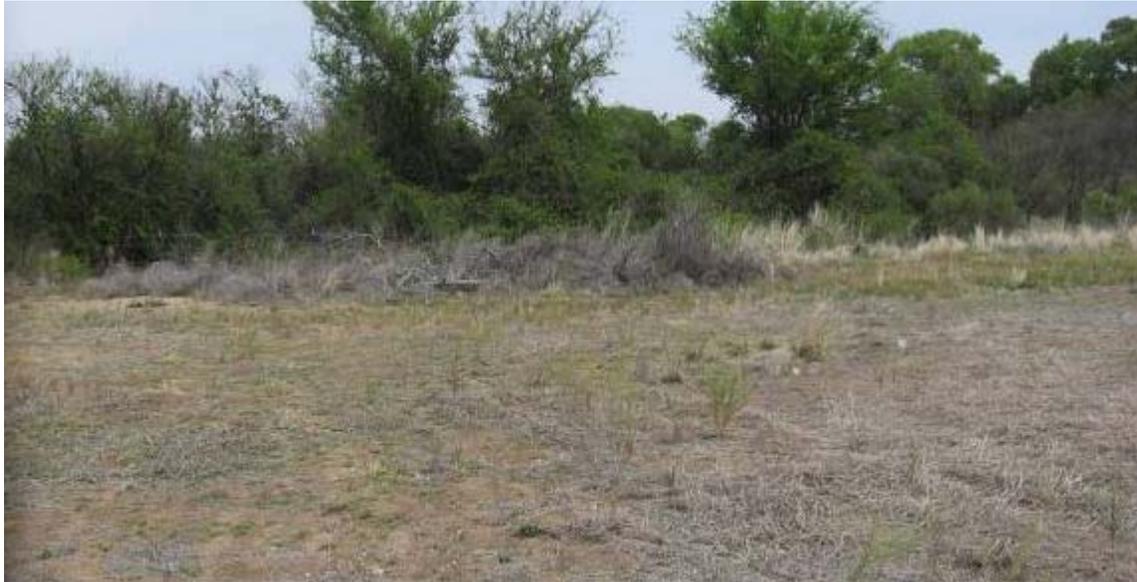
**Figure 29. Brush pile in the central field.**

2009 saw the construction of the wildlife improvements outlined in the design report. Efforts began with the construction of two brush piles along the riparian buffer area. These piles were created out of excess brush cleared out of the riparian buffer zone and placed into large piles to provide hiding cover for a variety of small native animal species (Figure 29).

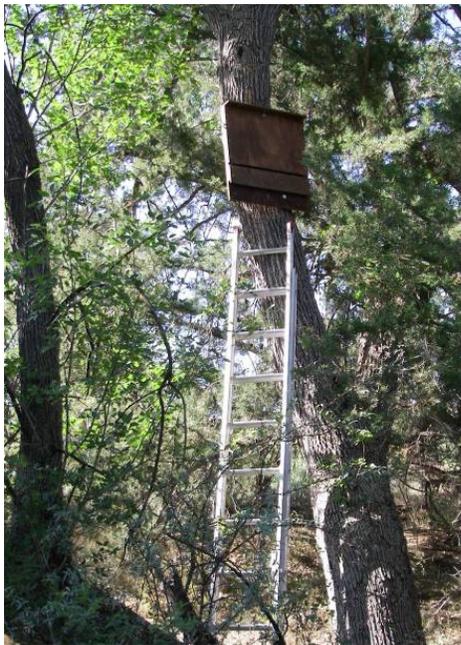
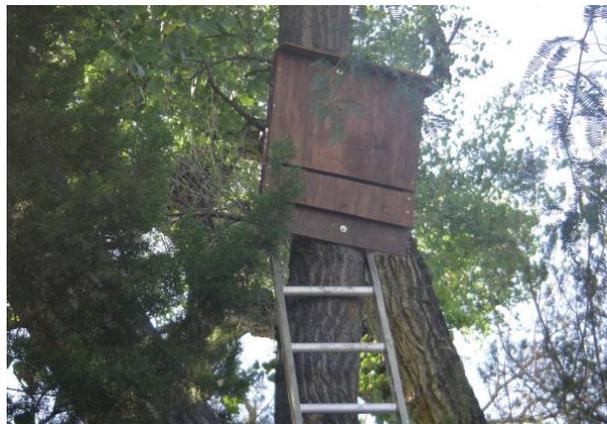
**Figure 30. Installed bat houses**

Two bat houses were constructed and installed in 2009 as well. The bat houses were placed on the southeast side of larger diameter ash and cottonwood trees approximately twelve feet up the trunk (Figure 30). The locations are shown in Figure 17.

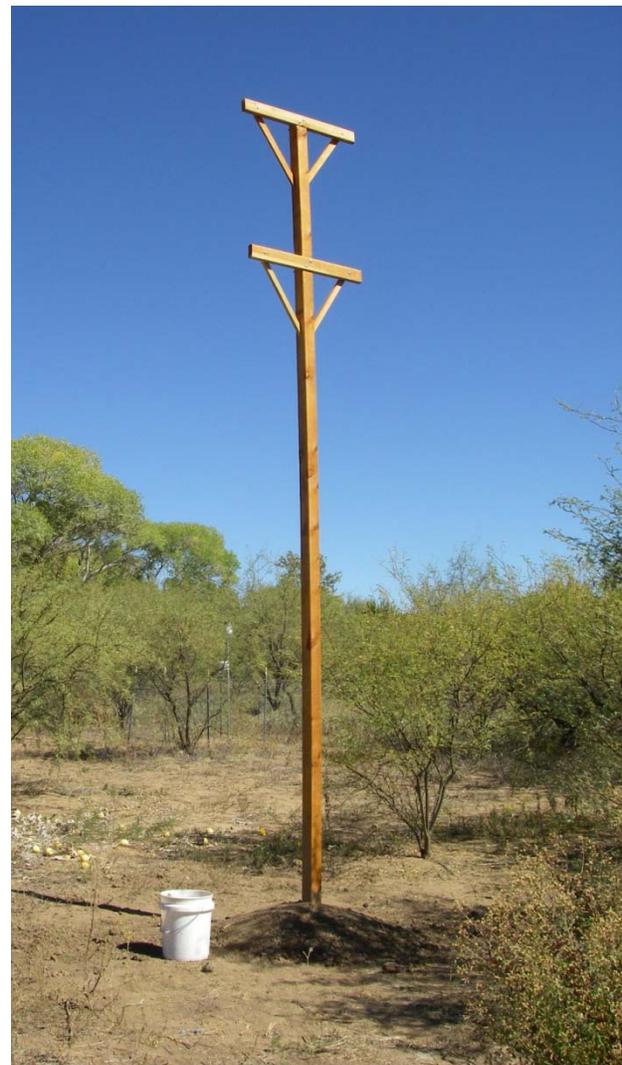
Figure 31. Raptor perch pole plans and installation in Central Field

Two raptor perch poles were manufactured for installation in the Central and West fields. The design deviated from the original plans. The new design incorporated 21ft. 4'X4' "Wolmanized" wood upright poles (of which 3ft. were buried), and twin redwood cross pieces, per a design for raptor perches in the Barn Owl Headquarters internet site by Bio-Diversity Products (Figure 31). The twin cross piece design was selected to address raptor preference toward perches that provide protection from attack from above and behind. In addition, discussion with NPS personnel regarding materials for the perches showed a preference for a wooden upright, vs. galvanized pole. The two raptor perch structures were mounted into concrete in 3 ft. deep excavations on October 8, 2009. Park Service personnel assisted with both installations. The locations of the installations are shown in Figure 17. Coordinates of the locations are: a) Central Field: 34° 38' 47.6" N 111° 45' 47.76" W (near the weather station); b) West Field: 34° 38' 47.68" N, 111° 45' 59.77" W.

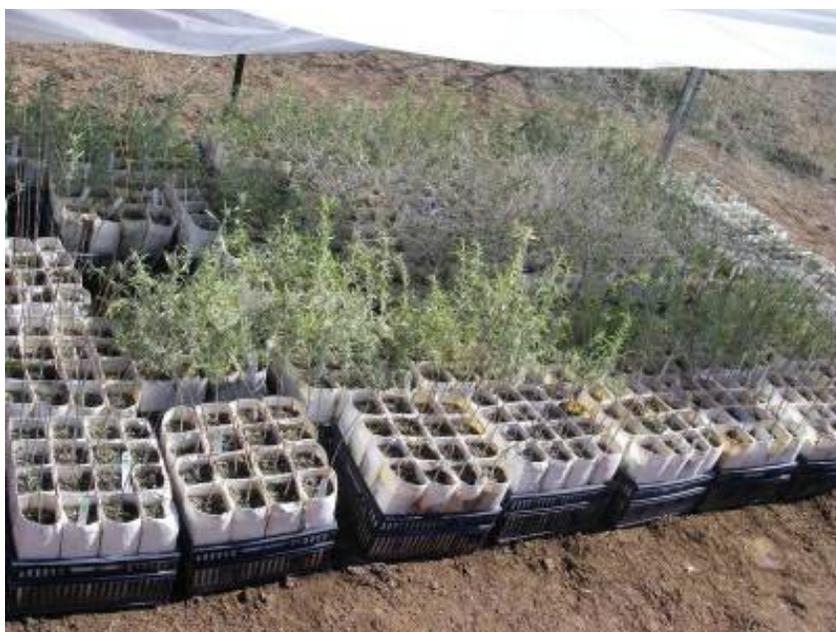
Figure 33. Seedlings prior to planting

A total of 832 containerized plants were grown by Tucson Plant Materials Center (USDA NRCS) and transported to the site (Figure 33). The plants consisted of four species of shrub and one species of tree (Table 15). Holes for the plantings were excavated using a 12-inch auger mounted on a mini-excavator. Water for the plantings was transported to the various planting areas using a 325-gallon tank on a flatbed trailer. It was transported from the tank to the plants in 5-gallon buckets. They were planted in the holes by hand and backfilled using a mix of the excavated native soil and water. Circular wire cages, two-feet high and approximately eighteen-inches in diameter were constructed to enclose the plants, protecting them from wildlife (Figure 34 and 35).

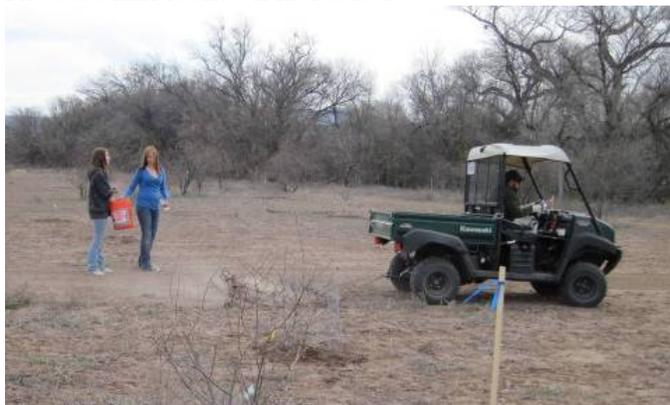
**Figure 36. Grass/forb seed planting**

A total of 157 pounds of native grass and forbs seed, consisting of a mix purchased from a commercial source and a variety of species collected locally by the NPS staff, were sown over disturbed areas throughout the project site. Seeding was conducted by NPS staff in December 2009 and January 2010. The soil in the areas to be planted was first loosened by pulling a chain-drag behind an ATV. Seed was then spread by hand-broadcasting at a rate of 6 pounds per acre and then raked into the soil (Figure 36). The seed mix is shown in Table 16.

Photo shows chain-drag attachment for roughing soil prior to broadcasting seed, with Camp Verde High School volunteers hand-broadcasting seed from buckets. Photo: Sharon Kim, NPS.

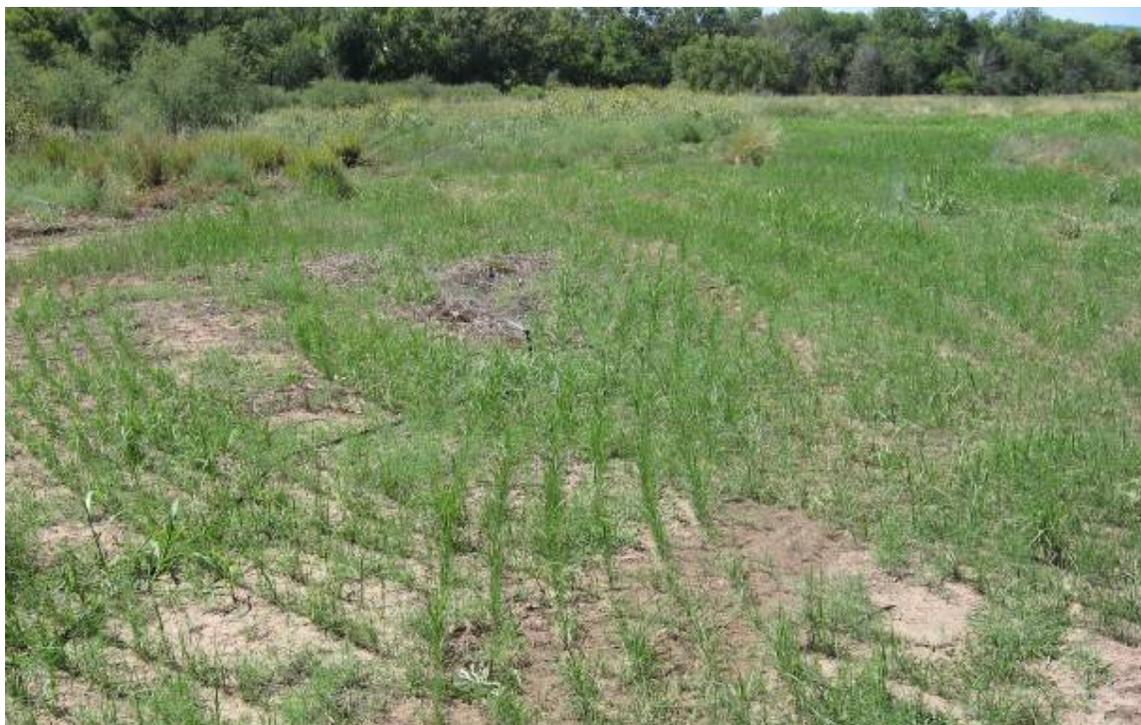
Figure 38. Grassland meadow later in the summer.

This seed mix was drill seeded on 4.6 acres and hand-sown on 0.9 acres for a total seeded area of 5.5 acres. Soon after the grass seeding took place, an inch of rain fell on the fields resulting in abundant germination (Figure 38).

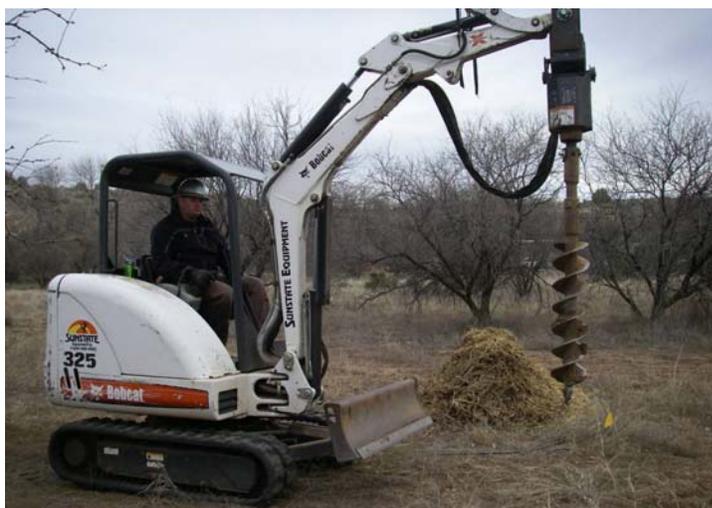
Figure 39. Hydraulic auger for plant installation

A rubber-tracked Bobcat excavator with hydraulic auger attachment was used to drill holes where plants were to be installed (Figure 39). This creates a large hole that, when backfilled, loosens the soil and could help root growth. The augered holes were nearly twice as deep as the pots that the plants were delivered

in, which allows a greater zone of loosened soil around the roots, but care was maintained to ensure that the plants were installed such that the top of the containerized soil was at ground-level. This maintains the roots of the plants at proper depth to uptake soil moisture properly. Water was poured into the hole before and during plant installation to thoroughly moisten the surrounding soil and eliminate air pockets that may develop during backfilling.

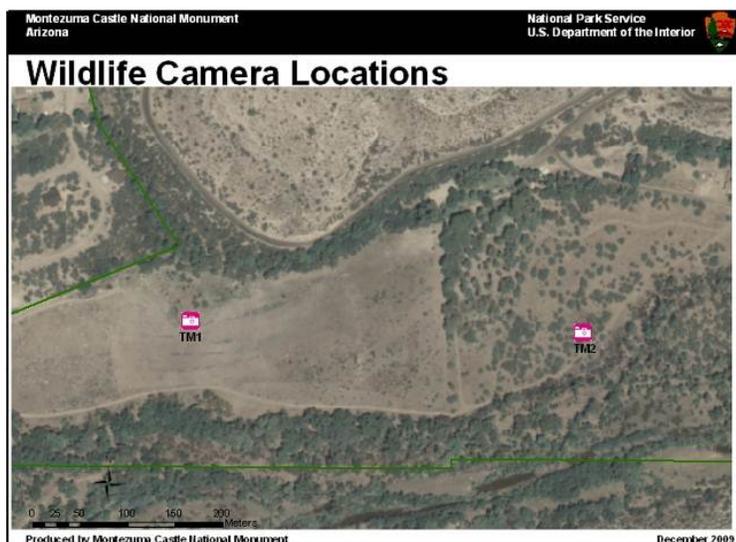
Figure 42. Wildlife camera locations

Park staff has been involved in providing information on wildlife sightings and observations. Motion detection cameras were installed at two locations (Figure 46). In 2009, wildlife cameras captured images of mule deer, coyote, cottontail rabbit, and domestic housecats. During 2010, the cameras operated inconsistently with technical difficulties, including battery failure, and so do not provide a consistent record of wildlife use in the project area. However, cameras did capture more than 200 images of several animal species between September 1 and October 4, 2010, including white-tailed deer and several spotted fawns, striped and hog-nosed skunks, and javelina in addition to the species photographed in 2009.

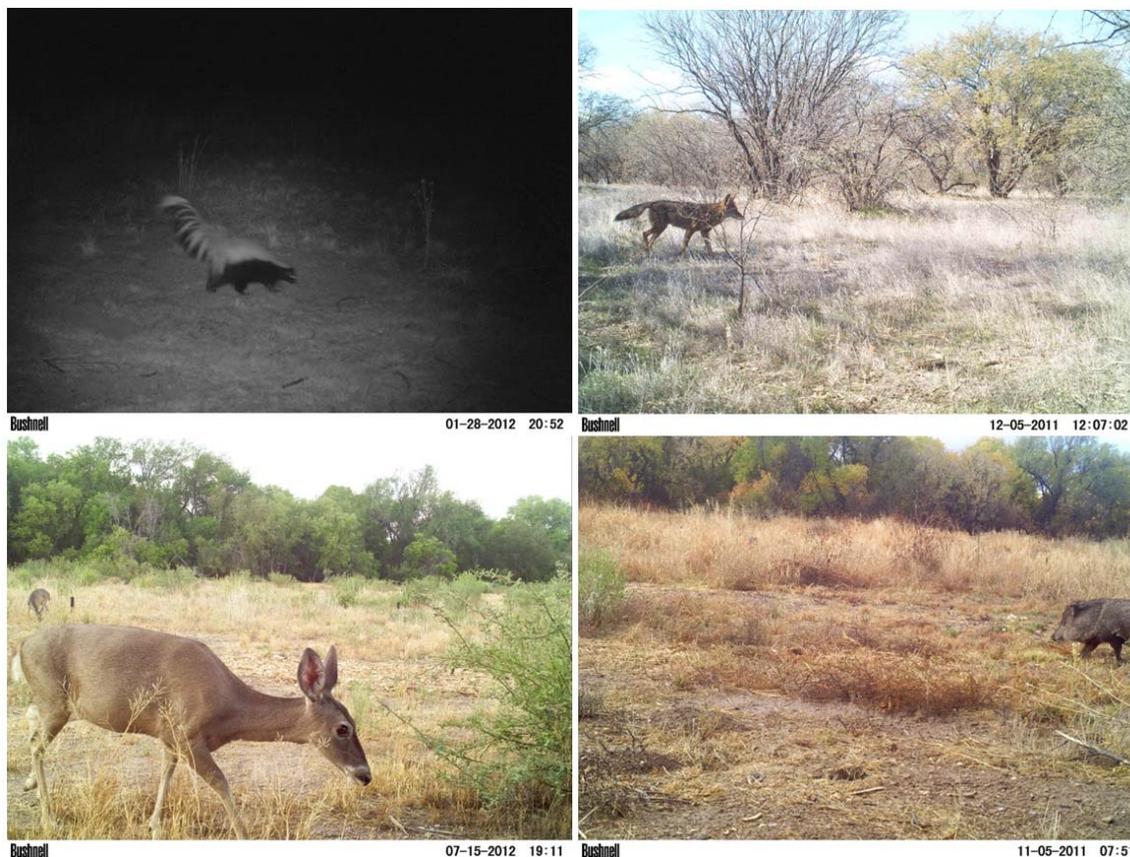
Figure 43. Animal Species Photographed by Motion Detection Cameras During 2012

In 2012 the camera captured over 1300 wildlife photos. The photos were primarily of deer and coyote, but also included rabbits, javelina, skunks, birds, and a fox plus a few cats and dogs in addition to a mountain lion (Figure 43).

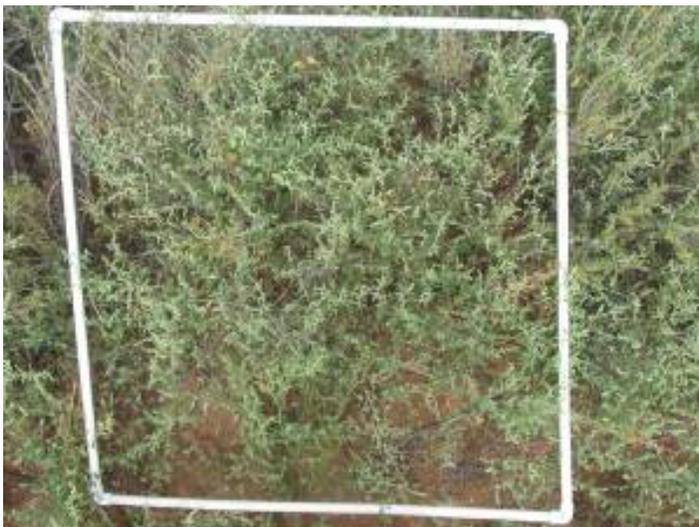
**Figure 45. 1-meter sampling frame**

Long-term monitoring transects were established to determine the composition of vegetation growing in the project area and to monitor the changes over time due to treatments and restoration. Three 900-foot long transects were located through the western, central and eastern pastures including the mesquite bosque and the grassland (Figure 46). Along each transect, thirty random sample plots were surveyed. Each plot was delineated by a 1-meter square frame as shown in Figure 45. Within the frame the number and species of rooted individuals was counted.

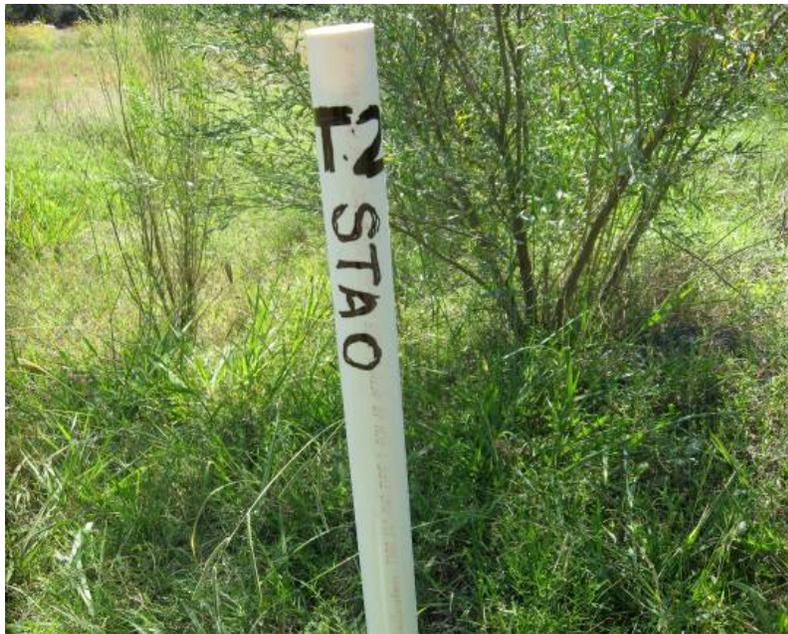
Figure 47. Transect markers

The naming convention indicates the transect number as T1 and STA 0 indicates the western most end of the transect, STA 900 indicates the eastern most end of the 900 foot long transect. To aid in identification in the field, each transect is marked by white PVC posts located at both ends as well as intermediate points (Figure 47).

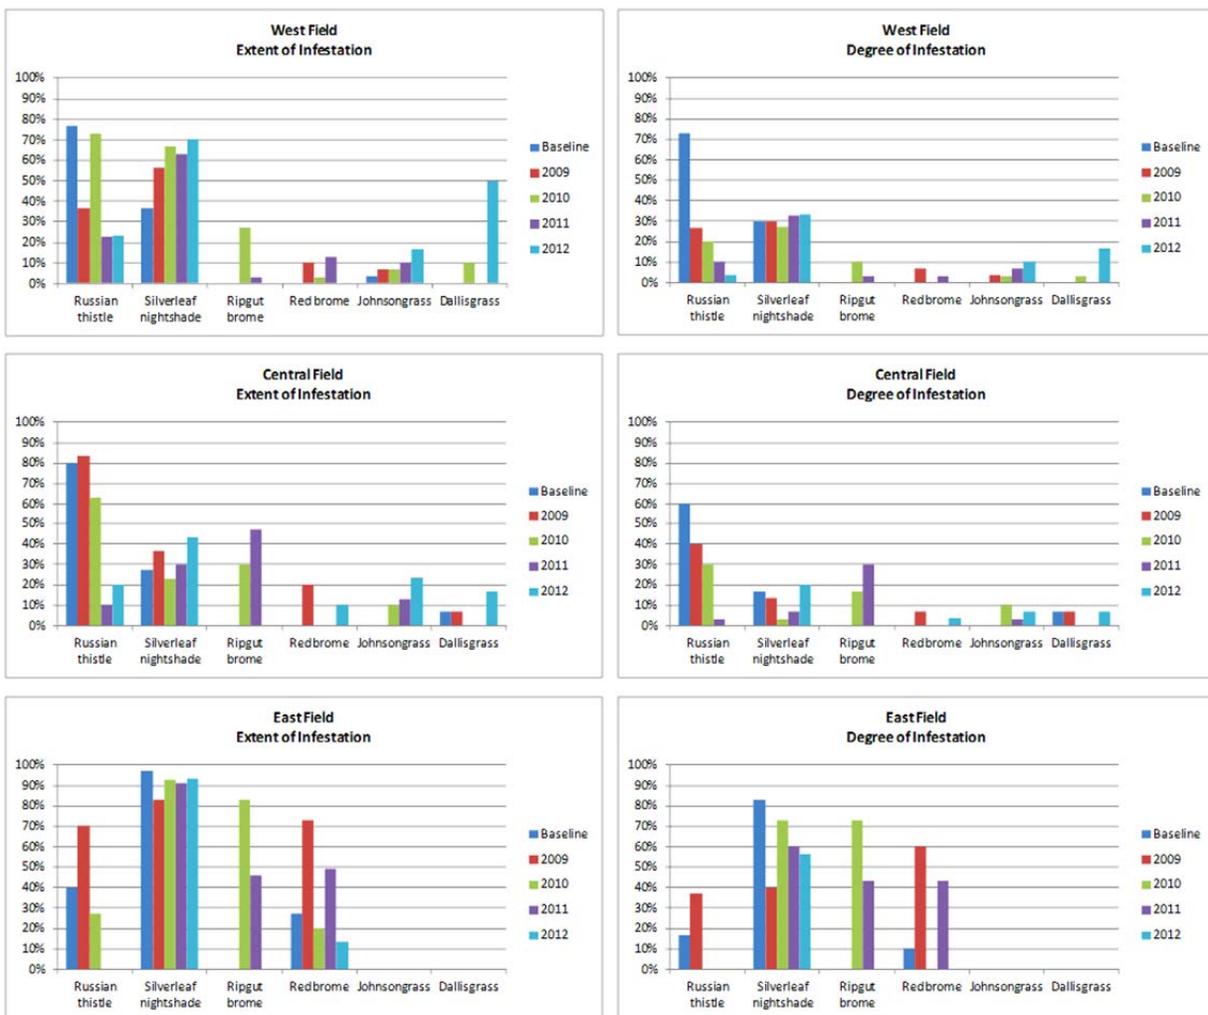
Figure 48. Efficacy of Weed Eradication for the Six Most Prevalent Species.

Figure 48 is a graphical representation of the efficacy of the eradication efforts since 2008 on six of the most widely distributed weed species. Russian thistle has responded very well to treatment, showing a large decline in both extent and degree of infestation on all transects. Silverleaf nightshade has not responded to treatment and has increased in the west and central fields while remaining essentially unchanged in the east field. Johnsongrass and Dallisgrass are also increasing in the west and central fields. Red and ripgut brome appear to be on the decline but this is mainly due to timing of the surveys. There is still a fairly large population of these spring annual grasses, particularly in the east field. Weed management activities will be needed for the foreseeable future in order to ensure that declining populations continue to decline and to focus management efforts on the expanding silverleaf nightshade population.

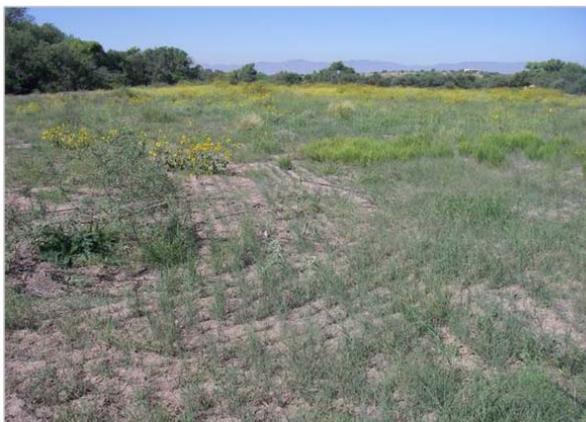
September 2010

Grass seed was planted prior to the summer monsoon with a seed mix provided by Natural Resources Conservation Service (NRCS) Plant Materials in Tucson. Seeded areas were watered with sprinkler irrigation to supplement scattered rain patterns. By mid-September 2010, young seedlings could be seen filling in areas where weeds had been removed and in 2012 the grasses were thriving (**Error! Reference source not found.**). Open areas have been filled in with supplemental plantings and grass species are becoming more frequent in the transect monitoring as well.

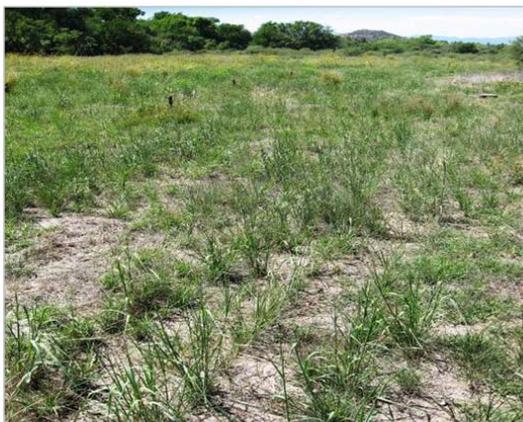
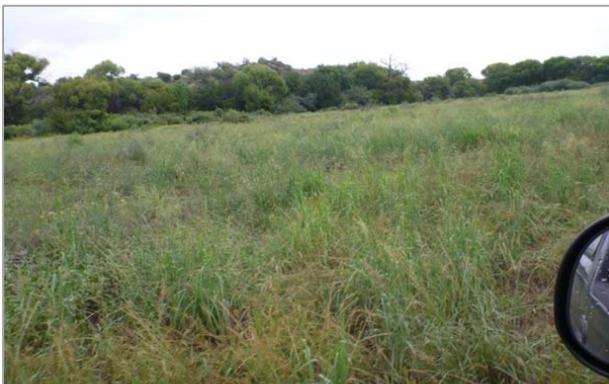
**Figure 51. Native grass establishment**

September 2011

August 2012 – Grasses have increased in density and height

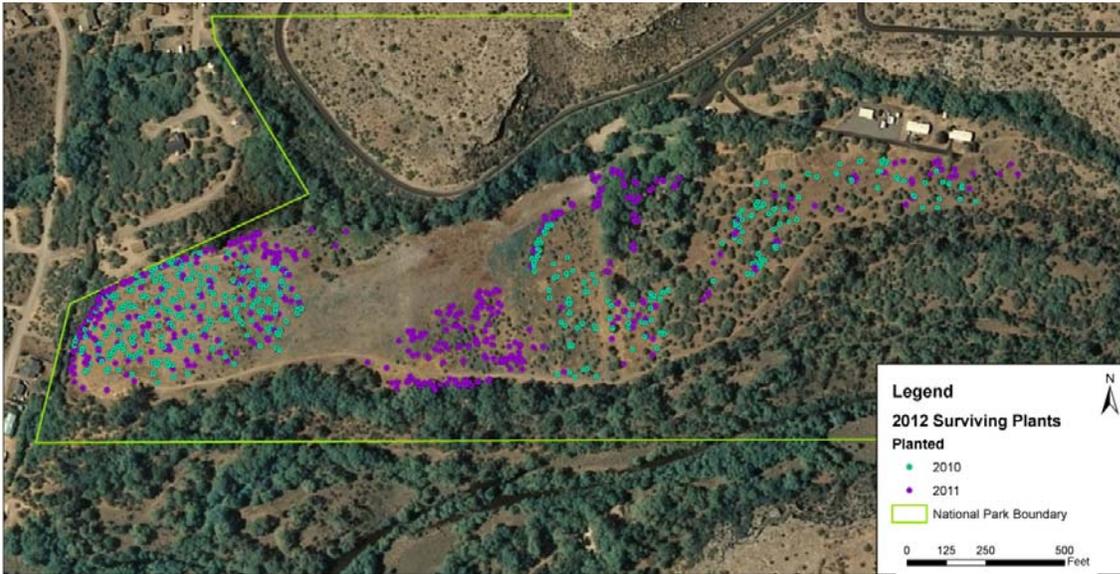
Figure 52. Location of Surviving Trees and Shrubs Planted in 2010 and 2011.

Plant mortality occurred in a random pattern and is not concentrated in any particular area or correlated with any one irrigation system. Of the small one-gallon plants that were planted in February 2010, many have experienced substantial rates of growth. The density and distribution of desirable native species is expected to increase as plants mature and natural recruitment begins to occur. Figure 52 illustrates the location of the surviving trees and shrubs.

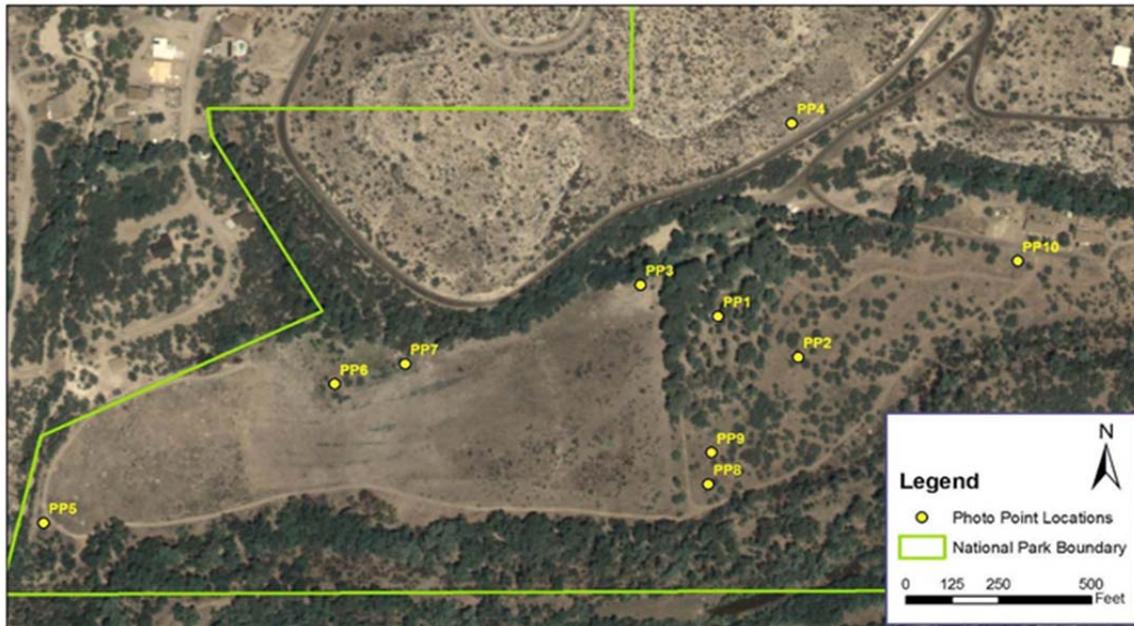
Figure 53. Photo Point Locations

Ten photo points were established around the project area Figure 53. These photo points were placed throughout the project area with the purpose of recording broad changes to vegetation over time. The following figures (Figure 54 through Figure 62) display the 2008 photos compared to the existing conditions photos.

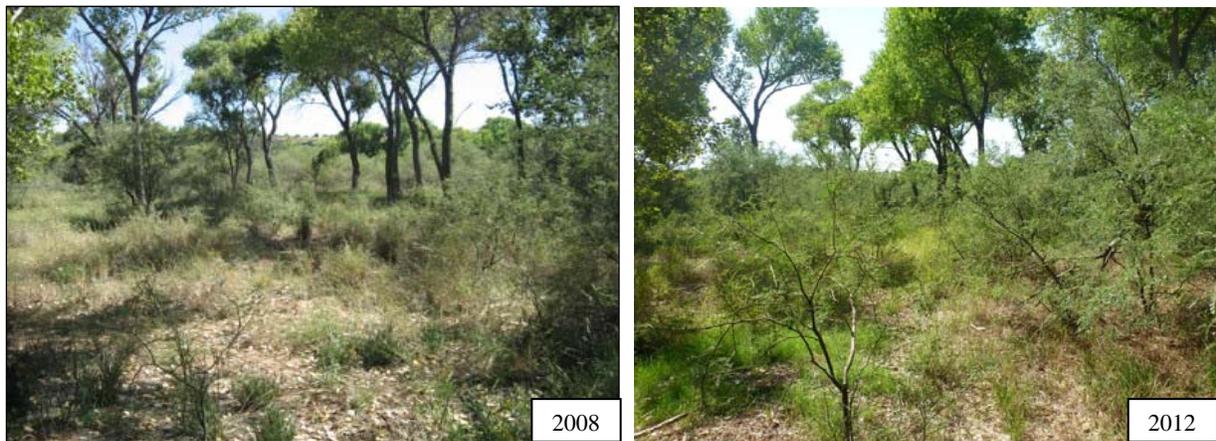
Figure 54. Photo Point 1 in Riparian Buffer, View to the East.

*Native grasses are beginning to replace non-native Johnsongrass*

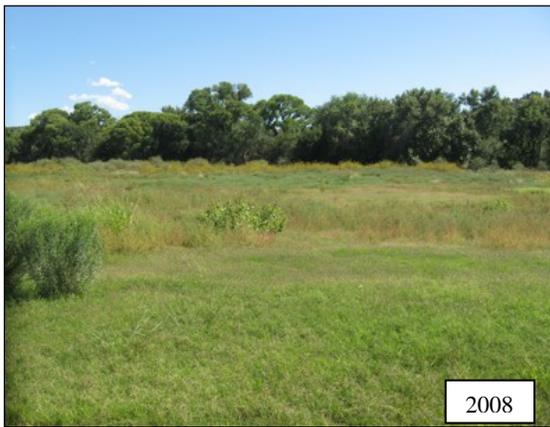
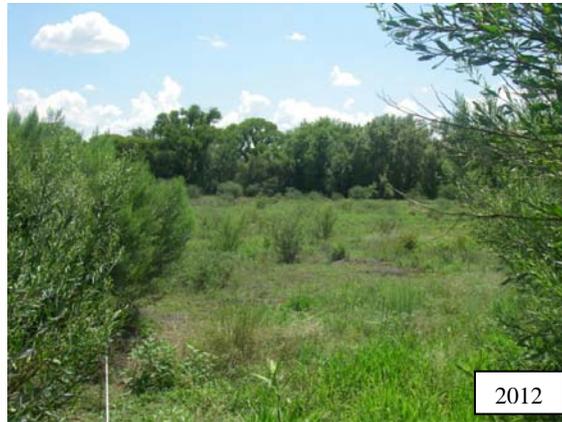
**Figure 59. Photo Point 7. Looking South.**

*The Bermudagrass visible in the lower half of the 2008 photo has been replaced with natives in 2012.*

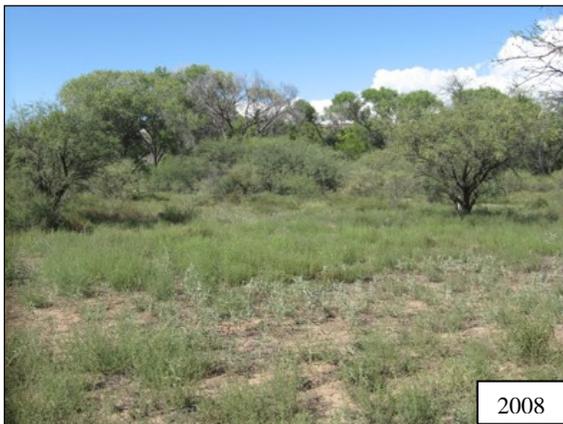
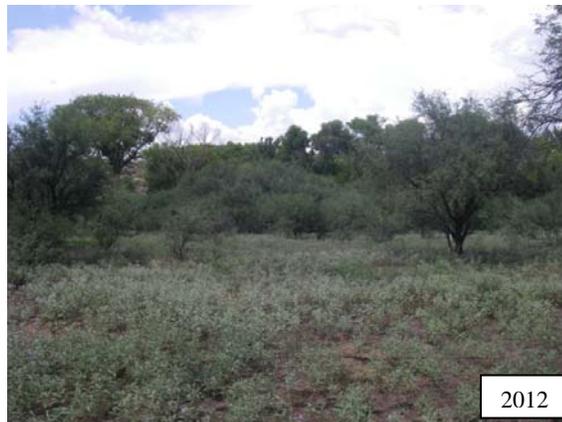
**Figure 60. Photo Point 8 – View to the North**

*The main difference at this photo point has been the elimination of Russian thistle and the expansion of silverleaf nightshade. No grasses have been sown here.*
