# Gila River Corridor Invasive Weed Control Project - #11-173WPF

**Final Report**

## **Gila River Corridor Invasive Weed Control Project - #11-173WPF**

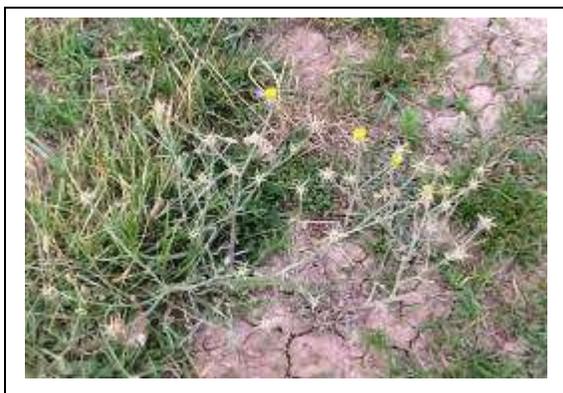
**Photo 1.** Yellow starthistle showing prostrate form after herbicide treatment in June, 2013..

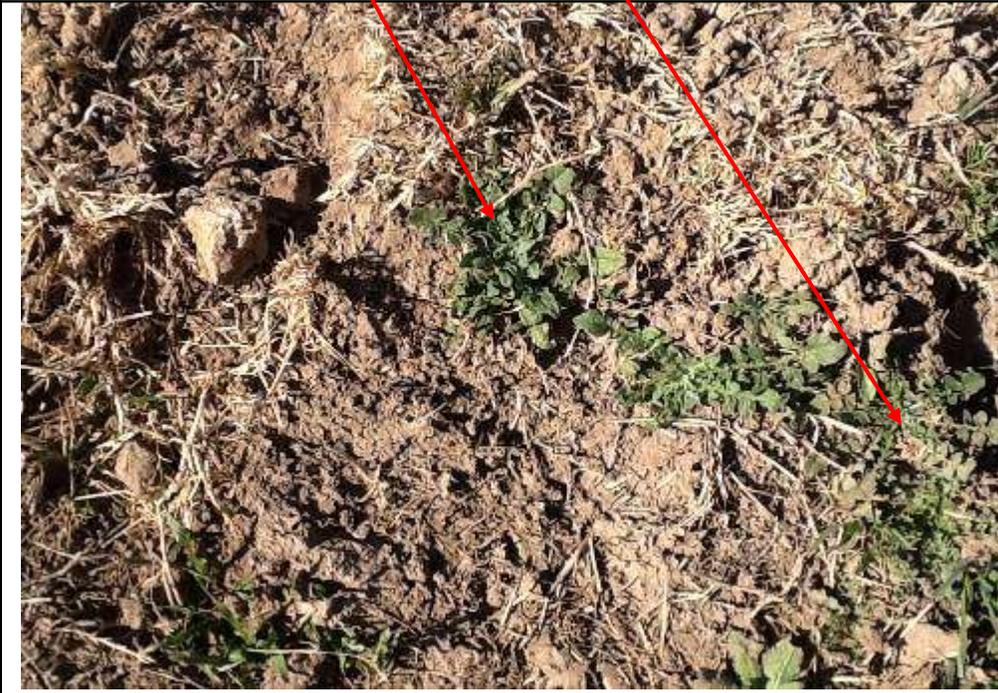
**Photo. 2.** Rosettes of Yellow Starthistle and Malta Starthistle. 3/26/13

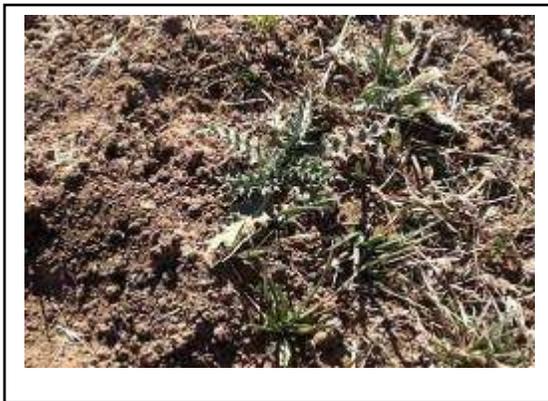
**Photo 3.** Bull thistle rosette,  
3/26/13

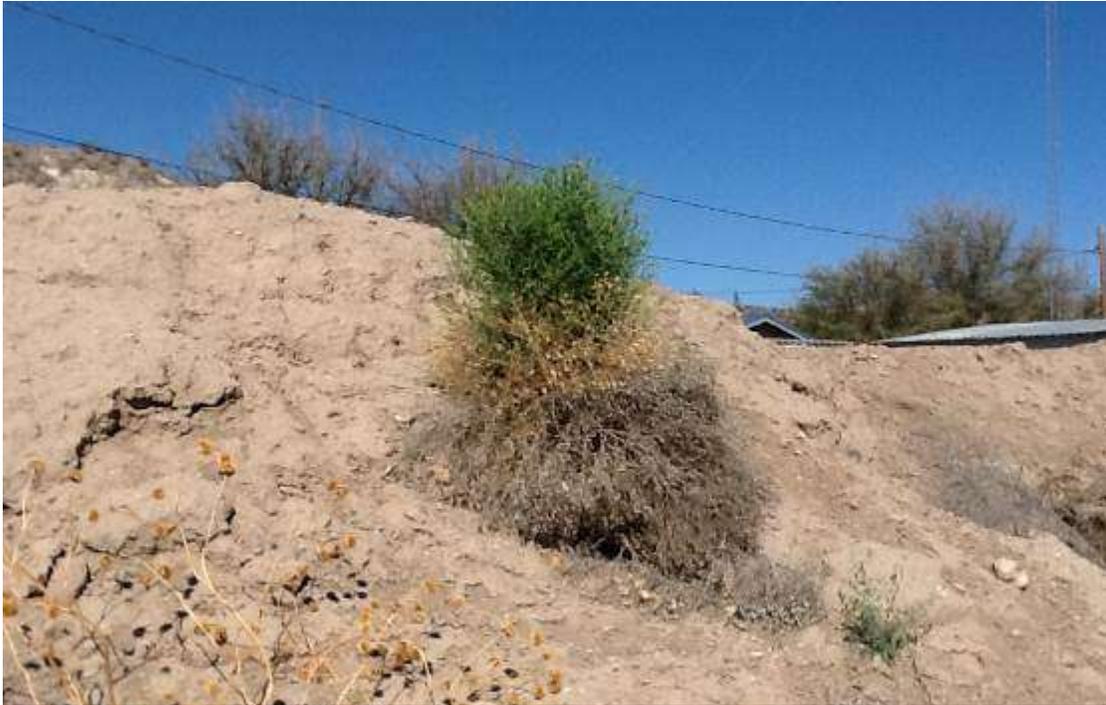
**Photo 4.** Old growth Russian knapweed plant. Plant is 32" in height. FFA Parcel south of High School. 4/19/13. Note successive years growth on this one single plant as evidenced by shading of dead dry material. This area has not been disturbed in three or four years of growth.

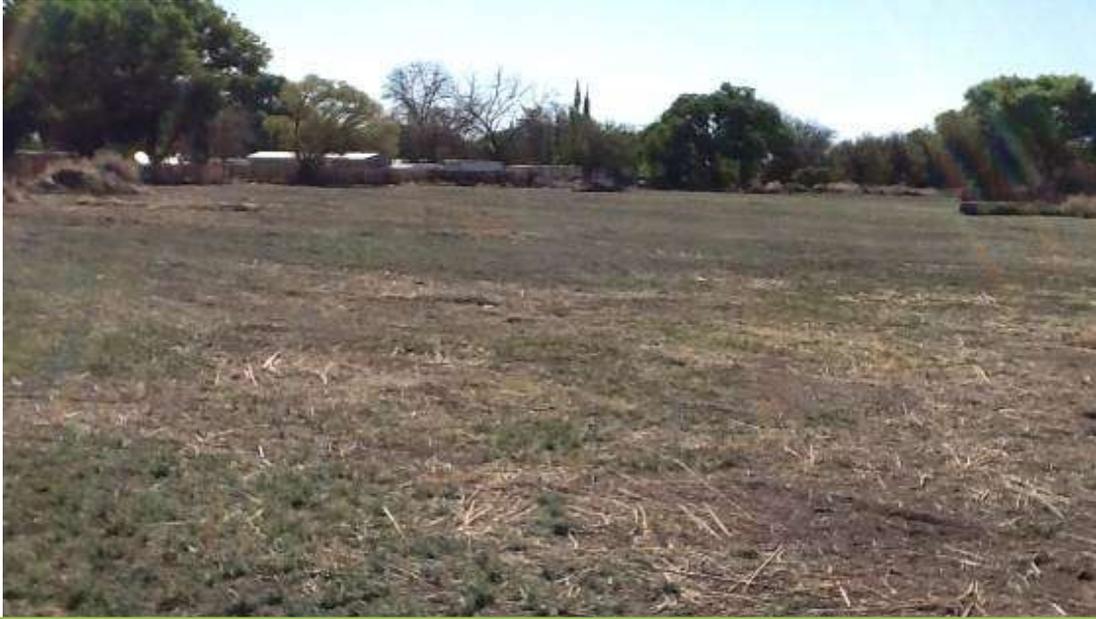
**Photo 5** taken in same infestation area where removal of dead tops has occurred each year. All the green plants in the photo are Russian knapweed, note density of plants, photo taken on same date Photo 4.

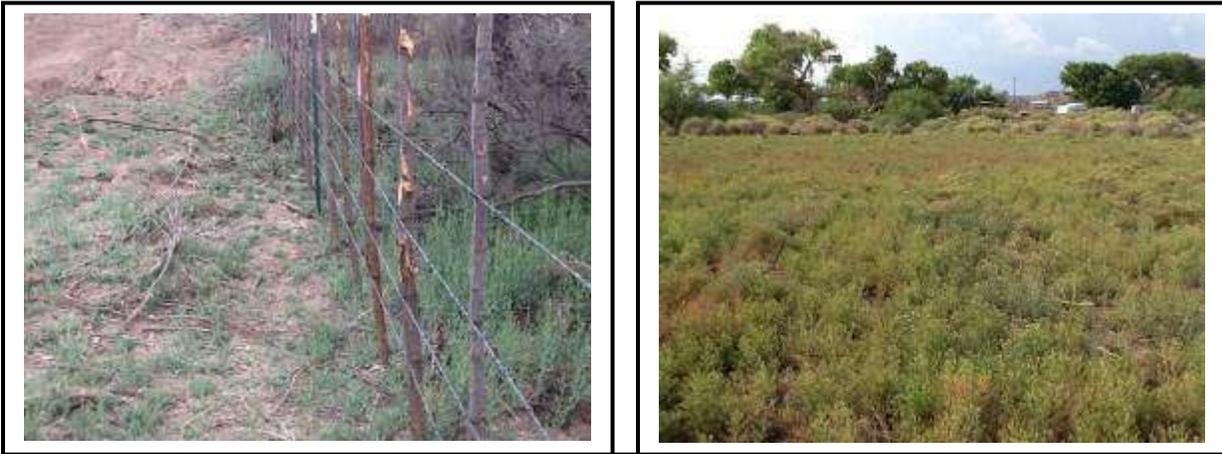
**Photos 6 and 7.** Photo 6 depicts heavy grazing by cattle of Russian knapweed, left side of fence, April, 2013. Photo 7 shows response of Russian knapweed first growing season following removal by fire, 07/10/13.

**Noxious Weed Infestation Treatment:** Confirmation of a noxious weed infestation did not automatically result in treatment with herbicide. Once the extent and acreage of infestation was obtained through the GPS/iPAQ technology, a direct discussion usually occurred between the contractor and the land owner concerning a desire or willingness to treat infestation(s) with herbicide. If the land owner desired to treat with herbicide, it was confirmed whether they were certified applicators (many farm operators have obtained this basic training), or had attended one of the workshops for applicators training offered by the Cooperative Extension. The location of infestations were discussed (and often flagged with pin flags where few plants existed, see Photo 12) and visited if the land owner was unaware of the situation. Various aspects of the treatment approach were discussed thoroughly, including timing, method of application, application rates, the appropriate herbicide and adjuvant and in many cases, integration of other control methods. In rare cases other methods of control were being practiced, such as concentrated grazing on farms and rangelands infested with Russian knapweed (See Photo 6).

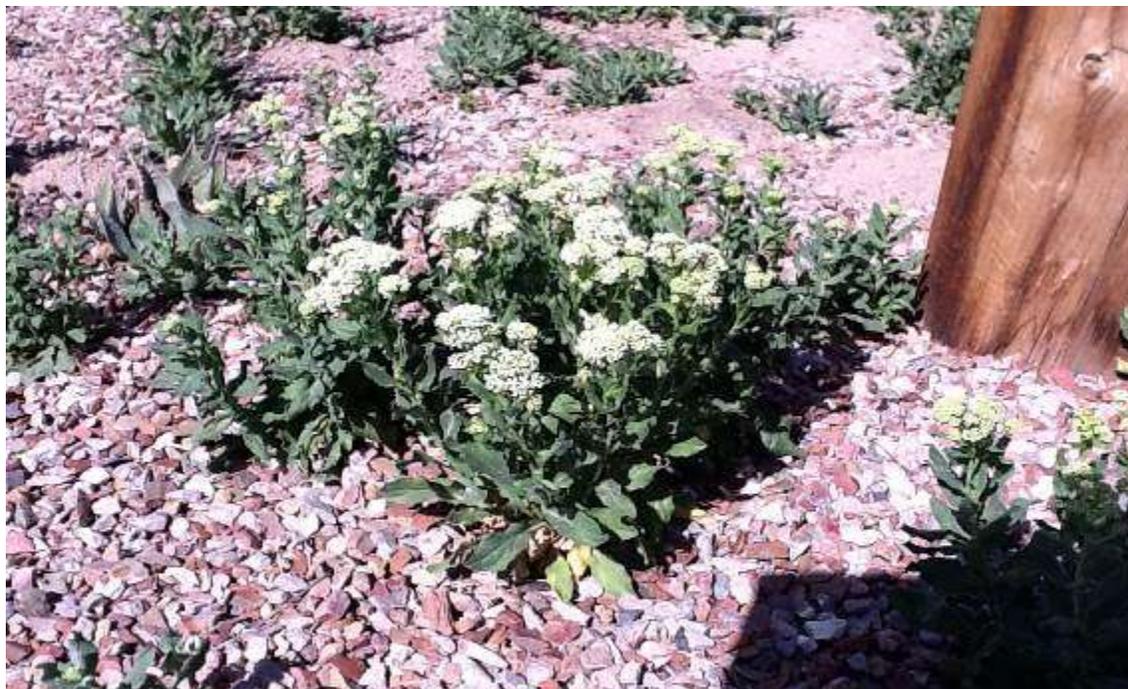
**Photo 8.** Whitetop growing in Highway ROW, Duncan. Note soil and substrate. 3/26/12. Plants are into early flowering for this time of year, triggered by poor soil and limited water. Height 10-12”.

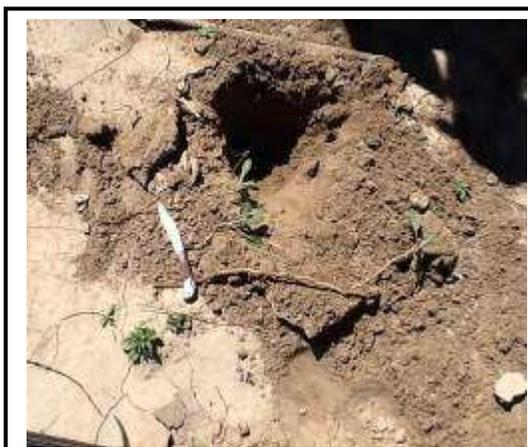
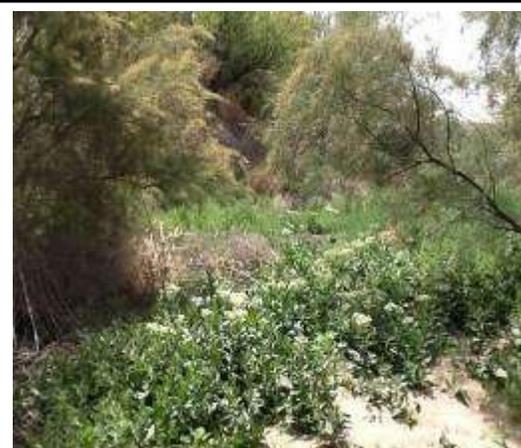
**Photos 9 and 10.** Left - Whitetop tubers and seedlings established in silt aggraded during late August 2013 floods, 10/04/13. Knife is 6” length. Seedling near knife, tuber with rosette from older plant buried in flood silt. Right- Newly established Whitetop population in backwater flood eddy, Parcel 425 in river corridor, 5/01/14. Plants are 12-16” height.

Whitetop (Hoary Cress)- This invasive perennial forb that is relatively new to the Duncan valley grows between 6" and 2 feet tall in the area, depending on soil and moisture availability. Though some references indicate it prefers alkaline soils,<sup>25,36,37,29</sup> the species inhabiting the project corridor has shown to occupy a diverse array of soils that might be alkaline in PH, but vary from shallow hard packed silty clay soils, deep loamy soils, to sandy loams.<sup>17</sup> Aptly named Whitetop because of the multi-branched flower (Photo 8), like Russian knapweed, this perennial is very deep rooted (6-8 feet), and can become established by seed or vegetatively. New plants and newly established populations were observed in 2014 following flooding in the Gila during late August, 2013 (See Photos 9 and 10).

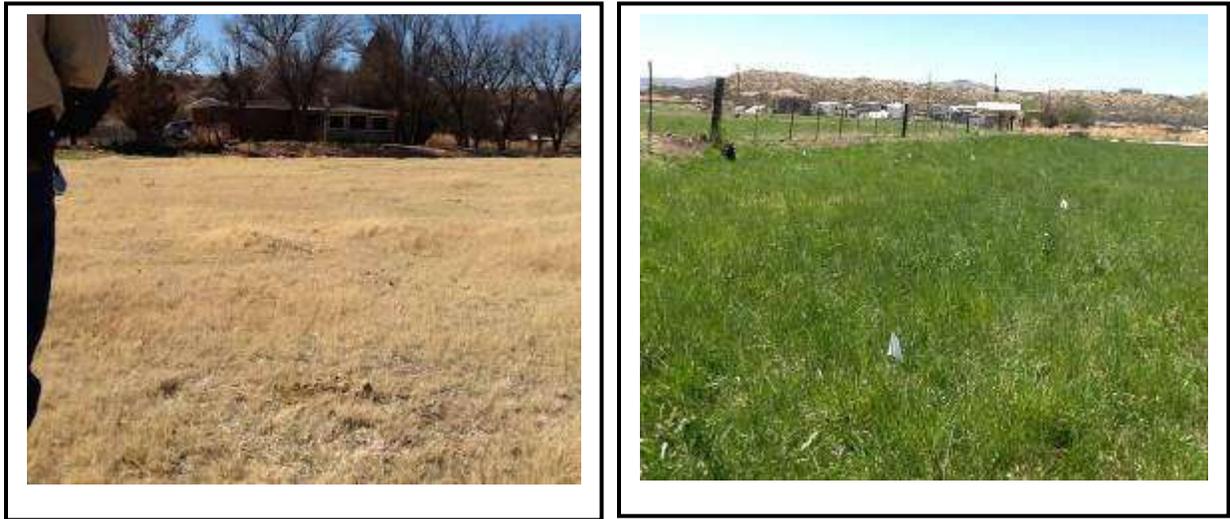
**Photos 11 and 12.** Pastures that were observed to reduce Whitetop establishment and expansion. Left Photo 11 is a dormant Bermuda grass pasture (3/07/14) that has one single Whitetop rosette while the adjacent residence site (background in picture) is inundated with Whitetop. Right Photo 12 shows locations of isolated Whitetop plants in excellent condition permanent perennial grass pasture. Whitetop plants are single stemmed, and display low vigor. 4/08/14.

These traits of a deep tubered root system, drought resilience, seed and vegetative capabilities to reproduce, and responses to disturbed soils and diverse habitat uses make control of Whitetop difficult once established. Although grazing with sheep has been shown to be effective to reduce seed production and plant expansion,<sup>9</sup> it may also result in spread of seeds if plants are grazed after full flowering occurs. Mowing can reduce seed production, but does may actually encourage vegetative reproduction, similar to effects of grazing or fire. Good perennial grass cover is one of the best methods of controlling infestation of areas by Whitetop,<sup>28,22,18</sup> and observed by the author (Note Photos 11-12).

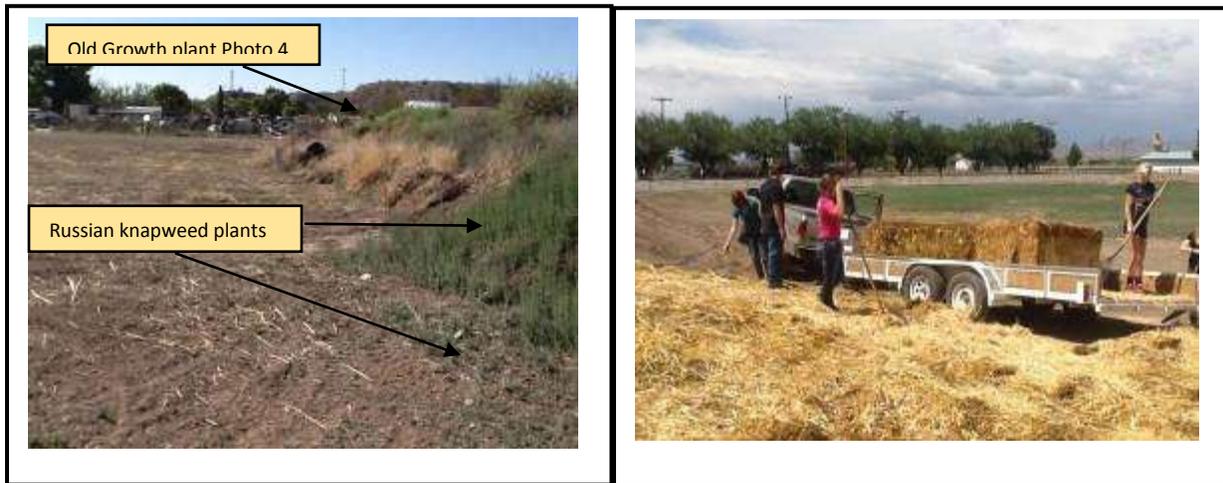
**Photo 13 left – Photo 14 right.** Duncan High School FFA land parcel. Left photo shows cleanup work by Town of Duncan where sloped area on west side was not cleaned, photo looks south. 4/19/13. Right photo shows FFA students spreading weed free straw to cover the area along this bank on opposite end of photo 13, this photo looks north. 5/14/13

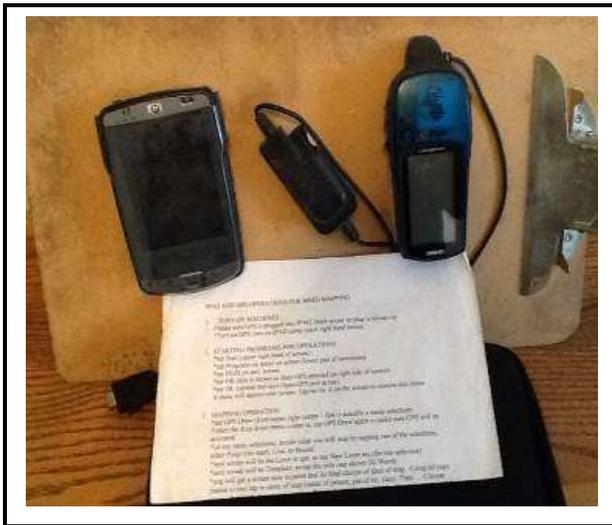
**Photo 15.** iPAQ and Garmin GPS combined for a geospatial tool kit that provides a relatively simple set of tools into a turnkey, field-based mapping tool (eXtension.org). Instructions and guidelines proved invaluable in field operations.

Extensive use of the iPAQ and associated Garmin eTrex mapping system provided by the Cooperative Extension office was used for plotting and populating data for point, line, or polygon infestation locations (Photo 15). Shape files for each infestation present were created and automatically downloaded onto an SD card for later reference and transfer to a computer. Field assistants were trained and familiar with the use of the system for their 2014 season inventory and mapping efforts.

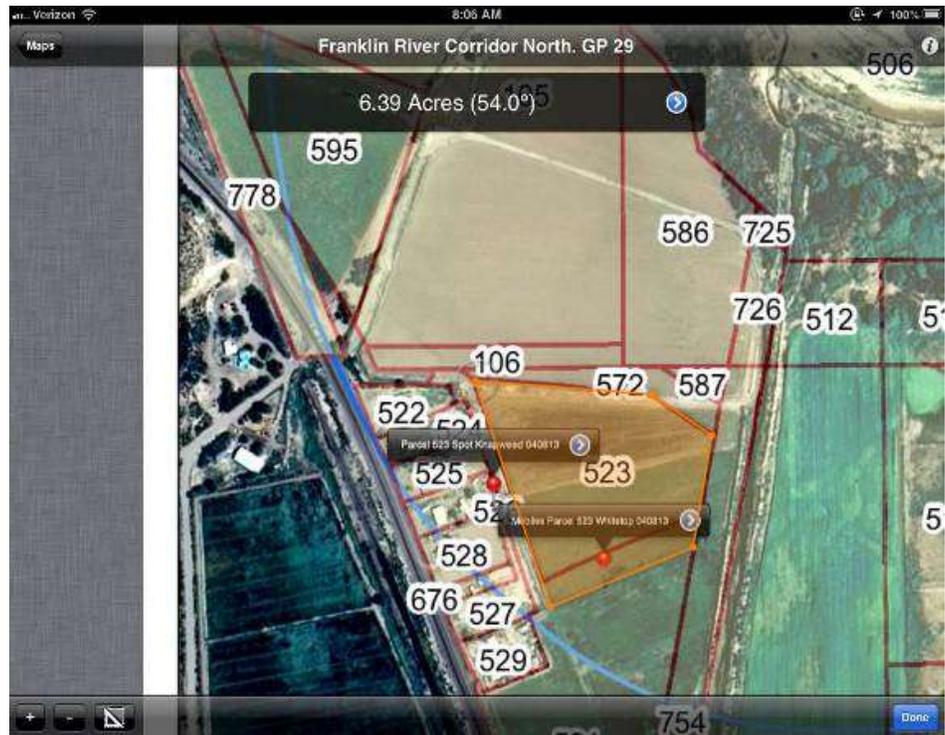
**Figure 3:** Parcel map 29 used with Avenza PDF application. Capability to calculate area or linear distances, GPS locations, and narratives with coordinates . Parcel 523. 4/08/13

imagery (examples shown in Fig. 2 and 3), along with digital photos of various inventory areas, infestations, and weed species. Use of geo-referenced parcel maps overlaid on Google imagery (developed by Andrew Brischke) with the mapped riverine corridor and associated land parcels in the Avenza PDF maps Apple application allows real time GPS tracking and mapping of infestations within each Parcel.

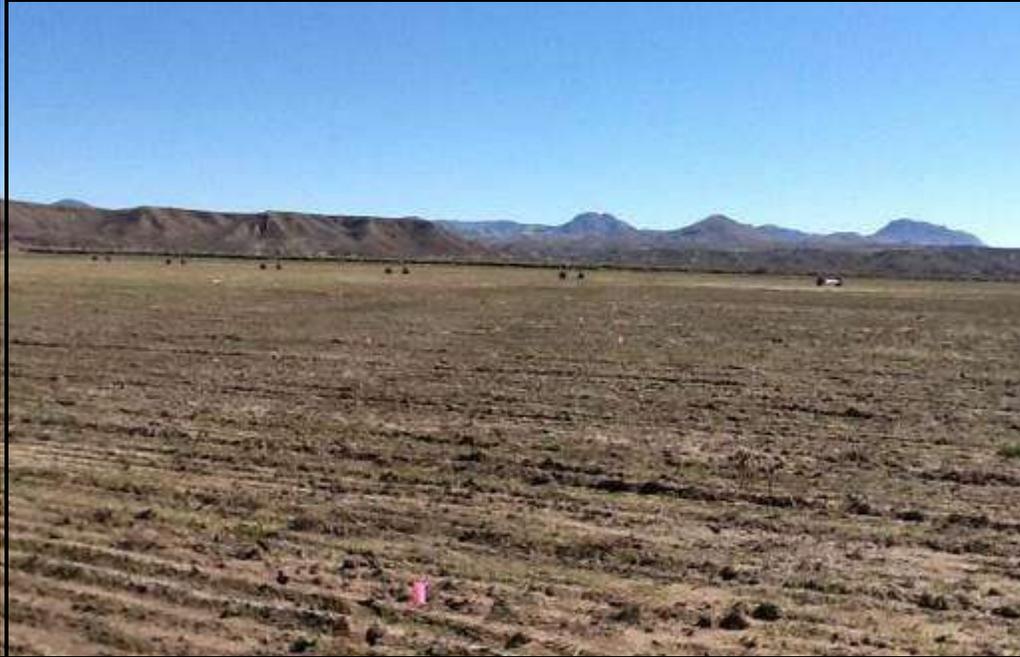
**Photo 18. 3/10/14.** Parcel 269 Pivot. Orange flag shows location of Whitetop rosette where several can be seen just emerging. As the soil warmed, the small colony erupted from this west most location to the pivot sprinkler in the background. Treatment of this area in 2013 was thought to be 90% successful, but was retreated in 2014.

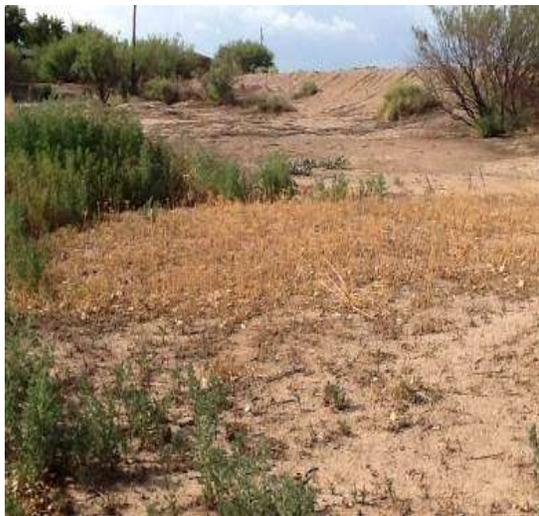
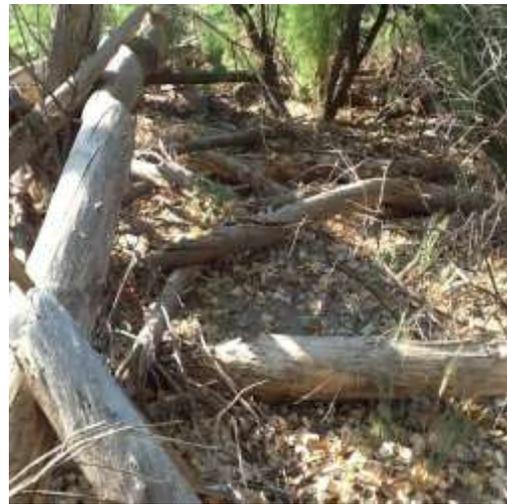
**Photo 19. 7/10/13.** Left photo shows a spot infestation of Whitetop, Parcel 7, sprayed with Escort and MSO in April, 2013. Wilt in plants did not appear until late June but recheck in early March showed no reappearance. **Photo 20. 6/27/14.** Right photo shows the location of a young spot infestation of Whitetop, Parcel 288, sprayed with Escort, late March. Plants have wilted and almost completely disappeared from residual, with no evidence of rosette formation.

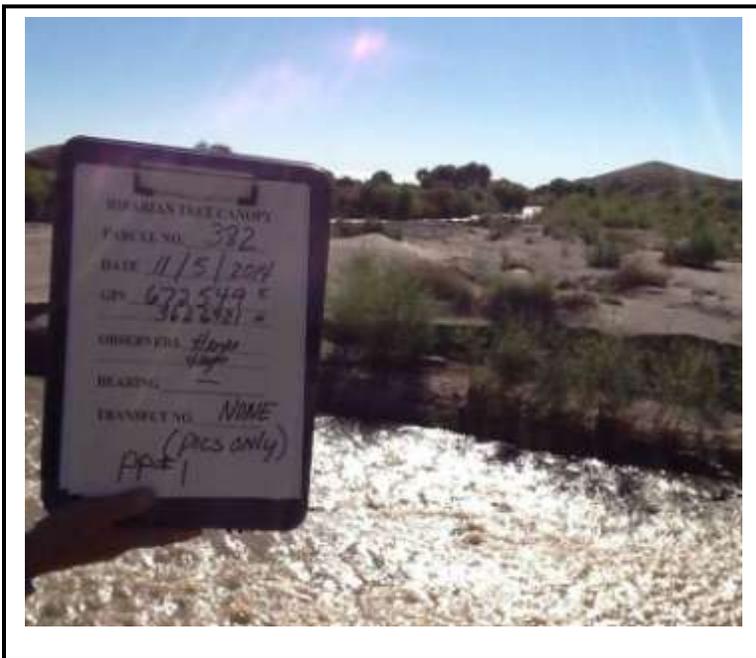
**Photo 21.** Parcel 382.  
11/05/14 Riparian corridor limited to none-existent. Photographs taken at site, no canopy cover transects established

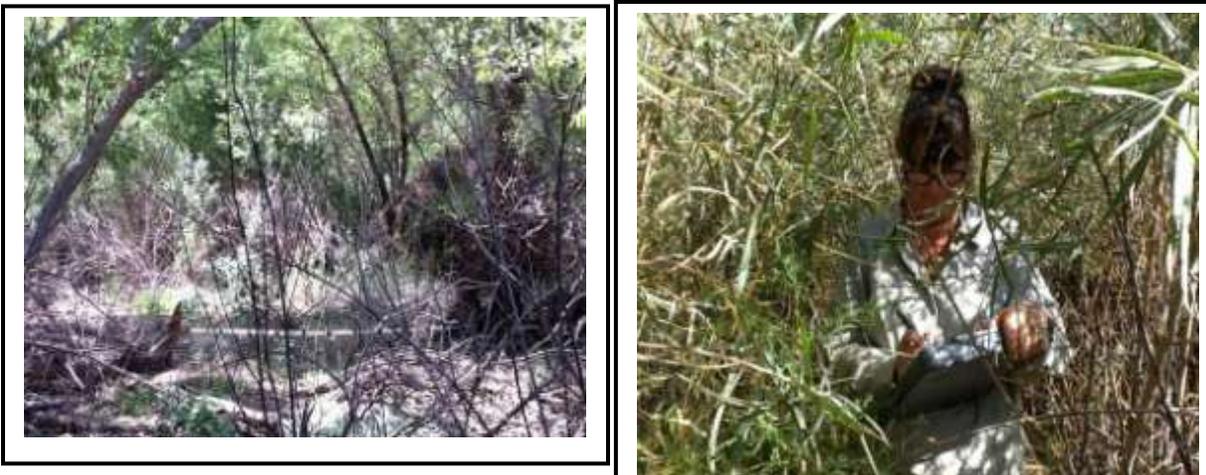
**Photo 22.** Riparian with overstory of multiple species, or sometimes dense stands of kochia weed. Photo shows the 3 meter rod used for estimating canopy cover of overstory species. **Photo 23.** Dense willows!

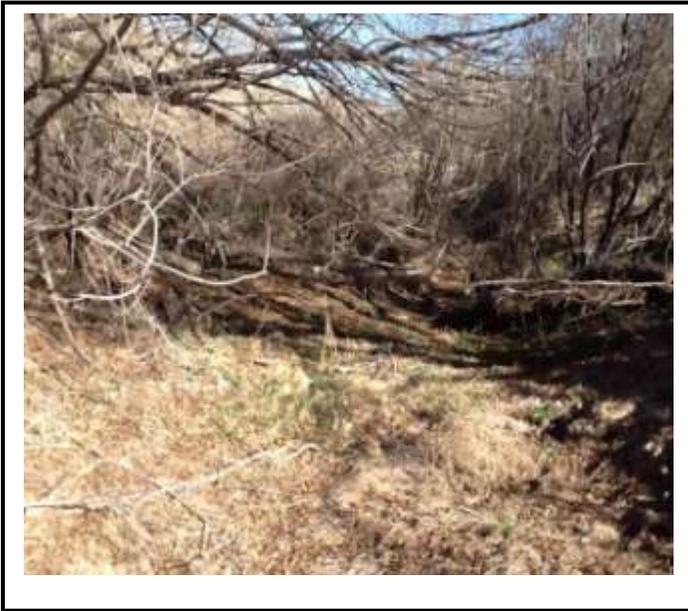
**Photo 24. 031014** The most northern known population of Whitetop in Greenlee County, newly established at this location following flood events, fall 2013. This site was discovered and inventoried in 2012, where a very small Russian knapweed population existed was treated, and was being monitored in early 2014. **12S 668611E 3638251N**

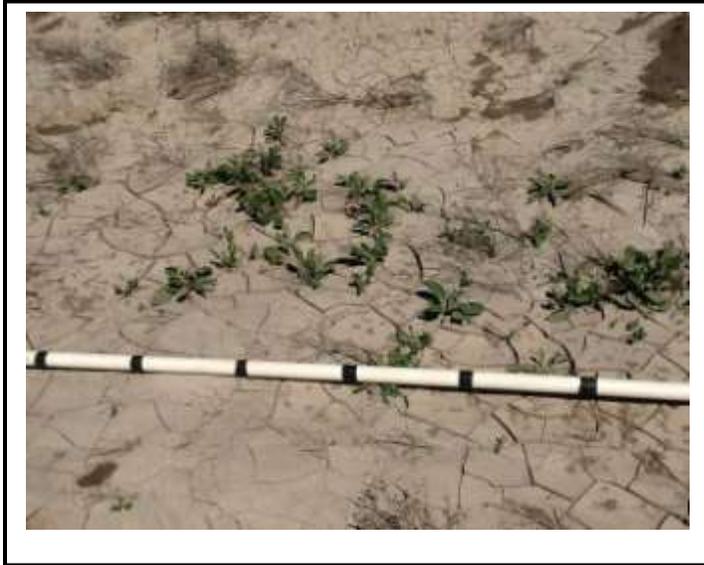
**Photo 25.** Parcels 6-7 10/14/13. Whitetop rosettes from rhizomes sprouting through silt deposition following high water in Gila River in late August and September, 2013.

In a large part, the documentation of infestations of noxious weeds, particularly Russian knapweed and Whitetop, increased dramatically as the amount of inventory increased, graphically displayed for each year of the program, Map 8 (2012), Map 9 (2013), and Map 10 (2014), and the three year program captured on Map 11. One important consideration to note is the apparent and observed expansion of Whiteop from 2013 to 2014, clearly discernable by comparing acreages of infestation shown in Table 1, along with comparing Maps 9 and 10. The data suggests about a 435% increase in infestation acreage of Whitetop between the two years. While the data for Russian knapweed indicates a similar increase (328%), much of this can be attributed to the acreage inventoried in 2014 that was known to have knapweed occupancy in 2013 but simply not surveyed. However, much of the acreage actually inventoried in 2014 where Whitetop infestations were documented, were also areas that were sampled for riparian canopy cover in 2013. In addition, they were either absent Whitetop, or the populations were not active or large enough to detect. Based on observations of actively growing rosettes of Whitetop in the fall of 2013 (Photo 25) and 2014, the documentation of Whitetop in 2014

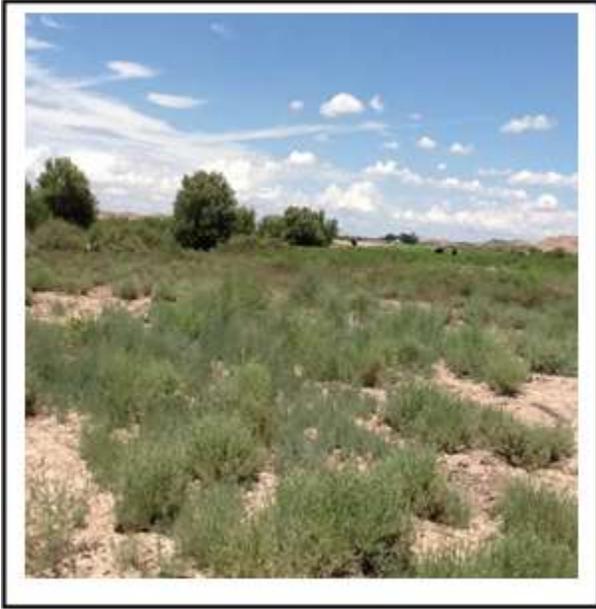
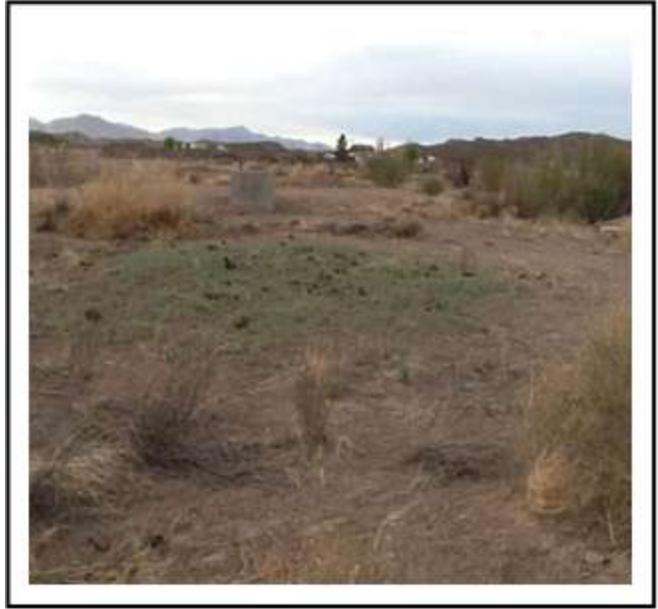
**Photos 26- 4/15/13. Photo 27 – 4/12/13, Rangeland parcel 437.** Russian knapweed in fallow ground. Note density of plants in left photo. Right photo small patch knapweed, grazed. Open rangeland.

Russian knapweed occupies the most acreage inventoried during the project period, not surprising since previous inventory information indicated that about 800 acres of lands within the Duncan valley (much outside of the riparian corridor) were infested with this knapweed species. The apparent three fold increase in acreage infested by Russian knapweed appears morrelated to the number of parcels of large acreages inventoried that are and have been occupied by the species than by an actual change in population numbers or size. Although Russian knapweed has been found occupying lands within the Gila River corridor, observations and inventory indicate this is a more dryland species, readily occurring and maintaining viable, albeit reduced density populations, on fallow farmlands or rangeland conditions (Photos 26 and 27).

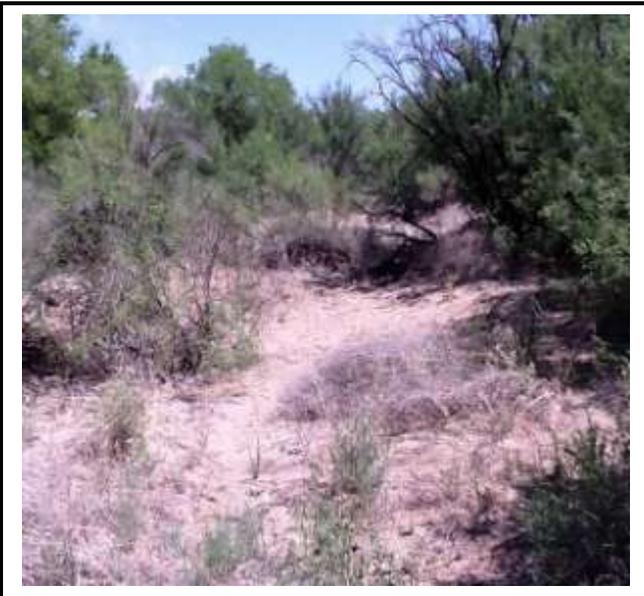
**Photos 28 (6/16/12) and 29 (5/22/12):** Russian knapweed population on River Parcel 260, small patch on sandy soils at edge of riparian corridor. Whitetop right photo, within riparian corridor, Russian knapweed found in small numbers only on dry bench within 100 feet of this location.

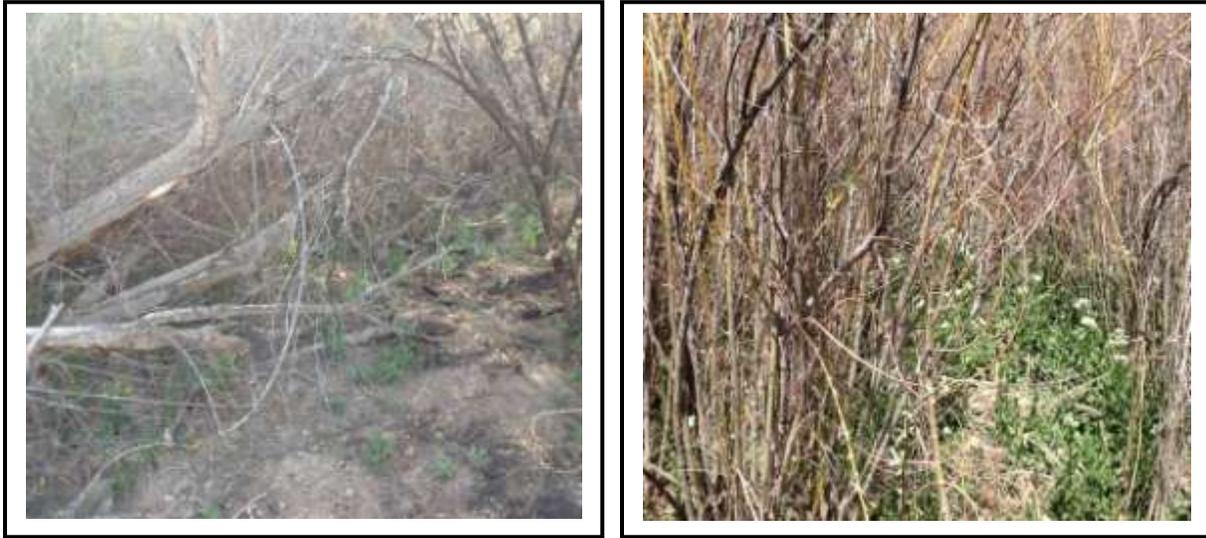
**Photos 30 and 31.** Left photo Whitetop infestation in Parcel 7, occupying green line of riparian vegetation (041013). Right photo Whitetop infestation well established in dense Coyote willow stand within Parcel 444 within critical habitat for Southwestern Willow flycatcher (4/04/14).

*Challenges:* Other factors are or will contribute to the success or effectiveness of managing noxious weed spread with herbicides, or other practices such as grazing. While Russian knapweed is widespread within the Gila River corridor, most infestations are located on upland sites, in most cases outside of the actual riparian vegetation and habitat zone. Whitetop, however, is primarily found within this more shaded, wetter zone, somewhat of a contradiction to other findings or reports. In many instances, infestations are literally impossible to access and effectively spray by hand, and certainly not by any aerial option (Note Photos 30 and 31).

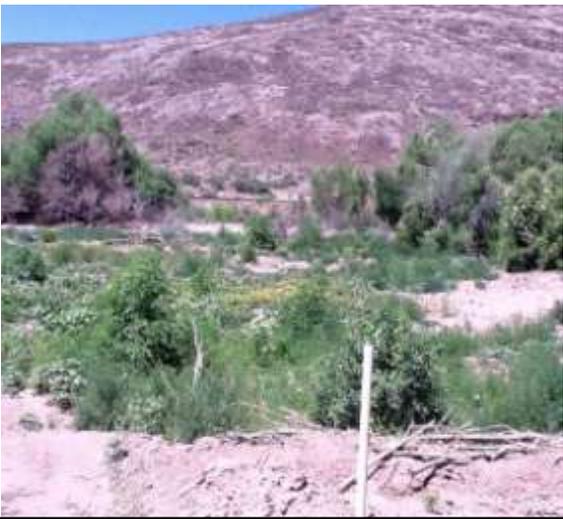
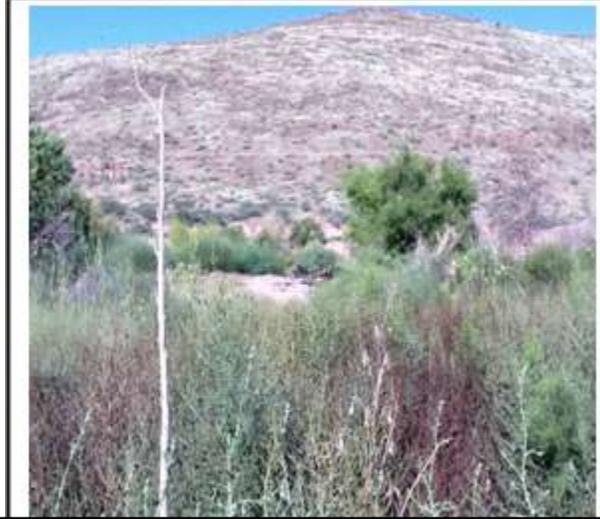
**Photos 32 and 33.** Photo left (5/23/12) in Parcel 575, documenting Whitetop infestation in mid-ground. Note lathe stake and disturbance from removal of non-native tree species. Photo right (9/04/12) shows growth of annual weed species at same location.

In 2010 and 2011, ADWR and U.S. Fish and Wildlife Service, in conjunction with the Gila Watershed Partnership, funded substantial riparian restoration improvements to assist Parcels 269/270/575 with removal and reshaping the east bank of the Gila River along with removal of non-native woody obligate species (e.g. Salt cedar, Tree of Heaven), and replanting of native woody and herbaceous species. Substantial dozer work was completed, along with pole plantings, and seeding, by the time inventory work was initiated in mid-May 2012. During inventory, substantial but relatively new populations of Whitetop were documented, easily observable in all parcels inventoried, including 575 (Photo 32). Upon returning in the fall, 2012, the amount of growth of annual weeds was almost unmanageable to access these areas (Photo 33). Later herbicide applications to treat these populations conducted in both 2013 and 2014 were significantly hindered by the continued presence and increase of annual weed production.

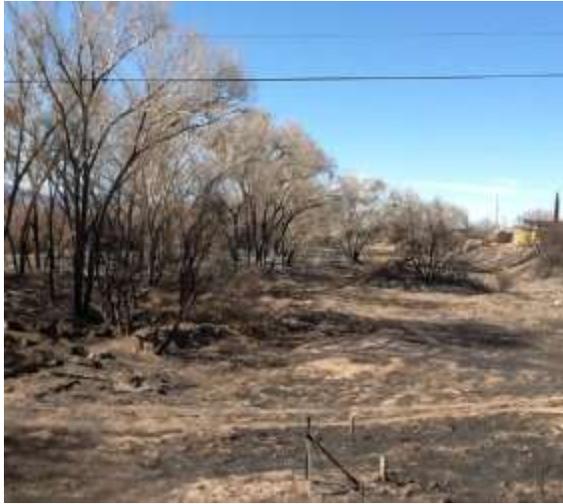
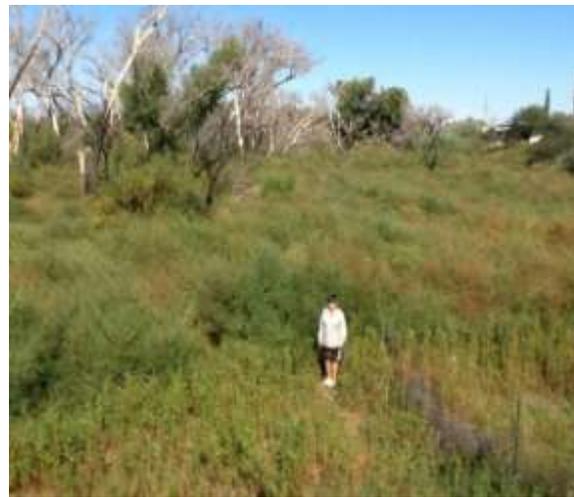
**Photos 34 and 35. Parcels 6/7.** Photo on left was a wildfire in March, 2013. Note home in background. Several Russian knapweed and Whitetop colonies were noted and treated with herbicide later in April, 2013 on this site. Right photo 10/23/14. Note annual herbaceous production. Woman in photo is 5'5" in height, Kochia weed behind her is over 6ft. There is a colony of Whitetop to her left that is now inaccessible.

In March, 2013, a wildfire in standing herbaceous production burned a portion of the riparian corridor of Parcels 6, 7, and 681 and adjacent upland areas just north of the Highway 75 bridge at Duncan, Arizona (Photo 34). As the photo depicts, this had a devastating effect on many riparian overstory trees, removing virtually the entire herbaceous understory, leaving the small narrow green line along the Gila River (far left side of photo). Inventory of this area in mid-April 2013, documented several populations of Whitetop and Russian knapweed, most of which had been impacted by fire (Photos 19, 30). Colonies in the open areas were easily treated with herbicide later in April of 2013, as Photo 19 shows. However, fire only invigorated both Russian knapweed and Whitetop, and the level of annual herbaceous production increased dramatically in the absence of any control, to the point where it was impractical to treat, as the comparison shown in Photo 35 provides.

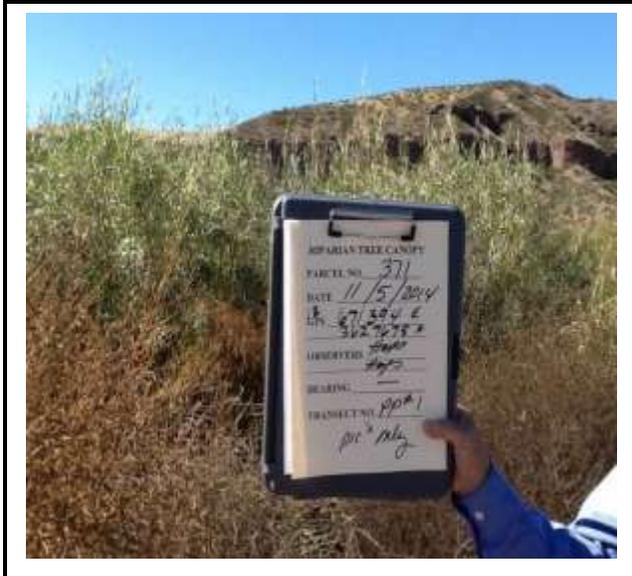
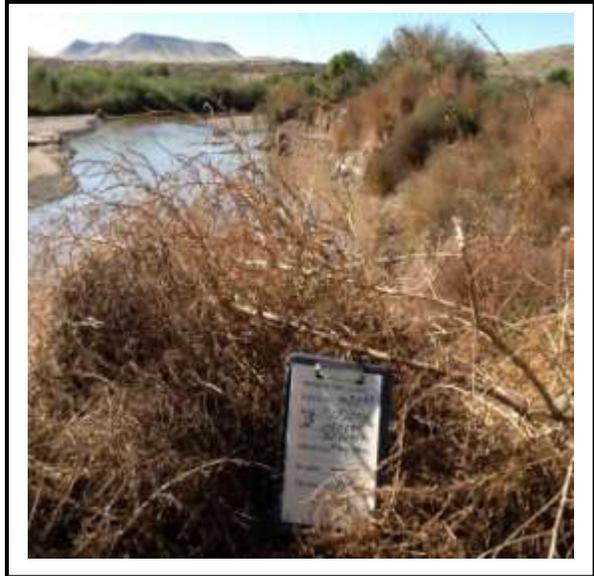
**Photos 36 and 37.** Left is photo point for Parcel 371 (11/05/14), between Sheldon and north Duncan. Coyote willow thicket in mid-ground of photo is less than 30 feet wide, and occupies a perpendicular bank. Right is photo point for Parcel 420 (11/05/14), north side of Gila River. Note steep eroding bank on photo side, and point bar on opposite side of river.

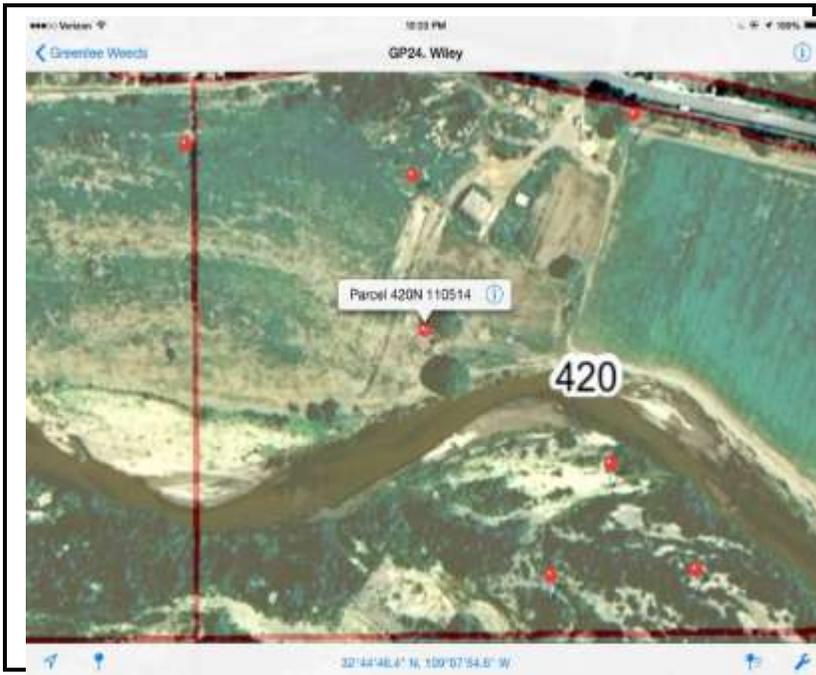
**Figure 9.** A portion of Parcel Sheet 24 showing part of Parcel 420. Note the photo point location for Parcel 420N. Large cottonwood tree south of the photo point is now in the middle of the river, and photo point is on river bank. Large point bar is filling in with young woody species (salt cedar, Coyote willow), but is infested with Whitetop.

Unfortunately, the opposite situation exists upstream (to the south) of Photo point 420N. Riverine functioning conditions are improving dramatically with expansion and development of extensive stands of Coyote willow, as depicted in Tables 3 and 4. Coyote willow comprises about 45% of the total composition of riparian cover species in this portion of the project area, followed by Salt cedar at 29%. More importantly, as documented by both observations and canopy sampling, Coyote willow is represented strongly by younger age classes (over 65% sapling and poles), indicating a strong upward trend in riparian cover condition characteristic of a riverine system healing through aggradation (Photos 40 and 41). Deposition of finer materials among dense stands of willows is contributing to the establishment of Whitetop, with little to no expansion of Russian knapweed noted within the river flood plain in this section of the river corridor.

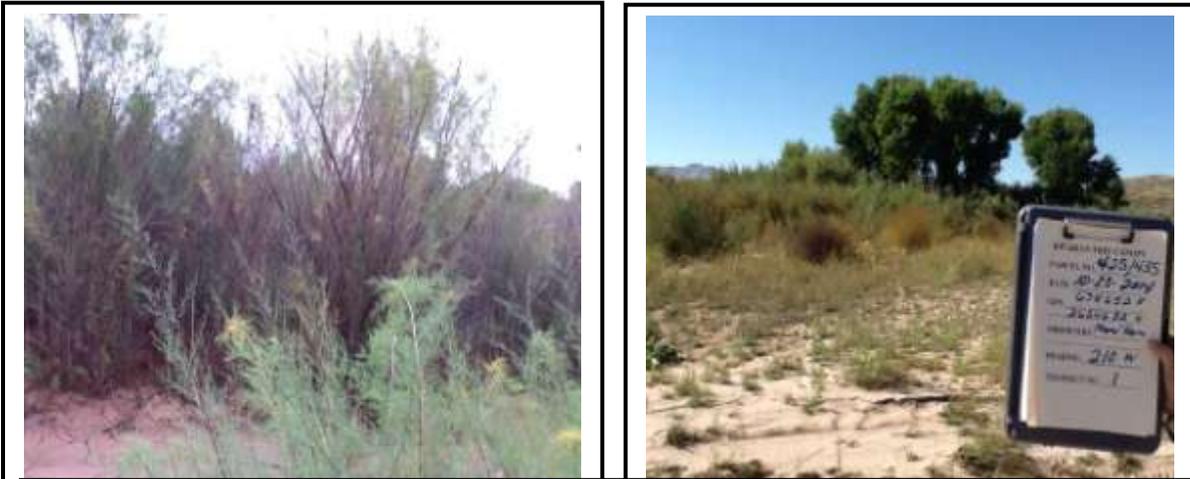
**Photos 38 and 39.** Left is photo taken on Transect 1, Parcel 433/434. 9/09/12, showing sapling Salt cedar in foreground, Coyote willow in mid-ground. Right is photo taken at start of Transect 1, Parcel 425/435 10/23/14. In foreground of photo are numerous Salt cedar seedlings, mid-ground pole size Coyote willow and Salt cedar. This area of the large point bar shown in Figure 9 was inundated by bank full flows in August 2013, and several flows in August-September, 2014. This point bar is infested with Whitetop.

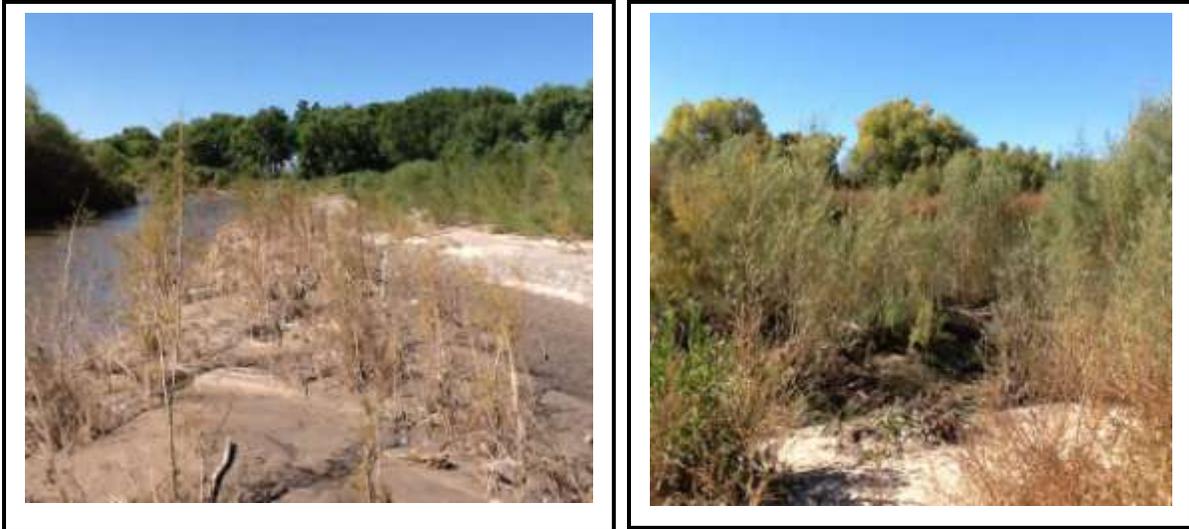
**Photos 40 and 41.** Left is taken at the start of Transect 3, Parcel 681. 10/04/13. Photo looks north. Note the large amount of deposition on this long silt bar, and the encroachment of Coyote willow saplings on the older right bank. Aggradation here is at least 18" in depth. Right is taken at the start of Transect 1, Parcel 430/446. 11/07/14. Note the age class of Coyote willow in the foreground, and mid-ground. This area also shows substantial deposition of fines from bank full flooding in the early fall, 2014.

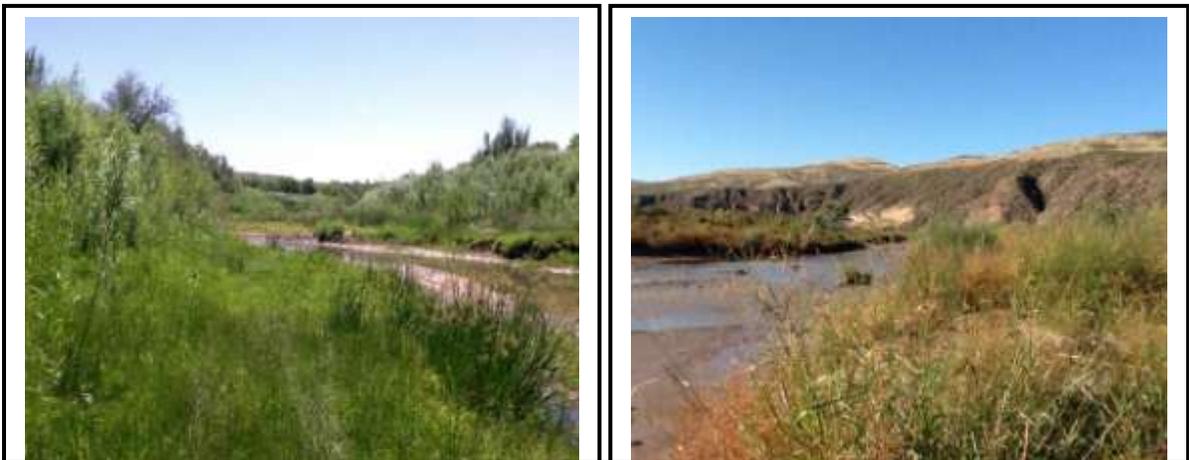
**Photos 42 and 43.** Left is riparian corridor adjacent to Parcels 575/270, near Apache Grove 5/23/12, compared with the lack of woody and green line vegetation in the Right photo, Parcel 353. 11/05/14. Bank vegetation in this photo is Johnson grass and Kochia weed, with Velvet mesquite a distant

There appears a change in soils and parent material substrate from the point of 420N, but whether this has influenced changes in riparian conditions, or change in gradient is unknown. Canopy sampling does show that all the common riparian tree species are present, but in varying percentages of dominance. With the exception of riparian sampling conducted at River Parcel 260 (which was removed from the data set), mature Salt Cedar and Velvet mesquite dominate overstory cover, followed closely with mature Gooding willow. At the end of the inventory season, Whitetop and Russian knapweed had been documented within this segment of the Gila River corridor, but colonies were not well established.
