**POTRERO CREEK WETLANDS**  
**BIOLOGICAL CHARACTERIZATION REPORT**

**Prepared for:**  
**Arizona Water Protection Fund Commission**  
**Grant Number 95-024WPF**

**Prepared by:**  
**EnviroNet Inc.**  
**7776 South Pointe Parkway West**  
**Suite 160**  
**Phoenix, Arizona 85044**

**September 1996**

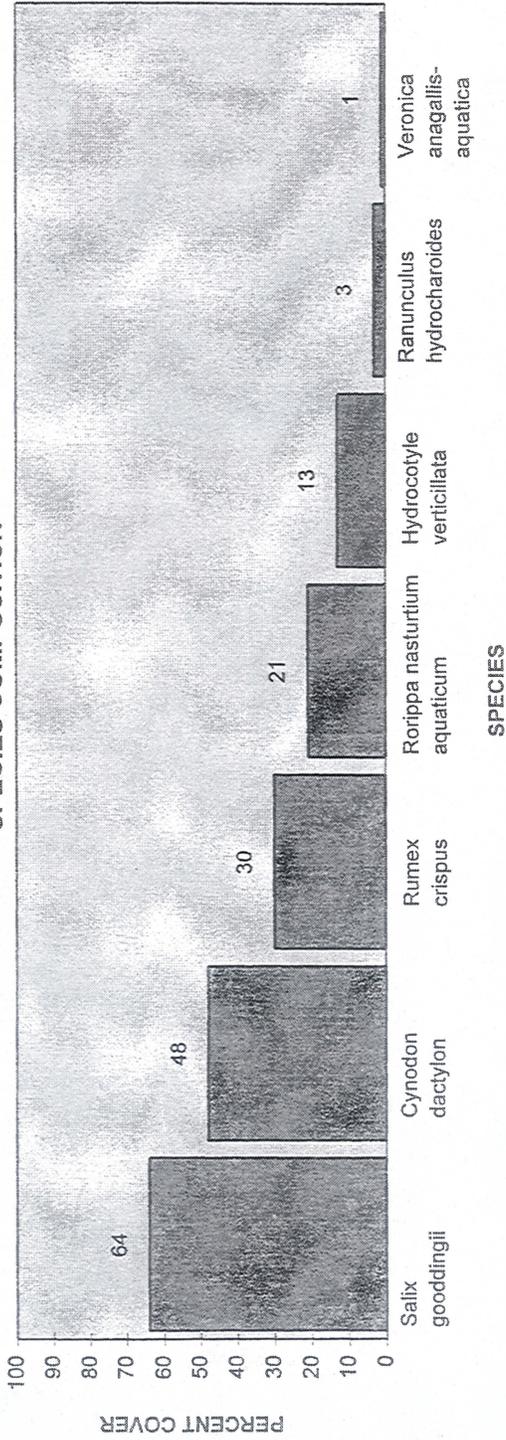
**FIGURE 5  
WILLOW BOSQUE A  
SPECIES COMPOSITION**

Transect results indicate that the understory of the willow bosque to the north of Country Club Road (Willow Bosque Community A) is composed primarily of bermuda grass (*Cynodon dactylon*), curley dock (*Rumex crispus*), watercress (*Rorippa nasturtium-aquaticum*), with occasional whorled pennywort (*Hydrocotyle verticillata*), buttercup (*Ranunculus hydrocharoides*), and water speedwell (*Veronica anagallis-aquatica*) (Figure 5). Although not encountered during point-count transects, vegetation also noted within the community includes brome grass (*Bromus catharticus*), Kentucky bluegrass (*Poa annua*), and meadow fescue (*Festuca arundinaceae*) in the understory and occasional Fremont cottonwoods (*Populus fremontii*) and juniper trees (*Juniperus coahuilensis*) (see Table 1). Percent total cover within Willow Bosque Community B is 94.

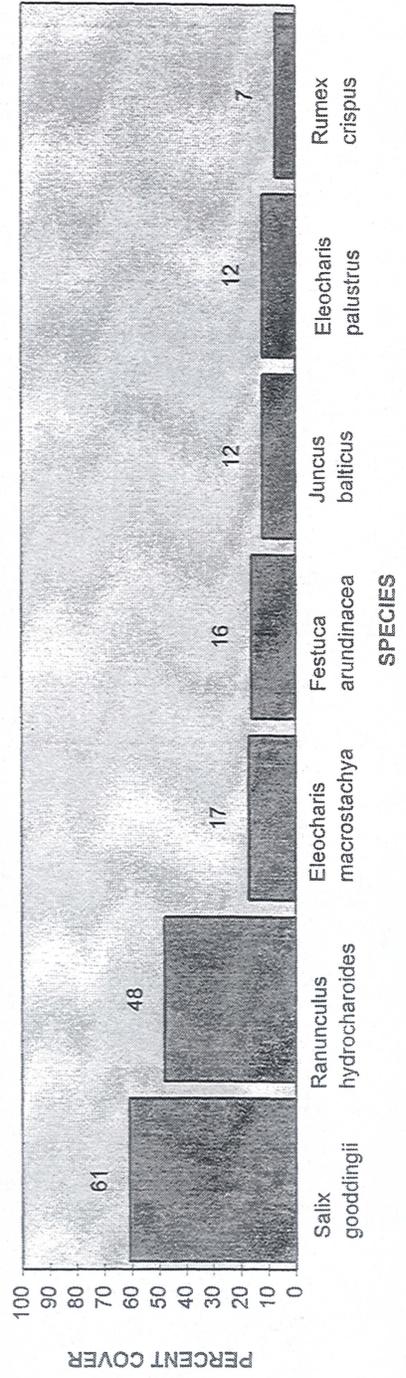
**FIGURE 6  
WILLOW BOSQUE B  
SPECIES COMPOSITION**

Results of the transect point-counts indicate that the understory composition of the more isolated willow bosque to the south of Country Club Road (Willow Bosque Community B) is dominated by buttercup (*Ranunculus hydrocharoides*), two species of spikerush (*Eleocharis macrostachya* and *E. palustris*), meadow fescue (*Festuca arundinacea*), and wire rush (*Juncus balticus*), with occasional curley dock (*Rumex crispus*) (Figure 6). Other species observed within the community included two additional rush species (*Juncus marginatus* and *J. tenuis*). Percent total cover within Willow Bosque Community B is 100.

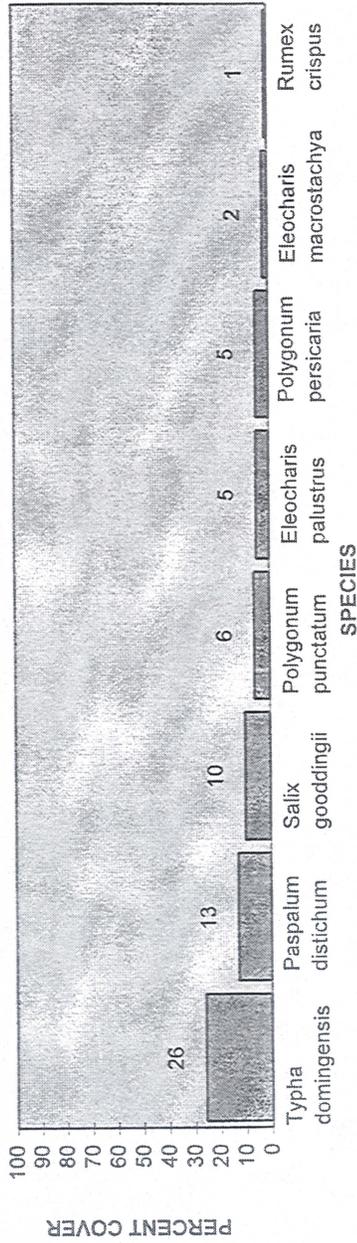
**FIGURE 7  
CATTAIL/OPEN WATER MARSH  
SPECIES COMPOSITION**

This community, represented by emergent marshland vegetation and open water, occurs in the central portion of the project site (see Figure 3 and Photograph 2). Patches of cattail marsh were also observed in other areas of the wetland where project access was not permitted. The dominant emergent species is southern cattail (*Typha domingensis*), occurring largely in pure stands. Other plants encountered during the transects include knotgrass (*Paspalum distichum*) in open water areas, willow (*Salix gooddingii*) on the community periphery, water smartweed (*Polygonum punctatum*), spikerush (*Eleocharis palustris* and *E. macrostachya*) on the water's edge, with an occasional lady's thumb (*Polygonum persicaria*) and curley dock (*Rumex crispus*). Species composition and percent cover for this community is illustrated in Figure 7. Transect results within the cattail/open water marsh area indicate 84 percent total cover for the community.

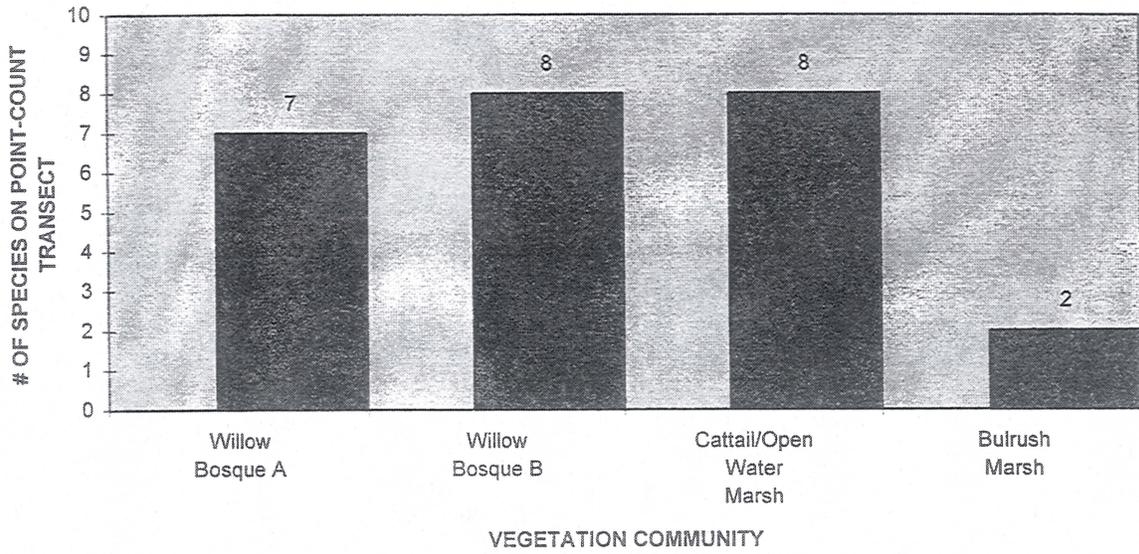
FIGURE 9  
RELATIVE DIVERSITY

Relative diversity was evaluated by comparing the number of vegetation species observed on transect point counts within each community. Relative to the other communities, the cattail/open water marsh and Willow Bosque Community B were found to be the most diverse (the greatest number of vegetation species were observed on the transect point counts within these communities), Willow Bosque Community A the next diverse, and the bulrush marsh the least diverse of the vegetation communities on observed at the wetland (Figure 9).

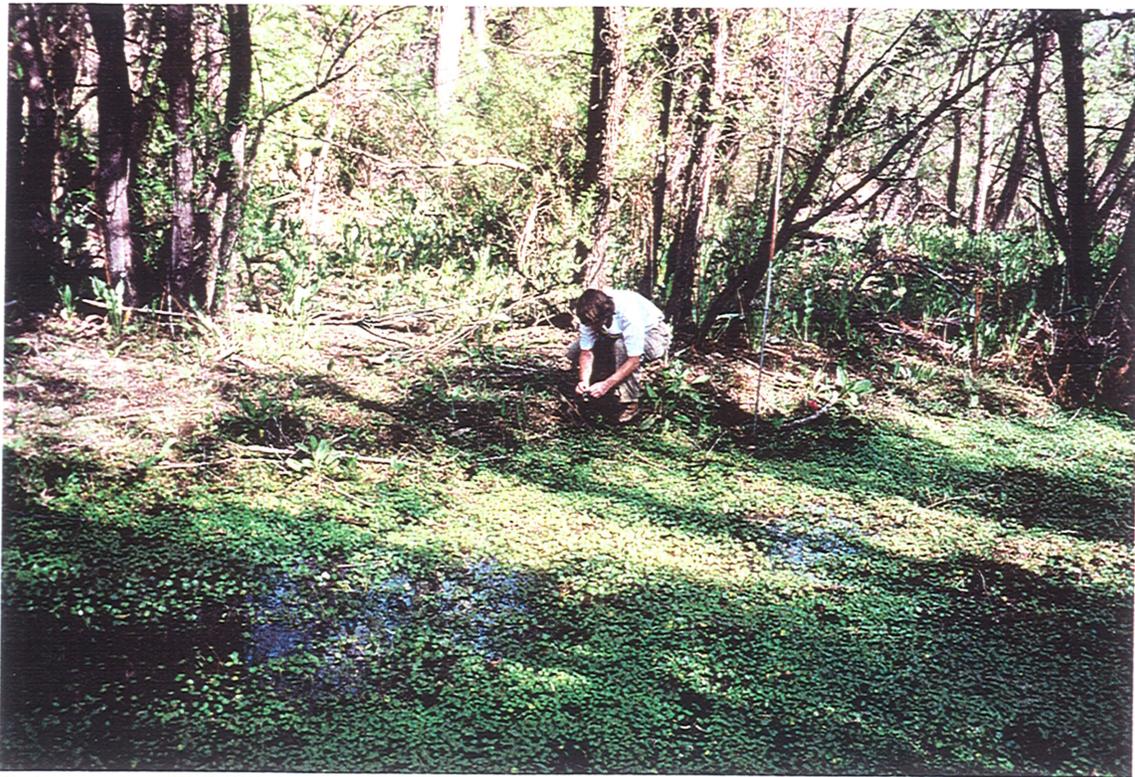
Photograph 1 Potrero Creek within Willow Bosque Community A (north of Country Club Road); April 1996.

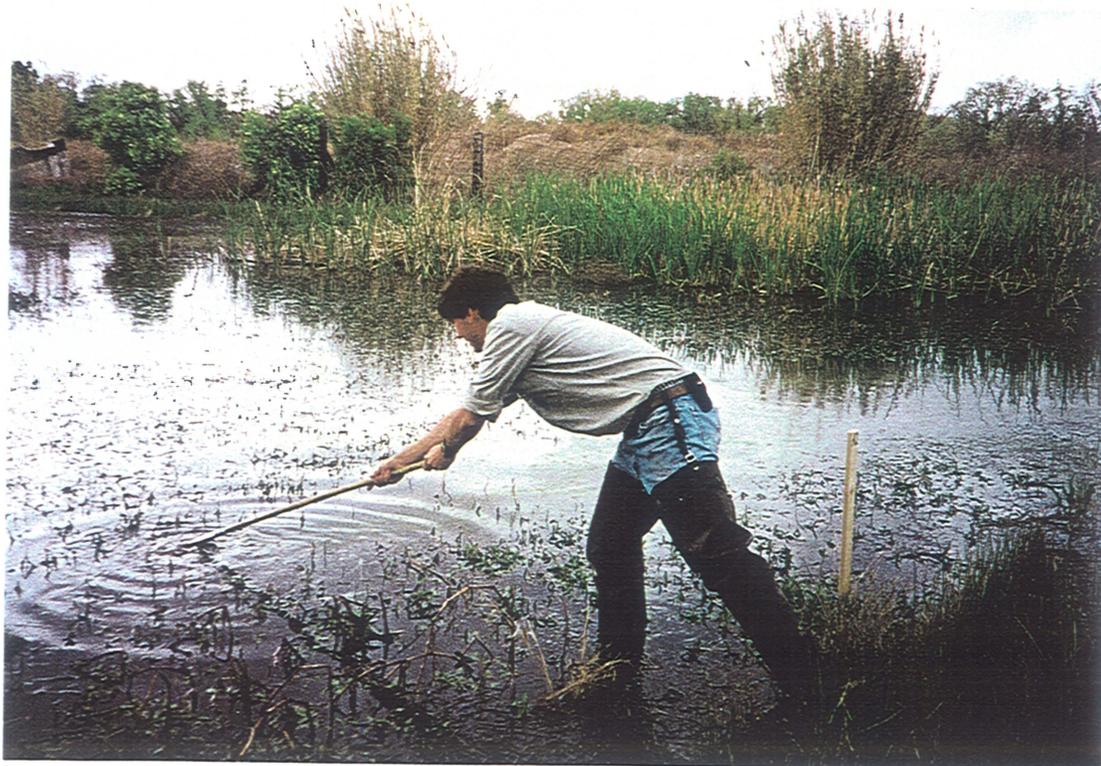
Photograph 2 Cattail/Open Water Marsh; April 1996.

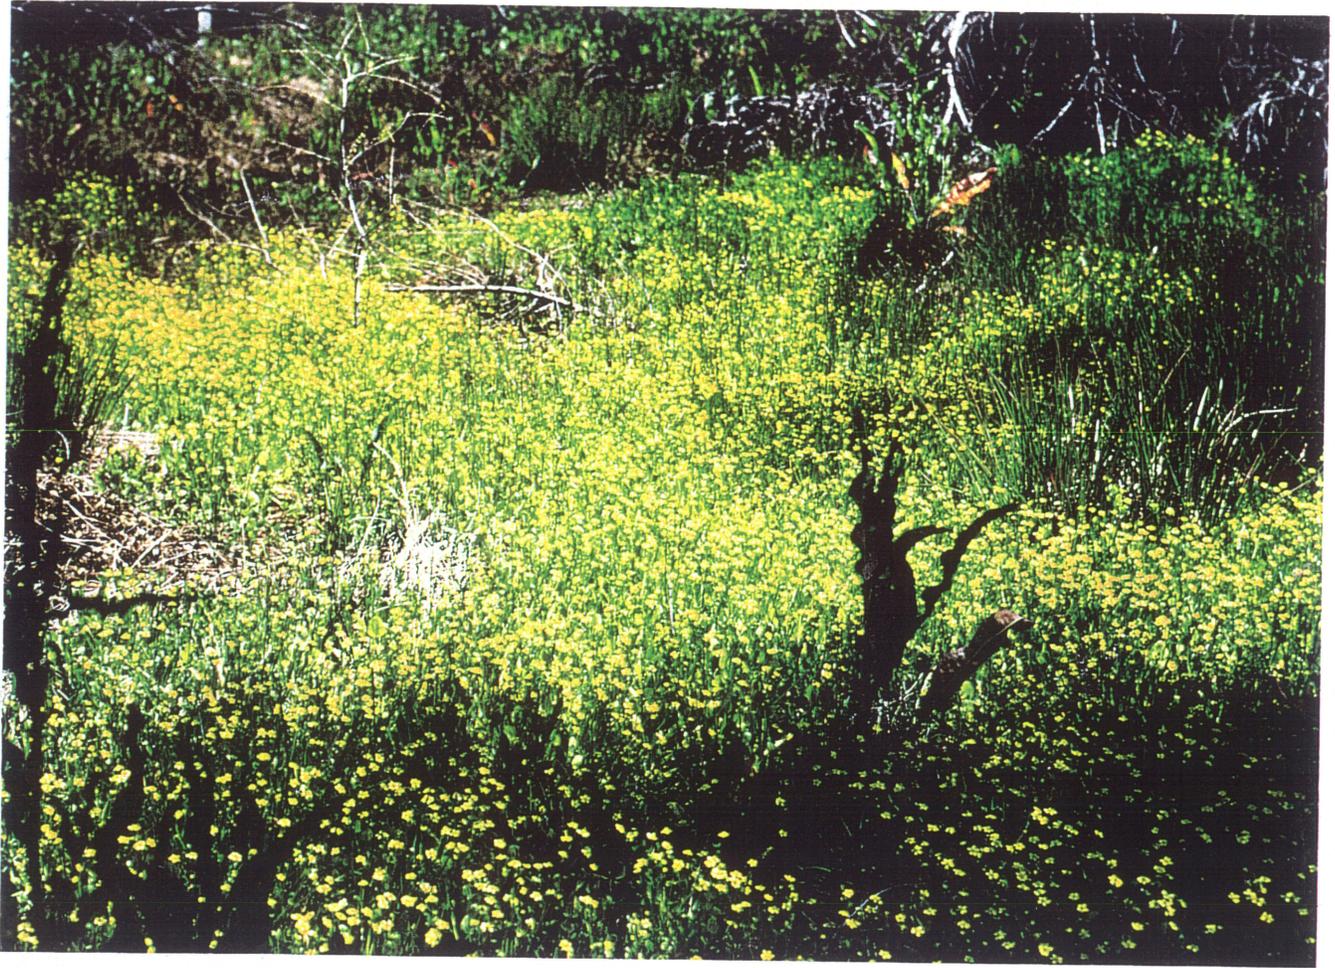
Photograph 3 Buttercup (*Ranunculus hydrocharoides*) flowering within Willow Bosque Community B; April 1996.

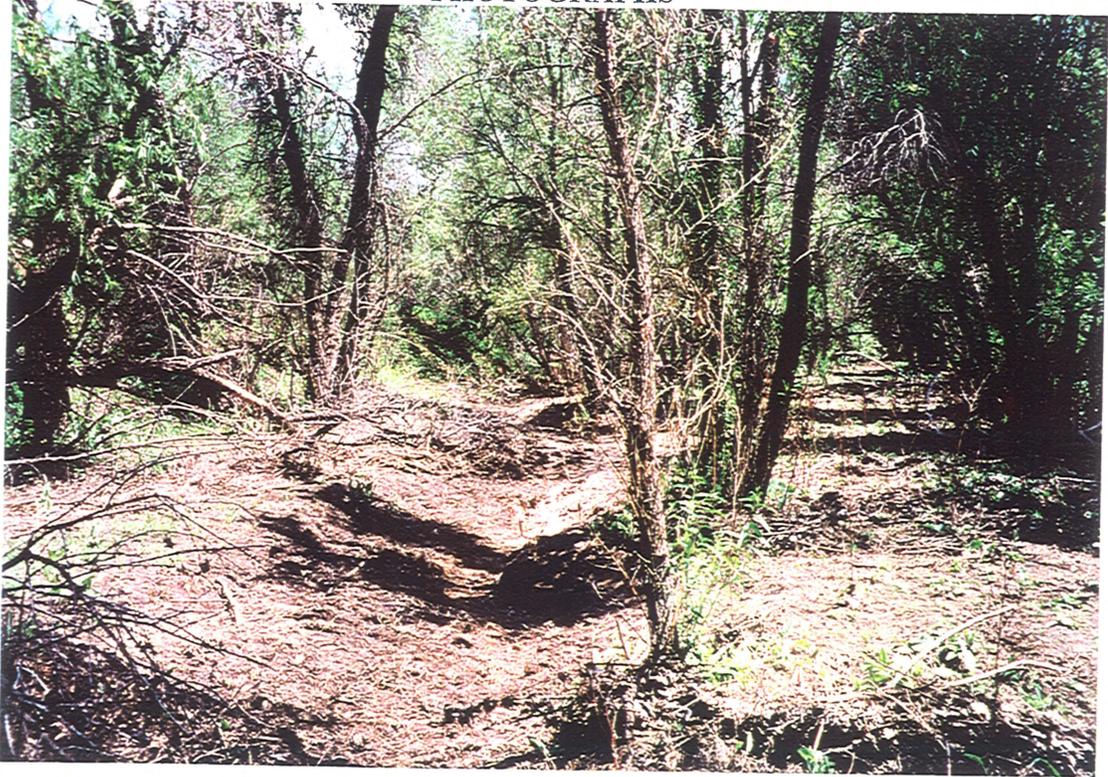
Recent creek deposits within Willow Bosque Community A

Summer biological monitoring of the project site was conducted on July 31, 1996. Conditions were sunny and clear, although it had rained the night before. Evidence of the recent storm event was observed along Potrero Creek channel, including recently crushed vegetation, debris, and flattened grasses from recent flows. Cut channel edges and sand deposits were evident. Pounded water was present under and immediately east of the Interstate 19 overpass.

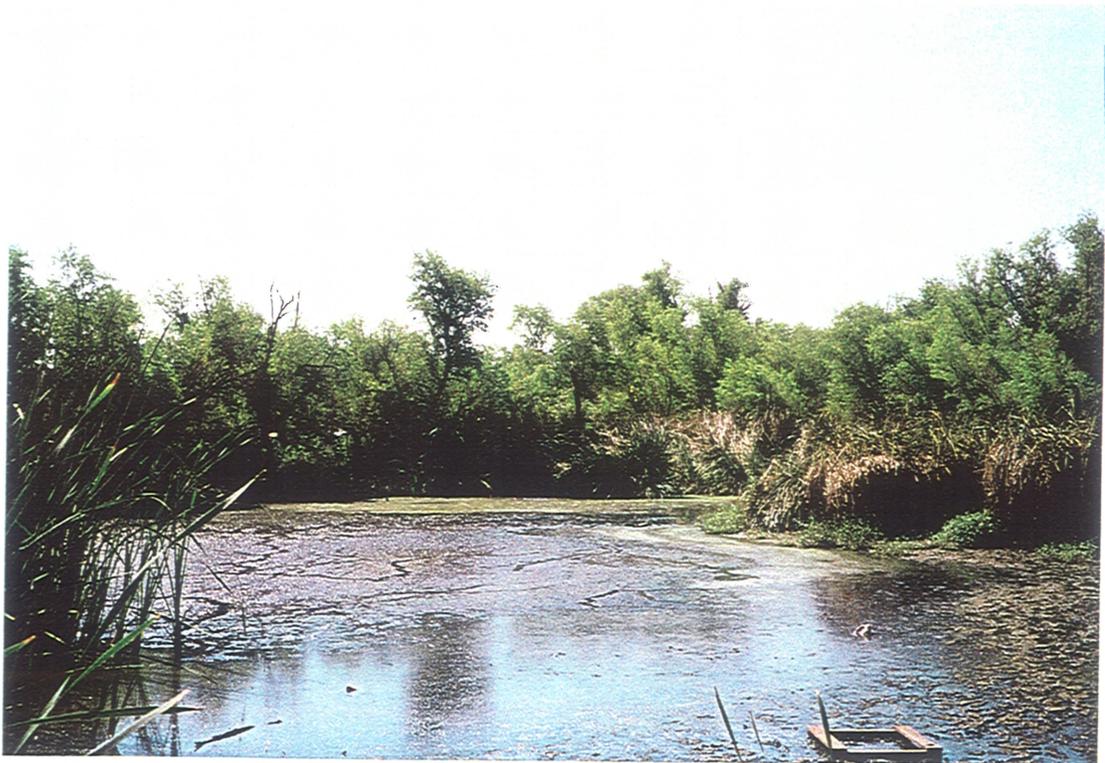
Remaining open water area

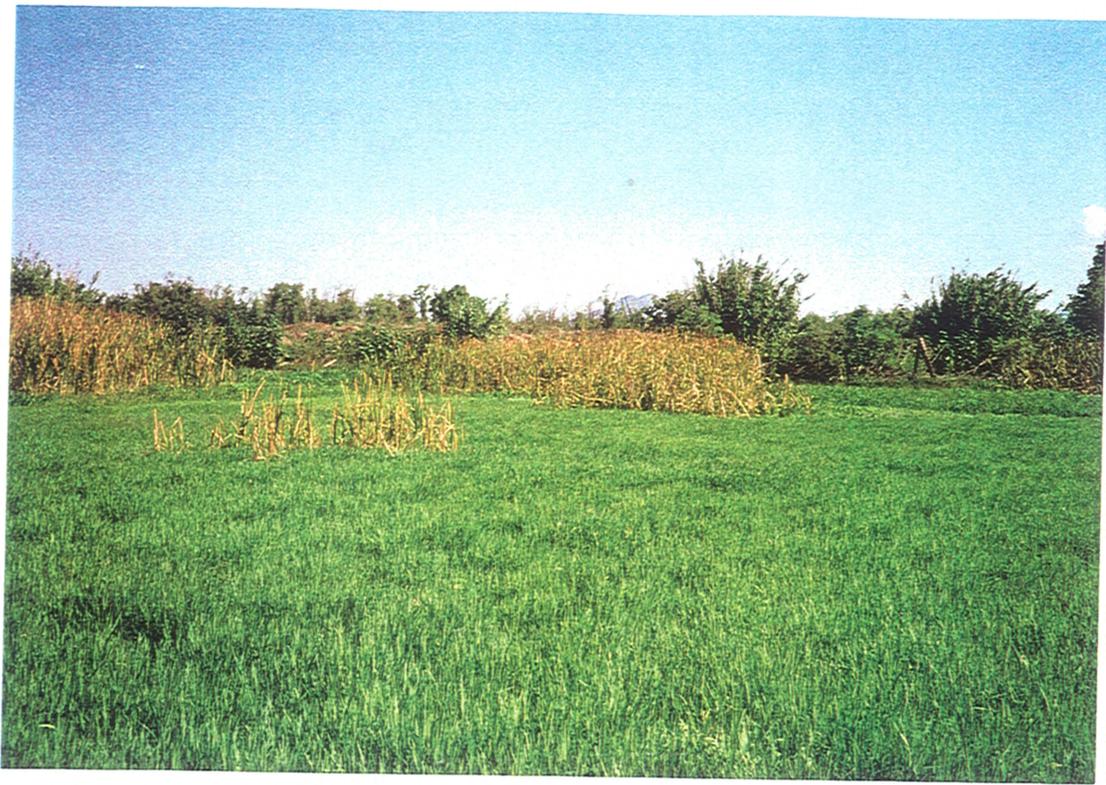
Previous open water area now covered with knotgrass (*Paspalum distichum*)

A live stand of bulrush (*Scirpus americanus*) was observed in the bulrush marsh during monitoring as compared to the dead vegetation earlier in the spring (see attached photographs). The majority of the open water within the cattail/open water marsh had evaporated. Nearly 100 percent of the previously observed open water area was covered with knotgrass (*Paspalum distichum*).

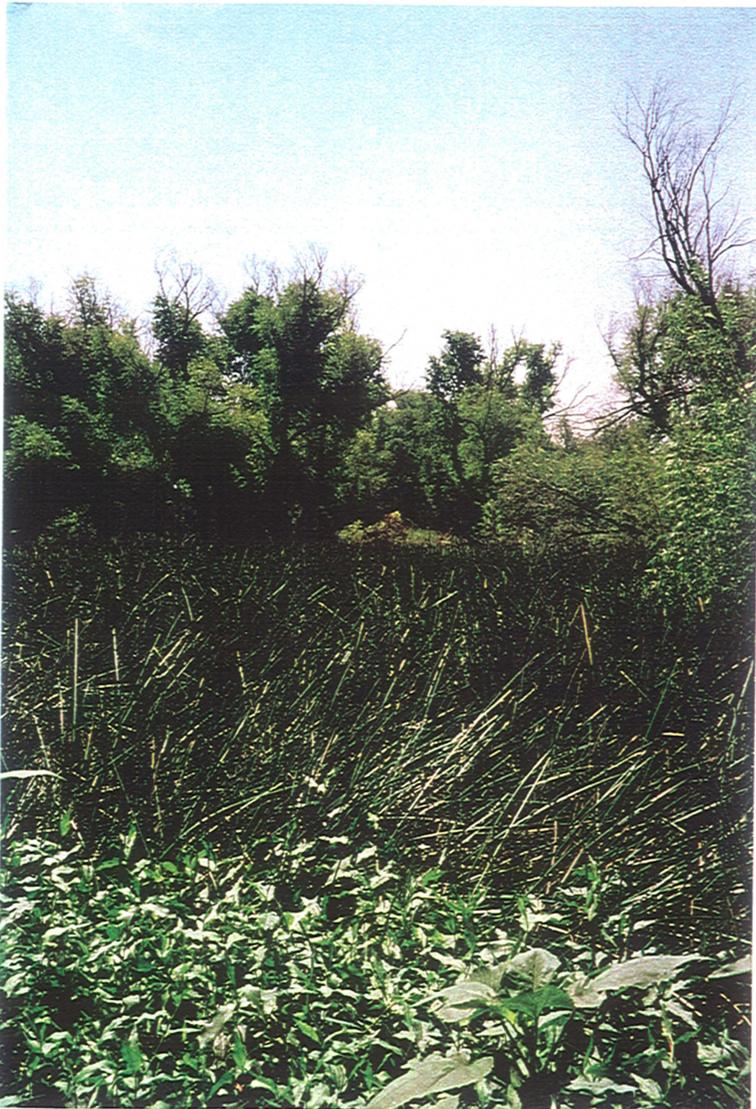
Live bulrush (*Scirpus americanus*)  
stand south of Country Club Road

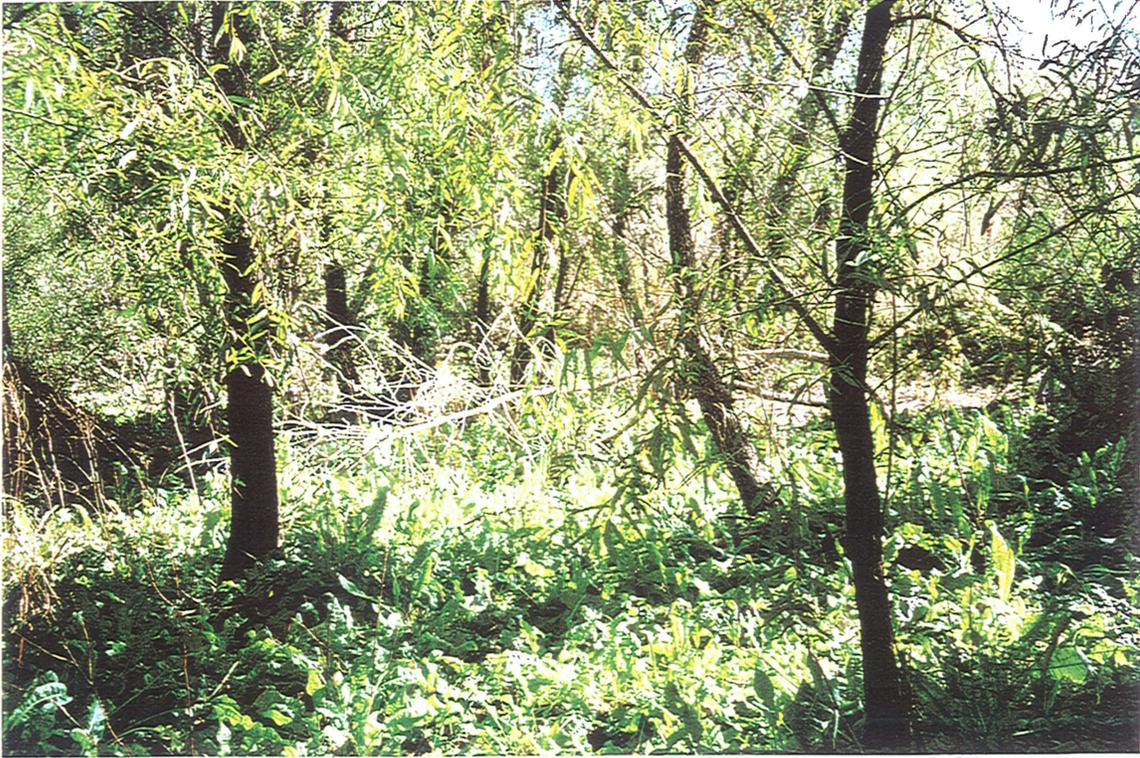
East side of Willow Bosque Community A showing 75 to 90 percent curley dock (*Rumex crispus*) groundcover.

**Vegetation.** Visual observations within Willow Bosque Community A (north of Country Club Drive) revealed that vegetation species density and diversity remained relatively unchanged. However, signs of new growth were observed. Willow (*Salix gooddingii*), curley dock (*Rumex crispus*), and bermuda grass (*Cynodon <sup>da c7410.v</sup>dactyon*) were the most predominant species within the community. Groundcover within the eastern area of the community was predominately curley dock (see photographs) while groundcover to the northwest of the community was largely bermuda grass. Whorled pennywort (*Hydrocotyle verticillata*), buttercup (*Ranunculus hydrocharoides*), and watercress (*Rorippa nasturtium-aquaticum*) were observed in damp areas along the creek itself. Rushes were not observed. Open water was not observed in the creek within Willow Bosque Community A, with the exception of one small area under the Interstate 19 overpass which had ponded water. Soils within the community were dry to slightly saturated.

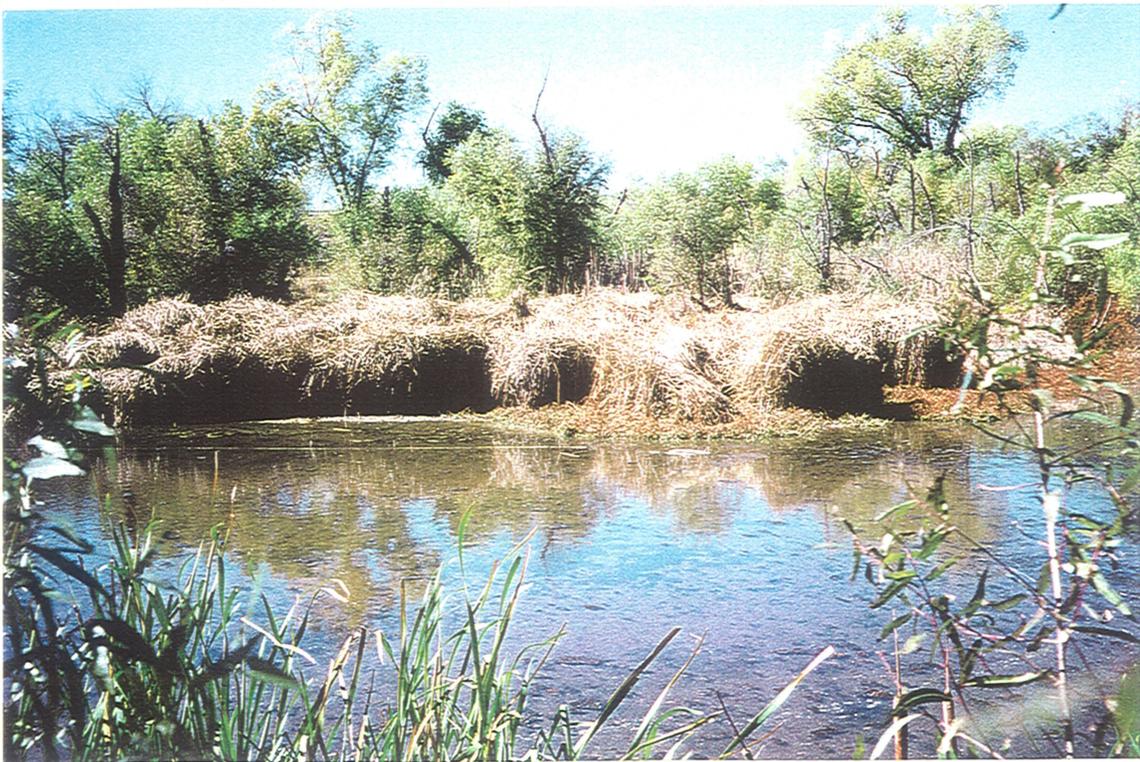
Remaining open water area north of Country Club Road.

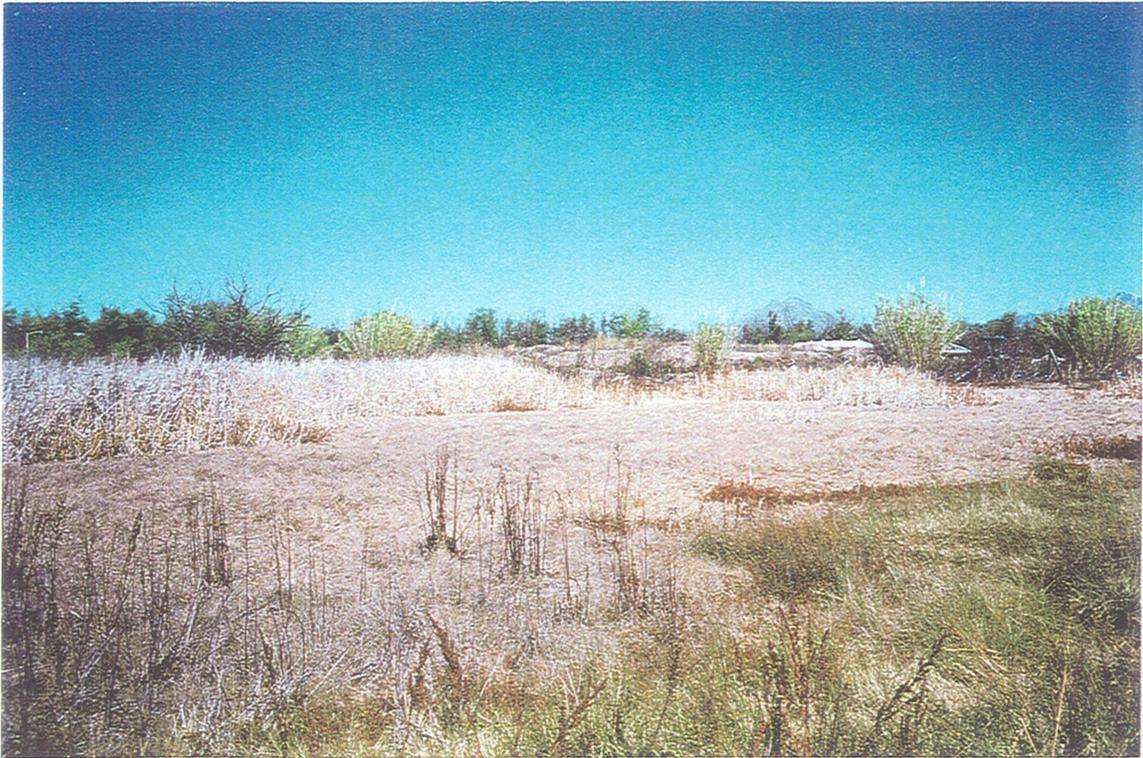
Previous open water/cattail area, now covered with dead vegetation, cattail (*Typha domingensis*) and knotgrass (*Paspalum distichum*). Note giant reed (*Arundo donax*) in background.

All of the open water within the cattail/open water marsh present during the spring (March/April) surveys had evaporated or recharged into the perched aquifer. Vegetation in the area of the cattail/open water marsh, predominantly cattail (*Typha domingensis*) and knotgrass (*Paspalum distichum*), was largely dead (see photograph). Some live cattail roots were observed growing between the cracks of the dry soil, apparently able to reach the water table. Spikerush (*Eleocharis palustris* and *E. macrostachya*) and wire rush (*Juncus balticus*) were observed along the eastern fringes of the marsh. Giant reed (*Arundo donax*) was observed on the northern fringe of the marsh (visible in background of photograph of cattail/open water marsh community). Soils within this community were dry to slightly saturated at the fringes of the community.

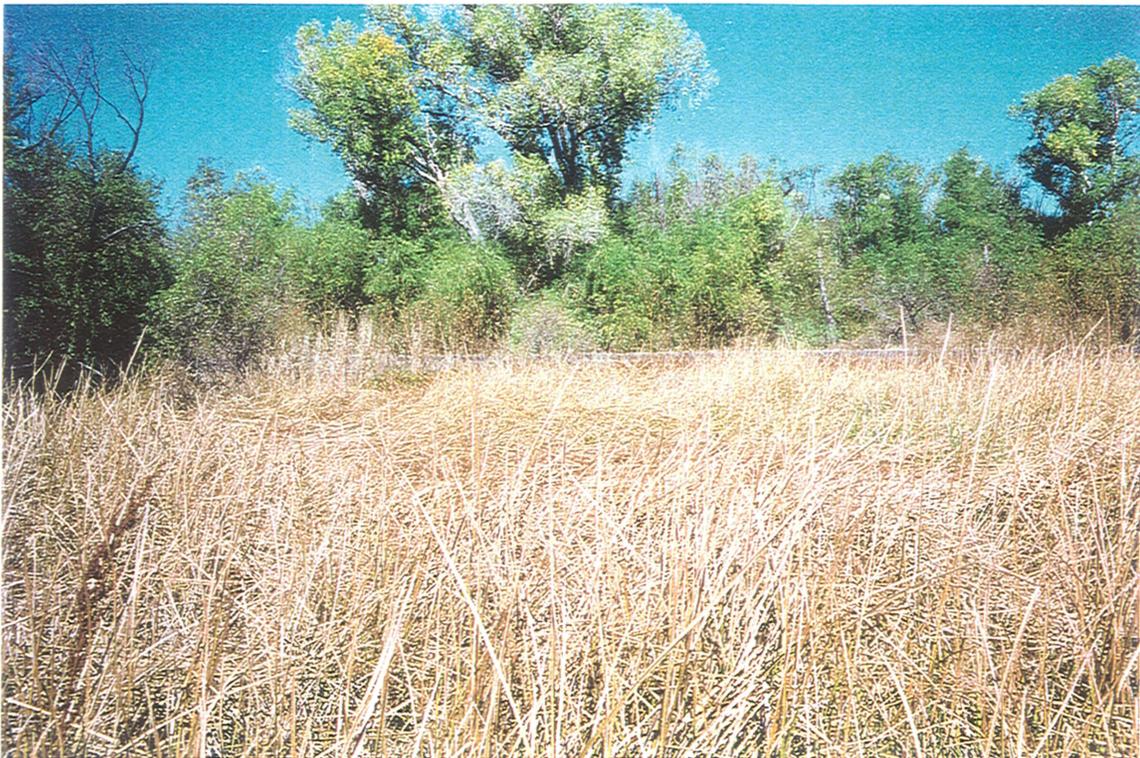
Bulrush (*Scirpus americanus*) marsh, looking towards Country Club Road.

The majority of the bulrush (*Scirpus americanus*) stand within the bulrush marsh adjacent to Willow Bosque Community B was dead. However, some plants were live, and live plants were evident underneath the biomass as well (see photograph). Wire rush (*Juncus balticus*), spikerush (*Eleocharis macrostachya*), and curley dock were interspersed with the bulrush at the fringes of the marsh.

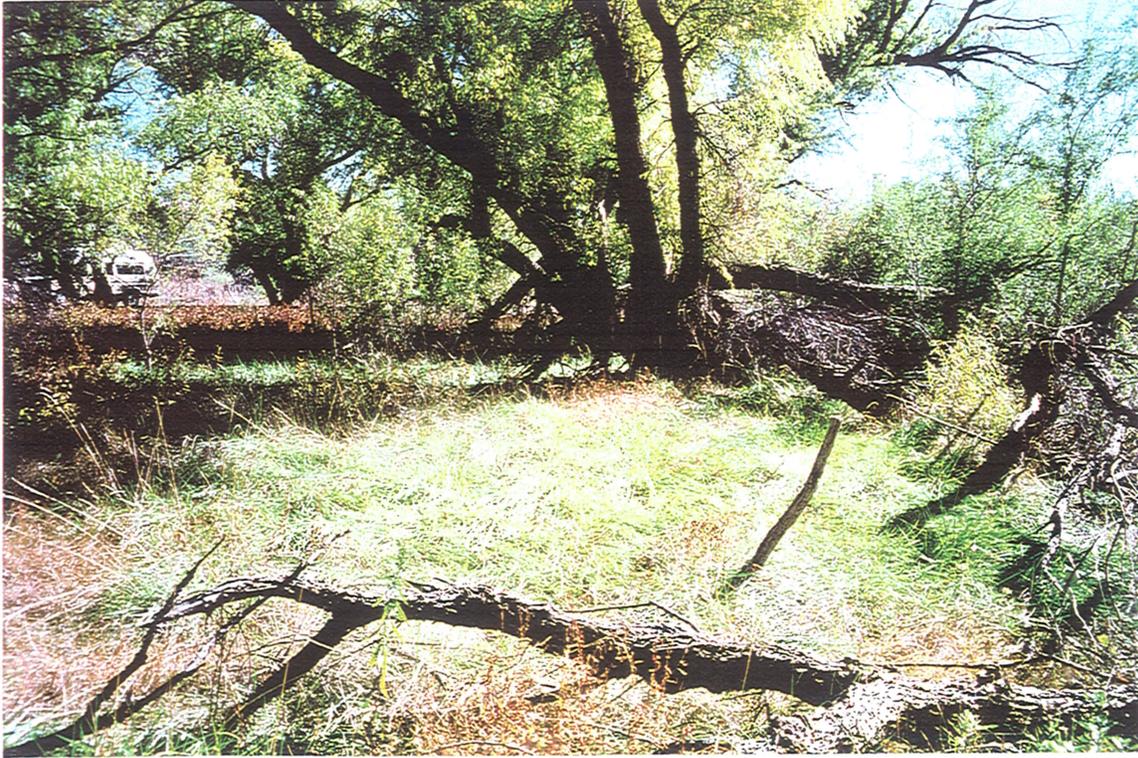
Meadow fescue (*Festuca arundinacea*) groundcover in Willow Bosque Community B.

Tamarisk (*Tamarix* sp.) was observed on the berm within Willow Bosque Community B. Groundcover on the eastern side of the community was meadow fescue (*Festuca arundinacea*), and seep-willow (*Baccharis salicifolia*) in the western portion of the community (see photographs). Some live rushes and sedges were observed (though rarely), including spikerush (*Eleocharis palustris*) and clustered fieldsedge (*Carex praegracilis*). Buttercup (*Ranunculus hydrocharoides*) and curley dock (*Rumex crispus*) were also observed within Willow Bosque Community B. Soils were dry to slightly saturated with no standing water.

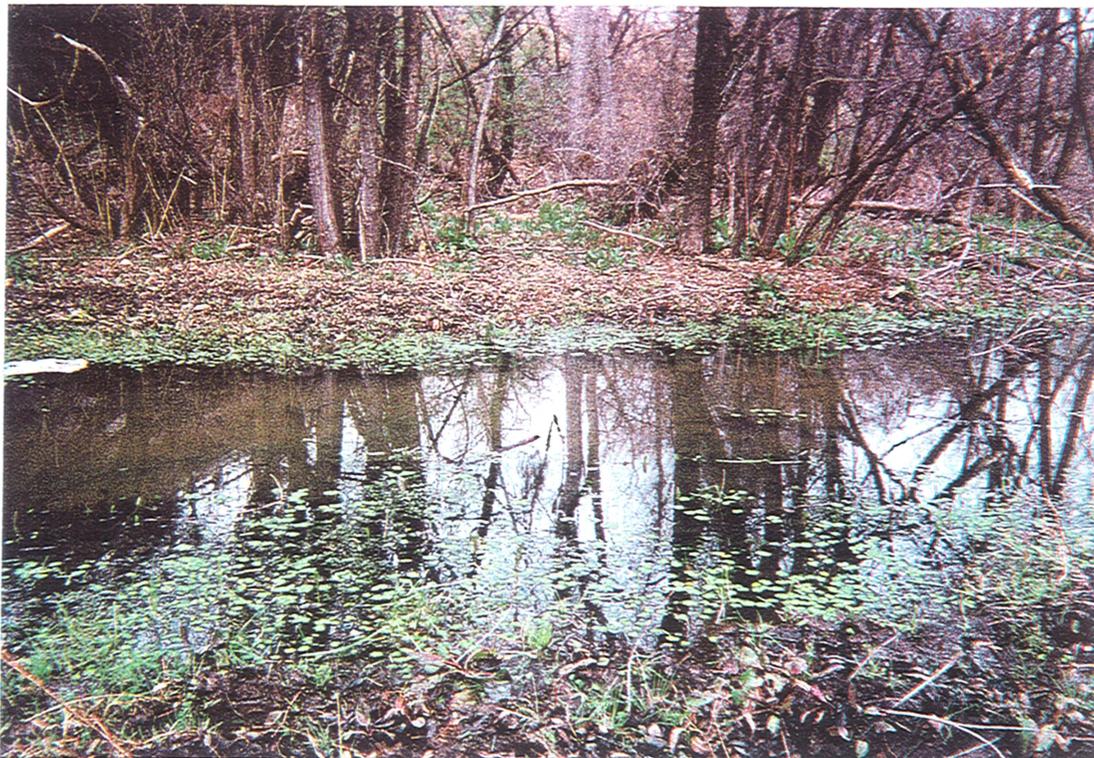
Potrero Creek at the west end of Willow Bosque Community A. Note aquatic vegetation, including whorled pennywort (*Hydrocotyle verticillata*), watercress (*Rorippa nasturtium-aquaticum*) and buttercup (*Ranunculus hydrocharoides*) on the surface of the water.

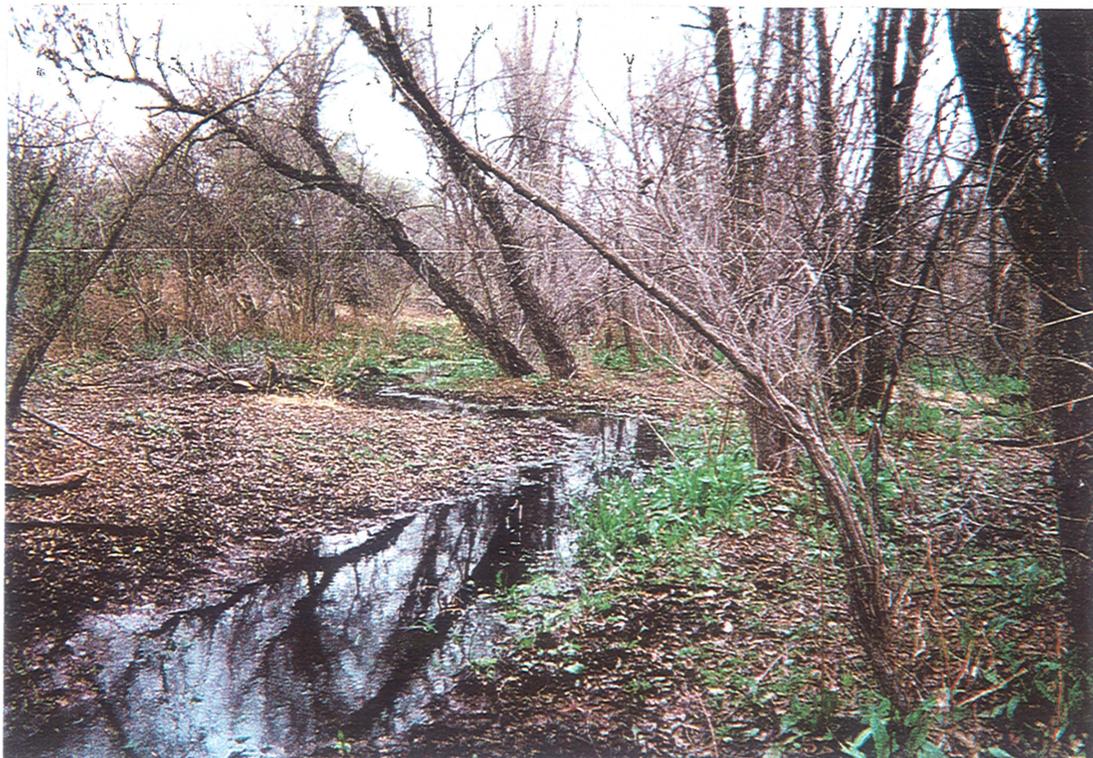
Potrero Creek on the northeast side of Willow Bosque Community A.

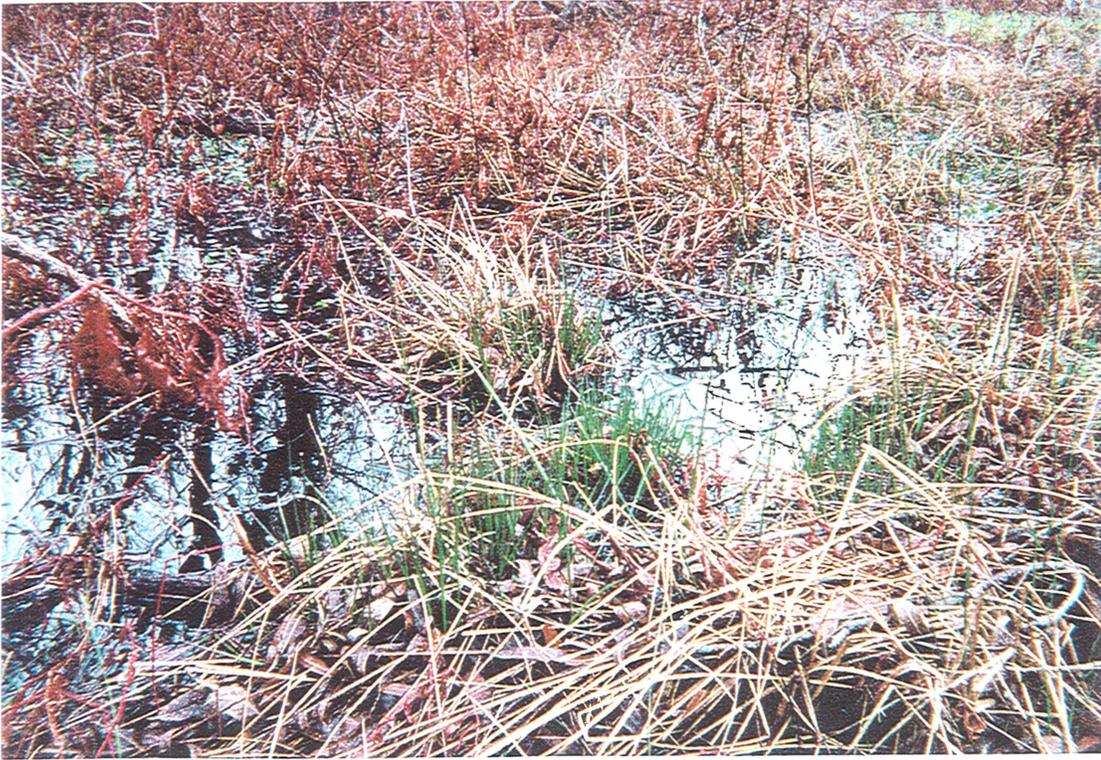
Spikerush (*Eleocharis macrostachya* and *E. palustris*) in areas of standing water within Willow Bosque Community B.

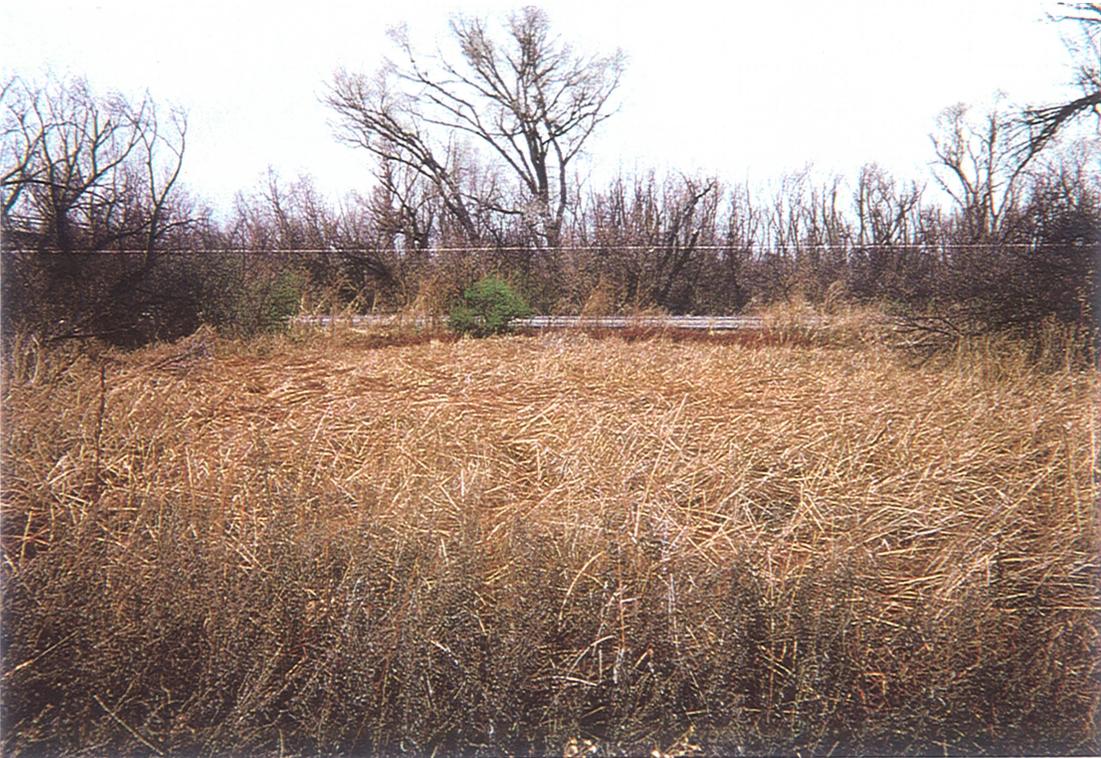
Bulrush (*Scirpus americanus*) marsh, looking towards Country Club Road.

The majority of the vegetation within the bulrush (*Scirpus americanus*) marsh was dead (see photographs), although live wire rush (*Juncus balticus*) and/or spikerush was observed along the fringes of the marsh. Few live bulrush species were detected underneath the biomass of dead vegetation. No standing water was detected within the marsh, although soils were saturated underneath the biomass.

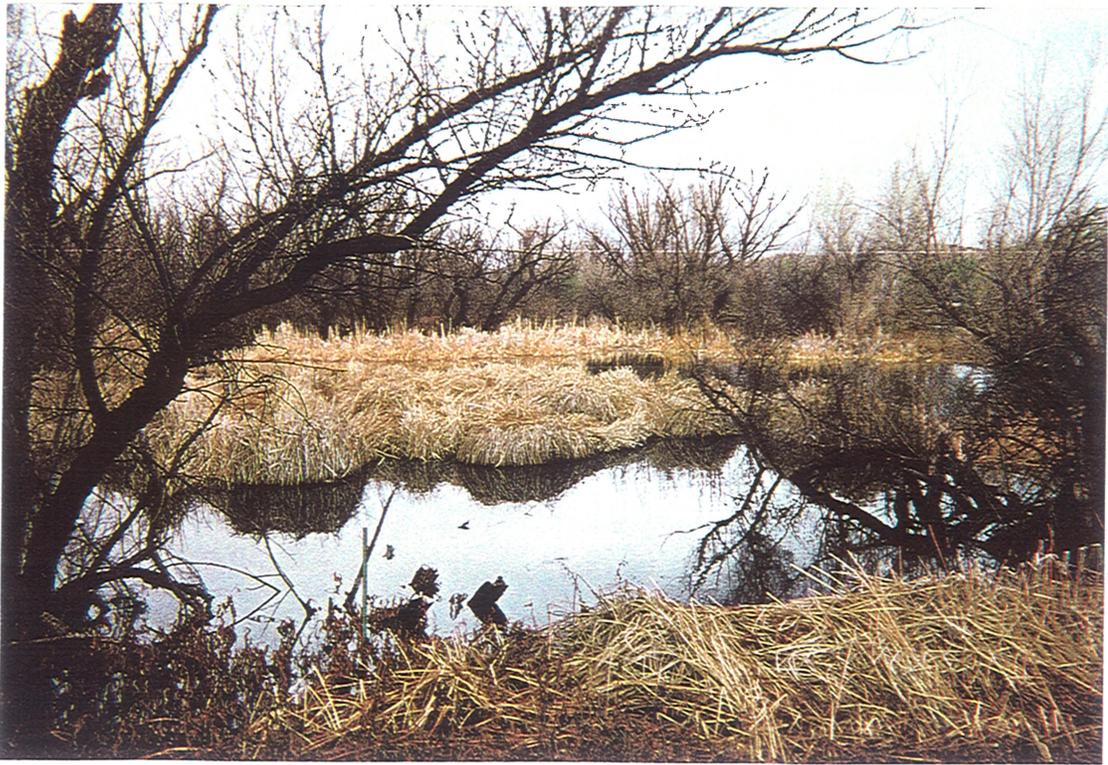
One of the few areas with open water throughout 1996, north of Country Club and south of Willow Bosque Community A.

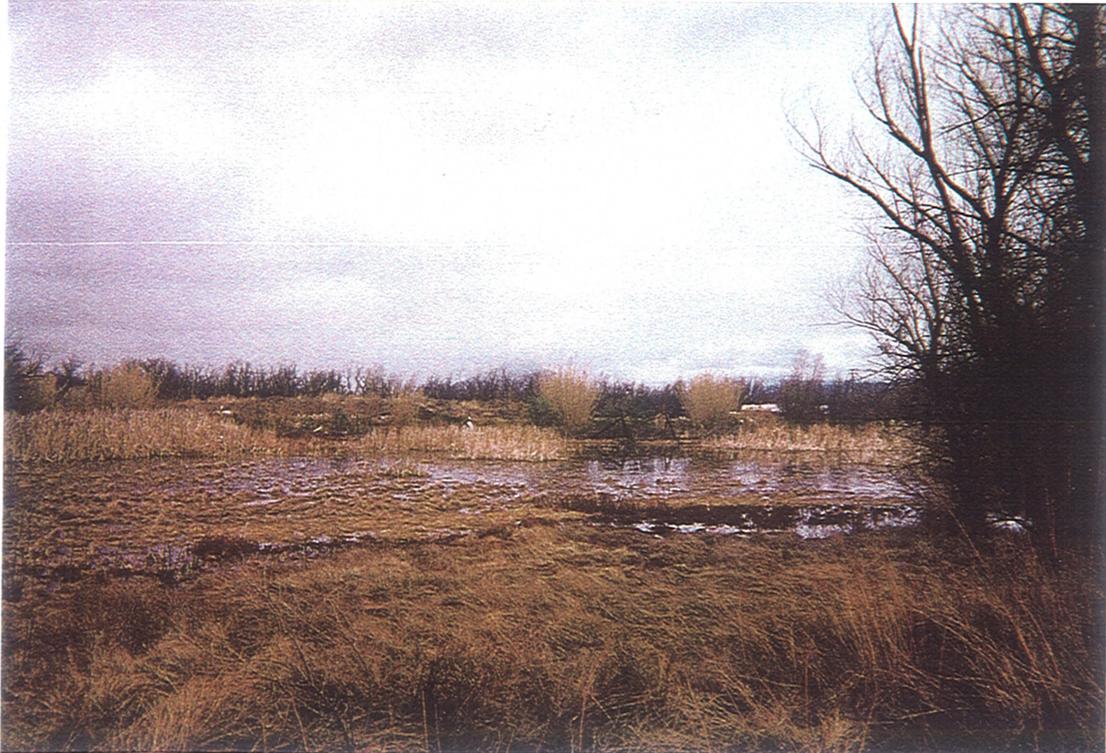
Open water/cattail marsh with standing water. Curley dock (*Rumex crispus*) fringes the marsh (note the reddish-brown color vegetation).

Vegetation within the cattail/open water marsh also showed signs of senescence and new growth. Standing water was present within the cattail/open water marsh. Vegetation in the area of the cattail/open water marsh, predominantly cattail (*Typha domingensis*) and knotgrass (*Paspalum distichum*) was largely dead (see photographs). Curley dock showed signs of senescence, as well as the knotgrass (*Paspalum distichum*) covering the ground surface in areas of open water and at the water's edge. Live rushes were observed from the water's edge to 20 to 30 feet upland, including spikerush, and possibly clustered fieldsedge (*Carex praegracilis*). Giant reed (*Arundo donax*) was observed on the northern fringe of the marsh.
