**Arizona Water Protection Fund
FY 2009 Grant Application Review**

Title of Project: EC BAR RANCH RIPARIAN BRUSH CONTROL PROJECT

Arizona Water Protection Fund
Application Cover Page
FY 2009

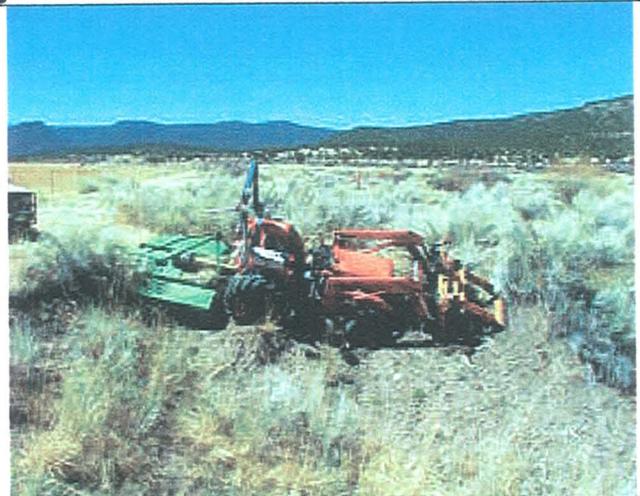
Step 1. Mowing Rabbitbrush to remove above ground brush is necessary prior to treating the root.

The project related remedies and treatment solutions to reduce Rabbitbrush within the project area are to cut-off the above ground plant canopy, sever the tap root below the surface by hand grubbing and/or apply selected herbicides, and then overseed the treated areas with a native grass (Western Wheatgrass) to prevent reestablishment and provide greater soil stability. A three year period of non-grazing during the project period growing season will allow native grasses in newly seeded areas to become established by natural precipitation. Riparian functional conditions that allowed Rabbitbrush to proliferate have now been mitigated so the natural balance will be restored within the project area so that water quality standards and aquatic/wildlife habitat can be maintained. Without the proposed project, the natural balance may never be restored to Nutrioso Creek.

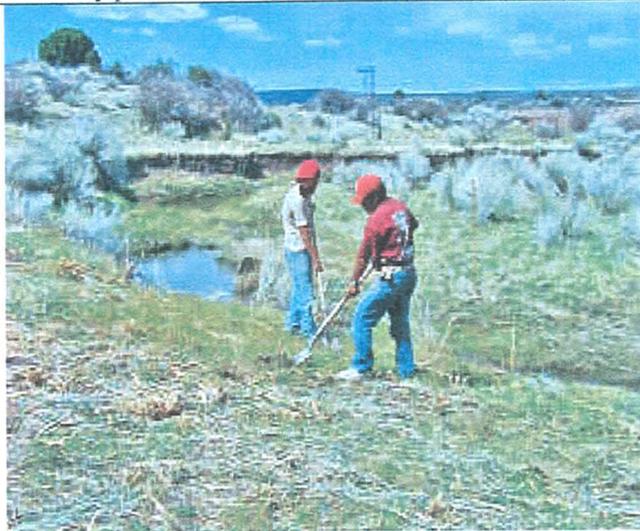
Step 1. Using a tractor to mow Rabbitbrush is often not possible due to steep terrain on terraces.

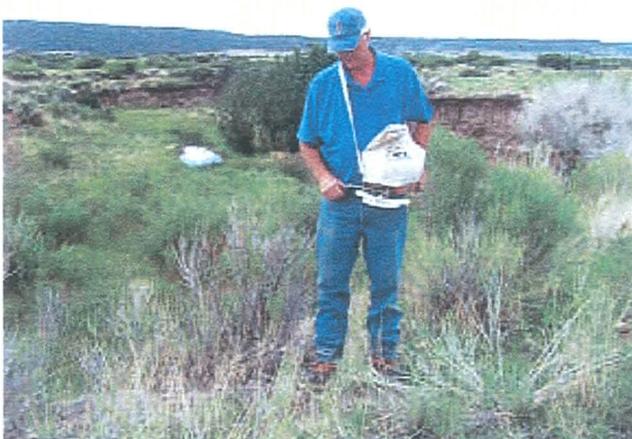
Step 2. Each Rabbitbrush plant must be treated by multiple herbicide applications using a backpack sprayer.

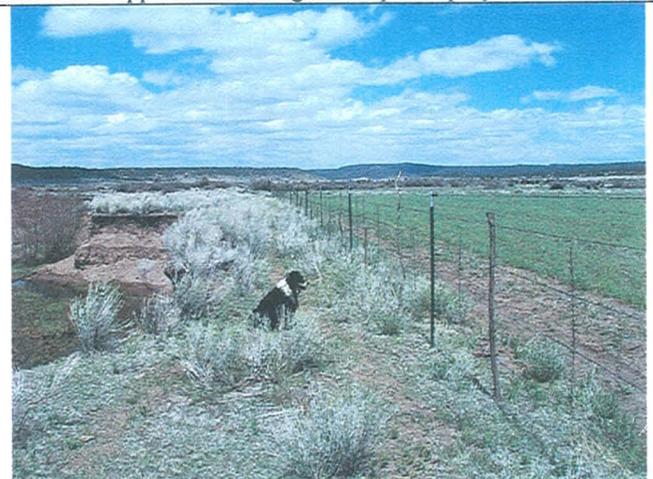
Step 3. Each treated area must be hand seeded with native grass to prevent reestablishment of invasive species/brush.

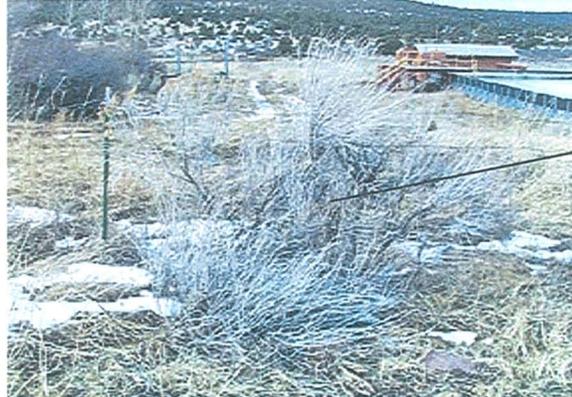
Rabbitbrush killed by herbicide without mowing canopy.

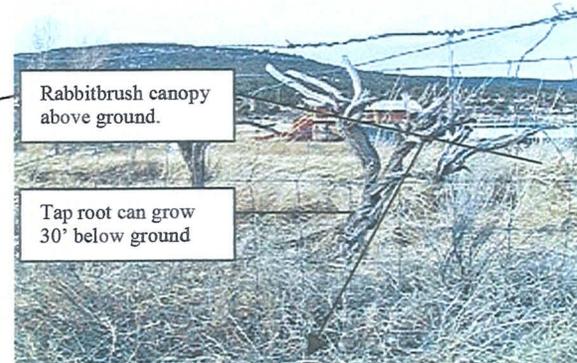
Rabbitbrush canopy above ground.

Tap root can grow 30' below ground

While it may seem that replacing Rabbitbrush with native grasses would have an offsetting impact on water consumption, the fact is that Rabbitbrush tap root can penetrate 30 feet or more to reach water stored in streambanks that is normally released as flows decrease, to help the system maintain a viable flow during the driest periods. Native grasses have dense roots that only penetrate about 30 inches, and even with the upward wicking action of the watertable, at least five feet or more of dry soil separates water stored in banks from the upper terrace grasses. Over time, the objective of a properly functioning riparian system in Nutrioso Creek is to raise the streambed and water table so grasses can utilize water from the stream to help stabilize soils and reduce erosion. In the near term, grasses must rely on natural precipitation for their source of water whereas Rabbitbrush are tapped directly into the water table. The net effect of removing Rabbitbrush may be to reduce 60 million gallons per year of water table consumption without adding any offsetting consumption by overseeding the treated areas.

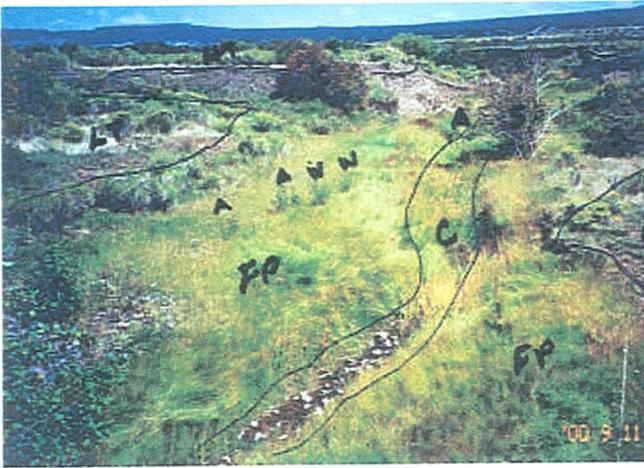
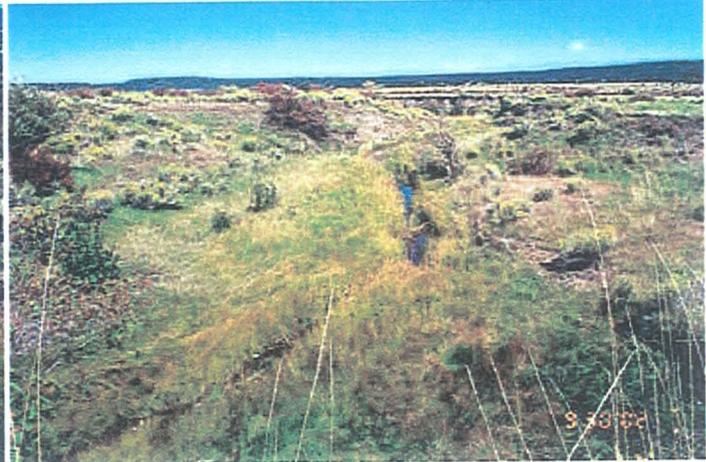
R-5 Photo 33, Roll #1 Reach: 2 Date: 9-11-00 Time: 11:02 a.m.
GPS: 12 S 0665919 - 3761030 Azimuth: 40
Looking downstream. This is the upper end of Reach 2.
Description: The high terrace (HT) is dominated by rabbitbrush with shortgrass understory. The low terrace (LT) has an overstory of rabbitbrush with moist grass/forb understory. The floodplain (FP) is fairly wide with good stand of wet grass/rush/sedge. Stream channel (C) mostly full of rushes and bulrushes. Note gravel in lower part of photo. Some young alders (A) and willows (W) are on the floodplain. Three large skunkbushes are present, 2 on the low terrace and 1 partly dead one on the floodplain.

R-5 Date: 9-30-02 Time: 12:30 pm
Observations: Alders in left center of photo have grown since 2000. There is more vegetation cover along the channel, the floodplain and the low terrace, e.g. note that rocks in creek are less visible. Creek was running here and water was clear.

This reach lies just downstream (north) of Reach 1 and runs from photopoint R-5 to just above photopoint R-7. The active floodplain and the low inner terrace are both wider than in Reach 1, but narrower than in Reach 3. There is some coarse gravel in the channel and the floodplain. The channel directly undercuts the higher terrace bank in some places. The bottom of the channel is silty except where riffles pass over gravel. Water flow is more or less continuous at time of observation. Water is turbid. There is relatively little silt deposition in the channel compared to Reach 3. Alders occur at certain points along this reach, apparently in association with gravel substrate; but fewer alders than in Reach 1.

Reach 2 includes photopoints 5-B (downstream), R-6, and JC-2. Reach 2 was classified as **FUNCTIONAL AT RISK** (Smith). The trend was estimated to be **UPWARD**, based on stable banks and regeneration of woody vegetation. In 2003, Bill Zeedyk classified the channel as a Rosgen F type in an "upward trend" toward PFC. In October 2005, Tom Subirge rated Reach 2 as "proper functioning condition". See description and photos at link <http://www.ecbarranch.com/monitoring/PFC/ECB%20Rch2pfc2005.htm>.

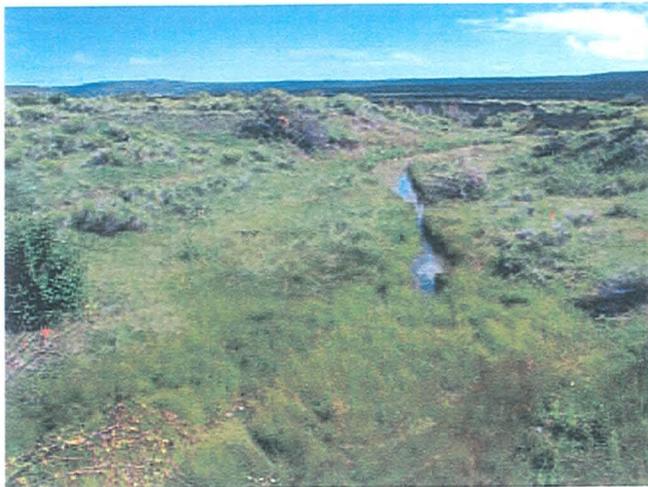
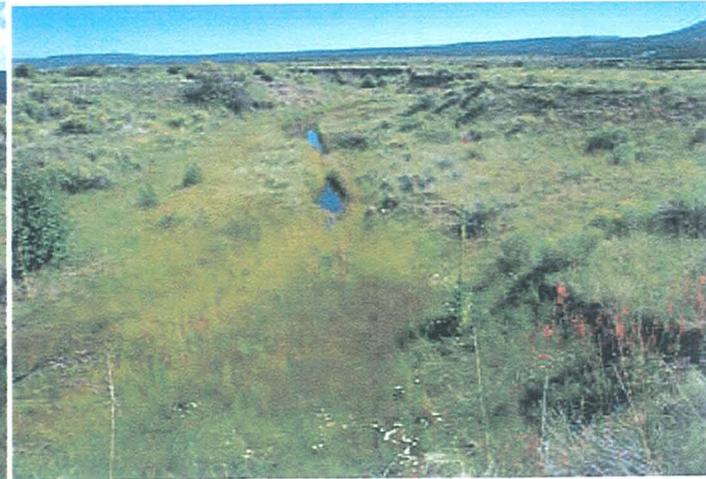
R-5 Picture 3242 Date 9-3-03 Time: 9:45 am
GPS: N33°58.037 W109°12.150
Sunflowers are growing where rocks were in 2000. Grass is now established on left bank due to sprinkler irrigation. Water flowing.

R-5 Picture 0216 Date 9-1-04 Time: 9:39 am
GPS: N33°58.037 W109°12.150
More rushes present.

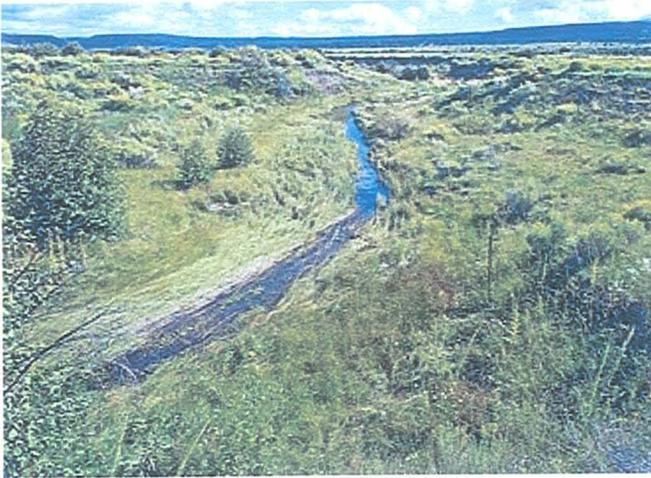
R-5 Picture 5812 Date 9-12-05 Time: 9:22 am
 GPS: N33°58.037 W109°12.150. More grasses present. Note sedges depressed after high water in August.
