**Arizona Water Protection Fund
FY 2009 Grant Application Review**

Application # WPF0381 Applicant: CARLYLE & MARTY CATHCART
Title of Project: WILD BUNCH ALLOTMENT RIPARIAN RESTORATION

Title of Project: Wildbunch Allotment Riparian Restoration

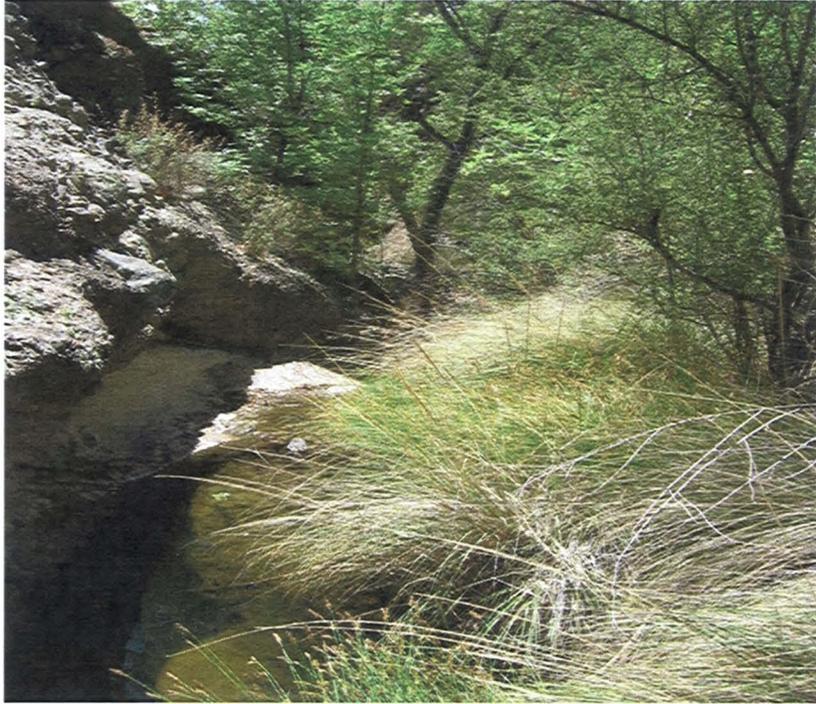
Photo on Page 10 shows a plunge pool and riparian in Cienega within a protected section not accessible by livestock.

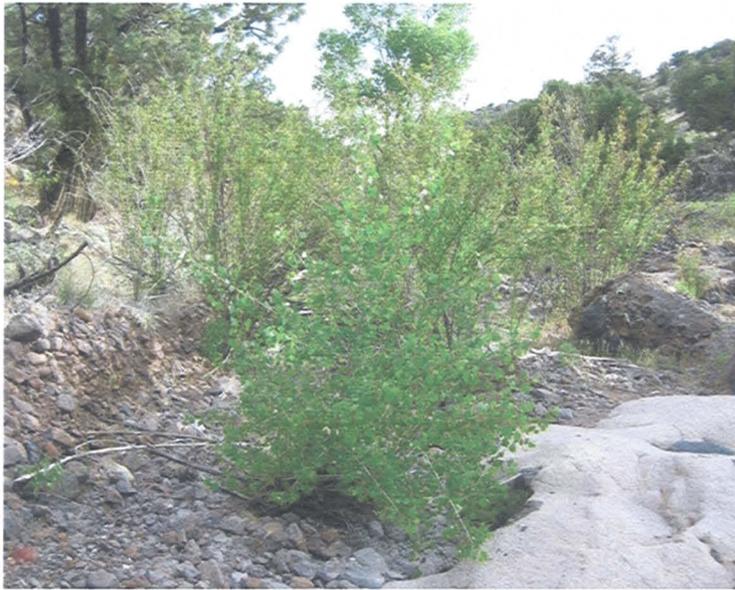
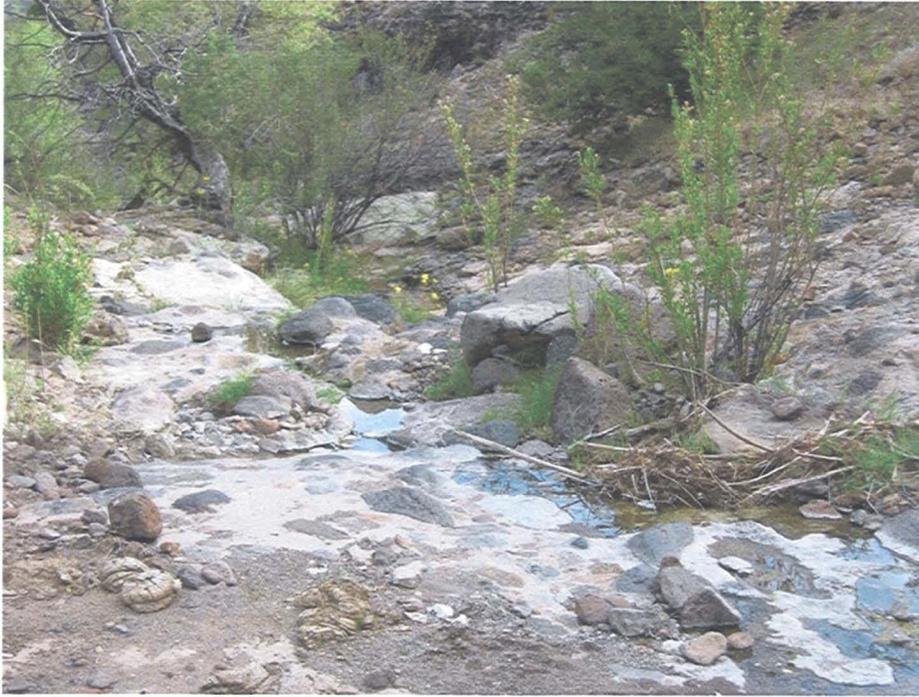
Dominant vegetation in the riparian area of Cienega Creek is Pine or Deer Muhly (a large robust bunch grass found only in intermittent or subsurface flows) with sedges and rushes found near perennial waters. Seep willow (not true willow) is common, but other willows and cottonwoods are present if only sporadically due to herbivory and lack of deposition of fines where seedlings can become established. Only one sapling cottonwood was observed and documented in Cienega Creek during an inspection in 2005. Alternating grazing and rest has enabled some recovery, but concentrated livestock during times of use continues to reduce recovery rate.

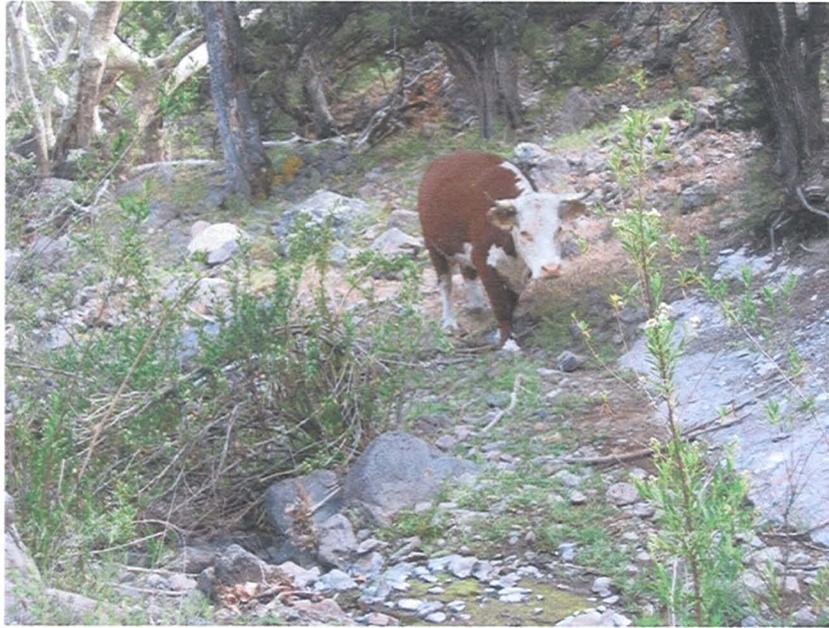
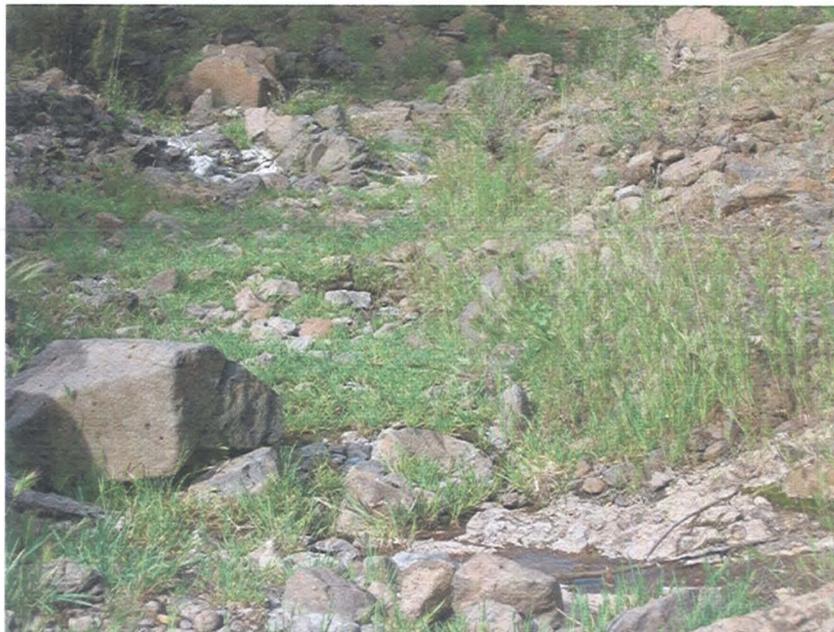
Reach Four – This stretch was also classified riparian due to remnant occurrence of woody species. Upper Cienega Spring, which is fenced from continued livestock use, and sporadic occurrences of other woody species and grasses and sedges occur within this stretch. It was rated properly functioning in 1999 primarily because of the amount of bedrock and uplands were having less of an impact on riparian establishment and conditions than lower reaches. The picture above is an example of this reach. Concentrated grazing on woody species was noted during seasonal periods of use, along with trailing as noted in the picture below.

The picture above is another example of concentrated use in Upper Cienega canyon where intermittent flows occur. Use is often occurring from very few animals that have drifted into the drainage, but is in stark contrast with the picture of healthy riparian on page 10.

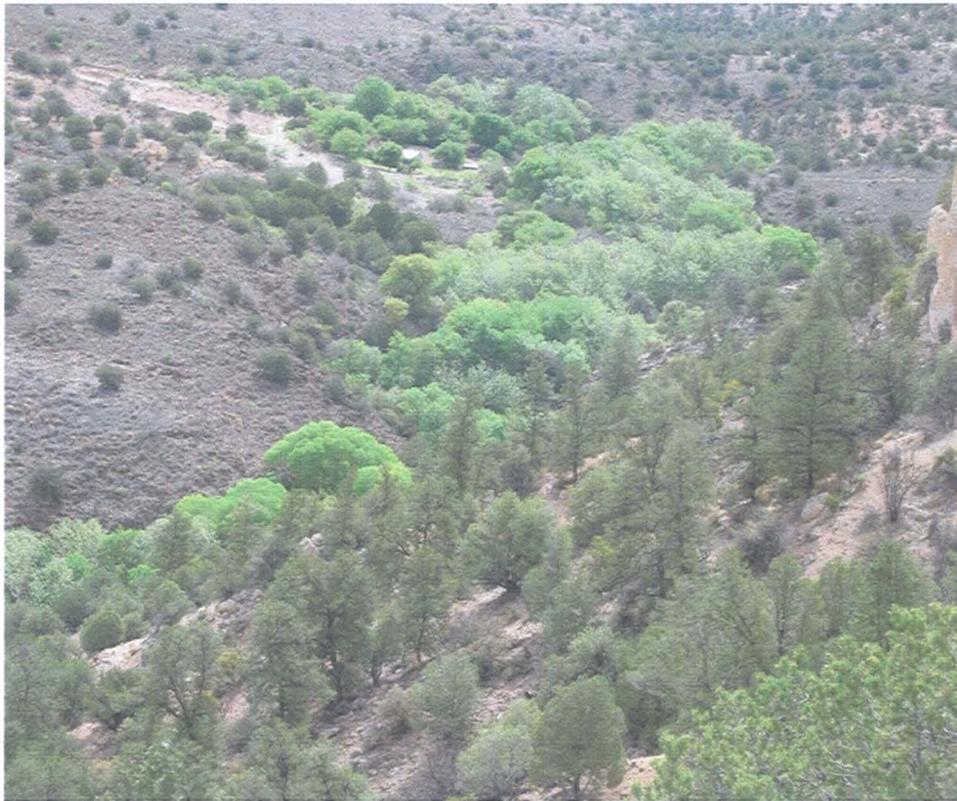
The upper reaches of Indian Creek, as shown in the picture above, are characterized by extensive galleries of old growth riparian woody vegetation along with encroachment of adjacent woodland tree species such as Single leaf Pinyon pine and One-see juniper. While there is some large woody debris present in the drainage, the actual channel is deeply incised much of the entire length except the upper 1 mile reach which is stable and considered properly functioning at present. Incised channeling in lower reaches, especially downstream of the confluence with Oak Canyon, has resulted in a loss of water availability for regeneration of woody and herbaceous species. While the present grazing program does provide for recovery of grazing effects, it cannot address invasive woody encroachment, lack of woody debris and deposition of fines for seedlings, and loss of flood plain function. The entire 2.5 miles is classified as a riparian drainage type, although perennial flows only occur in the top 1.5 miles of the canyon.

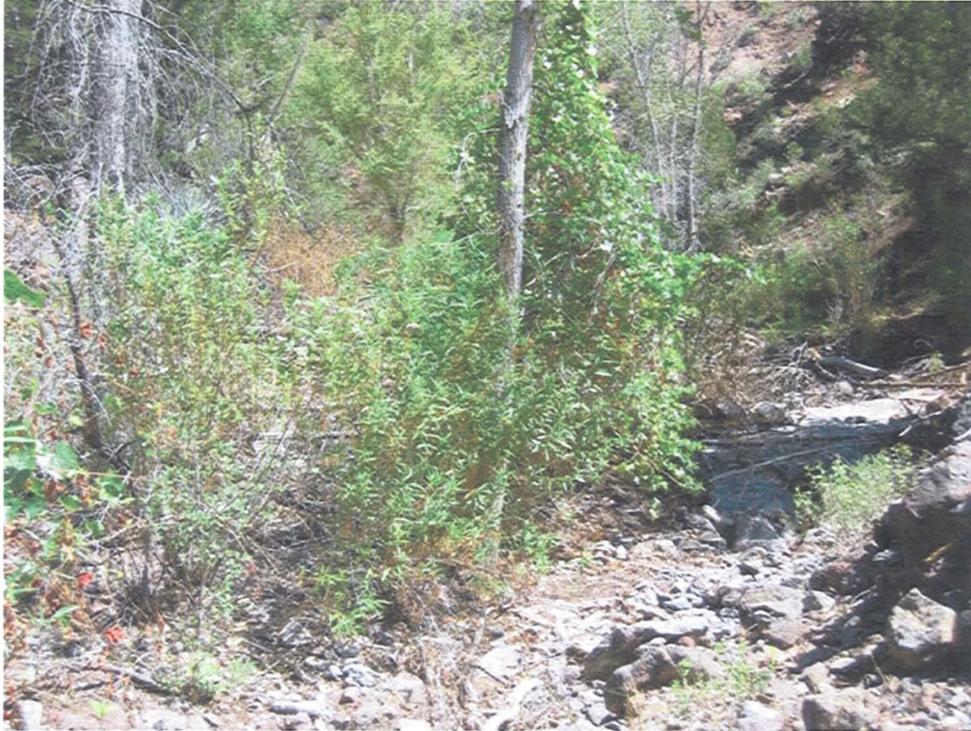
The picture above is within the deeply incised drainage area of Indian, and below most of the old growth galleries where perennial flows are found. Note lack of perennial flow in this picture.

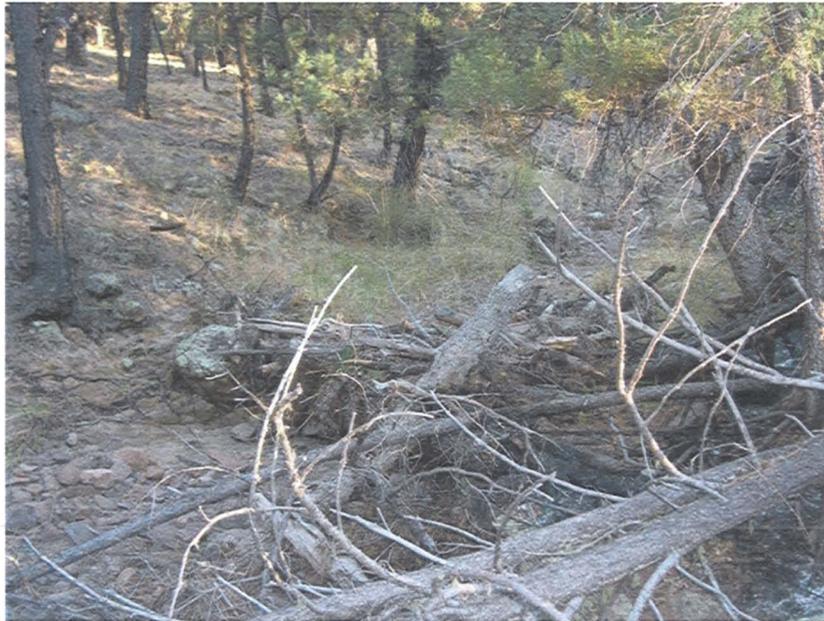
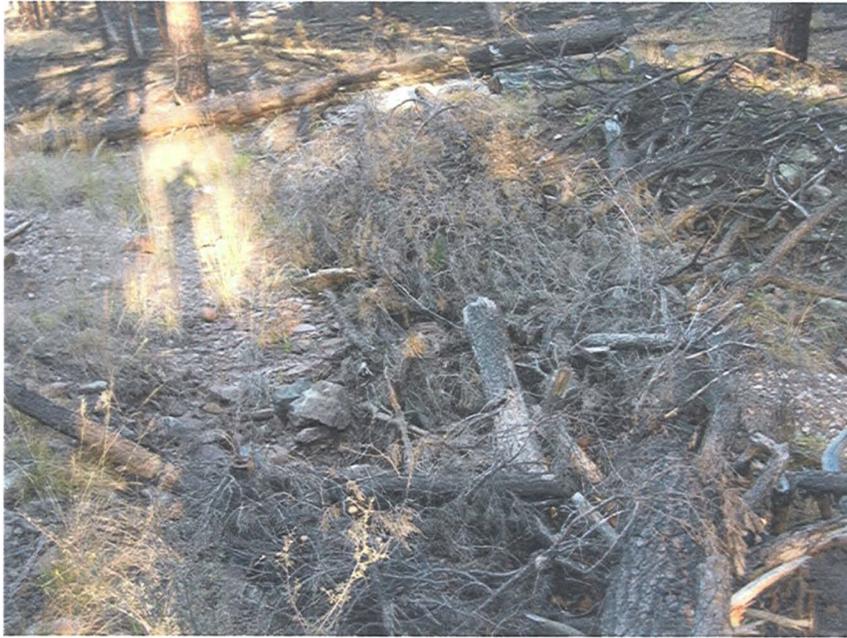
Photographic examples of debris jams created using local trees to felled to initiate woody debris establishment in an ephemeral system. Note the establishment of riparian woody species following one or two years of effective high flows followed by rest from ungulate grazing.

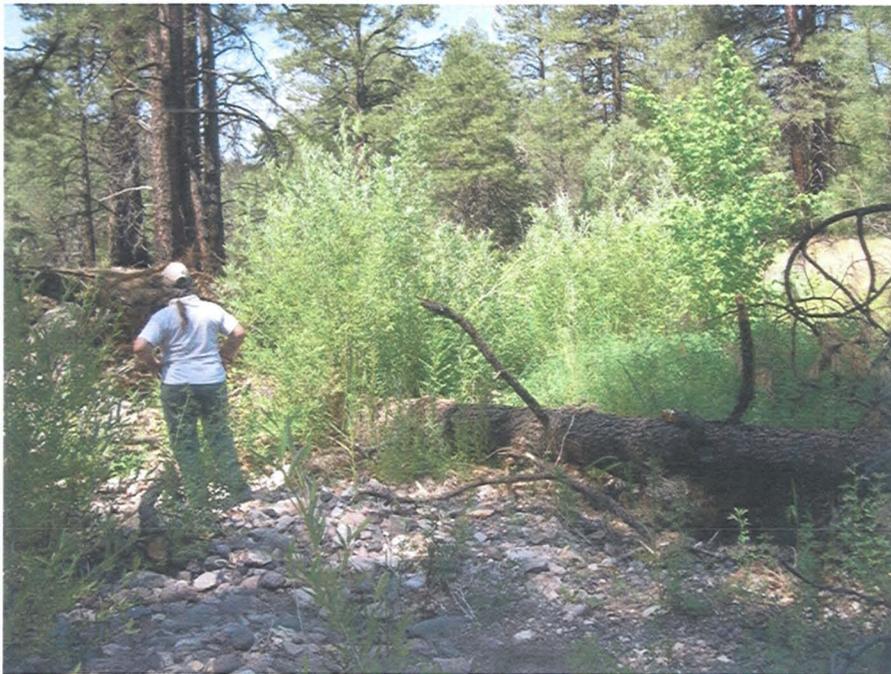
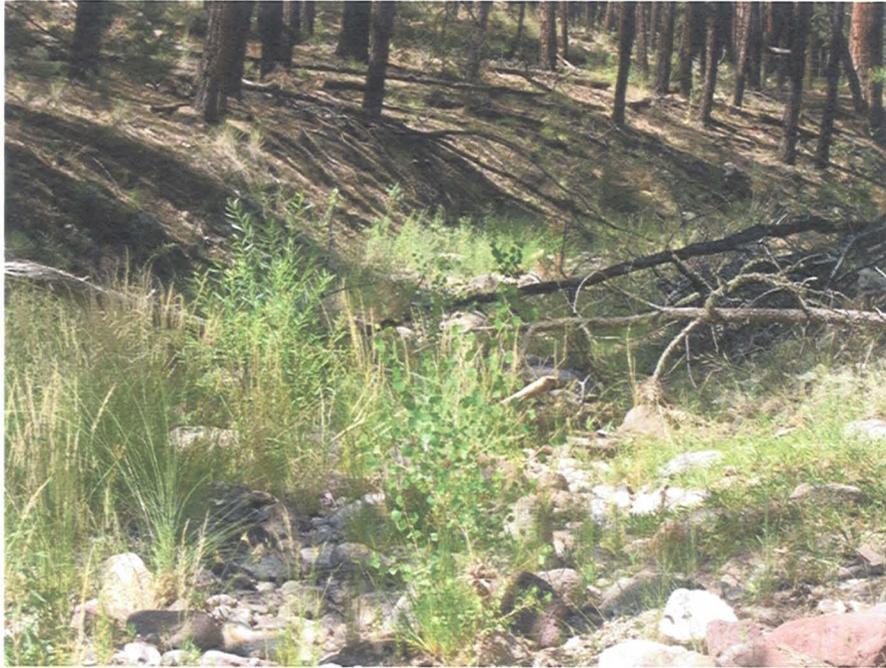
Re-establishment of riparian woody species following deposition of fines downstream and upstream of large woody debris jams created in Upper Sheep Wash.

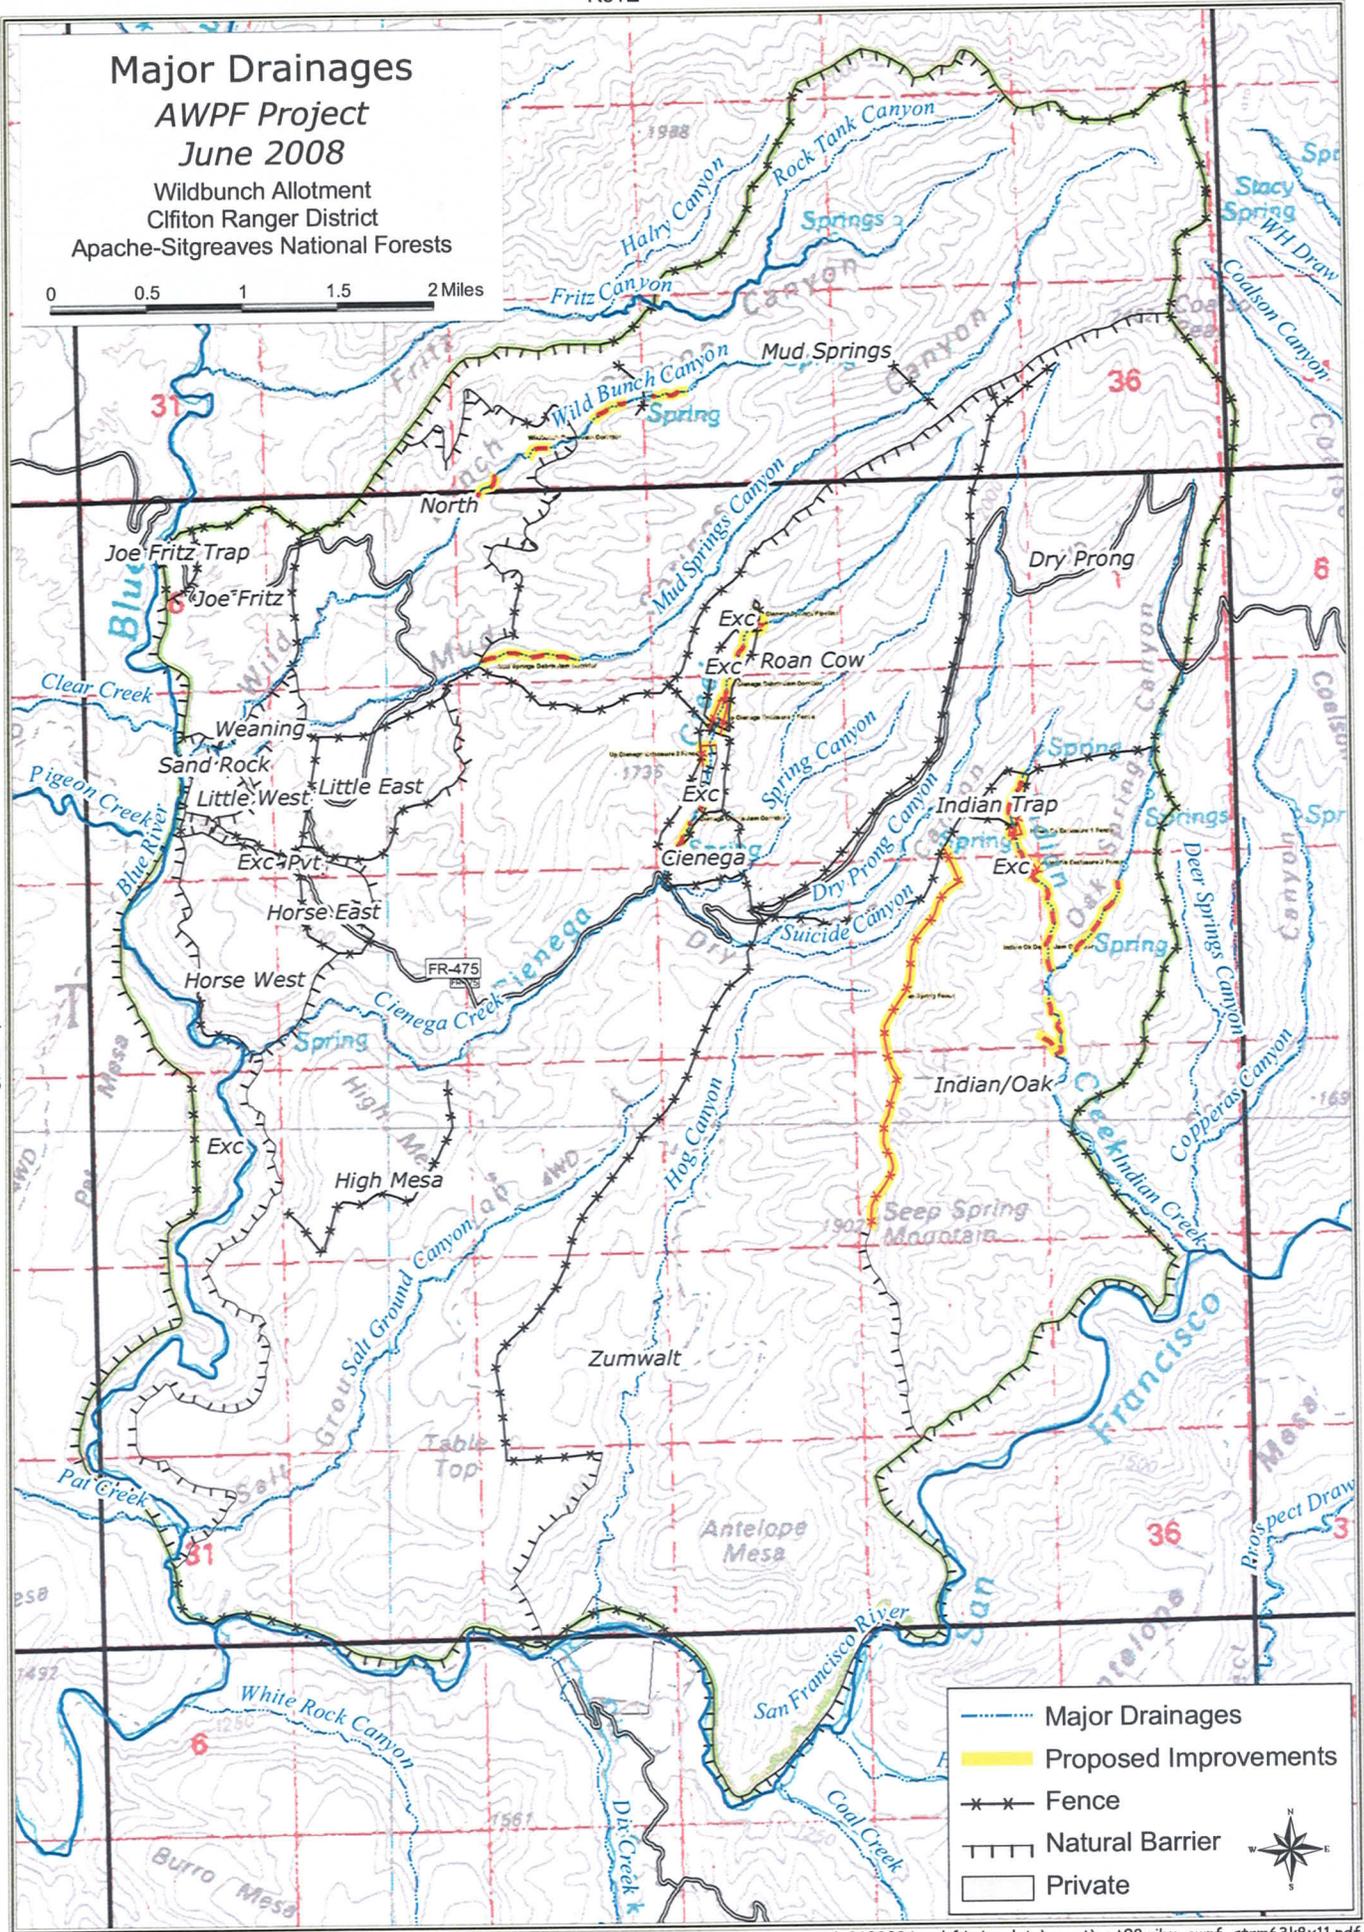
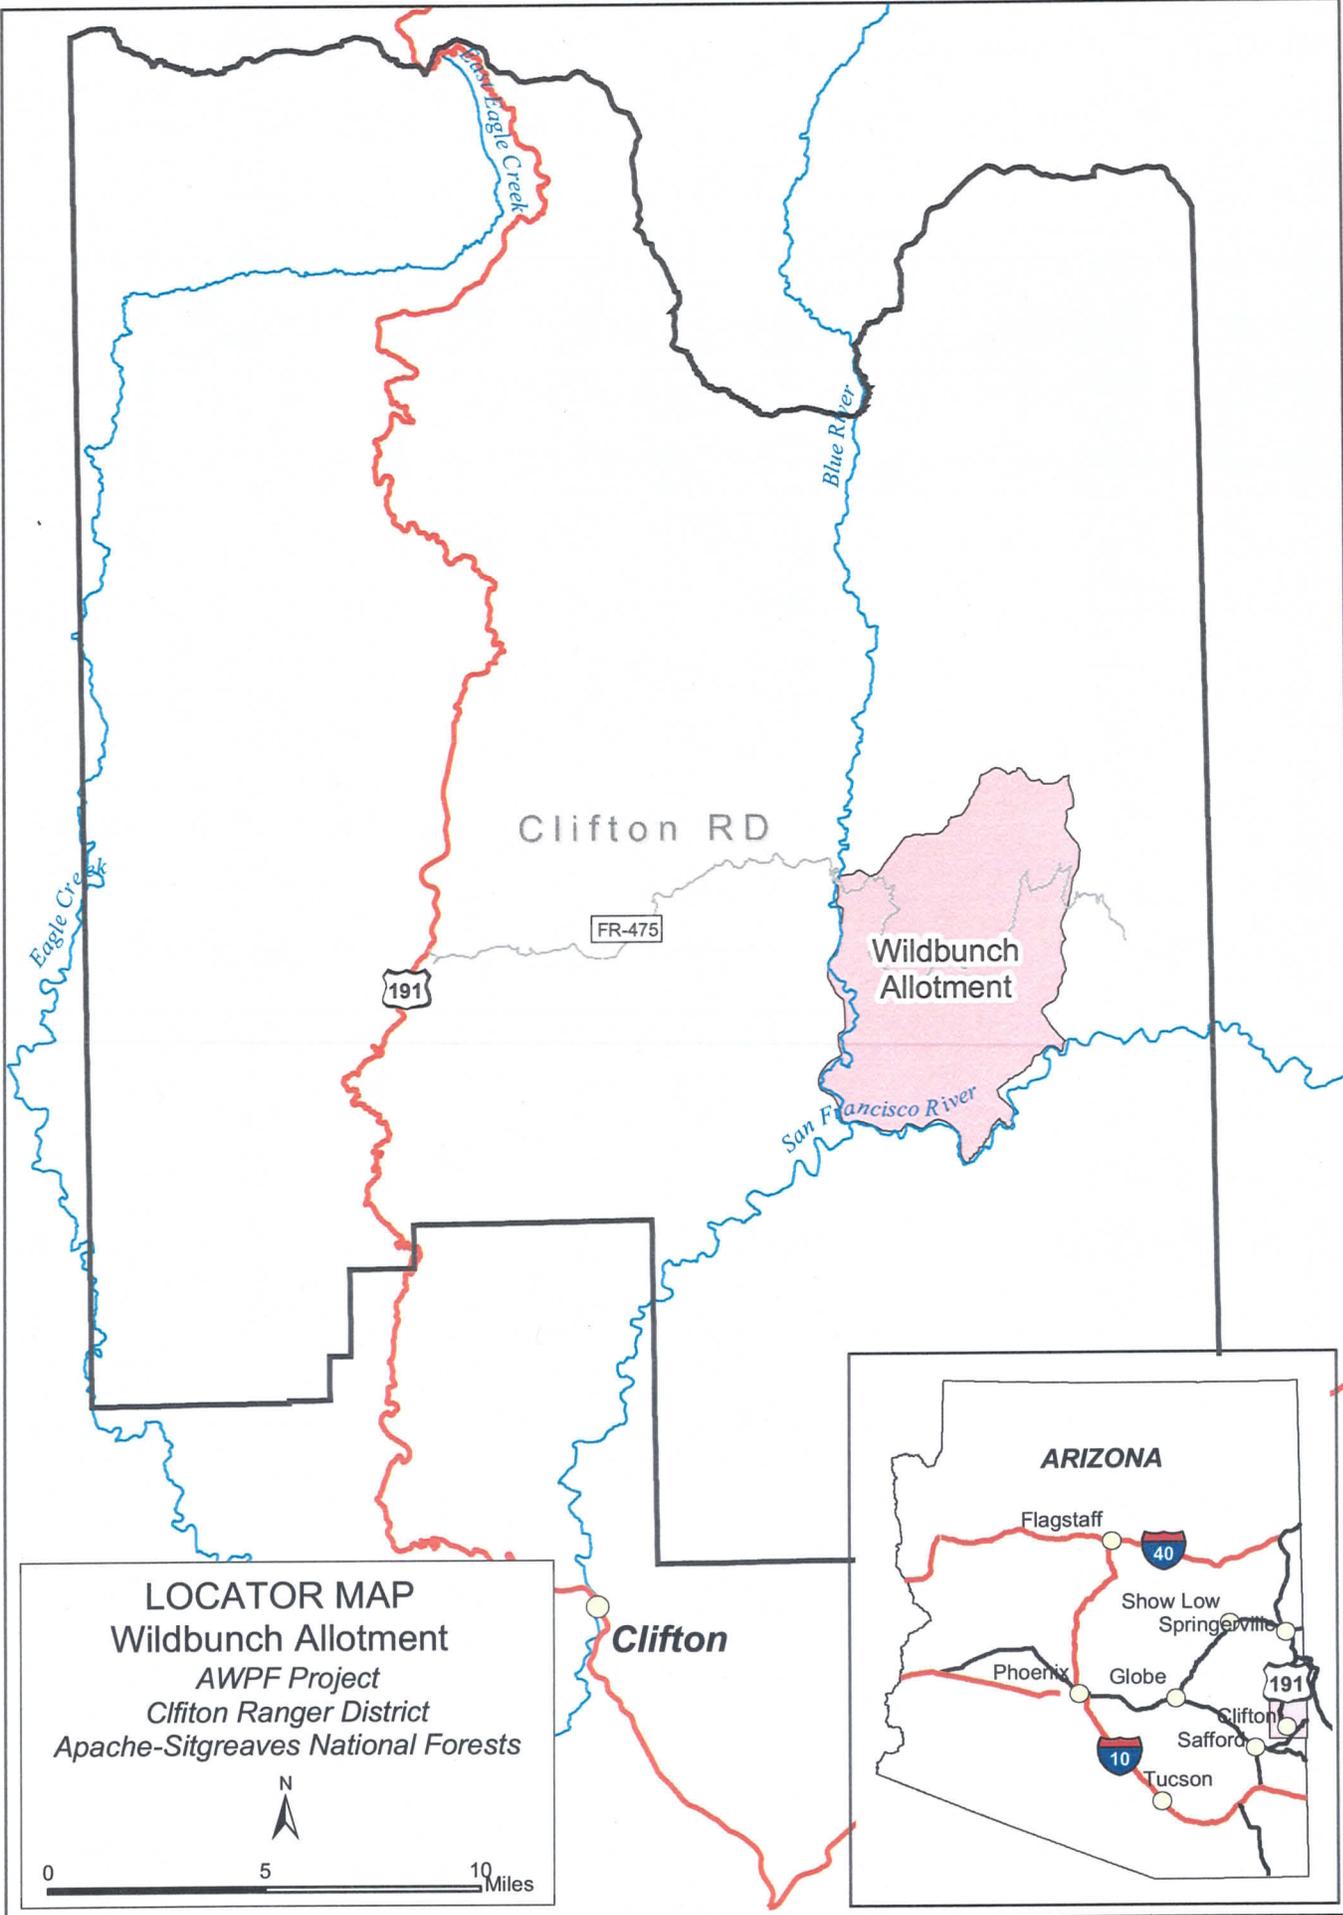
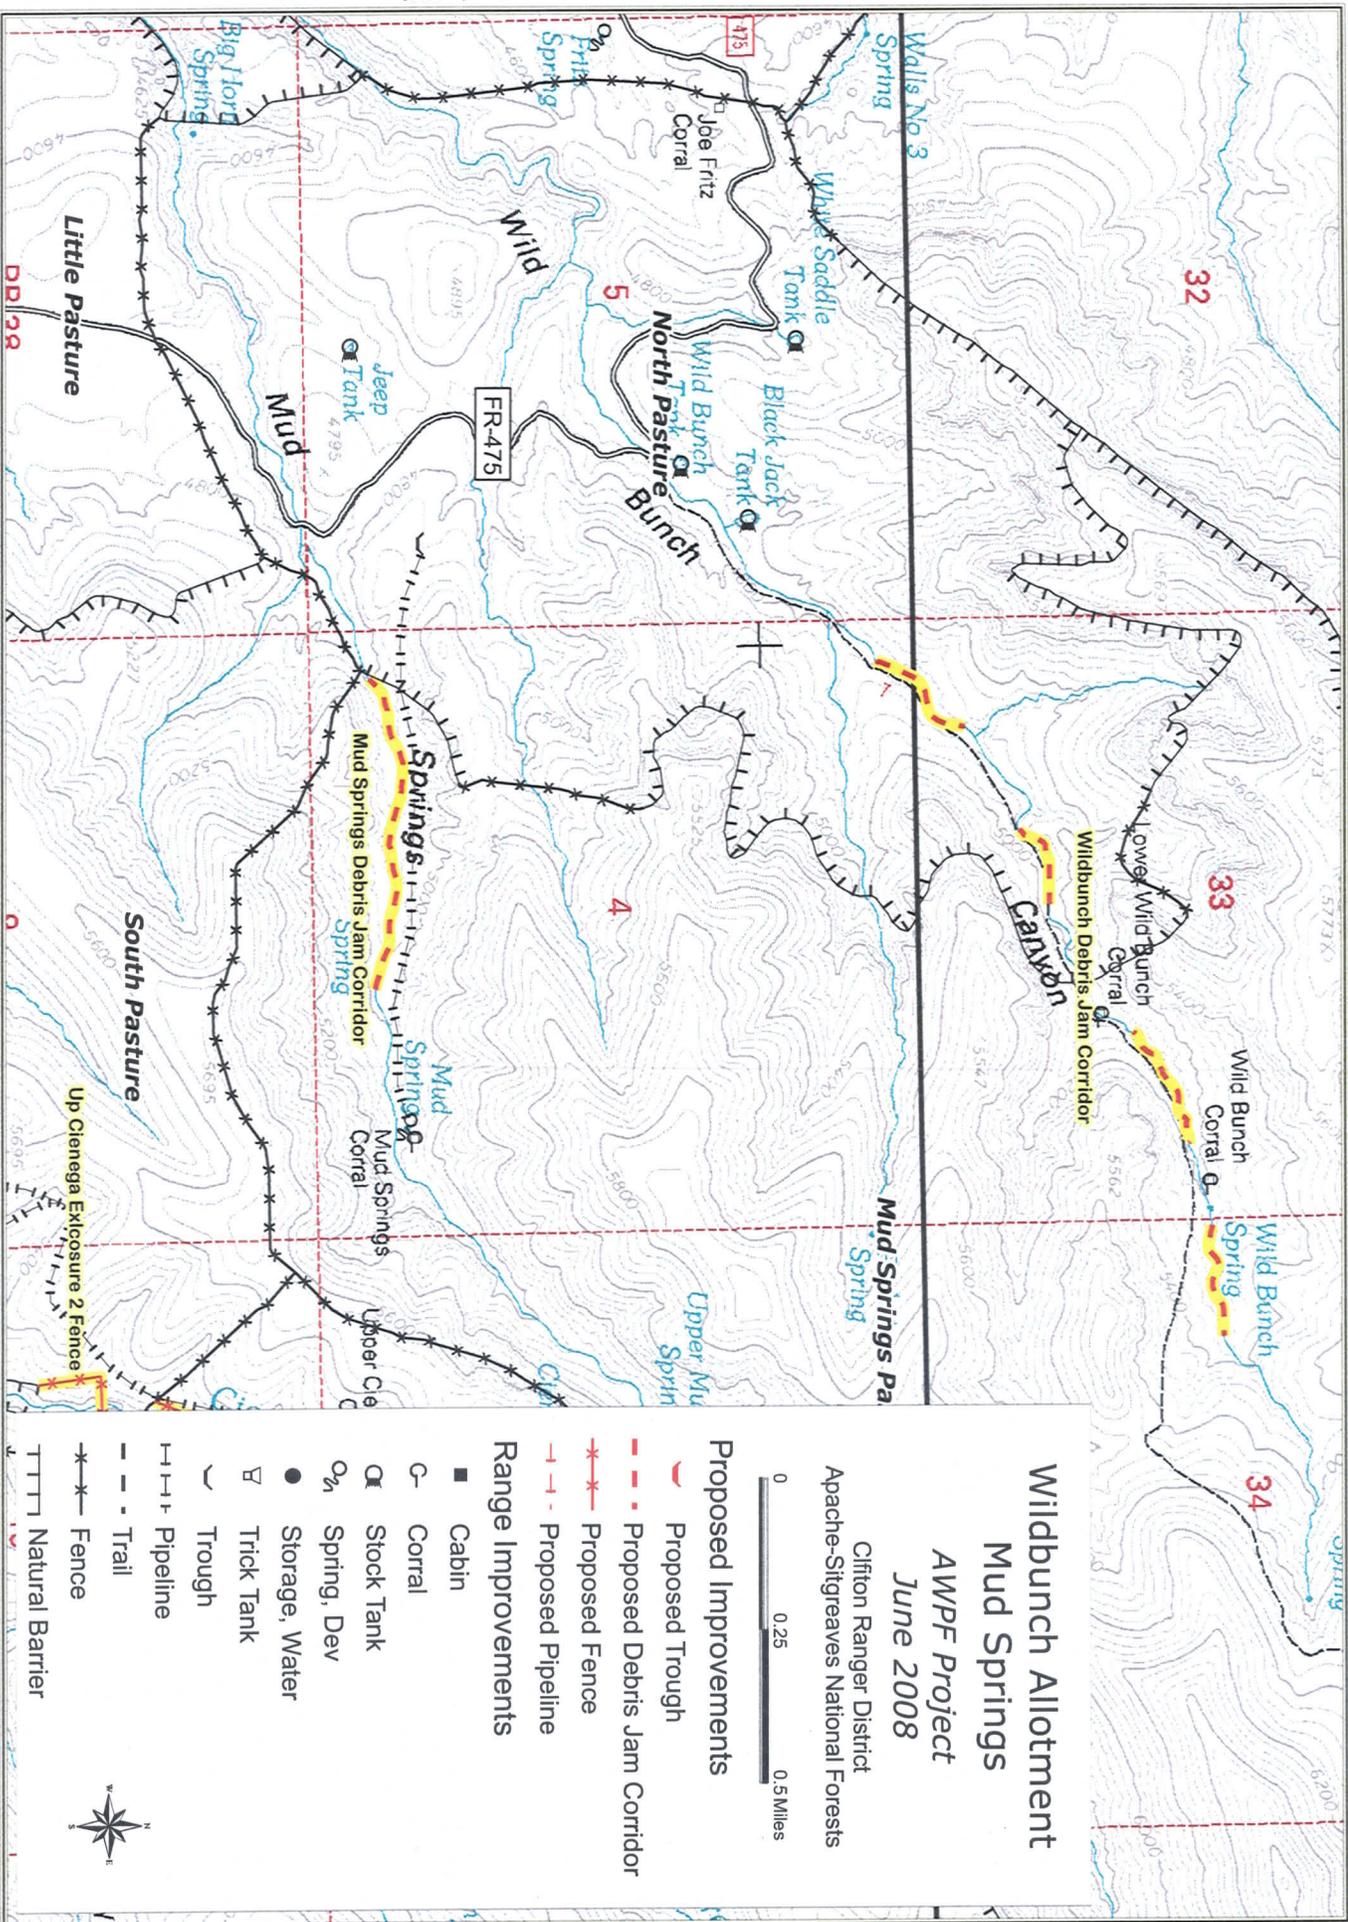
Major Drainages
	Proposed Improvements
	Fence
	Natural Barrier
	Private
