**Arizona Water Protection Fund
Application Cover Page
FY 2024**

R-C POND AND CHRISTOPHER CREEK RESTORATION PROJECT

CONCEPTUAL POND & STREAM IMPROVEMENTS CHRISTOPHER CREEK AT R-C SCOUT RANCH

Conceptual Design Assessment

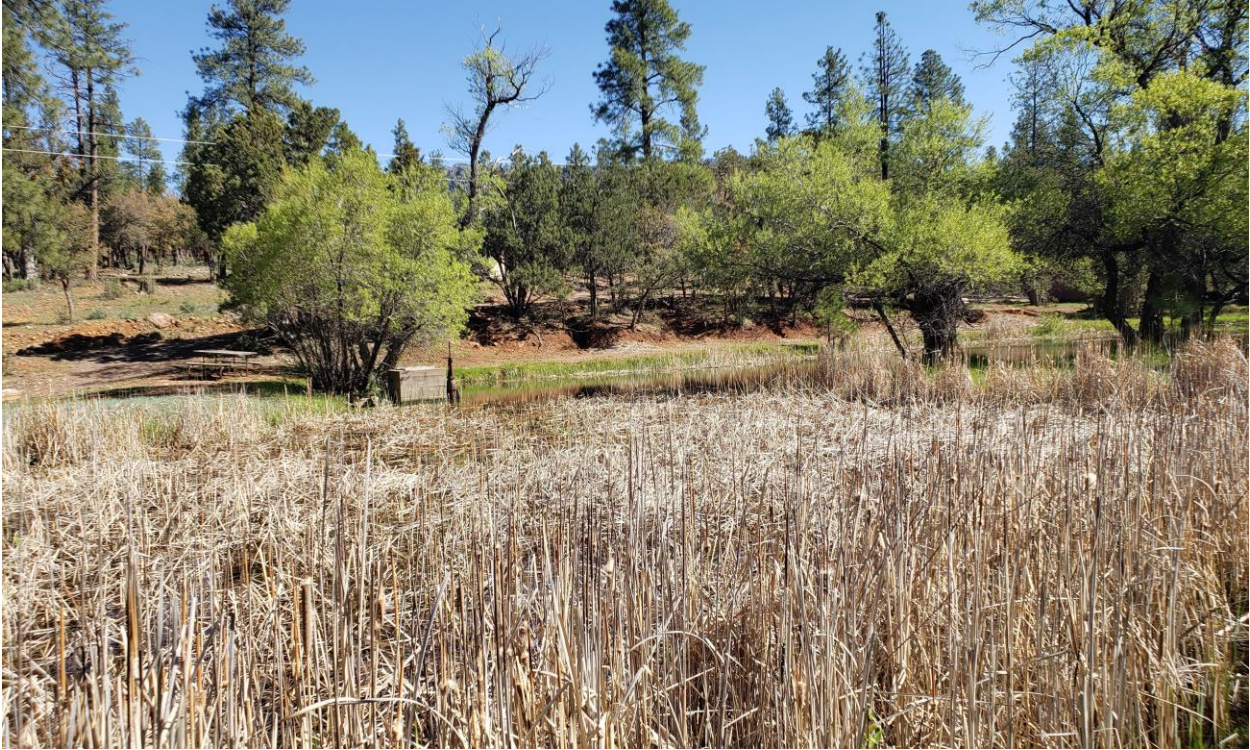
1 Early Picture of overgrown pond

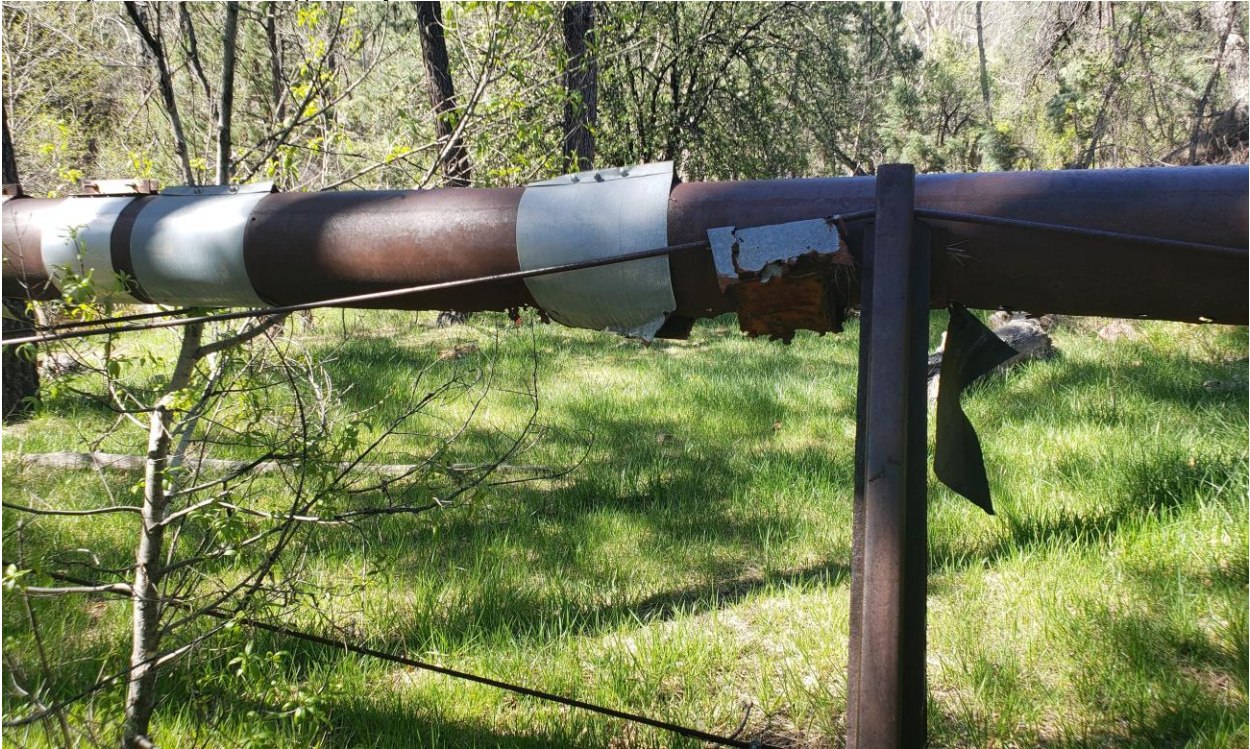
2 Aging pipeline

Task Description: Install a water pipeline from the existing spring, replacing the aging, leaking, failing circa 1946 metal and PVC aerial pipeline with a new underground pipeline.

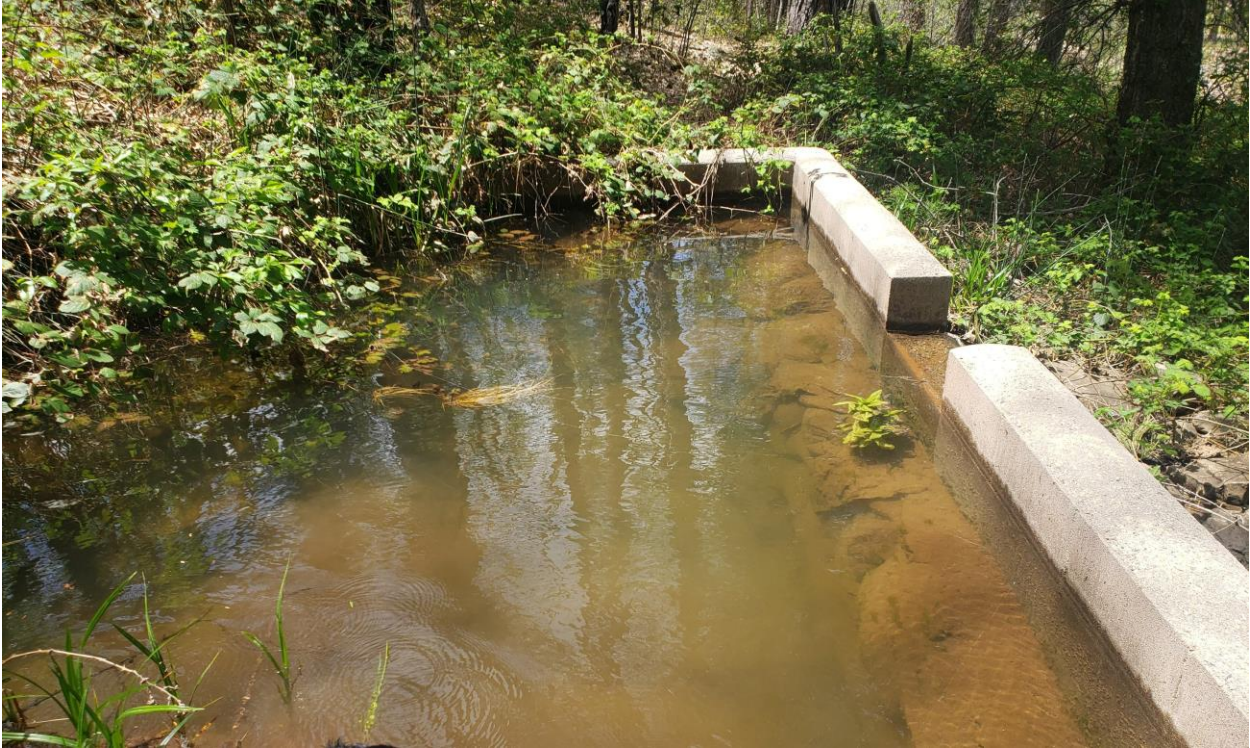
3 Spring Box

The existing spring box is in poor condition. The original spring box went dry as the spring outflow migrated away from the original structure. The newer structure has been undermined and spring flow passes below the walls in several areas. Building the new structure and keying the walls into 12-18" bedrock are key factors in replacement of this spring box.

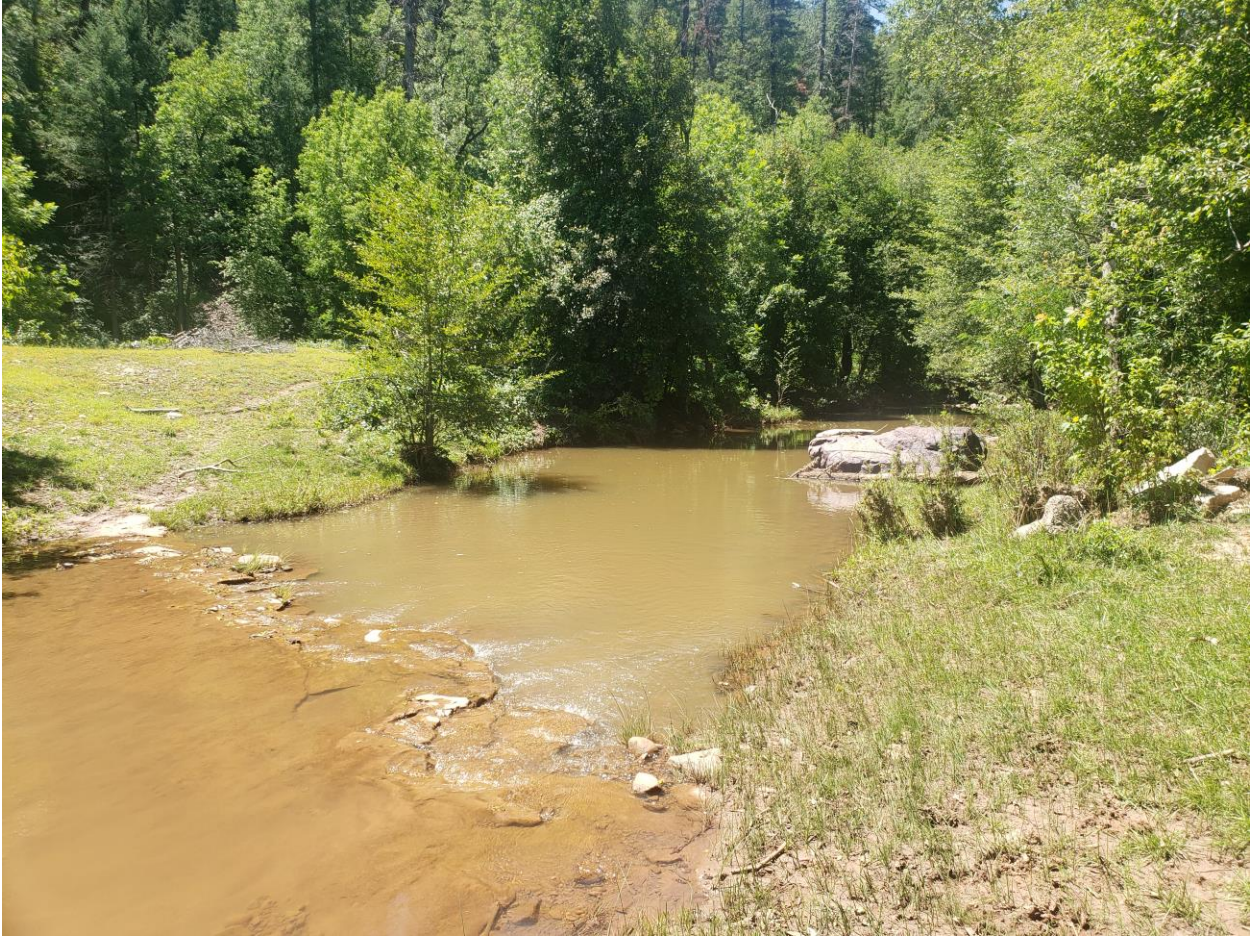
4 Christopher Creek looking downstream, post highwater event

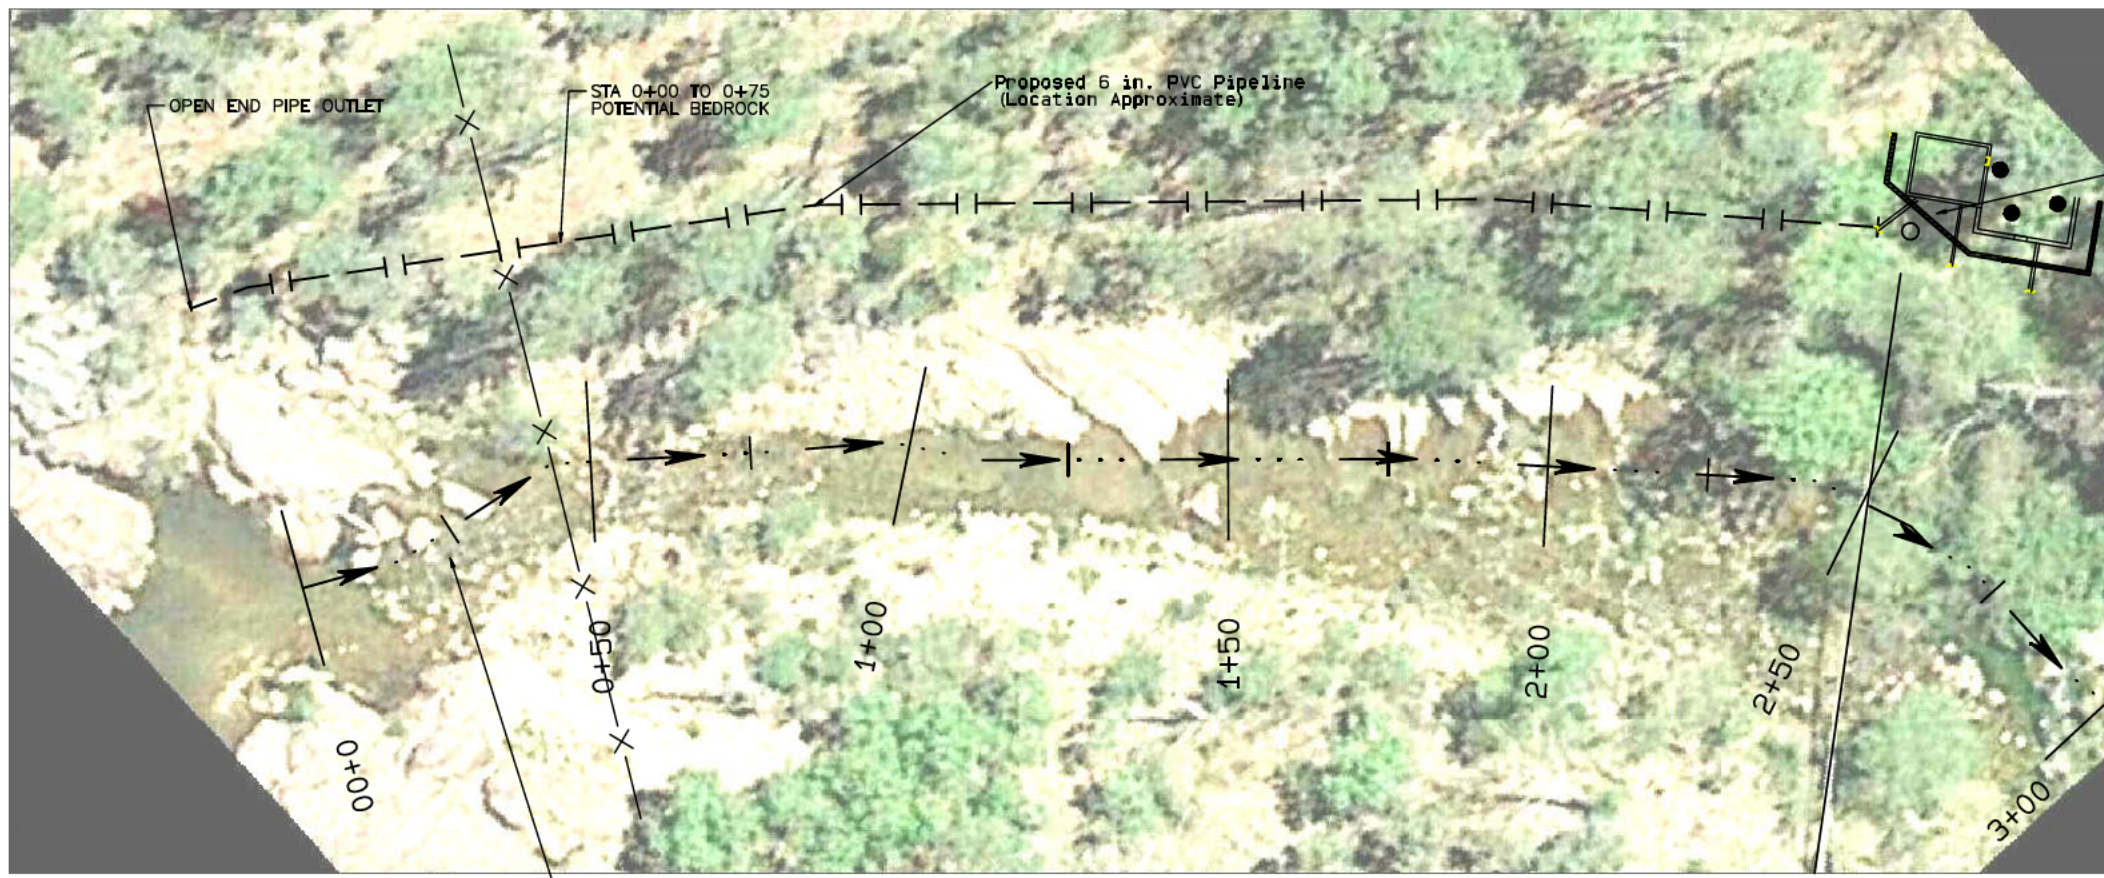
FLOW CONTROL SYSTEM AT SPRINGBOX PROFILE VIEW
(Not to scale)

Pool outlet riffle ele. 5535.5

Appx. ground at spring outlet ele. 5546.4 ft

PRELIMINARY NOT FOR CONSTRUCTION	NEW PIPELINE UPSTREAM CONCEPTUAL PLAN AND DETAILS	POND & STREAM IMPROVEMENTS CHRISTOPHER CREEK AT R-C SCOUT RANCH GILA COUNTY, AZ
DRAWN BY: MW, JF DESIGNED BY: MW, JF, AH, JE REVIEWED BY: NO. DATE BY REVISION	DRAWING NUMBER: DTI-02 DATE: 17 Dec 2020 NCD PROJECT NUMBER:	SHEET NUMBER: 11 of 11	2900 N. WEST ST. #5 Flagstaff, Arizona 86004 (928) 774-2336

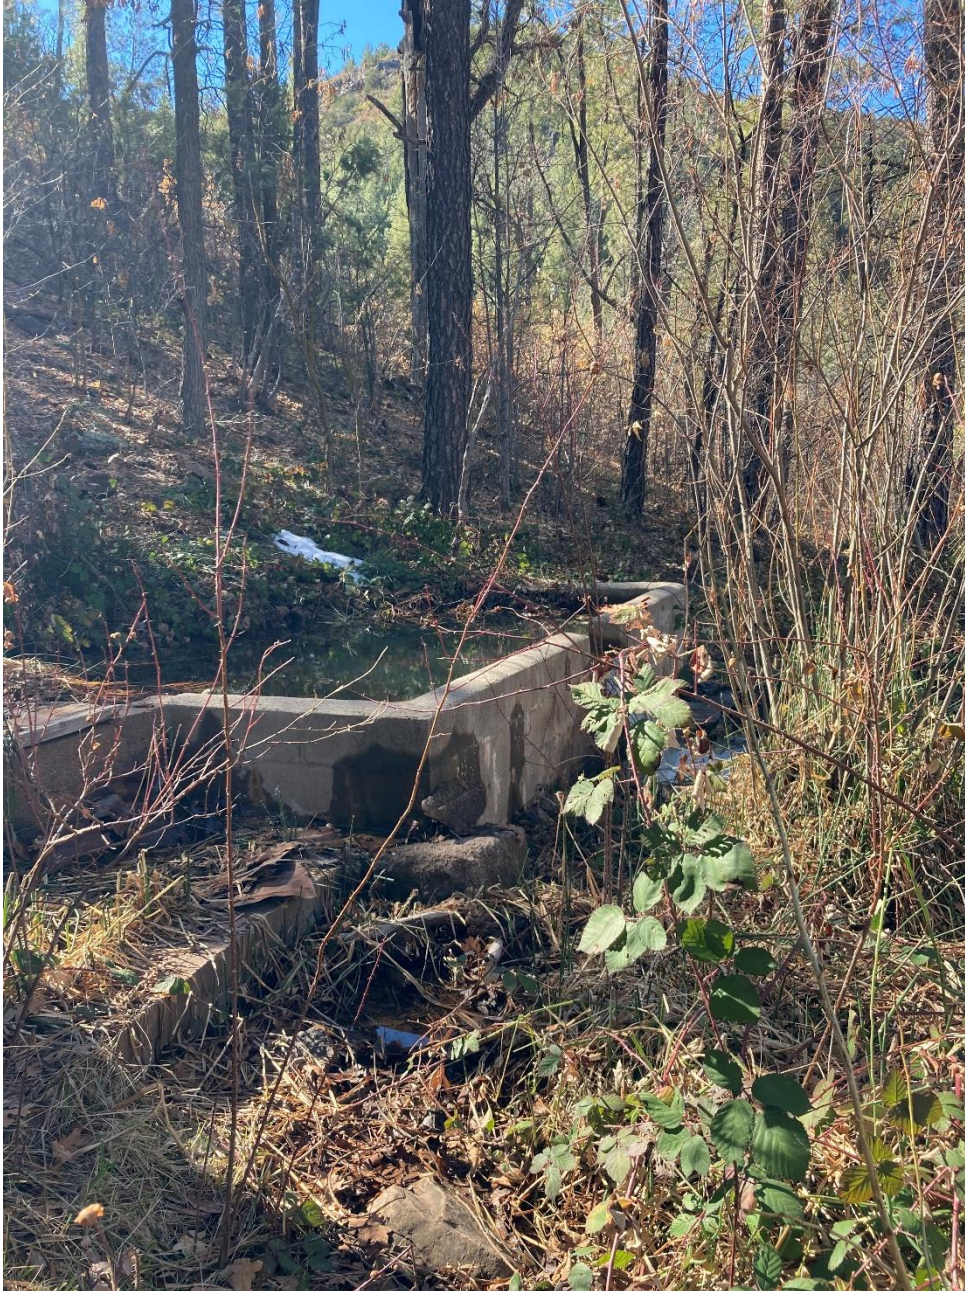
Photograph 1: Photograph of the existing spring box. The spring box leaks in multiple locations.

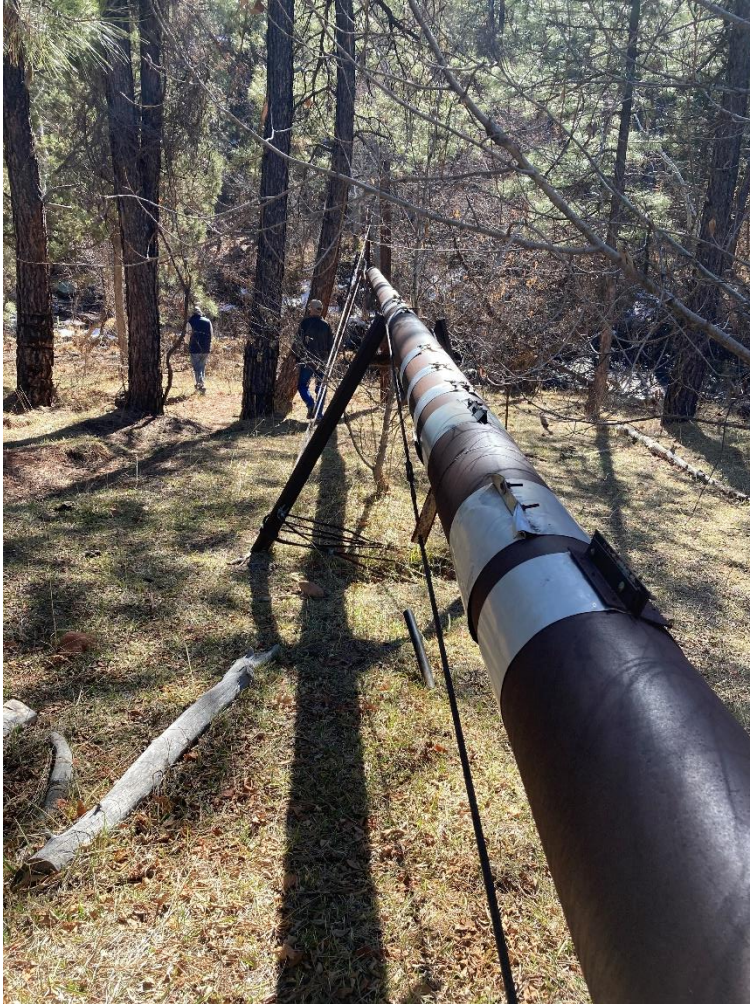
Photograph 2: Photograph of current piping that delivers water from the spring box to the pond. The pipe is elevated above Christopher Creek.

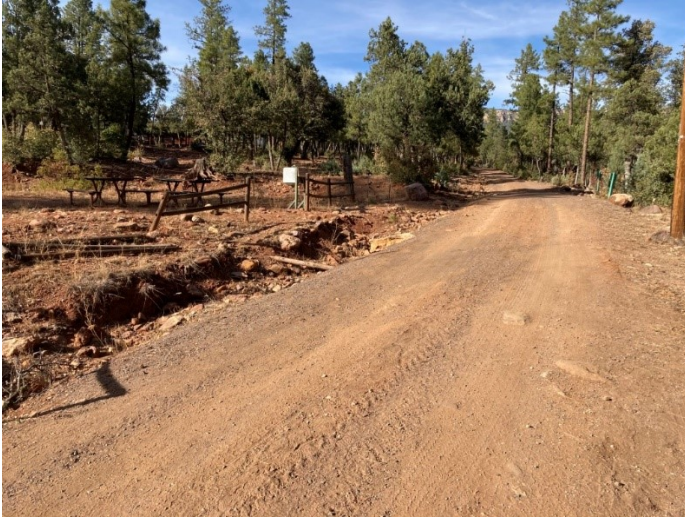
The road servicing the campground is the major source of sediment to the pond. The pond was recently dredged to provide the original volume and needs to be protected from further sediment deposition and degradation. The existing road drainage does not allow for water gather on the western (uphill) side to cross the road at regular intervals. This leads to increased erosion in the roadside ditch and to the road itself (Figure 3). Additionally, the road has sections which drain into the pond, adding sediment to the pond.

Figure 3. Existing road drainage

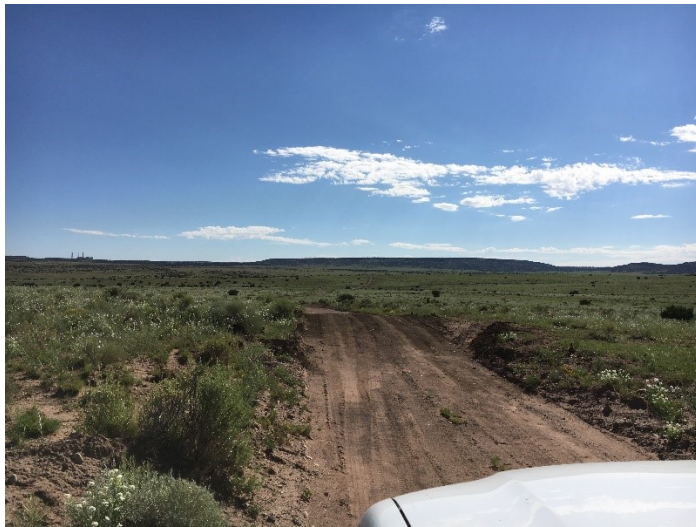
The road design will be to drain the road surface away from important infrastructure and to install road dips to allow water to cross the road. The rolling dips are a low point in the road with a raised section of road downstream of the dip. This pushes water across the road and allows it to spread out before it becomes too concentrated. The road dip design and spacing is based upon a NRCS specification from Apache county, Arizona. Each dip is spaced from 95 to 115 feet apart based on the slope of the road (6-11.4%). At the outlet onto the hillside from the dips, a small rock spreader structure will be installed to spread water and minimize erosion.

Figure 4. Rolling dip installed on dirt road in Apache County

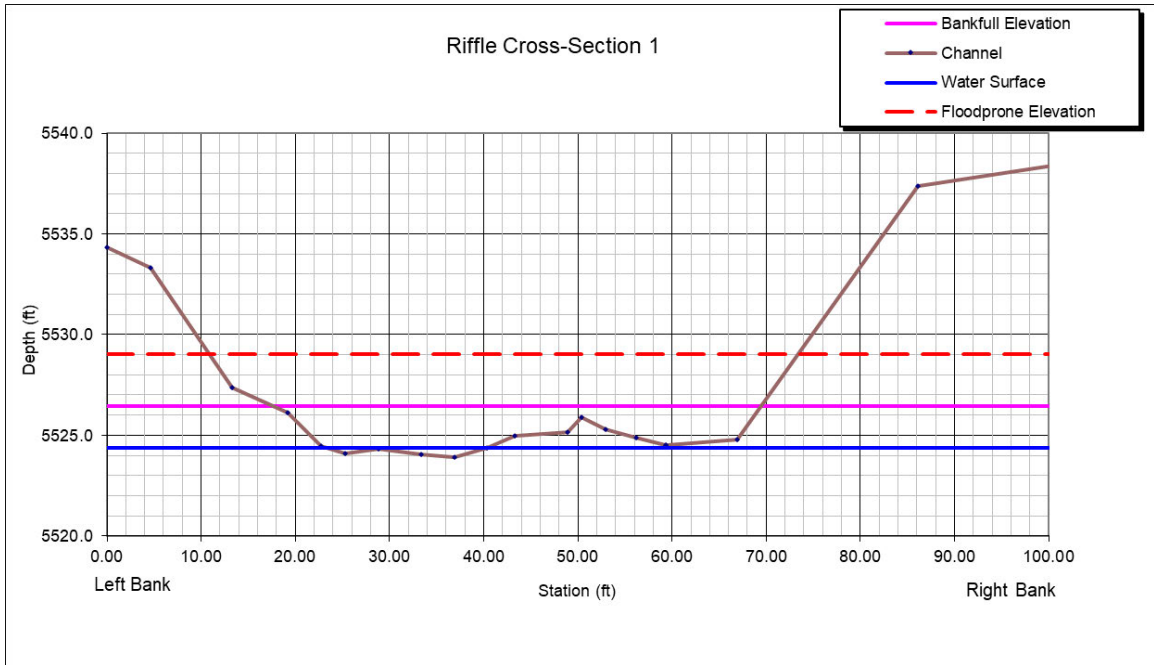
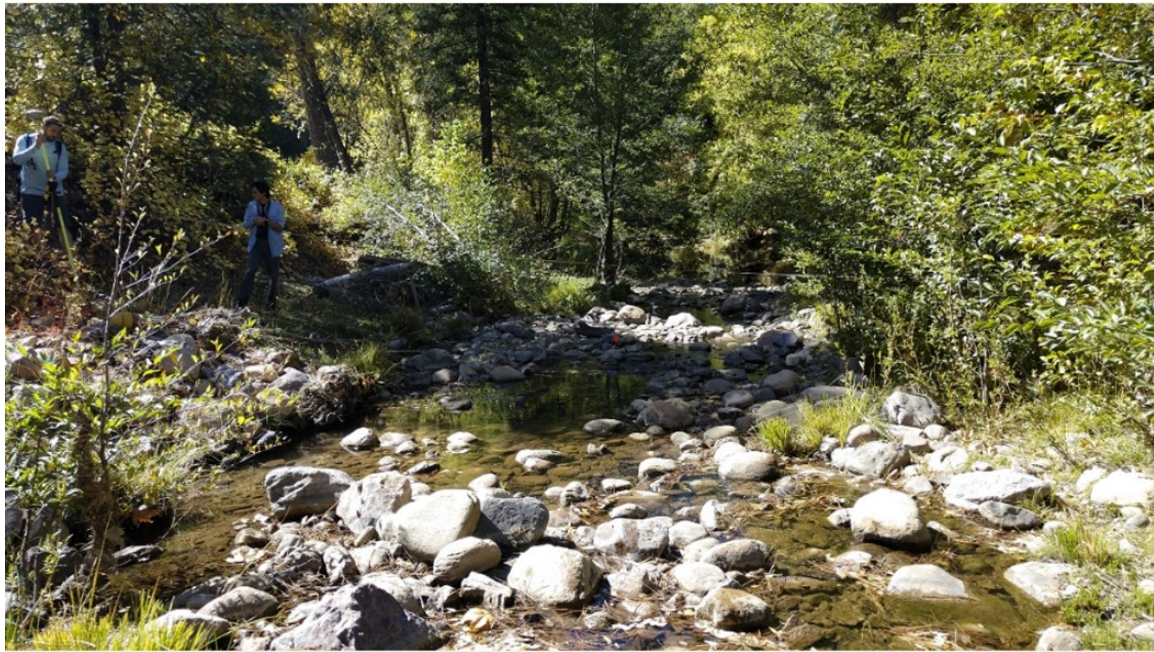
Riffle 1 at low water(base flow)

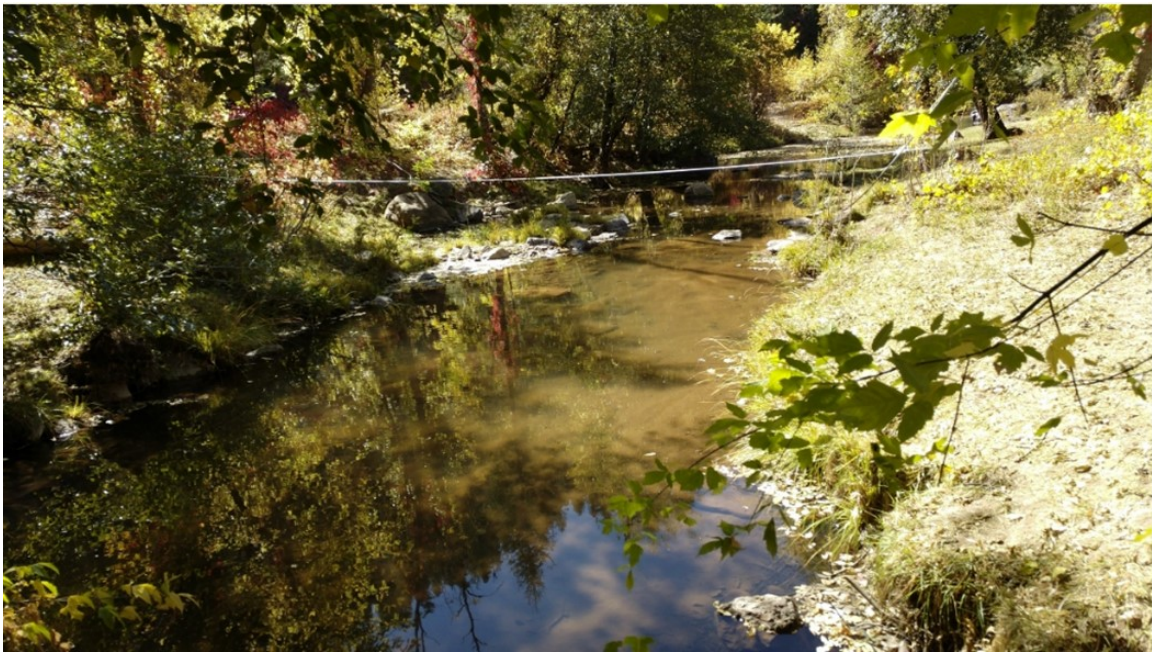
Shallow, bedrock dominated pool at low water

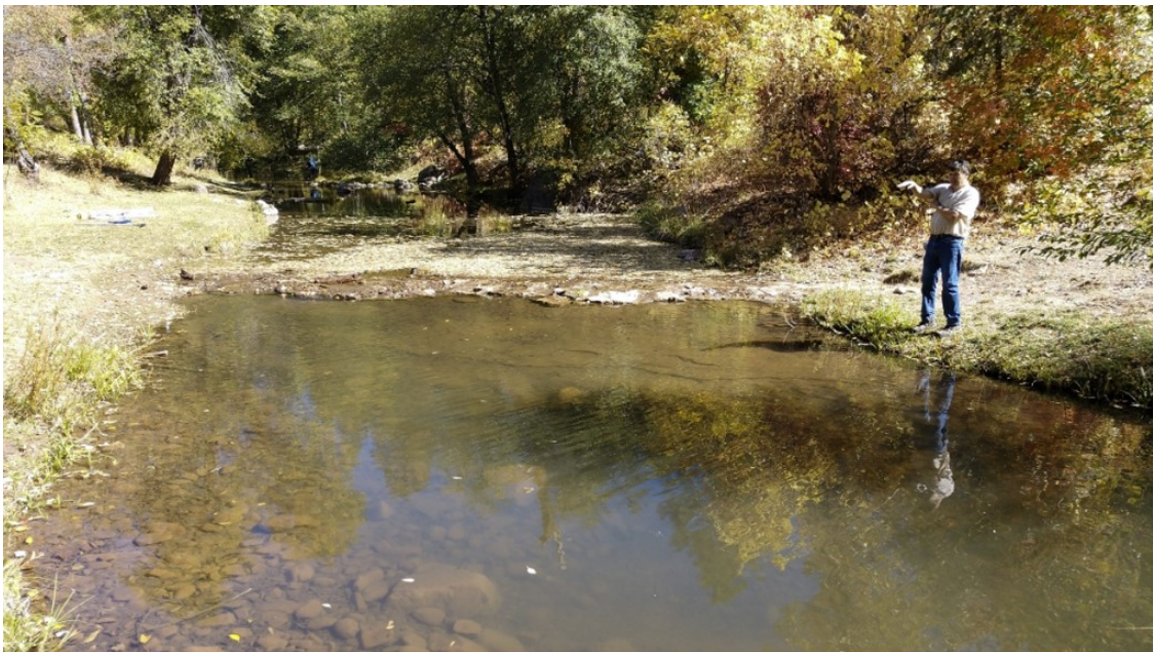
Bedrock dominated riffle utilized for stream crossing. Wide shallow flows likely prohibit fish movement between reaches at low water.

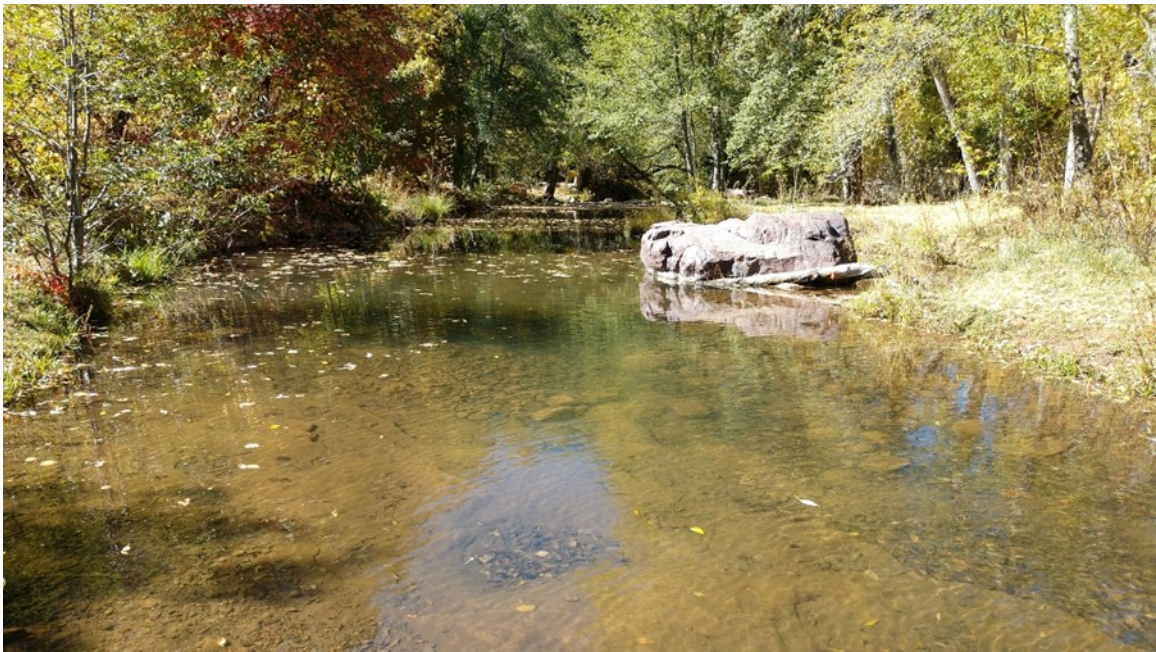
Pool with adequate depth but lacking hiding cover for larger fish.

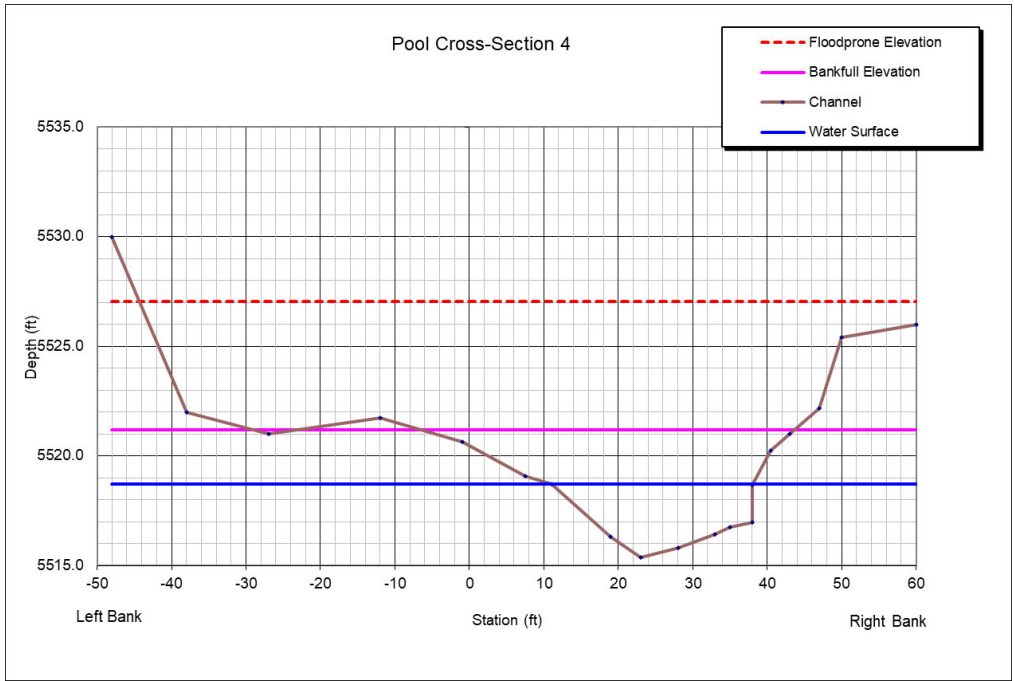
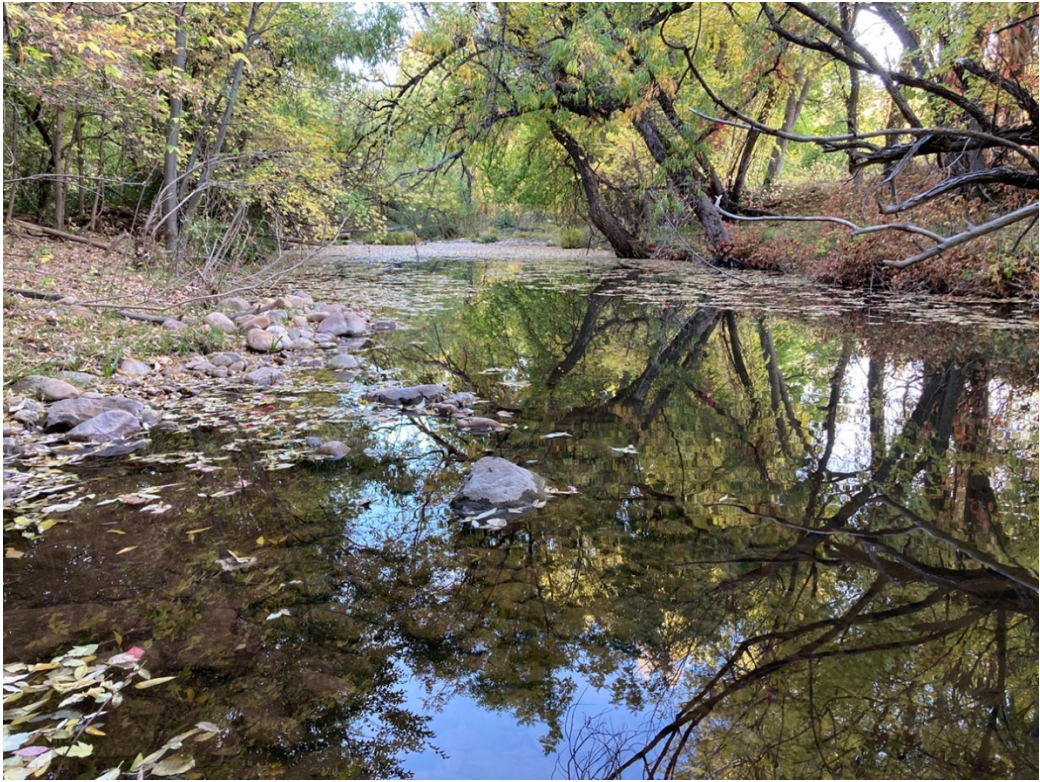
Good condition pool

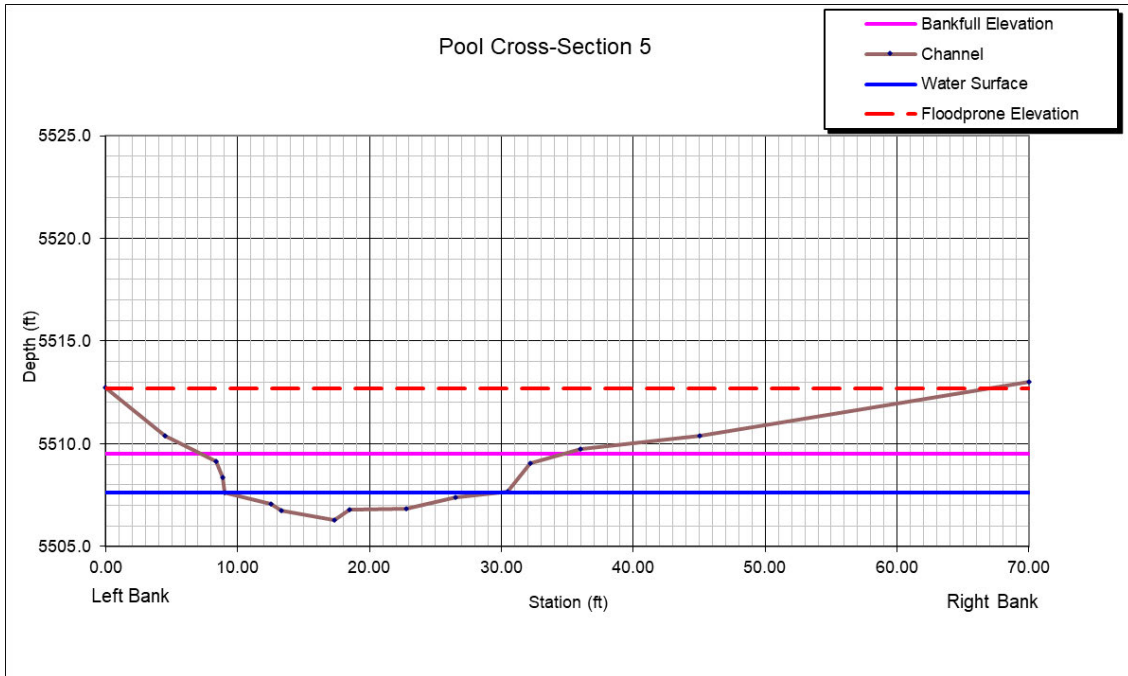
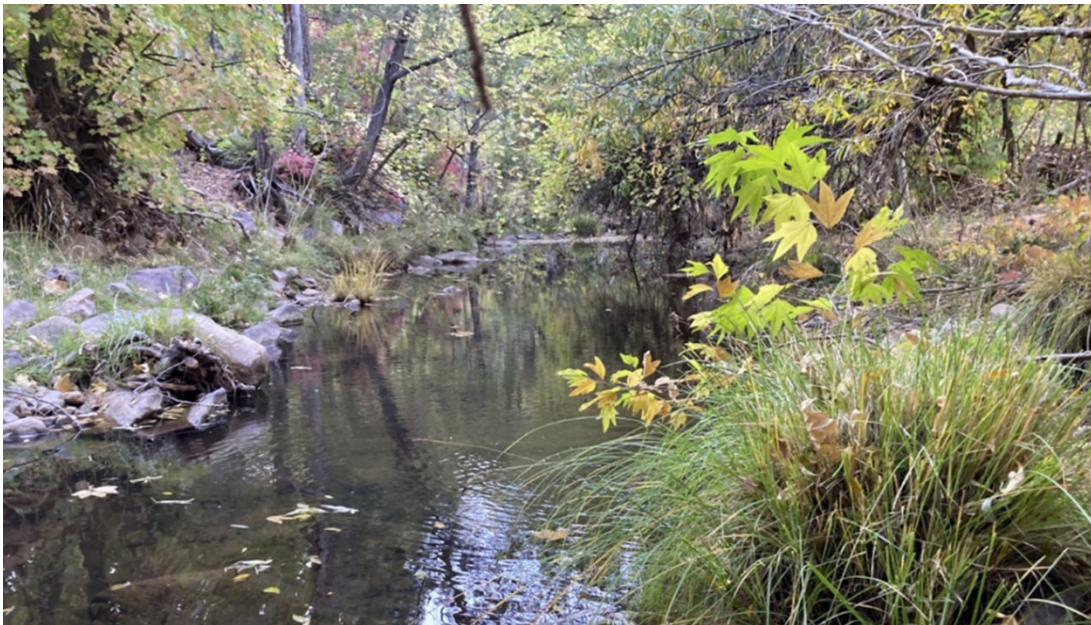
Shallow pool with relatively good alluvial and vegetative cover.

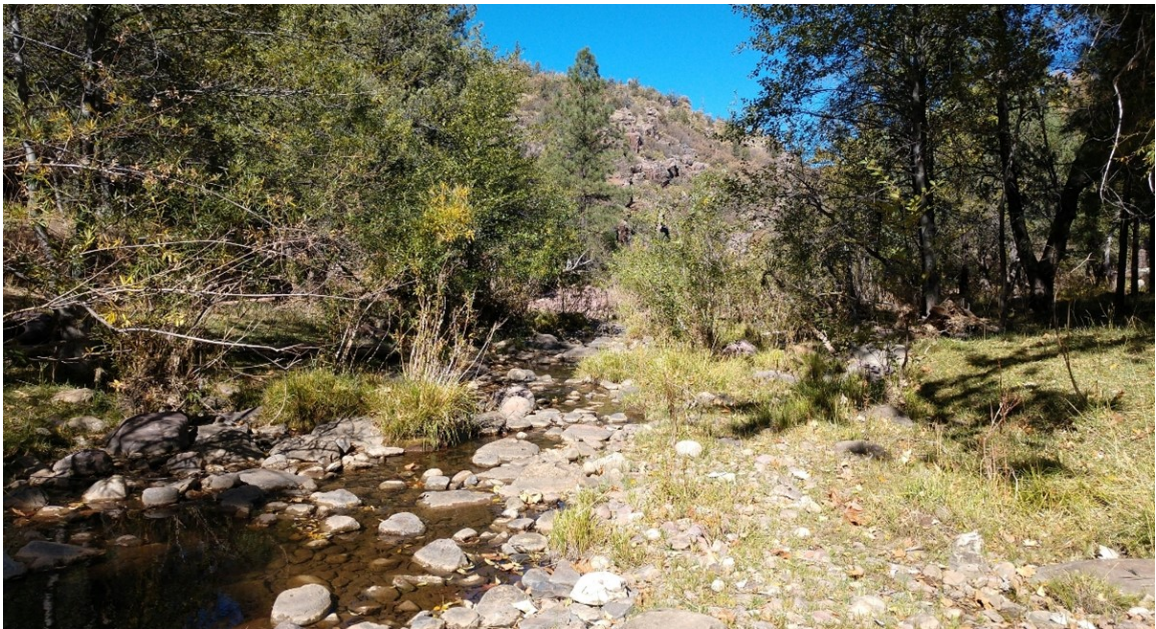
Typical riffle in lower reach.
