REVISED FINAL REPORT
**Test of Riparian Recovery Following Reduced
Groundwater Pumping, Lower San Pedro River**

Arizona Water Protection Fund Grant #08-151WPF

Submitted by: Dr. Gabrielle Katz, Appalachian State University, Boone, NC
May 7, 2010
Revised July 23, 2010

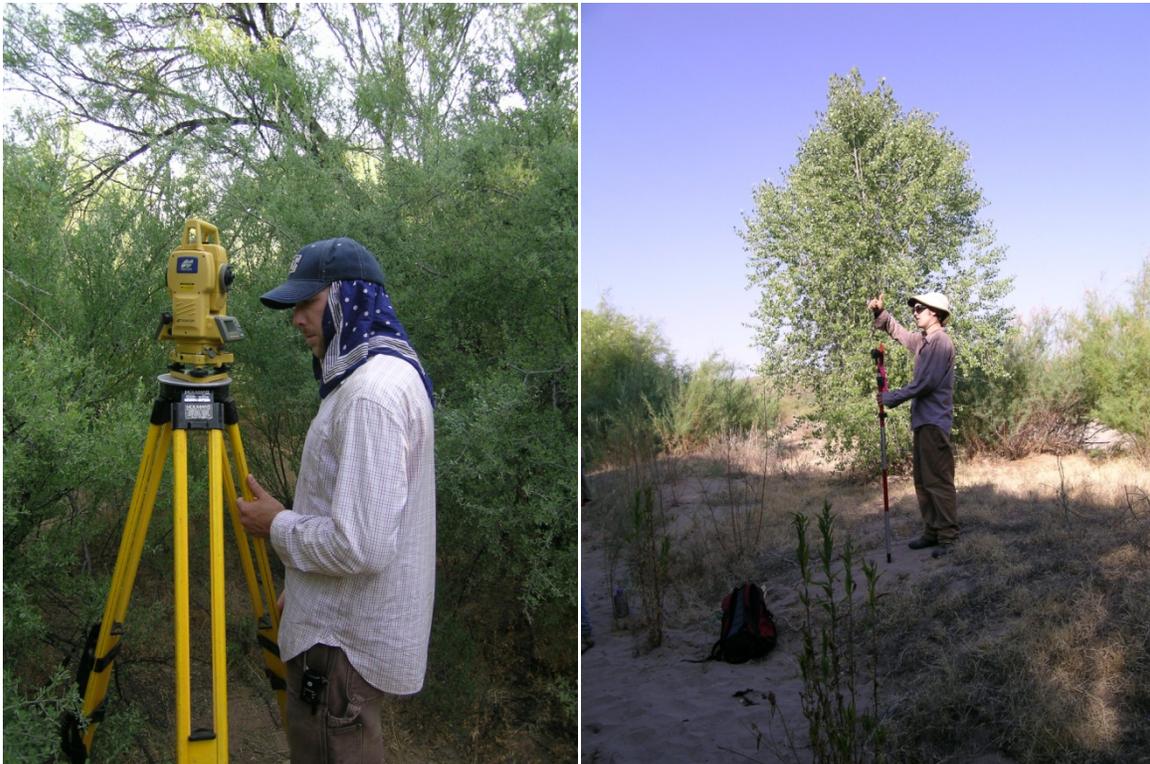
Figure 4. Survey field work. Left panel: the Total Station surveying instrument, rented from Holman's in Tempe, Arizona. Right panel: the prism (sighting target for survey instrument). Photos: W. Gandy.

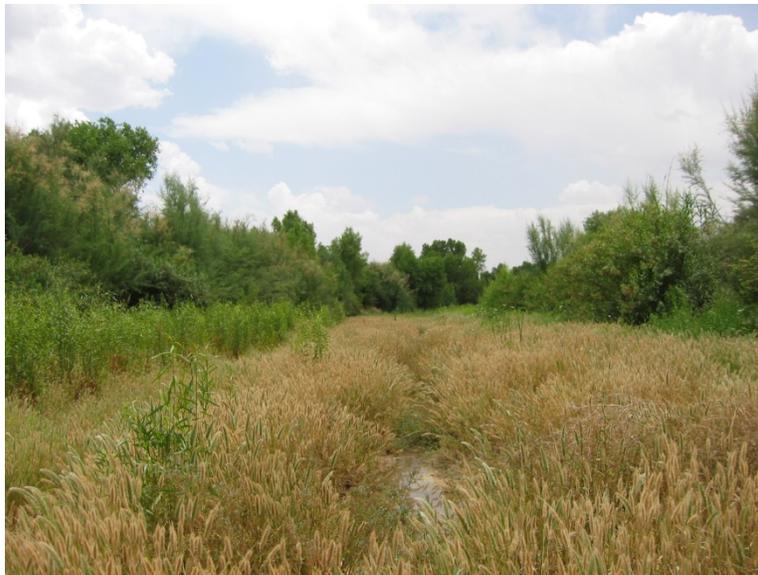
Figure 18. Site 3L2 in 2003. Note high streamside herbaceous cover dominated by the non-native annual grass *Polypogon monspeliensis*, and little streamside shade.

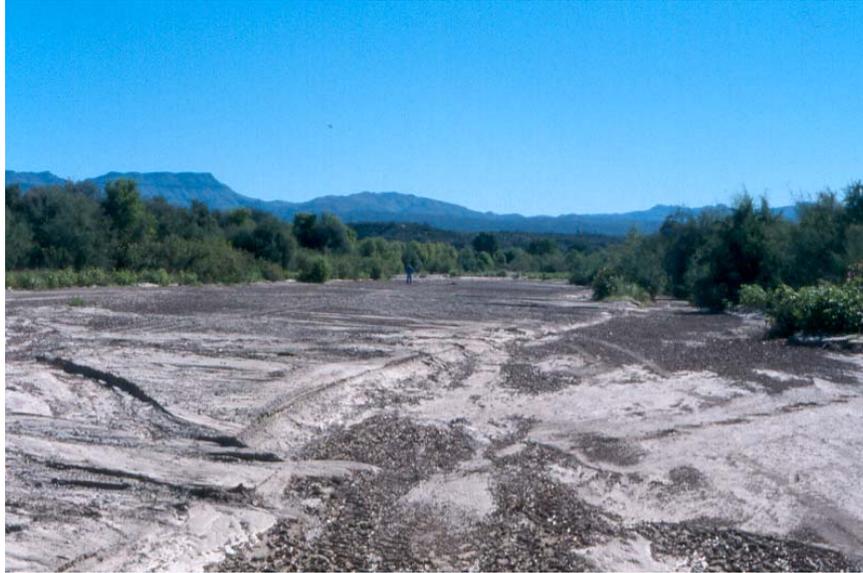
Figure 19. Site HE3 in 2003. Note the wide dry channel with low streamside herbaceous cover and little shade.

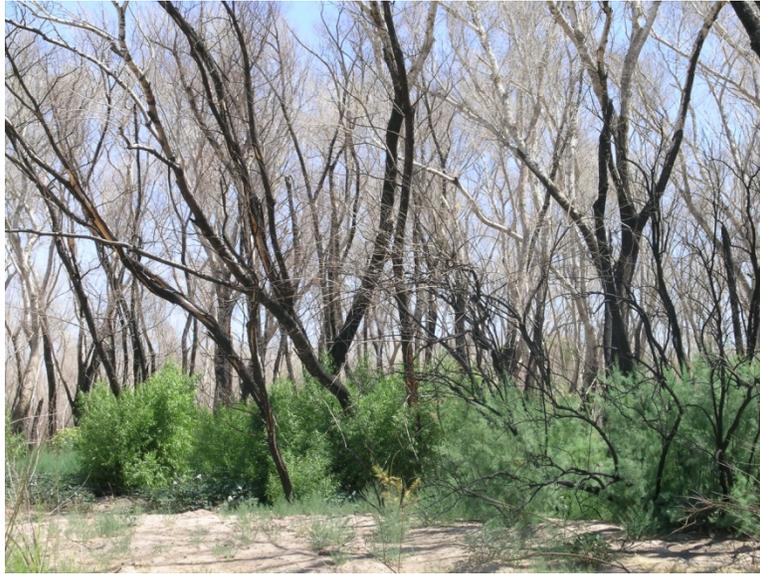
Figure 20. Site TNCP in 2006, approximately one year after wildfire. Former cottonwood forest patch, with dead cottonwood trees still standing and re-sprouting willow and tamarisk in the understory.

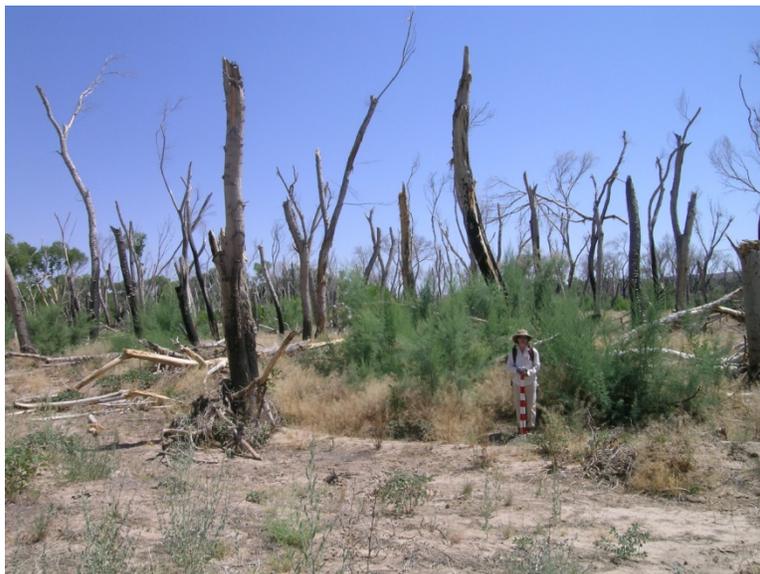
Figure 21. Site TNCP in 2007, two years after wildfire. Former cottonwood forest patch, with some bare stems of dead cottonwood still standing, and re-sprouting tamarisk in the understory.
