YUMA EAST WETLANDS
AHA 68 ACRE REVEGETATION PROJECT

FINAL REPORT

GRANT # 08-152WPF

August 2011

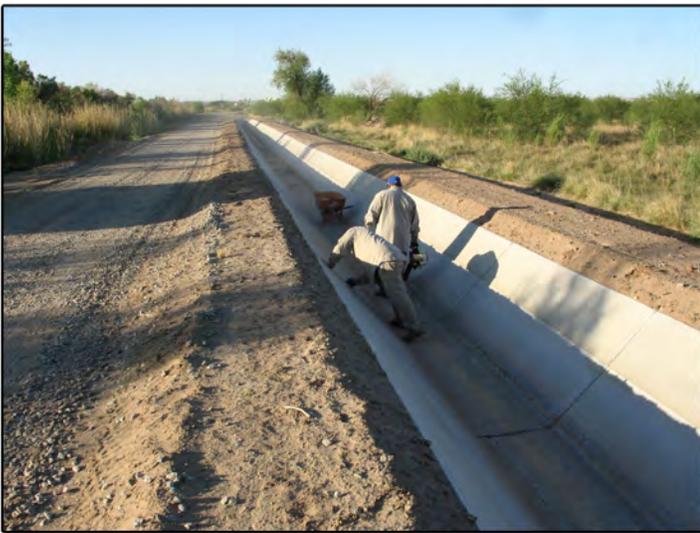
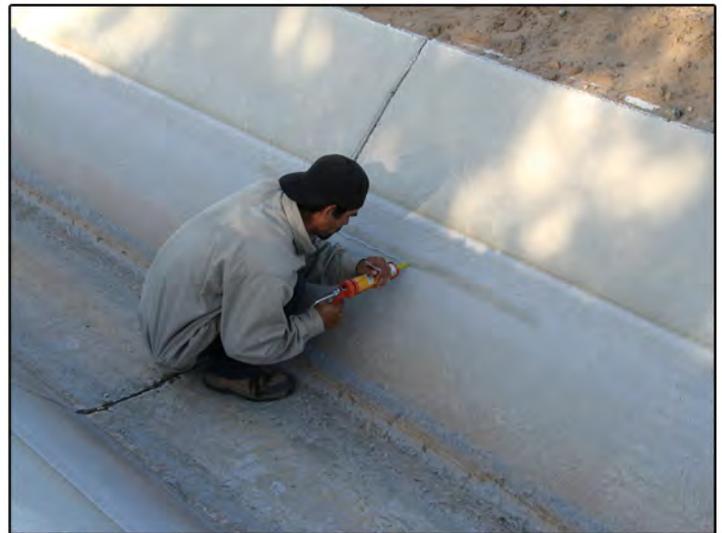
Irrigation infrastructure maintenance - repairing irrigation gates and cracks in the concrete

Funds were allocated at the end of the project period to repair irrigation infrastructure that had been damaged during normal operations. Irrigation maintenance occurred during May 2011 and consisted of repairing all cracks in the concrete lined irrigation channel. Sand and debris were removed to locate and properly repair all cracks. A concrete repair epoxy was used to repair hairline cracks. Plastic roof cement was used to repair larger cracks. A two foot concrete block wall was constructed at the pump outfall to divert spillover along the irrigation channel. Previously water would spill over the side of the irrigation channel, causing erosion and compromising the structural integrity of the channel. See Figure 2-3 for photos (Pg. 27).

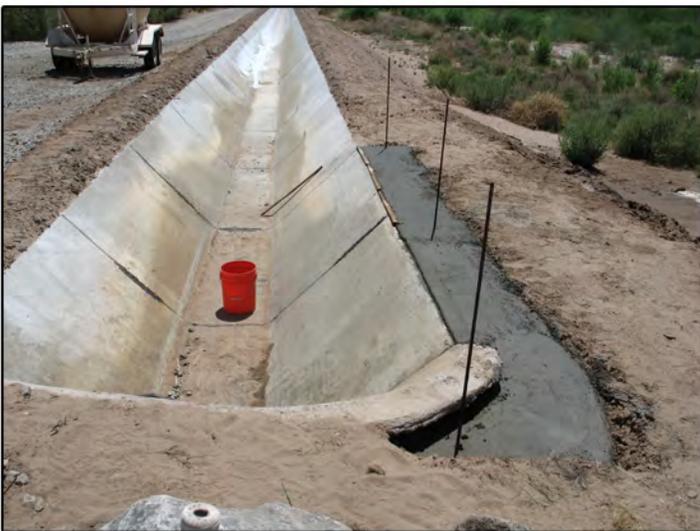
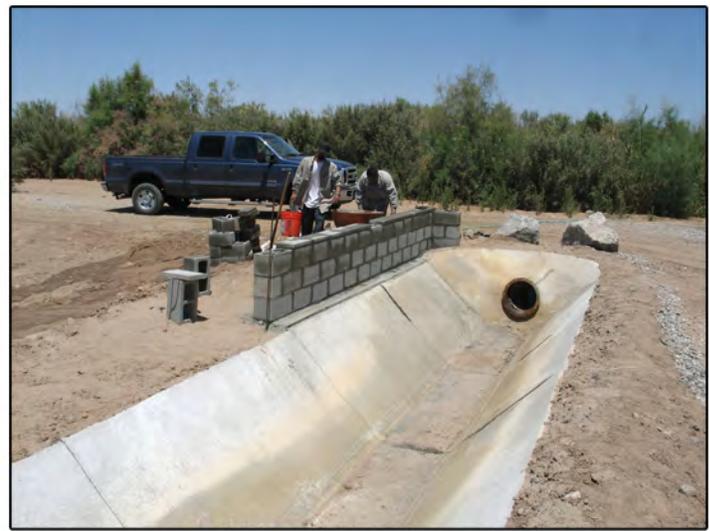
Installing concrete block wall to stop irrigation wall from eroding the slopes of the channel
