Cocopah Indian Tribe

Colorado River Restoration Project Final Report

AWPF #08-156WPF

February 2011

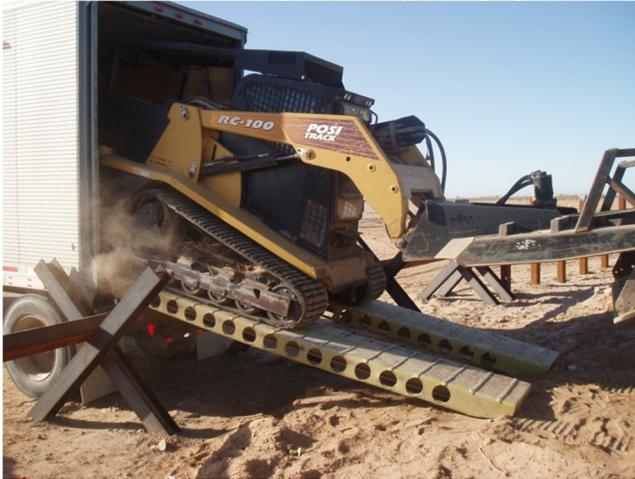
Figure 3: Custom ramp used to gain equipment access

The vehicle barrier precluded the use of equipment that was wider than the post spacing, so a tracked skid loader was deemed to be the most effective equipment for pole planting. A customized ramp was placed from the end of a truck over the vehicle barrier to gain access to the site (Figure 3). This allowed the equipment to be removed from the site each night to prevent vandalism and theft.

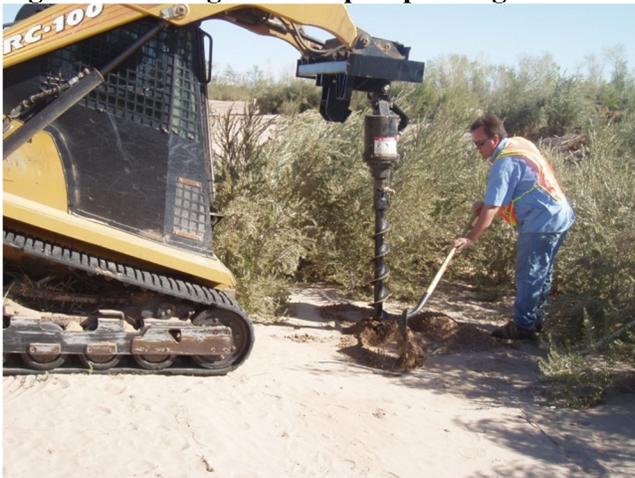
Figure 4: Drilling holes for pole planting

The cottonwood and willow poles were purchased from the Ahakhav Tribal Preserve near Parker, AZ. They were delivered the day before planting and were kept moist until planting. All poles ranged in length from 12 feet to 16 feet and appeared to be dormant at the time of planting. The holes were drilled using a tracked skid loader with an auger attachment and a 9-foot long by 6-inch diameter bit (Figure 4). The holes were drilled to a depth where the soil came up wet to ensure that the poles were planted in the capillary fringe or the water table. The holes were backfilled by hand and watered immediately to ensure adequate soil/stem contact and minimize air pockets that could inhibit survival (Figure 5). All of the poles were watered a second time three weeks after planting on March 10 – 12, 2009.

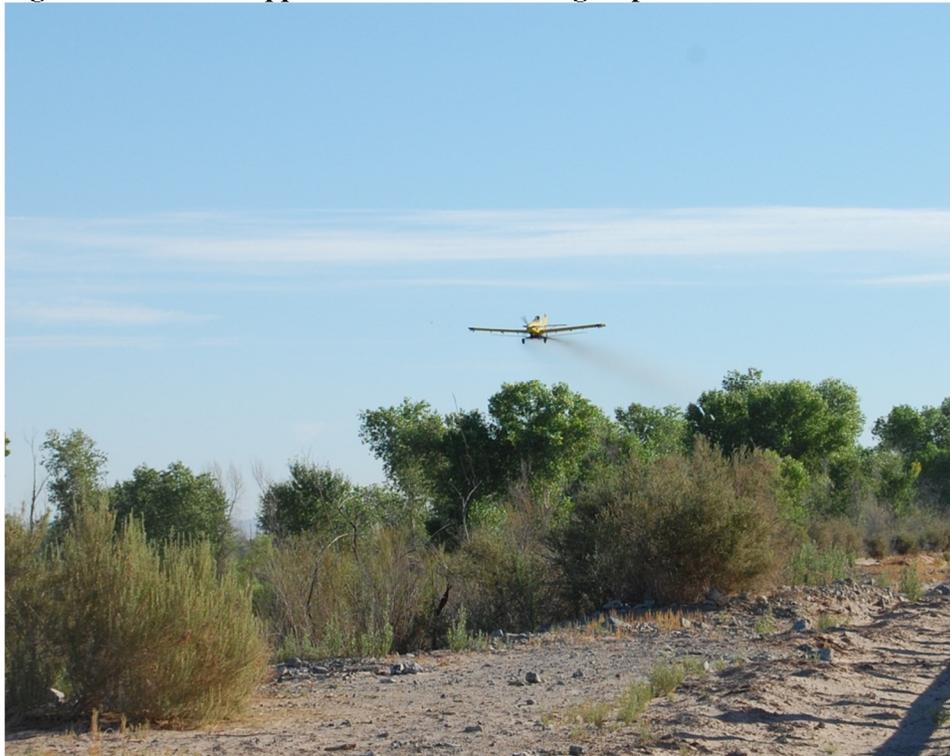
Figure 6: Fertilizer application with fixed wing airplane

Fertilizer was applied using a fixed wing aircraft with GPS functionality (Figure 6). Tri-Rotor Ag Services of Yuma, AZ applied the fertilizer on April 21, 2009. The airplane's GPS was loaded with polygons for each application (Biosol, P, K, and N) and the pilot controlled the spread based on the GPS position on his screen. The Biosol was applied in 4 loads of

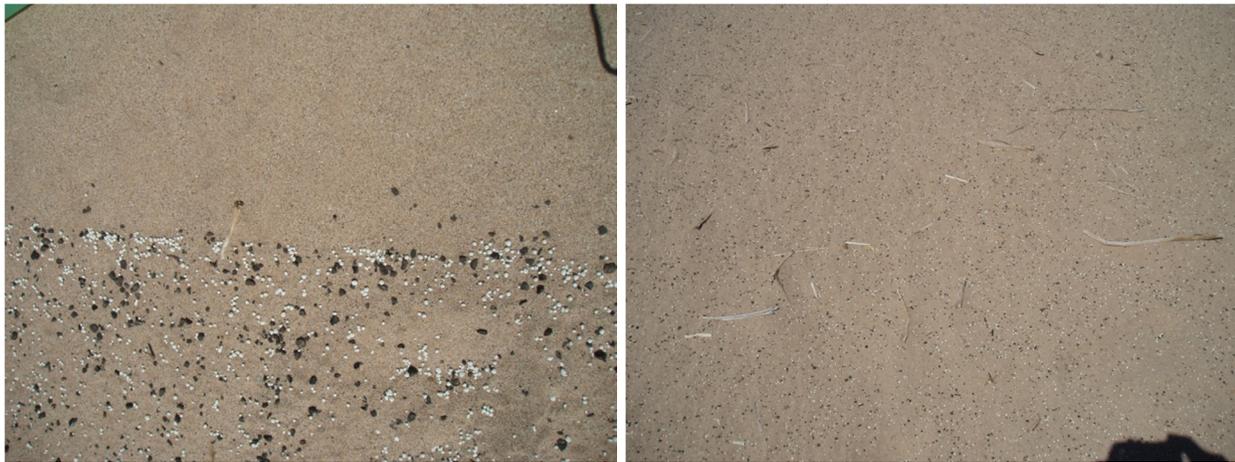
Figure 7: Fertilizer (A) along the edge of the P2O5 tarp, and (B) on the ground near the tarp
 (A) (B)

To test the accuracy of fertilizer application, a 1-square yard tarp was placed in each of three locations across the site. After the Biosol was applied the material on the tarp was collected and weighed for comparison to the expected quantity (Table 10). The same process was repeated for the P. Because the P was larger, denser, round pellets they tended to bounce when they hit the tarp. Thus, the quantity of P on the tarp was lower than expected, but there was a greater density on the ground along the edges of the tarp (Figure 7A). Photographs taken of the ground after Biosol and P application show an even distribution of both products (Figure 7B) and suggest that the P was likely applied accurately even though the tarp tests were inconclusive. Because the quantities and areas of N and K application were so small, they were not evaluated using the tarp test.

Nutrient	Acres	Expected Lbs/Acre	Expected Oz/SqYd	Observed Oz/SqYd				Accuracy
				Tarp 1	Tarp 2	Tarp 3	Average	
Biosol	12.31	500 lbs/ac	1.65	1.7	1.7	1.9	1.77	107%
P	31.55	444 lbs/ac*	1.46	0.7	0.7	0.5	0.63	43%
Total	50.29

* The actual P was applied at 200 lbs/acre, but the superphosphate used was only 45% P, so 44 lbs were applied.

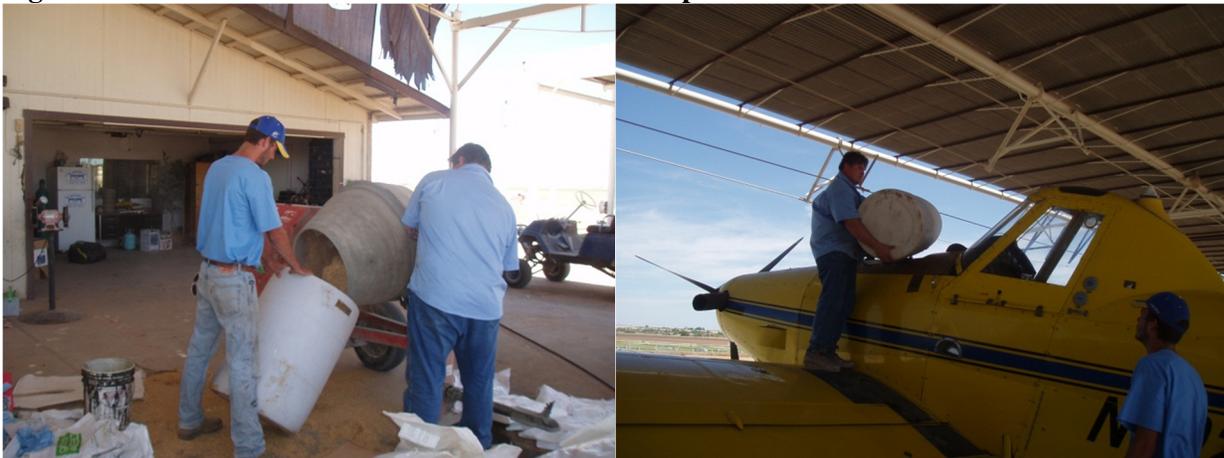
Figure 9: Seed mixed with rice hull and loaded into airplane in batches.

The seed was mixed with inert rice hulls at a ratio of 2:1 (rice hulls:seed) prior to spreading to increase the bulk and improve the spreading accuracy. Seed and rice hulls were mixed with a cement mixer in small batches and loaded into the hopper on the airplane (Figure 9).

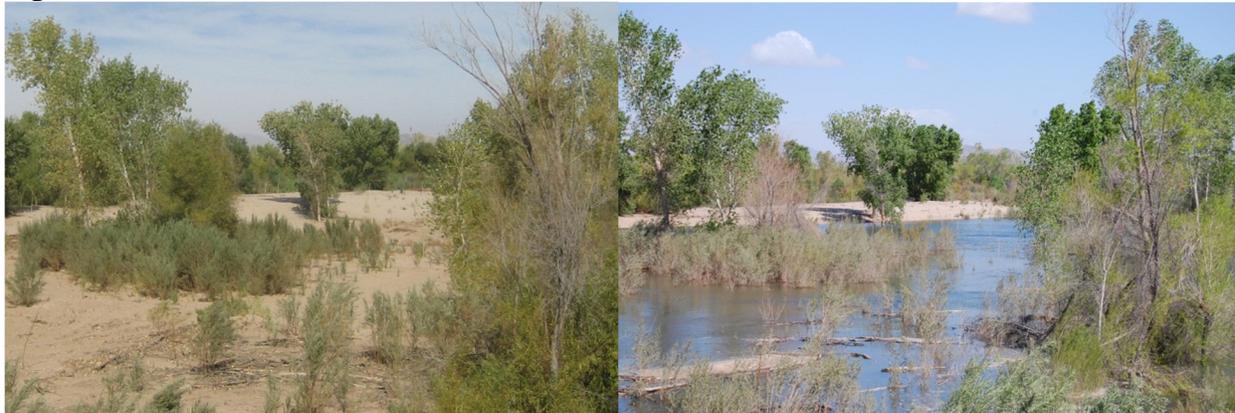
Figure 17: Photo Point 5 in October 2009 and March 2010

The vegetative cover observed at the site in 2010 was more than double that observed in 2009. This is likely primarily due to the overbank flooding experienced in March 2010. A release of water from the Morelos Dam upstream of the project site on March 7, 2010 caused overbank flooding in the project area for the first time since 1993. The portions of the north end of the site were inundated for several days (Figure 17). The flood caused substantial erosion (Figure 18), but also provided the moisture for a huge flush of new germination (Figure 19).

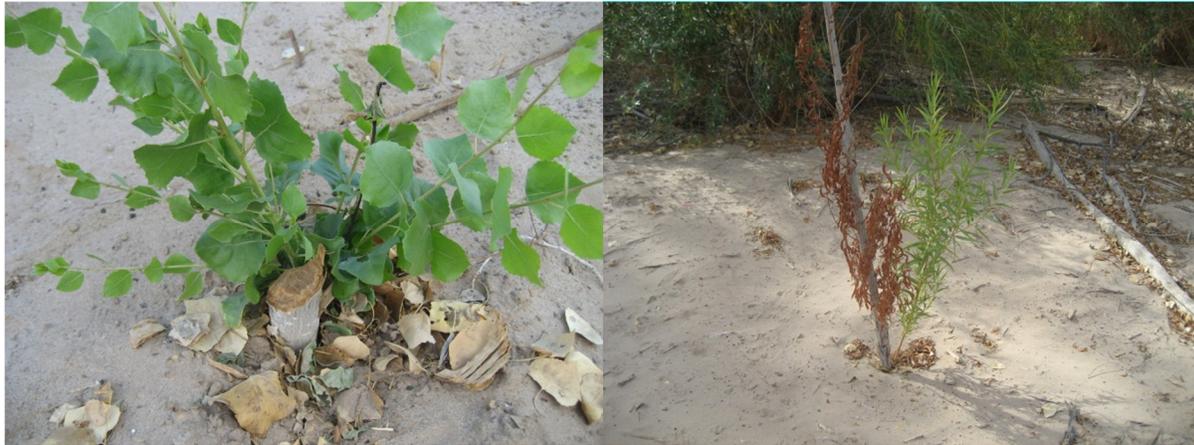
Figure 22: Resprouting pole (A) cut by beavers and (B) from the base of a dead stem
(A) (B)

It may have also been beneficial to cut poles to prevent leaf development. This hypothesis was generated from the observation that poles cut down by beavers were able to resprout and survive (Figure 22). Some trees that had leafed out were also able to resprout from the base and survive. The removal of most of the above ground portion of the poles could have minimized the potential for bud and leaf development, and possibly reduced heat stress by minimizing the poles exposure to the elements. However, this would have also minimized the amount of stem that could store energy for root development.
