Final Monitoring Report – Summary Grant #11-176WPF

October 2011 Workshop Site – Grant #11-176WPF

Double Circle Ranch Erosion Control Project

Grant # 11-176WPF

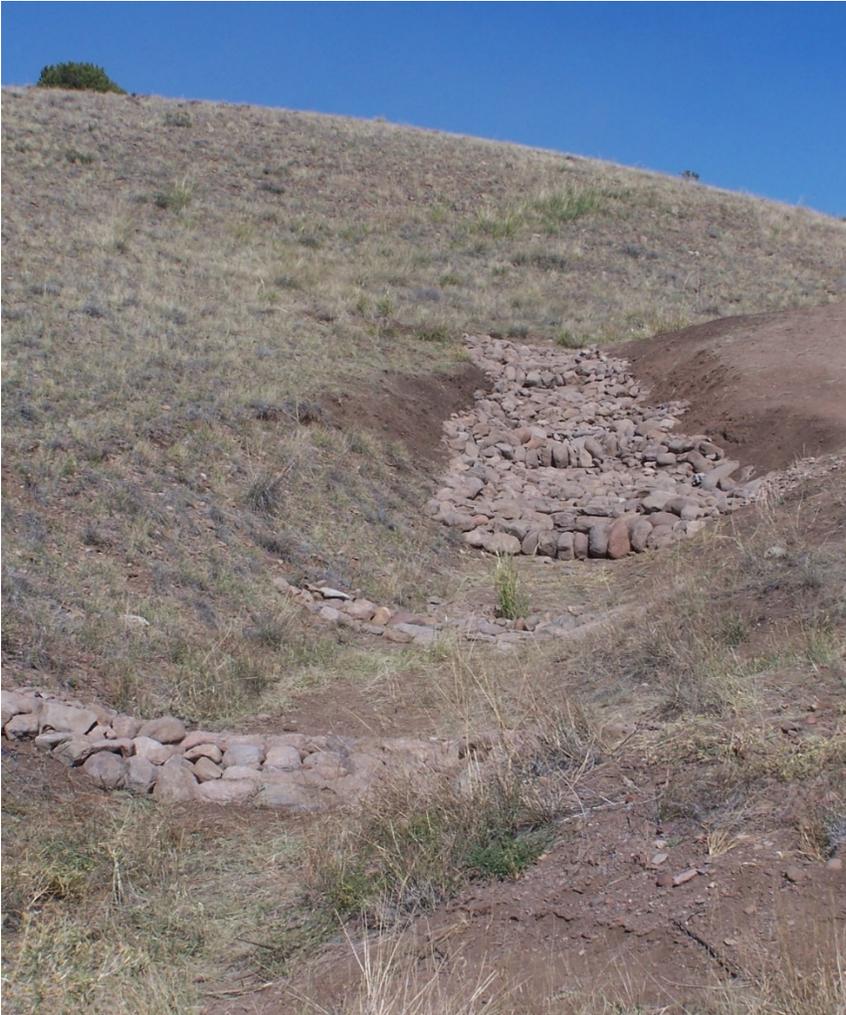
Overall View Before

The October 2011 workshop was designed to address erosion caused by a breached dirt tank dam spillway which was causing major channelization and bank undercutting as the uncontained flow from major rain events gained power. The breach was along the north edge runoff area of the dirt dam which assisted in the channelization and erosion. Three large rock bowl structures used at this location were integrated with 3 media lunas (rundowns) to begin slowing the flow and loss of sediment at the initial point, the breach location. Several one rock dams were constructed at direction changes along the remainder of the channel below the breach to further slow the flow and divert sediment.

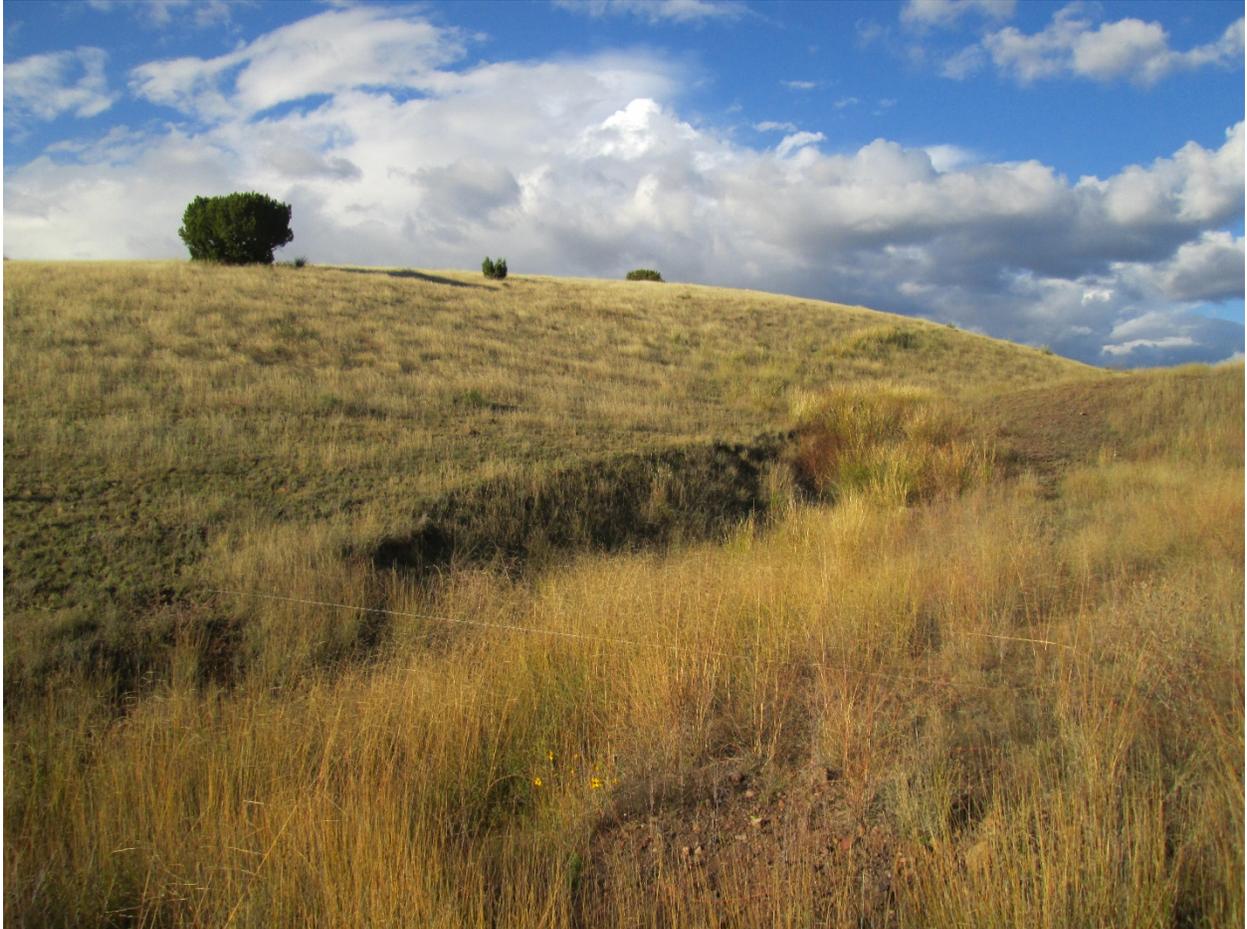
Overall View After

The three large zuni (rock) bowls constructed at this location to repair the spillway slope previously washed out when the original dam was breached have worked extremely well as is apparent in this photo. Volunteer labor and the correct use of larger available rocks for the structures has repaired the breached area and allowed extensive vegetation growth along this steep runoff area. Recent heavy flow events did no damage to this location, proving heavy equipment isn't always necessary when repairing larger erosion problems.

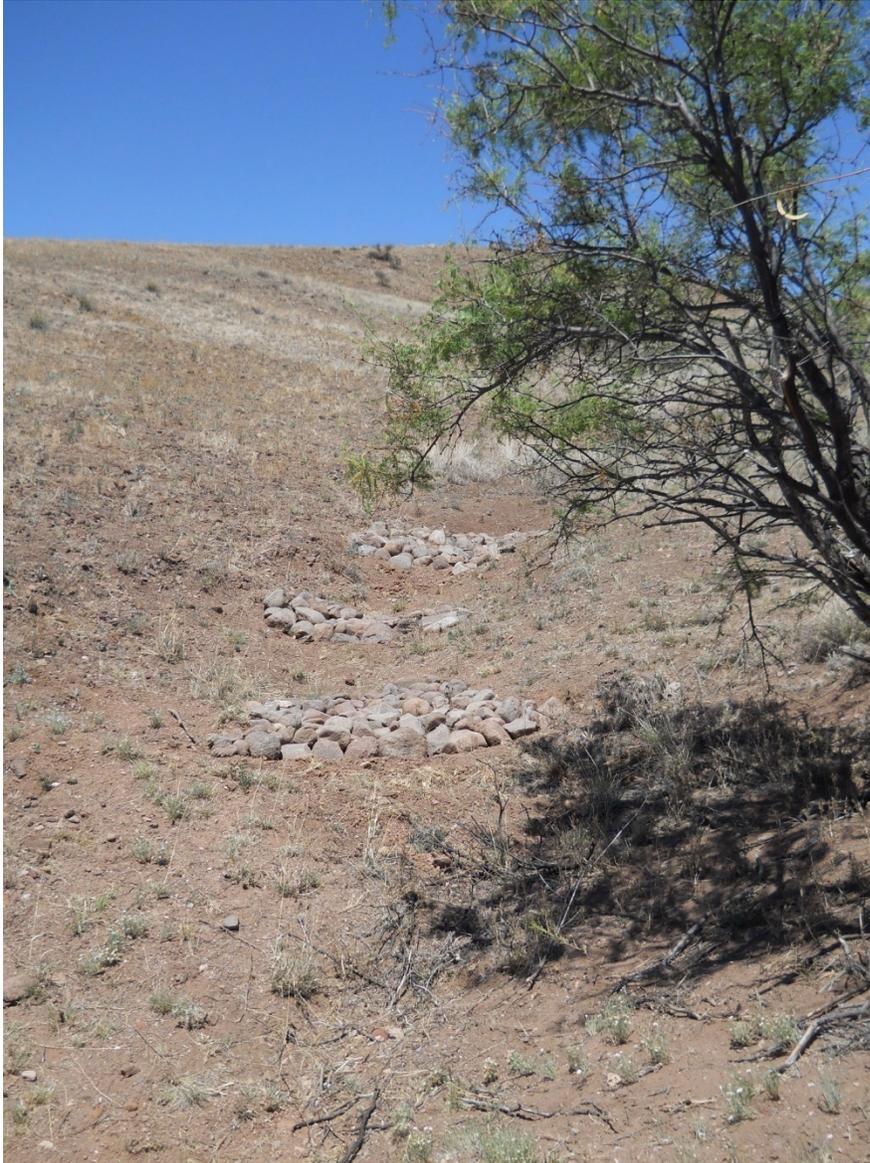
Overall View Before

The April 2012 workshop was designed to address erosion caused by runoff from 2 side slopes at a major headcut which were causing major channelization and bank undercutting as the uncontained flow from major rain events gained power. The 2 slopes joined high on the hillside which resulted in their flows combining and contributing to the channelization and erosion. Several one rock dams were constructed at direction changes along the channel below the breach to further slow the flow and divert sediment for deposition along the channel.

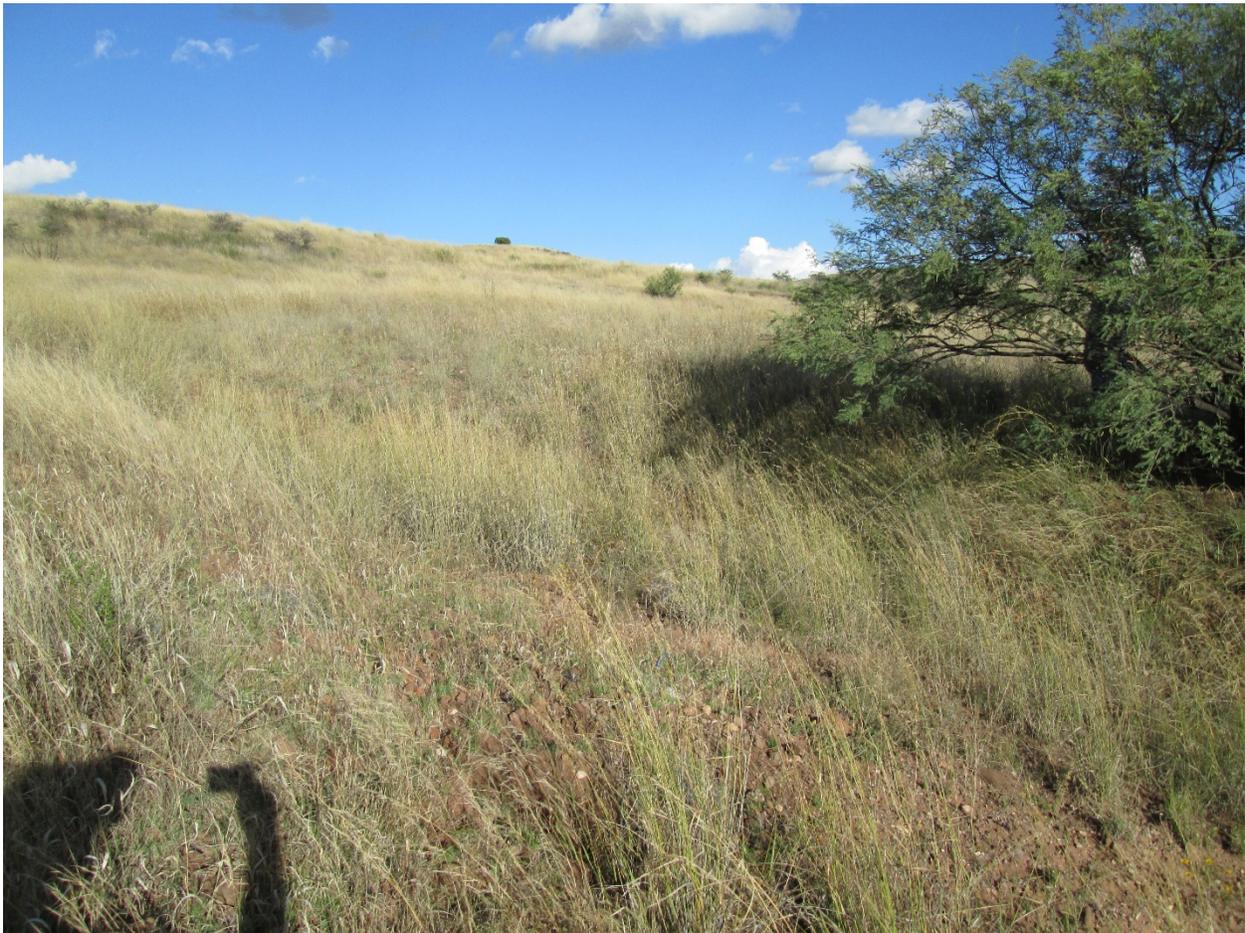
Overall View After

This location is at the top of a major headcut. The flow is first spread with a media luna, then the remaining flow is lessened by rock bowls and one rock dams. Vegetation along this section has improved greatly with the increased rainfall events. However the steeper area directly following this section is showing slight channelization due to the violent, heavy rain flows last monsoon season. The rock bowl and one rock dam structures below this portion of the channel were adequate at slowing the flow and arresting erosion during normal flows, but were slightly damaged during the heavy monsoons of 2014.

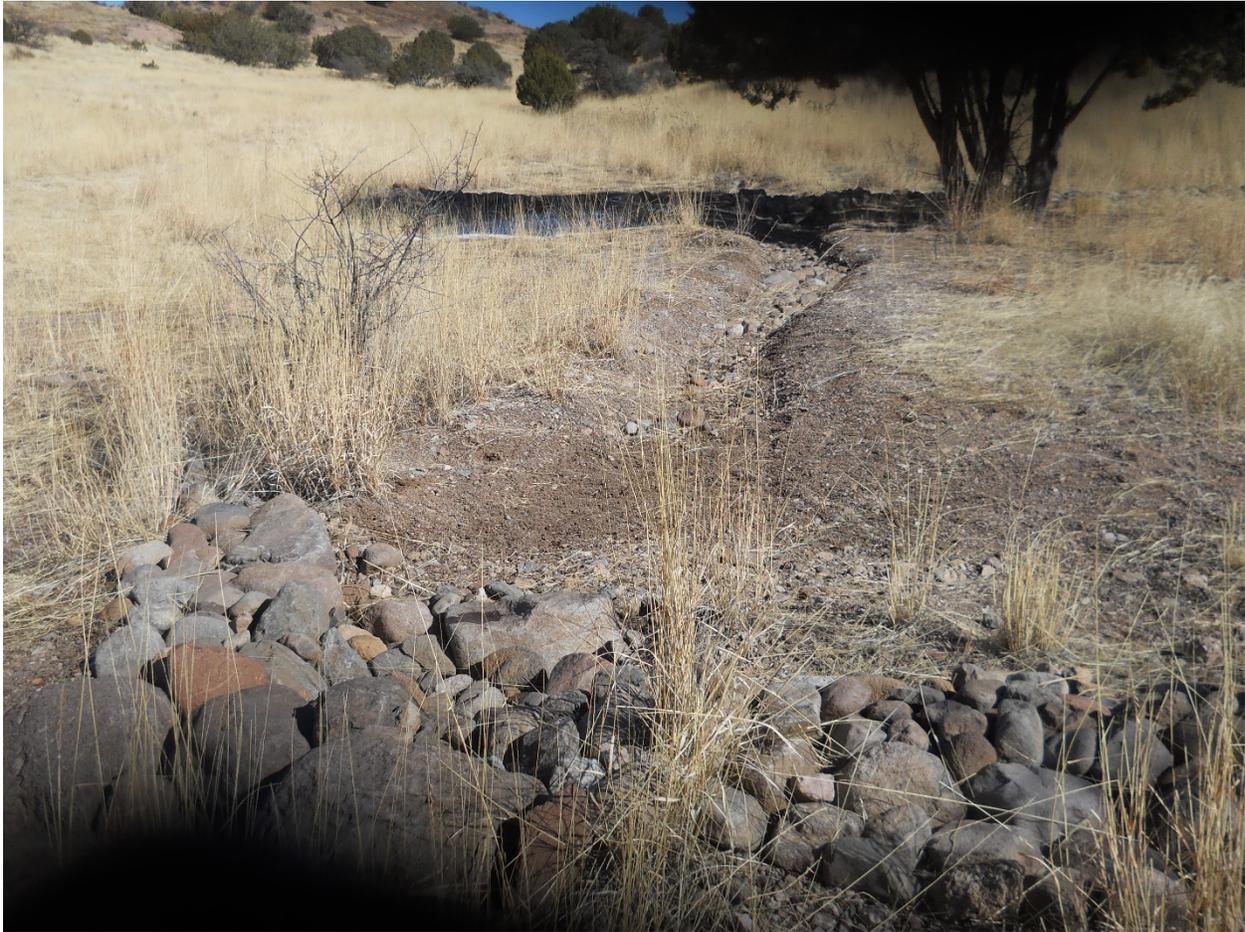
Overall View Before

The October 2012 Site was at a popular location which had been one of the original workshop locations from our previous grant and was used for demonstrating training and maintenance methods over the duration of previous workshops. The large amounts of flow along the drainage from 3 major culverts off of FR217 caused by several heavy monsoon rainfalls resulted in deep channelization the entire length of this site as seen in this photo. The large amounts of runoff made it a challenge to repair the damage using hand built erosion structures. The site was repaired using a large, 75 ft. wide media luna placed just above the tree in the photo along with several one rock dams and rock bowls above the media luna. Several smaller media lunas were placed below this site as well.

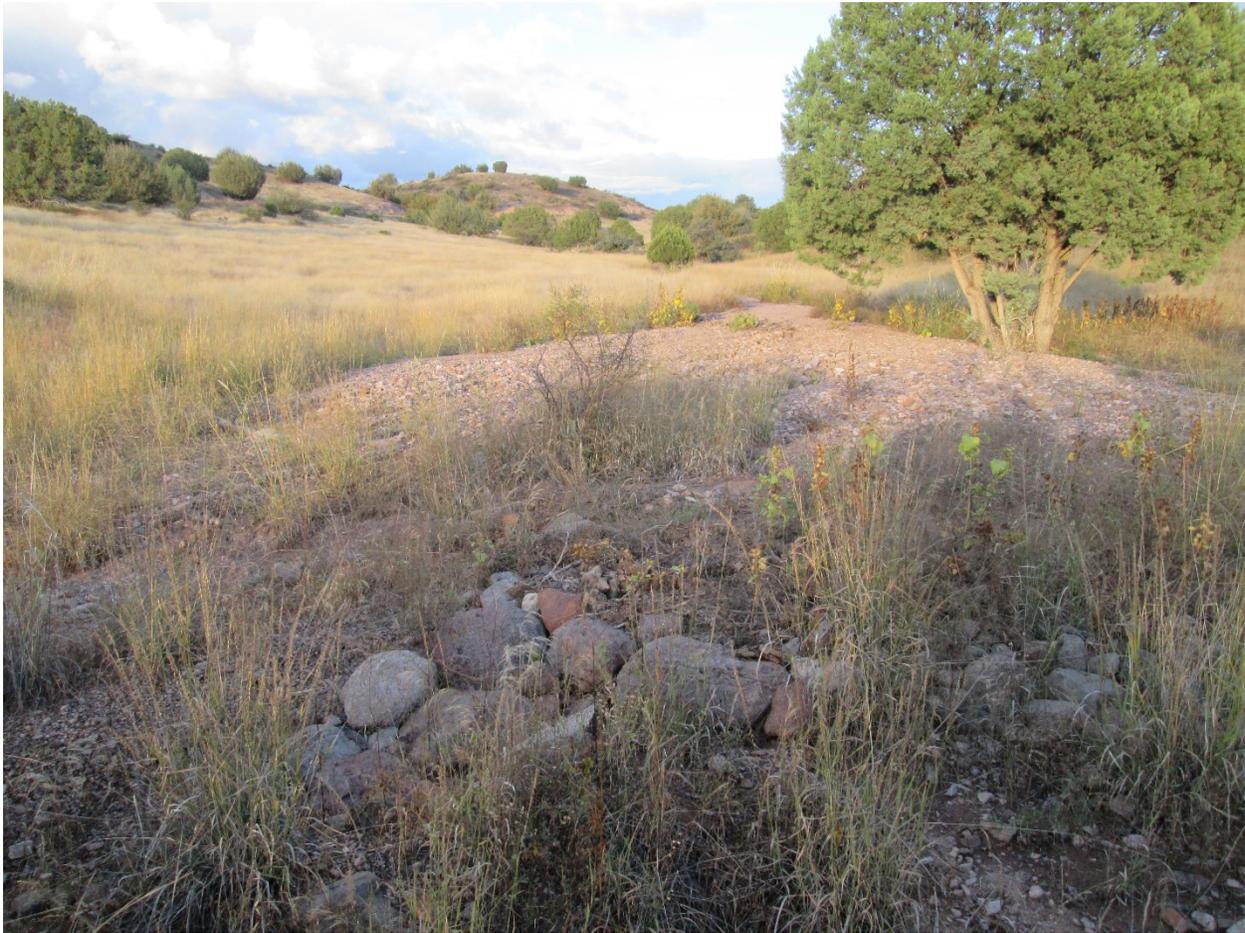
Overall View After

An overall view showing the October 2012 site 2+ years later. The initial deep channelization has been entirely covered and several small media lunas in the foreground are spreading any remaining flows across the lower portion of the site. As additional sediment is collected at this location, vegetation and ground cover should continue increasing.

The eroded channel is completely filled in and the spreading of sediment at this workshop location is obvious. This entire valley would have eventually eroded away and become a deep channel eventually emptying into Eagle Creek without the structures installed by the volunteer over several workshops completed at this site.

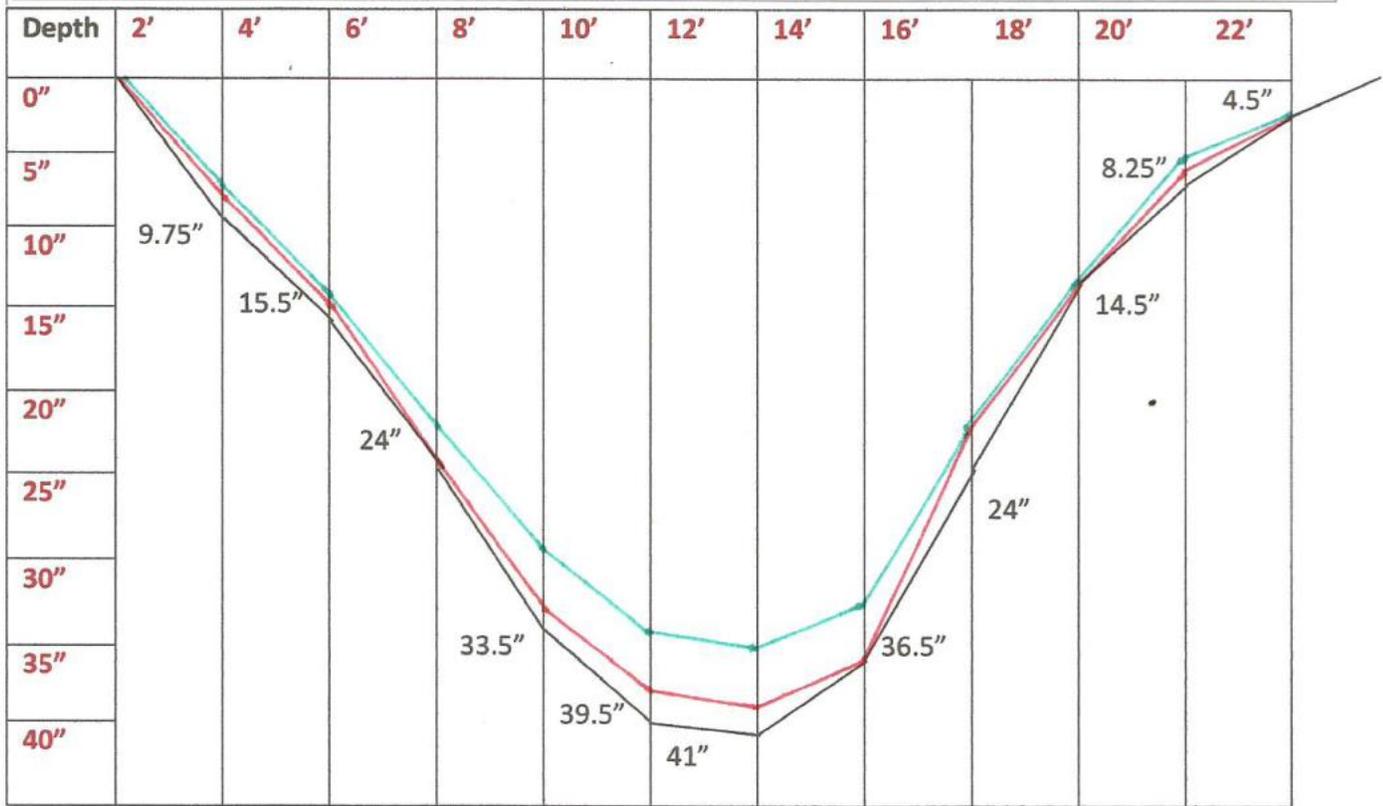
October 2011	Monitoring Point #1 Oct. 2011 Workshop
Measured Depth From Line @ 24" Intervals (ft.-inches)

- - 2012 Monitored Depth
- - 2013 Monitored Depth
- - 2014 Monitored Depth

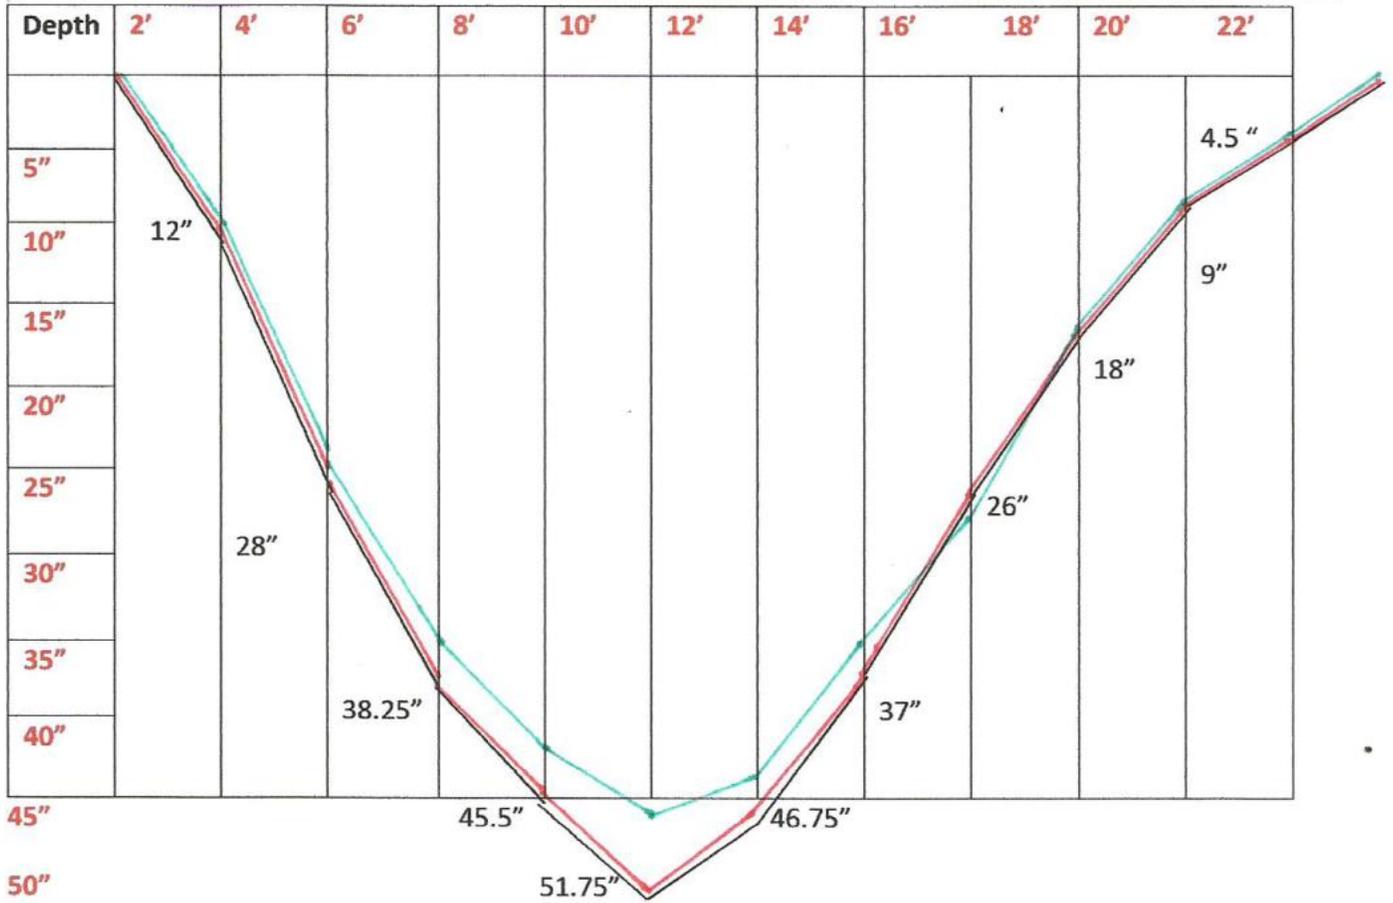
Monitoring Point #2 Oct. 2011 Workshop

Measured Depth From Line @ 24" Intervals (ft.-inches)

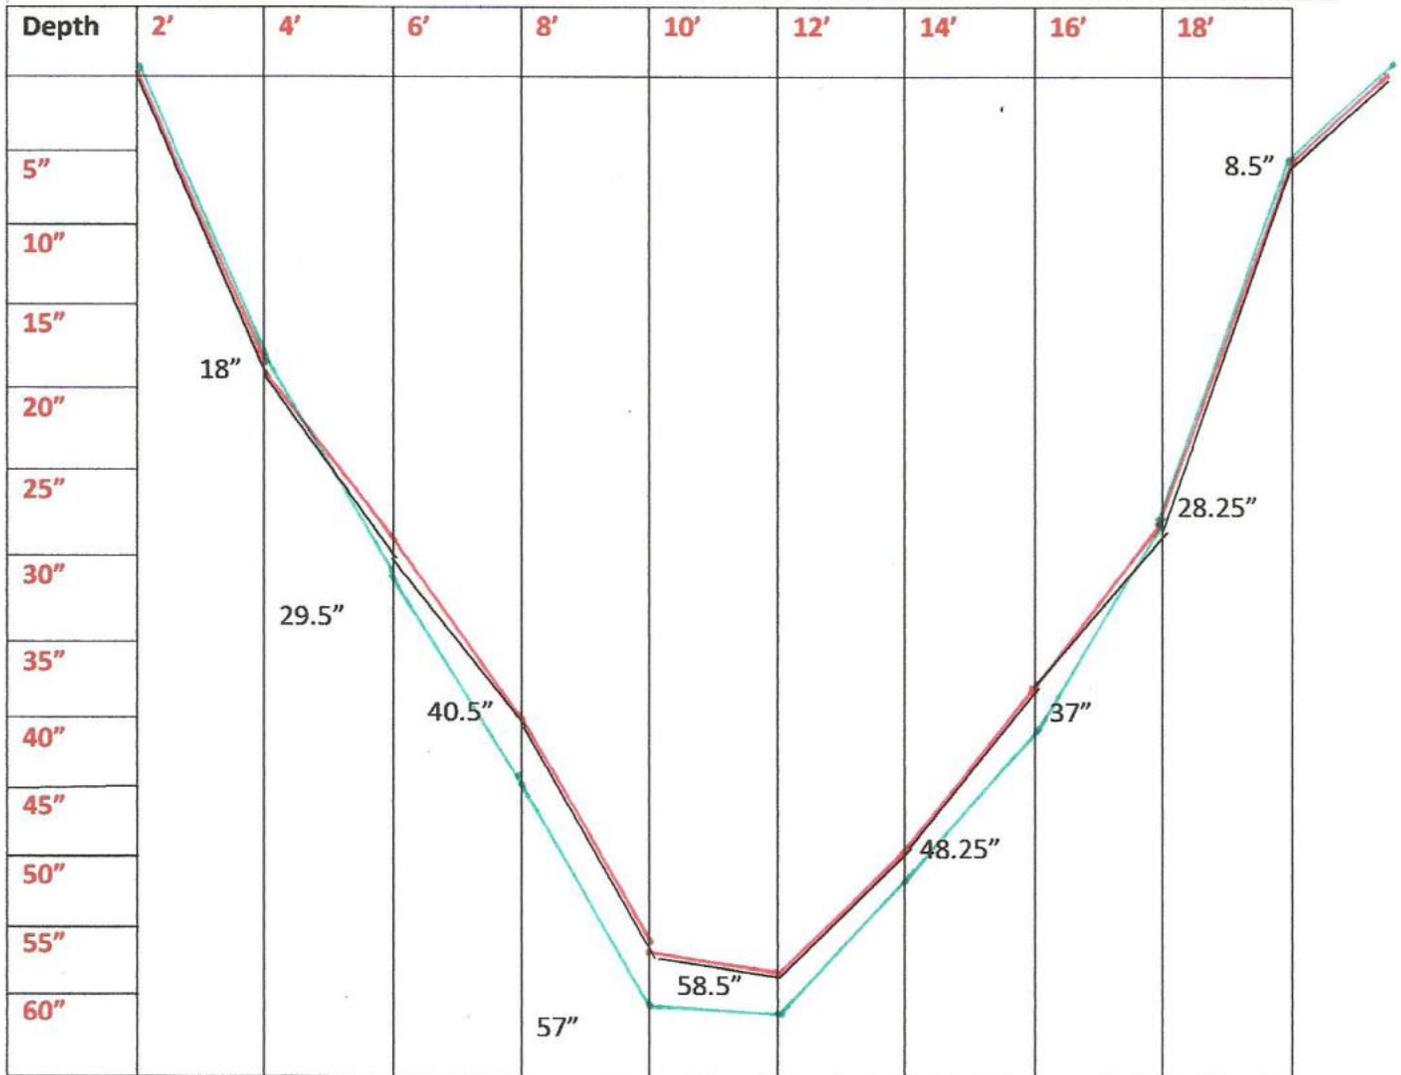
Monitoring Point #2 April 2012 Workshop

Measured Depth From Line @ 24" Intervals (ft.-inches)

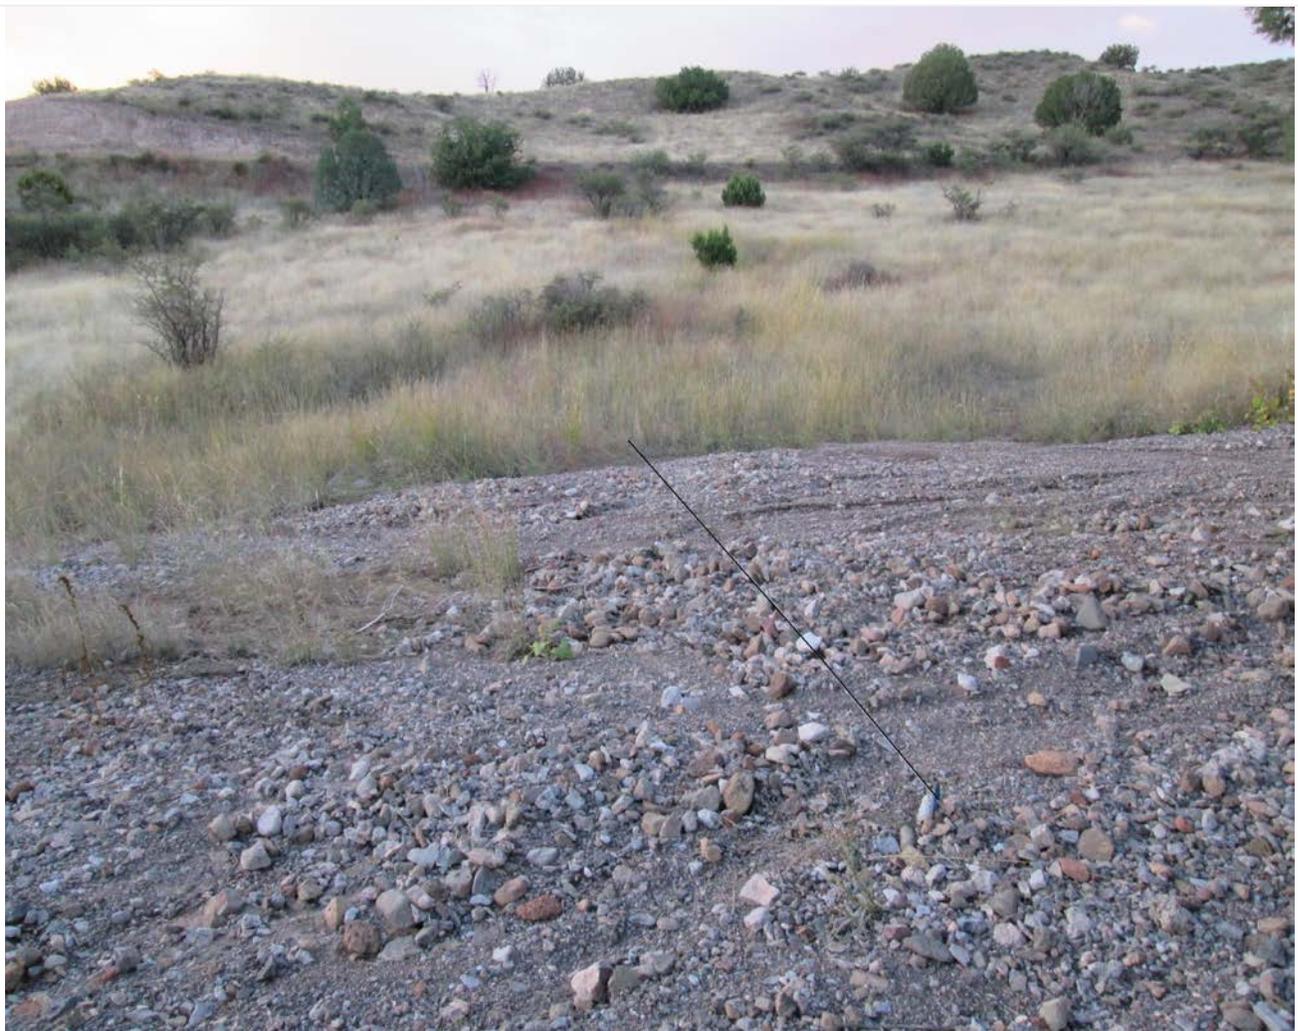
Photo MP#1

This point provides evidence the large media luna and zuni bowl are effective at slowing sediment loss. The monitoring shows the existing channel completely filled in with sediment. The structures have slowed the flow events from the 2014 monsoons and caused sediment from the USFS road to be deposited as well.

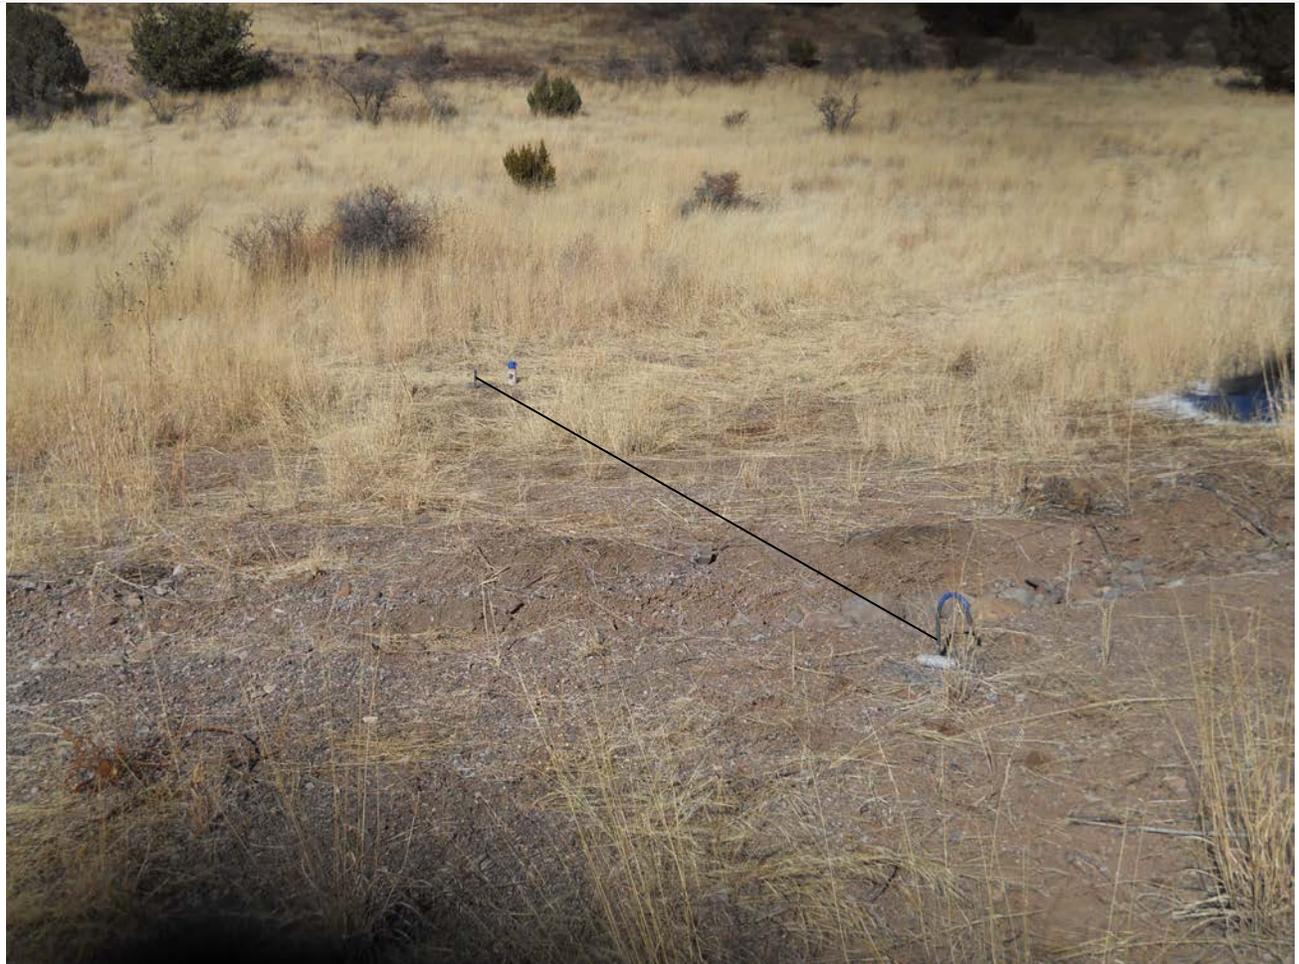
Photo MP#1

This point was selected just below the large media luna and zuni bowl to show the effectiveness of these structures at slowing sediment loss. The monitored area includes the new channel being formed (foreground) and a slight depression (background) , both of which are showing improvement resulting from the spreading of the flow events.

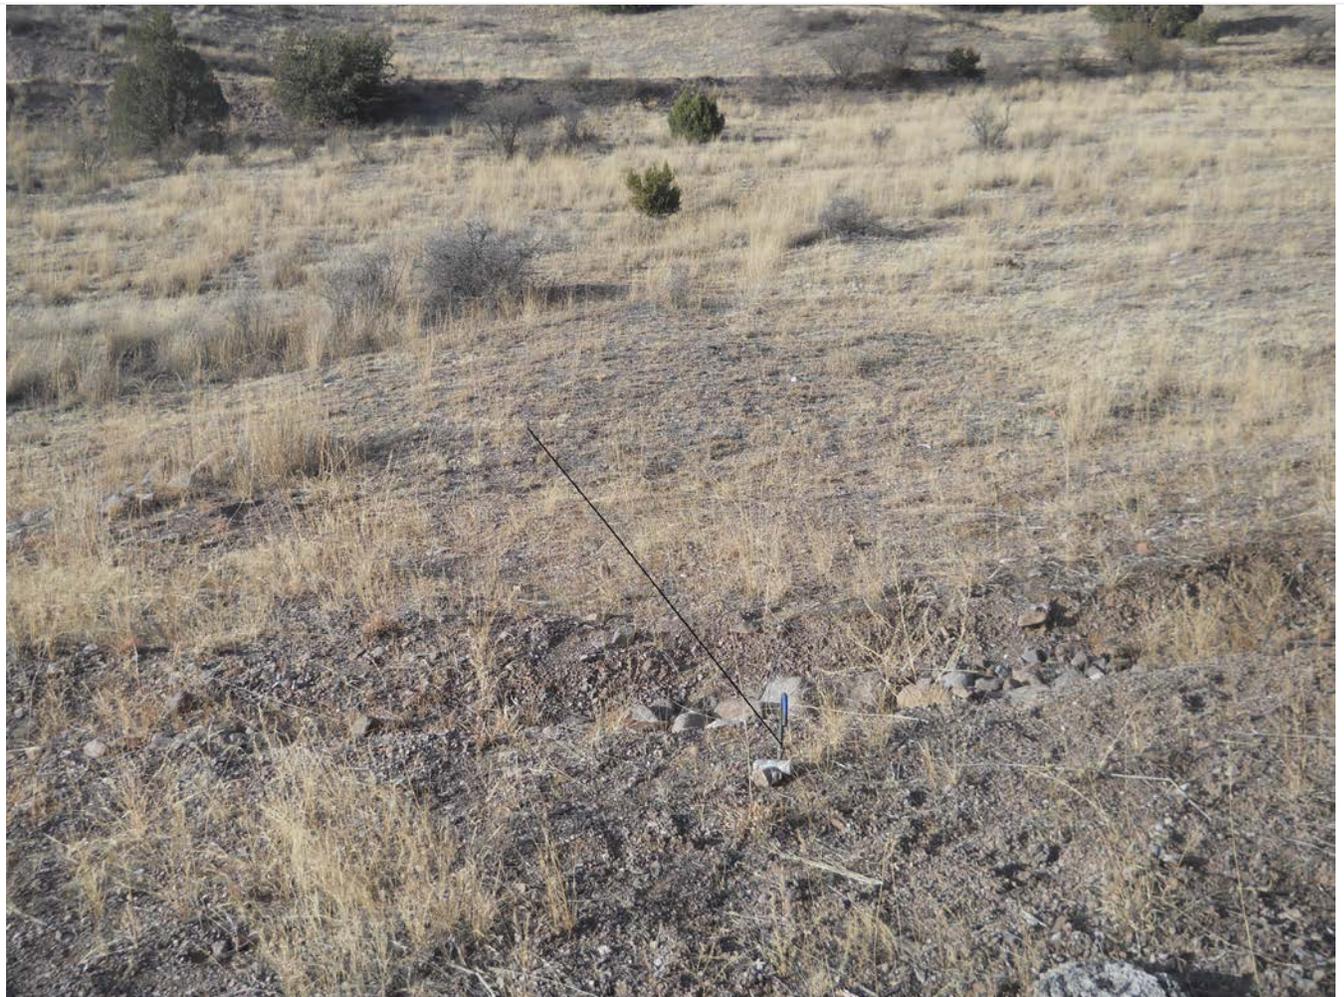
Photo MP#1

This point provides evidence the large media luna and zuni bowl are effective at slowing sediment loss. The monitored shows the new channel being filled in with sediment (foreground) and the slight depression in the background showing no change. The structures have slowed the flow events and caused sediment deposition.

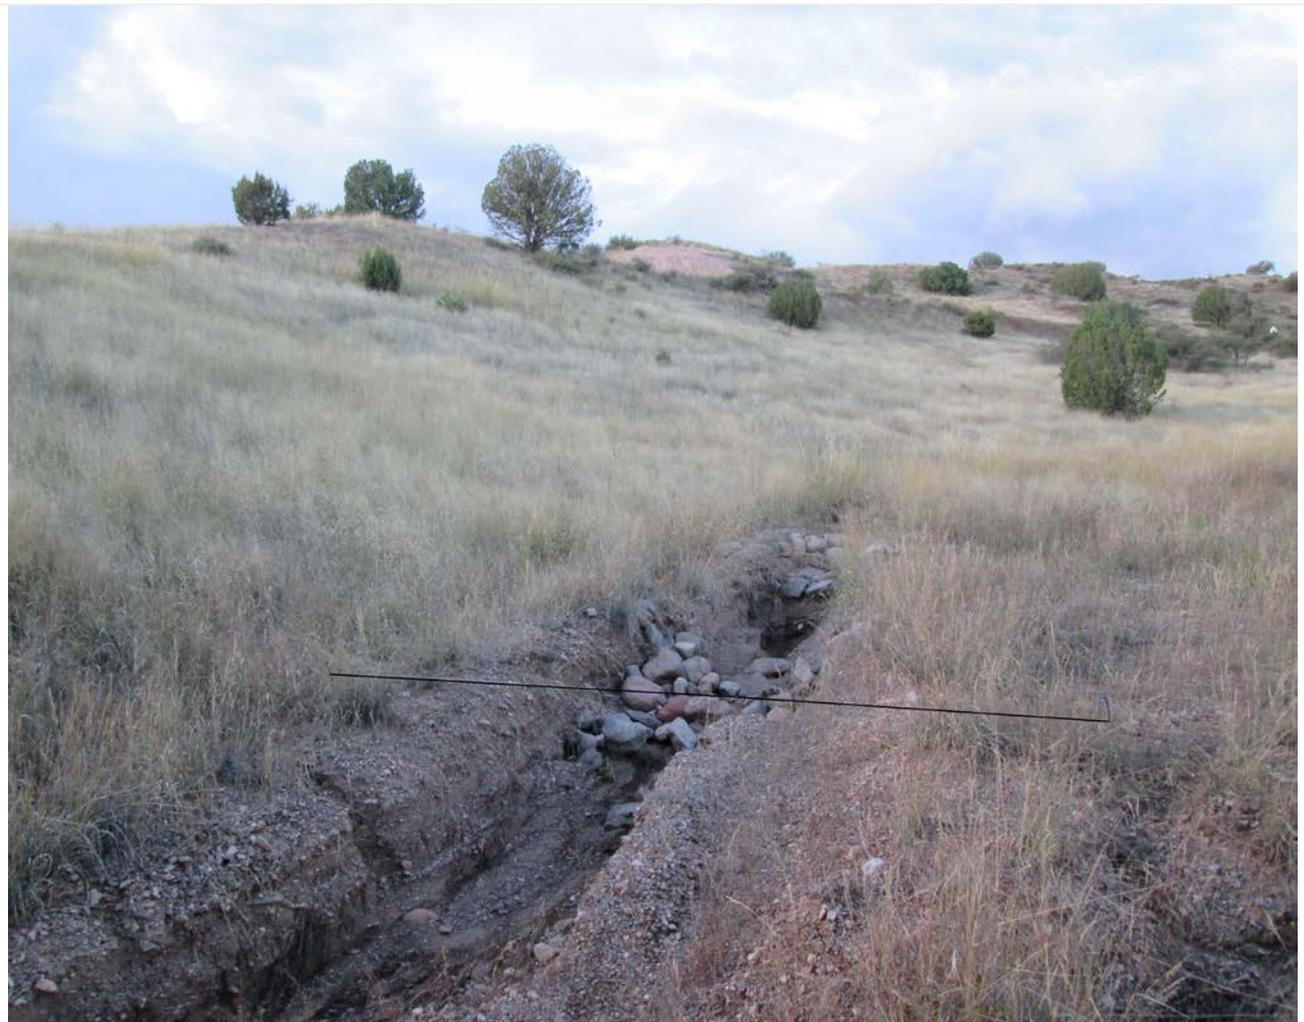
Photo MP#2

At the lower portion of the erosion worksite, several rock bowls and a series of one rock dams were constructed above this monitoring point to slow and disperse the flow. However, the large flow events from the 2014 monsoon season running off the USFS 217 road at the upper center of the photo did some damage to the structures. Deep channelization resulted, which should fill in after several normal rainfall amounts.

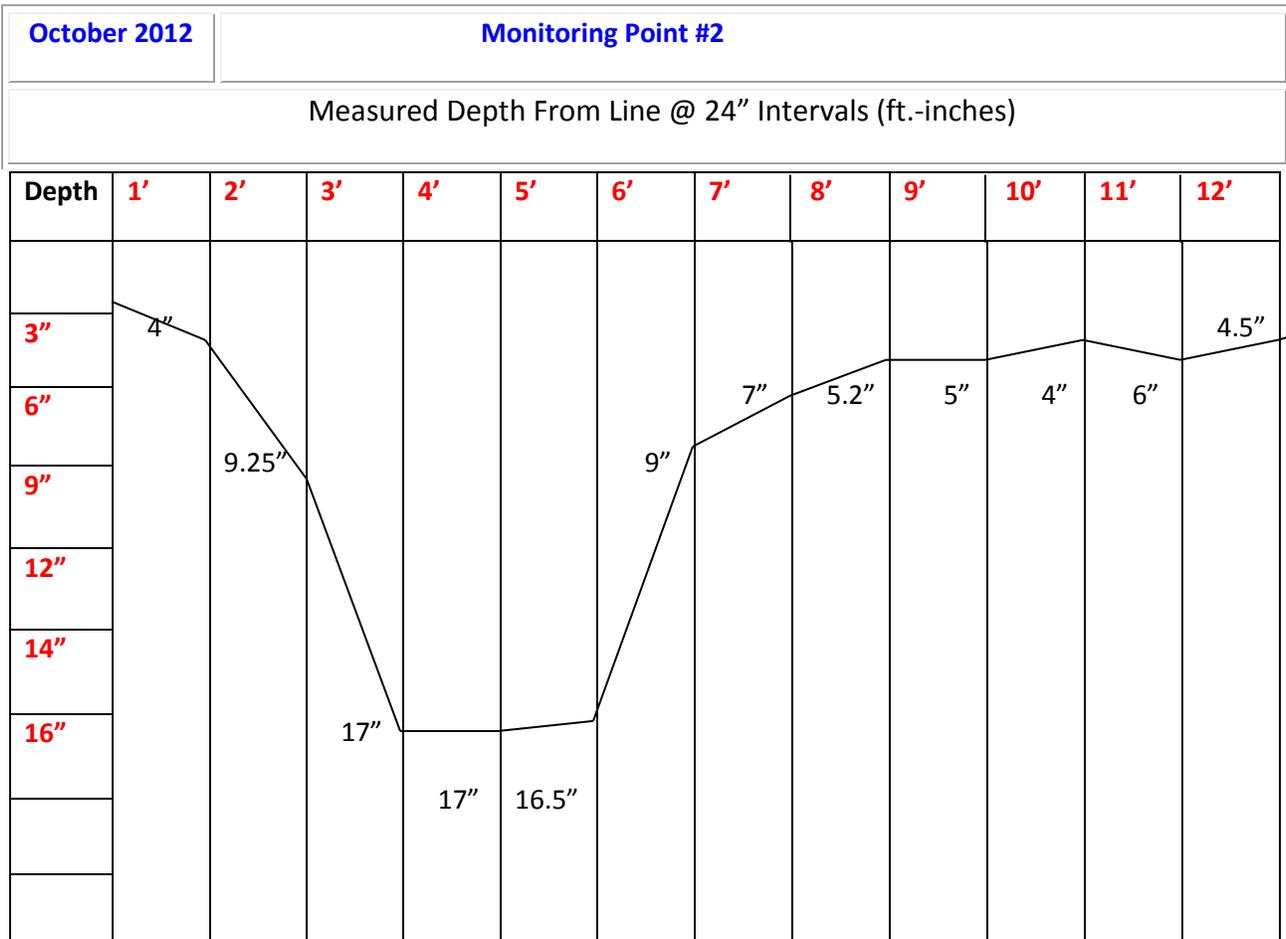
The measurements show a major channel formed by the large flows seen this season. Very large flows are reaching this area due to the heavy runoff from USFS 217.

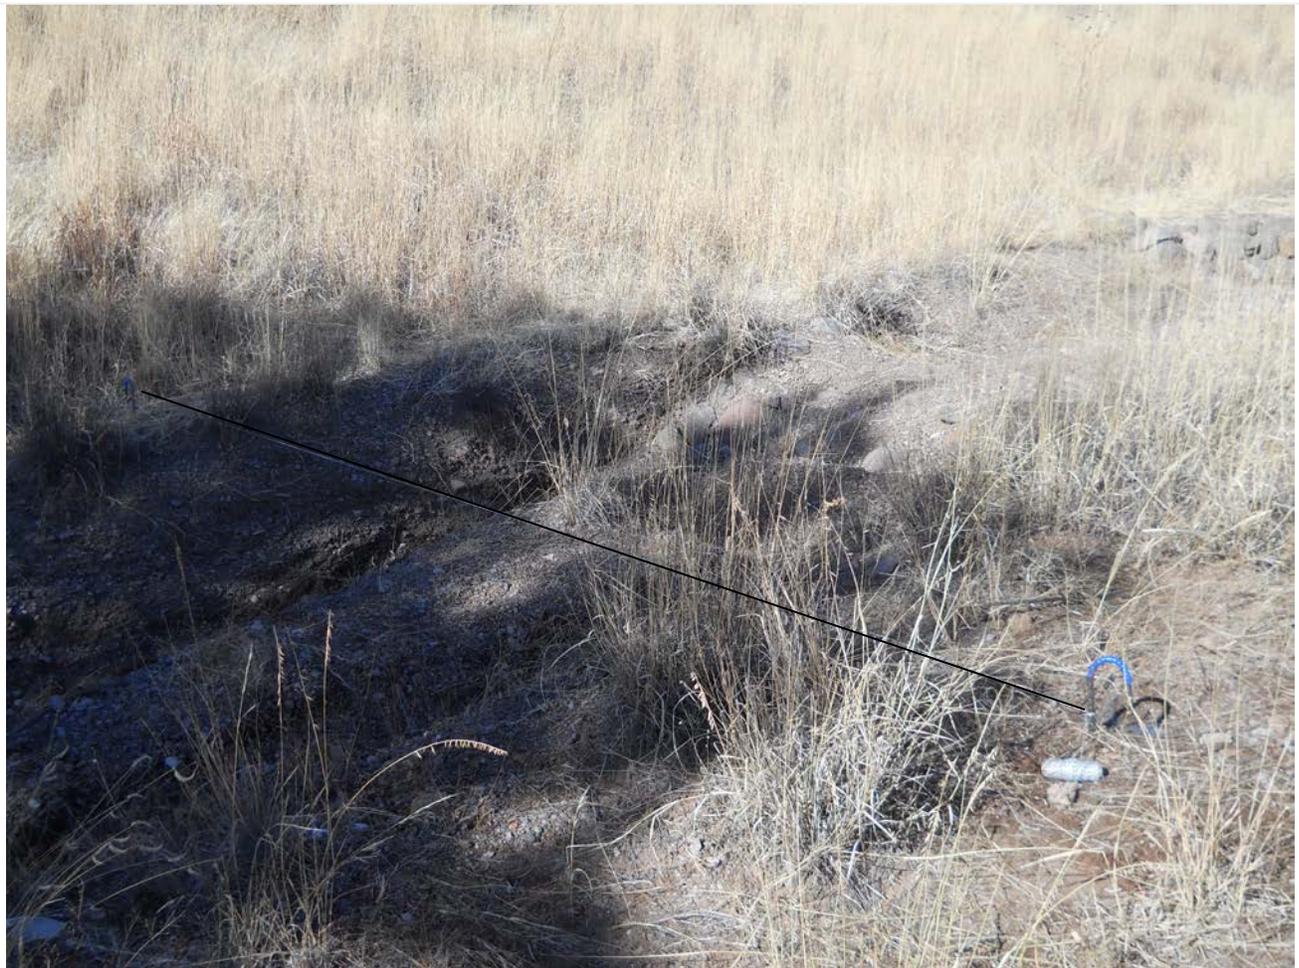
Photo MP#2

At the lower portion of the erosion worksite, the single channel had spread to several finger channels. Above this location, several rock bowls and a series of one rock dams were constructed in an effort to slow and disperse the flow causing the sediment to be deposited and begin the healing process. As this site is monitored, the incised channels should eventually begin infilling from the sediment deposition.

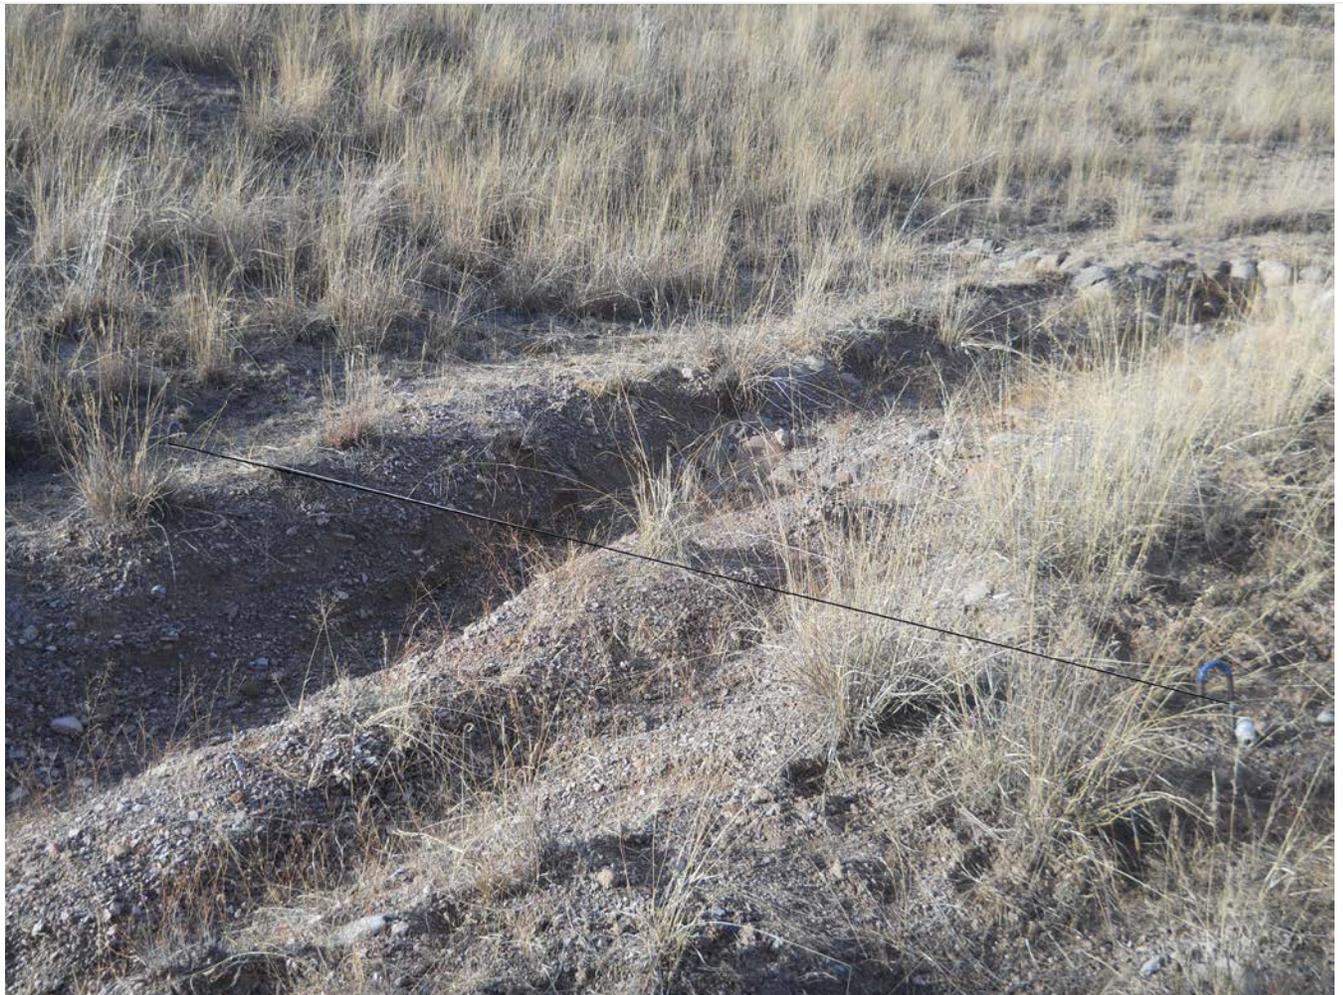
Photo MP#2

At the lower portion of the erosion worksite, the finger channels have begun infilling from the sediment deposition caused by several rock bowls and a series of one rock dams constructed above the site to slow and disperse the flow.
