Final Report

Grant Number 09-163WPF

Double Circle Ranch Erosion Control Project

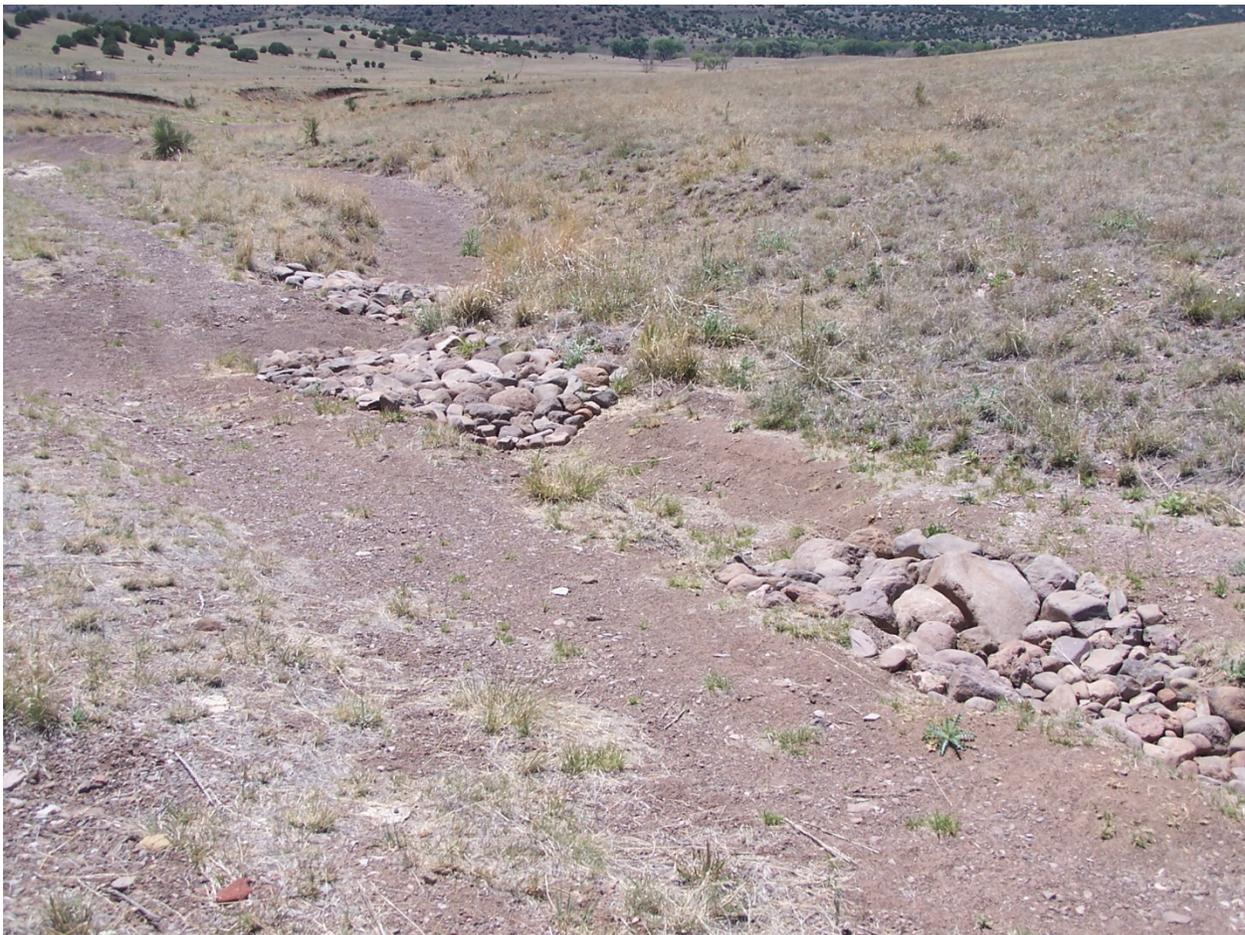
April 2010 Workshop Site – Roadbed Erosion Location

An existing two track roadbed ran along this channel allowing a straight flow of sediment towards Eagle Creek (at base of the distant hills). Several structures, one rock dams and small rock bowls, were constructed along this site to slow and rechanneled sediment flow. The road was moved far to the left of this photo (out of the channel) to aide in the revegetation process.

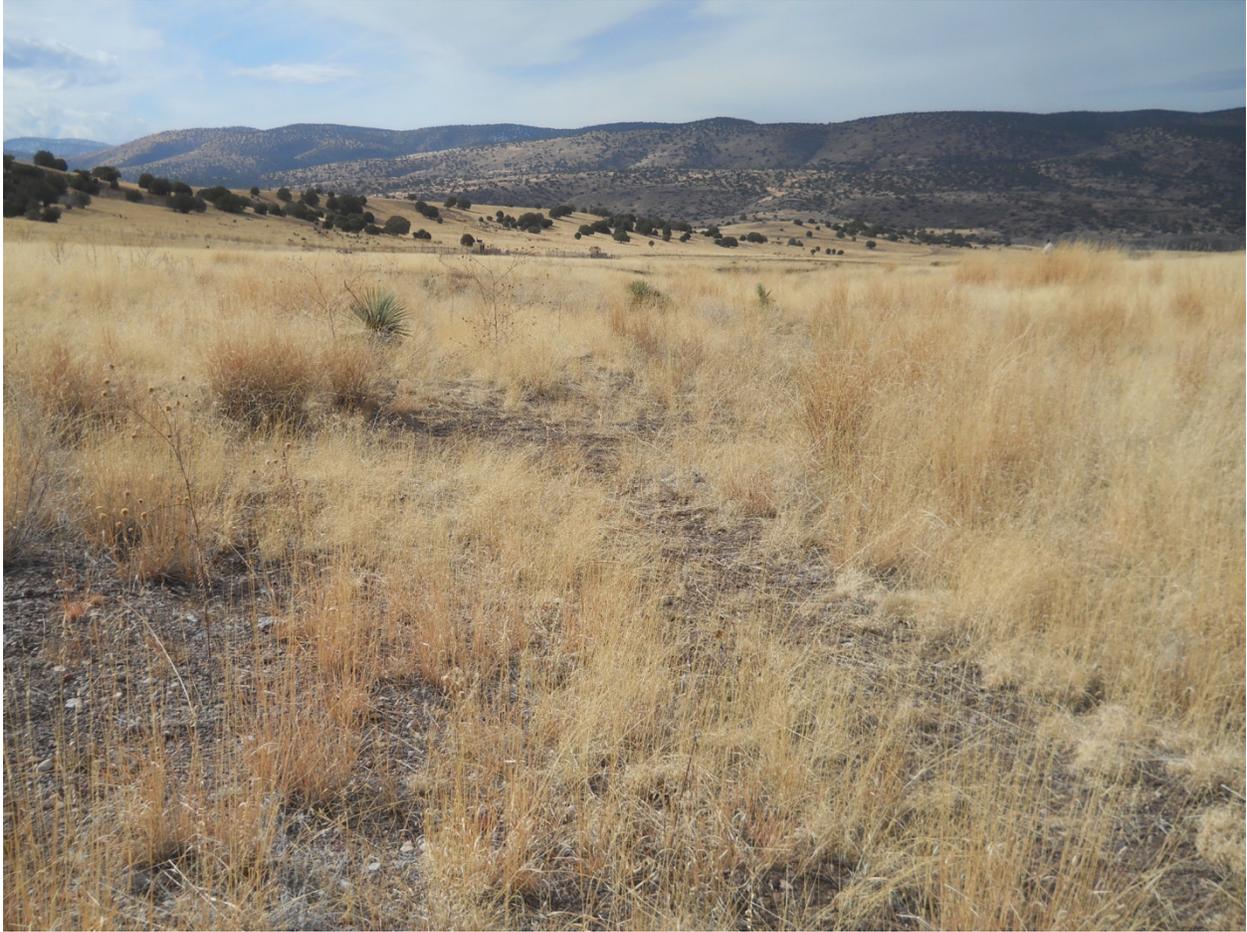
The majority of evidence of the previous road bed has vanished in the new forage. The channel has moved to the left and flows to a series of post vane structures which slow and redistribute the flow. During the maintenance workshop in October 2010 we added a second layer of rock to the one rock dams along the roadbed which had been completely covered with sediment and vegetation. Flow at this site is spread out across the entire area as the channel has been completely filled in.

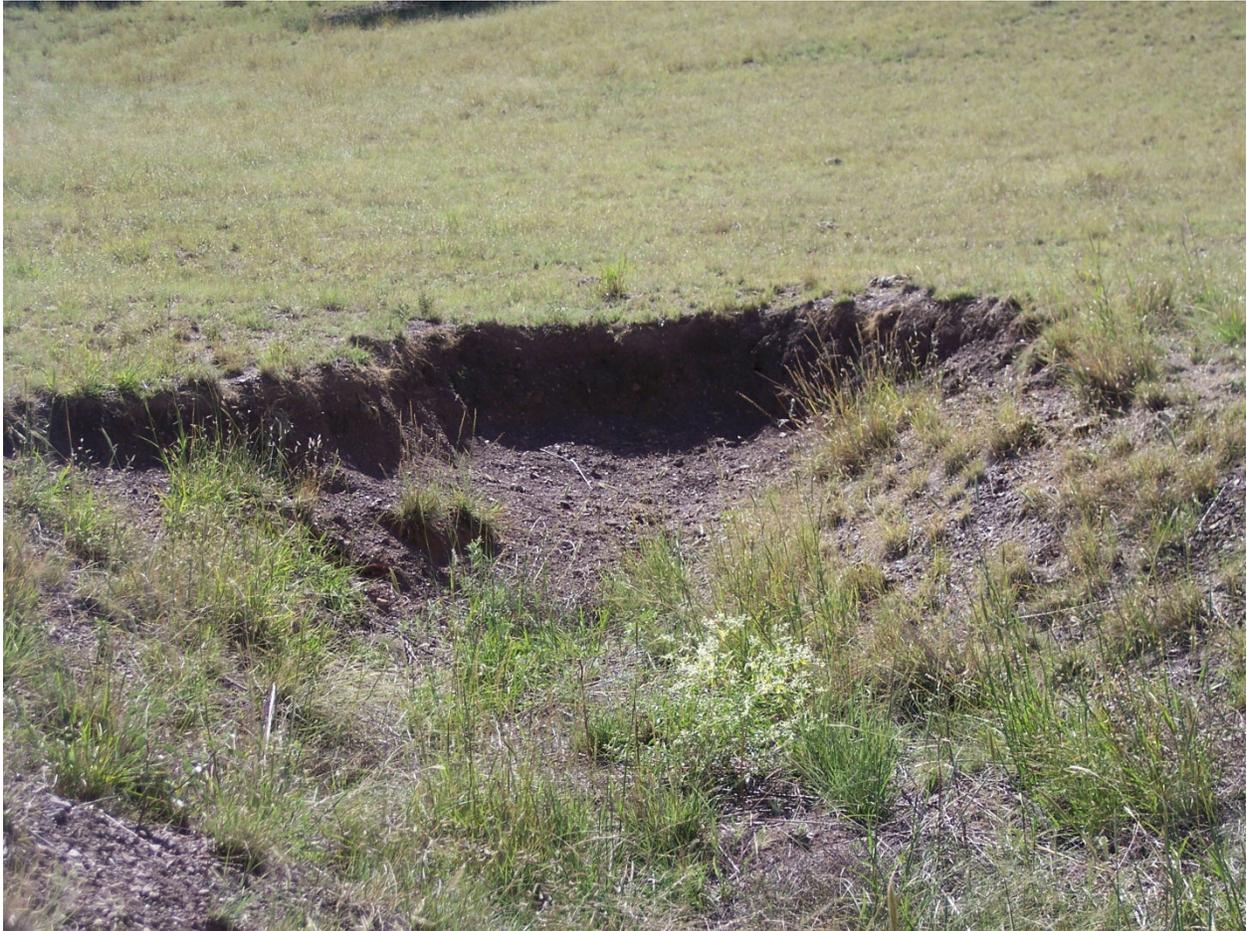
April 2010 Workshop Site – Zuni Bowl Location

This location featured a fairly large headcut travelling up a slight canyon. A large rain event would be extremely damaging to this type of site, causing additional erosion and sediment loss. A rock bowl (Zuni bowl) was constructed during the April 2010 workshop to prevent the headcut from extending further up the draw.

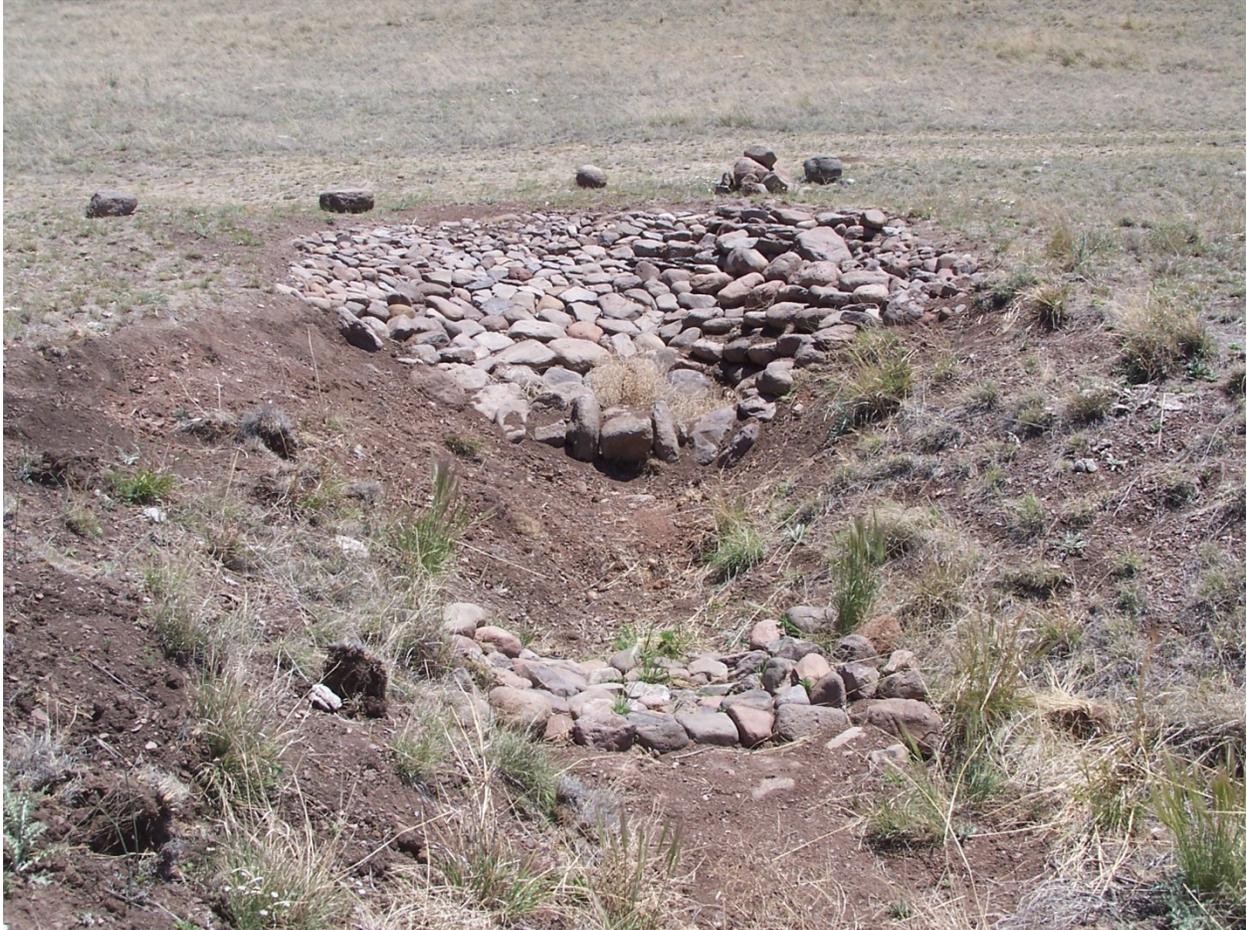
The completed rock bowl and a one rock dam should be sufficient for controlling future rain events. Notice how the structures have the rocks placed in a pattern, not randomly. The rocks interlock which will stabilize the structure as well as provide small crevices for sediment to deposit. A father and son team from California took this project on for themselves and had excellent results.

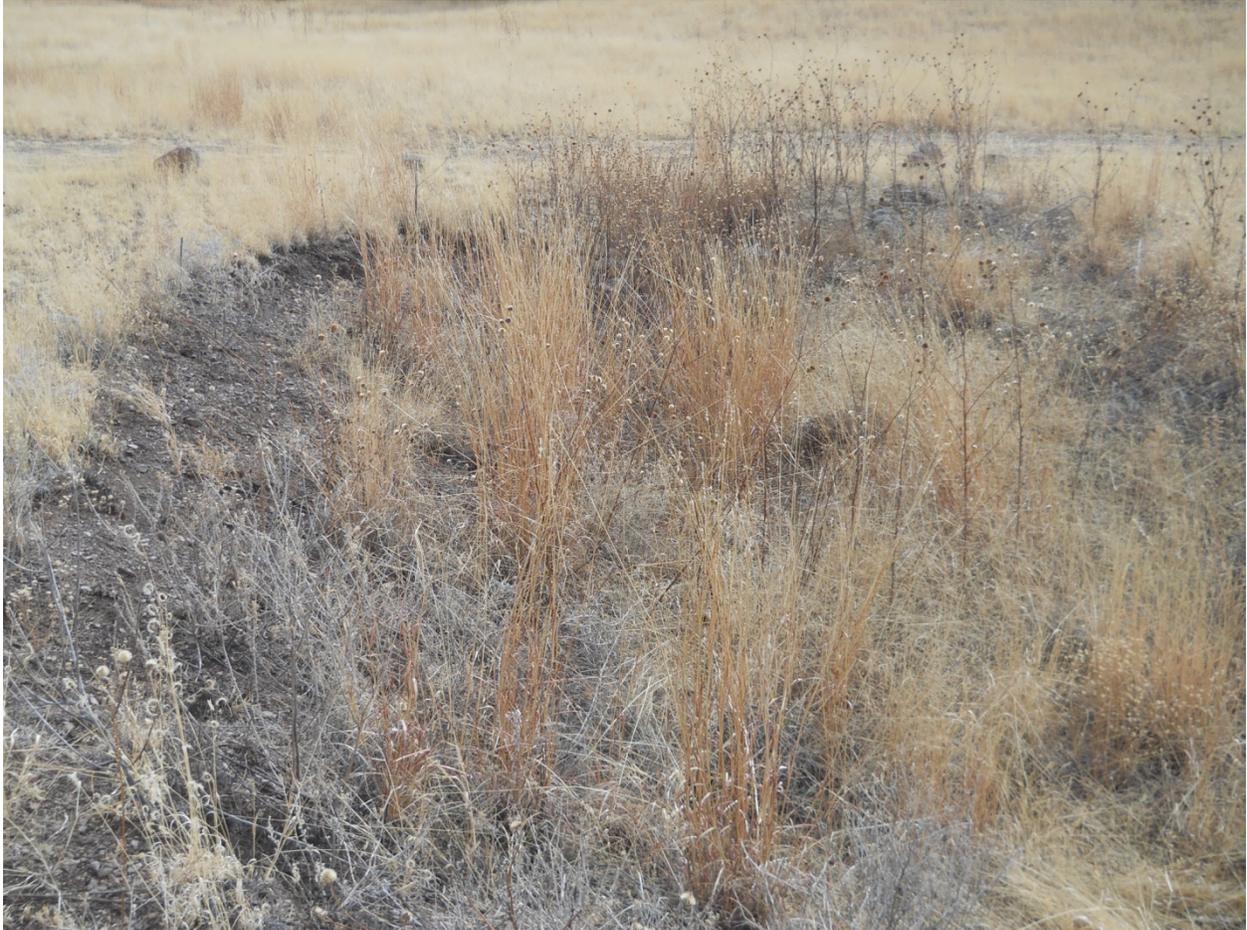
This recent photo of the Zuni bowl demonstrates the improvements in sediment retention and plant vigor. The upper end of the original headcut has ceased movement and the side walls have filled in the openings in the rockwork allowing soil stabilization and plant growth.

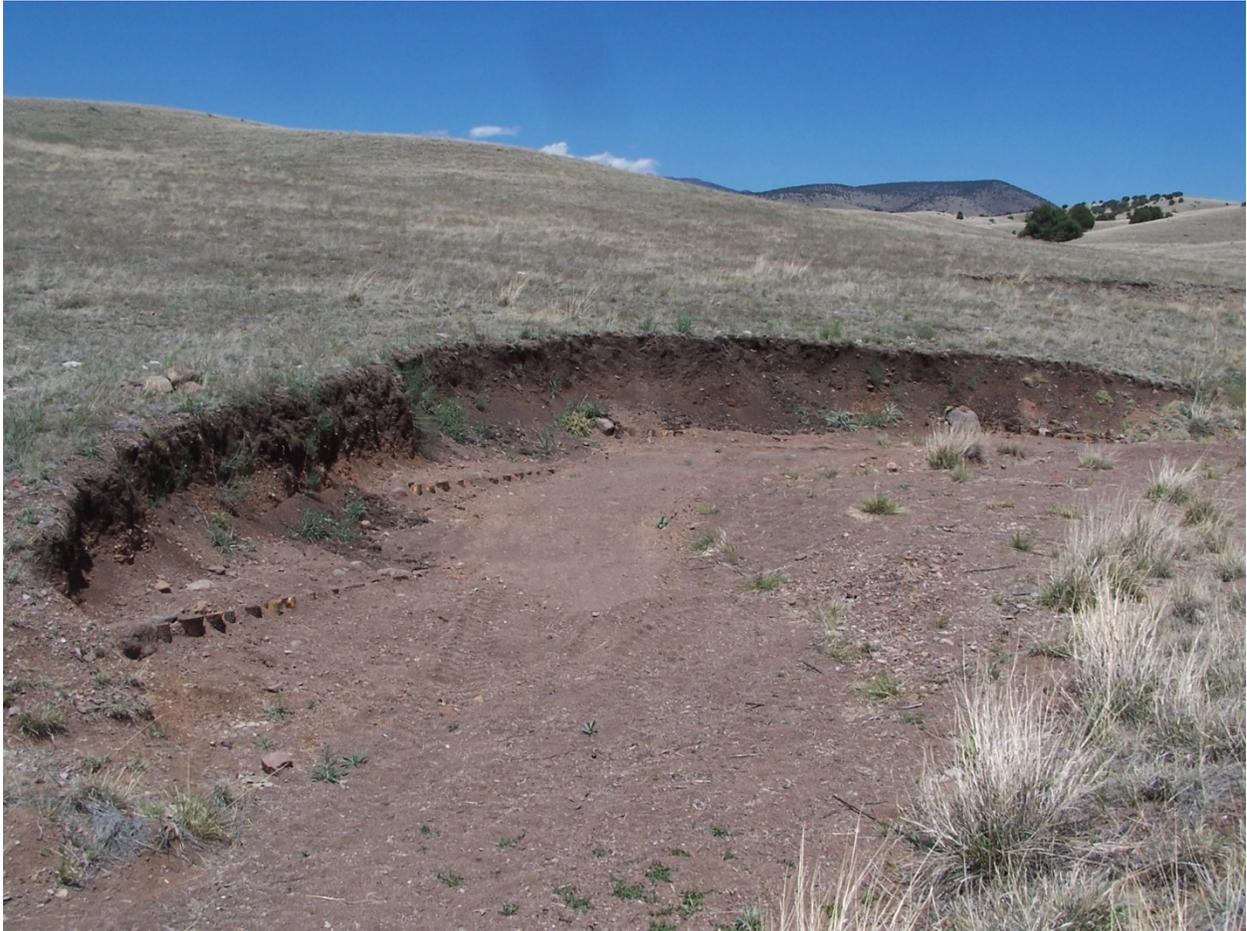
April 2010 Workshop Site – First Post Vane Location

Erosion of the cut bank at this worksite is ongoing and demanded attention. With the erosion caused by flow events around the gradual curvature of the channel this area would continue degrading further up the rise in the background. The post vane structures installed around the curve will move the flow away from the bank, arrest the flow velocity and allow revegetation along the edge.

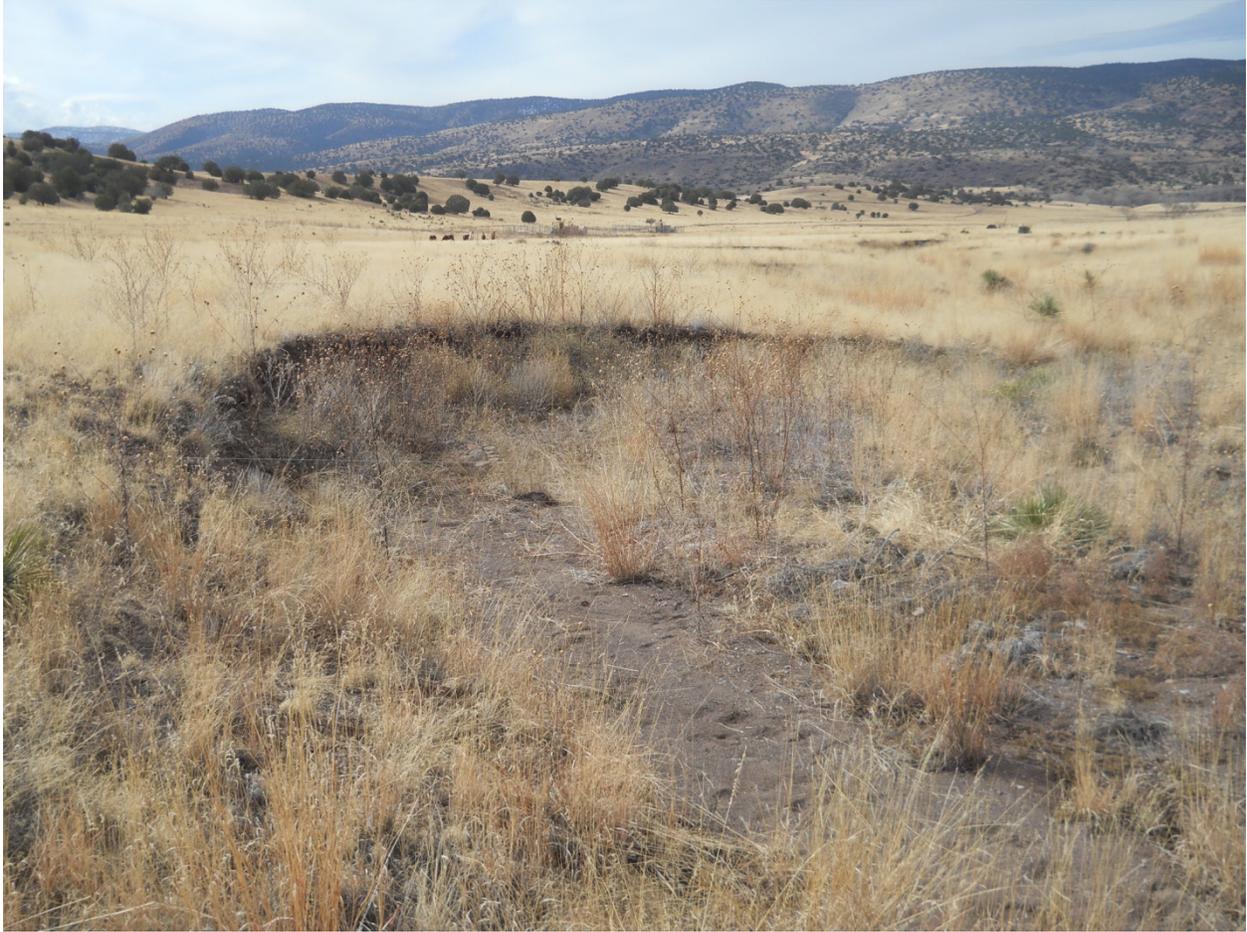
After the post vane structures had aimed the flow events away from the bank, the healing process began. Vegetation has filled in behind the post vanes and the slowing of the flow has allowed sediment to be deposited inside the curve radius, promoting soil recovery and regrowth.

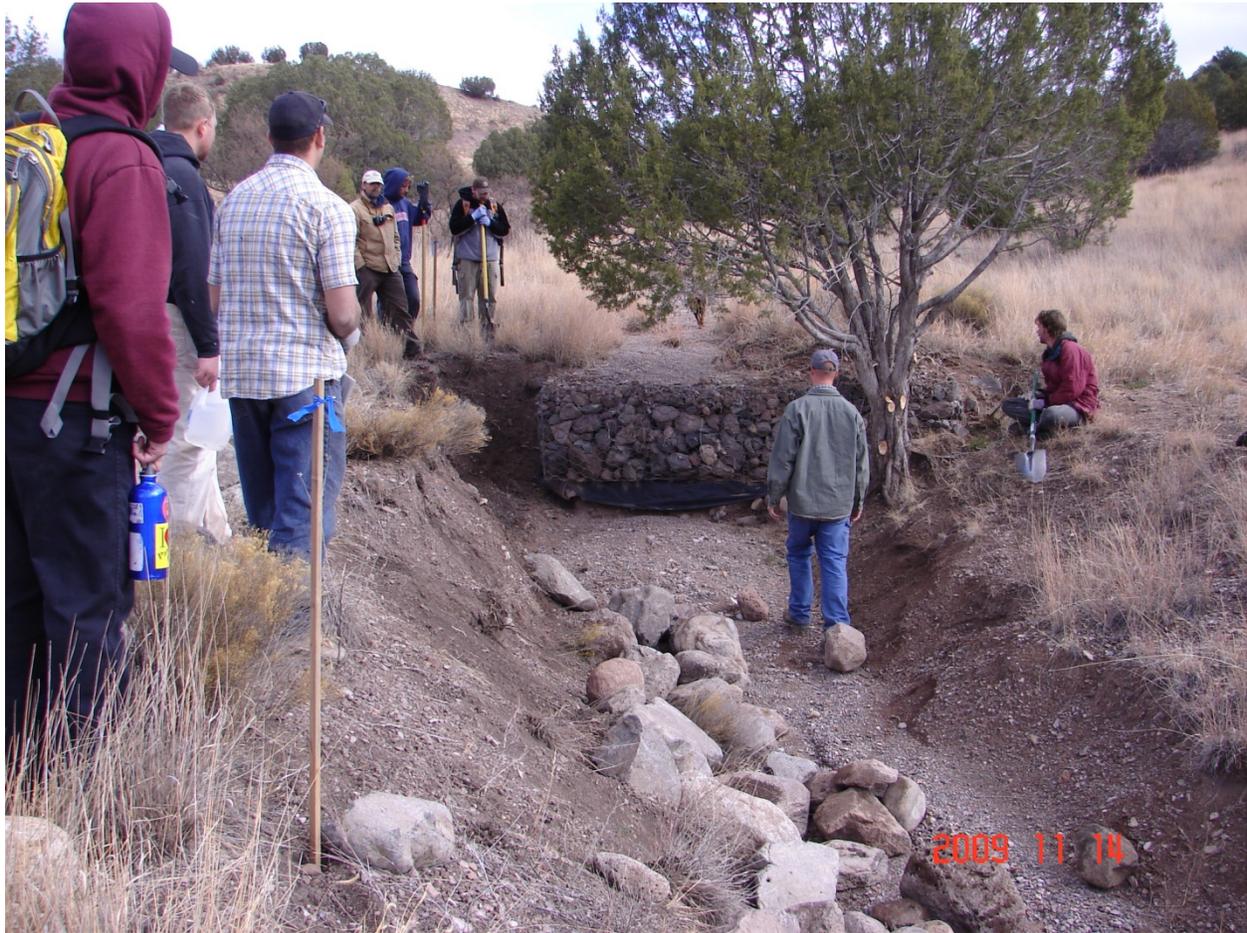
November 2009 Workshop Site – Large Zuni Bowl Location

Instructor Craig Sponholtz (standing in channel) explains the processes involved in repairing the existing wire gabion basket in the channel. The flow had cut around the basket and deepened the erosion causing extensive damage which would require a large rock bowl (Zuni bowl) and a series of one rock dams to begin healing the damage.

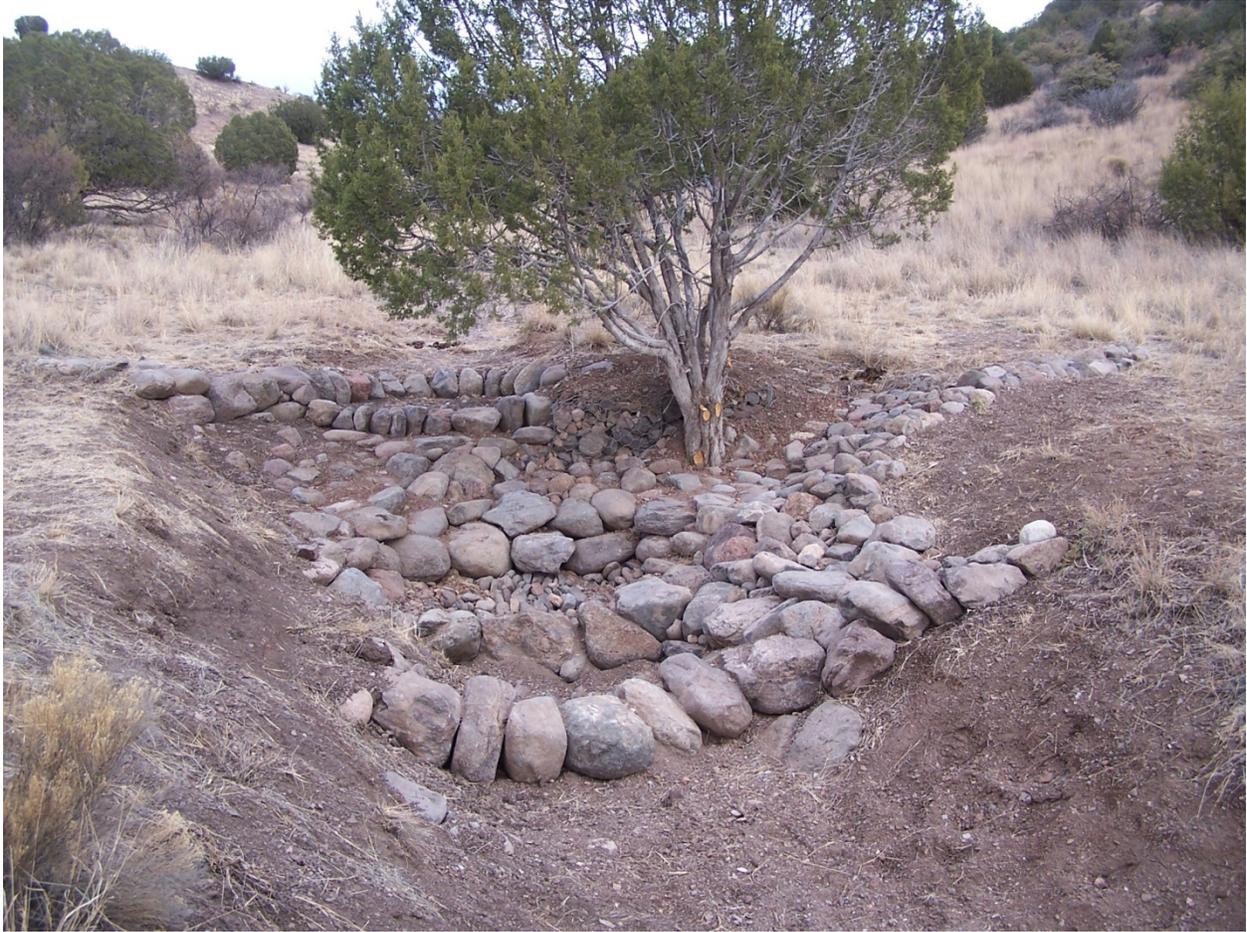
The completed structure consisted of 3 rock bowls in series with a media luna on the side. The elevation change of approximately 6 feet caused by the erosion required an extensive amount of volunteer labor which resulted in Craig's largest Zuni bowl constructed by hand. The structure "steps" down several times, which will allow sediment to deposit at several levels and eventually begin healing the damage caused by the wire gabion.

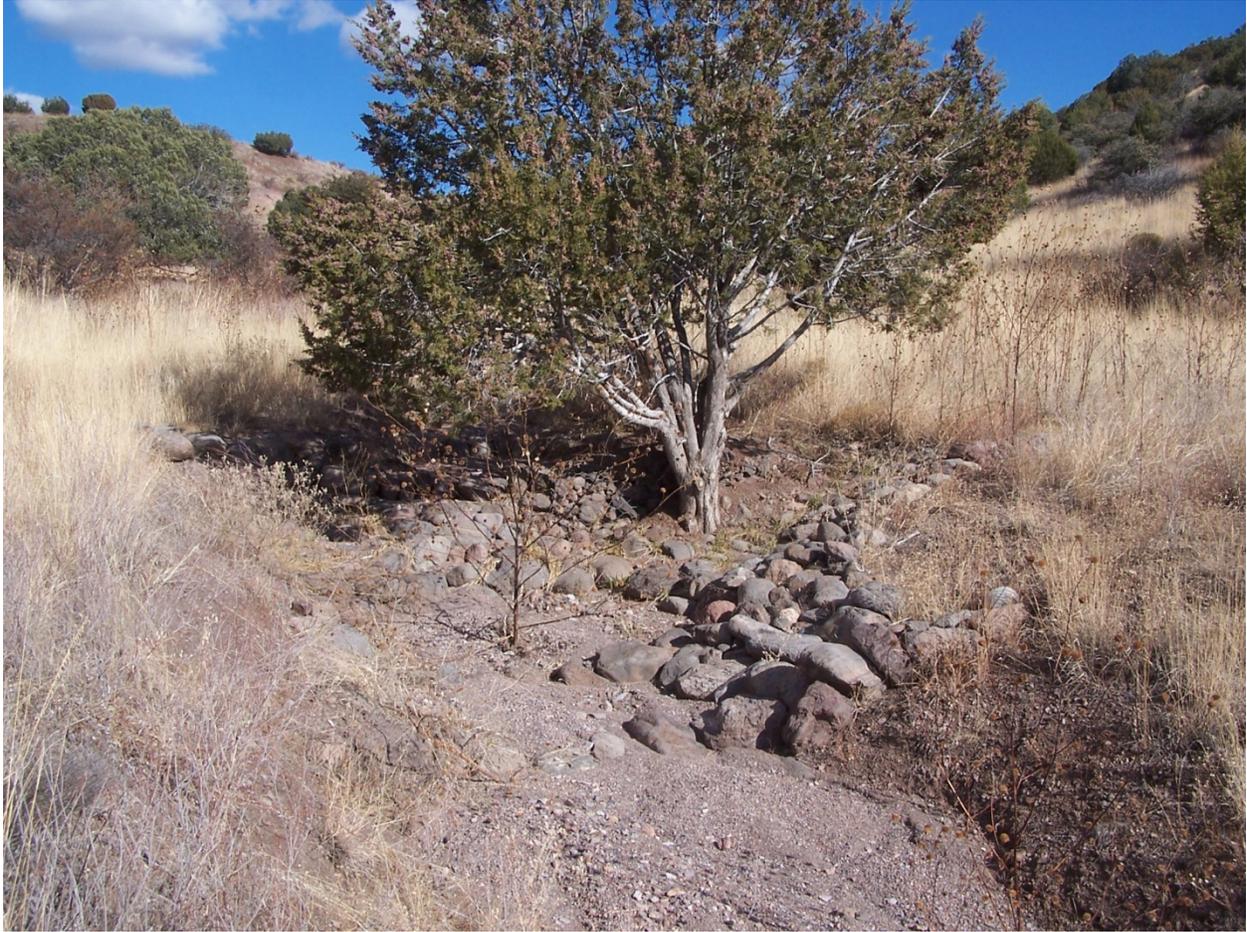
This is a fairly steep drainage fed by FR217 in several locations with a fairly large amount of flow during monsoon season, as evidenced by the amount of sediment deposited in the Zuni bowls. Revegetation is obvious and continuous with varied types of weeds and grasses. Sediment deposits of 12" – 15" were seen in the bowls which translates to much less sediment eventually flowing towards Eagle Creek. The entire drainage below this site was revisited during the Maintenance Workshop and extensive additions and repairs were added the entire length. The deep channel has virtually disappeared at the lower end of the site, further proving the value of the erosion control methods used.

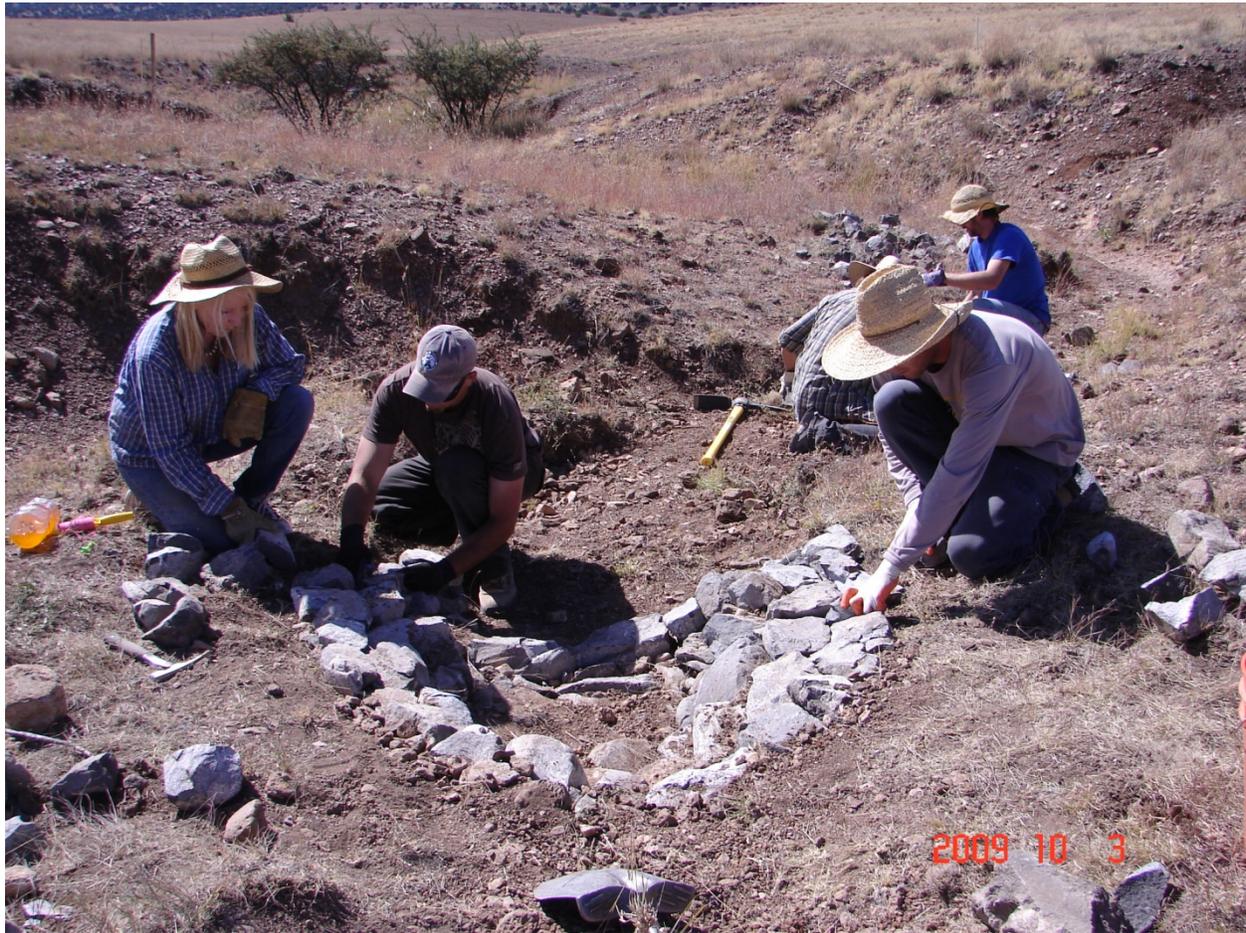
October 2009 Workshop Site – Drainage Channel

The drainage channel addressed in the October 2009 Erosion Workshop extended from FR217G to Eagle Creek and was being eroded by runoff from the forest road. Numerous rock bowls, one rock dams and several media lunas were constructed by volunteers to slow the flow and capture sediment along the channel. Rocks are interlocked while constructing a rock bowl at this location.

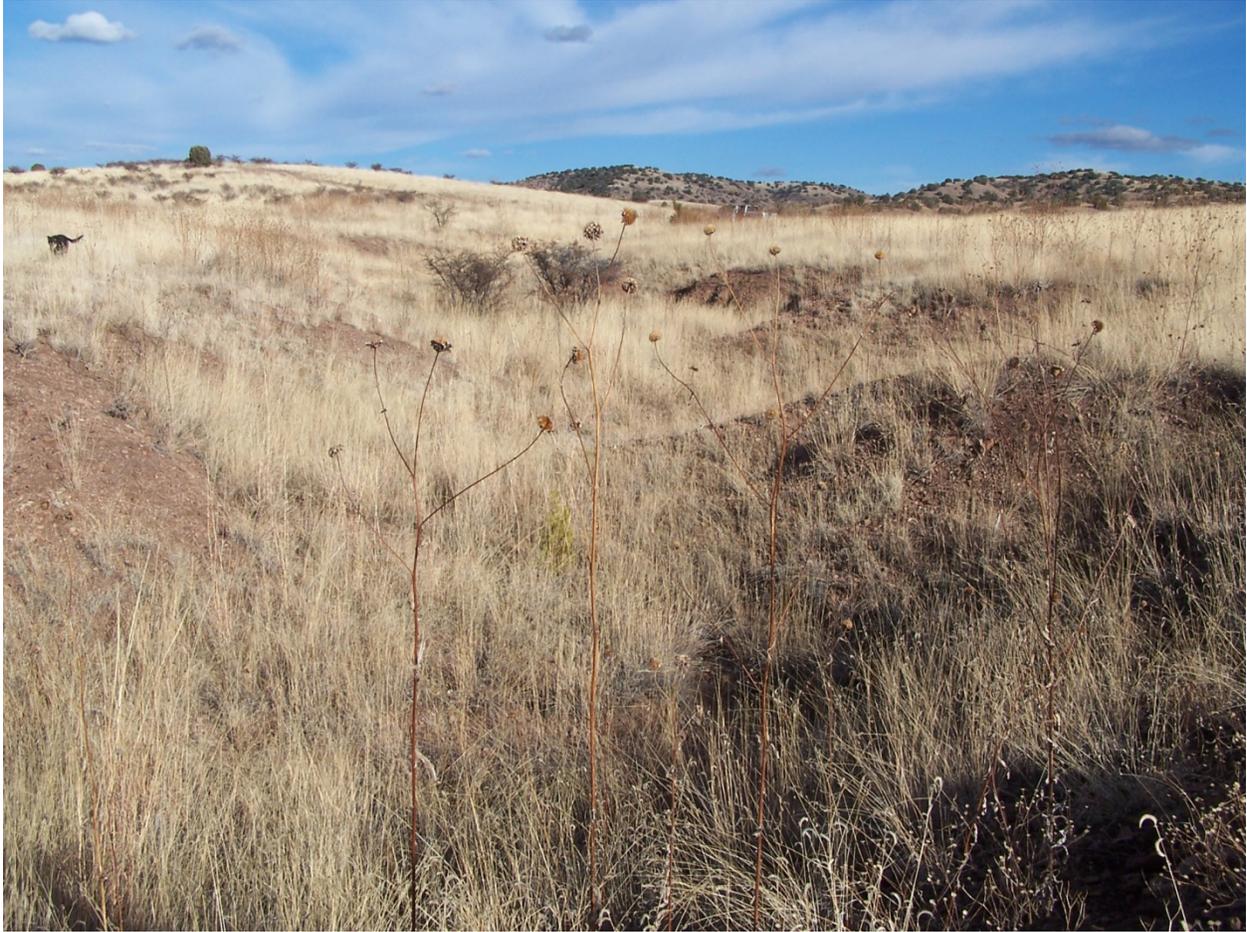
Revegetation dominates the site in this recent photo as a result of slowed flows causing sediment deposition in the channel. This particular channel empties directly into Eagle Creek, which will receive much less sediment as a result of the erosion structures installed by the volunteers.

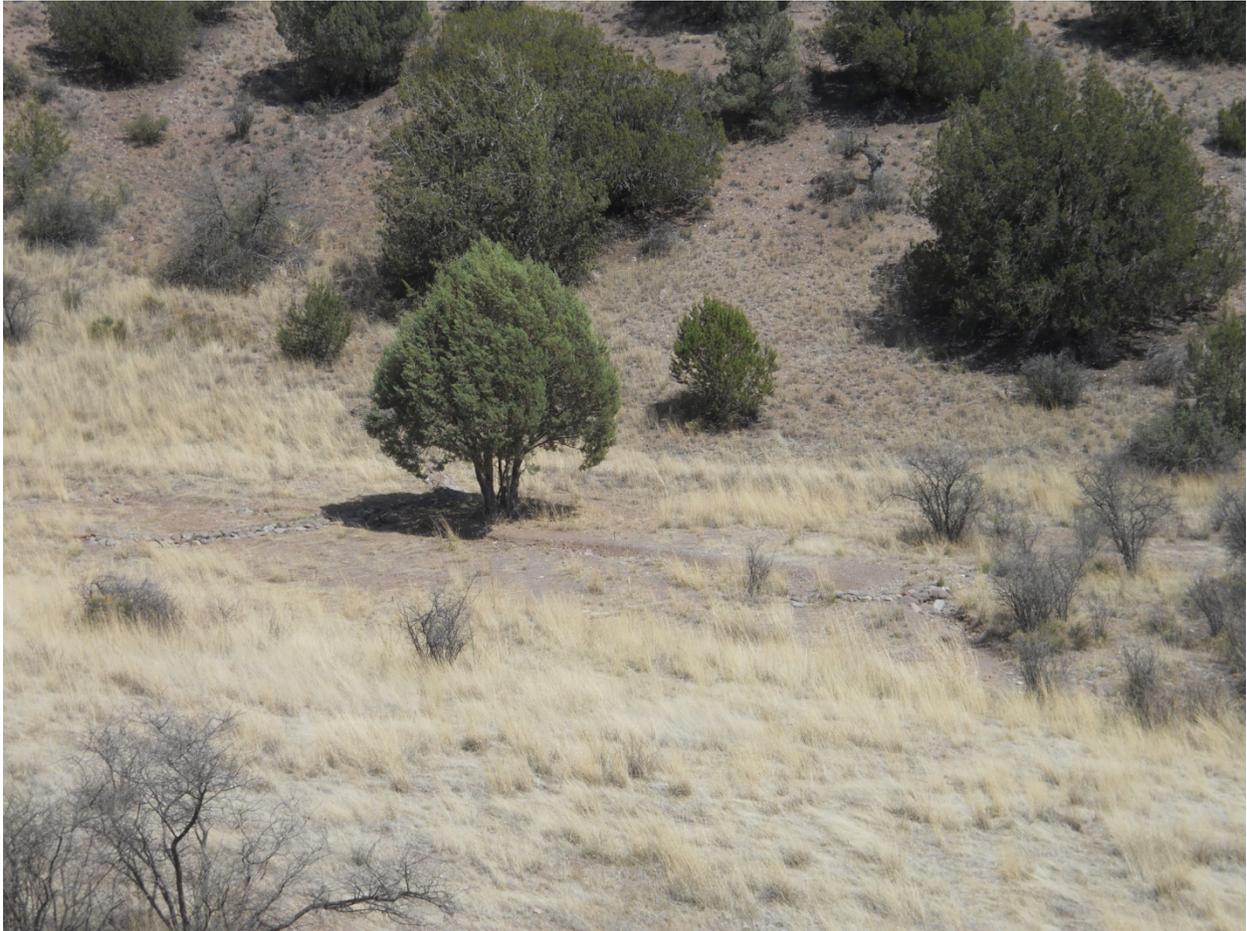
November 2009 Workshop Site – Overall View

The November 2009 Site was a popular location for training and maintenance over the duration of the workshops. The large amounts of flow caused by the drainage from 3 culverts off of FR217 resulted in deep channelization the entire length of the site and became a challenge to repair using hand built erosion structures. The site was revisited several times during subsequent workshops for additions and repairs which have resulted in the views in these photos. The initial deep channelization has been entirely filled in and several small media lunas are being used to spread any remaining flows across the lower portion of the site.

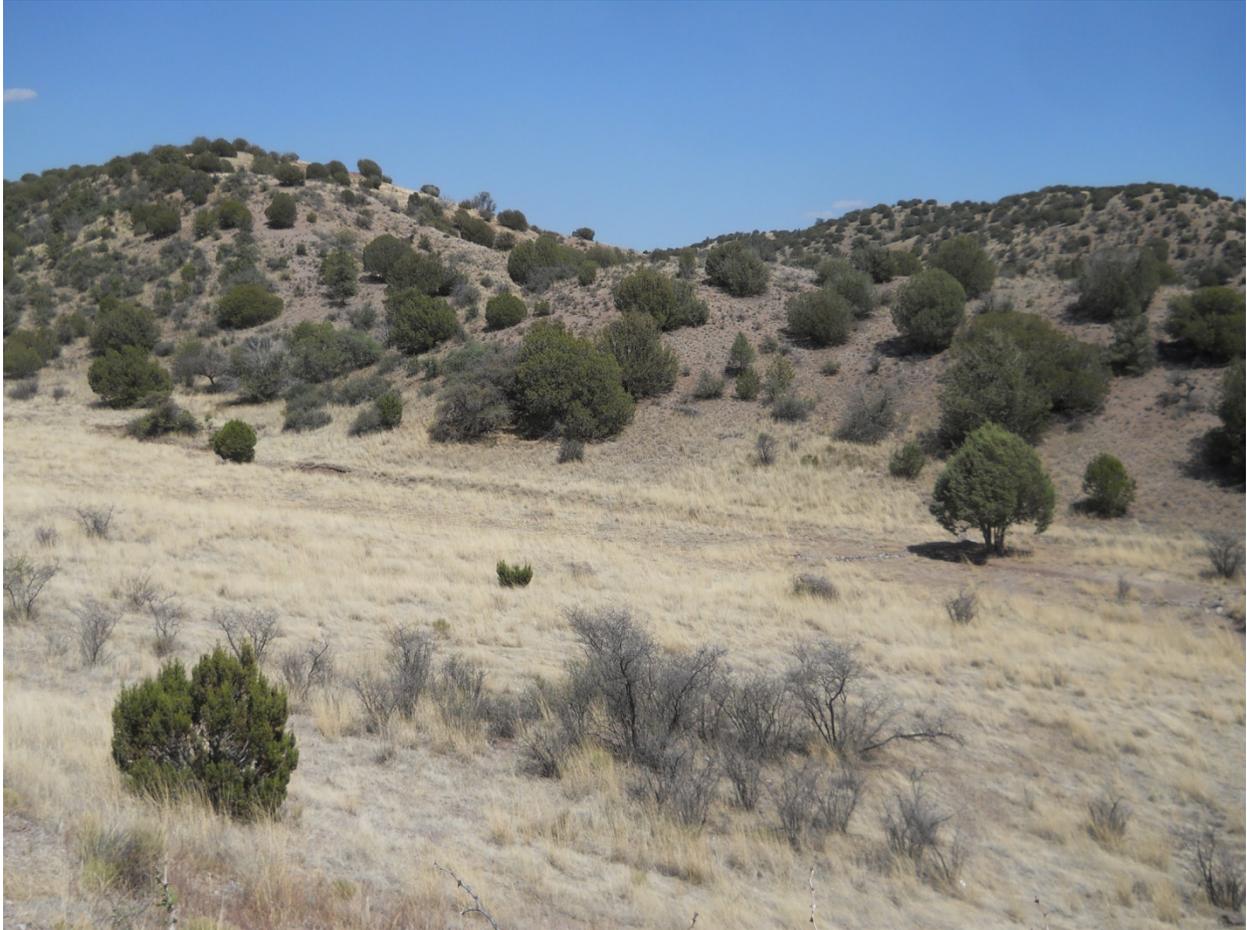
A second overall view showing the entire site. The original channel is for the most part filled in and the spreading of sediment at the lower end is obvious. This entire valley would have eventually eroded away without the structures installed by the volunteer workshos.
