**Arizona Water Protection Fund
Application Cover Page
FY 2019**

Title of Project: Harrenburg Wash Enhancement Project											
Type of Project: <input checked="" type="checkbox"/> Capital or Other <input type="checkbox"/> Water Conservation <input type="checkbox"/> Research	Stream Type: <input type="checkbox"/> Perennial <input type="checkbox"/> Intermittent <input checked="" type="checkbox"/> Ephemeral										
Your level of commitment to maintenance of project benefits and capital improvements: <input type="checkbox"/> < 5 years <input type="checkbox"/> 5-10 years <input type="checkbox"/> 11-15 years <input checked="" type="checkbox"/> 16-20 years											
Applicant Information: Name/Organization: Coconino County Address 1: Parks and Recreation Address 2: 2446 Fort Tuthill Loop City: Flagstaff State: AZ ZIP Code: 86005 Phone: (928) 679-8000 Fax: (928) 774-2572 Tax ID No.: XXXXXXXXXX											
Inside an AMA: Yes <input type="checkbox"/> No <input checked="" type="checkbox"/> If yes, which AMA: <input type="checkbox"/> Phoenix <input type="checkbox"/> Tucson <input type="checkbox"/> Prescott <input type="checkbox"/> Pinal <input type="checkbox"/> Santa Cruz											
Conta

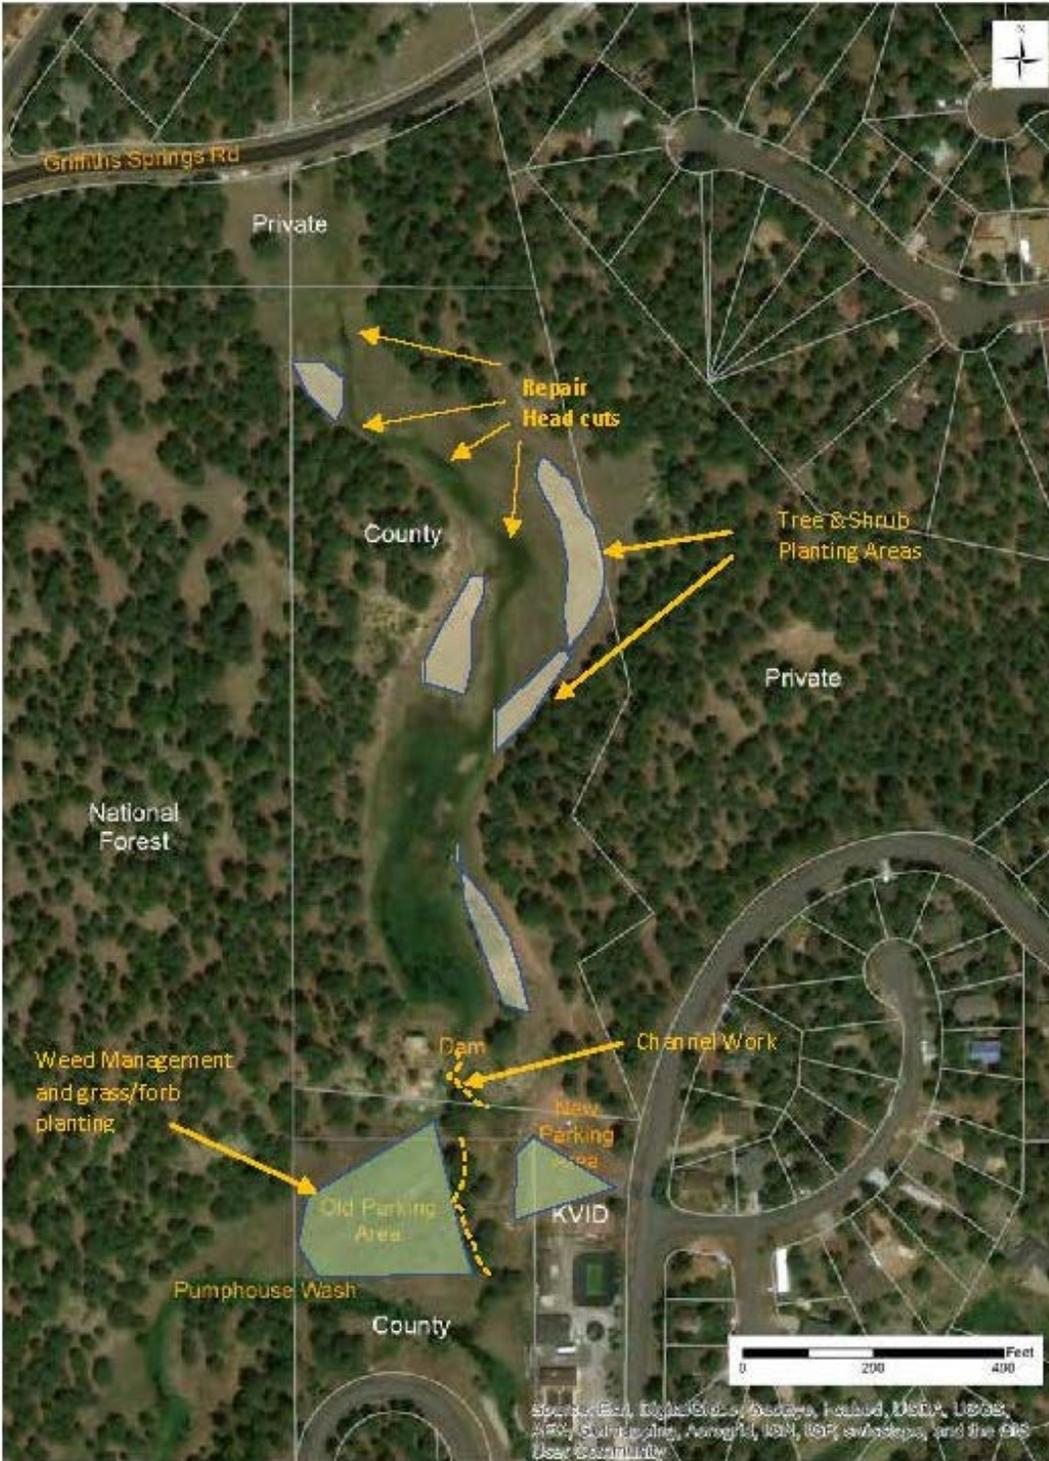
Figure 5. Harrenburg Wash Enhancement Project area map showing proposed weed management, planting areas, and channel work, prepared 9/6/18.

Harrenburg Wash runs north/south from private property boundary to Kachina Village Improvement District (KVID) and Coconino County lands. Project is bounded by private lands to the east and Coconino National Forest land to the west. This map illustrates where proposed project will take place.

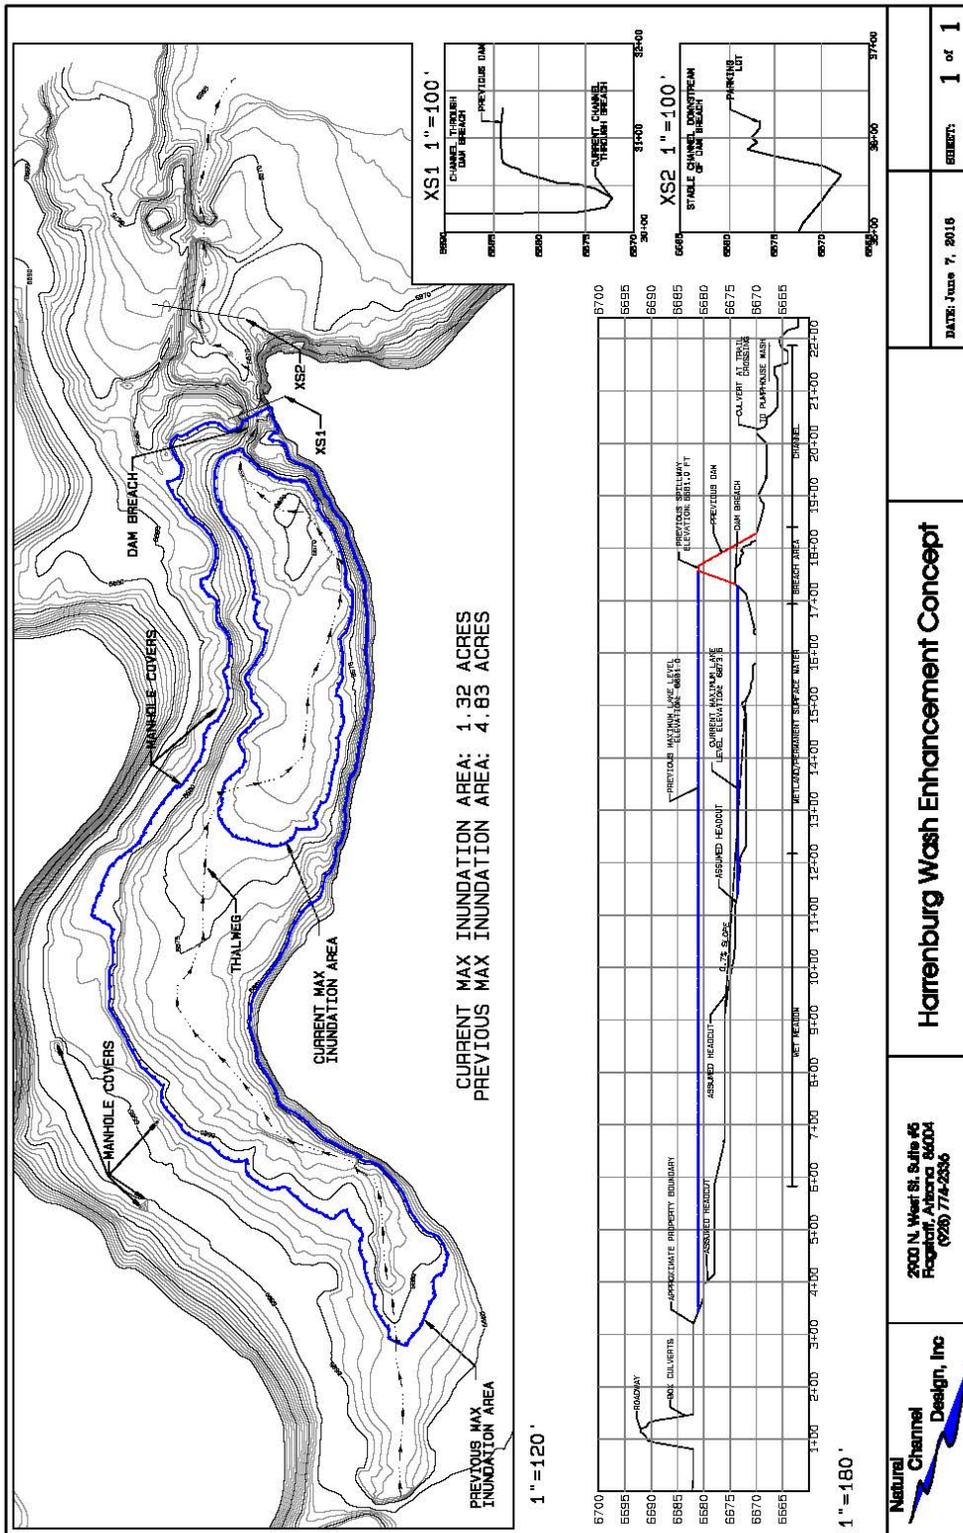
Figure 8. Topography and Channel Features of Harrenburg Wash, as mapped by Natural Channel Design.

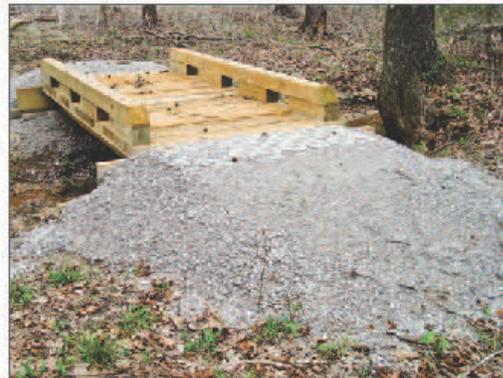
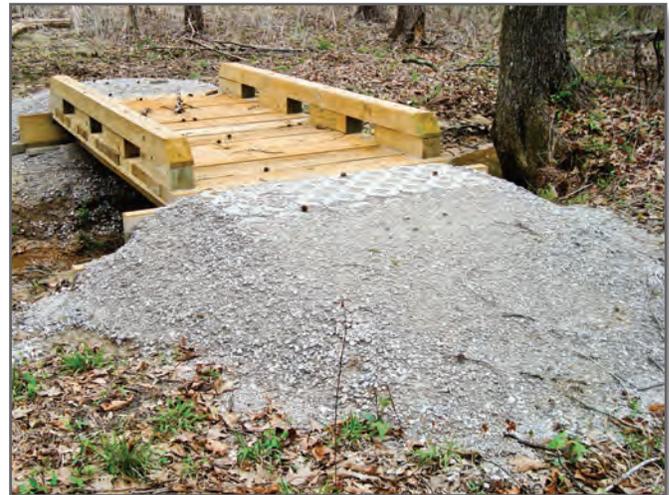
Figure 1—This bridge was constructed on an ATV trail at the Tombigbee National Forest, Mississippi.

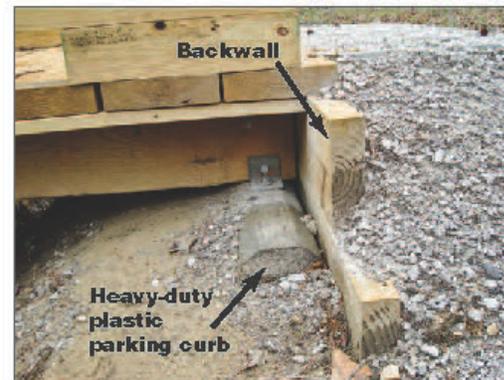
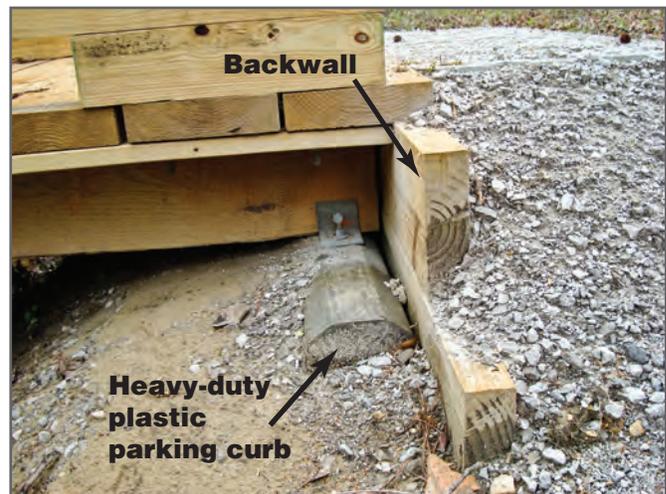
Figure 3—Heavy duty plastic parking curbs, anchored by Duckbill anchors, serve as sills. Two backwall planks are banded to the depth of the bottom of each sill. The backwall is extended well to the sides of the bridge to prevent earth-to-wood contact for both the sill and stringers. Decking extends over the top of the backwall to prevent water running down between the backwall and the end of the stringers.

Figure 3—Heavy duty plastic parking curbs, anchored by Duckbill anchors, serve as sills. Two backwall planks are buried to the depth of the bottom of each sill. The backwall is extended well to the sides of the bridge to prevent earth-to-wood contact for both the sill and stringers. Decking extends over the top of the backwall to prevent water running down between the backwall and the end of the stringers.

The sills consist of 6-inch by 6-inch by 8-foot heavy-duty recycled plastic parking curbs (figure 3) that resist decay. Each sill is anchored by one Duckbill earth anchor attached to a 4-foot-long, 1/2-inch diameter galvanized steel all-thread rod. The Duckbill anchor, like a toggle bolt, can be driven into the ground with a hydraulic or mechanical jackhammer with the aid of a steel rod gad. Then a ratchet is used to tighten the nut, pulling up the rod, causing the anchor to pivot in the ground, and anchoring it in place. About 3 inches of rod needs to be pulled up to obtain about 3,000 pounds of anchor force. The anchor keeps the sill in place and prevents it from floating off in floods (figure 4).

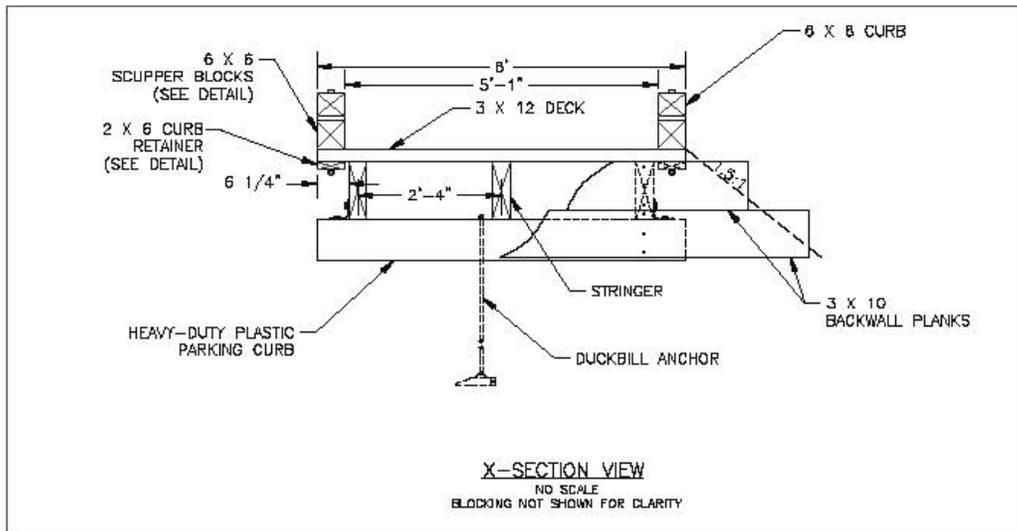
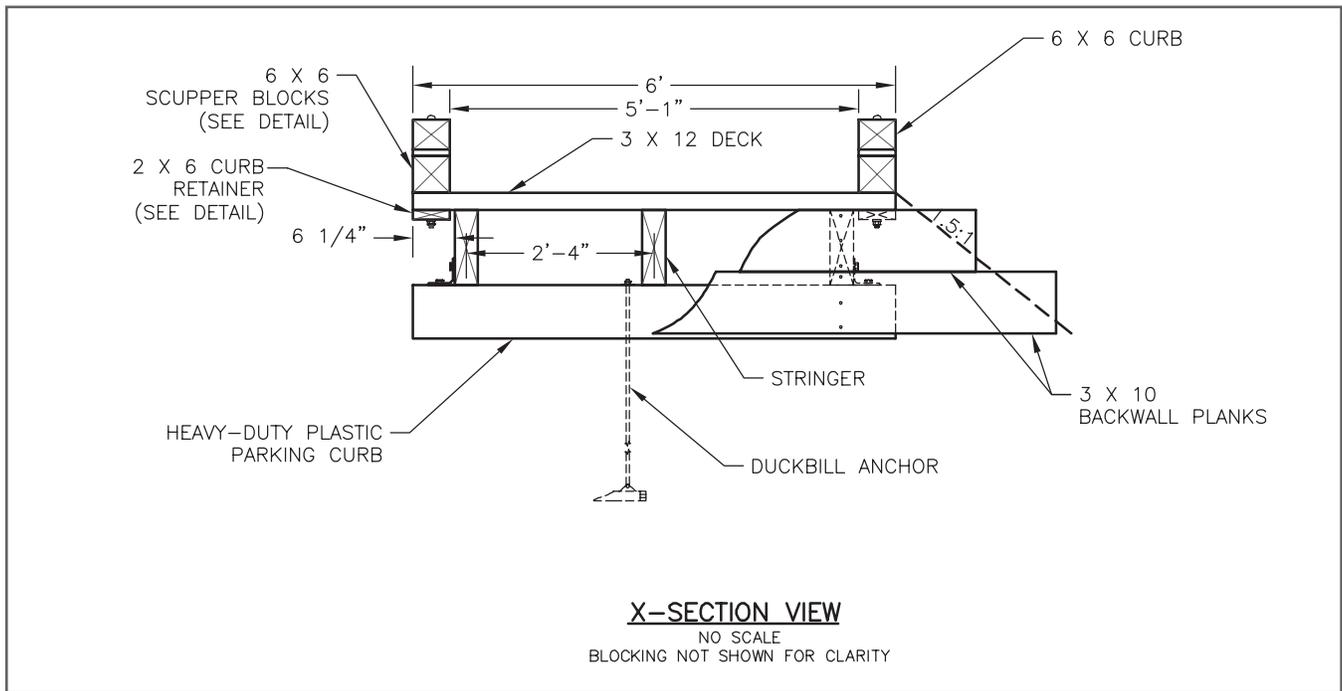
Figure 4—One Duckbill anchor holds each sill in place.

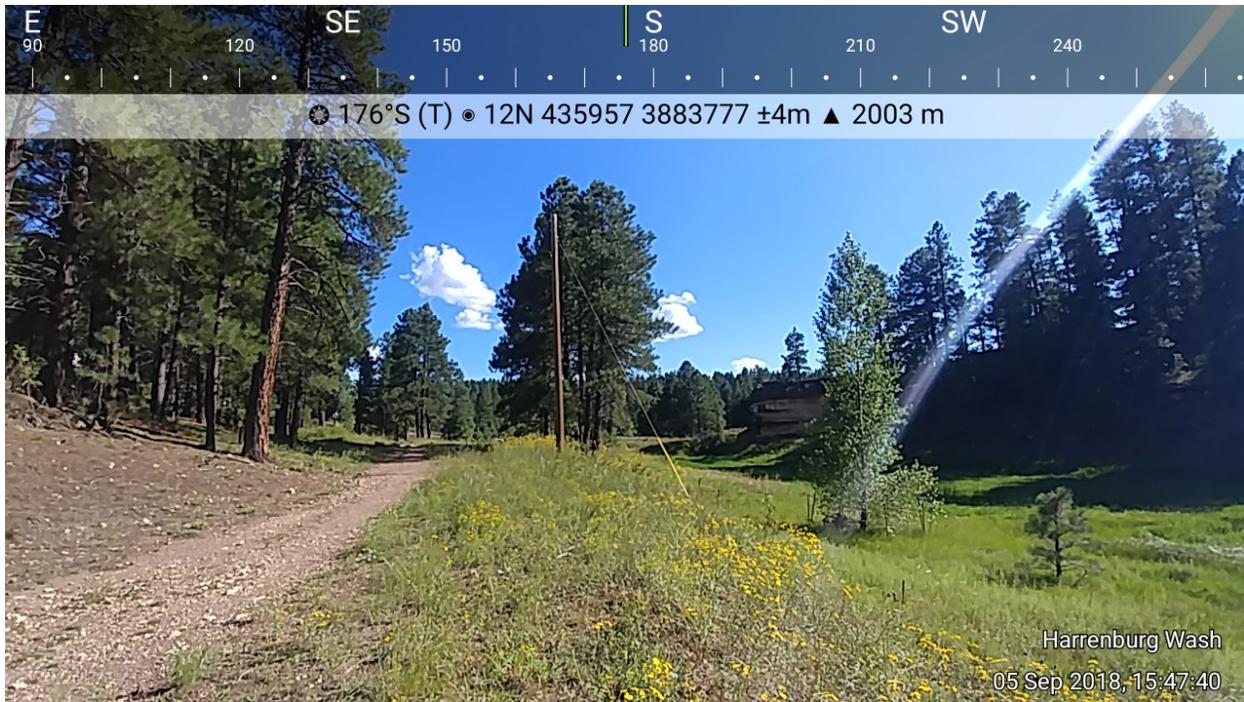
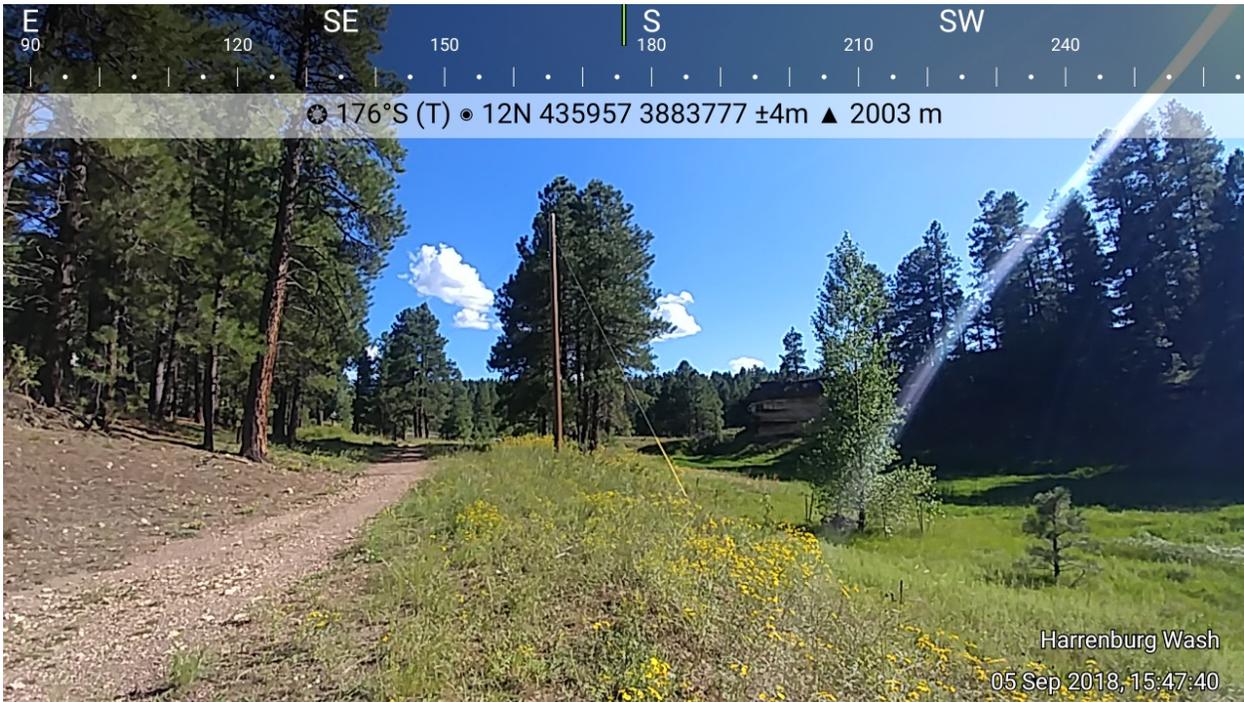
Picture 1. View of old electrical pole, with project area to the right.
This is the view looking north, with the breached dam in the distance next to the rocky outcropping.

Picture 10. View of old electrical pole, with project area to the right.
This is the view looking north, with the breached dam in the distance next to the rocky outcropping.

- There is an above-ground electrical line that dead ends near the wetland. This wire and two associated wooden poles should be removed from the site.
- There are several piles (~ 40 cu yds) of broken asphalt and concrete that have been dumped on the site. These should be removed and disposed of in a lawful manner. The remaining material should be smoothed over and replanted.

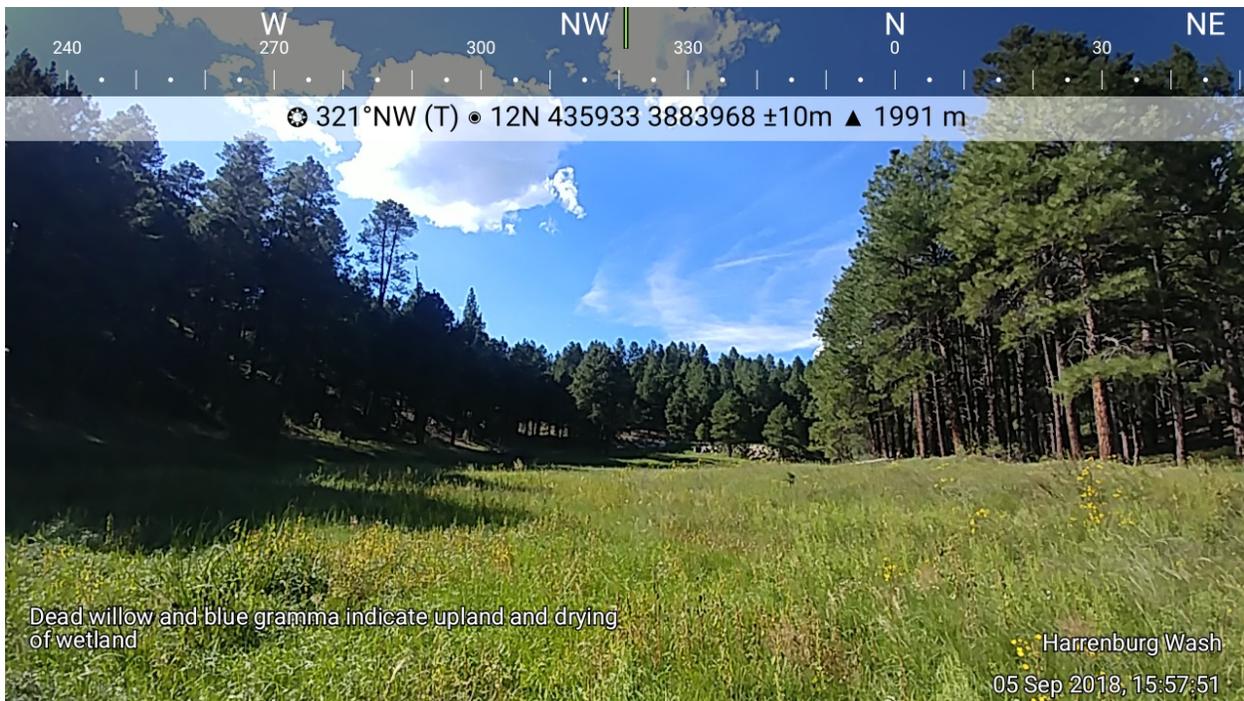
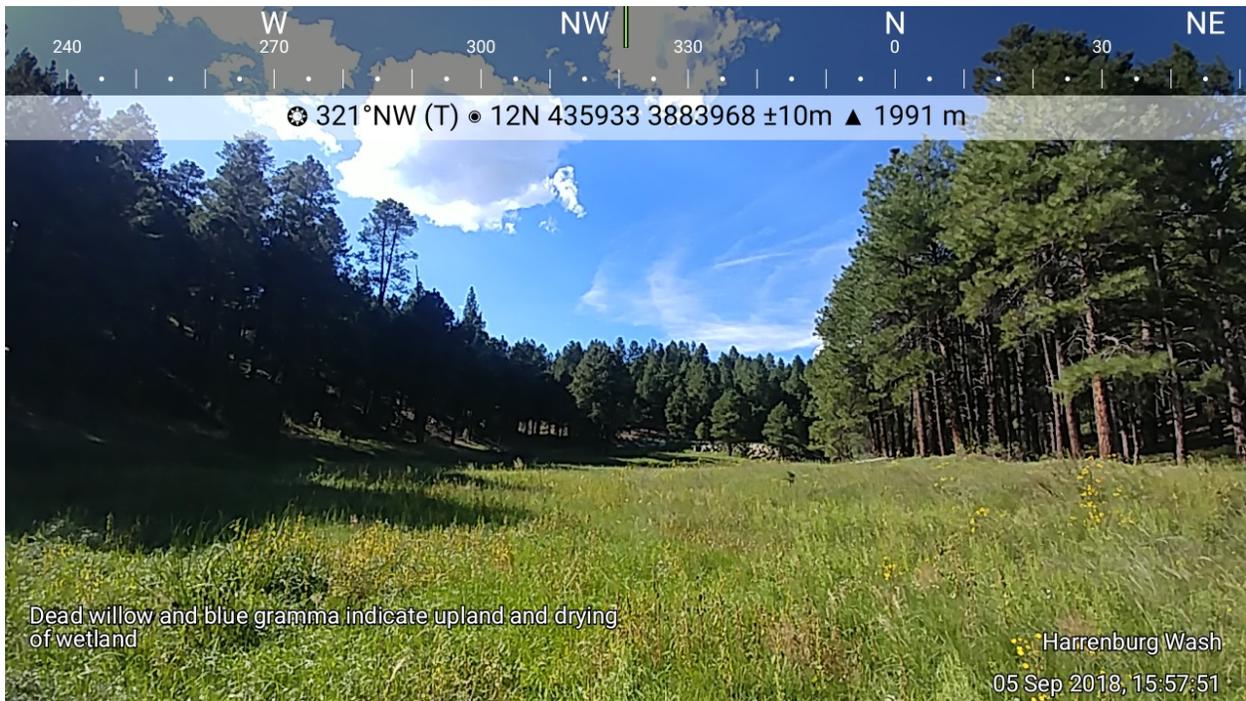
Picture 2. View of upland.
Looking south, a dead willow and blue gramma are indicative of drying of the wetland.

Picture 12. View of upland.
Looking south, a dead willow and blue gramma are indicative of drying of the wetland.

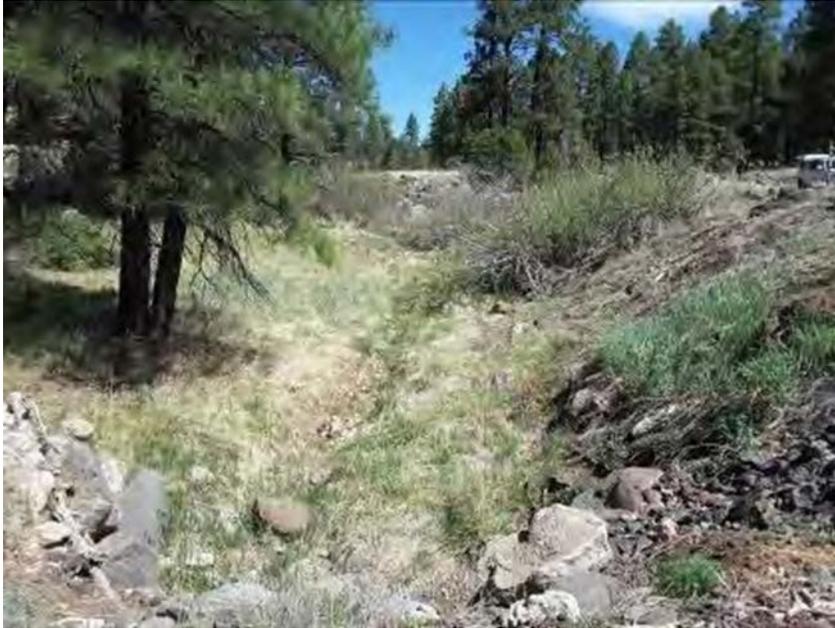
Picture 1. Generally stable channel conditions between confluence and old dam that is now breached.
View is looking upstream from trail crossing.

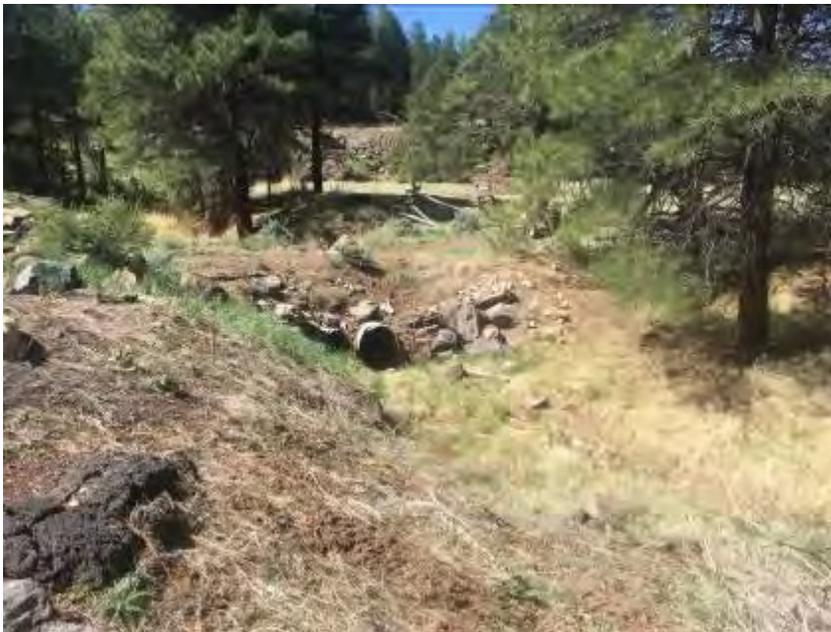
Picture 2. Undersized culvert and eroding trail prism.
Flows have overtopped the road prism and eroded the downstream side of fill prism. View is looking upstream.

Below the breach area, the undersized culverts should be replaced with a pedestrian bridge or a pedestrian low water crossing. The intent is to reduce overtopping of the trail prism and the resultant high velocity and erosion that occurs here. A prefabricated bridge would be a preferred alternative. However, the crossing could be accomplished with less expensive measures, including the placement of larger culverts in the existing prism. The full design process should explore the requirements of this crossing (equestrian, bike or pedestrian only traffic) and provide a cost analysis of various options. This is likely to be the most expensive task within the entire project. Costs will vary greatly given the design criteria of the bridge (traffic type and weight and flood discharge) as well as the type of bridge. Appendix B provides an example of a simple site built bridge which would likely be adequate for pedestrian and equestrian traffic up to a roughly 25 year return interval flow. This criteria and design will require considerably more discussion and scrutiny before it can be finalized.

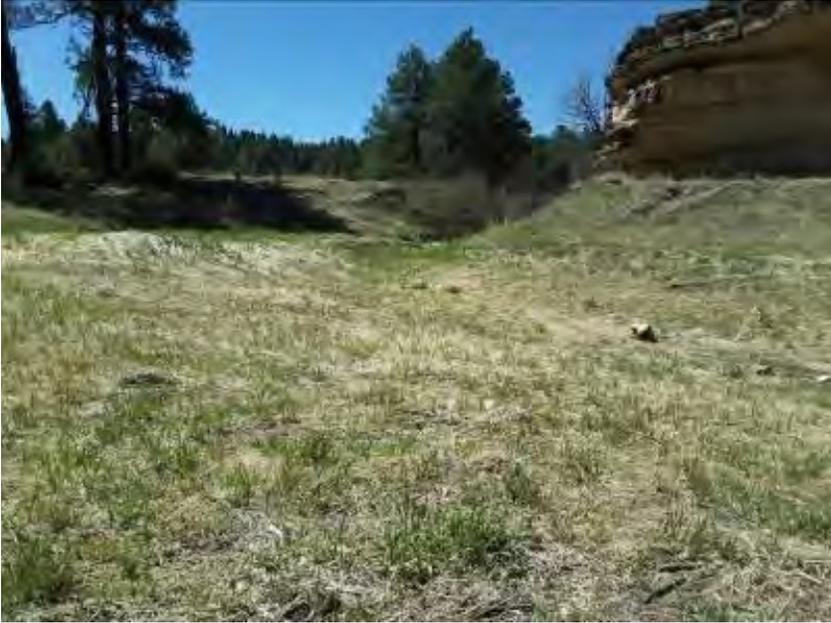
Picture 3. Breach through dam.
View is looking downstream from the wetland area that exists above the breached dam.

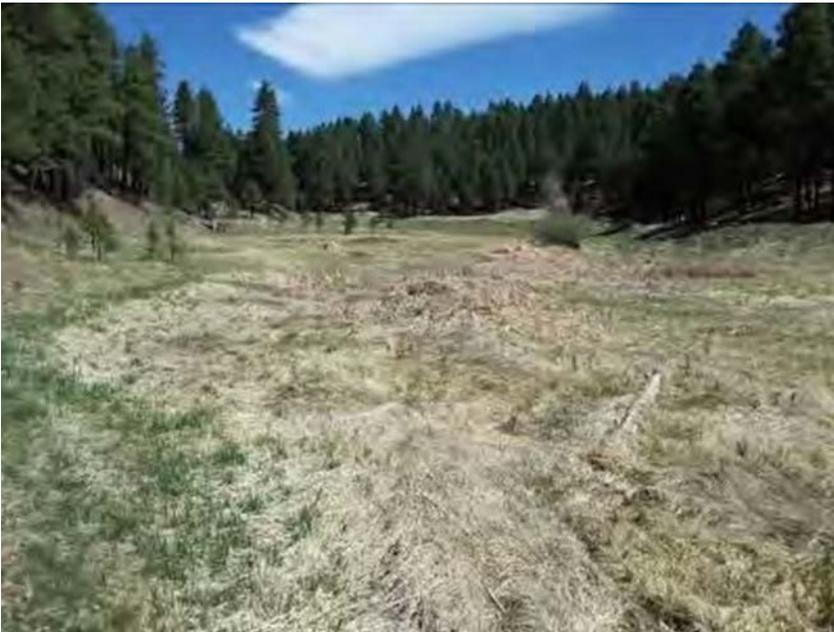
Picture 4. Wetland area.
View is looking upstream from breached dam. This area exhibits relatively permanent inundation except during extremely dry weather.

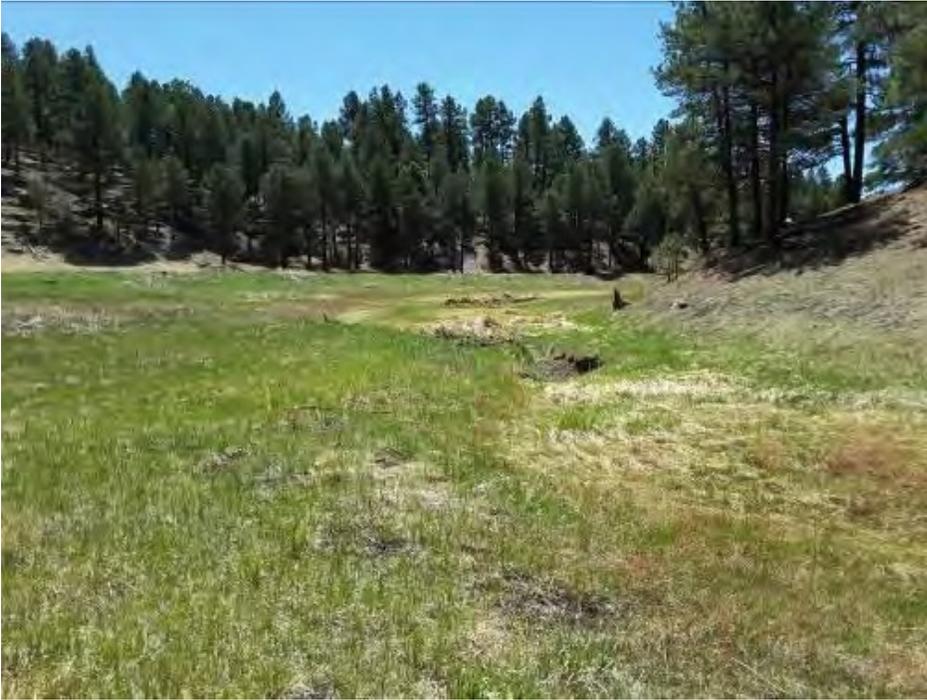
Picture 5. Typical conditions in upper meadow.

Flow channel is typically a shallow wide swale vegetated with wetland plants. However, potholes cut into the meadow have initiated headcuts.

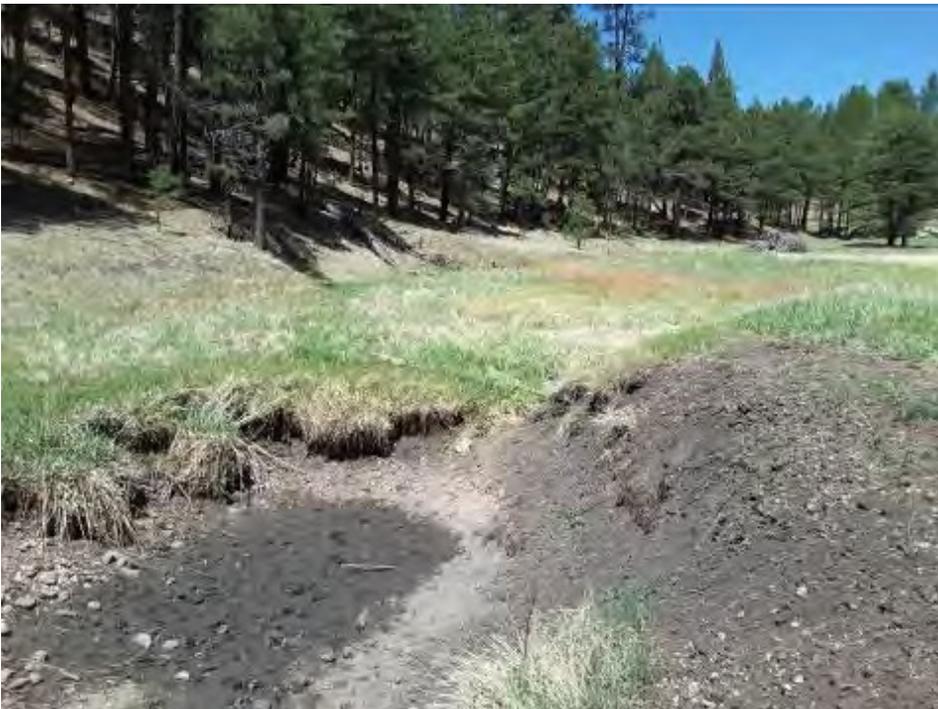
Picture 6. Excavated pool forming a headcut in meadow.

Note that excavated materials are still piled adjacent to excavation.

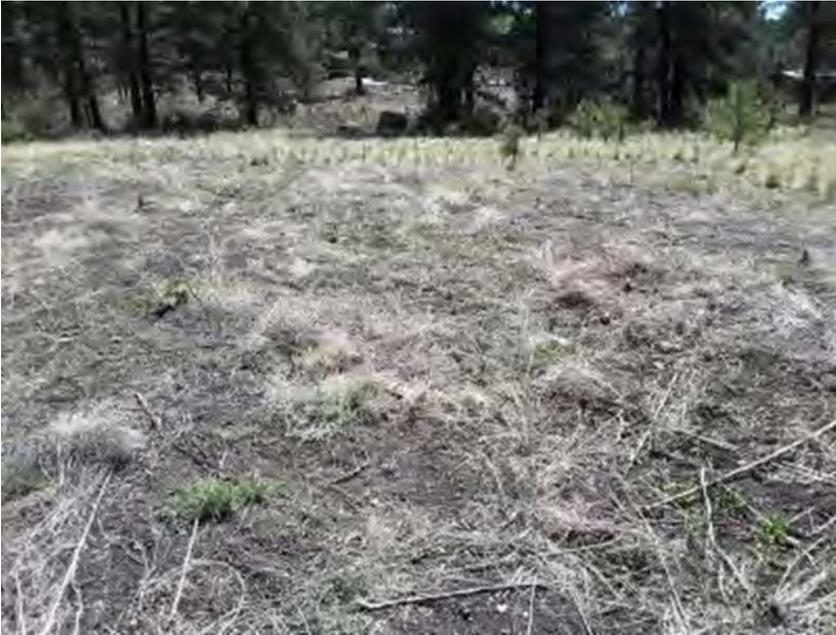
Picture 7. Restored area (previously a parking lot)
Has not regrown with native vegetation.

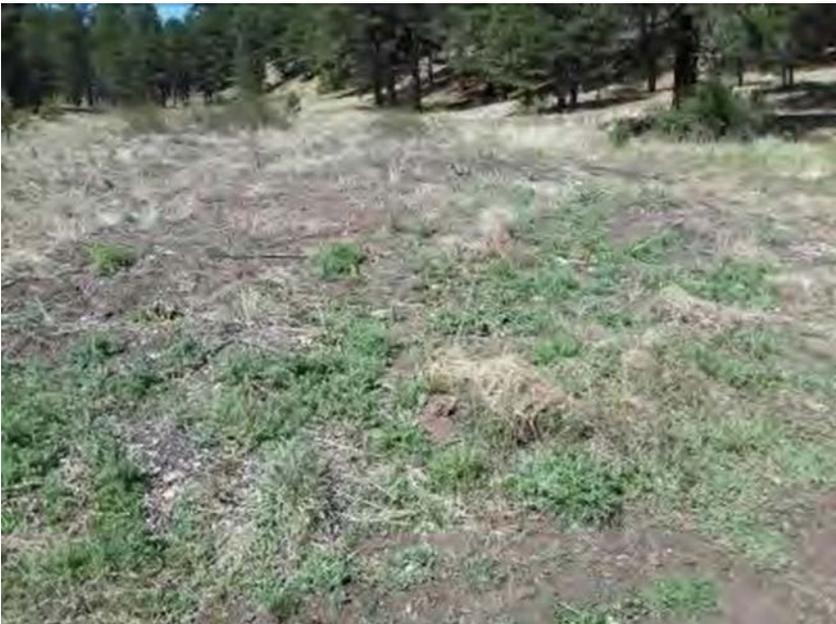
Picture 8. Knapweed infestation
Infestation is the most dense in bare portions of the old parking area.

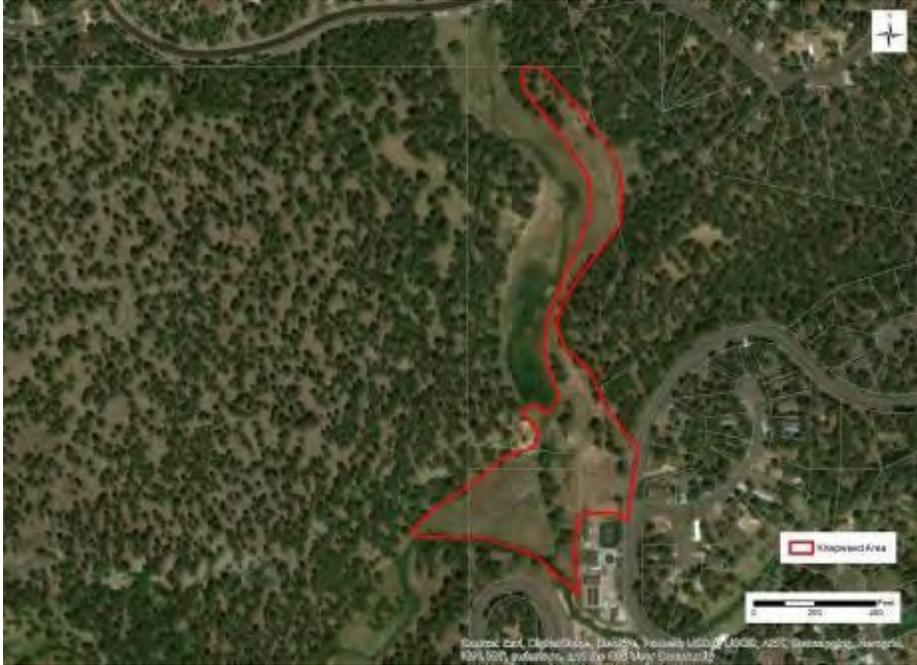
Picture 9. Approximate limits of knapweed treatment within the project area.
Majority of the 7 acres is not dense, however, the old and new parking areas have patches of denser infestations.

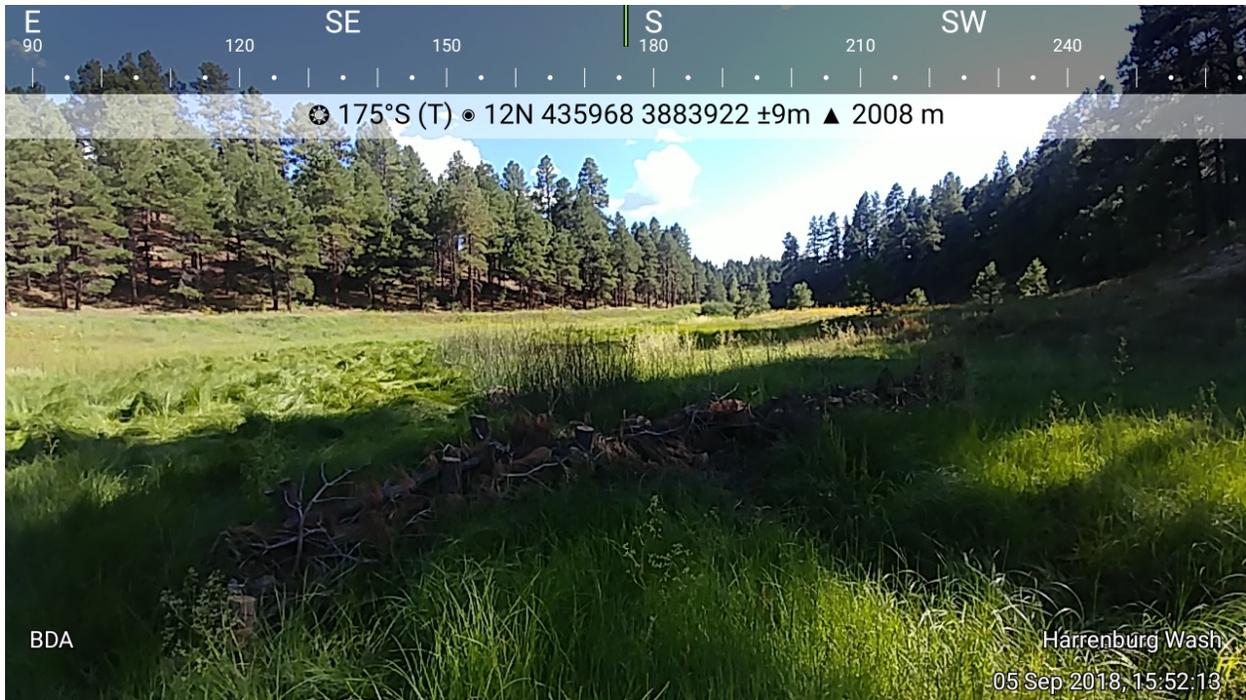
Picture 11. Beaver Dam Analogues (BDAs) in the project area.
Coconino County Parks and Recreation installed three BDAs in the project area last winter.

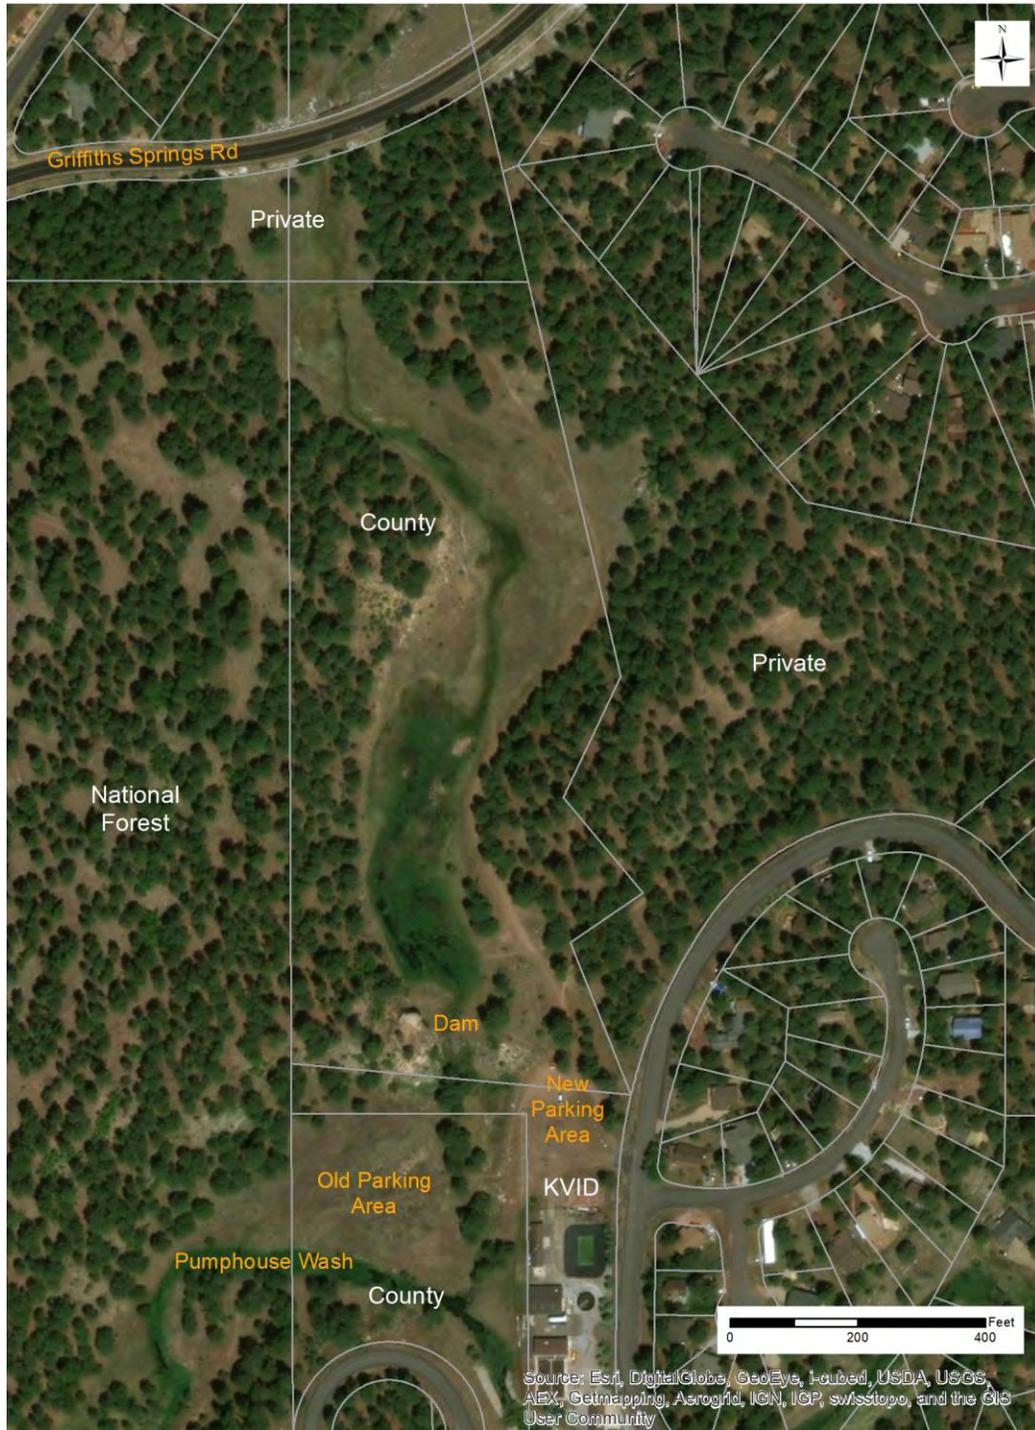
Figure 2. Project area map showing land ownership boundaries.

Harrenburg Wash runs north/south from private property boundary to Kachina Village Improvement District (KVID) and Coconino County lands. Project is bounded by private lands to the east and Coconino National Forest land to the west.

parcels) and Kachina Village Improvement District (1 parcel). See Figure 1 & Figure 2 on the following pages.

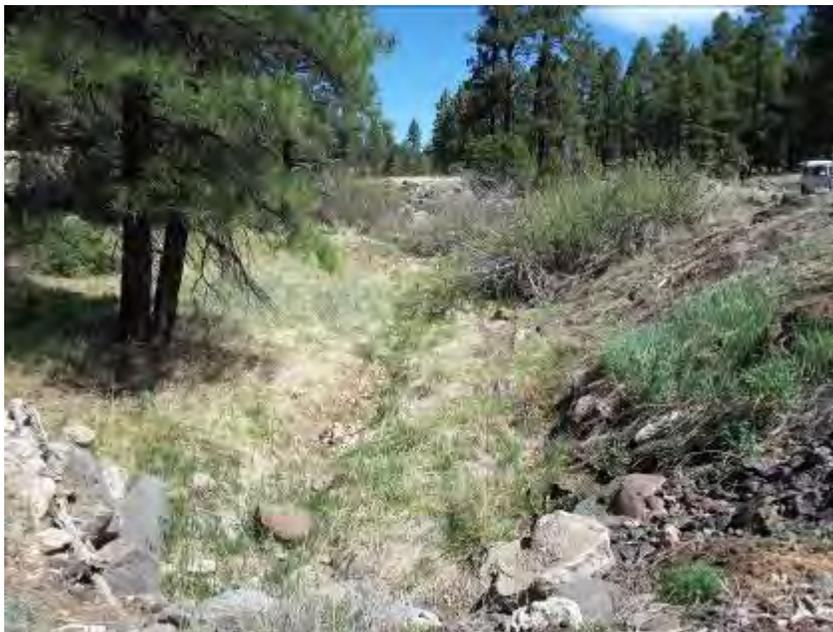
Beginning at the confluence, the first reach extends upstream to the base of the old dam. This channel has been incised into the valley floor but has widened to a point that shows an active channel combined with an appropriately sized flood plain. This channel appears to be relatively stable with fair amounts of appropriate native vegetation, including willows and grasses. The only impairment in this reach is a set of undersized culverts that form a road crossing to the old parking area, downstream of Kachina Village. These culverts show indications of having been overtopped and a portion of the crossing prism has eroded away. See Figures below.

Figure 4. Generally stable channel conditions between confluence and old dam.
View is looking upstream from trail crossing.

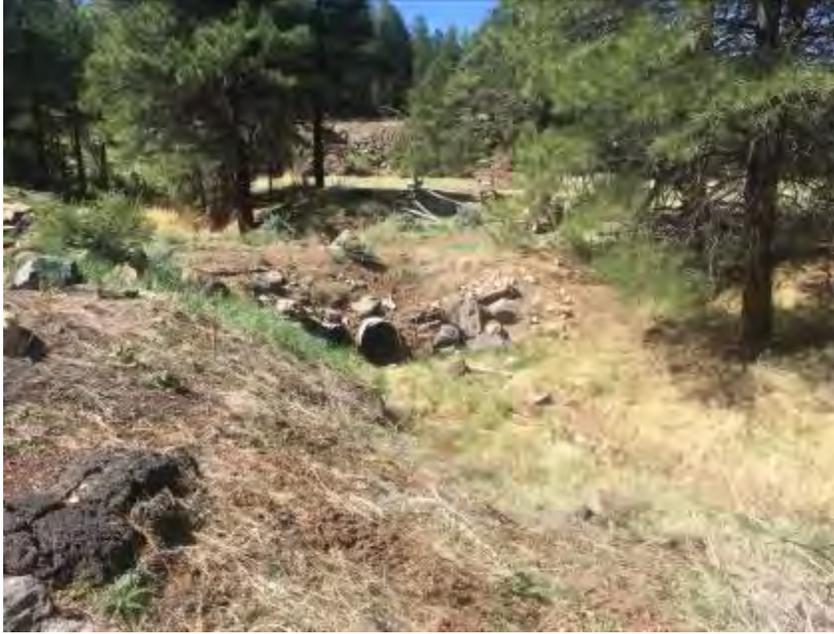
Figure 5. Undersized culvert and eroding trail prism.
Flows have overtopped the road prism and eroded the downstream side of fill prism. View is looking upstream.

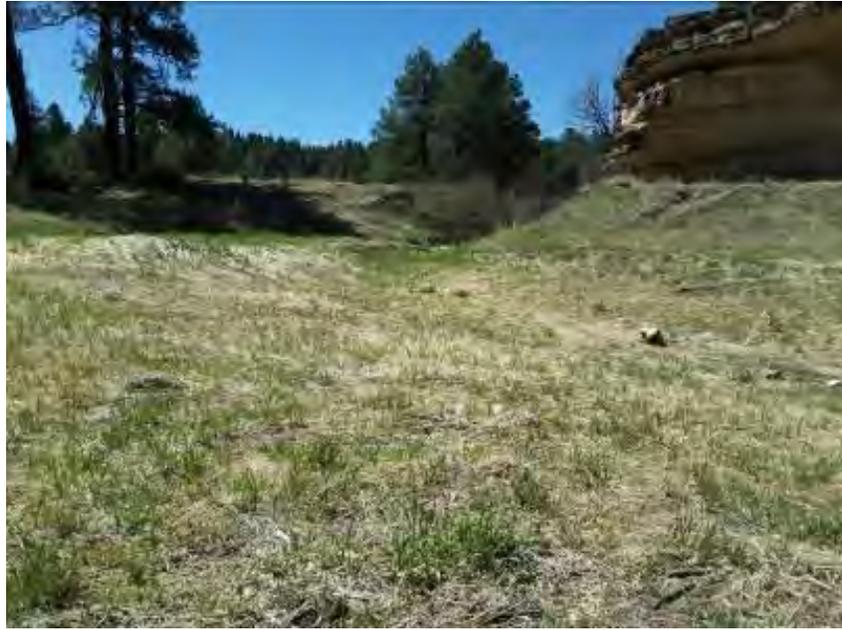
The second reach of channel is the short reach through the breach of the dam. The breach was opened up to the west of the historic channel such that water flowing through the breach has to form a new channel that eventually connects back to the original. This reach is steeper than the remainder of the channel and is protected from headcutting or extensive lateral erosion by very large rock which once formed the downstream face of the dam. There is a short reach of bank erosion caused by the channel forming itself in a new path and the actual breach through the dam has very steep banks without an adequate flood plain. This condition likely leads to higher velocities and downstream bank erosion during high flows. The overflow spillway is located on the eastern side of the valley in this reach. This channel has not experienced flow in many years, judging by vegetation and channel condition. Again, large rocks and a concrete sill at the top of the spillway help to prevent erosion in the unlikely scenario that this channel sees significant flow. Some flow may be provided by a small side drainage which feeds into the top of the spillway.

Figure 6. Breach through dam.
View is looking downstream from the wetland area that exists above the dam.

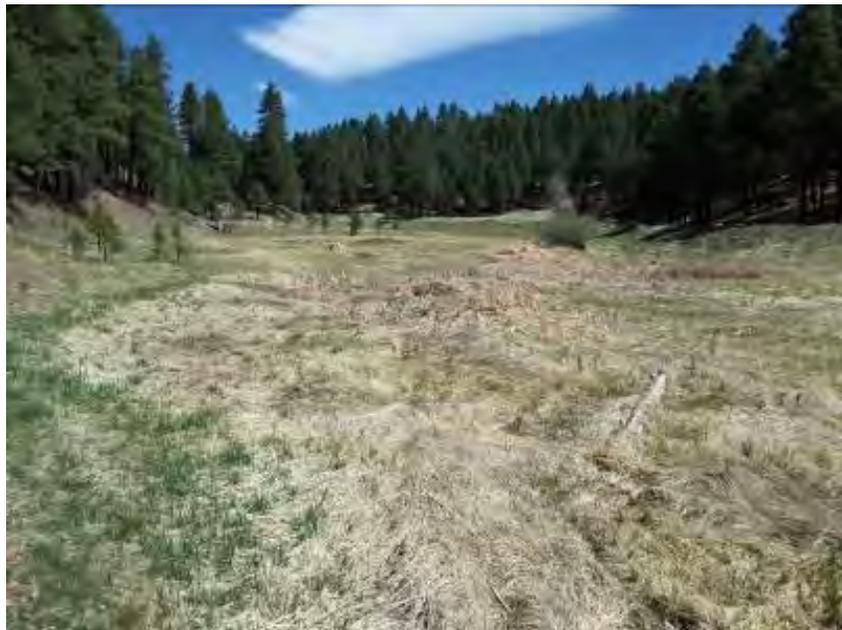
The third reach of the project area is just upstream of the dam and is represented by the small ponded area and wetland. The elevation of the outlet through the dam breach ponds water to a maximum depth of 3 feet. There is an obvious depression left over from excavation of the pond that forms the wetland. Vegetation is dominated by native wetland plants even during dry periods. Native willows and several narrowleaf cottonwoods have been planted just above the highwater line in this area.

Figure 7. Wetland area.
View is looking upstream from dam. This area exhibits relatively permanent inundation except during extremely dry weather.

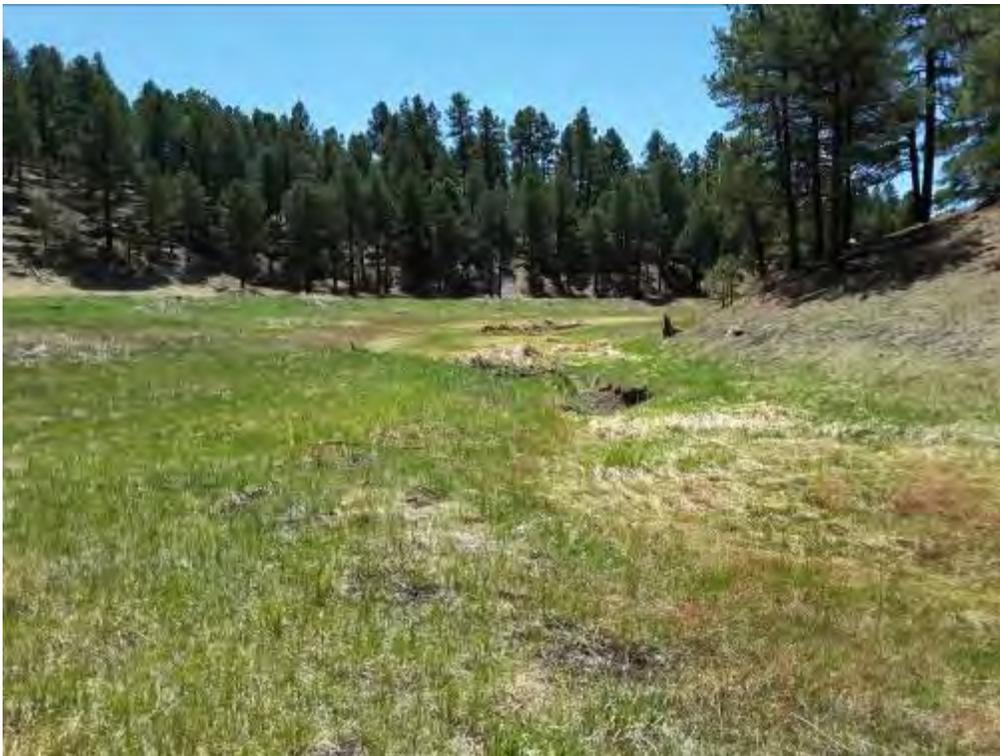
Figure 8. Typical conditions in upper meadow.

Flow channel is typically a shallow wide swale vegetated with wetland plants. However, potholes cut into the meadow have initiated headcuts.

There are several impacts to the channel that should be addressed in order for the area to reach its full potential. The potholed/excavated areas that have initiated headcuts need to be refilled with the materials that were removed. The intent is to have runoff closer to the surface of the meadow and be allowed to spread out, and infiltrate into the soil rather than running off quickly. This should extend the period of high soil moisture for the meadow and increase productivity. The fill areas will need to be protected with log spreaders or rock mulch in combination with planting of native wetland vegetation to foster the establishment of a healthy stand of native vegetation that will provide long term stabilization of the soils.
