**Arizona Water Protection Fund
Application Cover Page
FY 2019**

Title of Project: Harrenburg Wash Enhancement Project											
Type of Project: <input checked="" type="checkbox"/> Capital or Other <input type="checkbox"/> Water Conservation <input type="checkbox"/> Research	Stream Type: <input type="checkbox"/> Perennial <input type="checkbox"/> Intermittent <input checked="" type="checkbox"/> Ephemeral										
Your level of commitment to maintenance of project benefits and capital improvements: <input type="checkbox"/> < 5 years <input type="checkbox"/> 5-10 years <input type="checkbox"/> 11-15 years <input checked="" type="checkbox"/> 16-20 years											
Applicant Information: Name/Organization: Coconino County Address 1: Parks and Recreation Address 2: 2446 Fort Tuthill Loop City: Flagstaff State: AZ ZIP Code: 86005 Phone: (928) 679-8000 Fax: (928) 774-2572 Tax ID No.: XXXXXXXXXX											
Inside an AMA: Yes <input type="checkbox"/> No <input checked="" type="checkbox"/> If yes, which AMA: <input type="checkbox"/> Phoenix <input type="checkbox"/> Tucson <input type="checkbox"/> Prescott <input type="checkbox"/> Pinal <input type="checkbox"/> Santa Cruz											
Conta

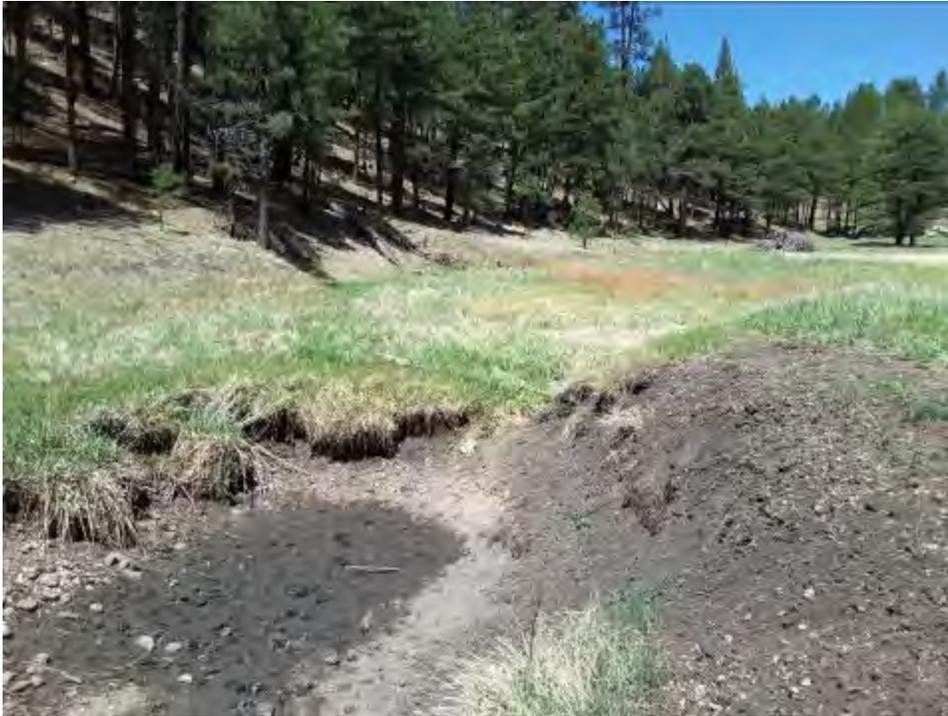
Figure 9. Excavated pool forming a headcut in meadow.
Note that excavated materials are still piled adjacent to excavation.

There are several impacts to the channel that should be addressed in order for the area to reach its full potential. The potholed/excavated areas that have initiated headcuts need to be refilled with the materials that were removed. The intent is to have runoff closer to the surface of the meadow and be allowed to spread out, and infiltrate into the soil rather than running off quickly. This should extend the period of high soil moisture for the meadow and increase productivity. The fill areas will need to be protected with log spreaders or rock mulch in combination with planting of native wetland vegetation to foster the establishment of a healthy stand of native vegetation that will provide long term stabilization of the soils.

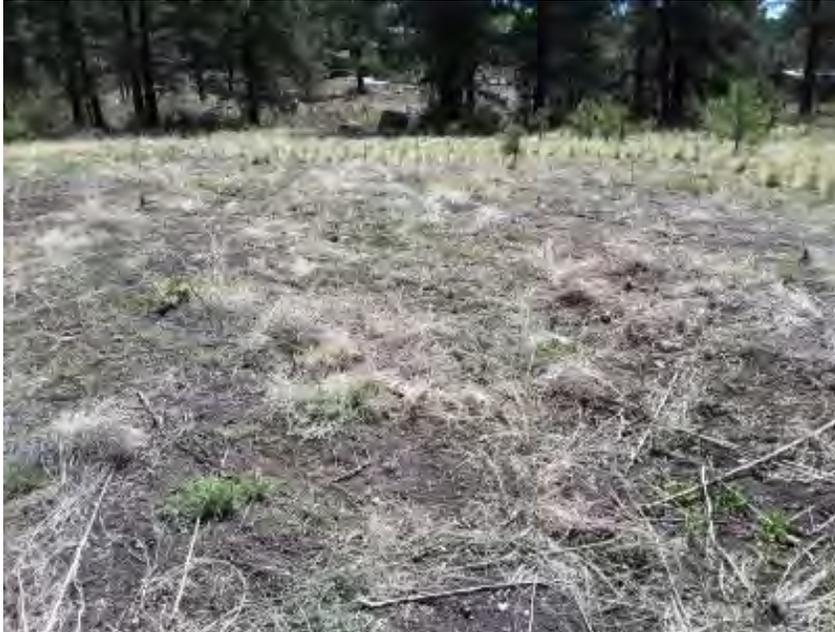
Much of the seeded area is doing well and is supporting appropriate vegetation for this flood terrace. However, approximately 0.5 to 1.0 acres remains bare or contains undesired species. The bare areas are also characterized by thick patches of cinder parking lot materials.

Figure 10. Restored area (previously a parking lot)
Has not regrown with native vegetaion.

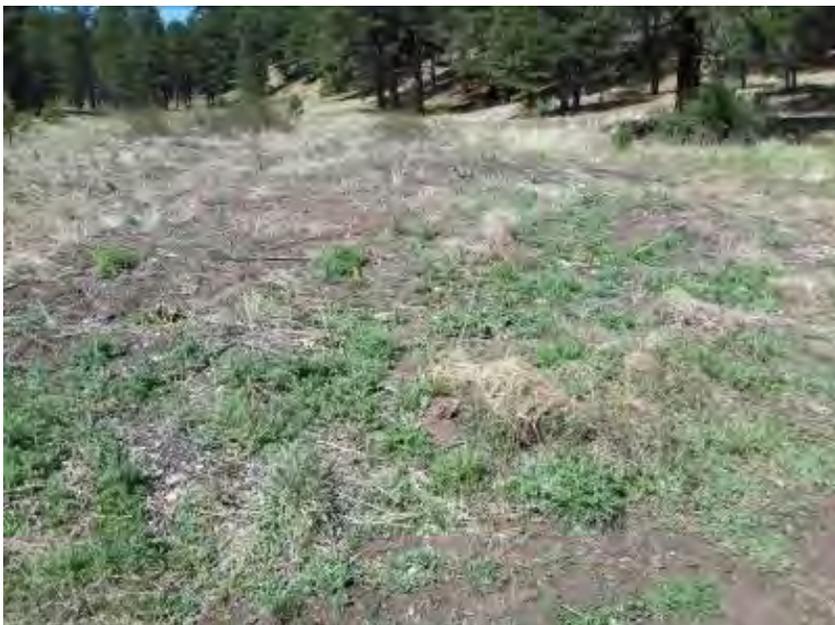
Figure 11. Knapweed infestation
Infestation is the most dense in bare portions of the old parking area.

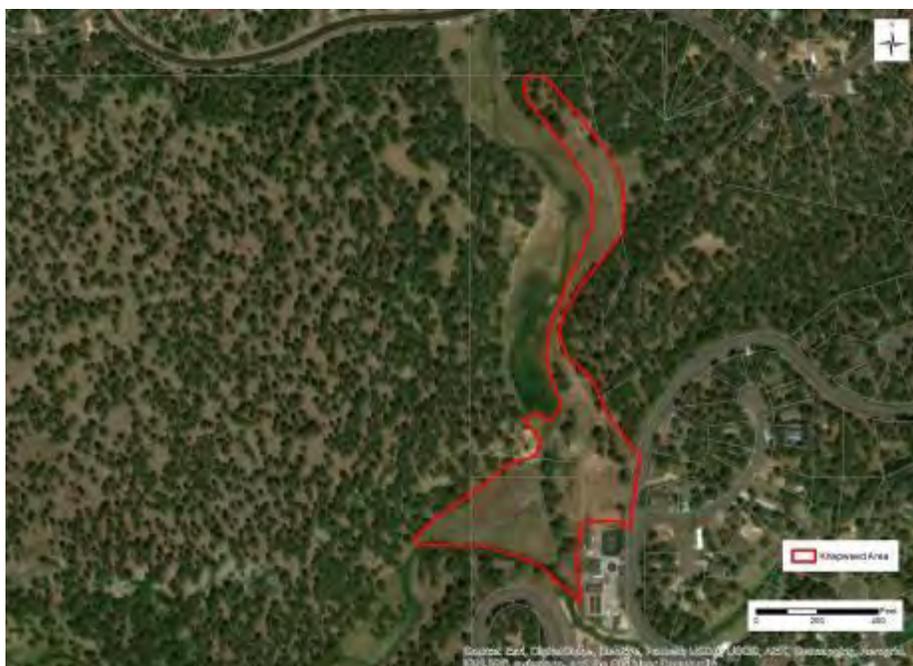
Figure 12. Approximate limits of knapweed treatment within the project area.
Majority of the 7 acres is not dense, however, the old and new parking areas have patches of denser infestations.

Approximately 7 acres should be treated to control diffuse knapweed. The most effective treatment includes spraying knapweed in the spring while it is still small and actively growing, followed by manual pulling and bagging in mid-summer when it is large and easily found but before it has begun to set seed. Current herbicide treatments costs can be estimated at \$175/ac. Therefore, herbicide treatment will cost approximately \$1,225 per year and the area will need to be treated for 3 to 4 years. Manual pulling should occur for 6 to 7 years to help prevent re-infestation from the seed bank and neighboring seed sources. This is anticipated to be a low level of effort compared to initial management efforts. Native vegetation should be well enough established to prevent re-infestation by then. The approximate treatment area is shown in Figure 12.

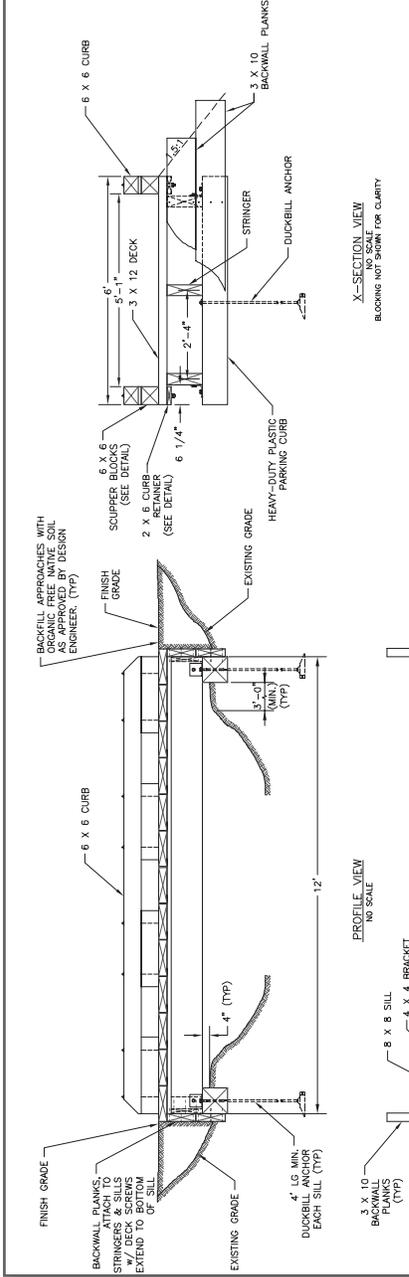
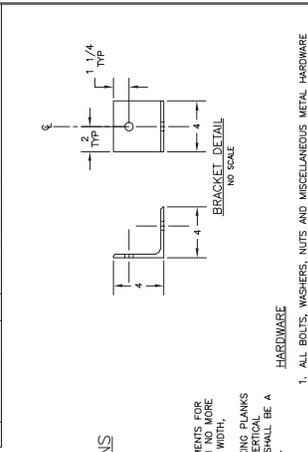
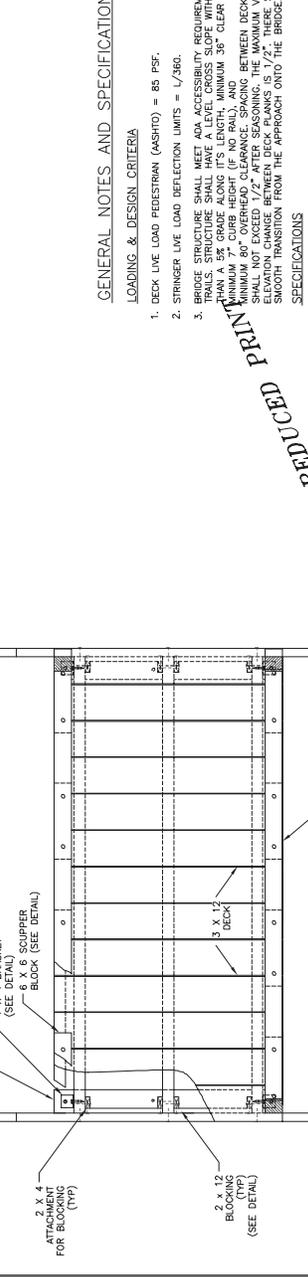
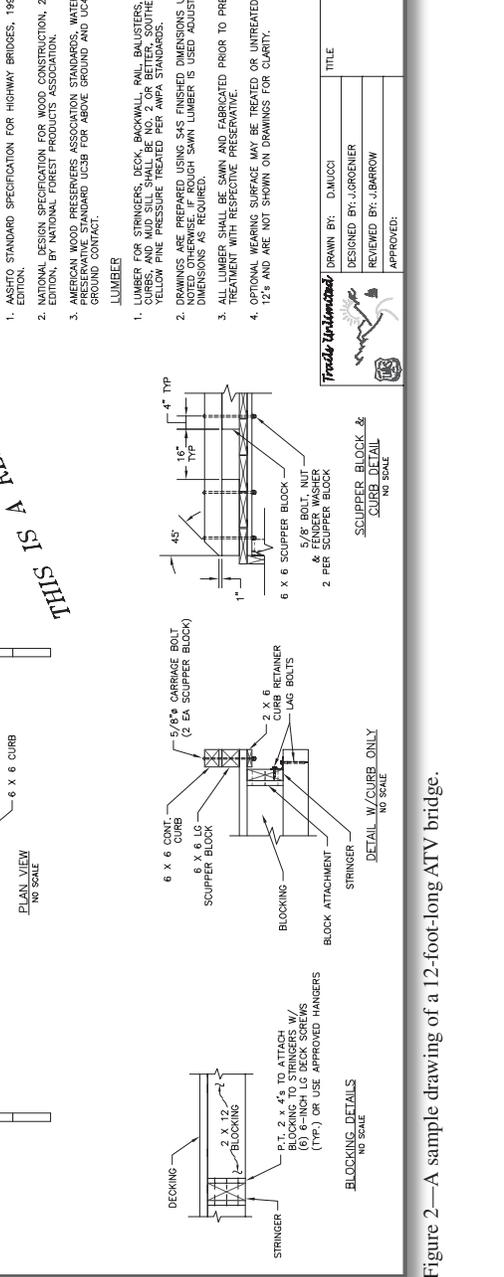
11	BRACKET	4	4" X 4" X 1/4" THICK ANGLE STEEL
12	LAG BOLT	4	5/8" 3-1/2" INCH LG. LAG BOLT
13	DUCKBILL ANCHOR	2	4" FT. DUCKBILL ANCHOR DRIVE, FORESIGHT PRODUCTS LLC, PART NO. MBBR OR EQUAL
14	LAG BOLT	4	5/8" 3-1/2" INCH LG. LAG BOLT
15	CARRIAGE BOLT	16	5/8" 6" X 18" INCH LG. CARRIAGE BOLT, NUT & FENDER WASHER
16	BECK SCREW	150	1/2" INCH LG. BECK SCREWS

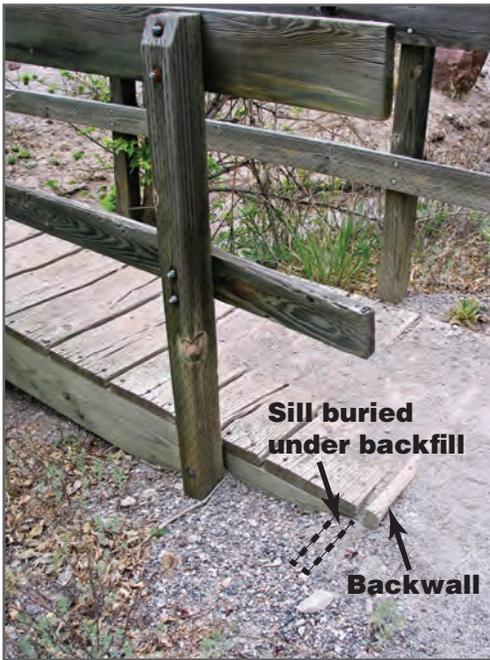
Figure 5—When backwalls are not extended beyond the sides of the stringers, backfill wraps around the backwall, which causes dirt to accumulate on the sills, causing the decay process to begin and allowing the bridge approaches to unravel.

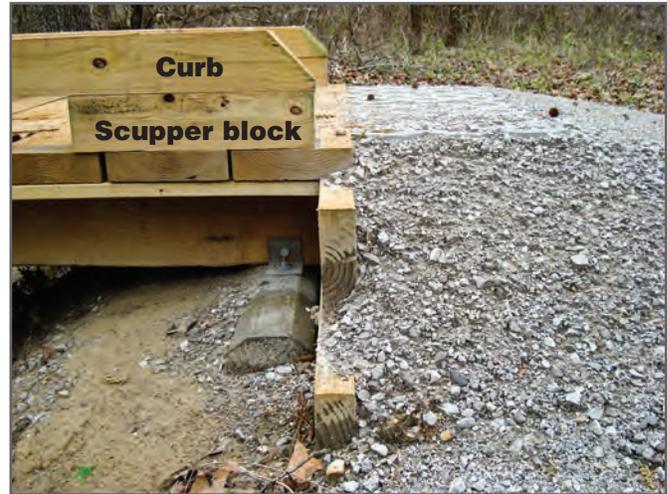
Figure 6—Place curbs on top of scupper blocks, which are held in place with carriage bolts placed through the curb, scupper block, decking, and curb retainer.

For an ATV trail application, 6-inch by 6-inch treated curbs placed on 2-foot-long sections of 6-inch by 6-inch scupper blocks work well (figure 6). It is difficult for ATV tires to drive over the curb without intentional effort (figure 7). The bridge curb ends should be beveled to protect ATV tires from abrupt impacts. Each 2-foot-long scupper block is fastened to the deck with two $\frac{5}{8}$ -inch-diameter carriage bolts, secured through the curb and deck to 2-inch by 6-inch curb retainers.

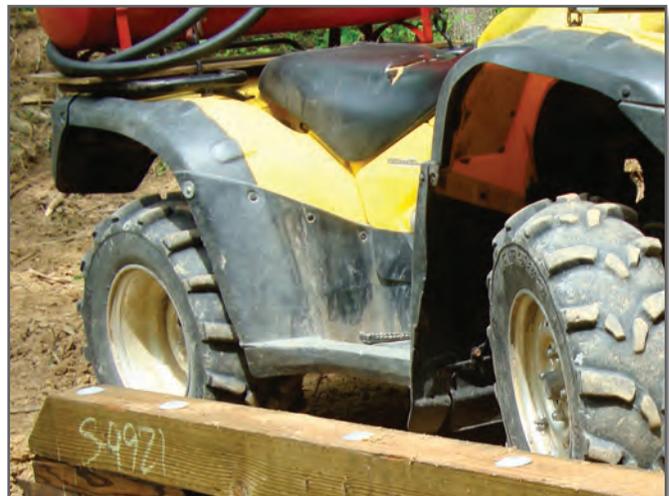
Figure 7—The curbs are difficult to drive over with ATV tires without intentional effort. The ends are beveled to protect ATV tires from abrupt impacts.

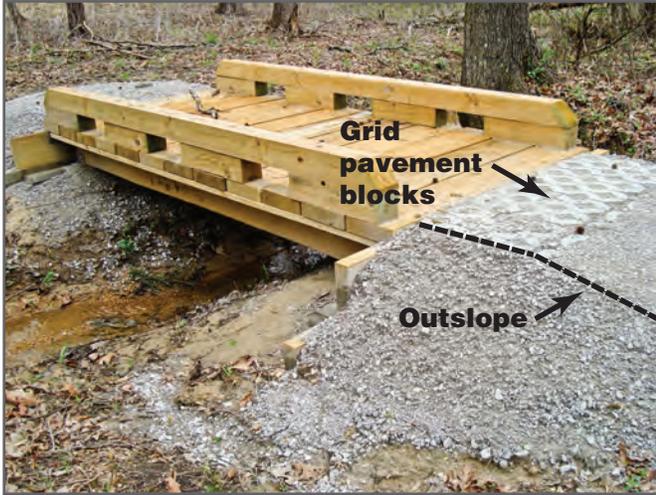
Figure 8—Completed bridge with outsloped paving blocks. Grid pavement blocks sloped downhill from the bridge help prevent the development of potholes adjacent to the bridge backwall. Object markers on each side of both bridge approaches are required for motorized trails on National Forest System lands. The object markers have not yet been installed.

The last row of grid pavement blocks is angled down to sit approximately 2 feet below the surface. This helps provide a sustainable transition for the approach.
