**Arizona Water Protection Fund
Fairchild Draw Riparian Restoration Project
Grant No. 07-150WPF**

Final Report

Submitted by David Dorum
Arizona Game and Fish Department

December 31, 2011

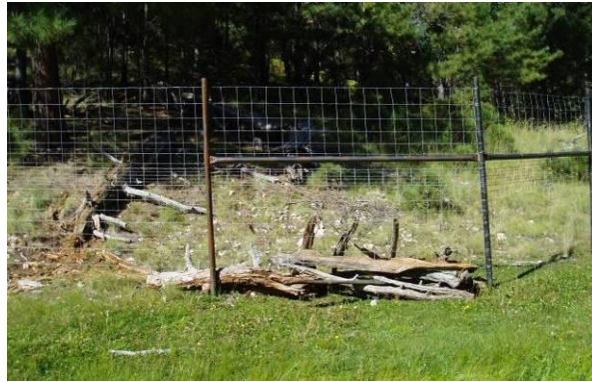
In 2008 exclosure fence effectiveness monitoring was conducted on September 18. At the time of the monitoring there was no sign that elk or any other large ungulate had gained access to the interior of the exclosures. There was however, evidence at one location where the terrain dipped (UTM 493681/3814497) that the bottom of the fence had been pushed upward. To reduce the chances of large bodied ungulates successfully penetrating the exclosure at this location in the

Figure 35 Large woody debris placed along bottom of fence, September 2008.

future, a number of pieces of large woody debris were placed along the bottom of the fence (Figure 35).
