Final Project Report
Little Colorado River and Nutrioso Creek Riparian
Enhancement Project
Springerville, AZ

AWPF Grant 07-143WPF

March 2013

Natural
Channel
Design, Inc.

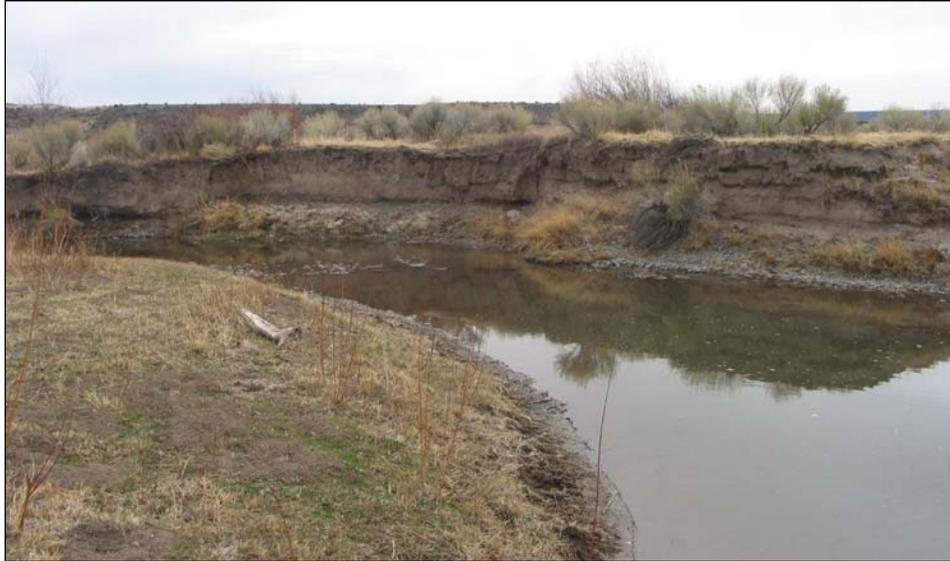
Figure 11 . Eroding vertical banks were common throughout project.

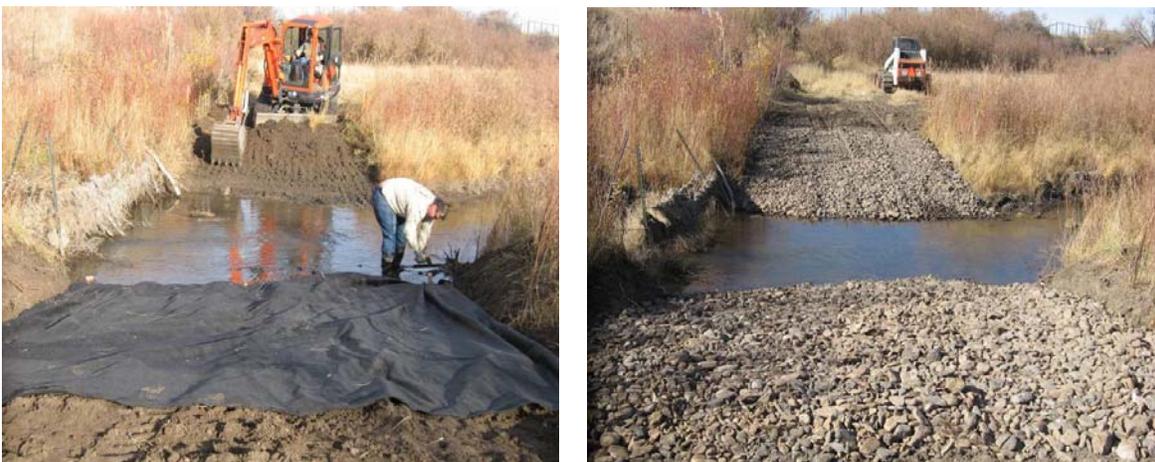
Figure 14. Cattle crossing installation

Above Bank A in the Burk property, a ramp 20 feet long by 15 feet wide on either side of the river was prepared by excavating and sloping the banks. Geotextile fabric was then placed with the lower end buried in a trench at the river's edge and all sides staked. The fabric was then covered with medium-sized gravel and small cobbles to a minimum of 6-inches deep (Figure 14).

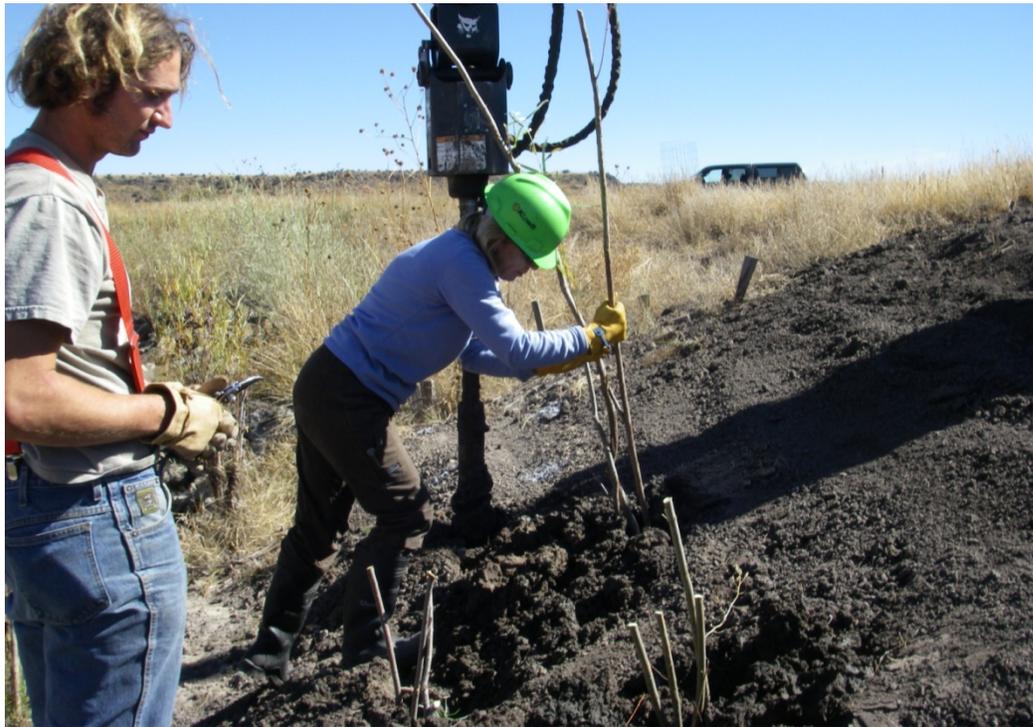
Figure 19. Installing willow clusters

Planting of the willow clusters along the banks was accomplished with a mini-excavator mounted auger. Clusters of three bare willow pole stems were then installed into each hole. The holes were then watered and backfilled (Figure 19 and 20).

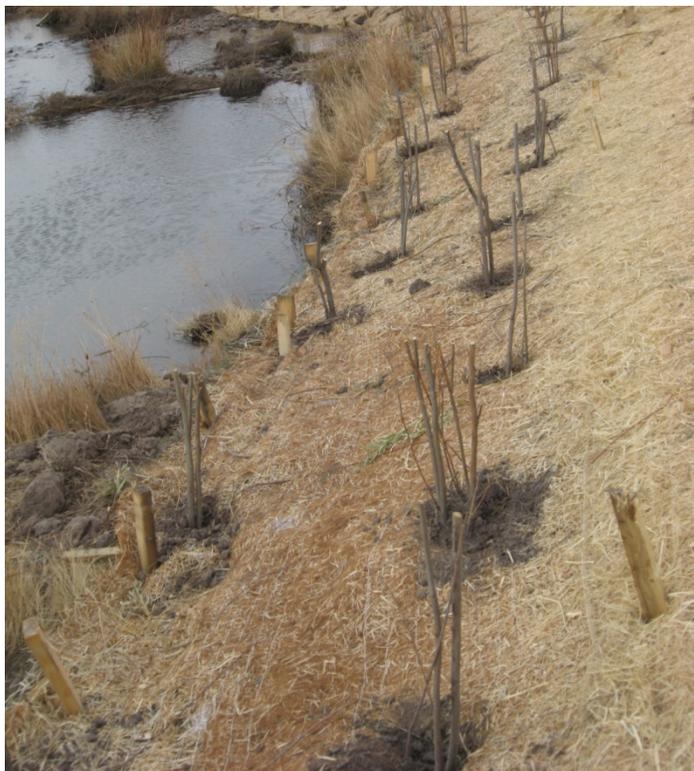
Figure 20. Planted willow clusters on Bank B3.

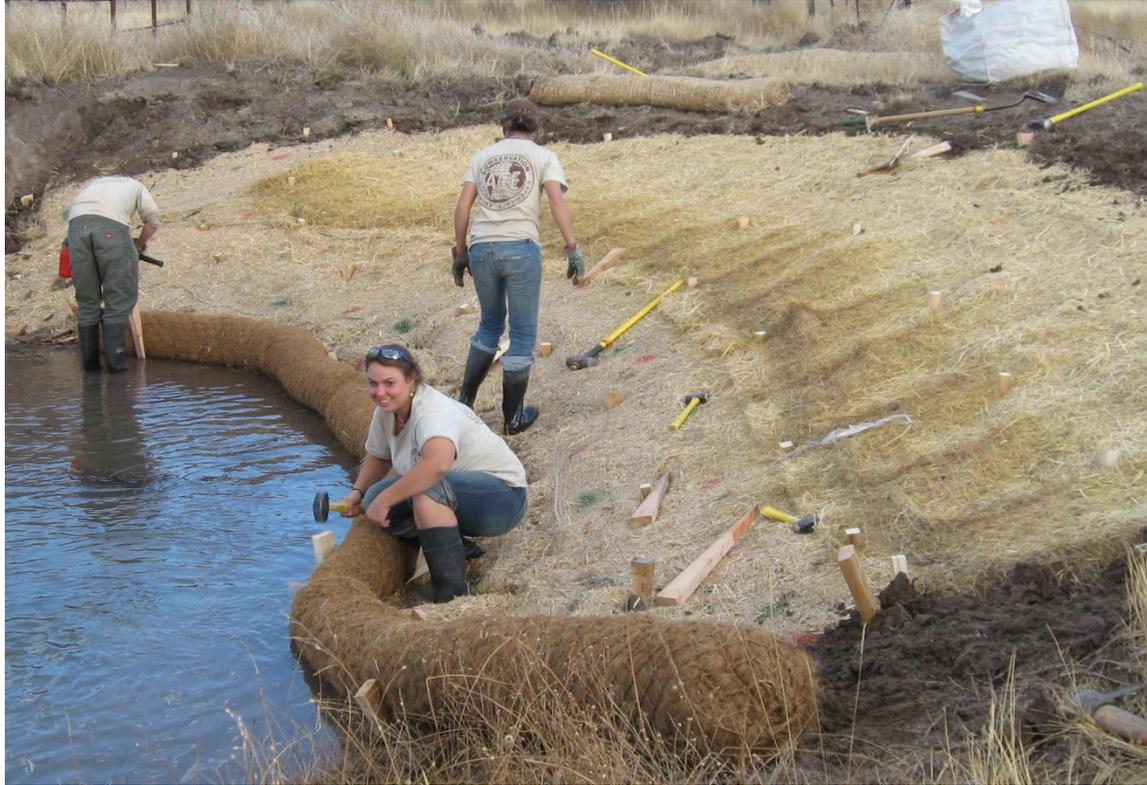
Figure 22. Installing coir logs.

Similarly, eighty feet of coir logs was installed at Banks A and G to protect the toe of the bank and help prevent soil erosion. Coir logs were placed at the toe of the bank down to the gravel of the riverbed. The upstream end of each coir log was embedded into the bank so that the log would not be compromised by water flowing behind it. Each log was tied and staked on both sides every five feet (Figure 22).

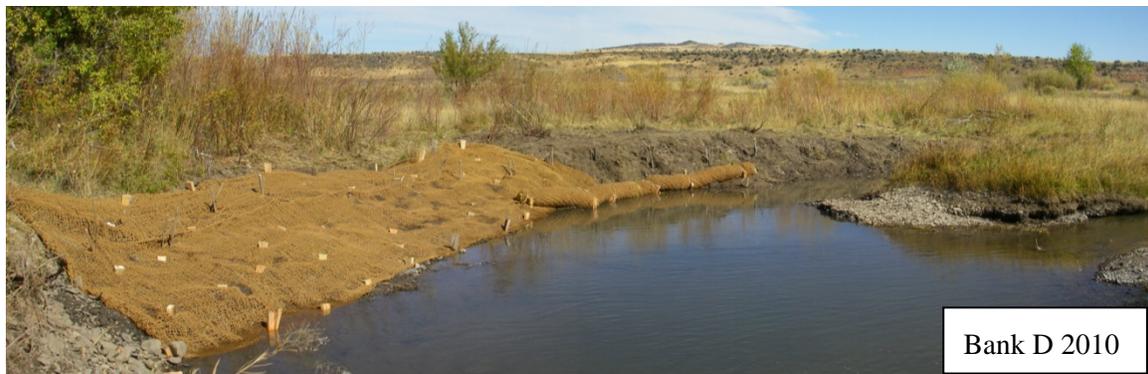
Figure 25. Bank D Construction 2010.

Bank D in particular required additional bank and channel work. At this location, the channel has a split flow caused by a small vegetated bar in the center of the channel (Figure 24). The channel on the left side of the bar was deepened to allow flow around this bar and reduce the back-eddy during high flows. The left bank was resloped and covered with a jute netting (Figure 25). This bank has now become vegetated with willows, sedges and grass and is stable (Figure 26).

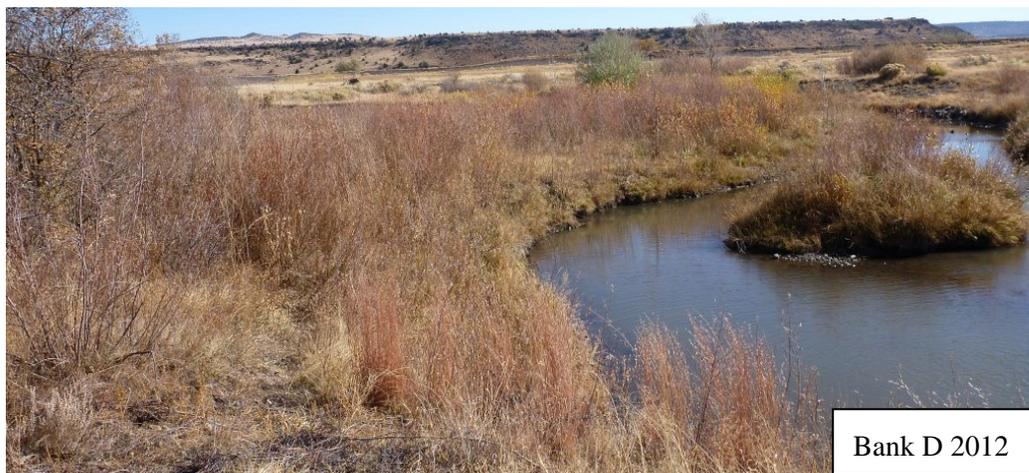
Figure 26. Bank D in October 2012.

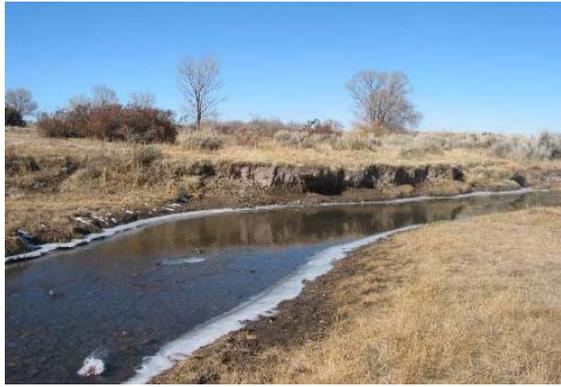
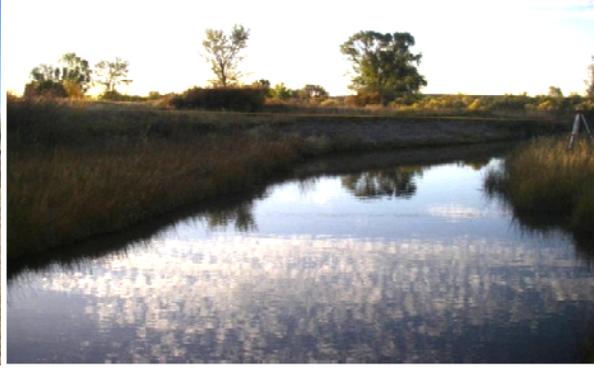
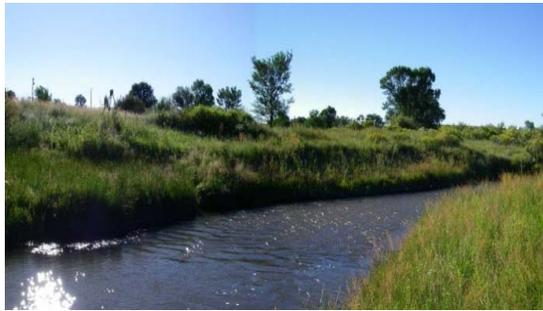
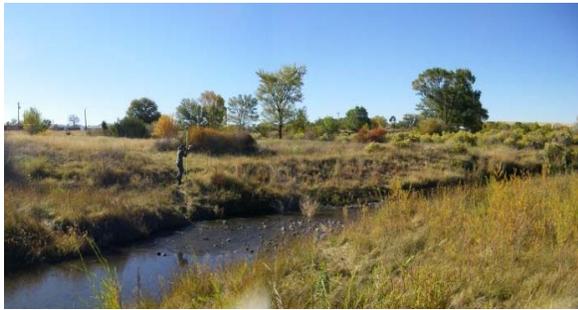
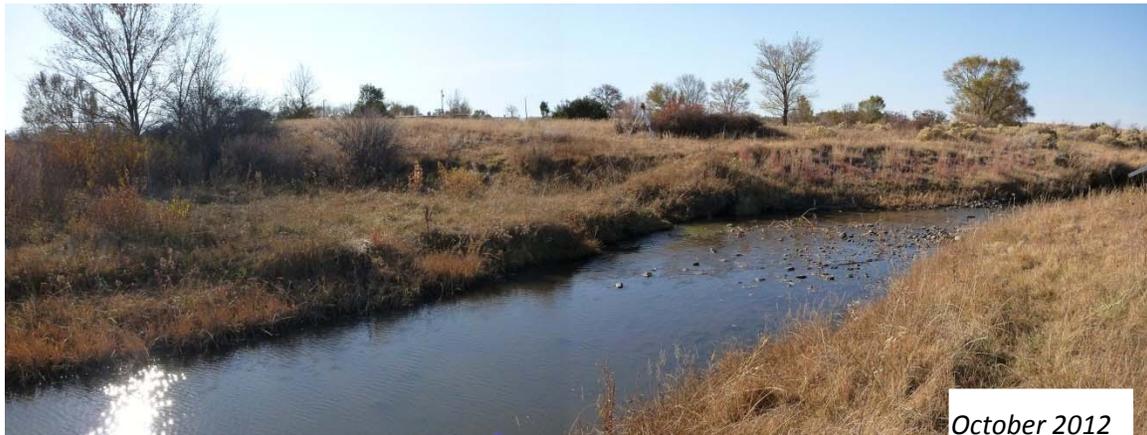
Photo Point 5

The general trend observed from comparing these photo points is that vegetation along the stream corridor is maturing and becoming denser. No change in the stream channel location or stability has been observed.

Figure 32. Example of General Site Photo time progression

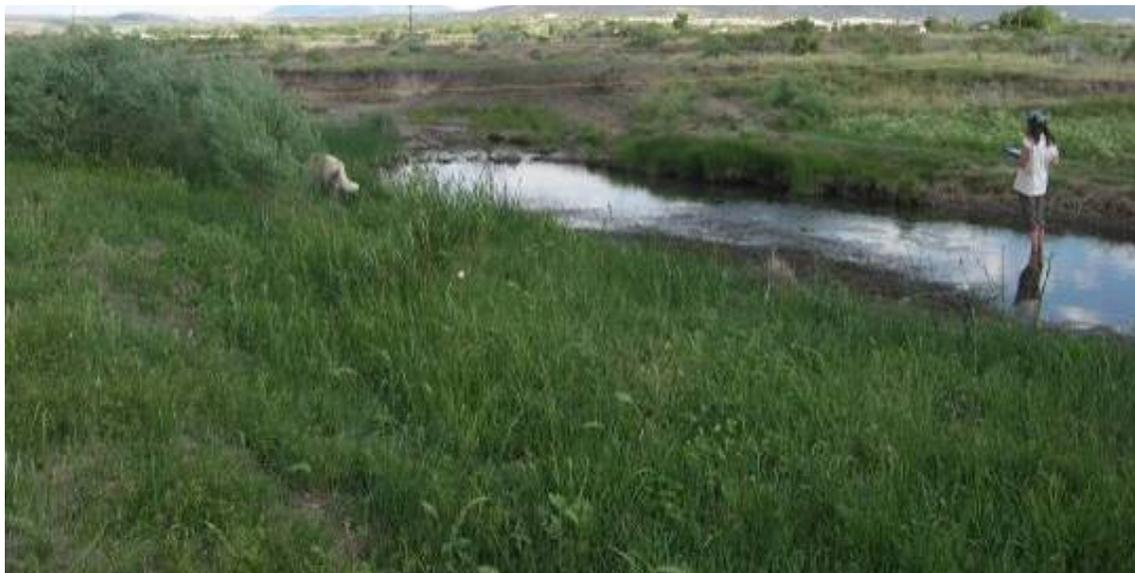
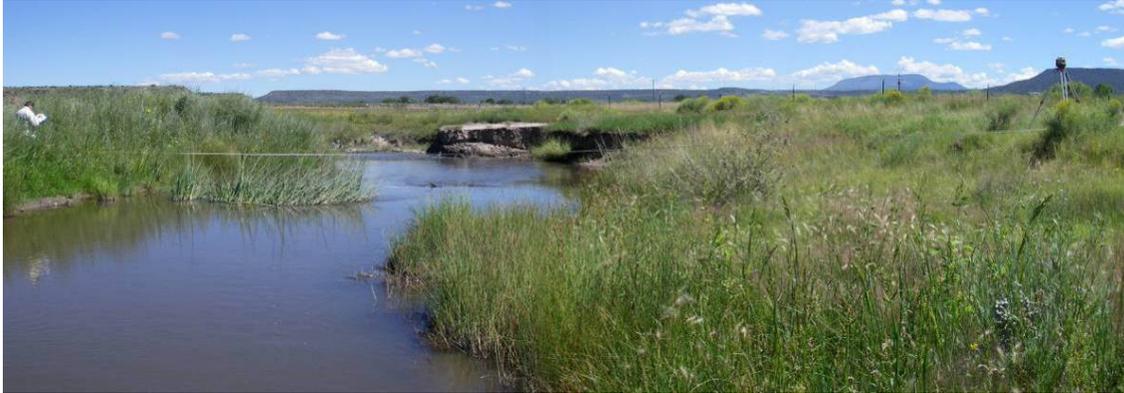
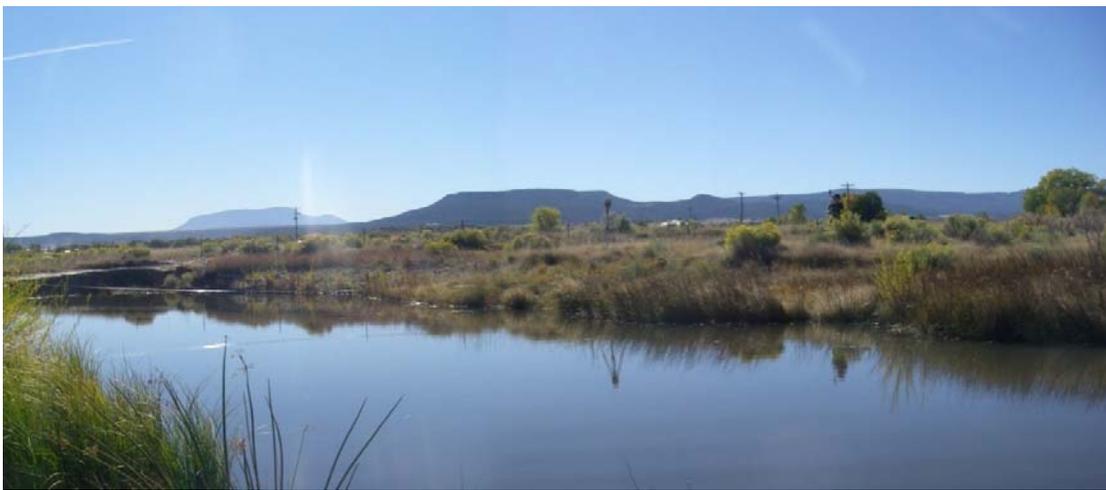
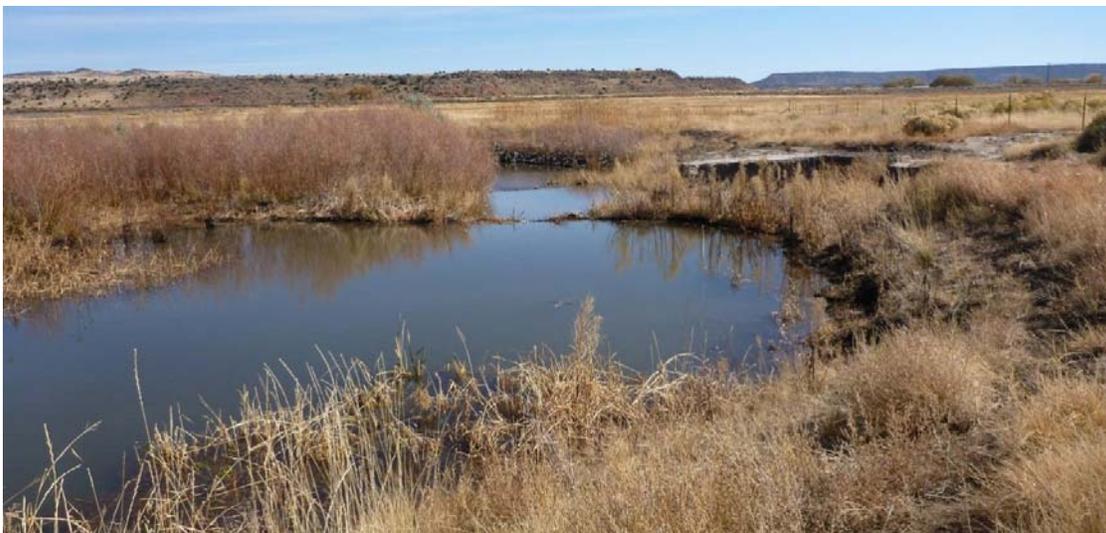
Figure 35. Channel Cross-section One.

There has been no change in channel geometry at this cross section other than the sediment accumulation behind the beaver dam. As shown on the graph, there was some buildup in 2011, and sediment continued to accumulate in 2012. This location has been affected by a beaver dam since initial construction (Figures 50 and 51). Even with the beaver dam, the cross-section is stable.

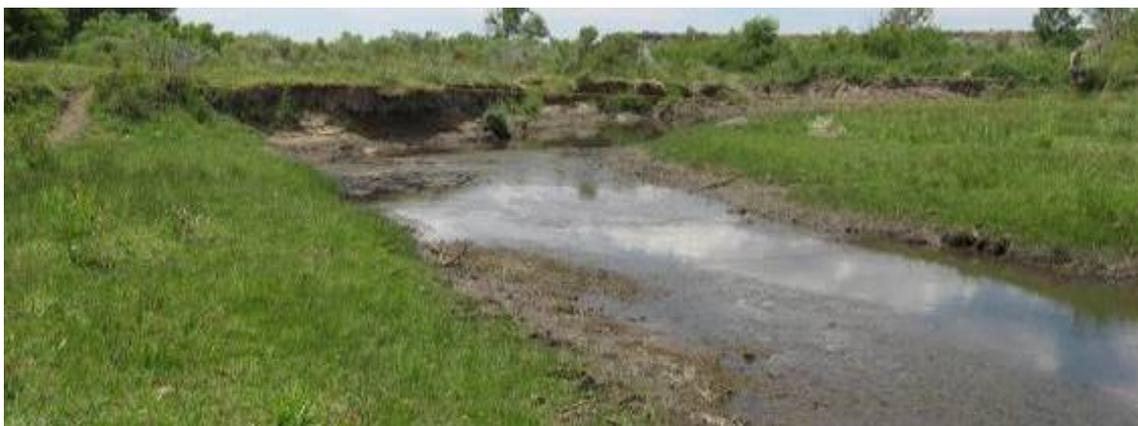
Figure 41. Pre construction photo of cross section three.

There have been no significant changes to this cross section over the past five years. High flows in early 2010 caused some sediment to be deposited on the point bar on the right, a normal occurrence for this type of channel. Vegetation along both banks remains robust and healthy (Figures 57-59).

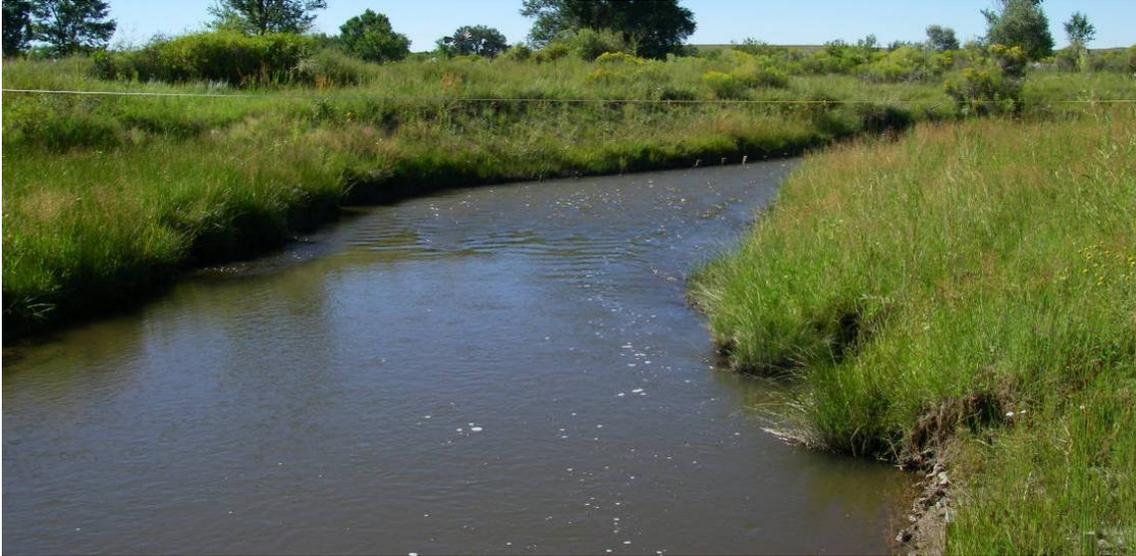
June 2007-Pre-construction. View is downstream from left bank.

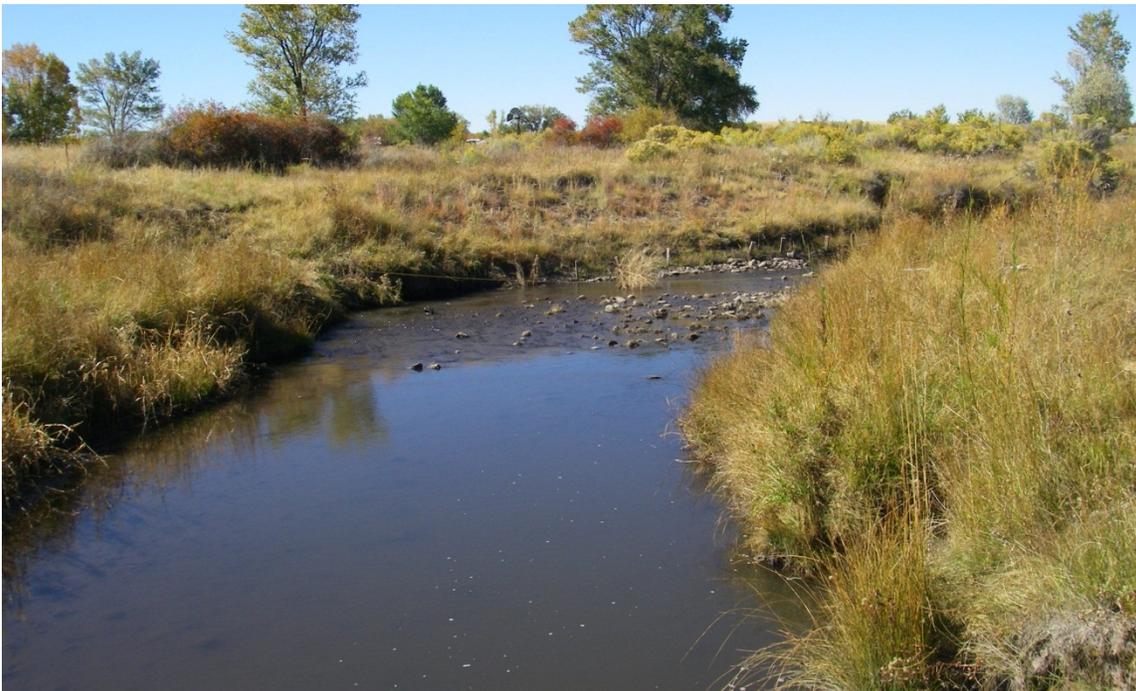
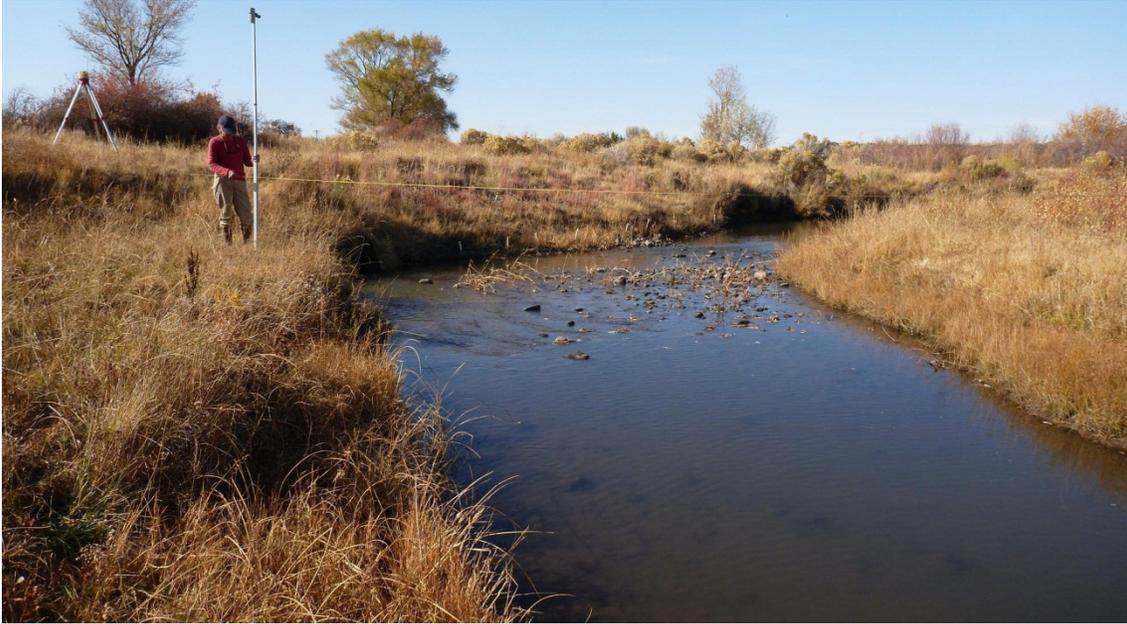
Figure 42. Cross section three in 2010 and 2011.

September 2010-View is from midstream looking downstream

October 2011-View is from midstream looking downstream
