PAKOON SPRINGS REHABILITATION FINAL REPORT

(TASK #9, AWPf GRANT CONTRACT #06-137WPF AND INCLUDING TASK #4 AND
TASK #8 FINAL MONITORING REPORTS)

Grand Canyon Wildlands Council, Inc.
P.O. Box 1594
Flagstaff, AZ 86002
(928) 556-9306
grandcanyonwildlands.org

30 December 2010

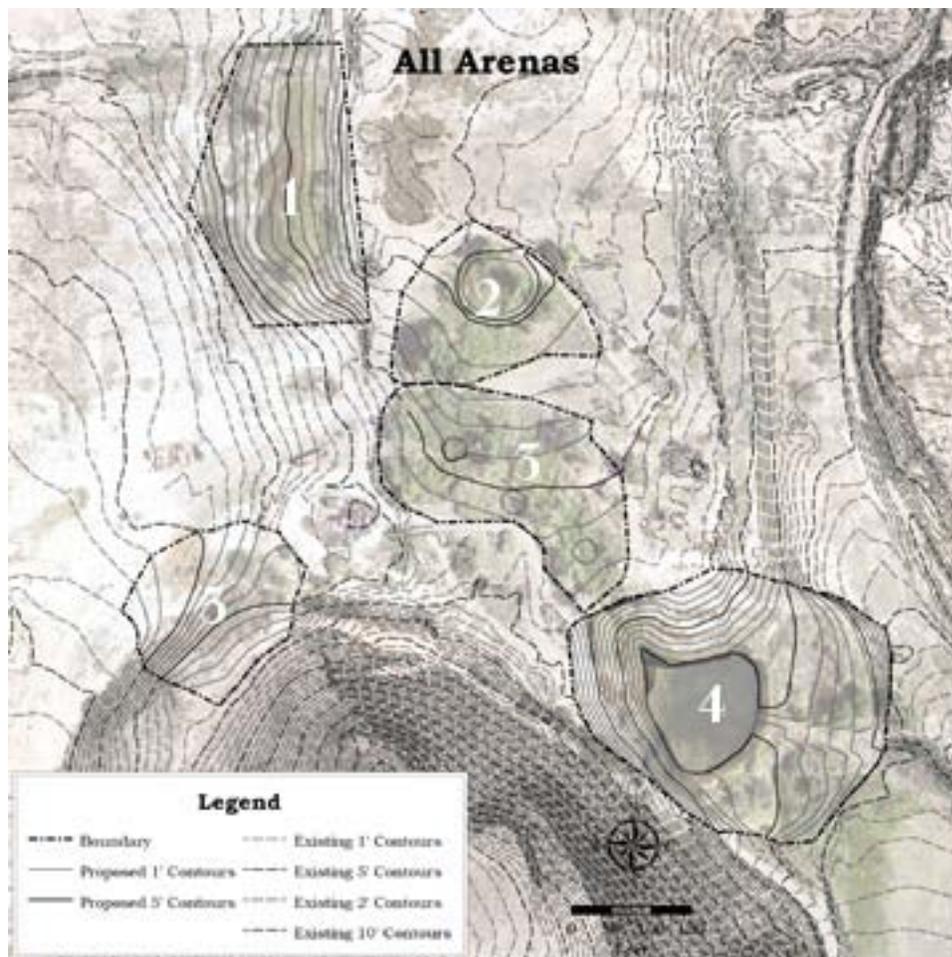
Figure 4-12 Existing and target contours for the five arenas, see Table 4-13

Arena 1 was an excavated quasi-rectangular pond, steeply bermed, and holding only shallow water (Figs. 4-12 and 4-14, Table 4-13). It was almost completely covered by cattail, with 1-2 Gooding's willow at the north and south ends, and with scattered honey mesquite, catclaw, and *Isocoma* along the bases and tops of the berms. The pond was thoroughly infested with nonnative bullfrogs and mosquitofish. Although we had not detected flow, it was presumed that Arena 1 represented a place at which a springs source in the paleosprings surface upslope had been excavated by the previous landowners, and that the 10' tall berm there had been constructed to retain the flow, presumably for the pastures downslope or other purposes. The full area under rehabilitation in Arena 1 was approximately 1.0 ac.

Arena 2 was a deeply excavated circular pond, less steeply bermed than the Arena 1 pond, and holding water as much as 5' in depth (Figs. 4-12 and 4-17 to 19, Table 4-13). It was virtually completely covered by cattail, with peripheral Bermuda grass, *Anemopsis*, and saplings of Goodding's willow on the berm. A 6'-tall, 3'-diameter culvert had been inverted and sunk as a well to a depth of 14' on the east side of the pond, and a large Goodding's willow had grown up densely around it. The well brought water up and the water flowed out into the surrounding area to the east. A large Fremont cottonwood and other smaller trees exist at the site, particularly on the east side. *Isocoma* and *Sarcobatus* occurred in the periphery around the arena. The pond was densely infested with nonnative bullfrogs and mosquitofish. Like Arena 1, Arena 2 likely represented a place at which one or more springs emerged. The site had been excavated by the previous landowners, and the berm had been constructed to retain the flow, presumably for an orchard downslope, for domestic use in the dwellings, and/or for other purposes.

Arena 3 was a trenched, heavily-altered desert wetlands that sloped gently to the south, and produced flow that entered Arenas 4 and 5 through eroding channels. (Figs. 4-12 and 4-20 to 22, Table 4-13). In recent years, Arena 3 had two or more open water ponds, and a highly modified stream channel that passed its flow into Arena 4. The depth of Arena 3 ponds may have exceeded 3'; however, those ponds had become densely invaded by cattail and were no longer serving as open water habitats. Substantial stands of native *Anemopsis* and *Schoenoplectus* sedge occur on the northern end of Arena 3, with peripheral Goodding's willow, quailbush, *Isocoma*, (likely) non-locally derived Fremont cottonwood, and fully nonnative Bermuda grass around the drier periphery. The largest Goodding's willow trees at the north end likely predate Anglo-European settlement of Pakoon Springs, and were protected during site recontouring. The wetlands were densely infested with nonnative bullfrogs and mosquitofish. Several spring sources emerged in this arena. The channel and perhaps the ponds themselves were excavated by previous landowners, and former flow to the east or west may have been manipulated to augment flow into the Arena 4 pond.

Arena 5 is a paleosprings portion of the Pakoon Springs rehabilitation site, and lies immediately north of “Mt. Pakoon” (Fig. 4-12). It is shown on the U.S. Geological Survey 7.5’ map of the site to have been a flowing springs prior to about 1950, but obviously has not flowed in recent decades, or perhaps even in recent centuries. It has been partially modified by having been graded, but its basic geomorphology as a paleosprings remains mostly intact. The vegetation covering it includes honey mesquite and quailbush, with catclaw at the lowest elevations, and desert shrub species, particularly creosote-bursage at its upper edges.

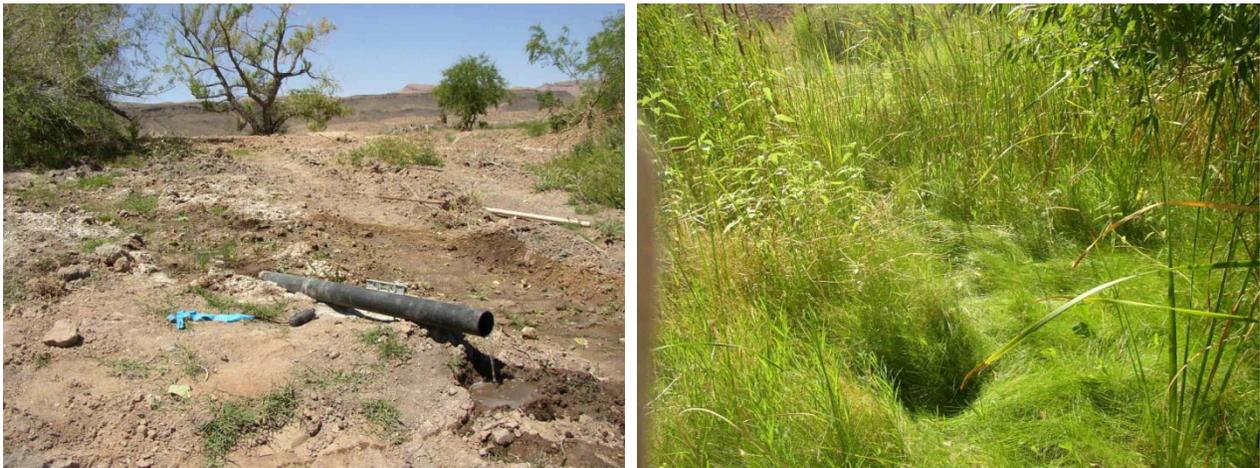
Figure 4-26 Comparison 1: April 2008 versus August 2010

In the course of photo-documenting the hydrologic monitoring activities, some startling before and after rehabilitation comparisons were captured. Below is a series of comparison photos taken at three distinct monitoring locations (Figs. 4-26 to 28). In the last comparison, the 2010 photo is taken from a distance and the monitoring location is in the center of the thicket behind the field gear.
