**Billy Creek Natural Area  
Riparian Restoration Project**

**Task 9: FINAL REPORT**

**AWPF Grant 08-154WPF**  
Town of Pinetop-Lakeside, AZ

January 2014

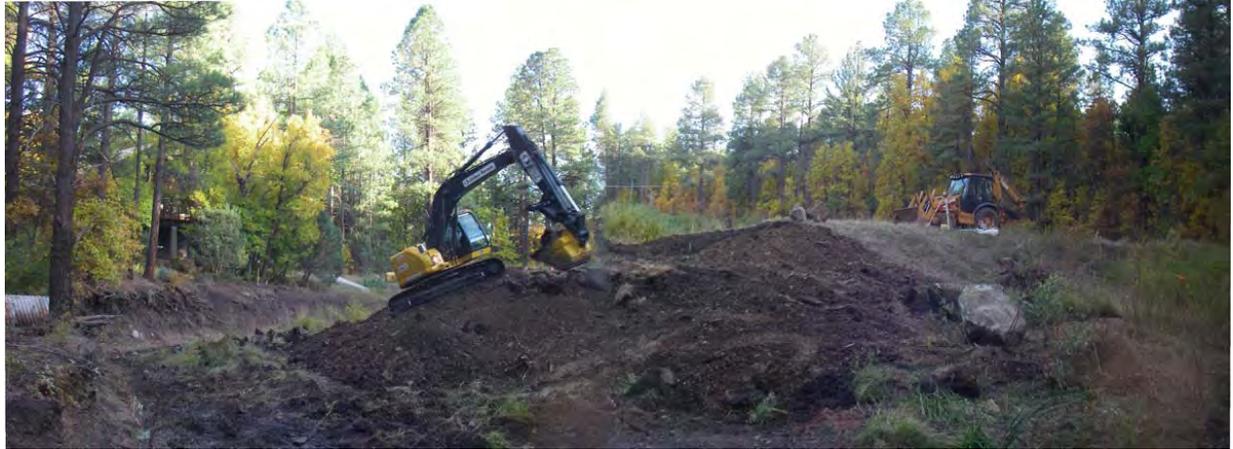
**Figure 17: Excavation at Station 2+00 to 3+50**

This section had approximately 1290 cubic yards of material excavated from the existing berm. This material was placed in the old channel alignment and used to build back the eroded bank section and to form a new channel. (Figures 17 & 18).

*Photo is looking upstream at initial excavation at Reach 1. The old channel at left of photo was kept open until a culvert was installed to carry the creek's flows during excavation of the new channel.*

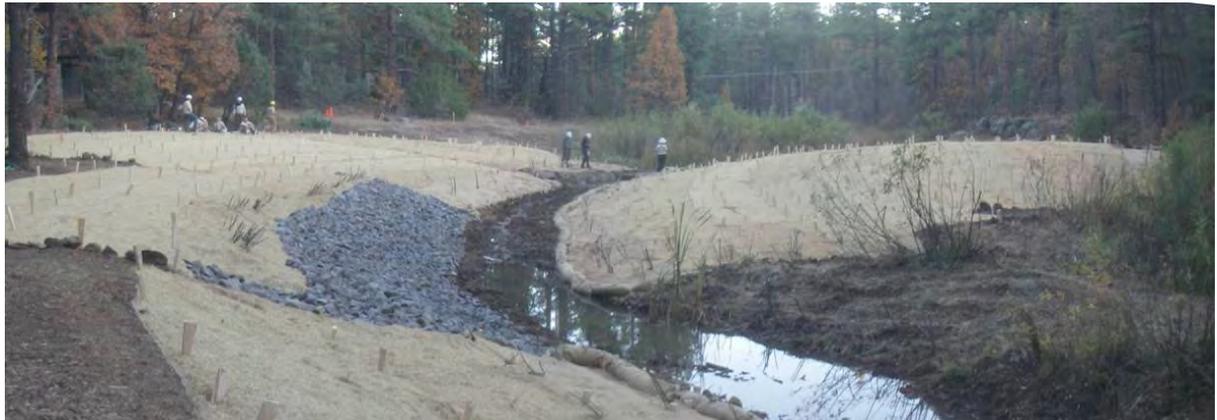
**Figure 18: Station 2+00 to 3+50 after construction and re-vegetation.**

*Photo shows the same upstream view of Reach 1 after construction and re-vegetation have taken place. Toe rock is left of center, and a portion of the cross-vane-weir can be seen at center by workers. Installed erosion control fabric and erosion control logs are shown, as well as the tops of willow clusters through the fabric.*

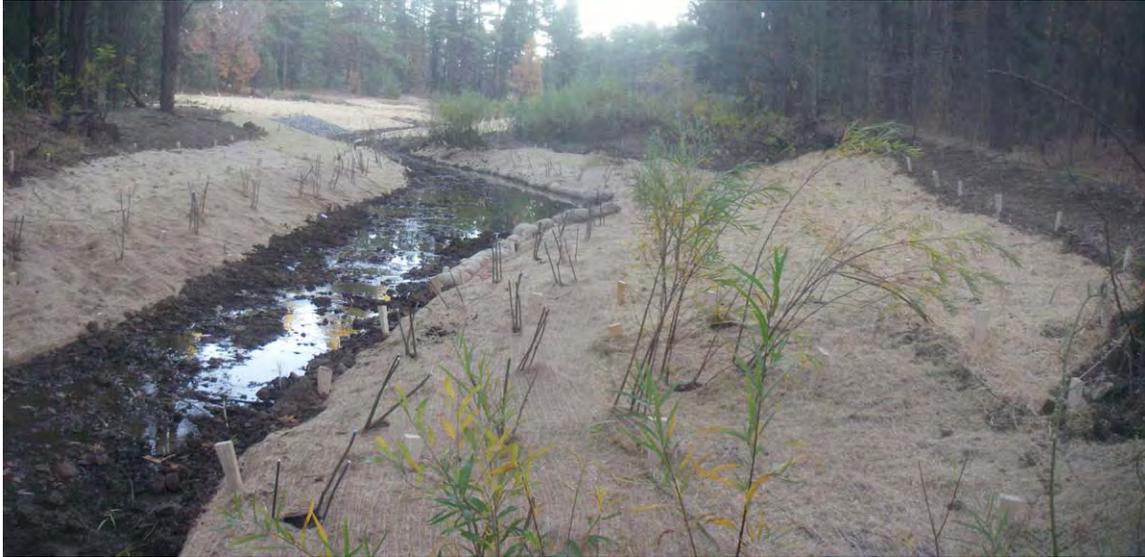
**Figure 19. Completed channel restoration at end of Reach 1.**

Approximately 165 linear feet of vertical bank downstream from the berm were re-sloped. An area of fill was compacted and shaped into the right bank. The banks were then planted with willows, seeded and covered with erosion control fabric. Erosion control logs were also installed on the outside of meanders. The whole channel then had wetland plug plantings installed along the toe of the channel (Figure 19).

*Looking upstream at re-sloped and bioengineered banks in the lower section of Reach 1.*

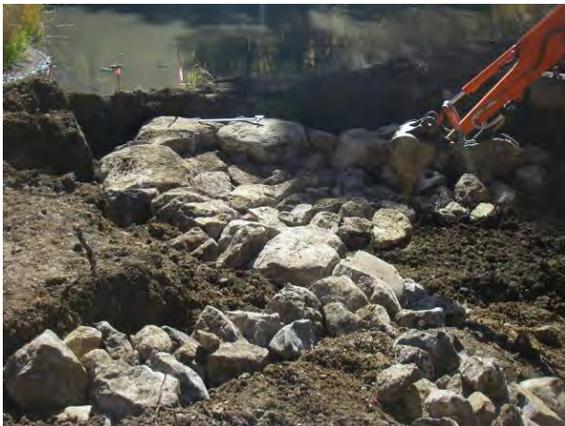
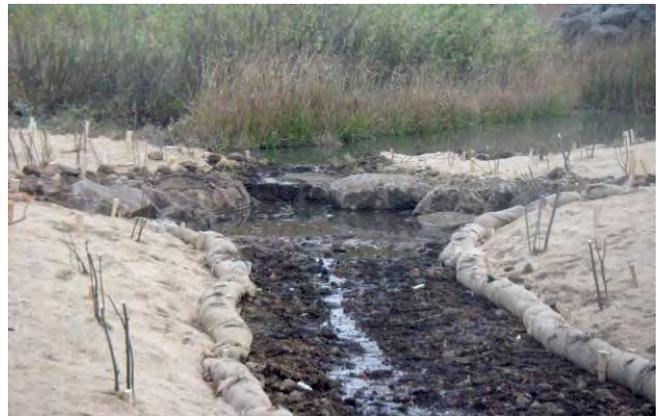
A Cross-Vane Weir was installed at the outlet of the pond at the berm to maintain and stabilize the new channel grade, and prevent draining the existing pond. Boulders uncovered during excavation were used for construction (Figure 20 & 21).

**Figure 20: Cross-Vane Weir installation.**

**Figure 21: Completed Cross-Vane Weir.**

*These pictures show the cross-vane weir at station 2+00 during construction and after completion.*

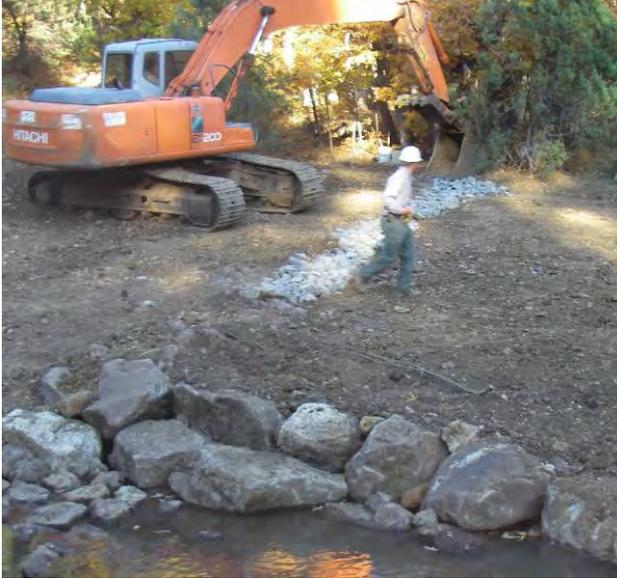
**Figure 22: Rock Cutoff Sill installed.**

A rock cutoff sill was installed across the old filled channel and tied into the right wing of the Cross-Vane Weir structure. This sill is used to prevent downcutting through the old filled channel section (Figure 22). The rock will prevent a gully from forming if concentrated water flows over this area of floodplain.

*Photo shows approximately 30 linear feet of rock installed at Station 2+20. Photo taken from across creek looking east.*

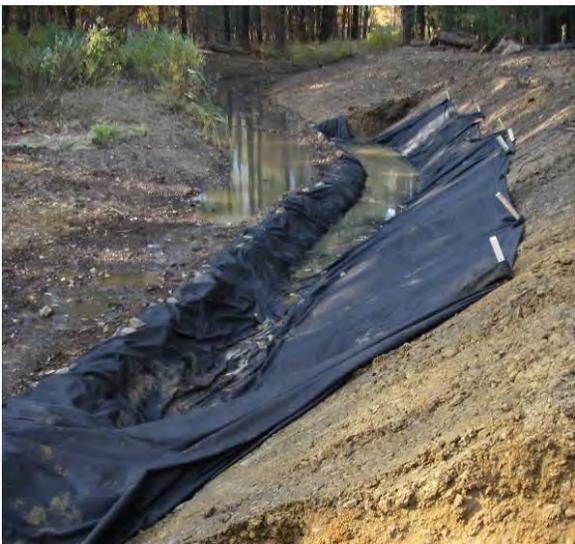
**Figure 23: Completed Toe Rock**

The bank downstream of the weir had approximately 47.7 cubic yards of toe rock installed along the right side of the newly excavated channel. This rock was placed to protect the streambank from potential lateral erosion. Non-woven geotextile was installed behind the rock to prevent fine soils behind the rock from being removed (**Error! Reference source not found.** & 24).

*Photo shows completed toe rock at Station 2+75 to 3+45. Photo taken from upstream looking north.*

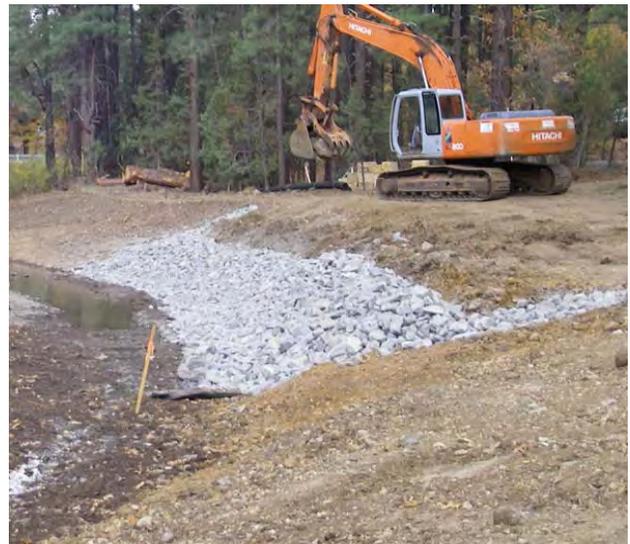
**Figure 24: Preparation for Toe Rock.**

*Excavation and installation of geotextile for toe rock at Station 2+75 to 3+45. Photo taken from upstream looking north.*

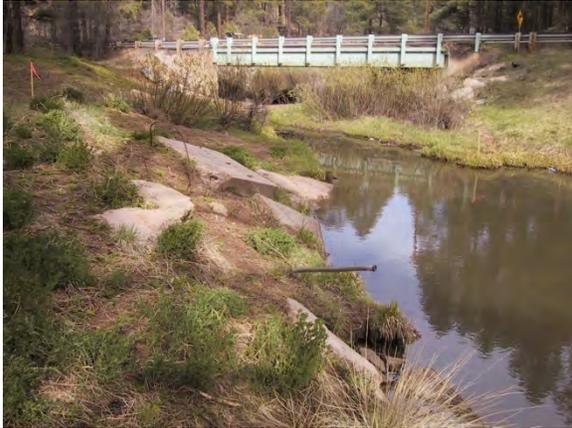
**Figure 26: Debris downstream of the bridge.**

Six tons of concrete and metal debris were removed from a section of streambank just downstream of the Meadow Lane Bridge. The debris was removed using a mini-excavator and removed to a commercial waste disposal site by dump truck. Approximately 60 feet of bank was re-sloped and bioengineered with willow clusters, seed, erosion control fabric and excelsior logs with wetland plugs (Figure 26 – 28)

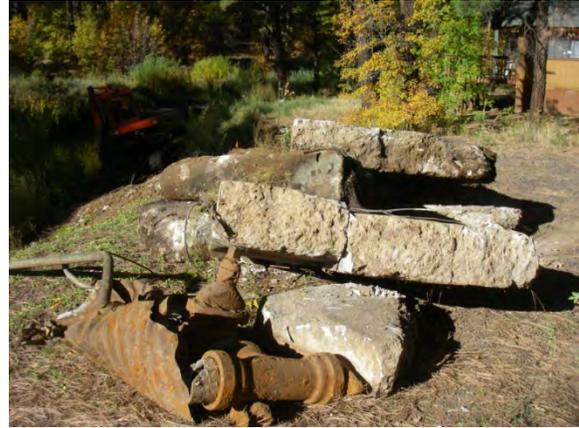
**Figure 27: Debris removed from channel**

*This photo shows the six tons of debris that was taken out of the bank below the Meadow Lane Bridge. Photo taken looking northwest.*

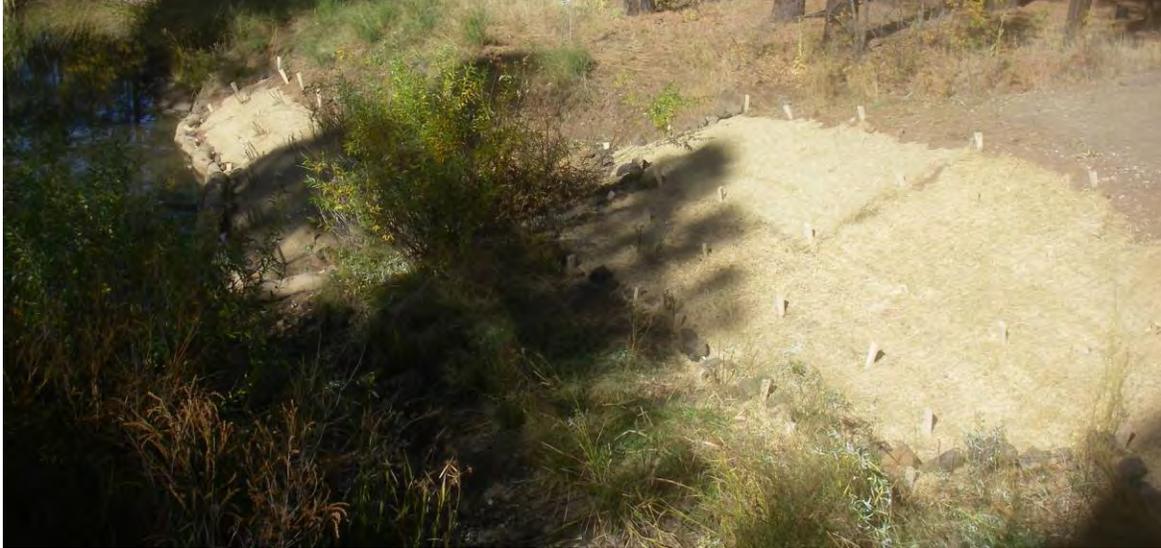
**Figure 28: Bioengineered bank after debris removal.**

*This photo shows the bank below the bridge after removal of six tons of debris and re-sloping. The bank was planted with willow clusters, seeded, and covered with erosion control fabric. The downstream portion, at water's edge, had excelsior logs installed at the toe. The logs were then planted with wetland grass plugs. Photo taken from the bridge looking downstream to the north.*

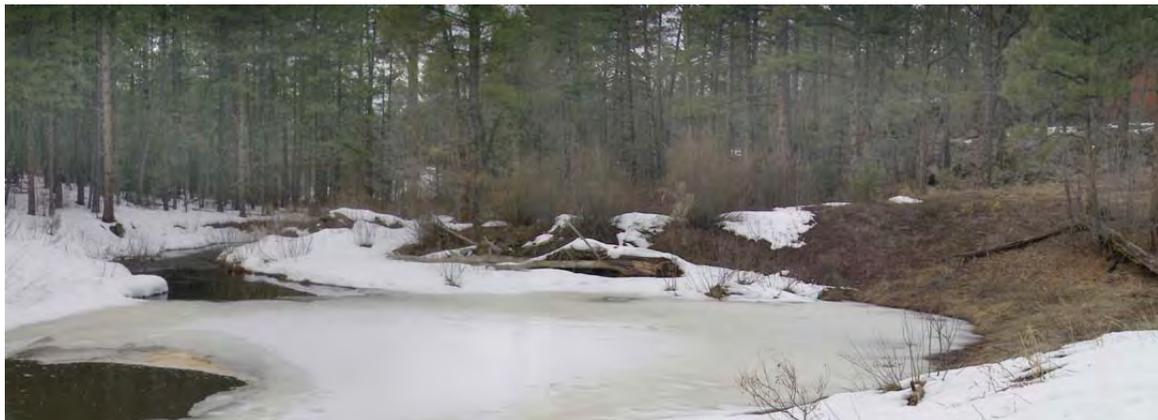
**Figure 30: Berm in Reach 2 prior to excavation.**

Downstream at Reach 2, approximately 675 cubic yards of material was excavated from the existing berm to form a new channel. The excavated material was used to fill the old eroded channel alignment. Bioengineering practices include seed and fabric, willow clusters, excelsior logs and wetland plugs (Figure 30 & 31).

*This photo shows the berm in Reach 2 prior to excavation. Photo taken from upstream, looking north in January of 2009.*

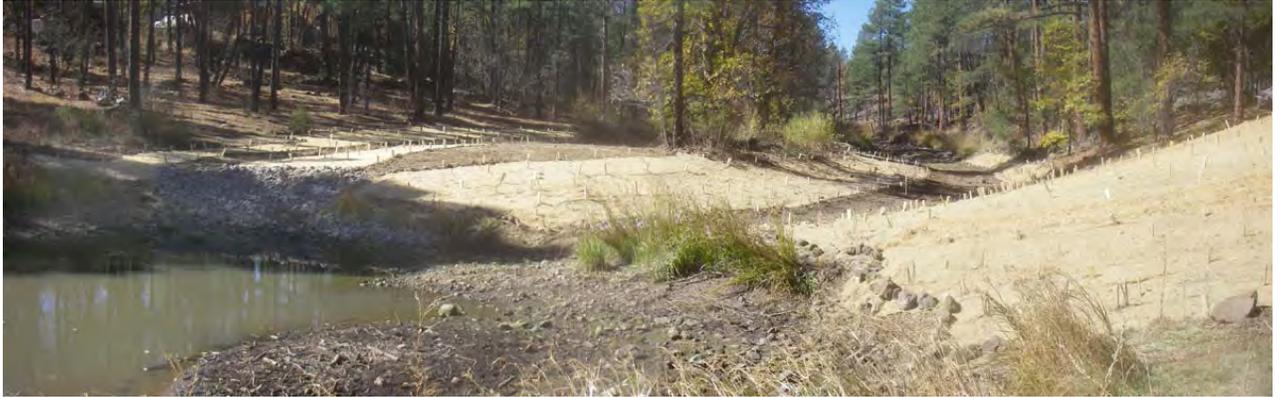
**Figure 31: Reach 2 after work was completed.**

*Completed work at Station 12+50 to 14+20. The berm has been removed and the new stream channel excavated, rock installed at the mouth of the old channel (left side of photo) and bioengineering installed.*

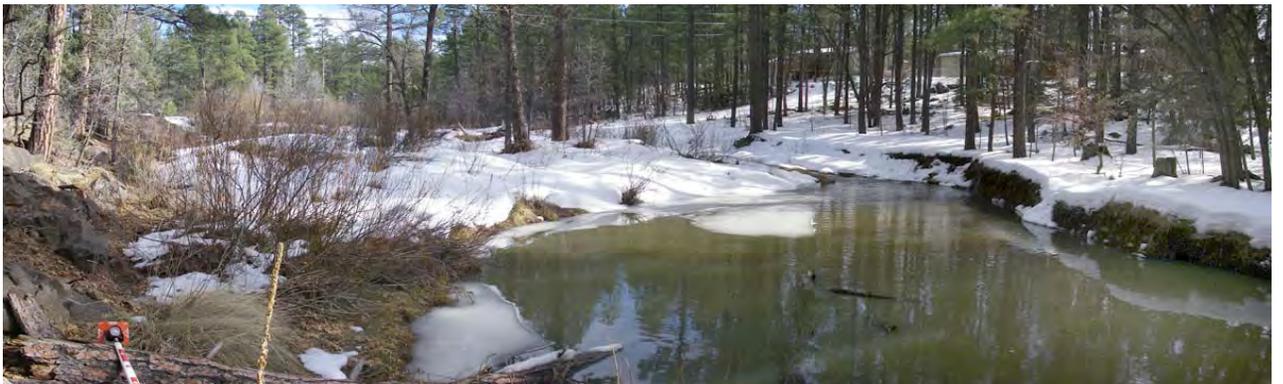
**Figure 32: View looking upstream at Reach 2 before construction.**

*This photo shows the cutbank along the old channel in Reach 2, at the right of the photo, prior to excavation.*

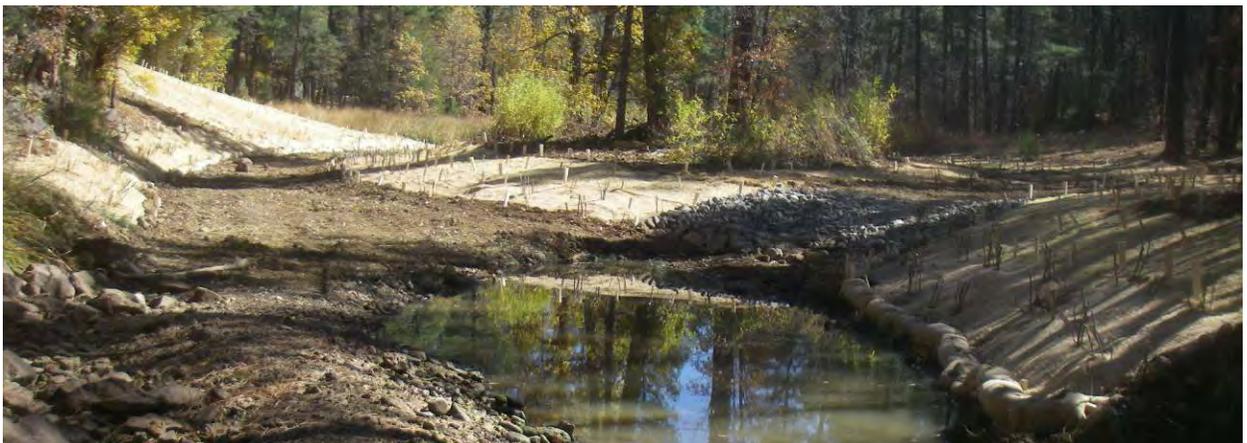
**Figure 33: View looking upstream at Reach 2 after construction.**

*This photo looking upstream of Reach 2 shows the new channel on the left and the overflow channel on the right. Rock armoring at the outlet of the overflow channel can be seen right of center. The bank in the right foreground was re-sloped. Photo taken from downstream looking south.*

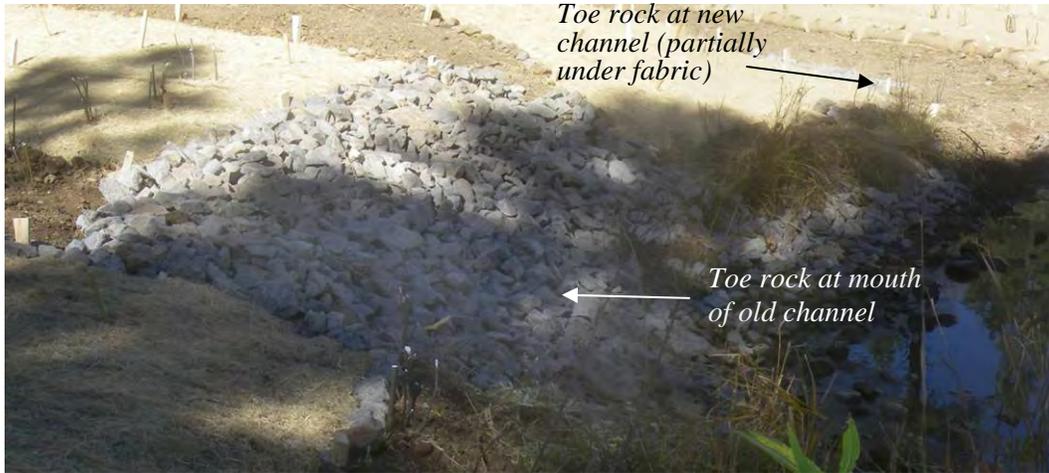
**Figure 34. Toe rock at Station 12+35.**

*Photo shows toe rock installed at the mouth of the old channel and left side of the new channel. Photo taken from left side looking northeast.*

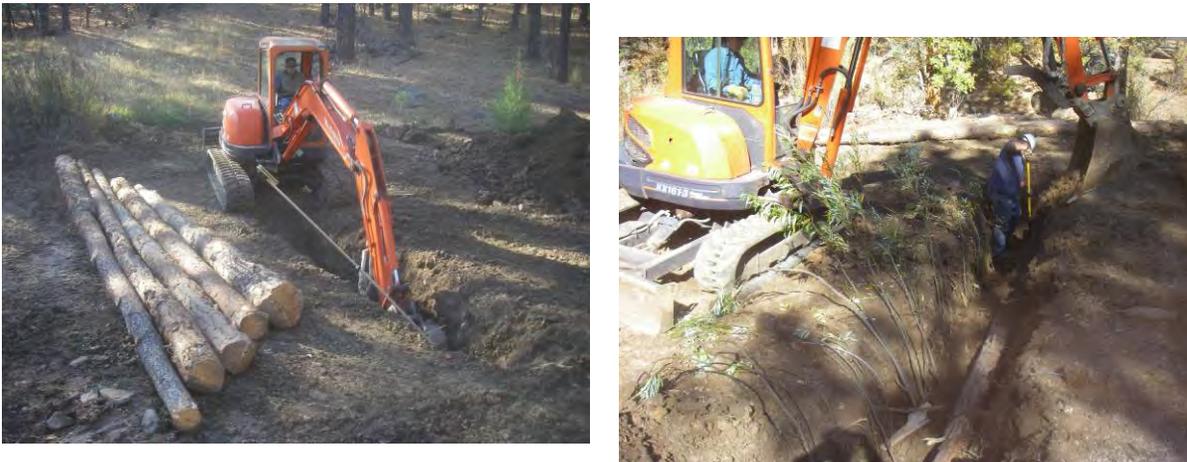
**Figure 35. Log sill installation**

*These photos show excavation for the first log sill at Station 13+00, and the logs as they are stacked in the trench. Cable used to secure the logs together was placed in the trench before the first log was placed, and the ends clamped after the top log was in place. Willows are placed in trench prior to backfilling.*

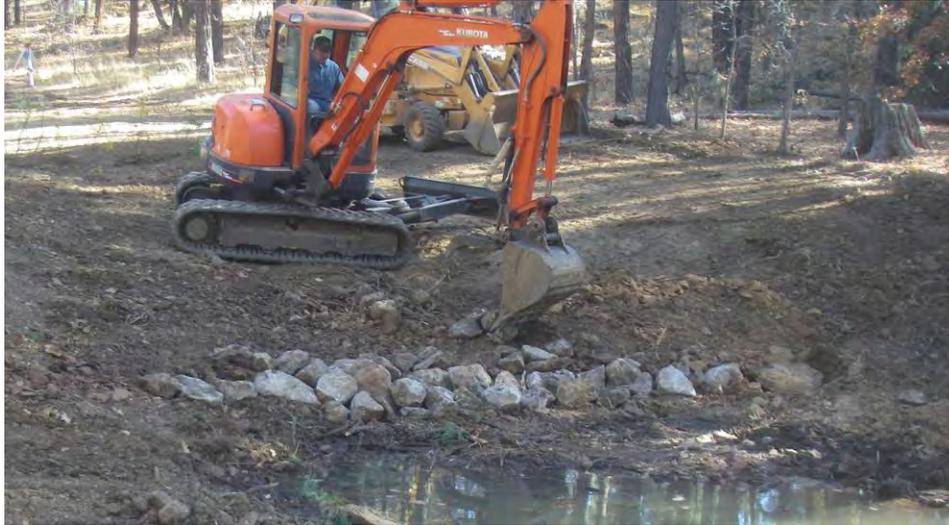
**Figure 36: Boulders harvested from site used as footer rock for apron.**

*Boulders uncovered during excavation were embedded in the base of the overflow channel's outlet to act as footer rocks for the rock apron. Photo taken from across main channel looking southwest.*

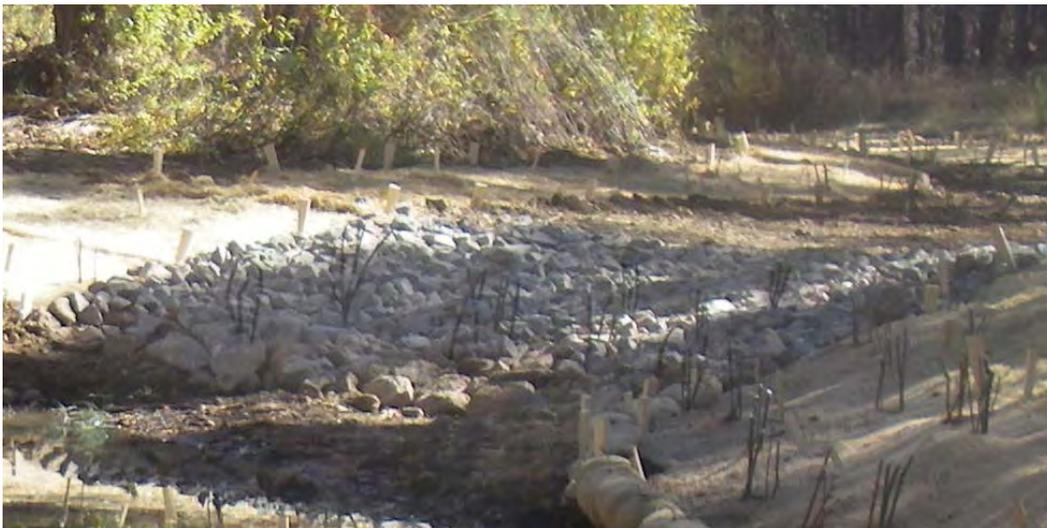
**Figure 37: Rock Apron at Station 14+00.**

*Completed rock apron at Station 14+00. Willow clusters can be seen planted within the apron. Photo taken from downstream looking south.*

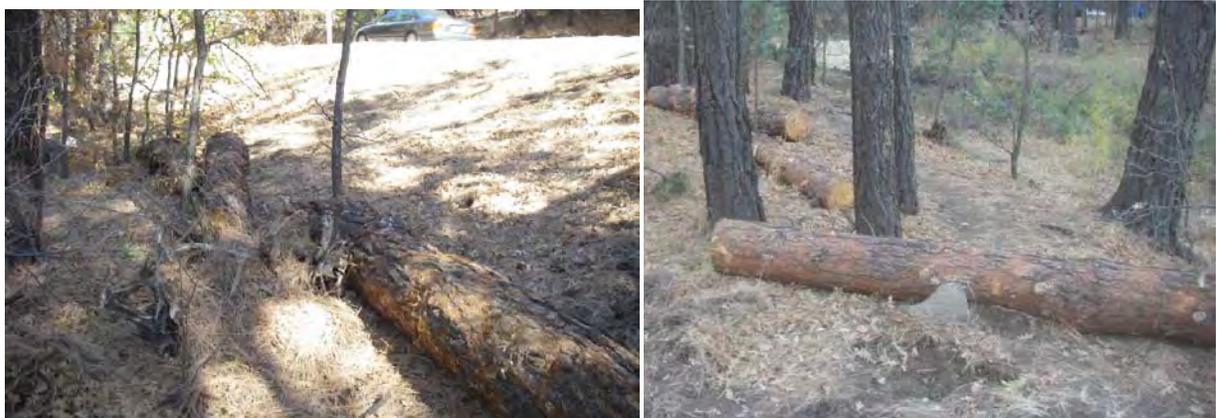
**Figure 45: Logs blocking ATV access.**

*This photo shows one of several places where logs were placed to limit ATV access.*

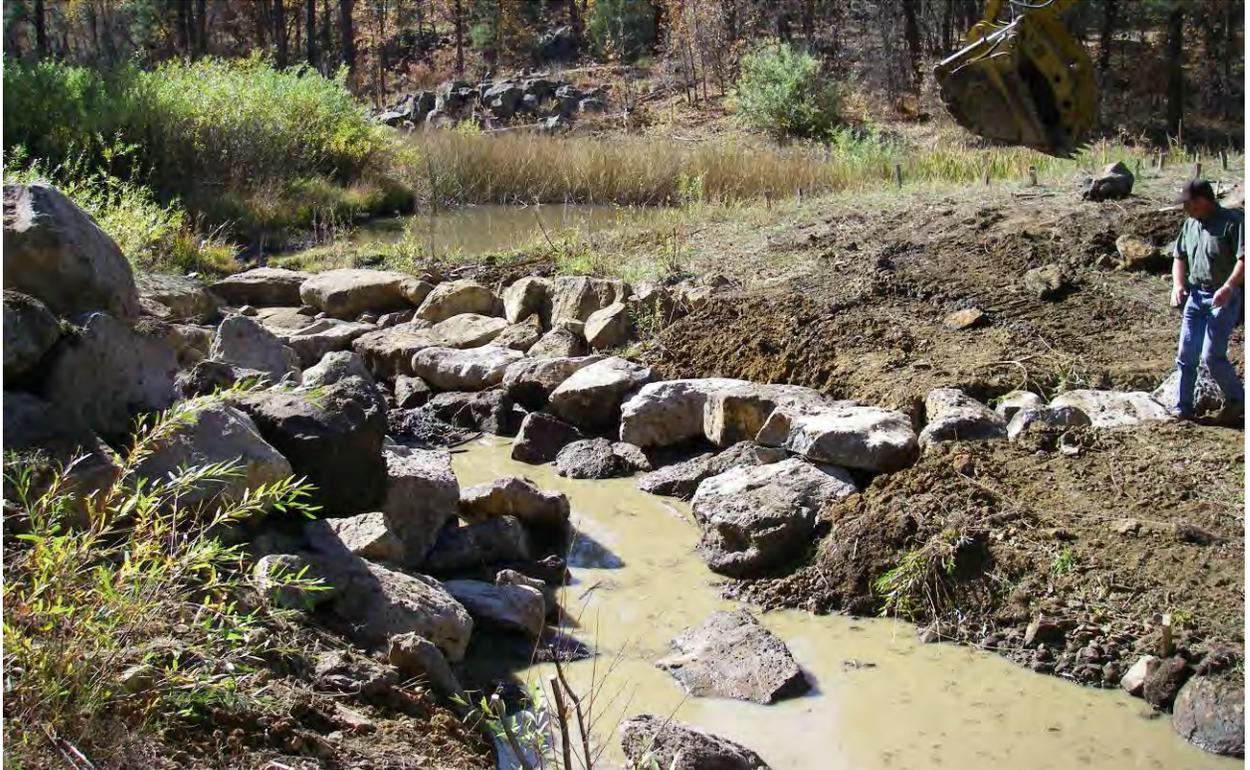
Figure 48: Completion of the left vane arm.

During the second phase of construction, a modified grade stabilization structure was designed and installed to replace the original weir structure. The flow event that damaged the first structure was large (~25-yr recurrence interval event), so the site and structure was first analyzed to determine the cause of failure.

The original structure utilized rock found on site during the initial construction and the structure was ultimately too small for the elevation drop of the stream. The replacement structure utilized more and larger rock and also incorporated two smaller step-pools to aid in energy dissipation. This new structure was tested in 2013 when several flows over bankfull occurred (the largest at 259 cfs or ~10-year event). No damage to the structure occurred during that flow.

The modified grade stabilization structure took just over a day to install. The structure is built out of a series of two and three-foot rocks aligned in a chevron shape with the point of the “v” pointing upstream (Figure 47). The construction sequence included excavating a trench along each vane arm three to four feet deep and installing 2-ft footer rocks along the base. Then 3-ft rocks were installed on top of the footers to complete the weir outline (Figure 48). Between the vane arms, a rock apron consisting of smaller 1.5 foot graded rock was installed to prevent undermining of the structure. This apron was extended downstream from the weir to the existing section of rock rip-rap bank protection installed during the previous construction phase.

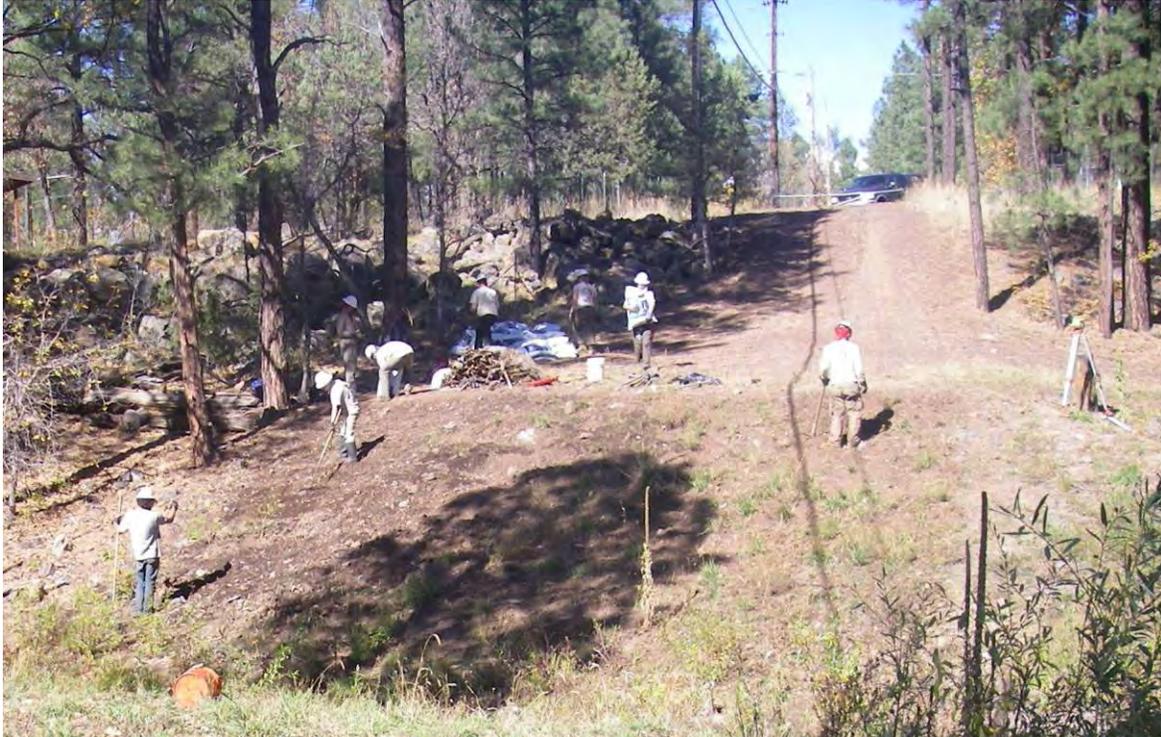
**Figure 63: Preparation of the right bank in Reach 2.**

*During bank preparation, any grass species found growing on the bank were avoided and left to grow.*

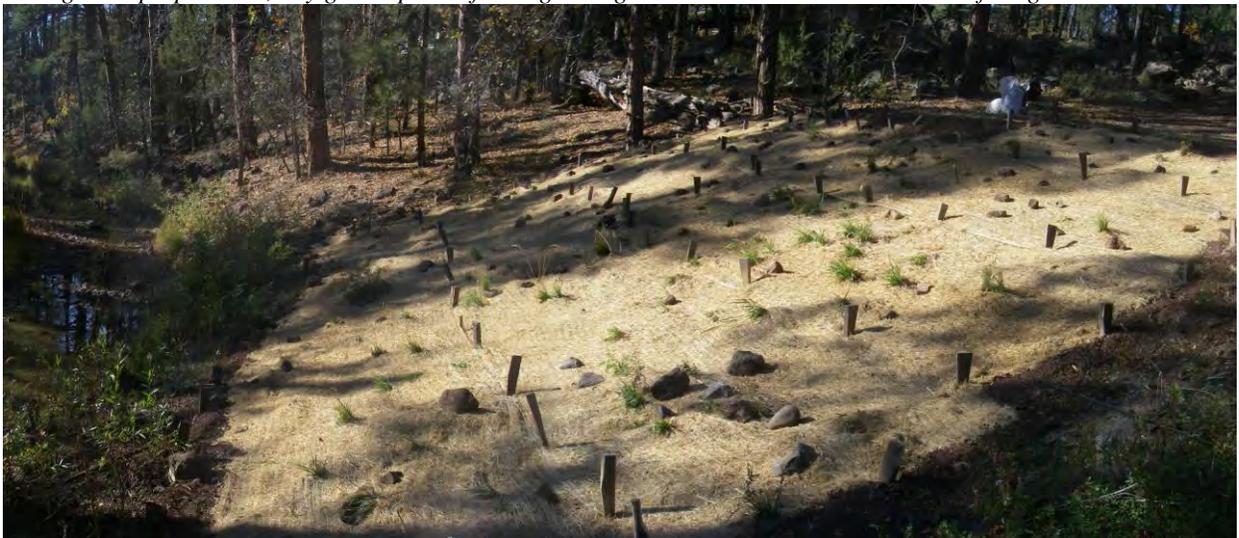
**Figure 64: Completed bank in Reach 2.**

*Existing grass plants were pulled through the fabric during installation.*

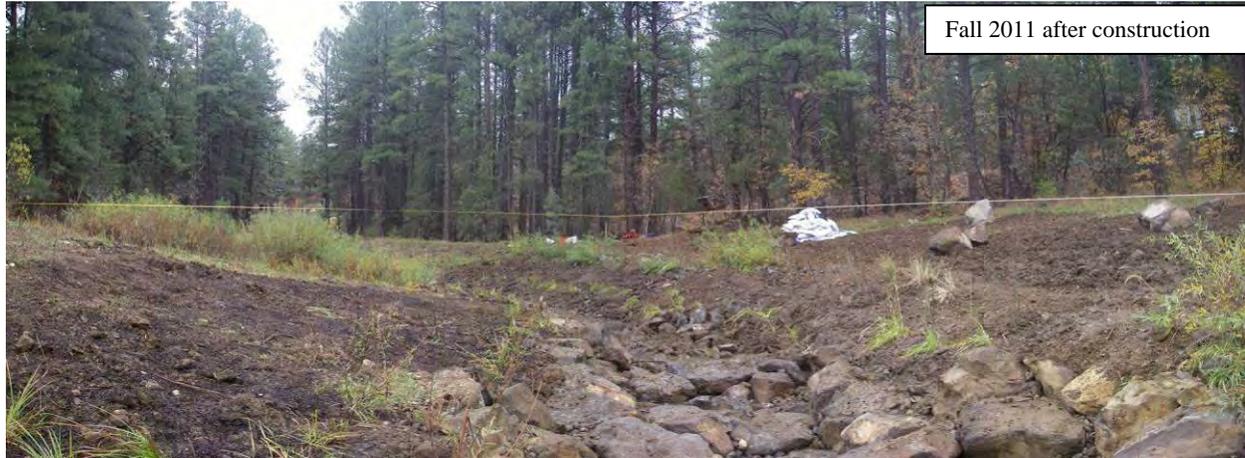
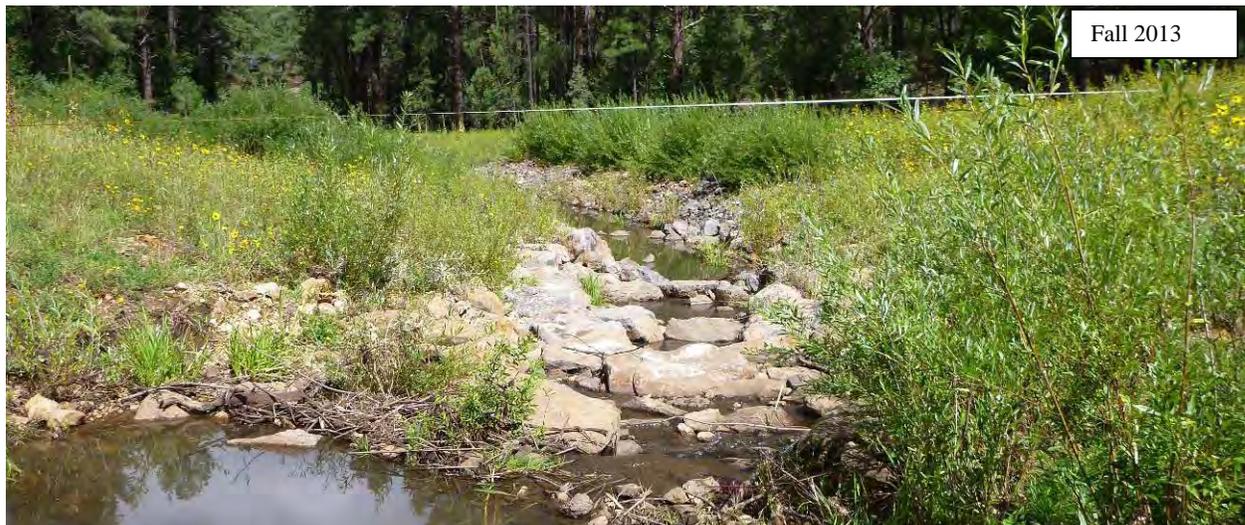
Figure 68: Cross-section 1 Photos.

This cross section is located at the beginning of the project area. The original rock weir installed in 2009 was modified in 2011 after high flood waters caused erosion at the structure. This monitoring cross section was originally set up downstream from the rock weir, but the improvements of the weir extend through this location. This cross section now measured the rock structure and helped to detect any changes to the structure.

During the 2013 survey, the left end pin for this cross section was found to be missing, so the cross section in 2013 does not line up perfectly with previous years. This resulted in a slight shift in the cross section and is the reason that some of the cross section data is different in 2013 compared with the previous two years. This cross section is stable and in the throat of the rock weir. No rocks have moved since the previous survey. The vegetation continues to grow and fill in around the channel and weir. There was a small amount of scour around the top end of the right side of the weir but it is not threatening the integrity of the structure and the weir is intact and functioning properly.

*These photos are looking down through the weir at cross-section 1.*

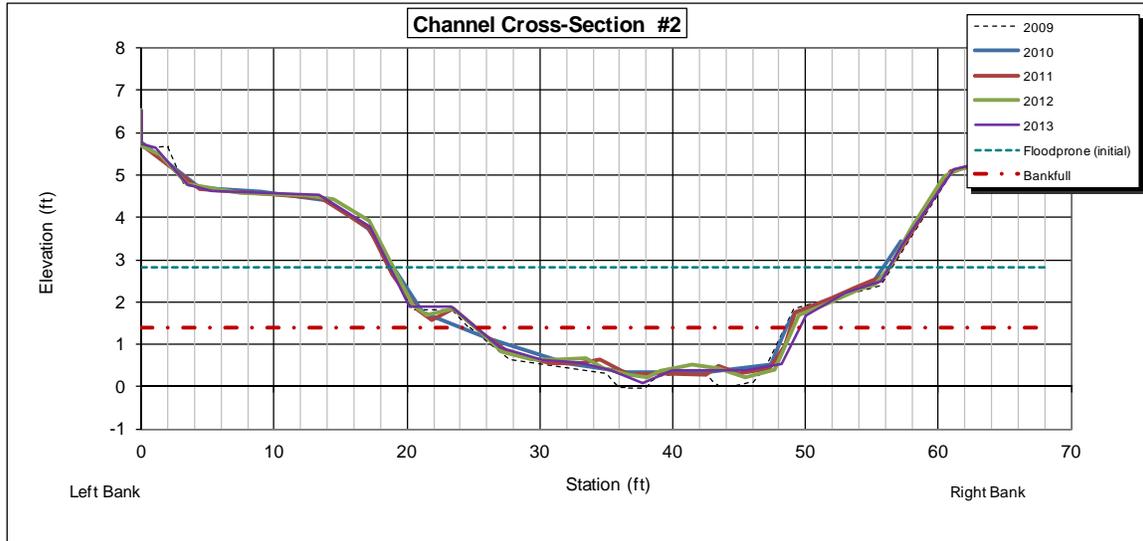
Figure 69: Cross-section 2, 2009 to 2013 profiles

Cross-section 2 is located at the end of Reach One, in a location that did not receive any ground disturbing activities. Other than vegetation growing, no change occurred at this cross section.

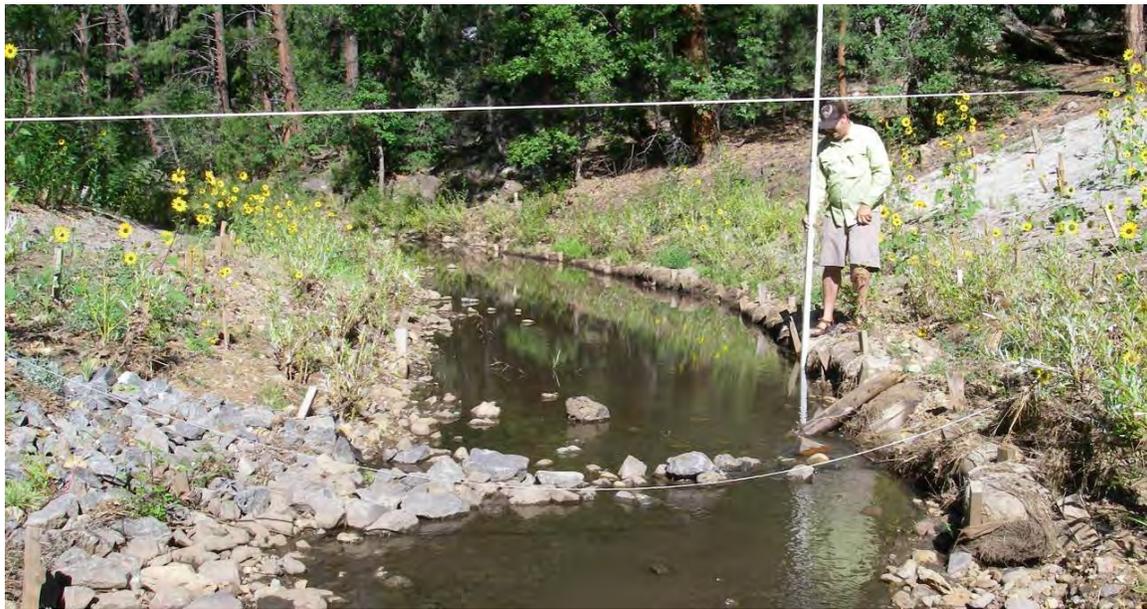
Figure 72. Cross-section 3, September 2010.

Cross-section 3 is located at the outlet of the pool in Reach 2. The flood in 2010 causes some scour in the soft, newly constructed bed that has since filled to the current, stable elevation.

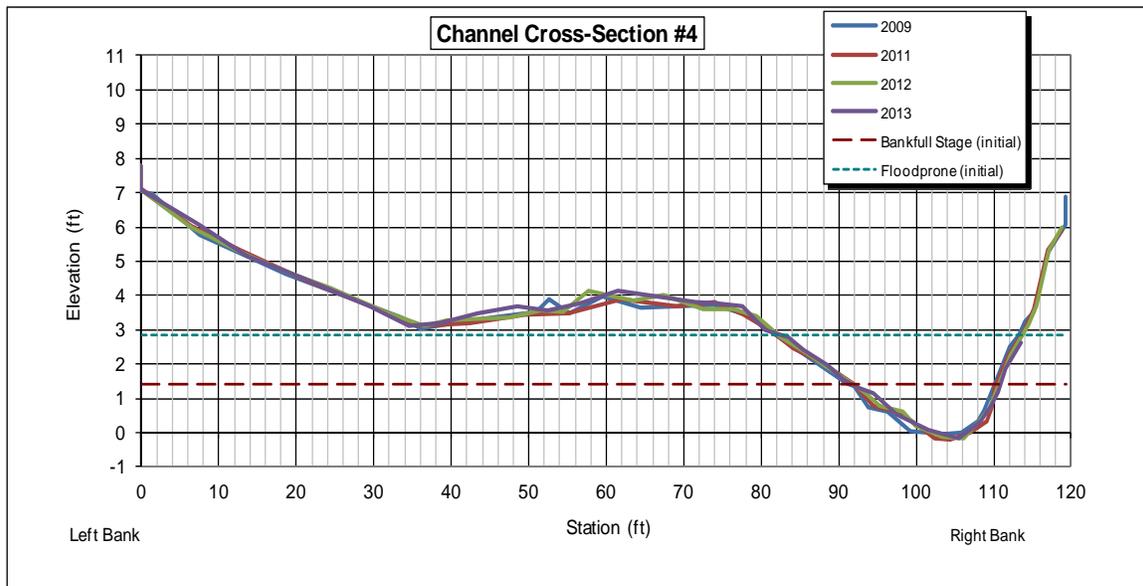
Figure 74. Cross-section 4, 2011 to 2013 profiles

Cross-section four is located at just over one hundred feet downstream from Cross-section 3. No change to the cross section was noted during the 2013 monitoring. The cross section remains stable.

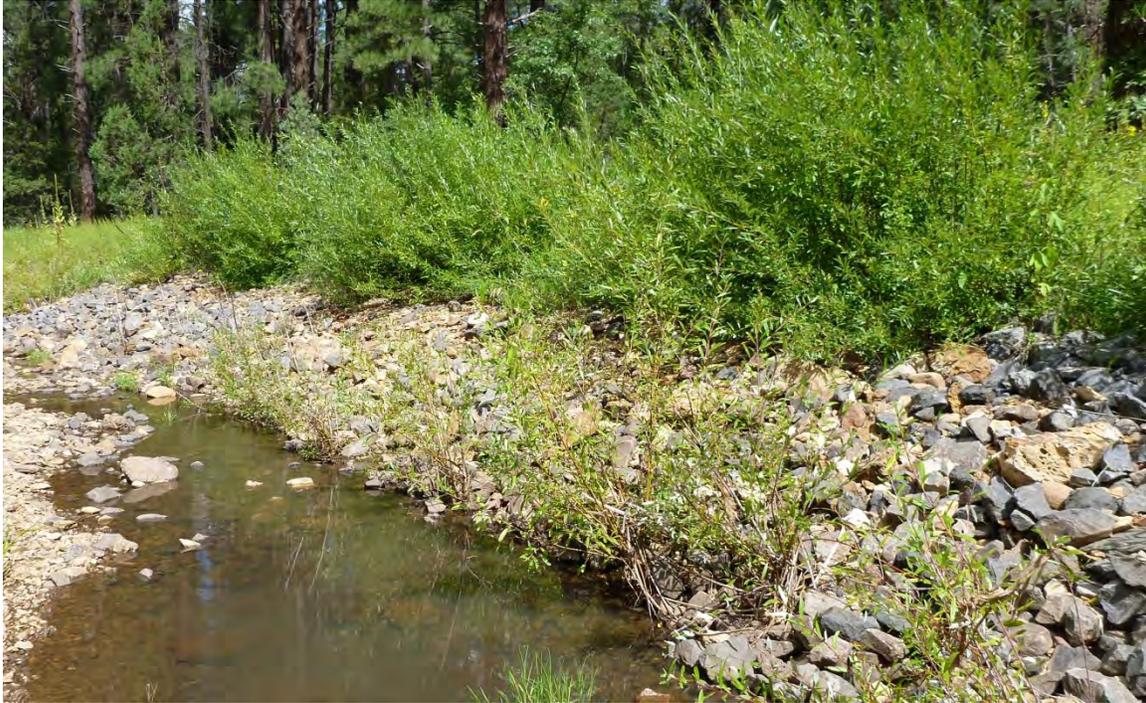
**Figure 78: Toe rock at Reach 1.**

*The toe rock in Reach 1 is stable. Willows planted along the toe in 2011 are growing and filling in.*

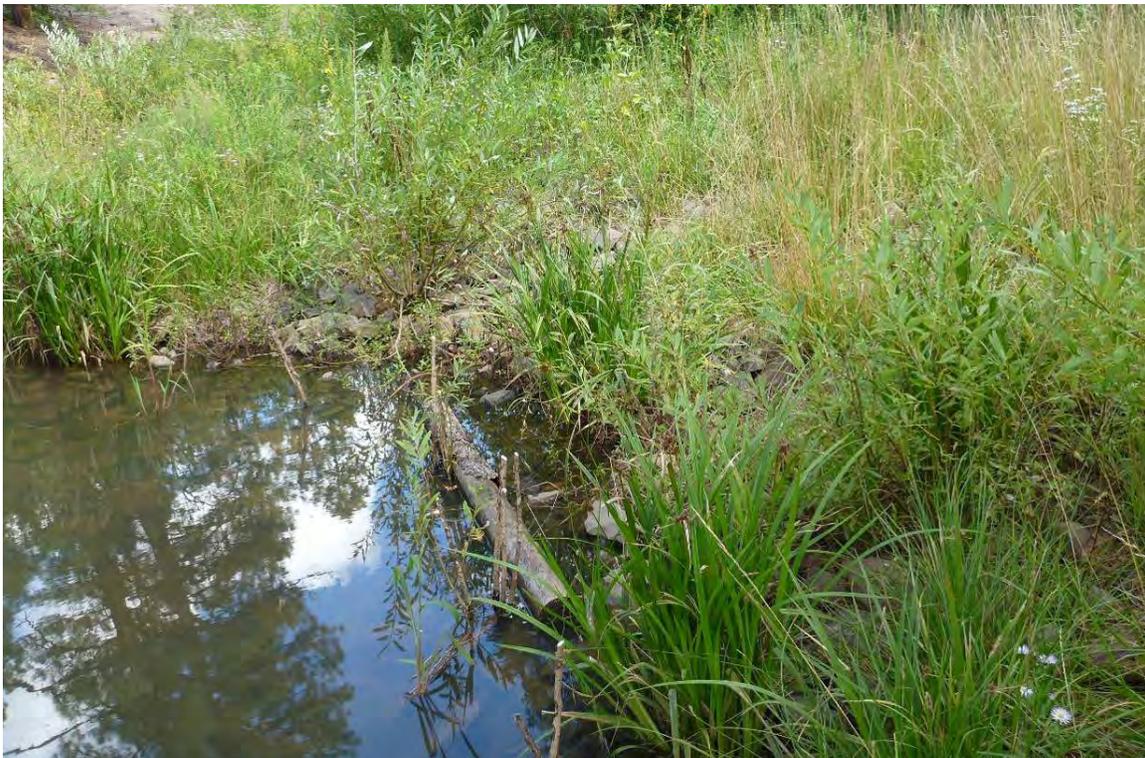
**Figure 81. Rock apron at outlet of old channel, Reach 2**

*The rock apron is becoming more obscured with vegetation.*
