E. COLI REDUCTION ON THE SAN FRANCISCO RIVER THROUGH
ALTERNATIVE LIVESTOCK WATER ON THE KALER RANCH

FINAL REPORT

CONTRACT NUMBER 11-175WPF

May 31, 2013

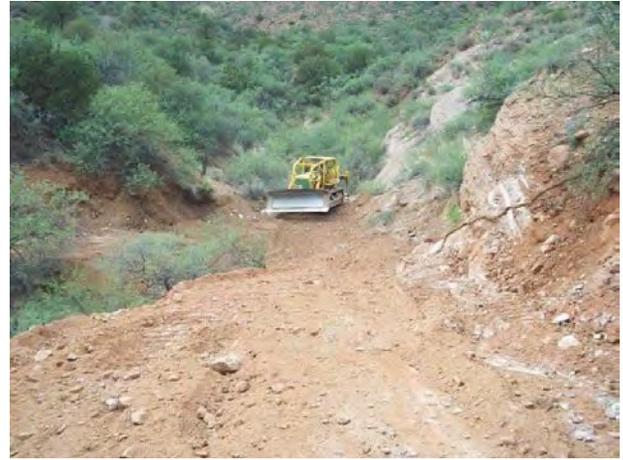
Fig. 4 Road preparation.

Mr. Kaler used his equipment and his ranch hands to repair and widen the steep, narrow road to the fourth well site, characterized by steep grades and hairpin turns, to permit safe passage for the well drilling equipment, and for future maintenance of the sites. In the final 3/4 mile, heavier equipment proved to be necessary, and the well contractor brought in their newer and larger Caterpillar, to complete the work. It was during this phase that the highway accident occurred that left Mr. Kaler widowed and severely injured. The contractor quickly stepped in to complete the job.

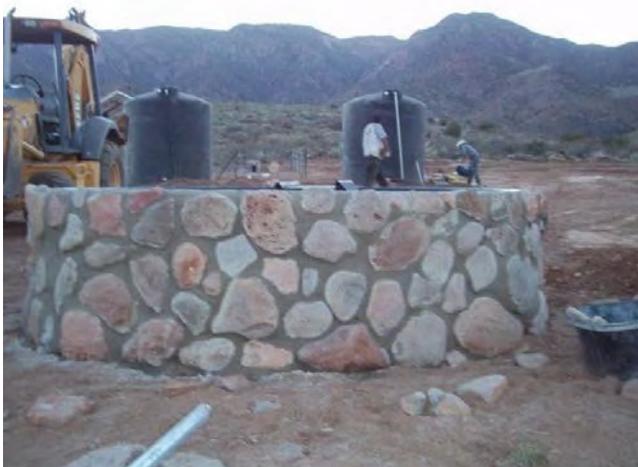
Fig. 5 The completed trough, with water tanks in the background.

Next, two 3,000-gallon black plastic water storage tanks and one 718-gallon galvanized watering trough were installed. The galvanized water trough was surrounded by rock set in concrete, to minimize damage from livestock and wildlife.

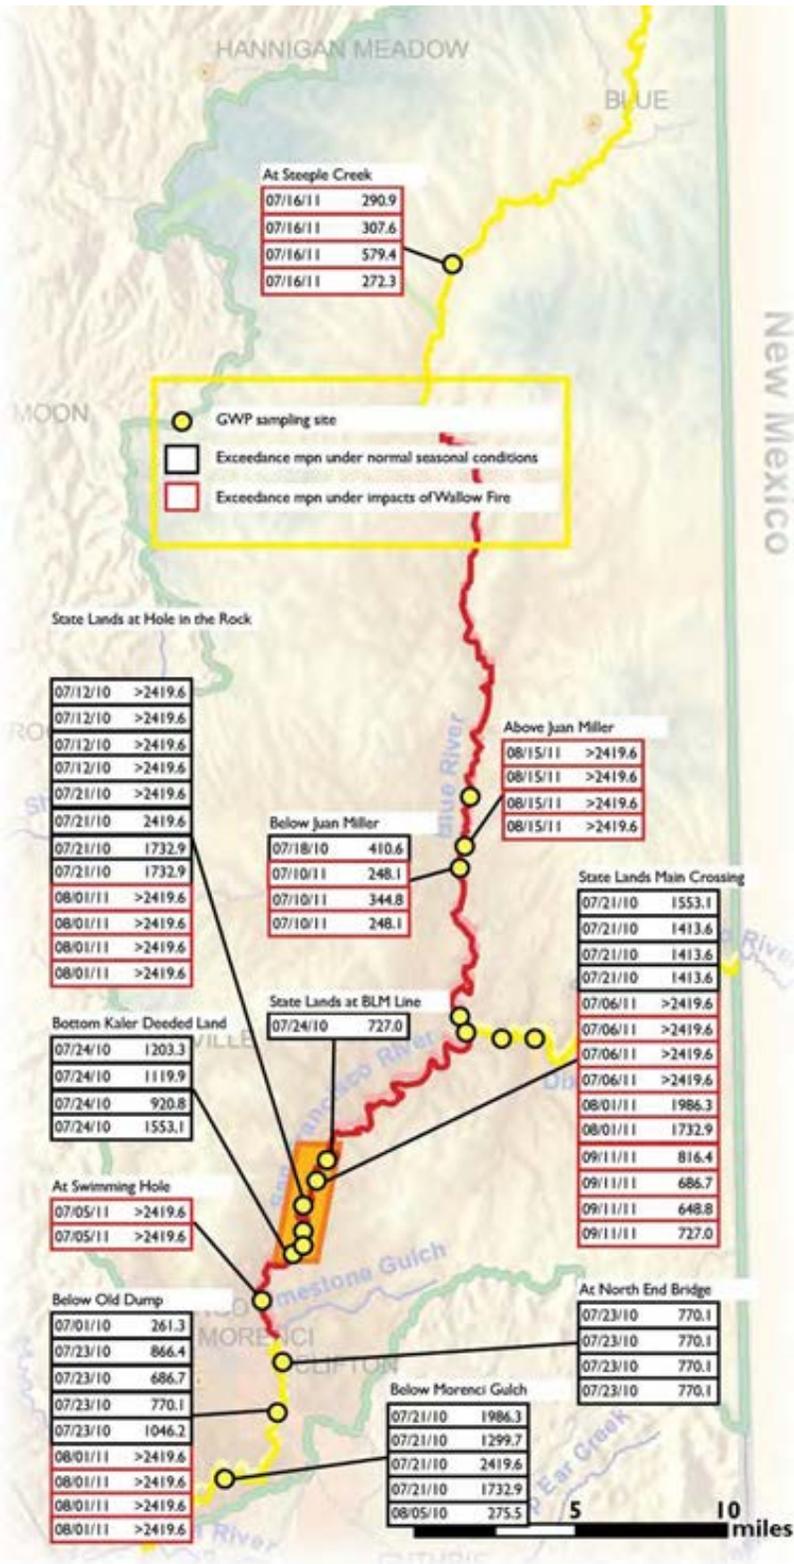
Fig. 5. Map of exceedances recorded by GWP 2010-11. The orange-shaded box is the area where Kaler ranch livestock graze.
