Hunters Hole Restoration Project

HUNTER'S HOLE RIPARIAN AND WETLAND RESTORATION PROJECT

GRANT # 09-166WPF

FINAL REPORT

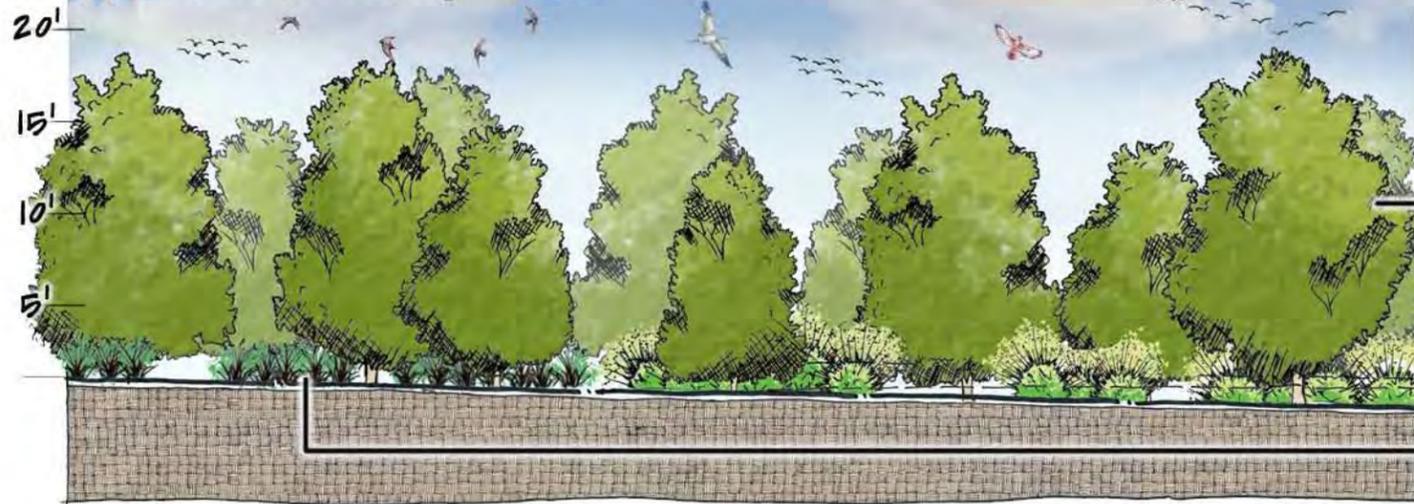
SECTION VIEW: 2-3 YRS

Populus fremontii

Sporobolus airoides

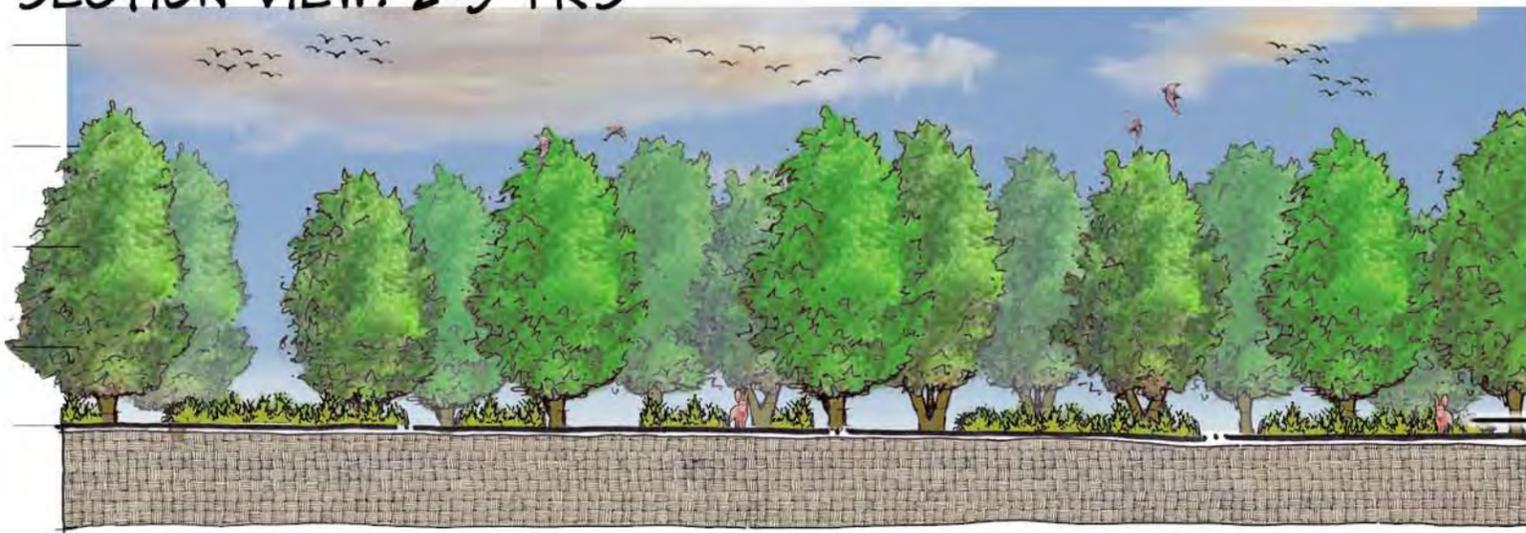
SECTION VIEW: 2-3 YRS

Salix gooddingii

Distichlis spicata

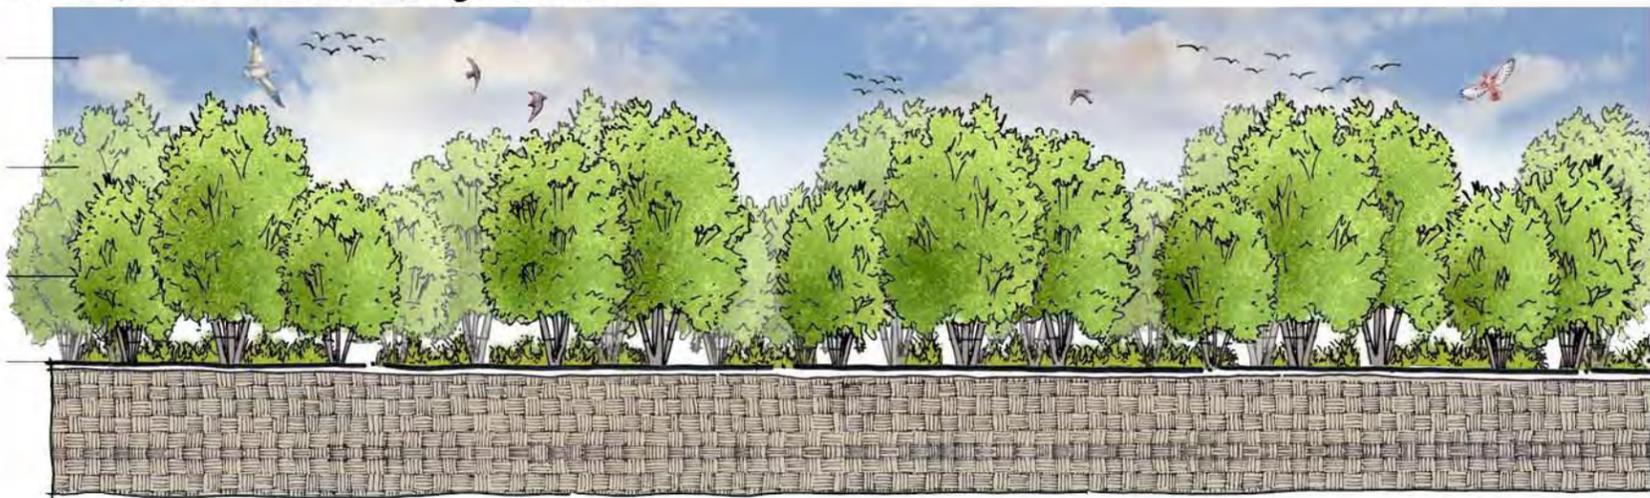
SECTION VIEW: 2-3 YRS

Salix exigua

Distichlis spicata

* *Distichlis spicata* 4" plugs hand planted randomly 5' O.C.

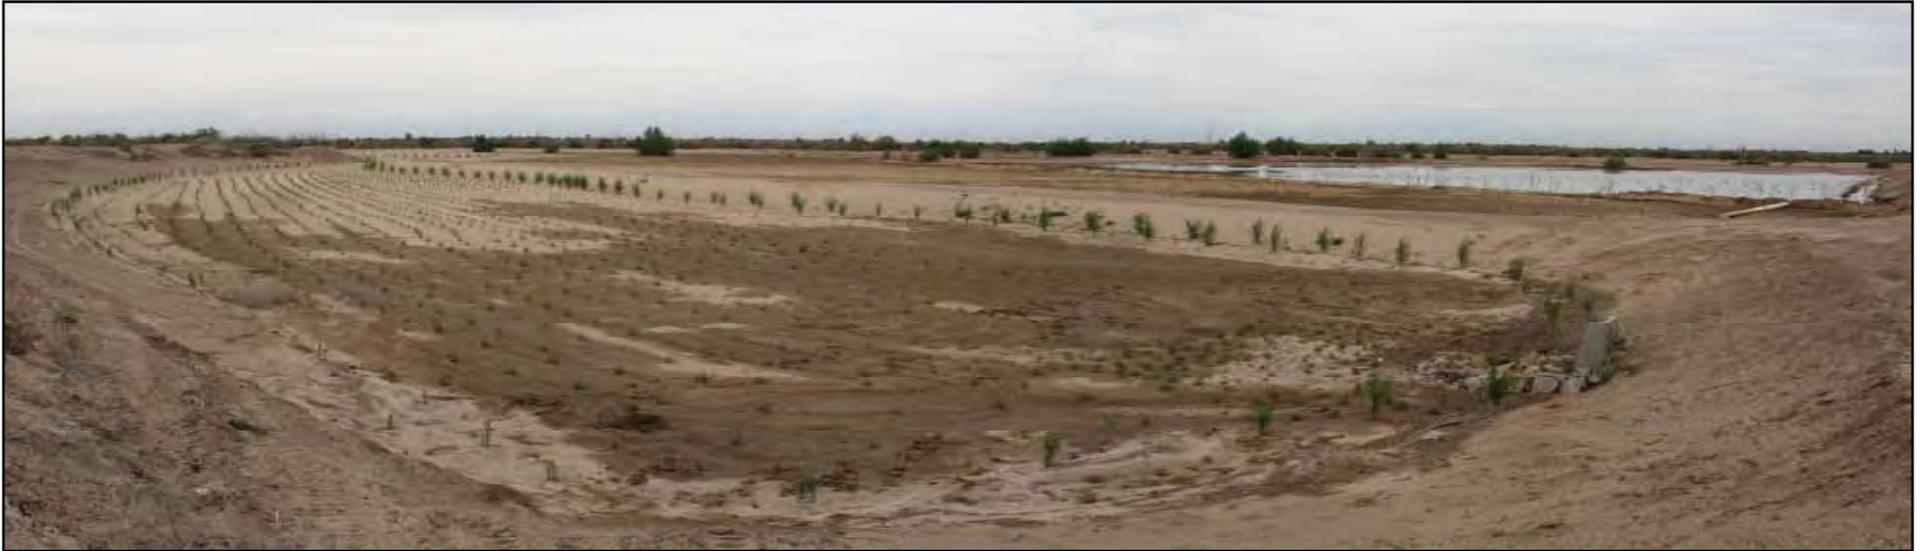
Hunter's Hole Photomonitoring Point #1. Looking southwest at cells 1 and 4 from the northeast end. 3 pics no zoom. April 2012.
N 32° 31'09.29" W 114° 48'04.50"

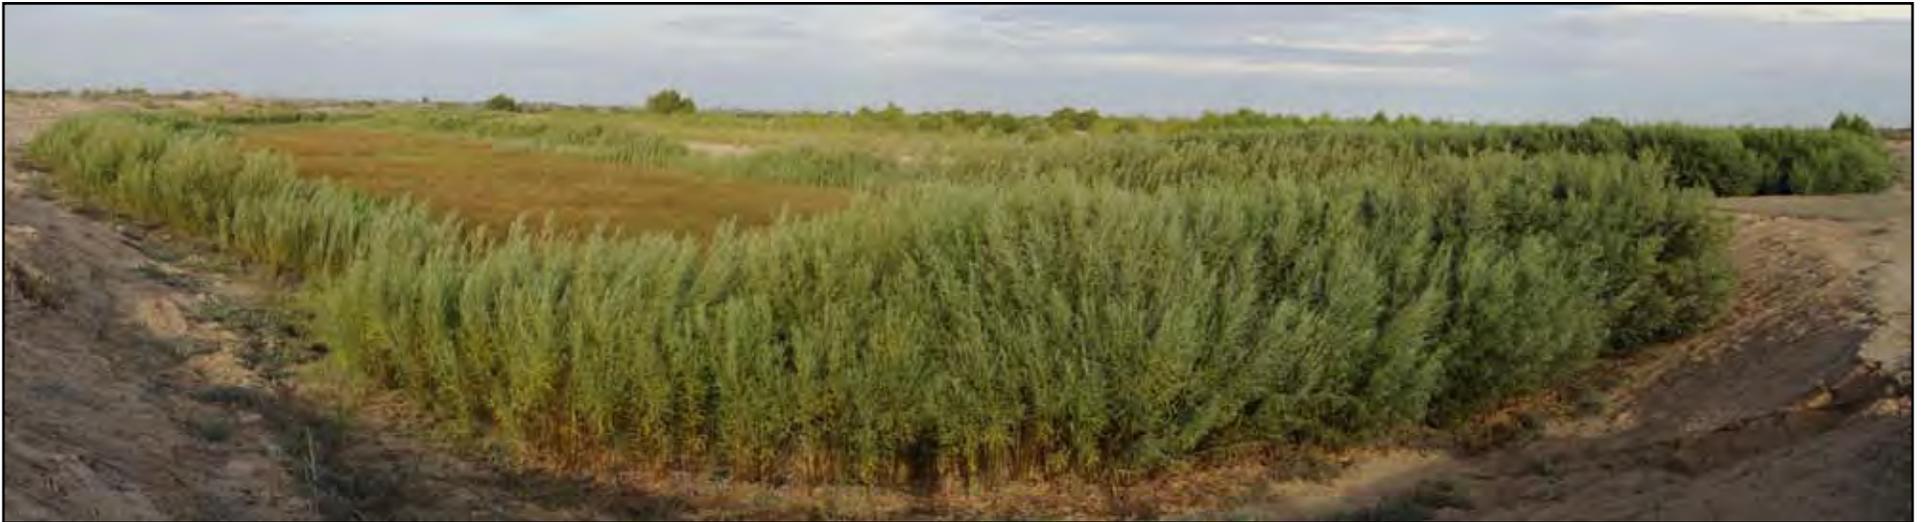
Hunter's Hole Photomonitoring Point #1. Looking southwest at cells 1 and 4 from the northeast end. 3 pics no zoom. July 2013.
N 32° 31'09.29" W 114° 48'04.50"

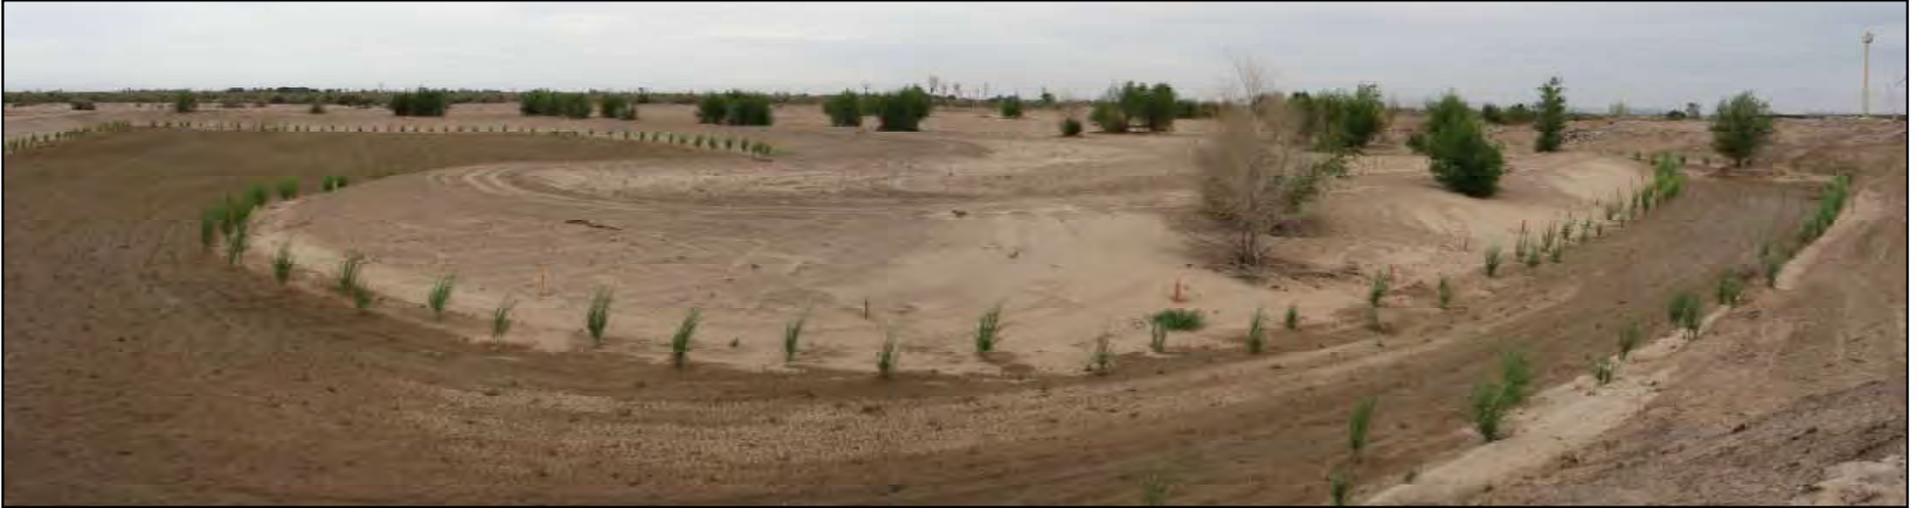
Hunter's Hole Photomonitoring Point #2. Looking northwest at cells 4 and 2 from the east side. 3 pics no zoom. April 2012.
N 32° 31'10.63" W 114 ° 48'04.24"

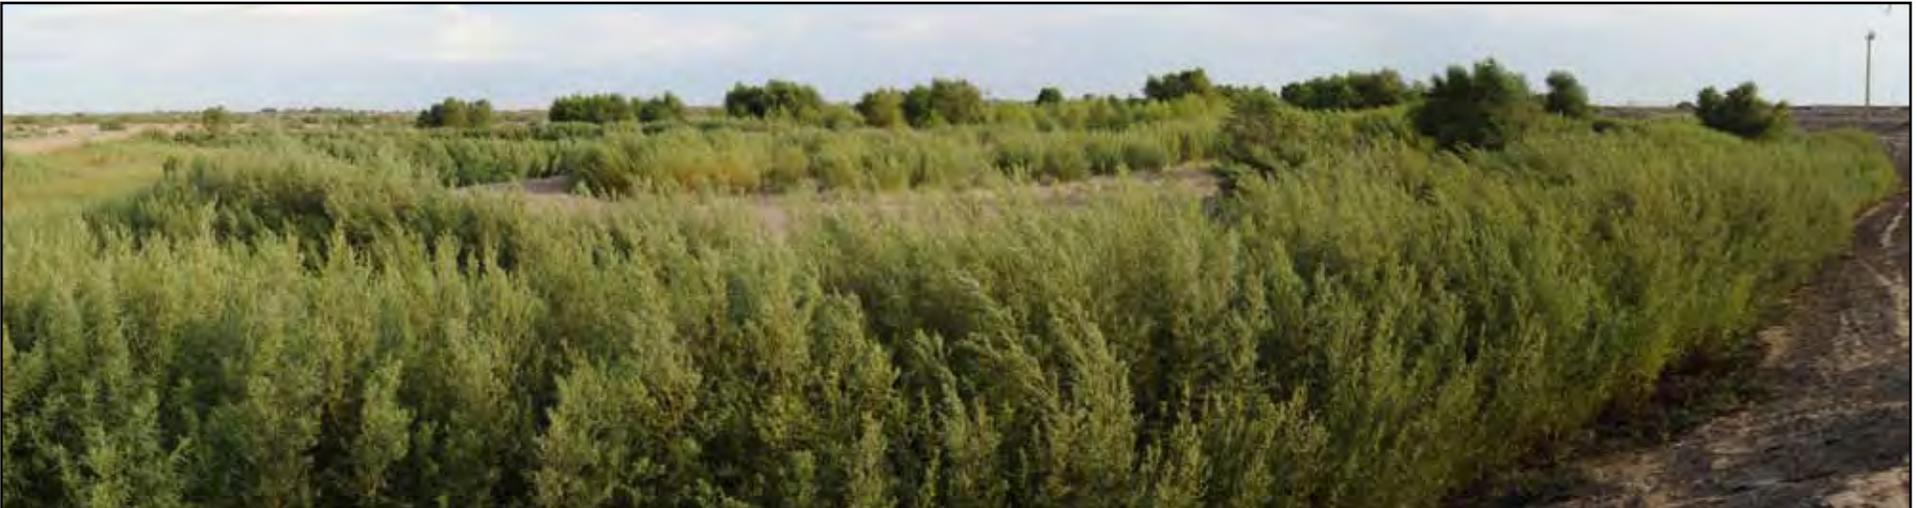
Hunter's Hole Photomonitoring Point #2. Looking northwest at cells 4 and 2 from the east side. 3 pics no zoom. July 2013.
N 32° 31'10.63" W 114 ° 48'04.24"

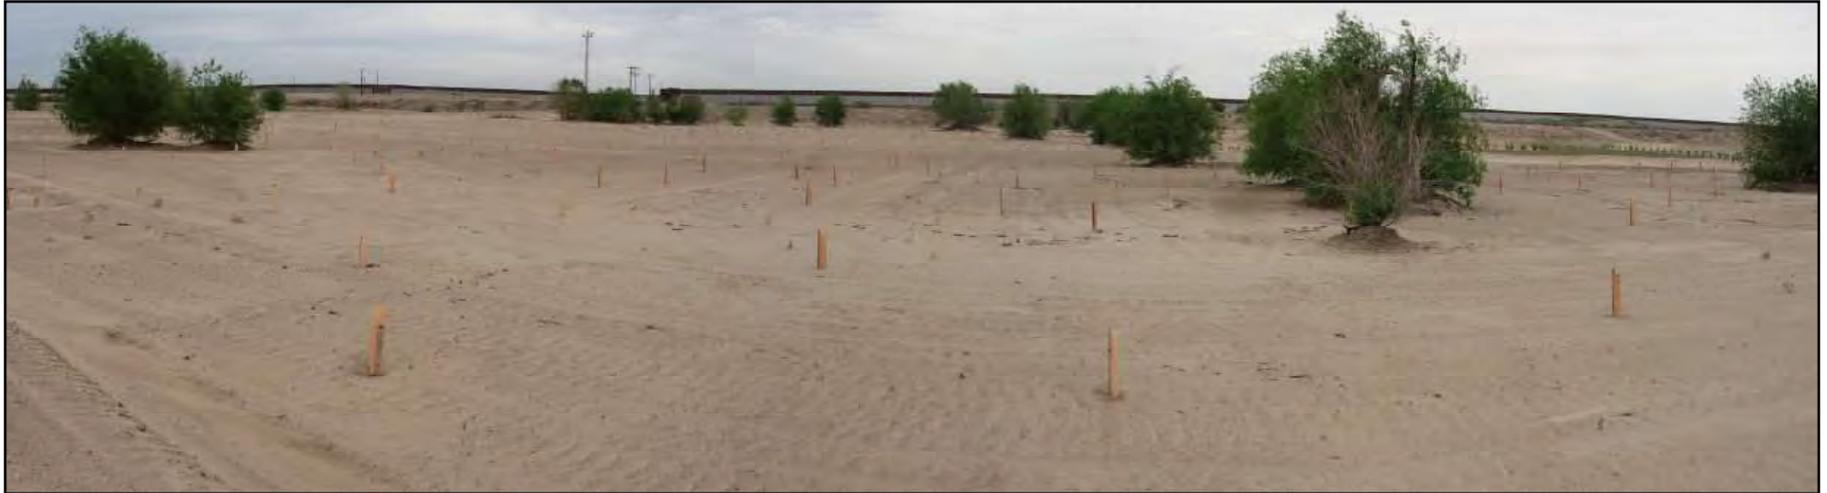
Hunter's Hole Photomonitoring Point #3. Looking east at cell 2 from the midpoint of the cell's boundary road. 3 pics no zoom.
April 2012. N 32° 31' 15.51" W 114° 48' 10.27"

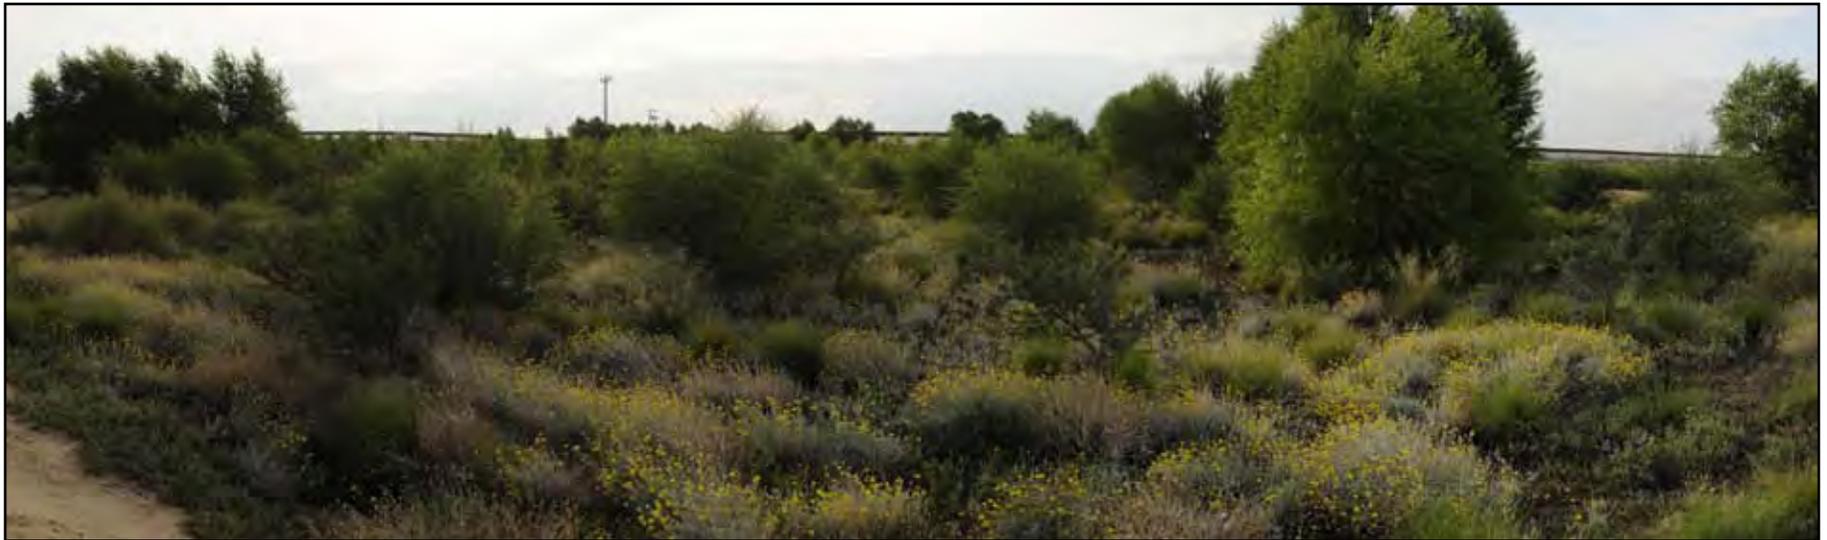
Hunter's Hole Photomonitoring Point #3. Looking east at cell 2 from the midpoint of the cell's boundary road. 3 pics no zoom.
July 2013. N 32° 31' 15.51" W 114° 48' 10.27"

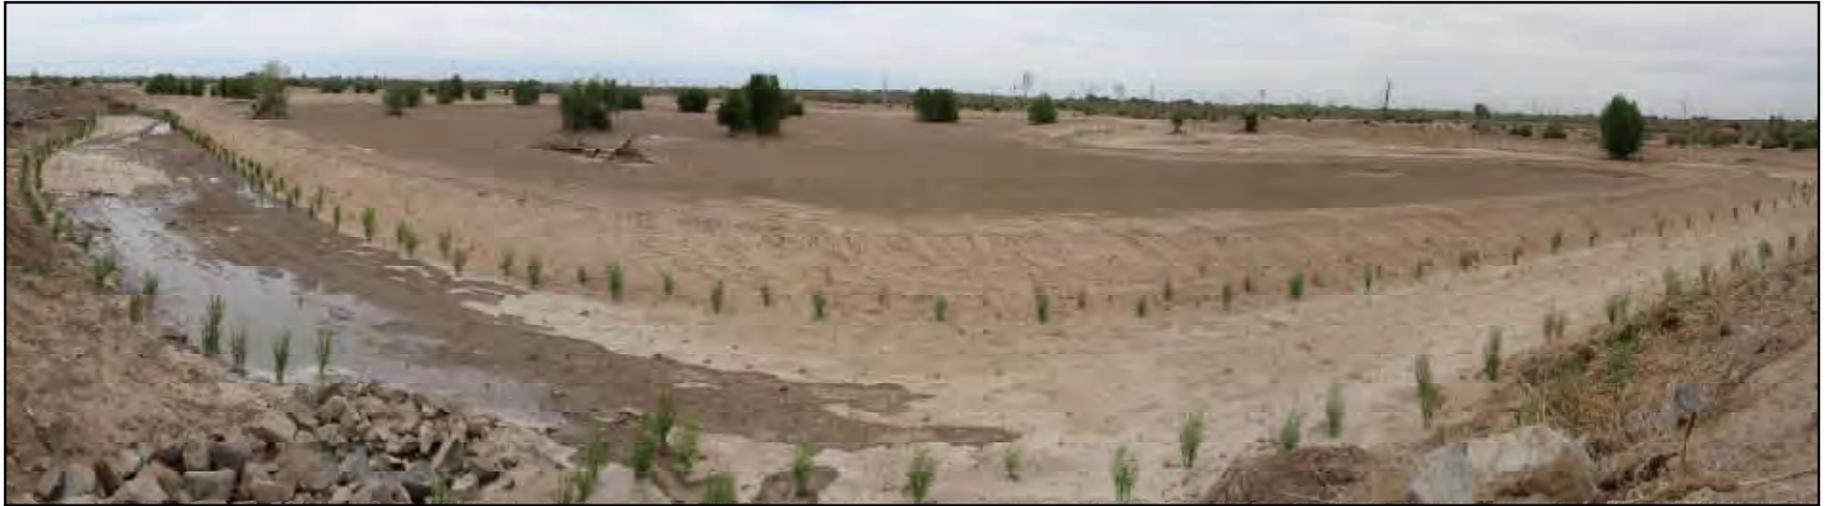
Hunter's Hole Photomonitoring Point #4. Looking northeast at cell 3 from the west boundary road. 3 pics no zoom. April 2012.
N 32° 31'21.64" W 114 ° 48'07.06"

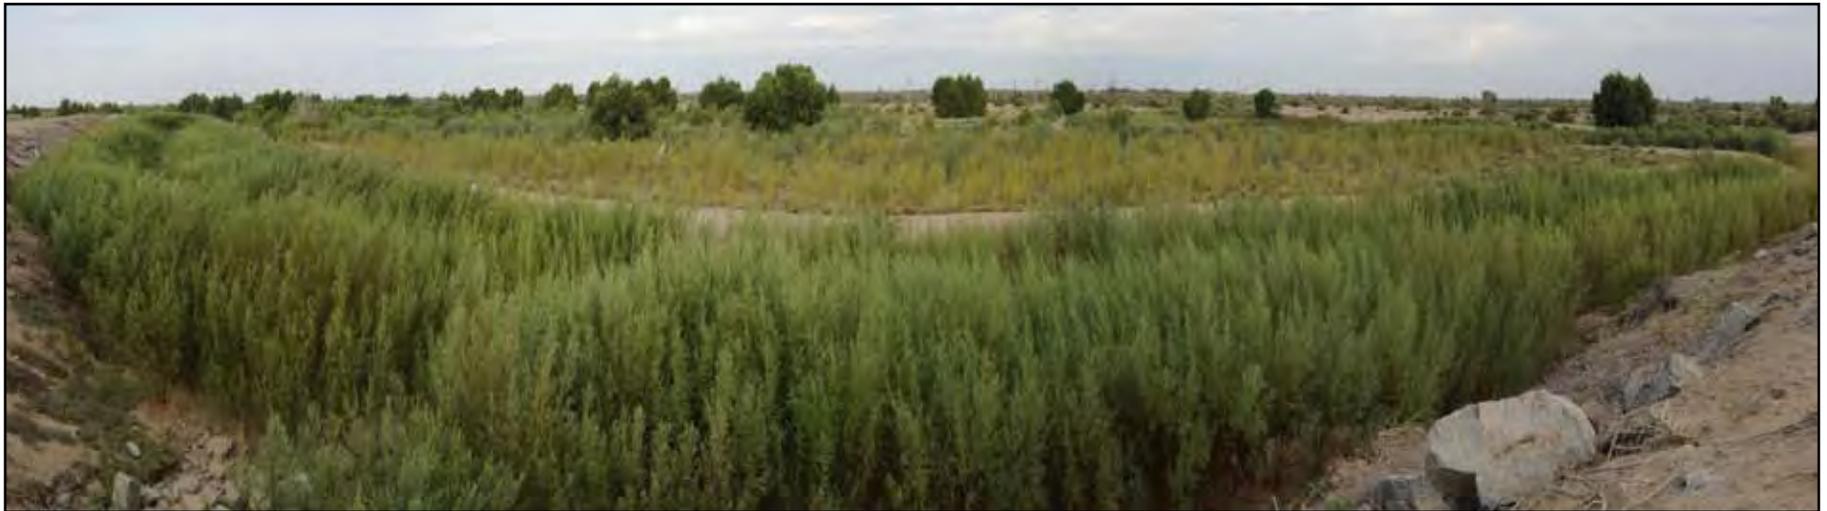
Hunter's Hole Photomonitoring Point #4. Looking northeast at cell 3 from the west boundary road. 4 pics no zoom. July 2013.
N 32° 31'21.64" W 114 ° 48'07.06"

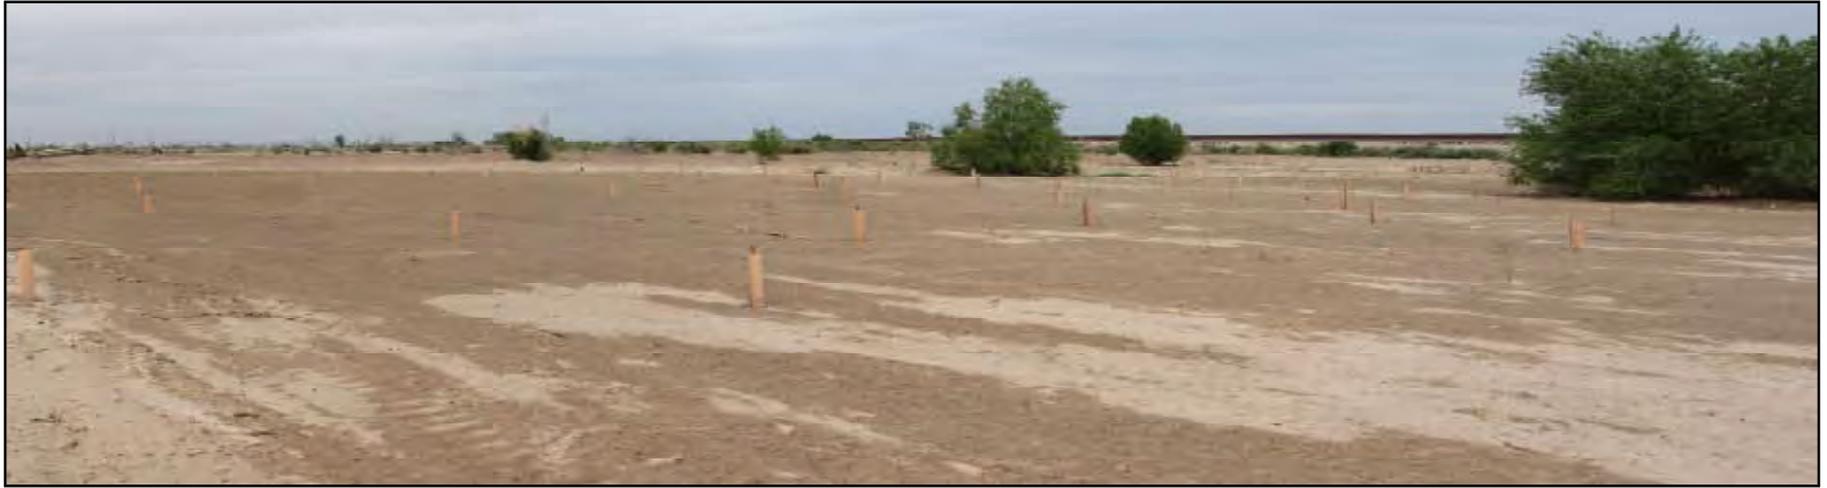
April 2012.

Hunter's Hole Photomonitoring Point #5. Looking west at cells 3 and 5 from the east boundary road. 3 pics no zoom.
N 32° 31'21.52" W 114 ° 47'59.44"

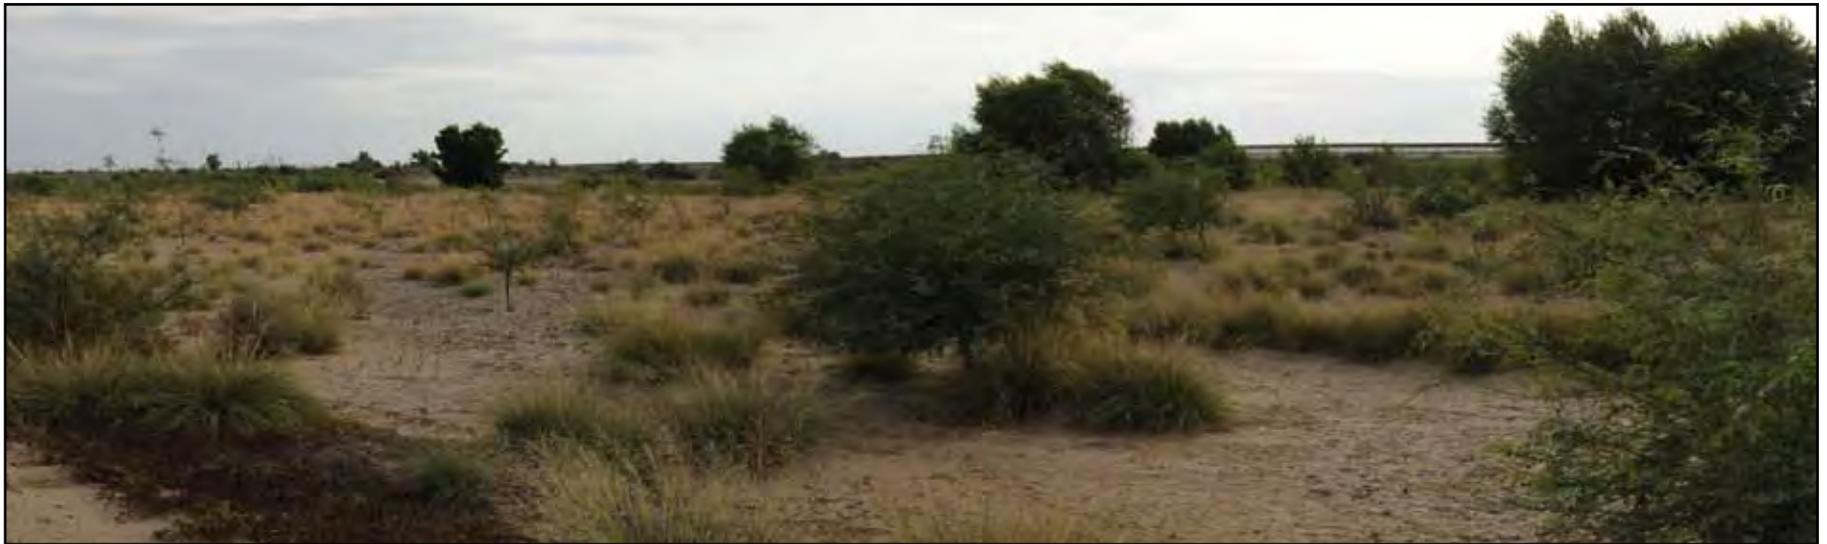
July 2013.

Hunter's Hole Photomonitoring Point #5. Looking west at cells 3 and 5 from the east boundary road. 3 pics no zoom.
N 32° 31'21.52" W 114 ° 47'59.44"
