**Arizona Water Protection Fund
Fairchild Draw Riparian Restoration Project
Grant No. 07-150WPF**

Final Report

Submitted by David Dorum
Arizona Game and Fish Department

December 31, 2011

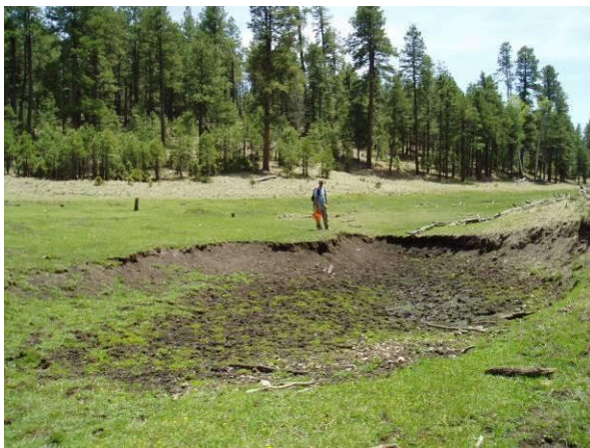
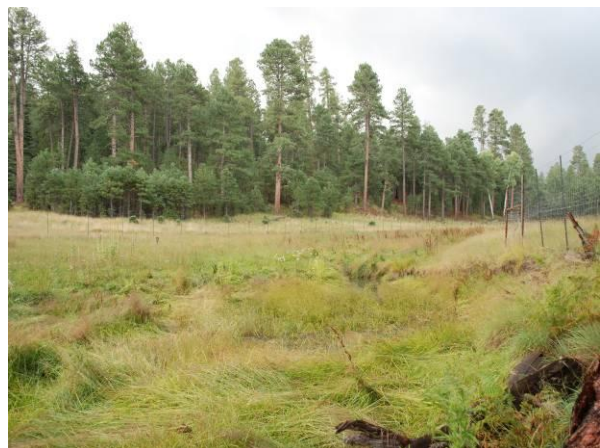
Figure 12. Proposed bank treatment area B1, May 2007 (left), and natural recovery September 2011 (right)

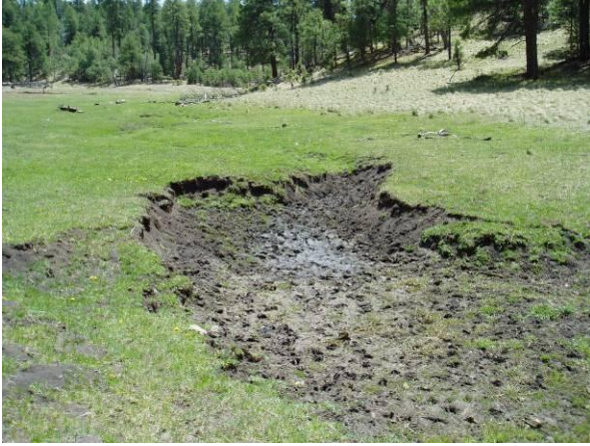
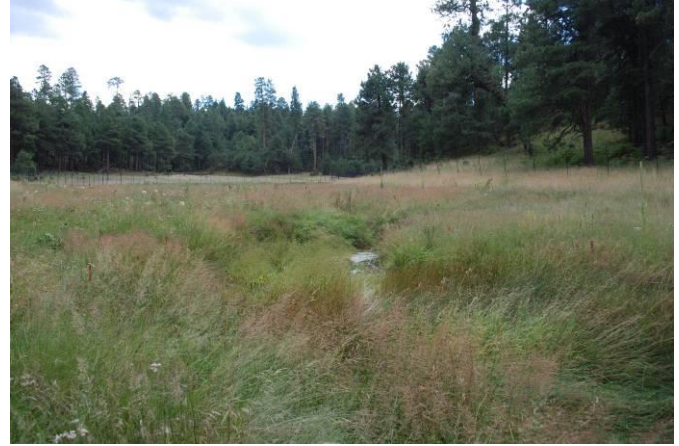
Figure 13. Proposed bank treatment area B2, May 2007 (left), and natural recovery September 2011 (right)

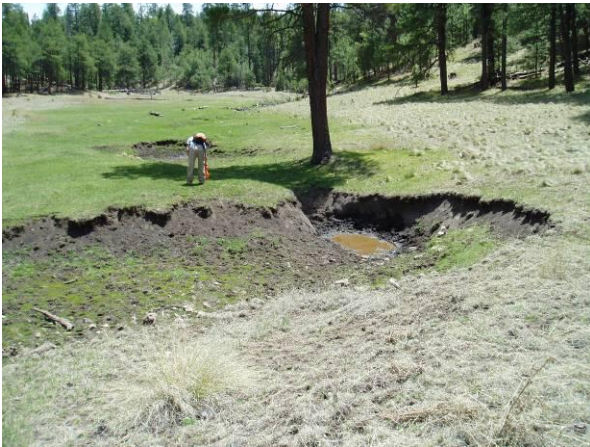
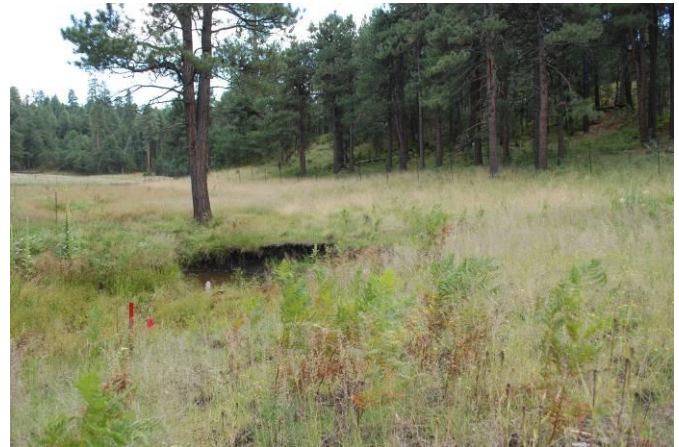
Figure 14. Proposed bank treatment area B3, May 2007 (left), and natural recovery September 2011 (right)

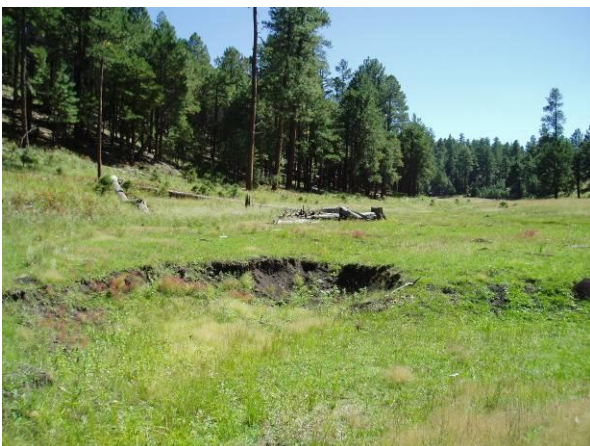
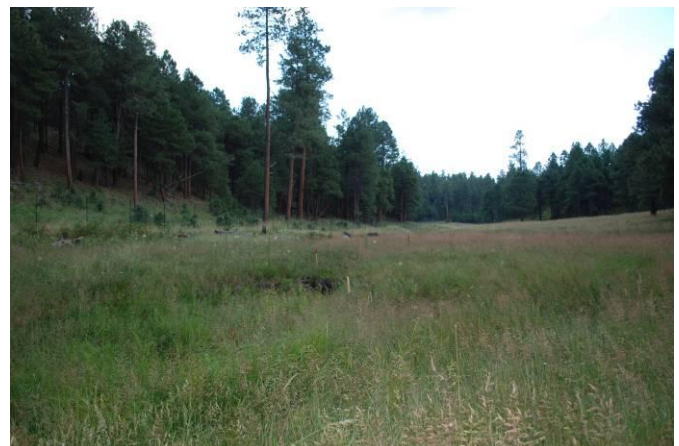
Figure 15. Proposed bank treatment area B4, September 2007 (left), and natural recovery September 2011 (right)

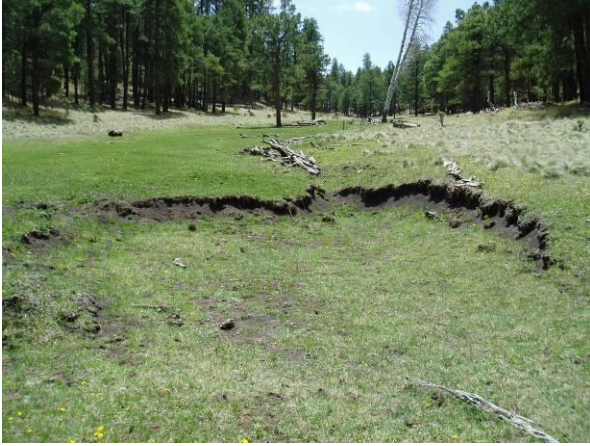
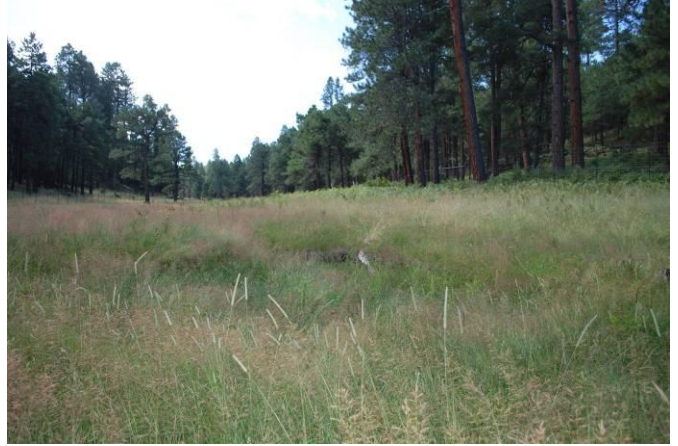
Figure 16. Proposed bank treatment area B5, May 2007 (left), and natural recovery September 2011 (right)

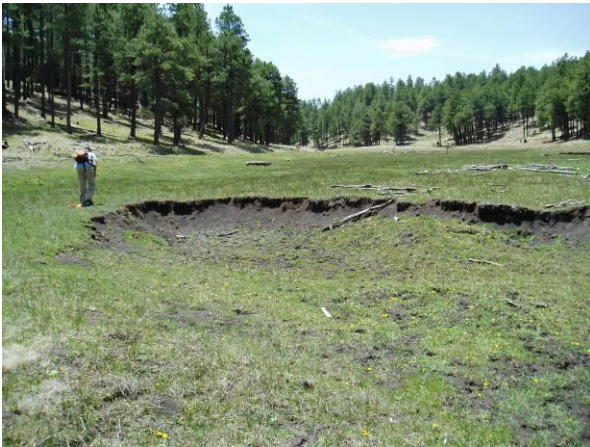
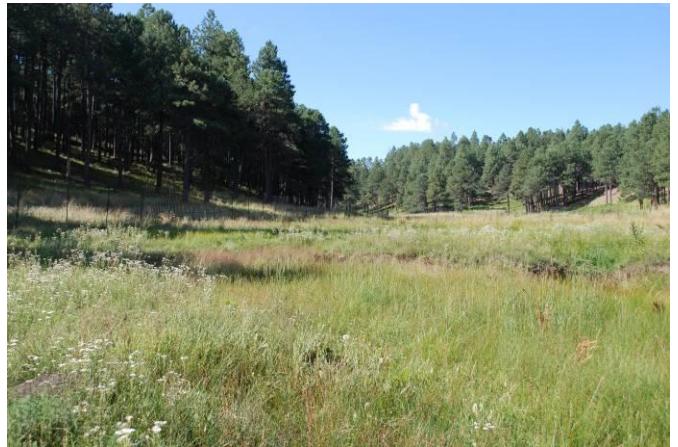
Figure 17. Proposed bank treatment area B5, May 2007 (left), and natural recovery September 2011 (right)

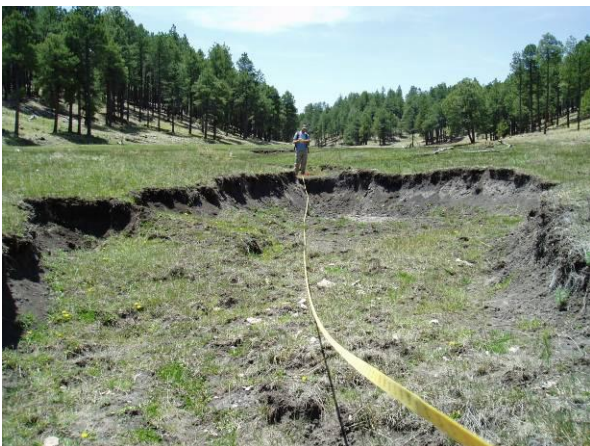
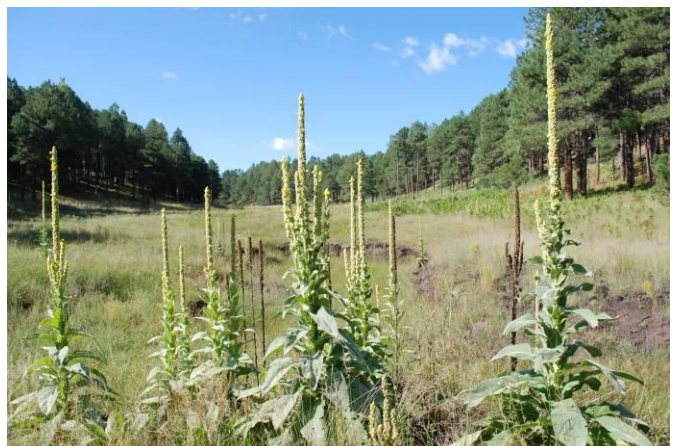
Figure 18. Proposed bank treatment area B5, May 2007 (left), and natural recovery September 2011 (right)

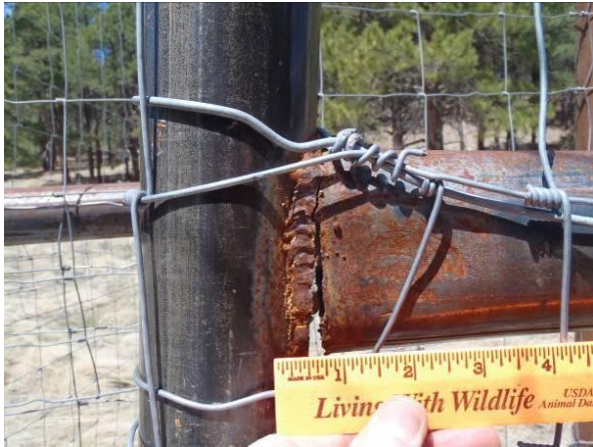
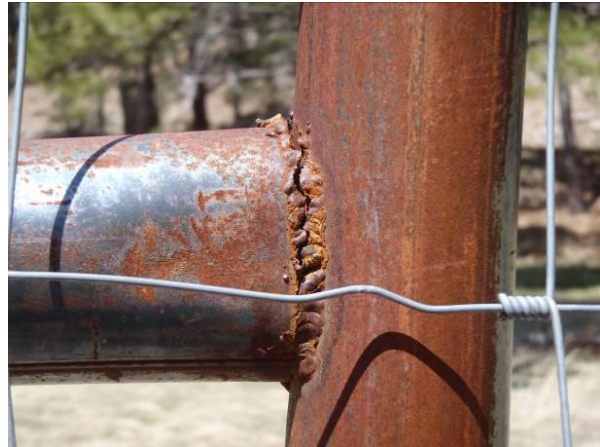
In 2011, enclosure fence condition monitoring was conducted on April 19 and September 8. The April monitoring showed continued expansion of the cracks in the H-braces that were noted in

2010. In total, eight welds showed signs of cracking (Figures 31 and 32). Due to concerns related to welding and wildfire risk, repair work was not performed until November 16th, after the first snow fall had fully ameliorated fire risk.

Figures 31 and 32. Cracked welds, April 2011.

Maintenance of the fence has consisted of removing two downed trees from the fence and repairing the damage that they had caused. The need for such activities had been expected, and is not considered to have been excessive. Of greater concern, however, is the cracking of the welds on the H-braces and the inward leaning of portions of the fence. Annual inspection of these welds and prompt repair will be key in maintaining the integrity of the fence.

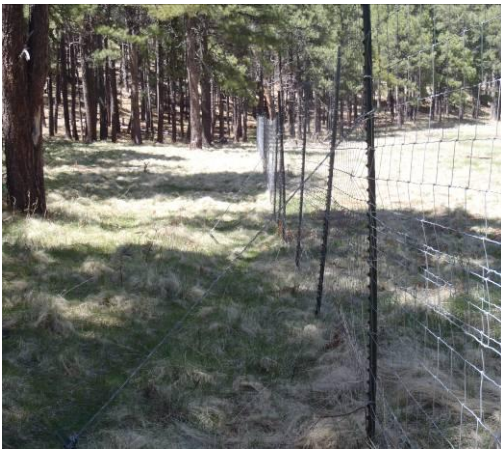
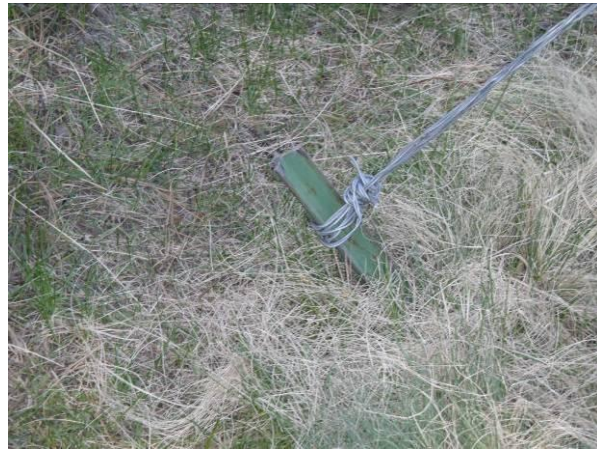
In addition, short segments of the fence began to lean inward. T-posts and fence wire were used to pull the fence segments back.

Figures 33 and 34. Leaning fence stabilization, April 2011.

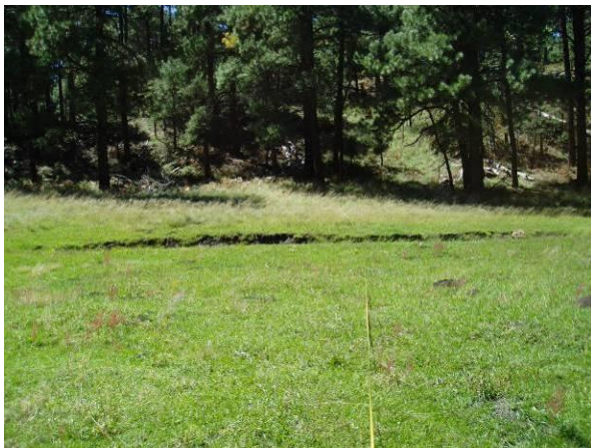
Plant vigor, as measured by plant height, increased dramatically from that measured during the baseline monitoring. Table 1 summarizes plant height data for each of the five transects, from the baseline monitoring data collected in 2007 through the 2011 annual monitoring. Average plant height for all herbaceous species measured was 47.4 cm in 2011 compared to just 5.1 cm in 2007. Plant height continued to increase each year following construction of the fence. Figures 37 through 39 help illustrate the rapid response of the herbaceous plant community.

Figure 37. Transect 2A, September 2007.

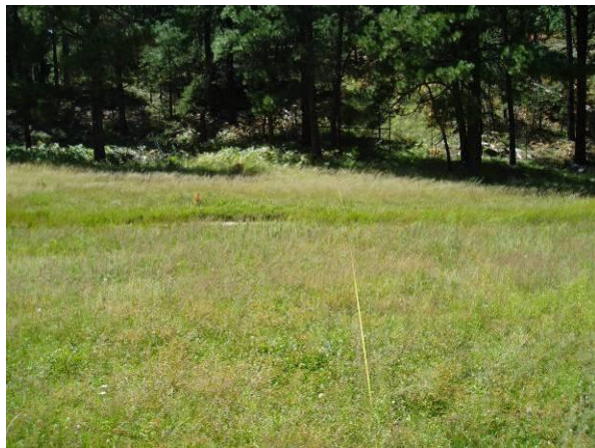
Figure 38. Transect 2A, September 2008.

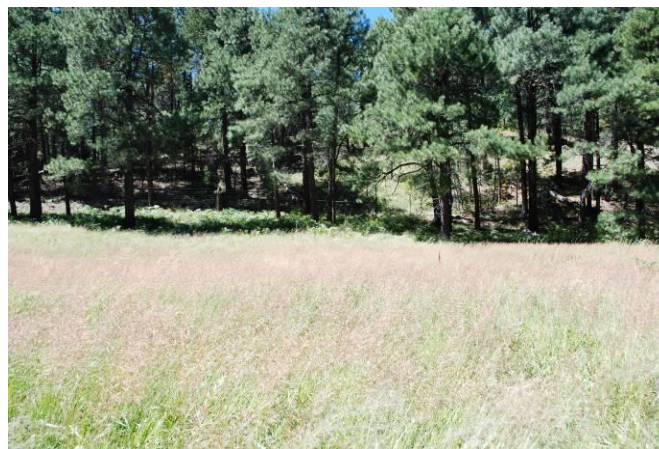
Figure 39. Transect 2A, September 2010.

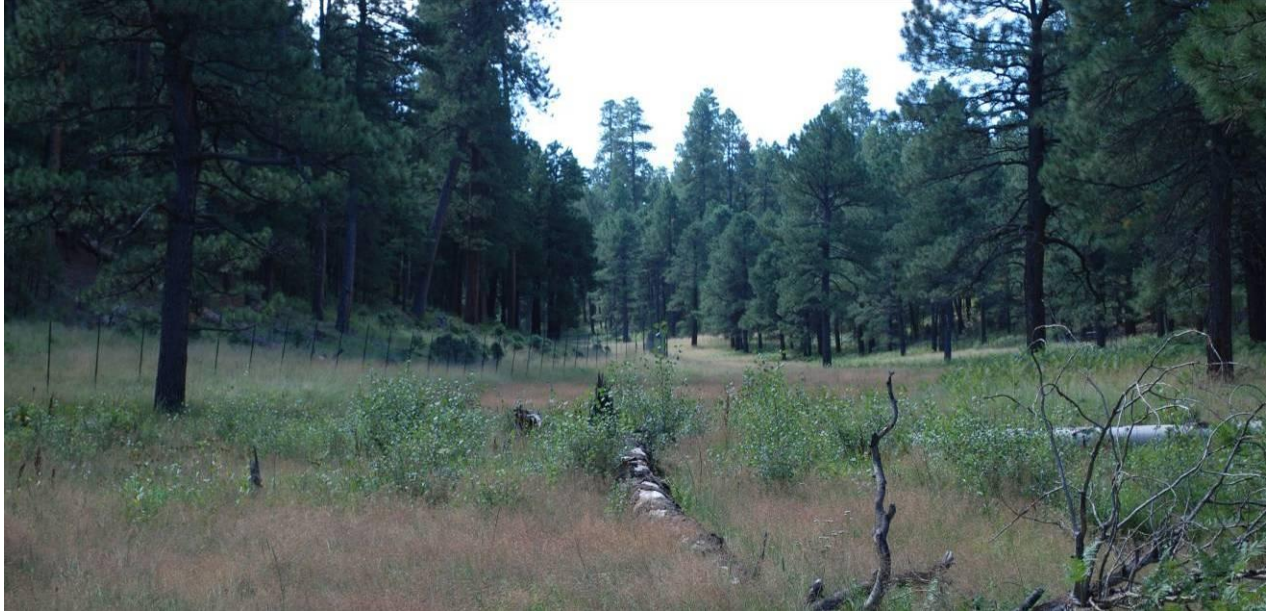
As was expected, successful aspen recruitment occurred following completion of the enclosure fence. Aspen shoots were recorded during the 2008 monitoring, which was within two months following completion of the enclosure fence. A similar response of aspen was not noted outside of the enclosure fence.

Figure 41. Aspen recruitment, September 2011

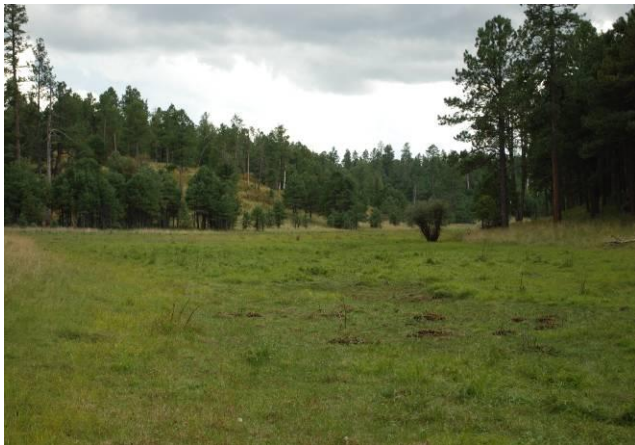
The impacts of elk and cattle on the meadow within the Upper Fairchild Draw enclosure were dramatic, and highlight the need for continued long-term maintenance of these enclosure fences under current forest, livestock, and elk management. Figures 48 through 51 show the impacts from ungulate access to the Upper Fairchild Draw Restoration project area. Photos were taken in September 2011.

Figure 48. General view of grazed meadow

Elk Exclosure Fence Maintenance: As the Upper Fairchild Draw Restoration Project has shown (see discussion above), maintenance of exclosure fences should be considered as a likely long-term undertaking. Although site-specific conditions vary from location to location, allowing elk and especially livestock to access formally protected wet meadows will result in at least some level of site degradation. If the continued protection of young browse species, such as willow and aspen are not of concern, an eventual transition from a dual purpose elk and livestock exclosure to a livestock only exclosure should be considered as a longer-term, if not permanent solution. This will minimize ongoing expense and time commitments for fence maintenance, reduce visual impacts resulting from an eight-foot high exclosure fence, and allow greater use by a more diverse assemblage of wildlife species and the public, while still offering significant protection to the financial investment made as well as the natural resources of the wet meadow.

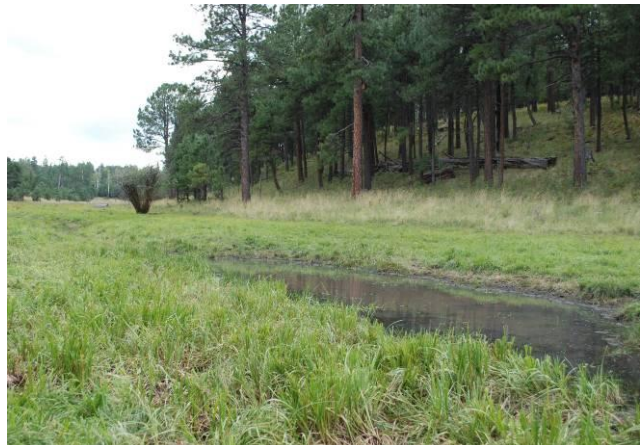
Figure 49. Grazed sedge

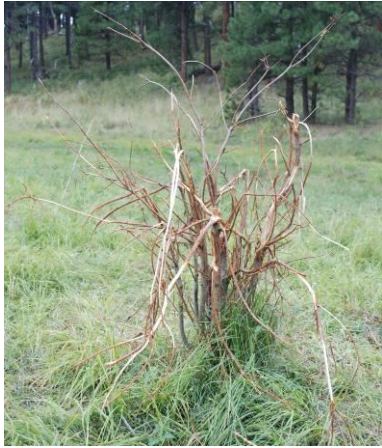
Figure 50. Browsed Bebb's willow
