FINAL REPORT

CONTRACT NUMBER 11-177WPF
August 30, 2013

Arizona Water Protection Fund By the Gila Watershed Partnership of Arizona 711 S. 14th Avenue Safford, Arizona 85546

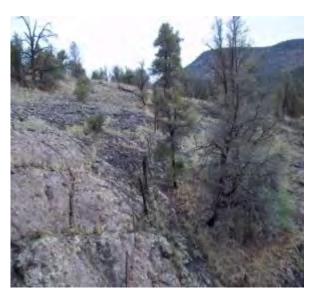
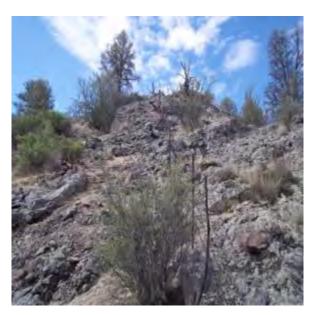
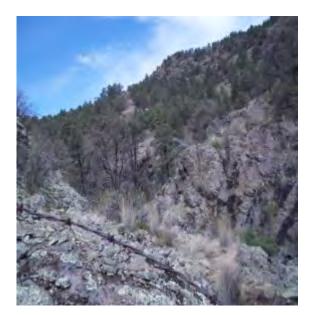
PHOTO POINT #1 DATE: 06/08/2013 DIRECTION: N&E&S&W

NOTES: Northern start of fence

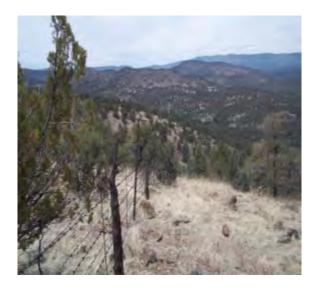
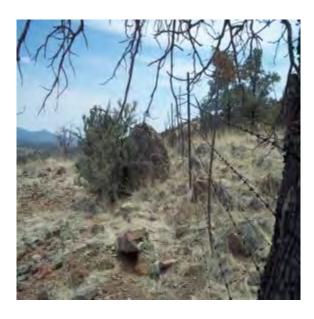
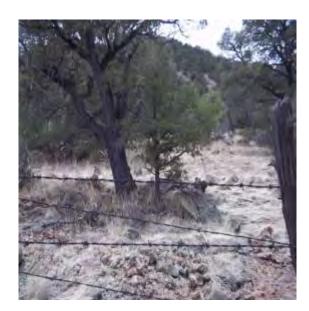
PHOTO POINT # 7 DATE: 06/8/2013 DIRECTION: N&E&S&W

NOTES: North start by Wet Prong

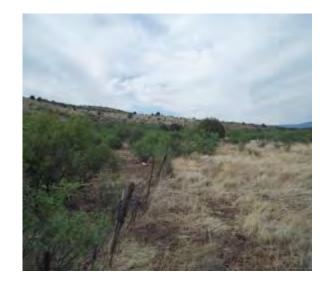
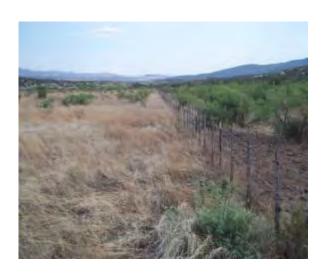
PHOTO POINT # 19 DATE: 06/08/2013 DIRECTION: N&E&S&W

NOTES: Northern Corner of 7 + A Ranch & Southern End of Fence

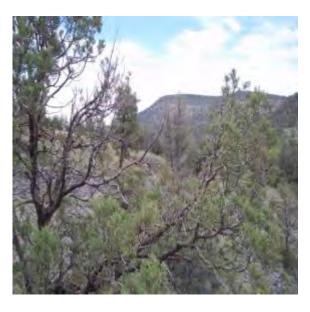
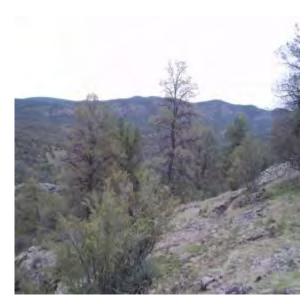
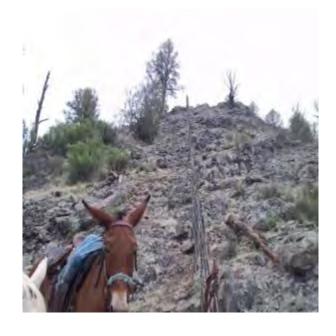
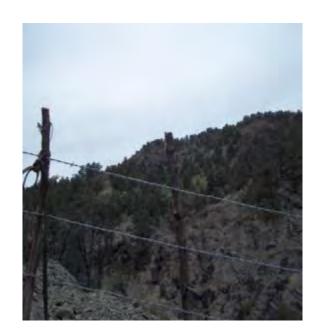
NOTES: Northern start of fence

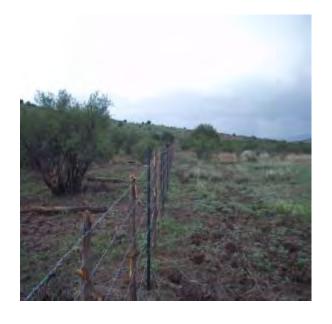
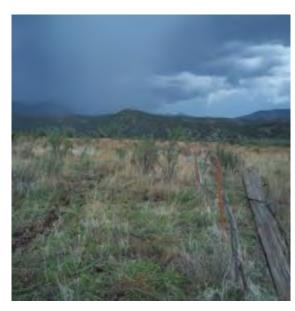
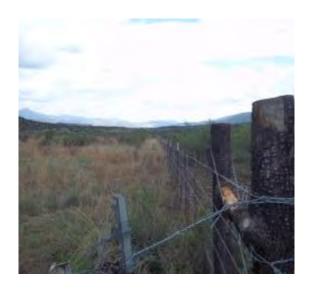
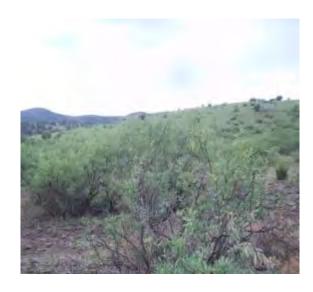
PHOTO POINT #19 DATE: 07/20/2013 DIRECTION: N&E&S&W

NOTES: Northern Corner of 7 + A Ranch & Southern End of Fence

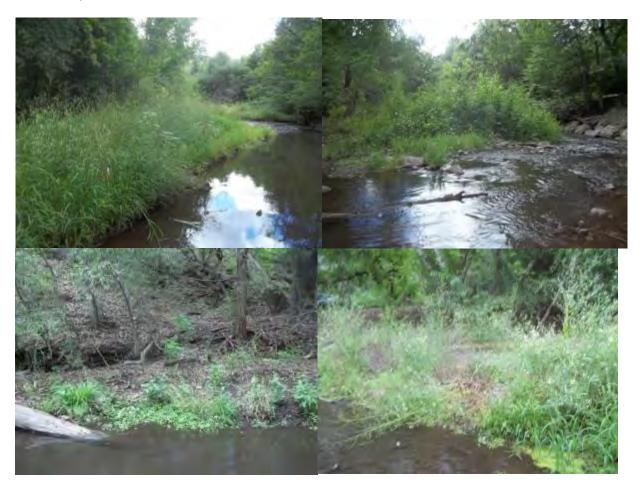
Site: Above Honeymoon Campground (prior site below campground was not accessible because workers were removing a fallen tree on the road at the site)

Colilert result: 93.2 colony forming units (cfu), most probable number (mpn)

Turbidity: 12.0 pH: 7.2 Air temp: 27 C Water temp: 25 C

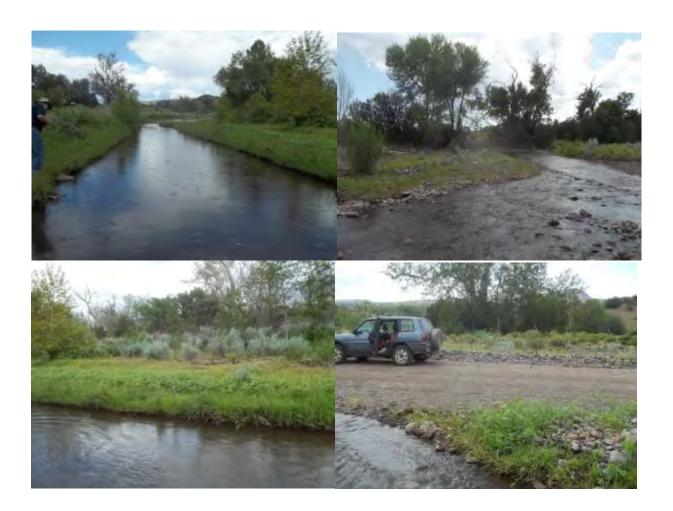
Site: First Crossing (above Big Dry Creek)

Colilert result: 73.3 colony forming units (cfu), most probable number (mpn)

Turbidity: 18.4 pH: 7.8 Air temp: 26 C Water temp: 26 C

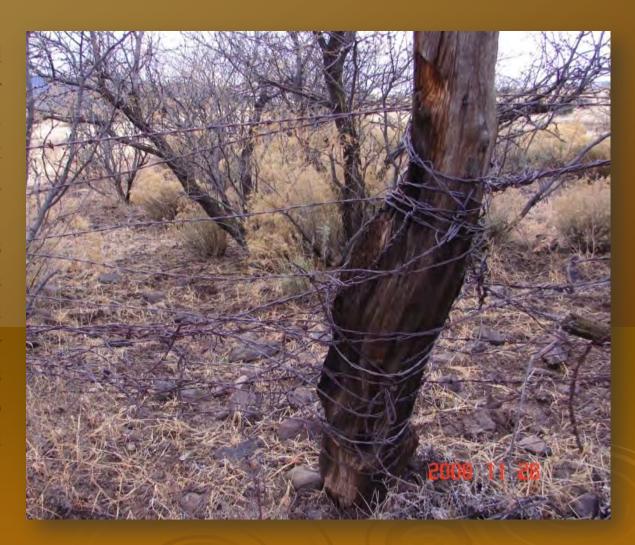
The original fence was over fifty years old. Livestock fences have a useful life of 25 years. This one was in disrepair and no longer functioning as a barrier to vehicles and cattle.
